INSPECTION REPORT
15 Rolling River Drive
The Haven
Bluffton SC

INSPECTED BY
Mark Johnson
Blue Water Home
Services, LLC
SC RBI 48768

INSPECTION DATE
📅 5/5/2026
🕒 12:00 PM

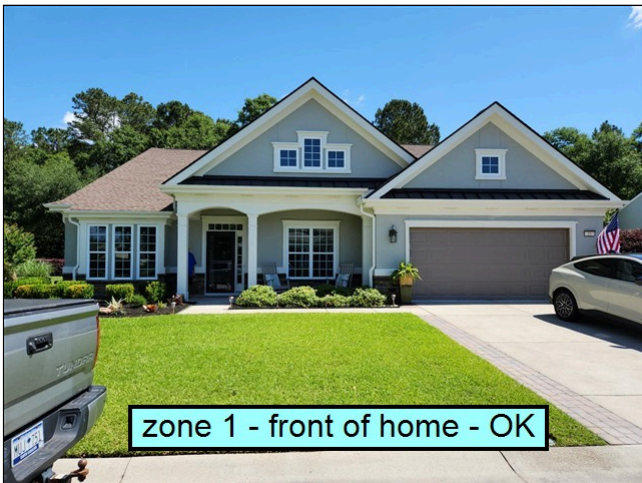
2.0 Item 1 (Picture)

Zone 1 - Front of home

Scanning Results (non-invasive): OK

Readings with wall scanner were within acceptable range, and no anomalies were detected with Thermal Camera.

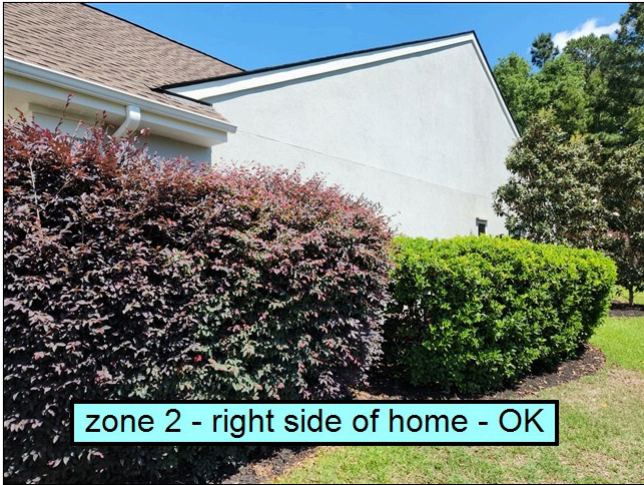
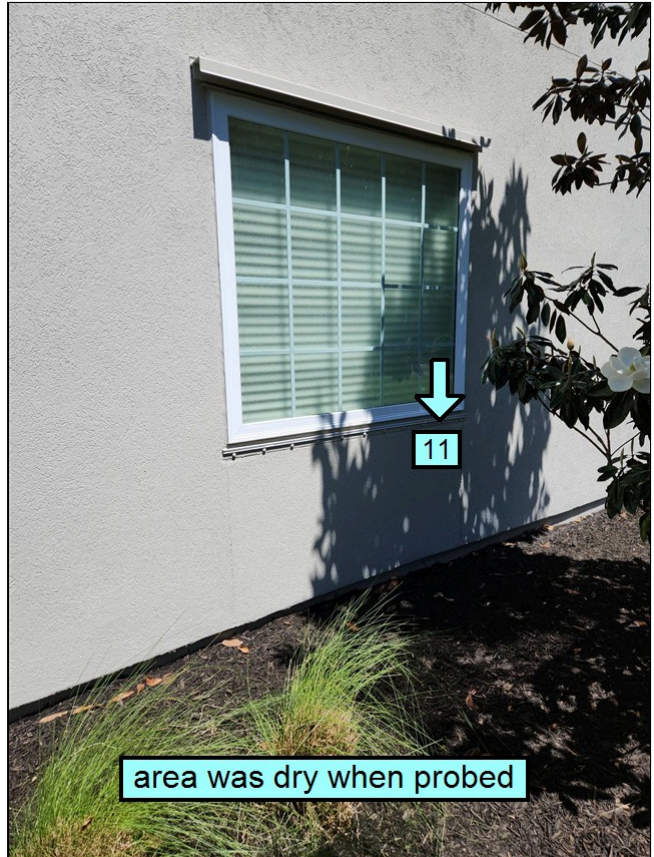
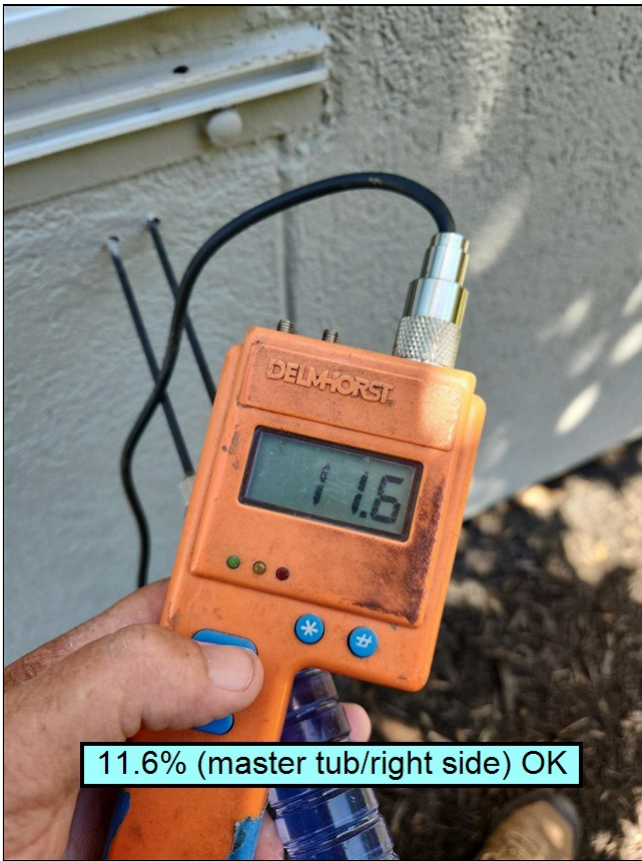
Zone 2 - Right side of home

Invasive Probing Results: OK

- Beneath right side of master tub window @ 11.6% (**FIRM**)

- L/R sides of master toilet window - 1/2" - **FIRM**

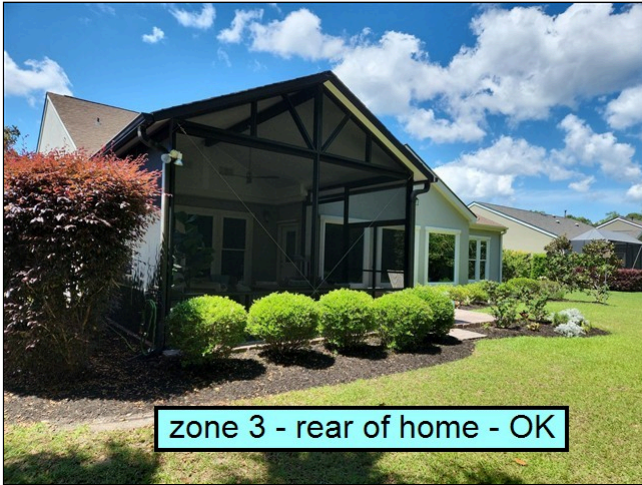
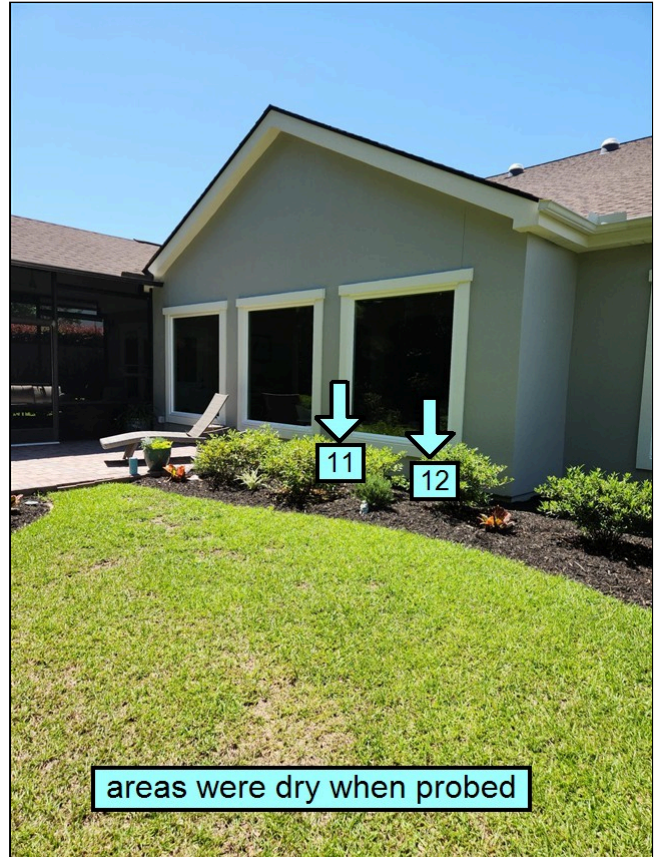
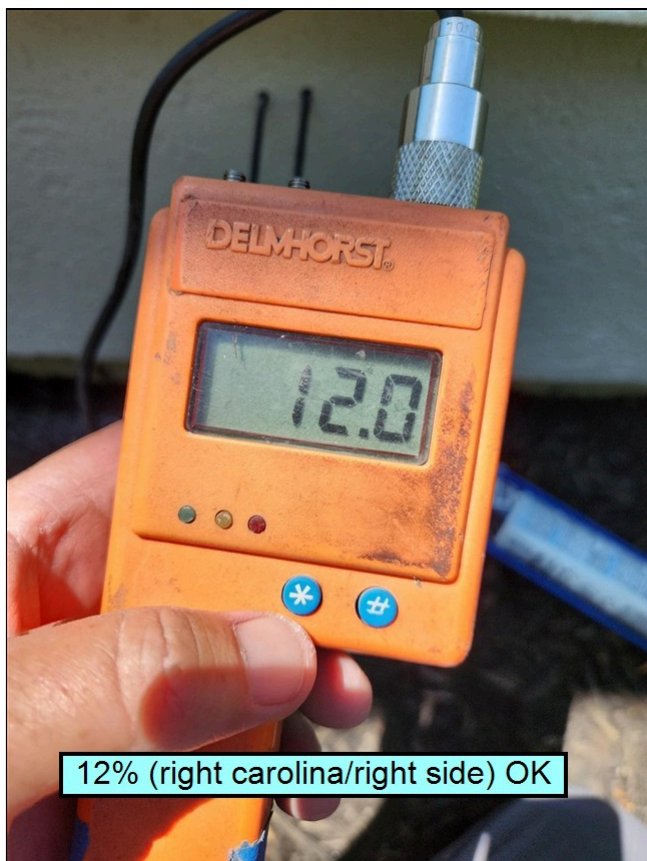
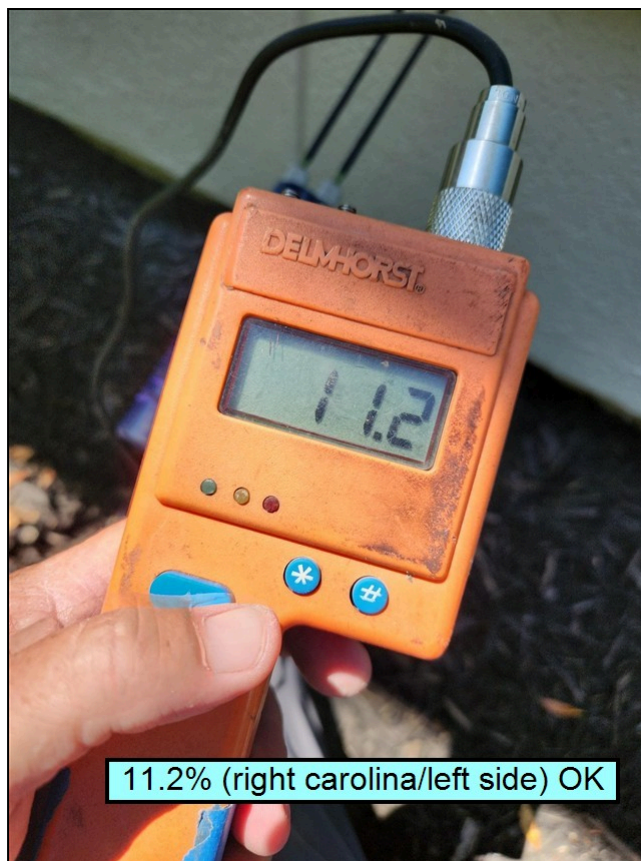
Zone 3 - Rear of home

Invasive Probing Results: OK

- Beneath left/right sides of right carolina room window @ 11-12% (**FIRM**)

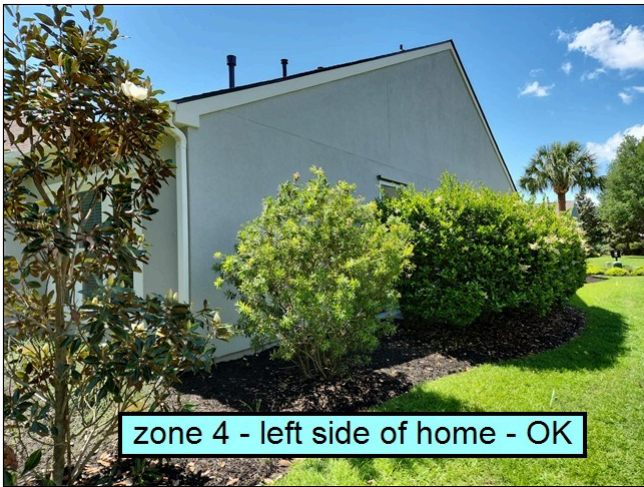
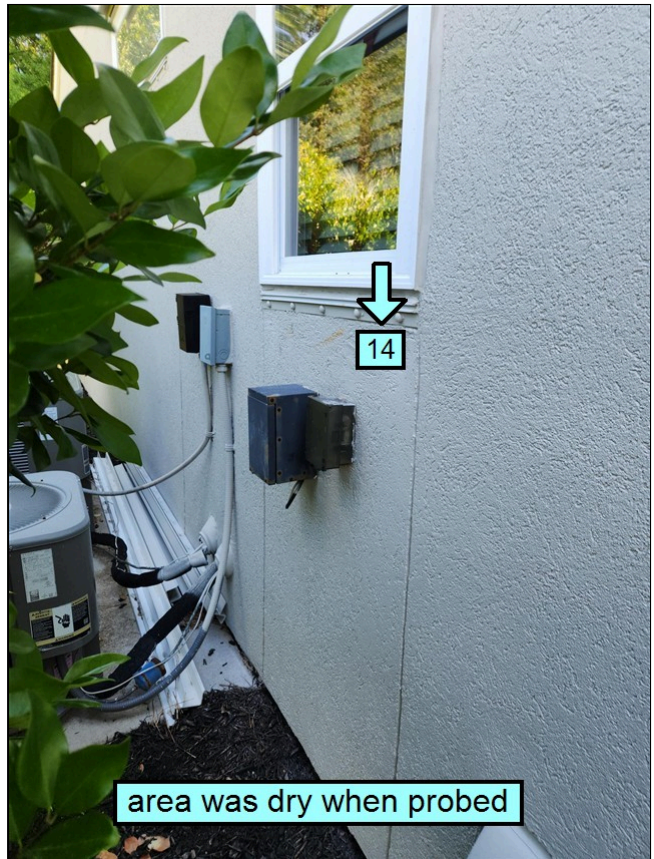
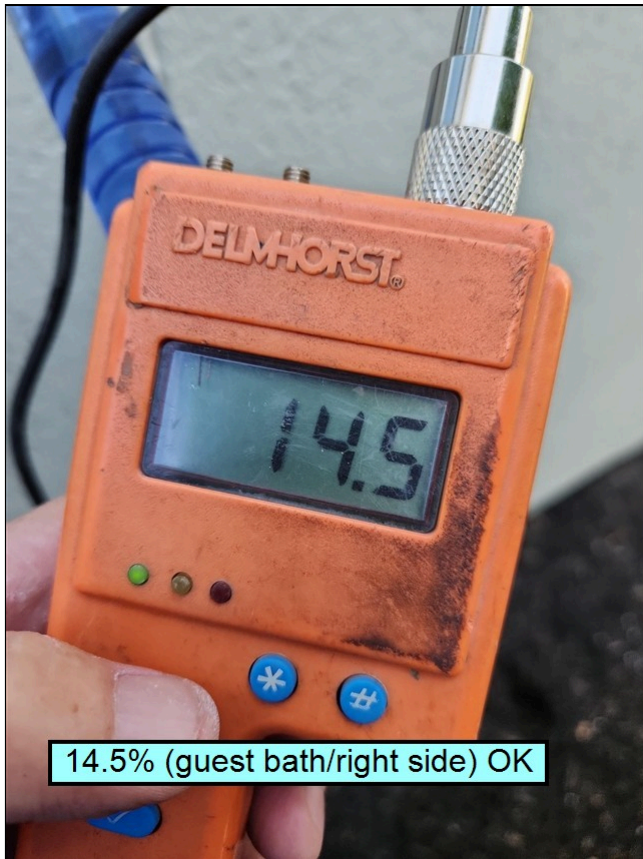
Zone 4 - Left side of home

Invasive Probing Results: OK

- Beneath right side of guest bathroom toilet window @ 14.5% (**FIRM**)

- Left side of bathroom toilet window - 1/2" - **FIRM**
- L/R sides of both forward bedroom windows - 1/2" - **FIRM**
