# HMHendrick Enterprises, Inc.

Heath M. Hendrick, PE

July 28, 2024

Re: 319 Park Avenue, Sanford NC - Structural observation and assessment re: existing foundation and proposed remediation

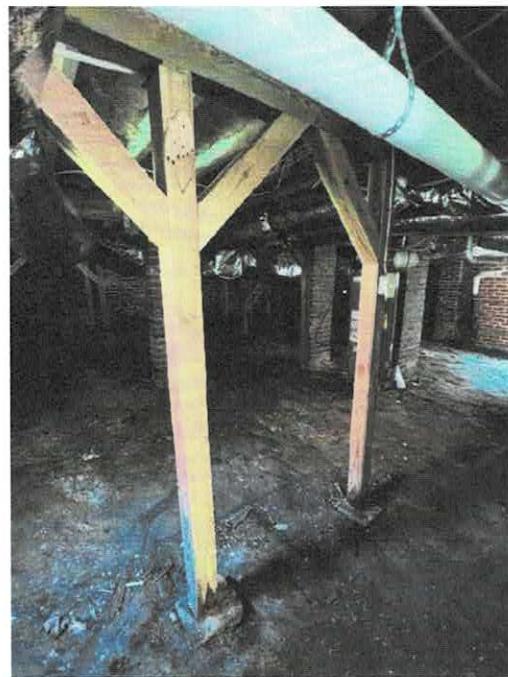
**Site Photo 1:** "Existing/ original" intermediate joist support.

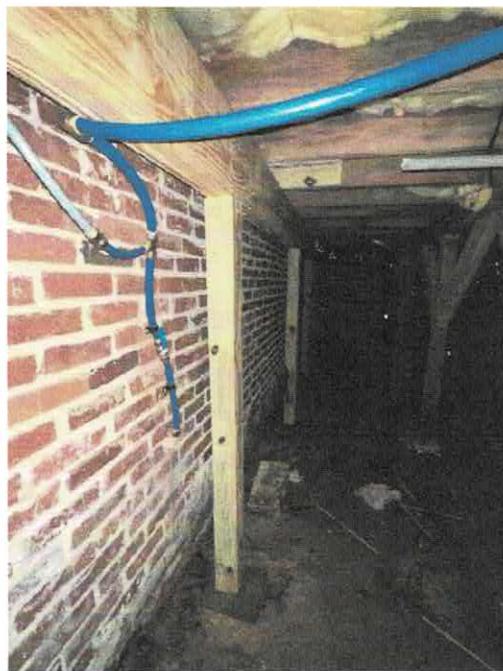
To remedy this issue, a new support line, consisting of a double 2x10 girder w/ 4x4 support posts had been installed approximately 12" off of the wall, to provide a new line of primary support to the joists in question, and reduce/ remove the bearing load along the foundation wall. The new posts were supported by masonry pavers to spread the load to the compacted soil below, similar to the other/ existing intermediate supports constructed under the house.

Upon my observations, this construction/ configuration is structurally sound, and provides adequate permanent support for the primary floor of the home, and is in adherence with the requirements of the current North Carolina Residential Building Code, for foundations and foundation support. With that said, while the existing wood support posts are sound in their current condition, discoloration was noted at their base which signifies direct exposure to moisture/ moisture transfer through the foundation below. The wood was probed and did not

display signs of decomposition at the time of observation, however prevention/ mitigation of the localized moisture in the area is recommended.

**Site Photo 2:** "New" joist support girder line at joist bearing end closes to Park Ave.

**Recommendation:** It is to be noted that all wood framing is subject to damage and decomposition through continued exposure to moisture, insects, and UV. Given the location of the framing in question, UV is not a concern in this case, but the damp nature of a crawlspace is. It is highly recommended that a continuous vapor barrier be installed to limit ground driven moisture from driving up high humidity in the crawl space, which both encourages decomposition of the wood fibers, as well as creates an environment for wood destroying pests/insects. Once a vapor barrier is installed, it is also recommended that the native humidity be monitored and if it remains high, additional dehumidification measures be taken as appropriate. With these recommendation in place, it is to be noted that the existing structure as observed, is sound with no apparent cause for structural concern in its current condition, however the recommended measures outlined above will ensure that this remains the case in the long-term.

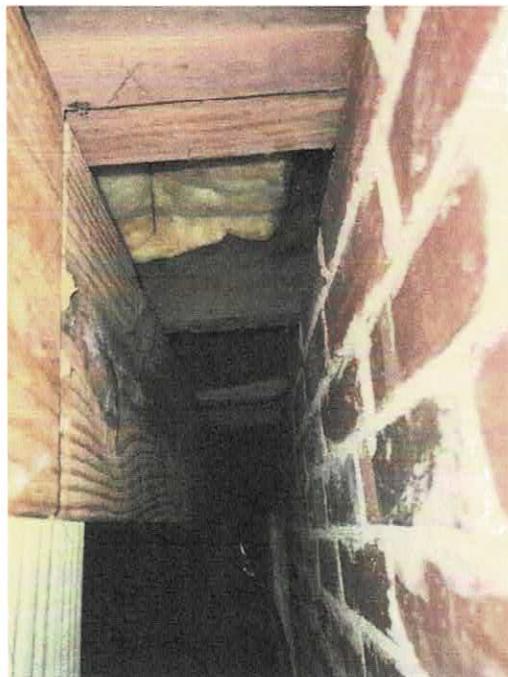
**Site Photo 3:** “New” joist support girder line at joist bearing end closes to Park Ave.
