Jeffrey J. Moss, P.E.
Senior Structural Engineer

Re: Structural Investigation
319 Park Avenue
Sanford, NC 27330
Project #24177

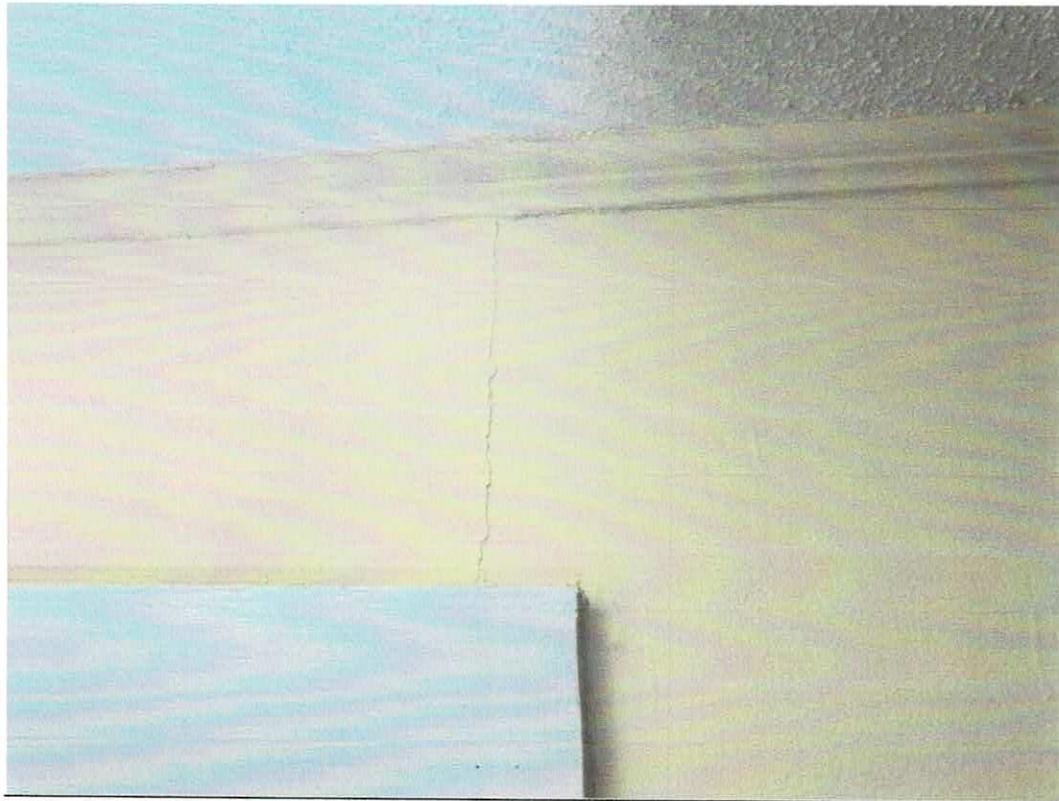
PHOTO 1

- There was a minor drywall crack that is not a structural issue (photo 1).
- The roof sheathing had some cracks (photo 2).
- There was no access to the rear attic space (photos 3 & 4).

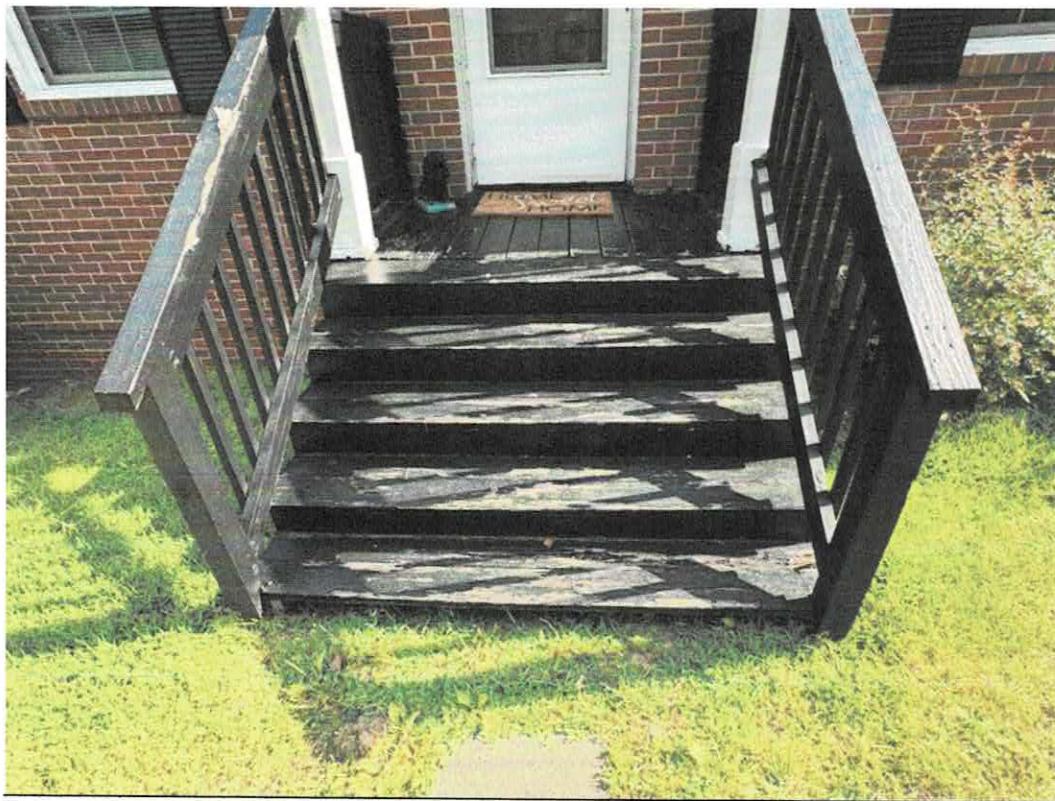
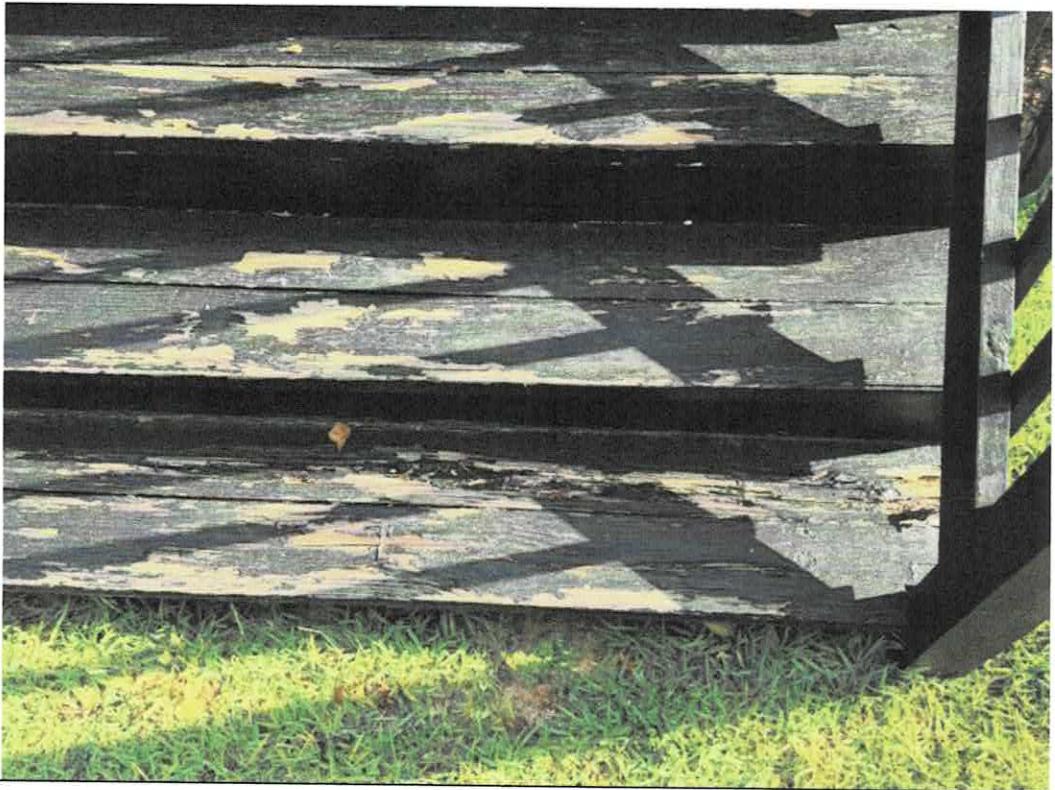
- The front steps had wood rot (photos 5 & 6).
- There was a crack in the brick façade at the left side (photos 7 & 8).
- The mortar at the rear wall was loose (photos 9, 10 & 11).
- There were no joist hangers at the rear deck and steps (photos 12 & 13).

- Repair the wood rot at the front steps.
- Repair the brick cracks and loose mortar at the perimeter by repointing the brick joints.
- Provide joist hangers at the rear steps and landing.
- Remove and replace the rear stair handrail.
- Remove the temporary support and provide a permanent support at the sun room.

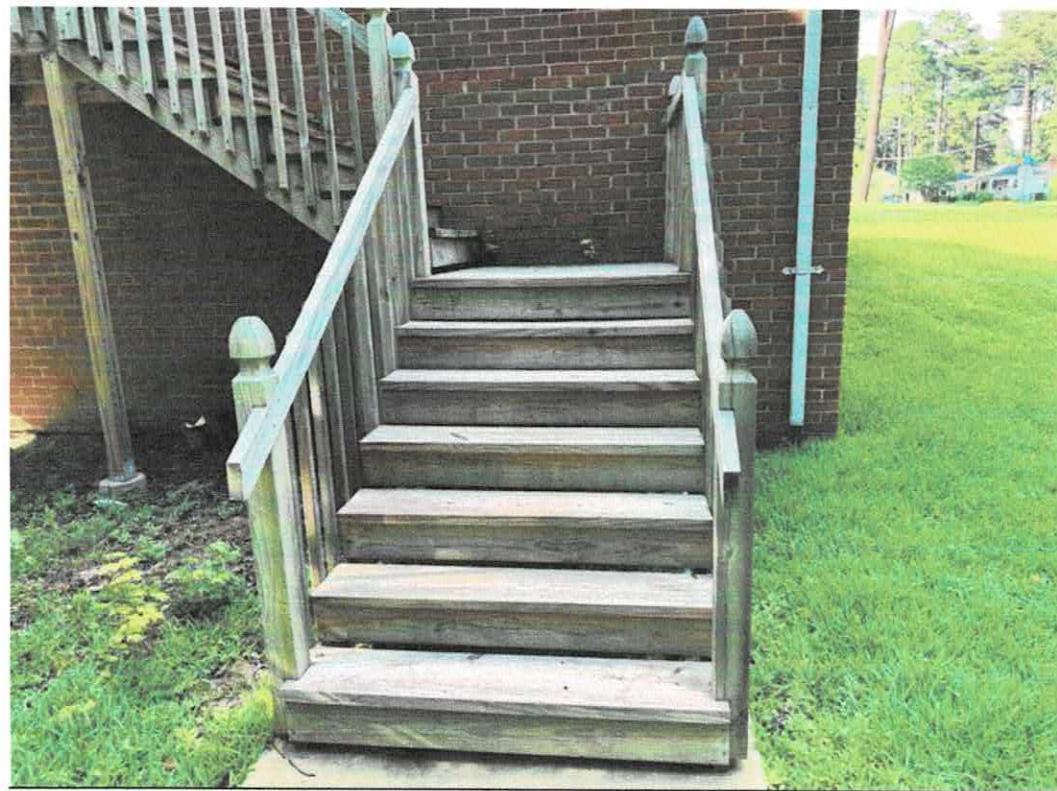
PHOTO 14

- The handrails at the rear steps were loose (photo 14).
- There was a repair to the floor of the sunroom at the top of the stairs that was not standard (photos 15 to 17).
- There was a crack in the brick façade at the right side (photos 18 & 19).

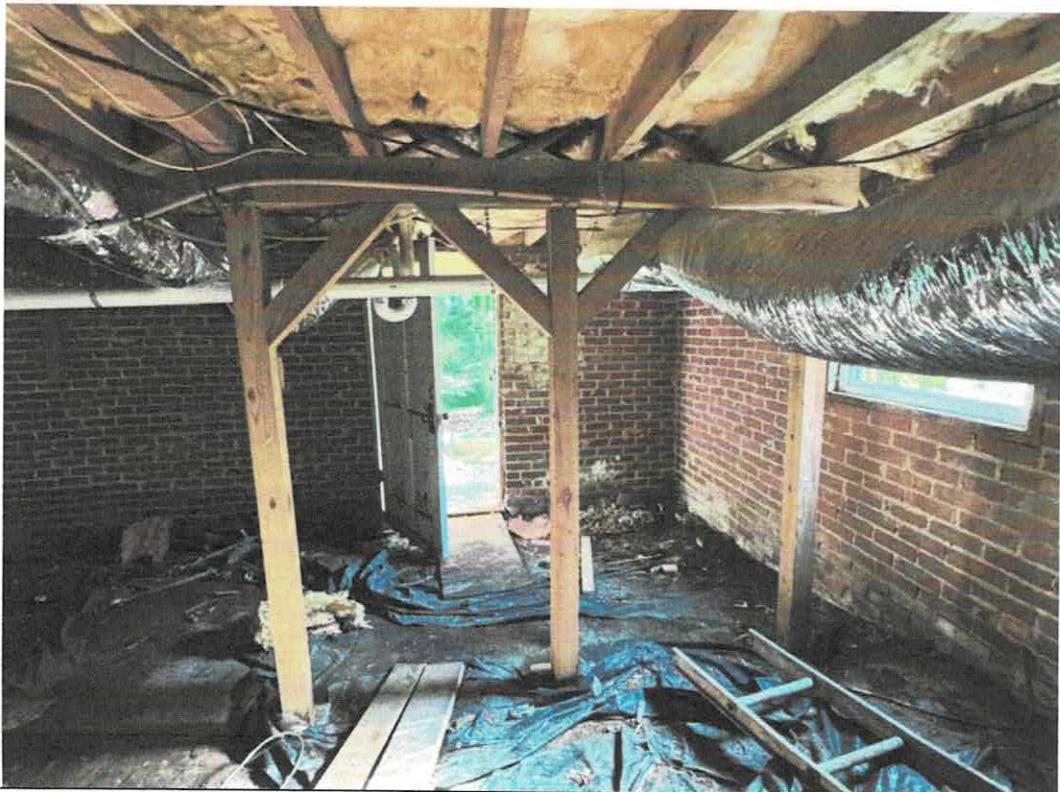
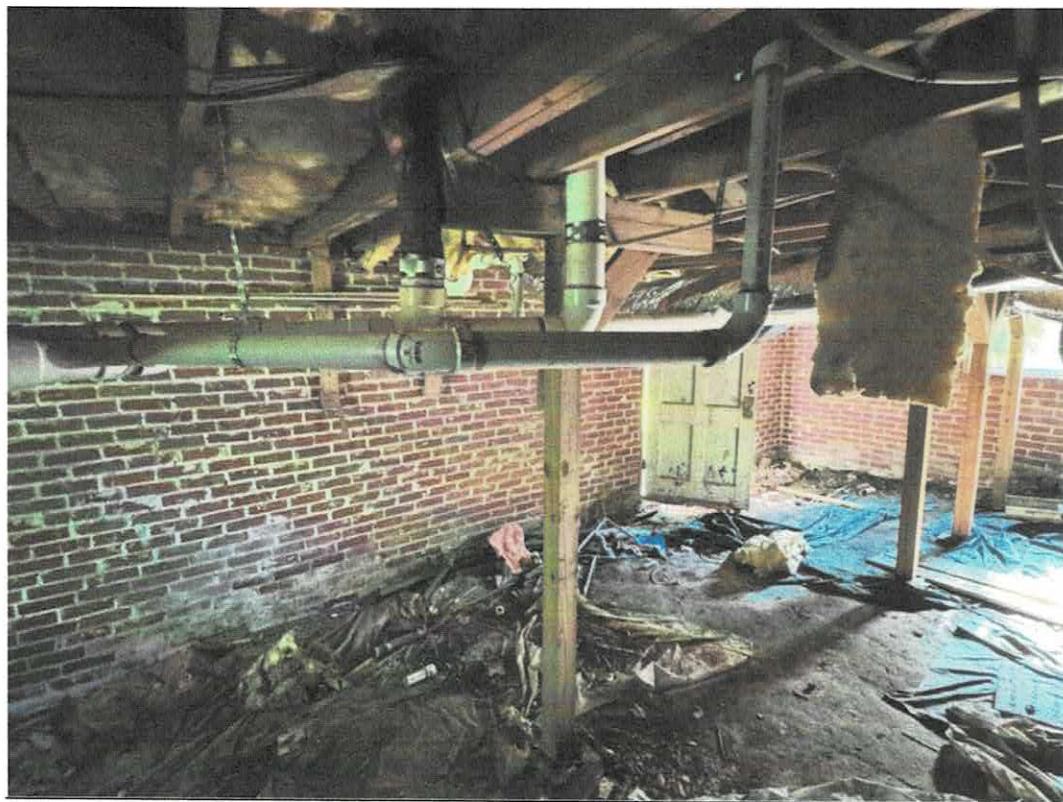
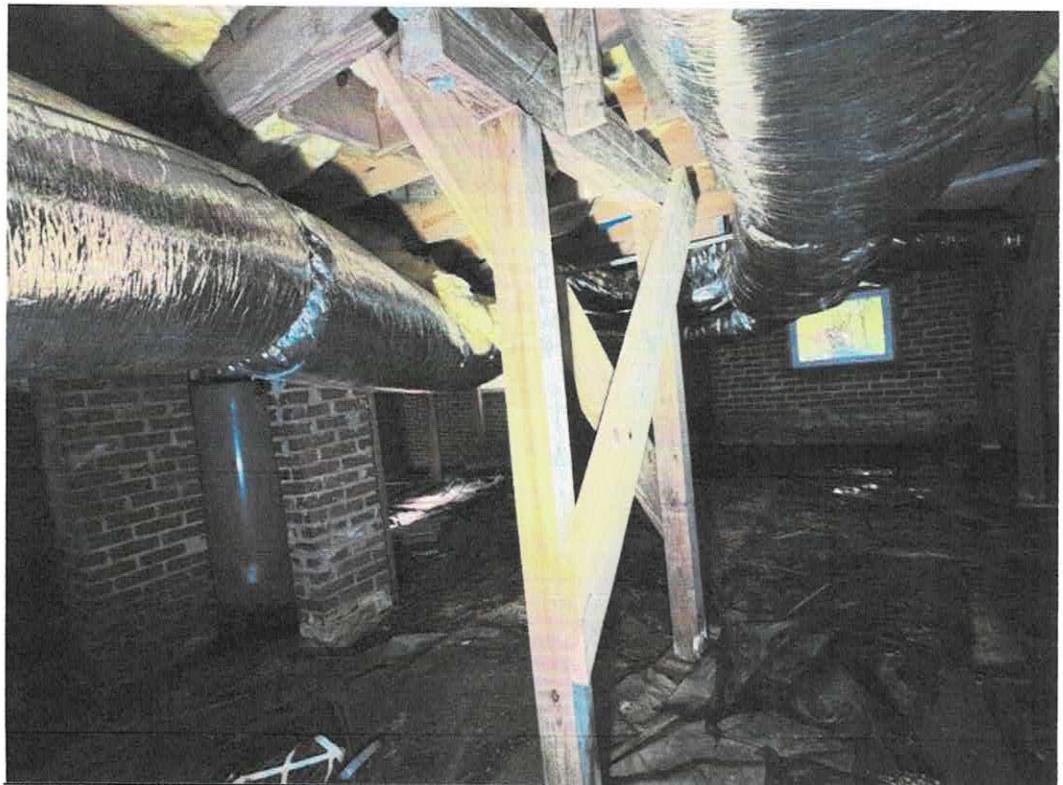
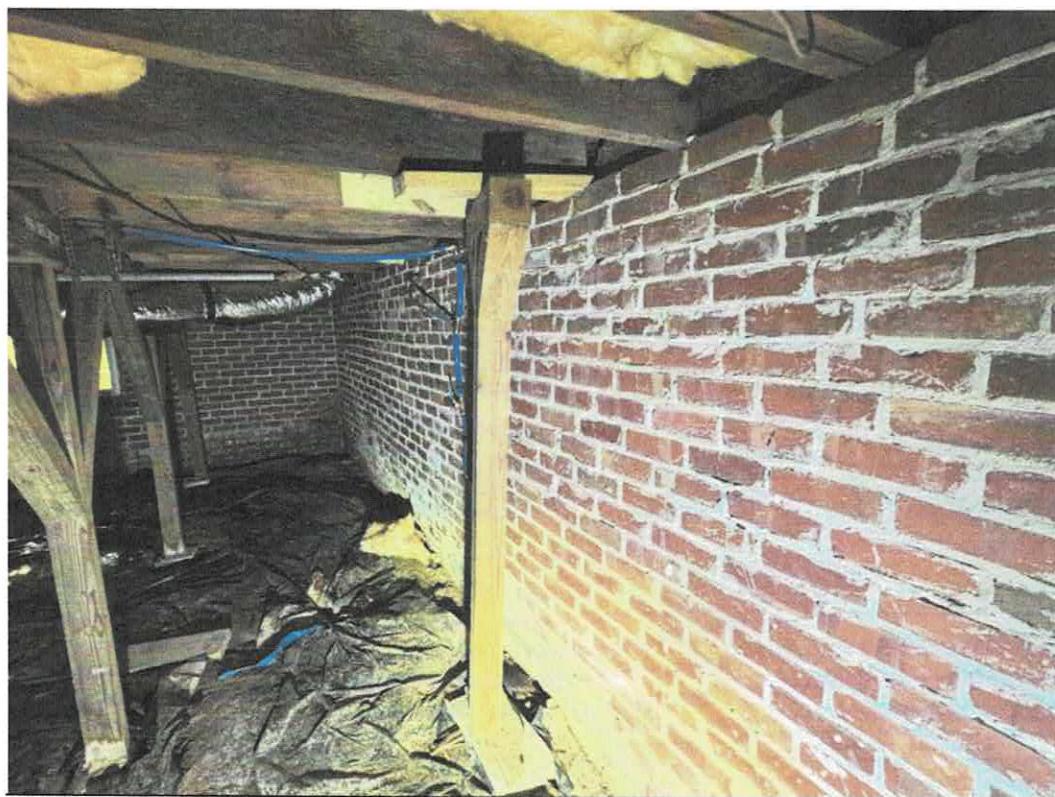
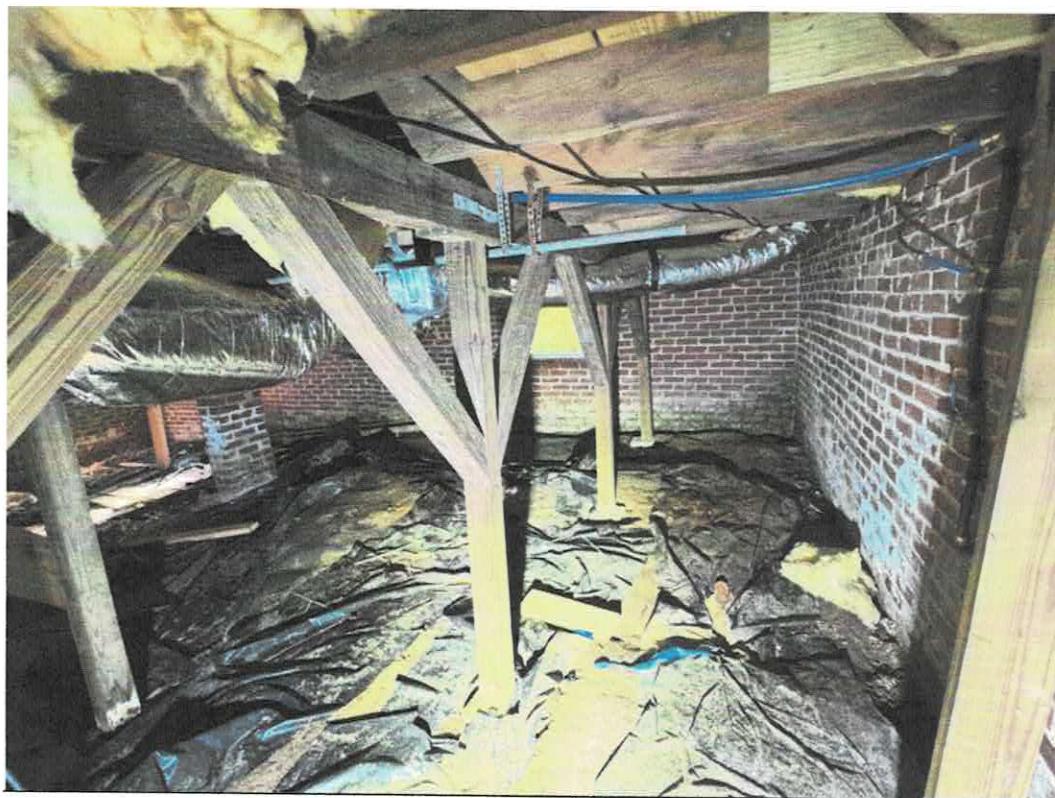
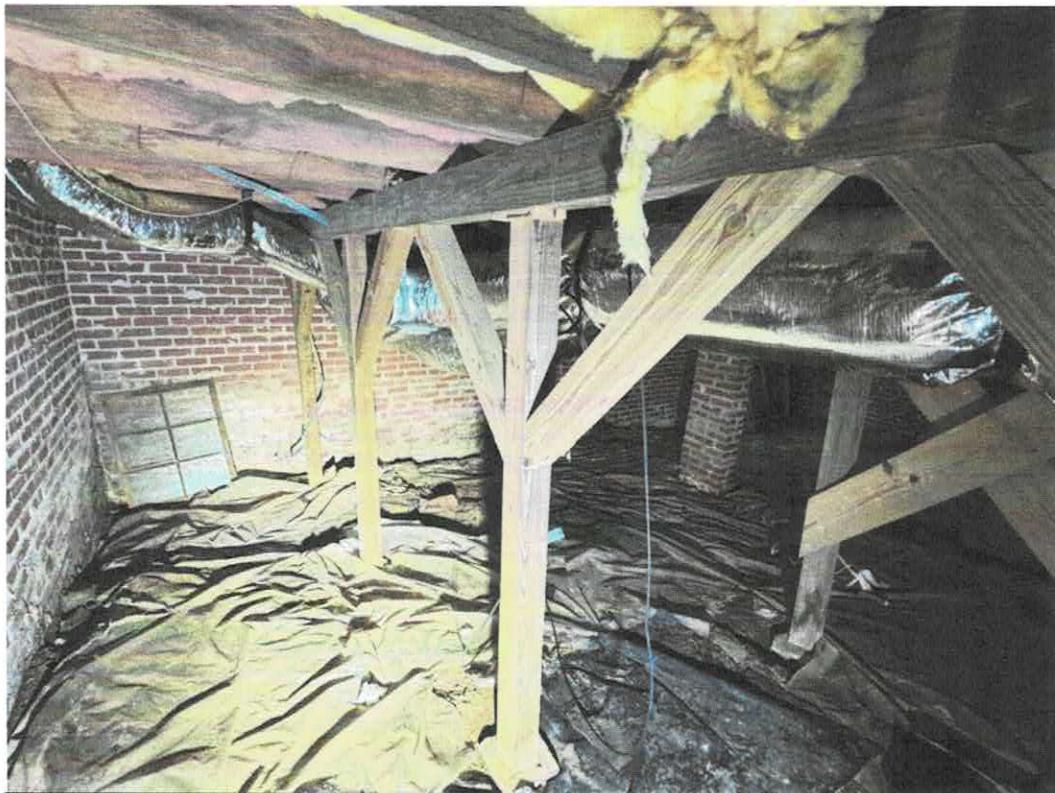
- There were several temporary supports in the crawl space supporting the floor joists (photos 20 to 25).
- There was wood rot in at least one of the floor joists at the front (photo 26).
- The bearing of the floor joists at the front of the crawl space was inadequate (photos 28 to 29).
- There were splices in the girder at the center (photos 30 & 31).
- There was a piece of the girder missing in the girder (photo 32).

- Remove the temporary supports within the crawl space.

- Provide a (3) 2x10 girder to support the floor joists at the front and rear.
- These girders shall be supported by brick piers similar to photo 33 or metal posts.
- The piers or metal posts shall be supported by concrete footings.
- Repair the wood rot at the front floor joist.
- Provide hangers similar to photo 34 at the front and rear floor joists at the front and rear crawl space walls.
- Provide new 2x10s each side of the girders where the splices are located.
- Provide new 2x10's where the piece of girder is missing.
