Septic System Evaluation Report

103 Moat View Dr
Albany, NH 03818
Inspection Prepared For: Kevin Hutchens
Inspection Date & Time: 7/1/2024, 8:30 AM

Inspector: Jacob Lemieux NH #207
243 Brickett Hill Rd, Pembroke NH 03275
(603) 893-2011
Info@SepticCheckNH.com

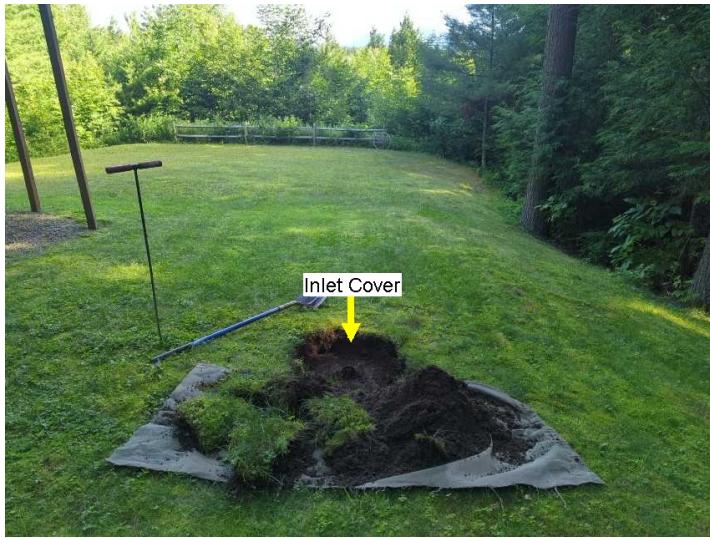
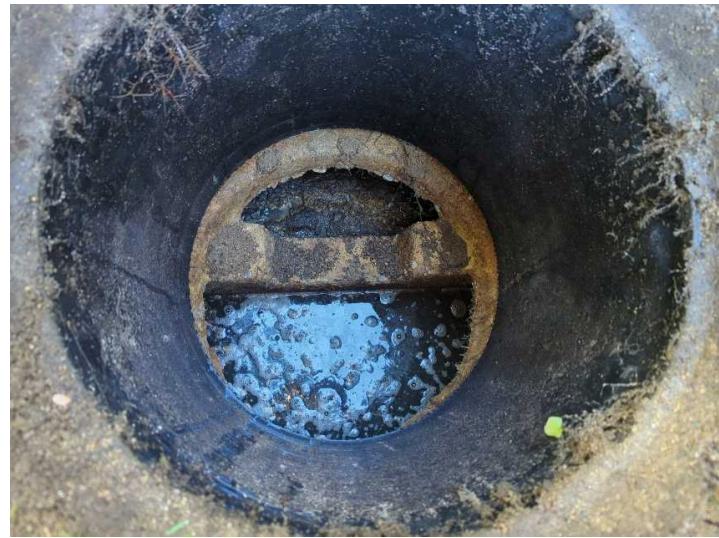
- The inlet and outlet baffles are in good condition
- At the tank Inlet , there is 3 inches of sludge and 2 inches of scum. There is a total operating depth of 5 feet.
- No effluent filter is installed in this tank.
- Septic tanks should be inspected at least annually and pumped when the combined sludge and scum layers equal 1/3 of the total tank volume.

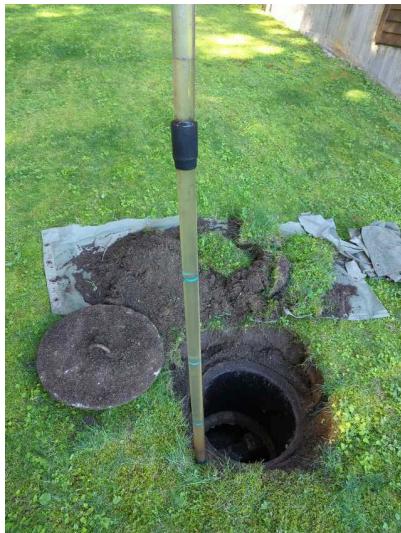
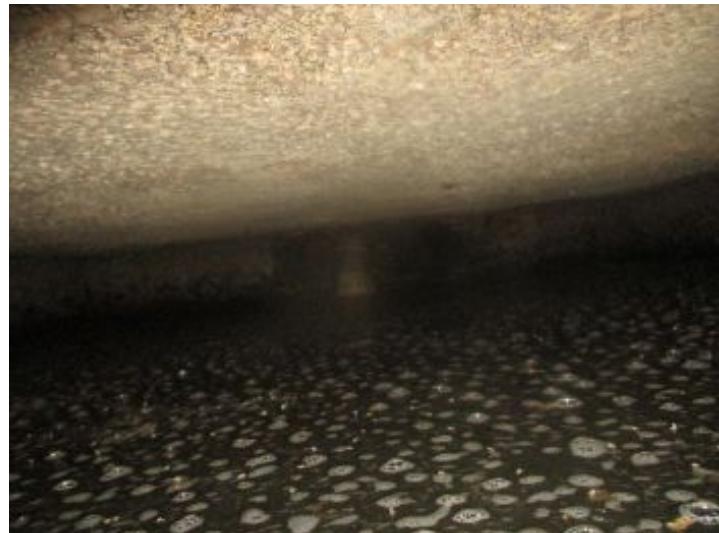
Outlet Baffle Intact

- The tank is concrete
- The tank capacity is disclosed as 1250 gallons. This evaluation cannot confirm the capacity of the tank.
- The accessed covers are intact
- A riser cover could be installed on the outlet cover of the septic tank to provide access for future maintenance purposes.

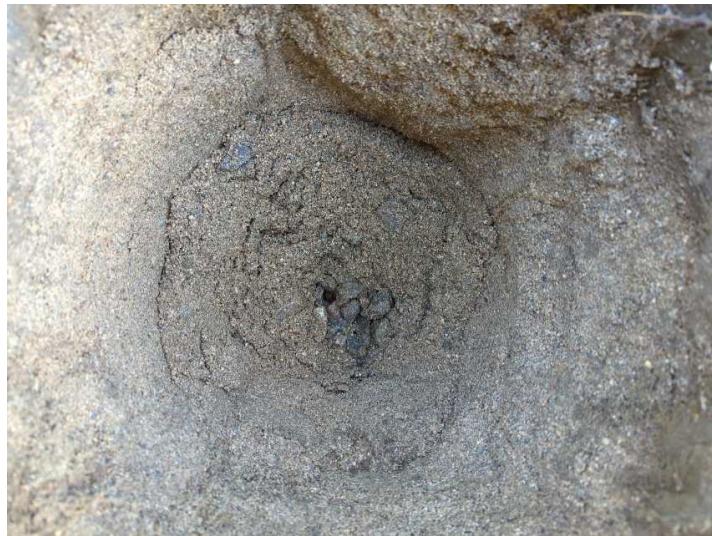
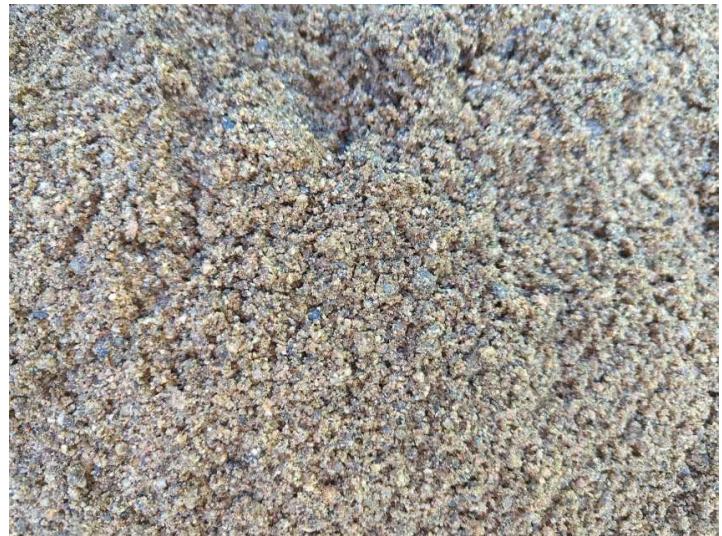
- I was able to probe to the bottom of the EDA; there was no standing effluent and the sand and stones were clean

Clean sand

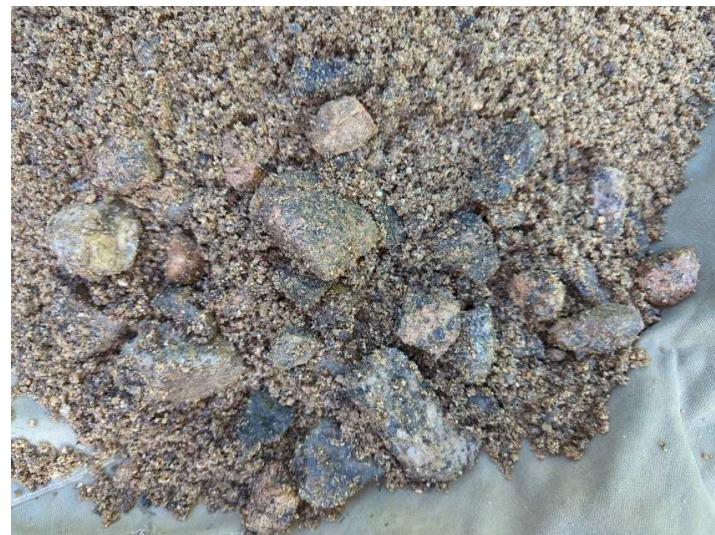
Clean stones

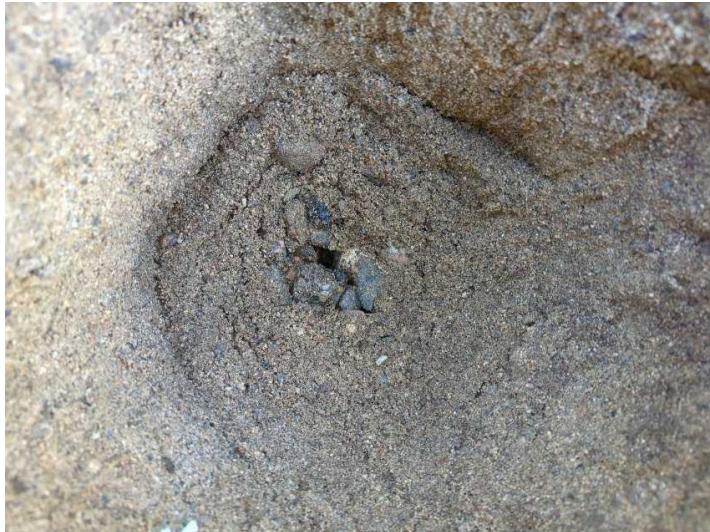
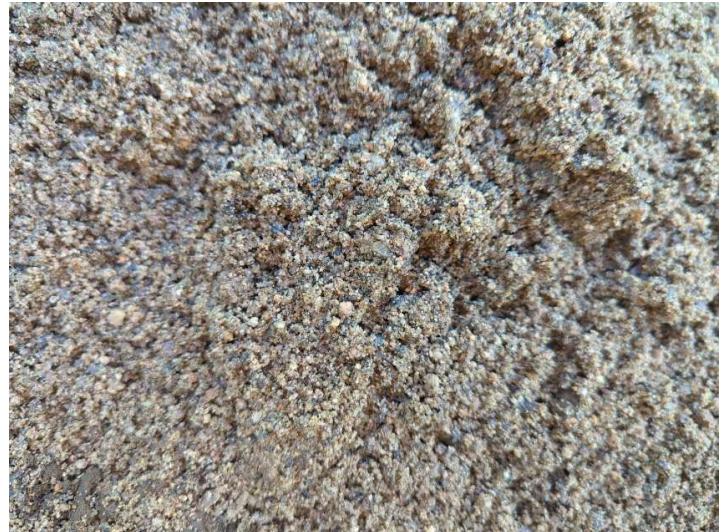
- I was able to probe to the bottom of the EDA; there was no standing effluent and the sand and stones were clean

Clean sand

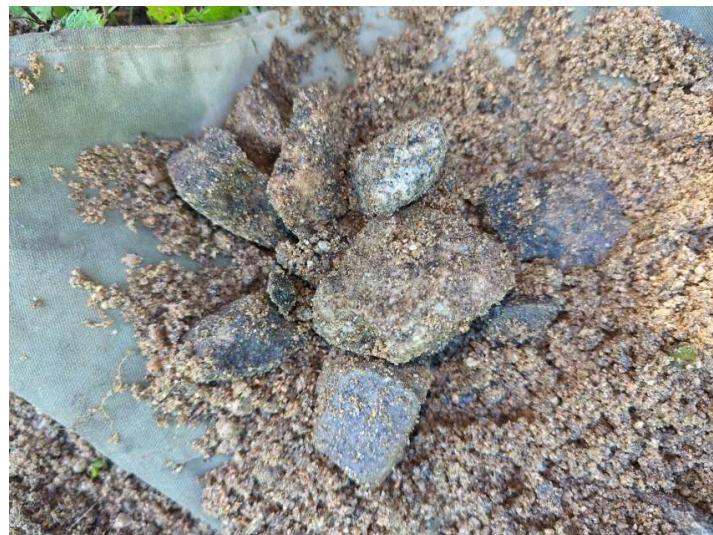
Clean stones

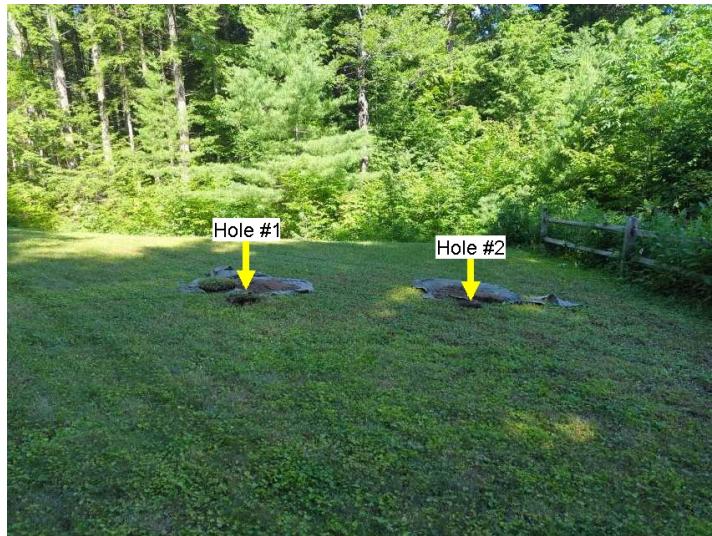
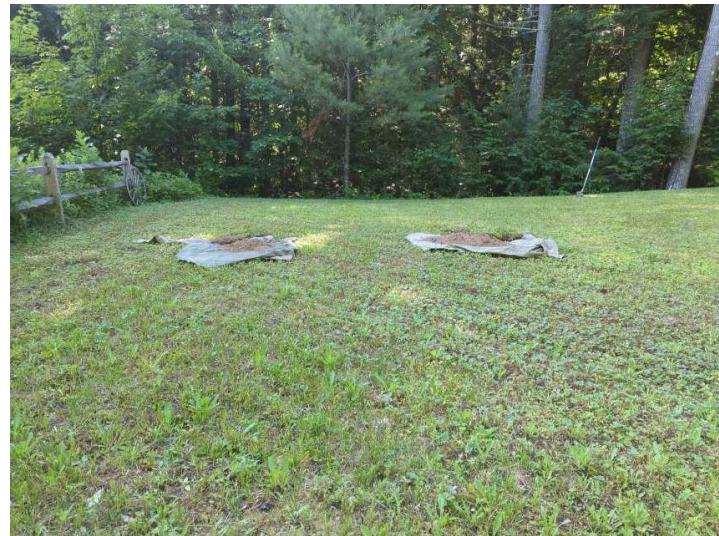
- System condition: GOOD- No visible effluent and no signs of previous high effluent levels in the leaching area.
- For information on keeping your septic system working properly visit the resource page on our website.
