# Four-Point Inspection Form

Address Inspected: 3502 Washington Rd. West Palm Beach, FL 33405

Date Inspected: 2/11/2025

Affordable Home Inspection  
 Company Name

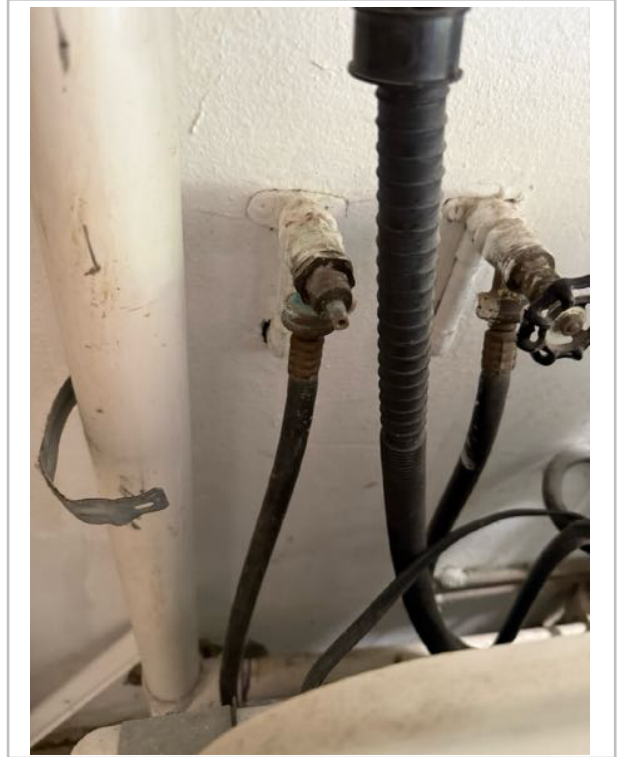
Washer connection

Water damage right of sink guest apartment bath, missing shutoff guest apt. Washer stem  
 Leak at store room toilet. Work in progress master bathroom

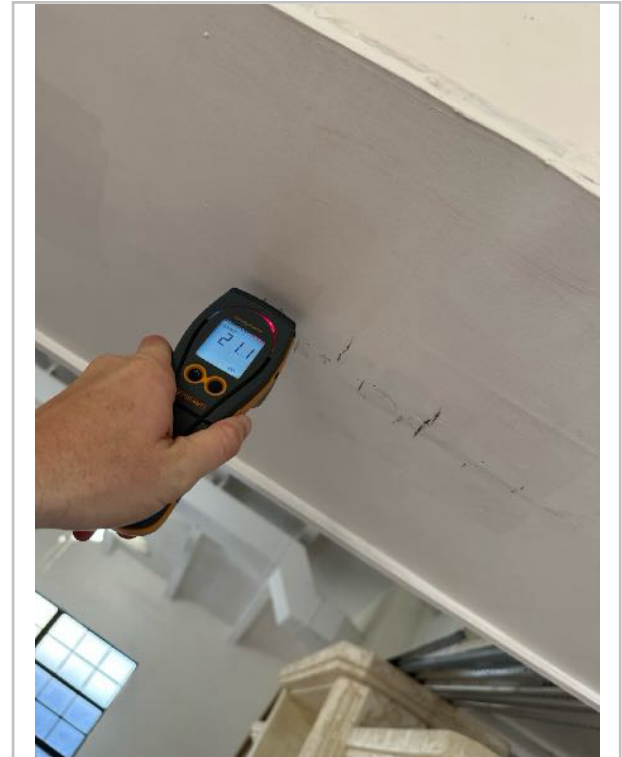
## Roof leak over kitchen guest apartment

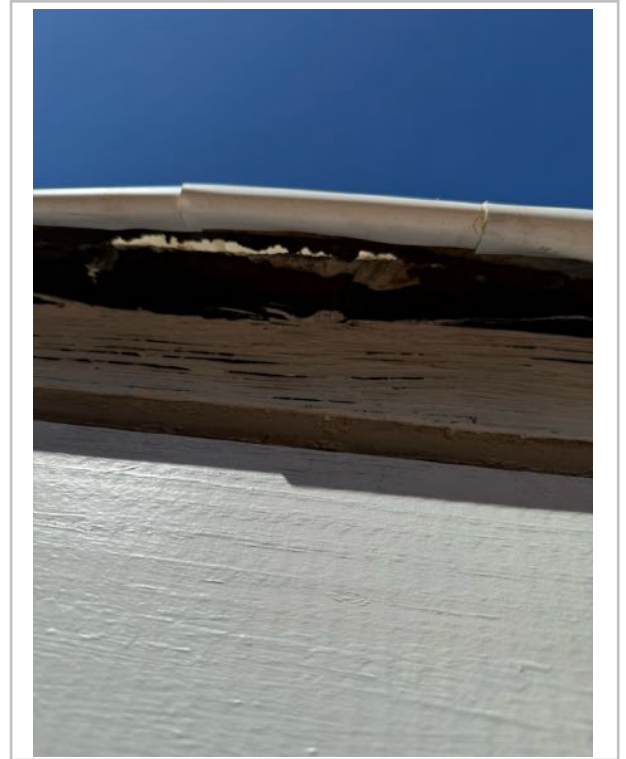
Example of leak at eaves

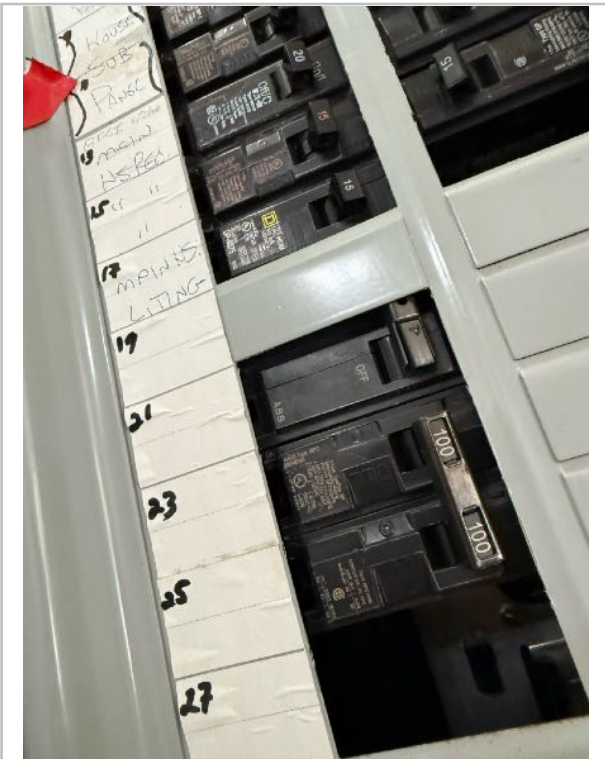
Breaker obstructed guest apt. panel

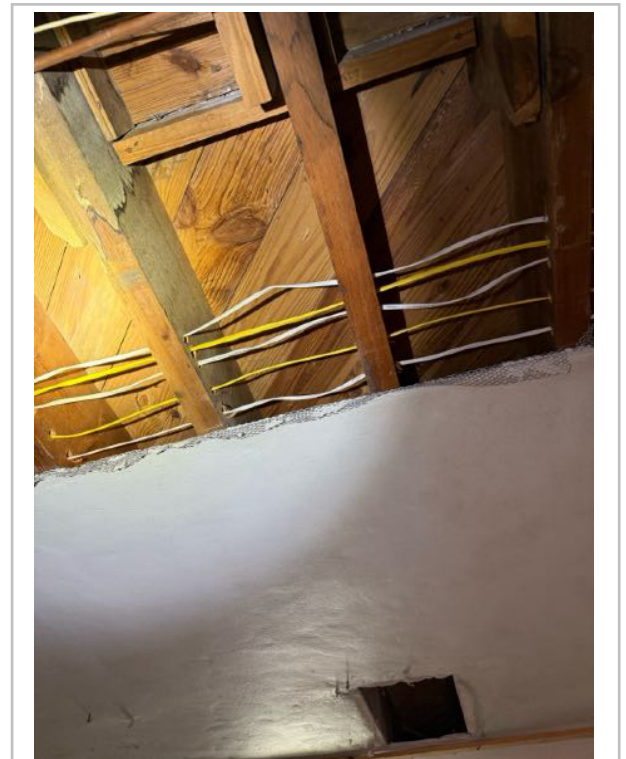
Several areas of exposed wiring. Improper splice under kitchen sink. main house panel is obstructed

Example of exposed Romex wiring

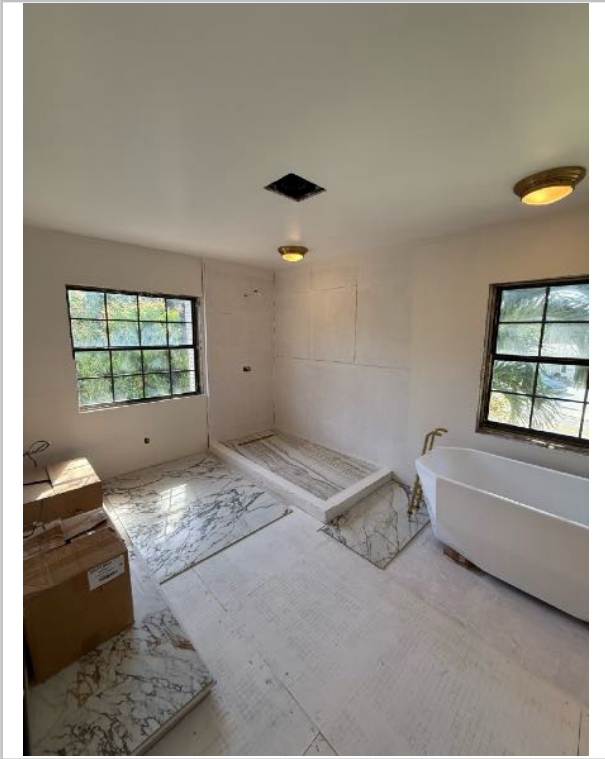
Ex. of work in progress bathroom

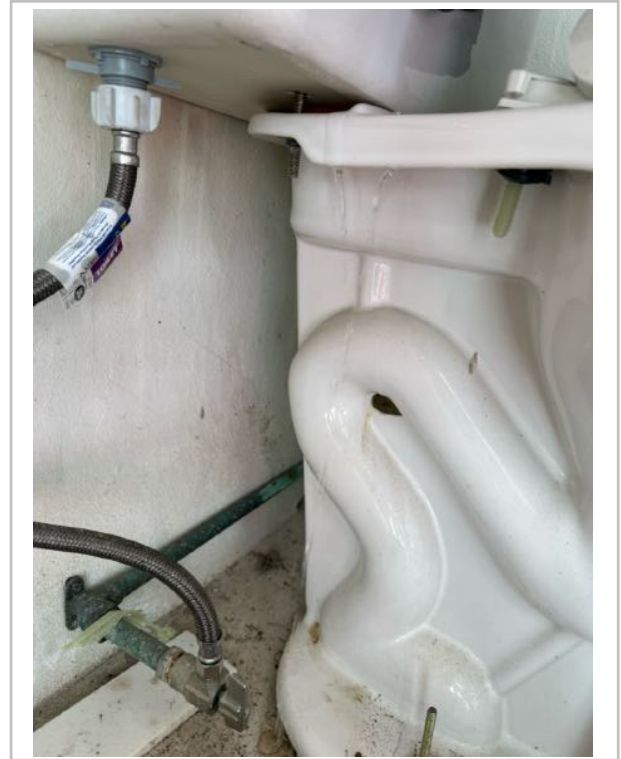
Store room toilet leaks

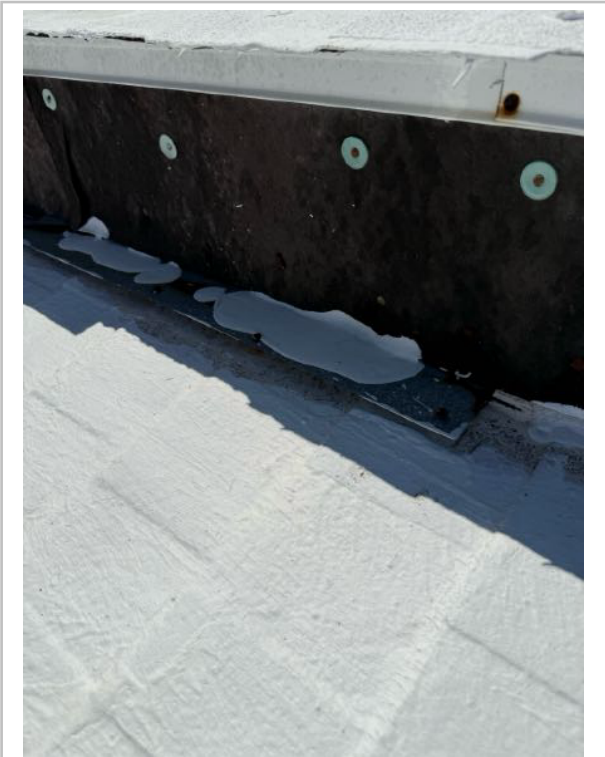
Improper roof repair
