PHOTOGRAPH PAGE  
Affordable Home Inspection, Inc.

**Client:** David Gansky

**Report No:** 33082

3502 Washington Rd. West Palm Beach, FL

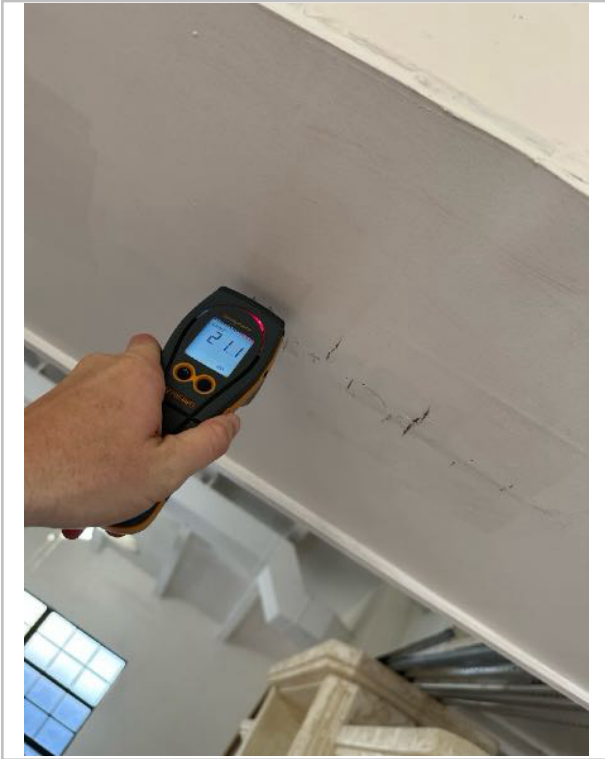
Moisture in beam over guest apt, kitchen

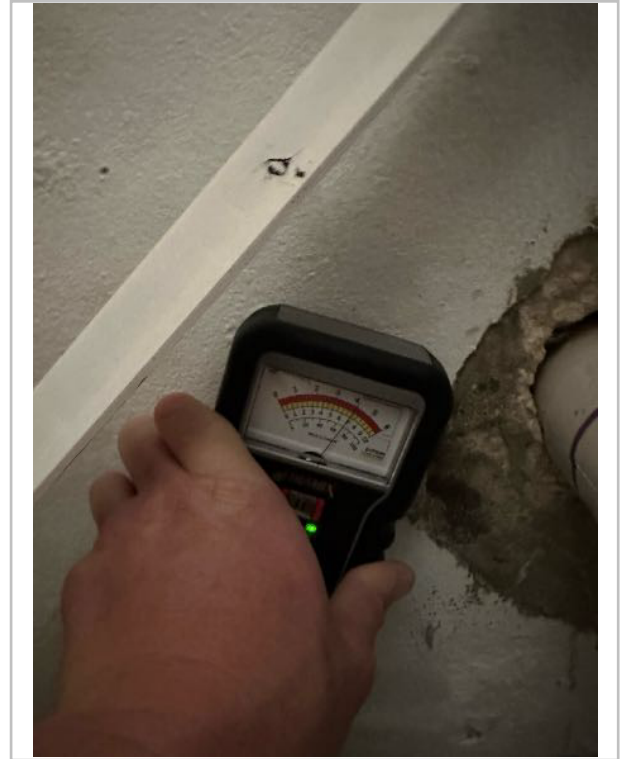
Moisture in guest apt. wall by laundry

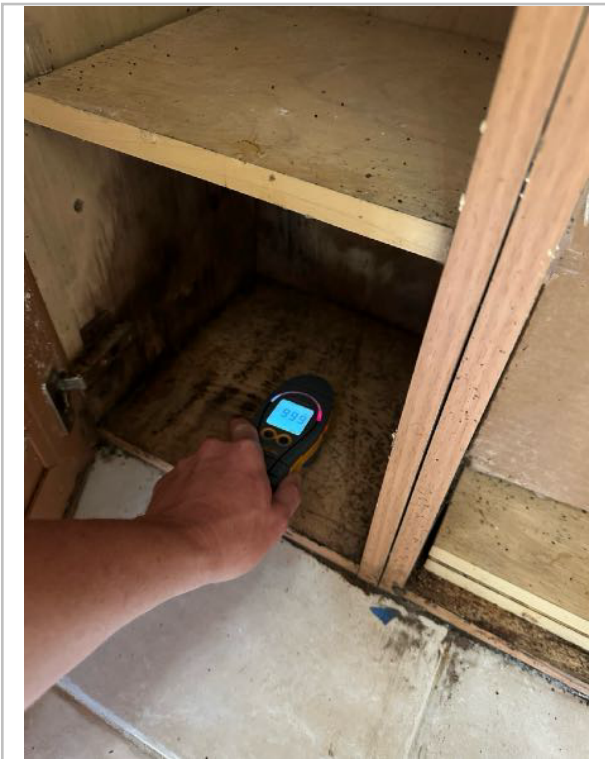
Moisture in guest apt. cabinet

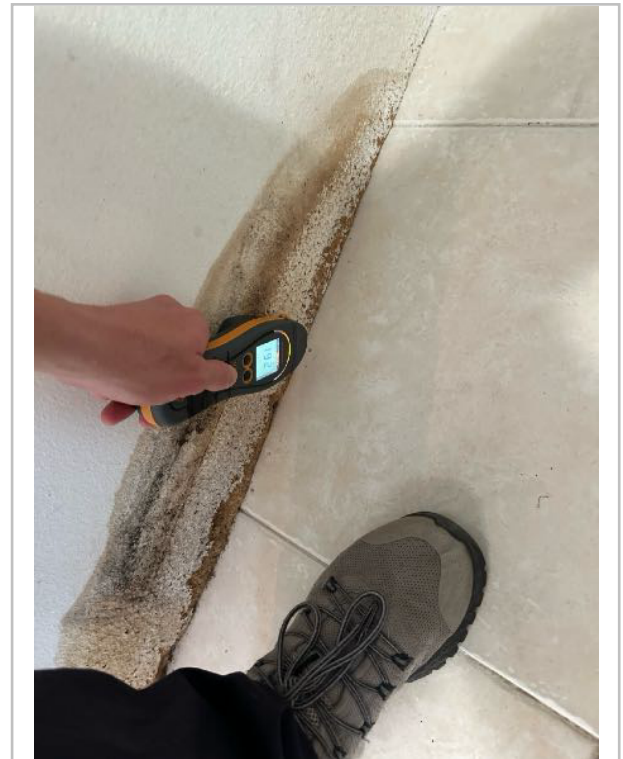
Moisture in guest apt. partition

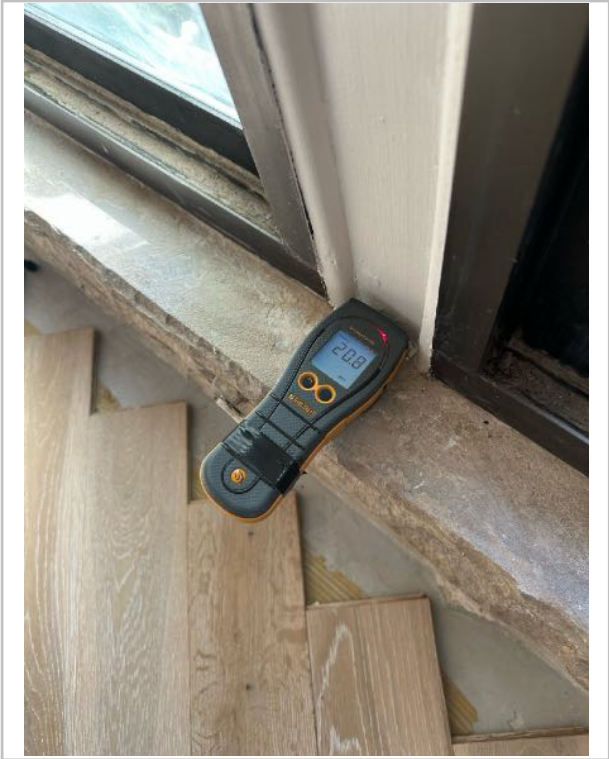
Moisture in family room wall at windows

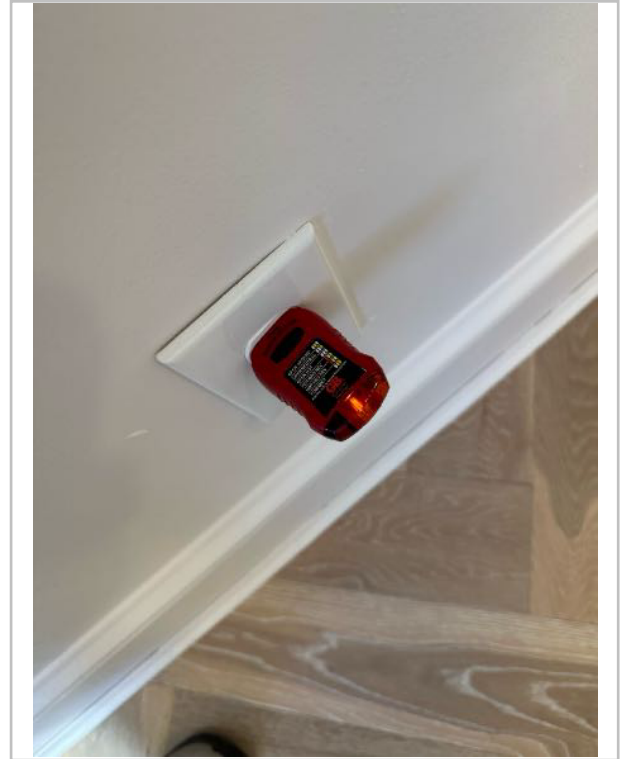
Example of open ground outlet

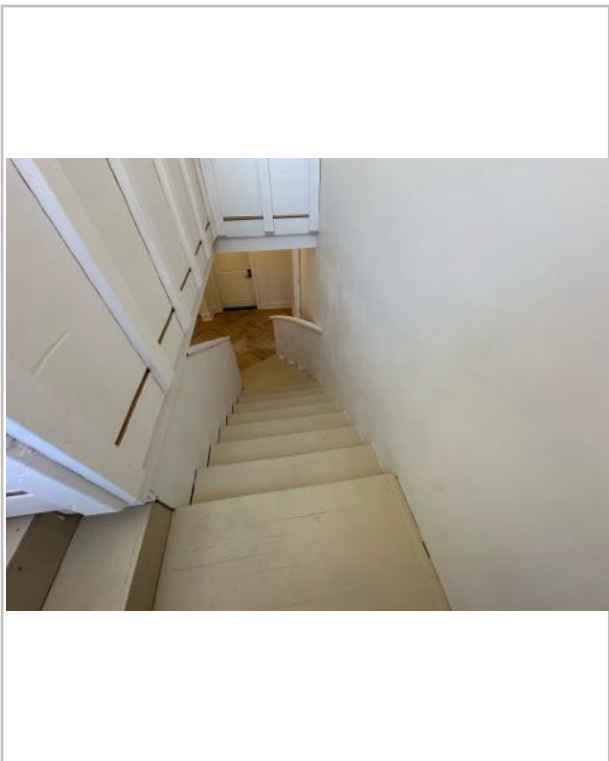
No handrail at stair landing

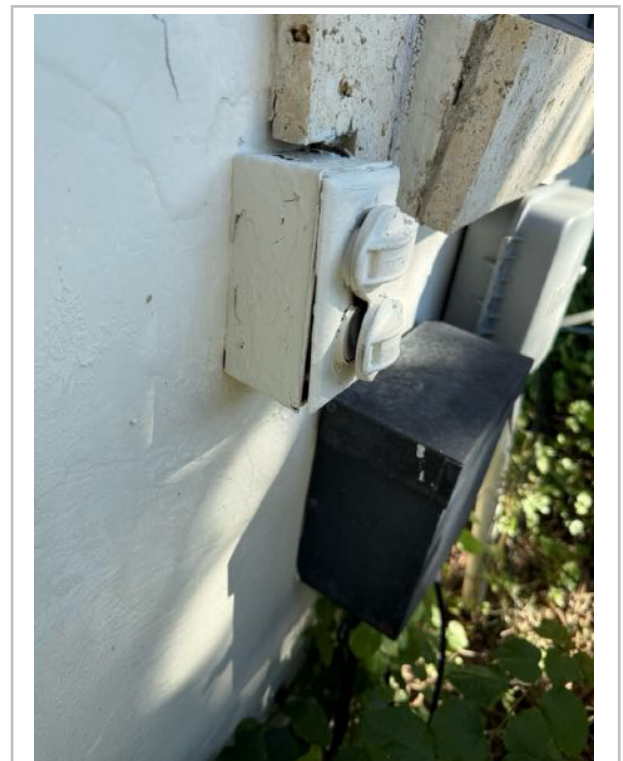
Outlet right of entry not secure / gfc

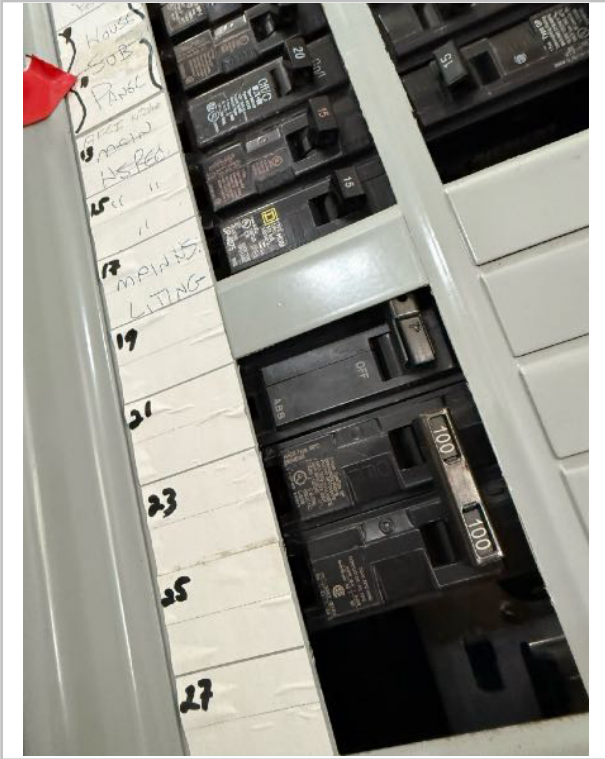
Breaker obstructed in Siemens panel

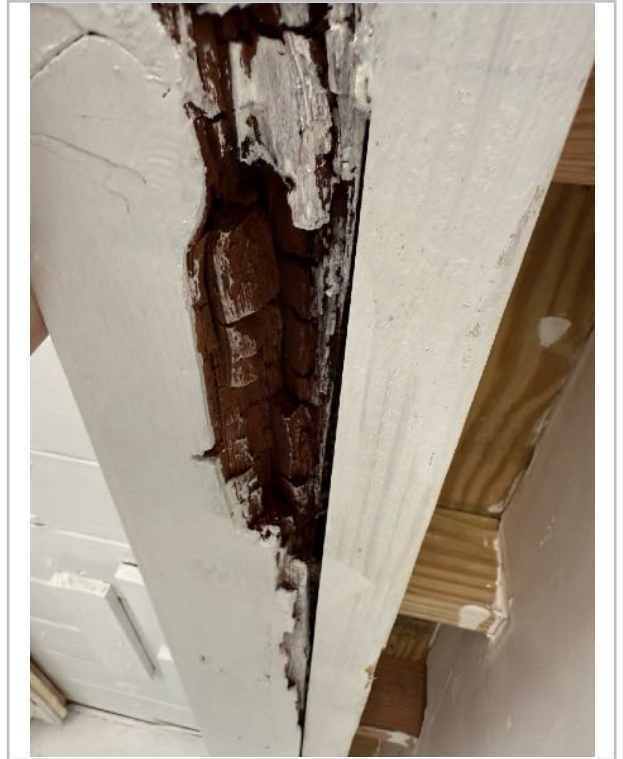
See separate WDO report

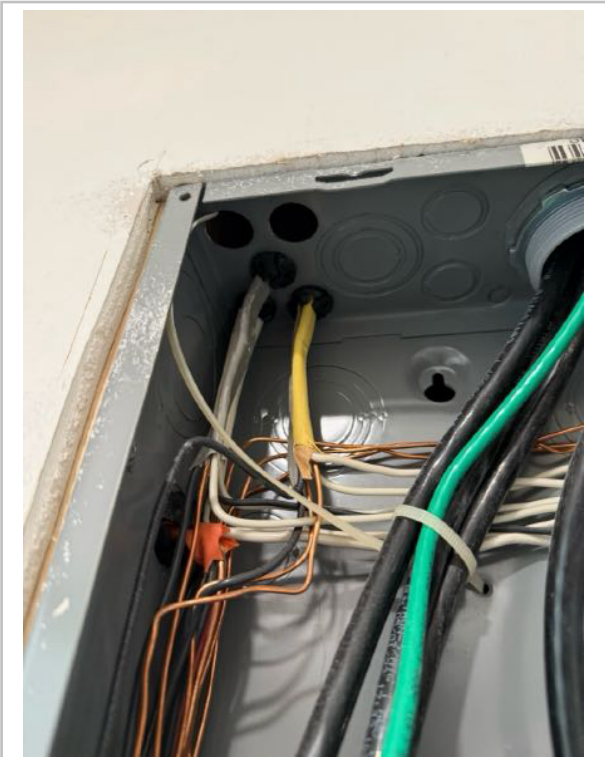
Example of missing knockout

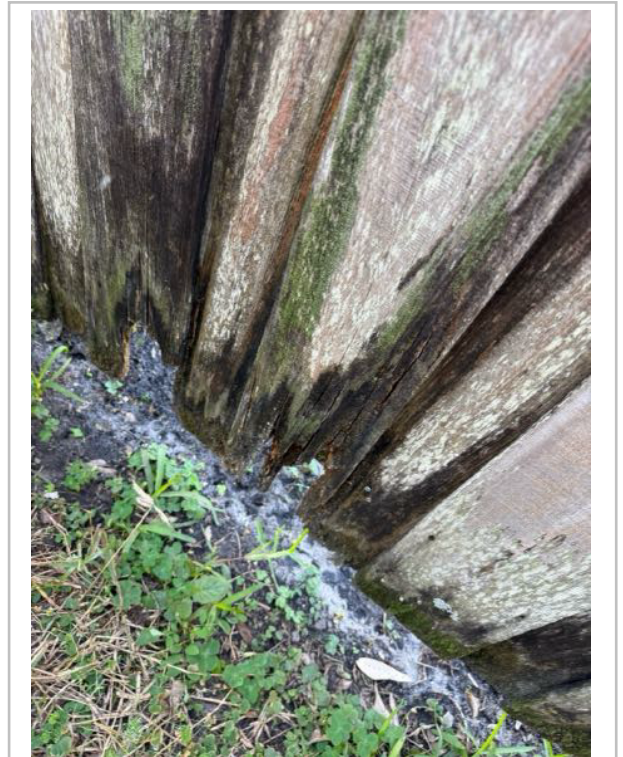
Example of damage to wood fence

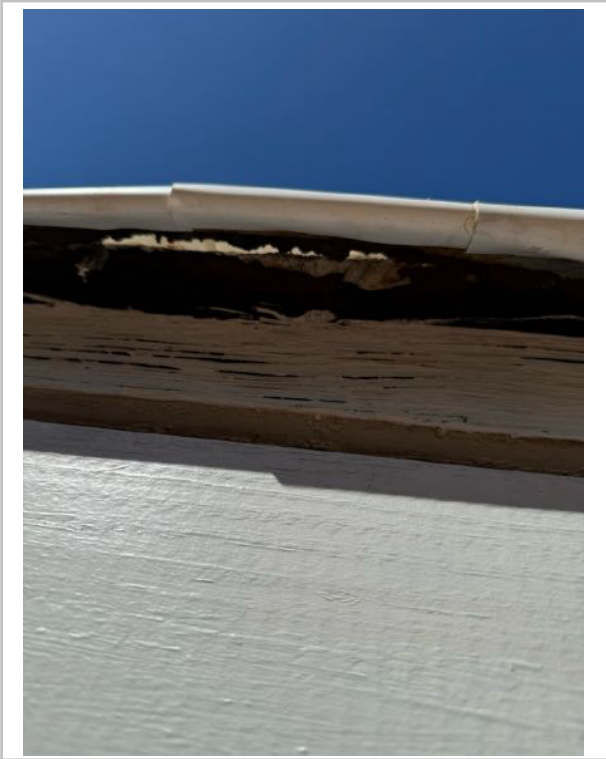
Leak at eaves lower level East side

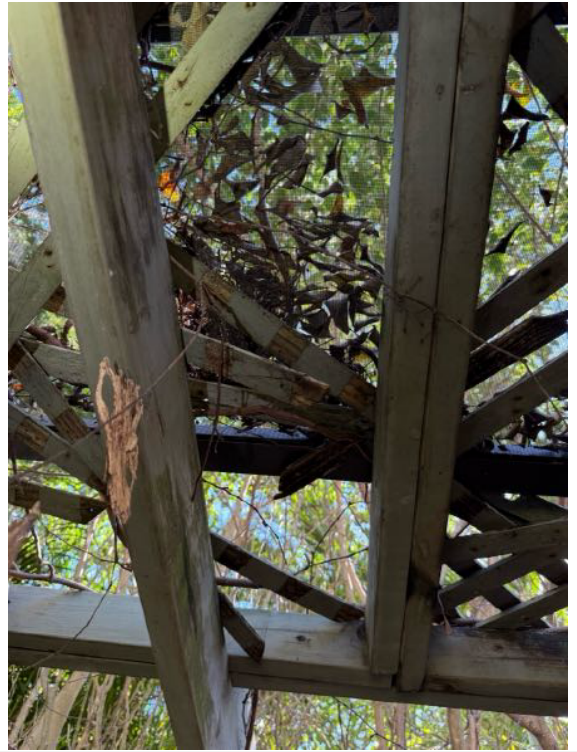
Example of damaged wood at pergola

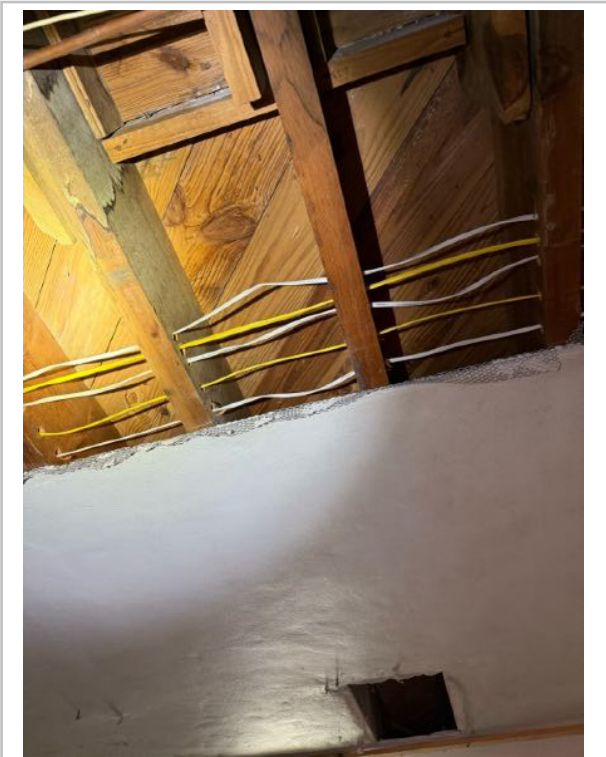
Example of exposed Romex wiring

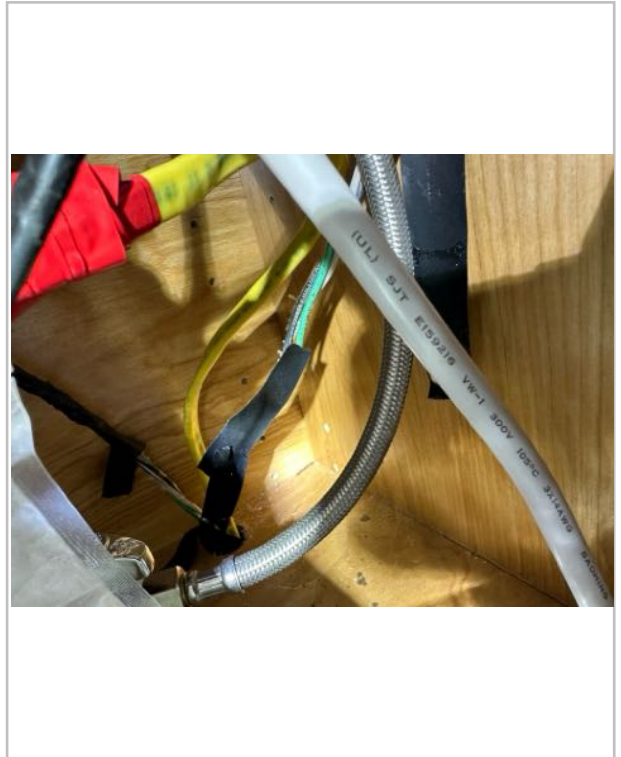
Improper splice under kitchen sink

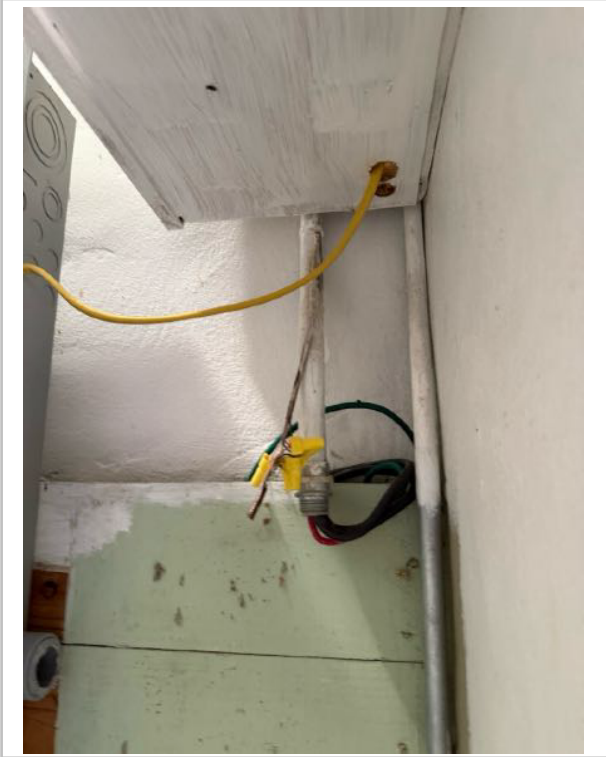
Example of exposed Romex wiring

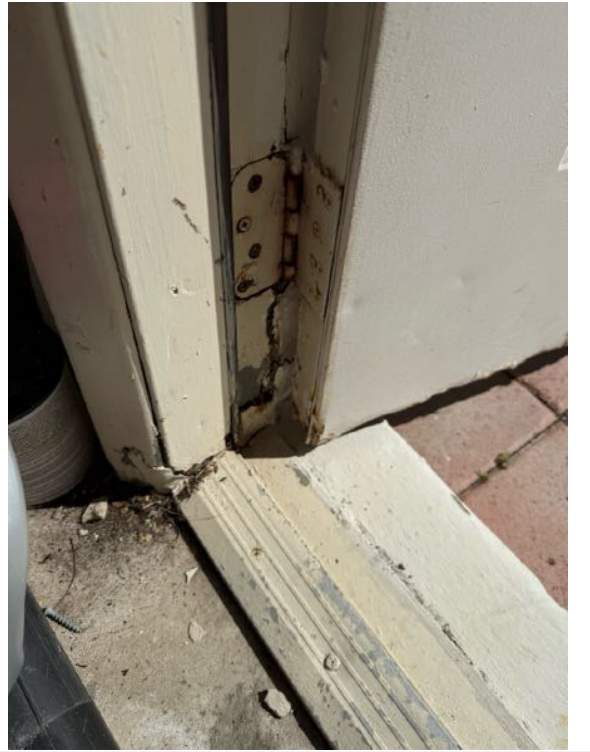
Damage to store room door and frame

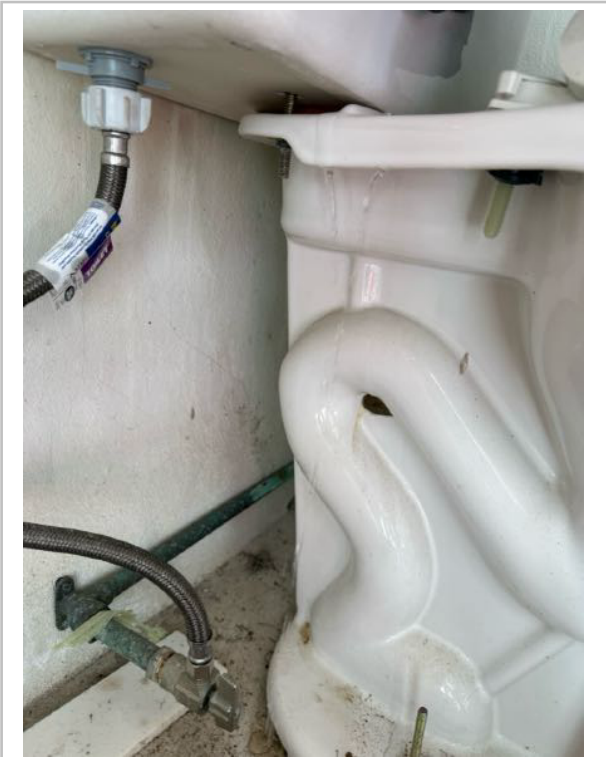
Leak at store room toilet

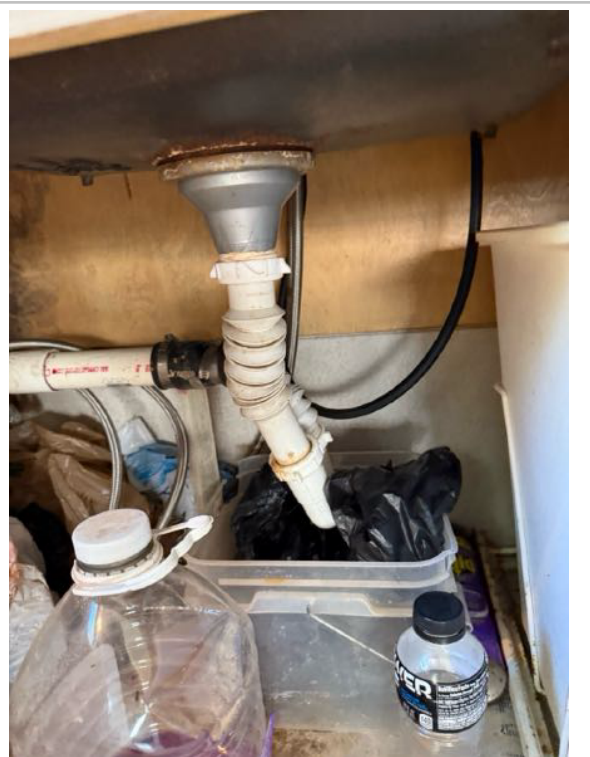
Flex pipe at guest apt. sink drain line

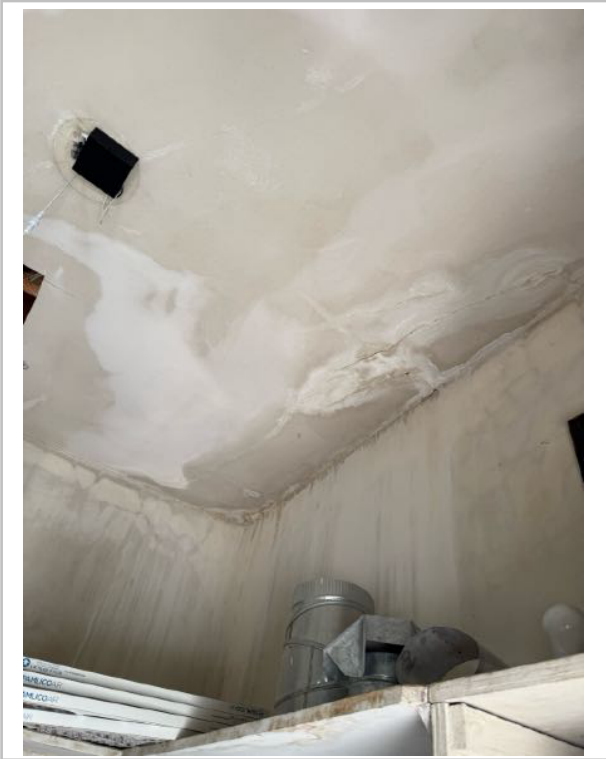
Damage to store room ceiling

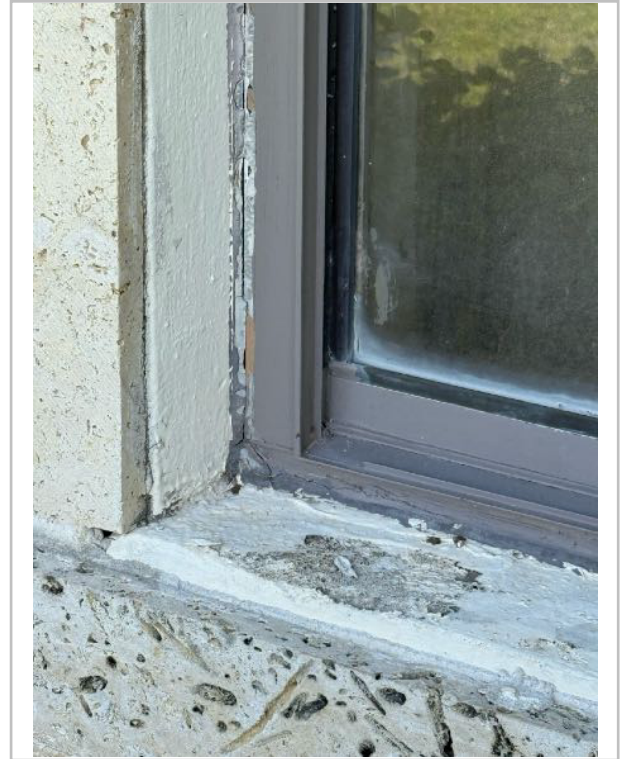
Ex. of voids in window caulking

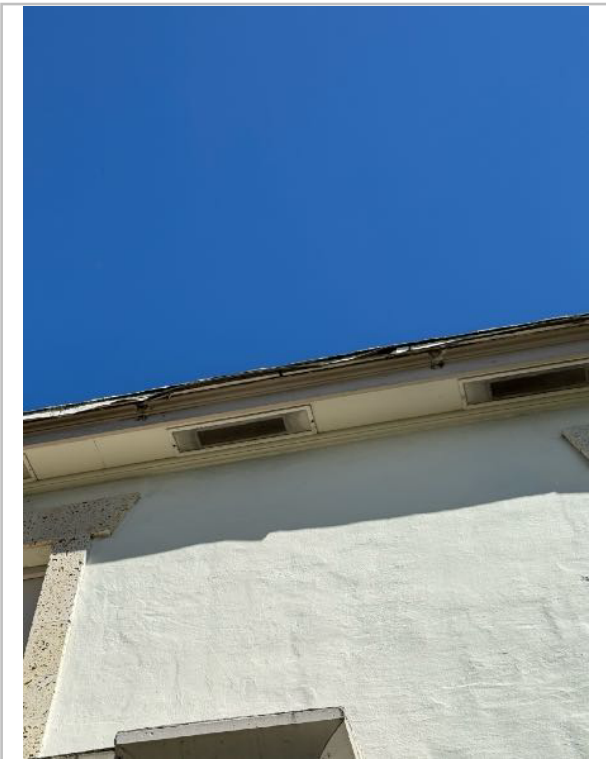
Example of damage to drip edge

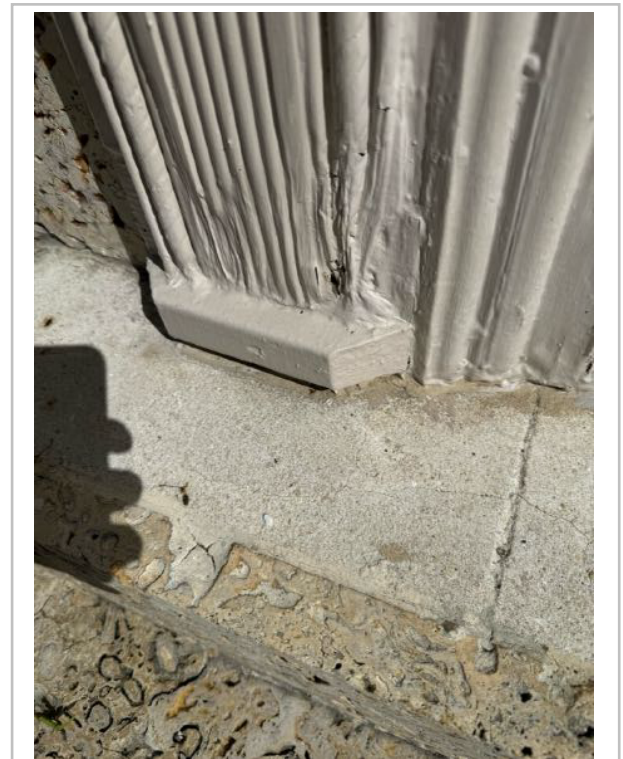
Damaged wood entry door frame

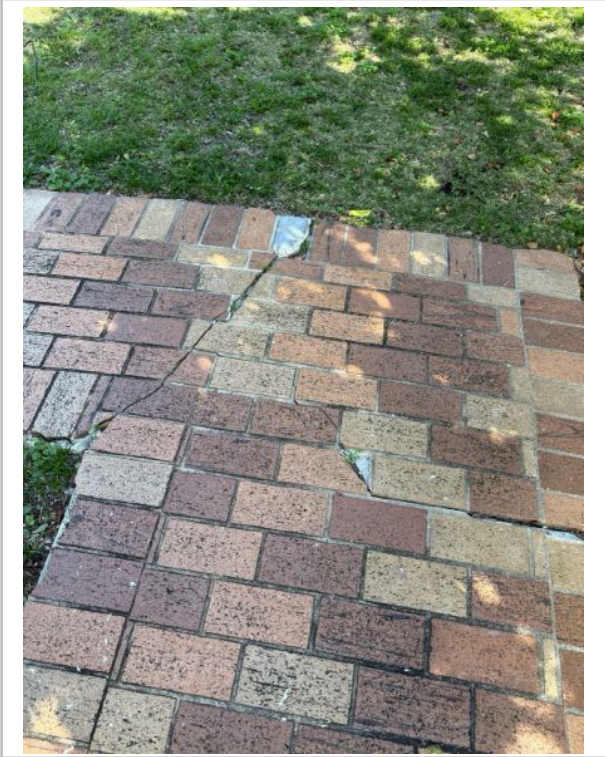
Example of cracks to walkway

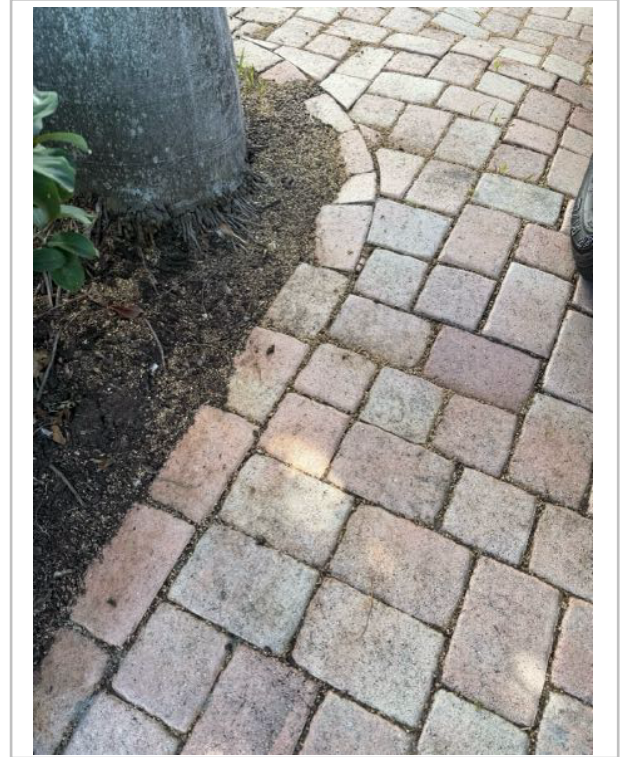
Ex. of displaced driveway pavers

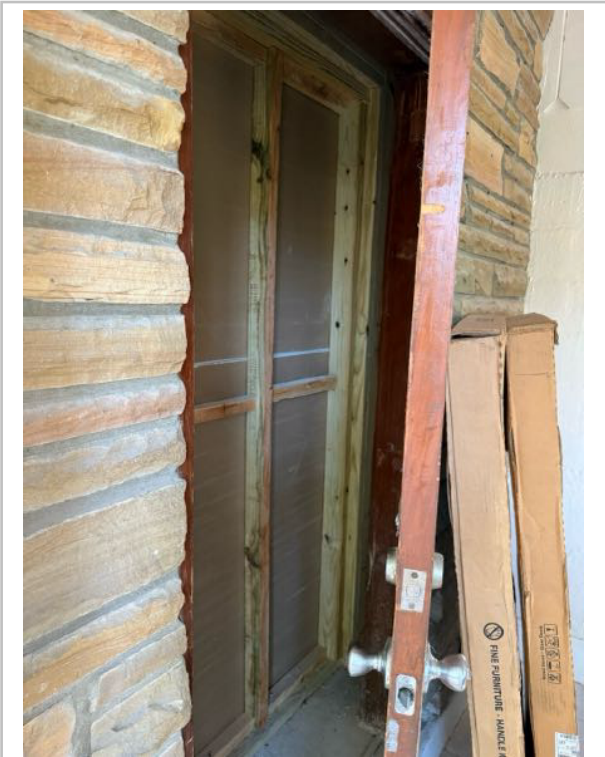
Open wall cavity at guest apartment

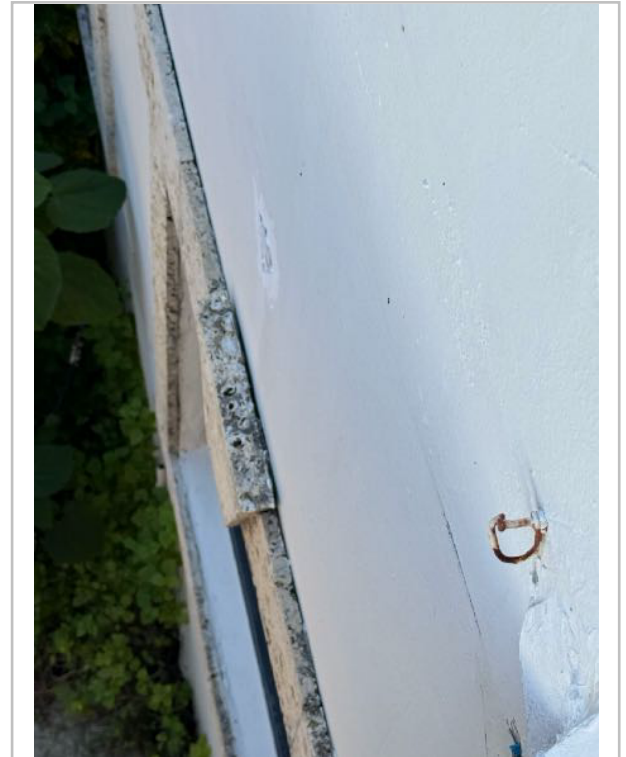
Ex. of voids at cast stone trim

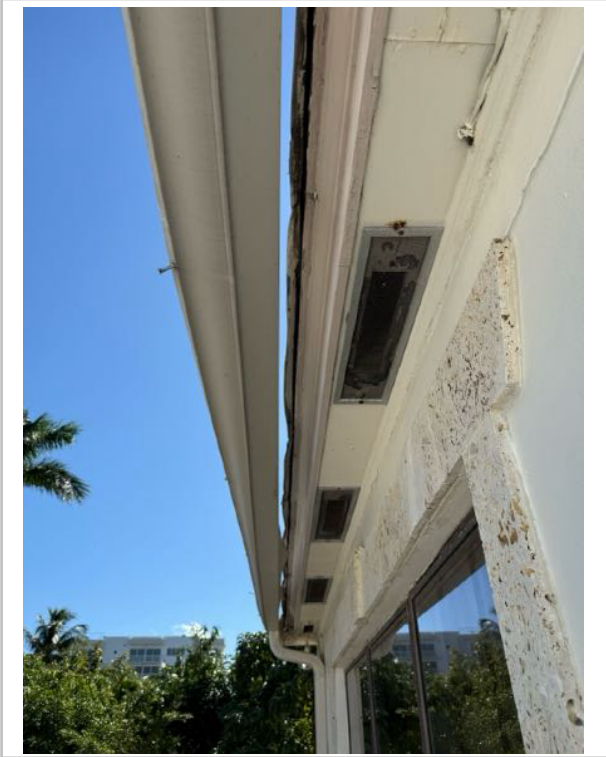
Example of damage to gutter

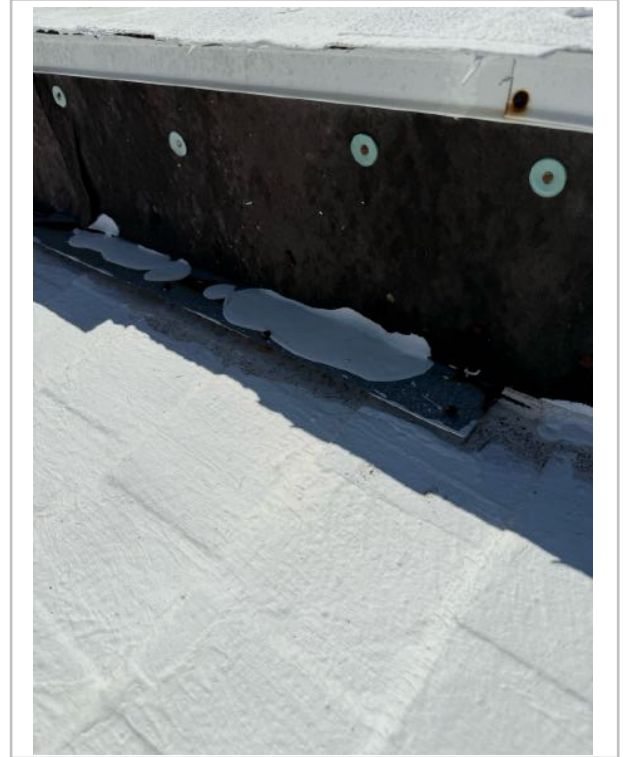
Improper repair lower level East

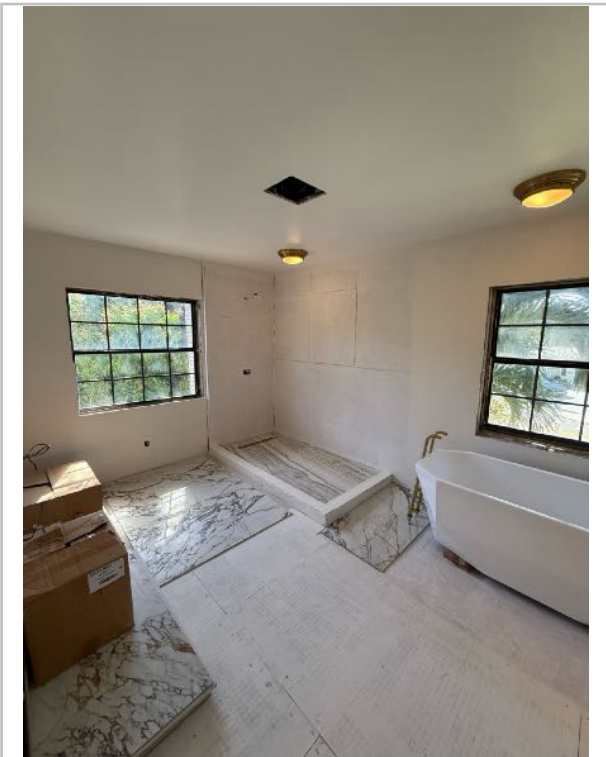
Example of work in progress
