# 4-Point Inspection Form

Insured/Applicant Name: Richard Carlier Application / Policy #: \_\_\_\_\_  
Address Inspected: 6011 Key Largo Circle Punta Gorda, FL 33955  
Actual Year Built: 1993 Date Inspected: 07/10/2026

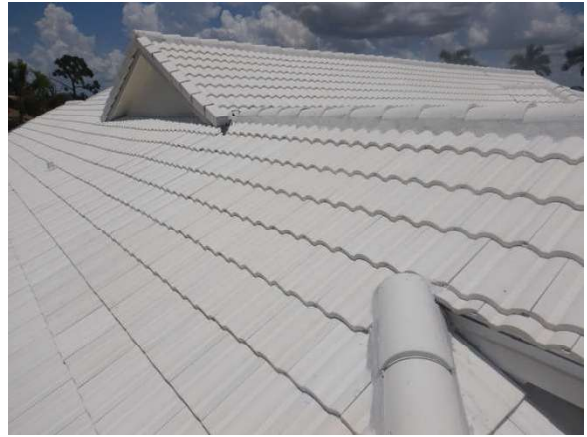
Roof – Hip & Gable (Gable more than 10%)

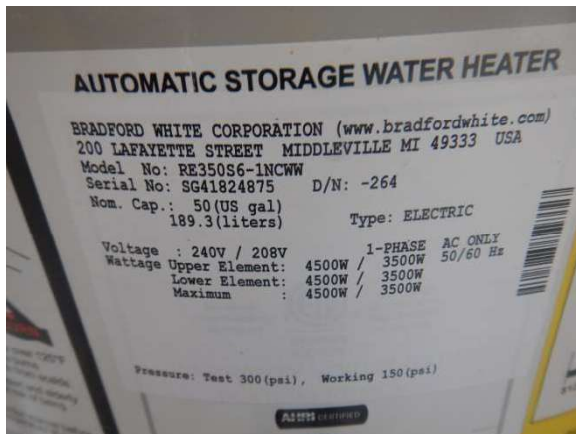
Plumbing – Water Heater Updated 2018

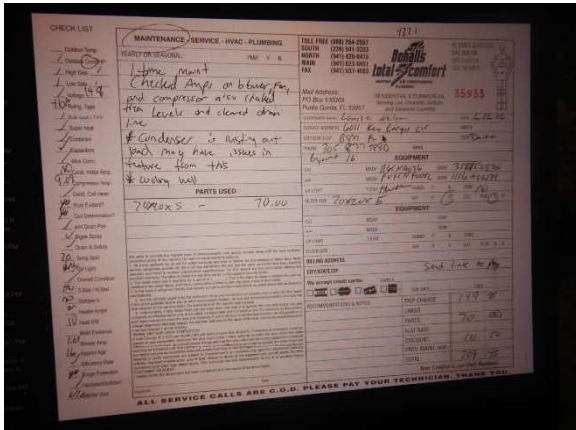
HVAC – Last Serviced 06/26/2026

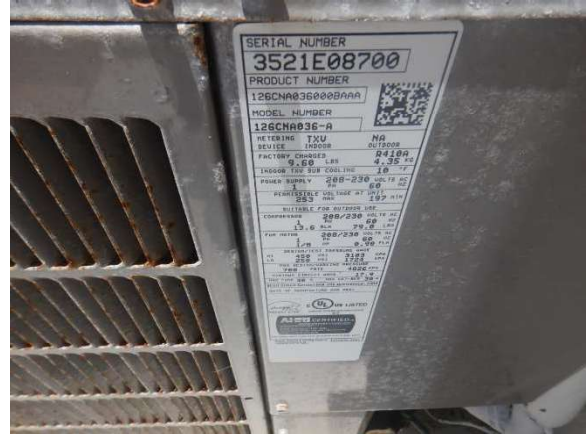
HVAC – Updated 2021

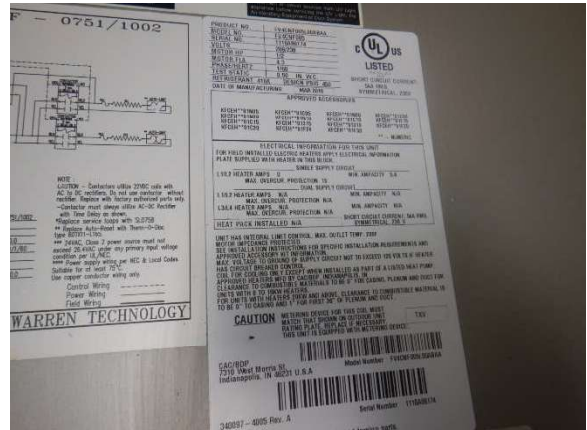
HVAC – Updated 2016

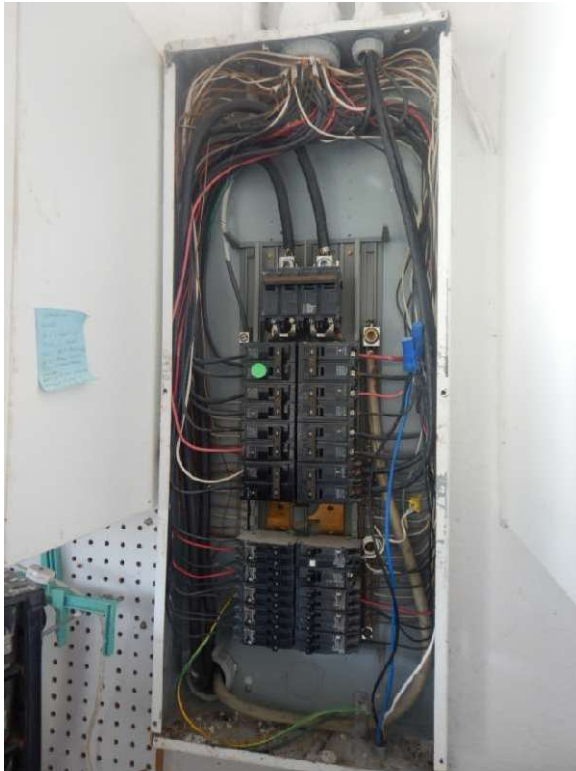
Electric – Main Panel 200A CB

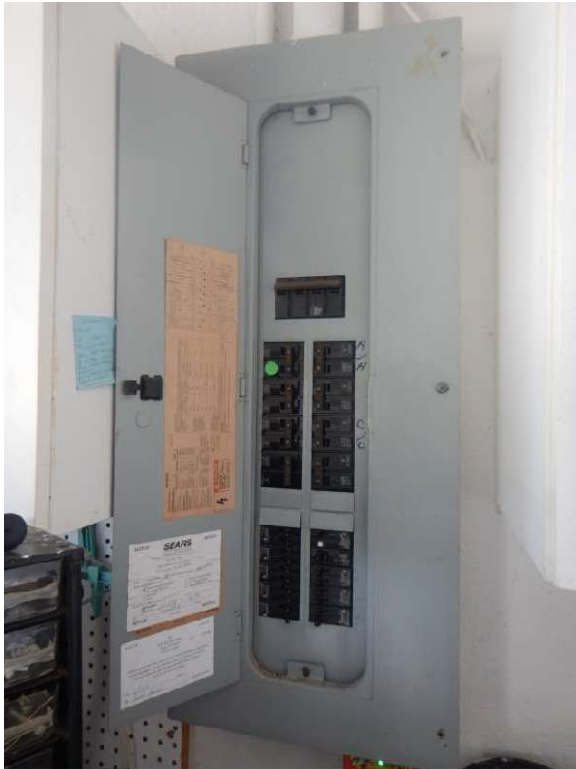
Electric – Main Panel Siemens
