MR. CHRIS FORSTER

SOLAR PANEL CLEANING/ THERMAL IMAGES

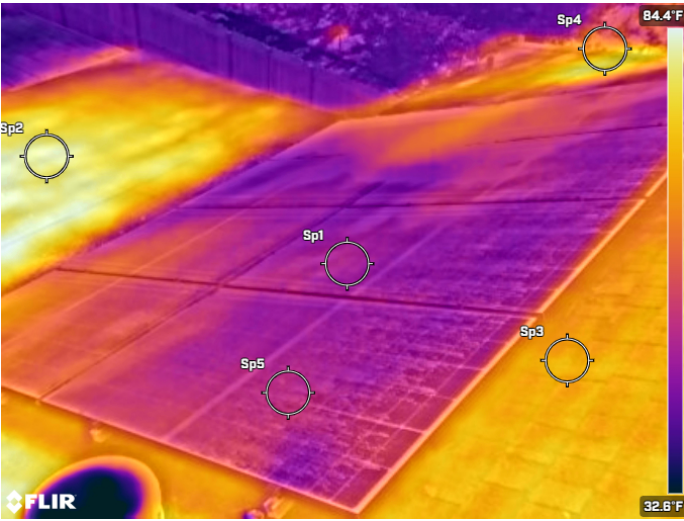
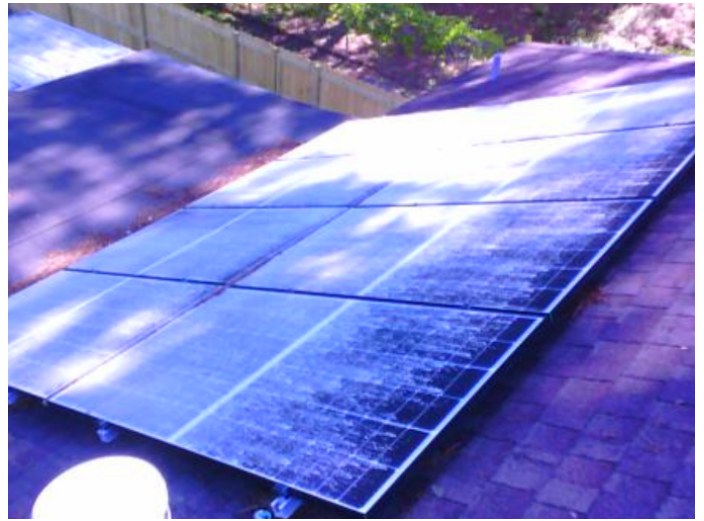
IR - FLIR0216 .jpg

⊕ Sp1	54.8 °F
⊕ Sp2	81.4 °F
⊕ Sp3	70.1 °F
⊕ Sp4	66.0 °F
⊕ Sp5	55.6 °F

REAR ARRAY. NO VISIBLE DAMAGE OR HOT SPOTS

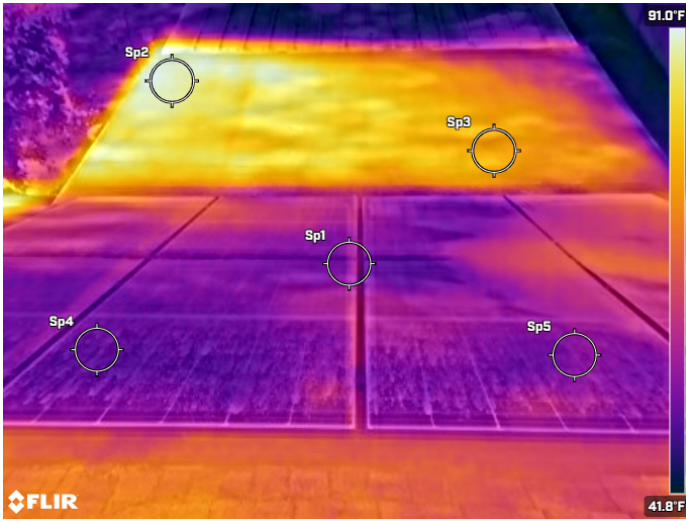
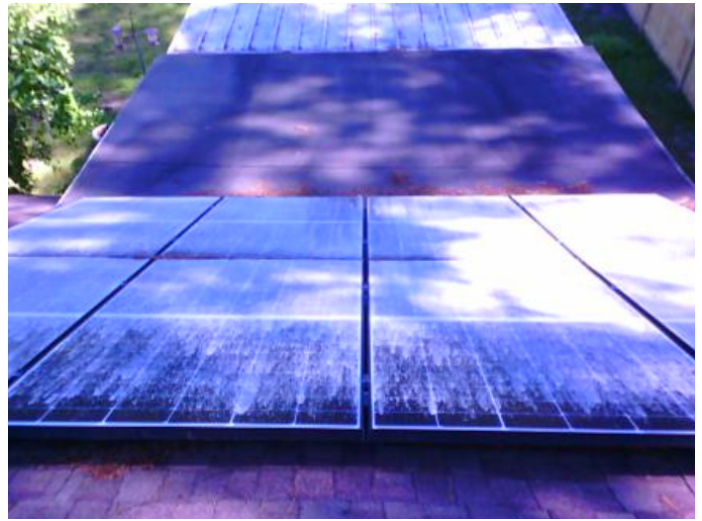
IR - FLIR0217 .jpg

⊕ Sp1	53.7 °F
⊕ Sp2	88.7 °F
⊕ Sp3	71.2 °F
⊕ Sp4	52.1 °F
⊕ Sp5	53.5 °F

REAR ARRAY. NO VISIBLE DAMAGE OR HOT SPOTS

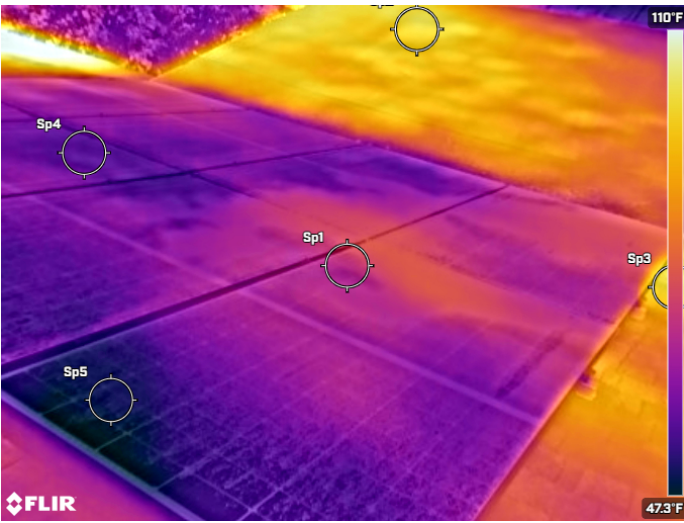
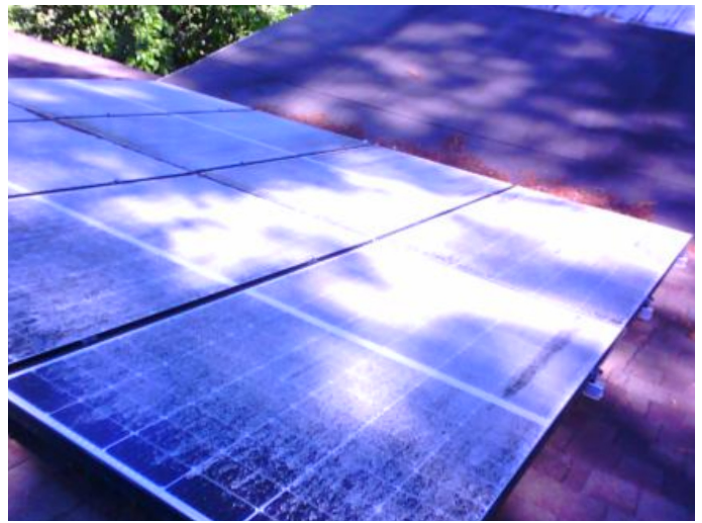
IR - FLIR0218 .jpg

⊕ Sp1	64.6 °F
⊕ Sp2	92.8 °F
⊕ Sp3	91.9 °F
⊕ Sp4	57.3 °F
⊕ Sp5	51.6 °F

REAR ARRAY. NO VISBLE DAMAGE OR HOT SPOTS.

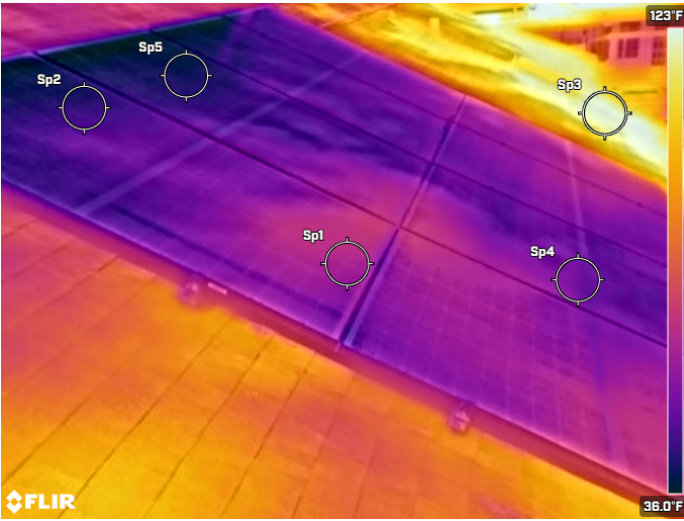
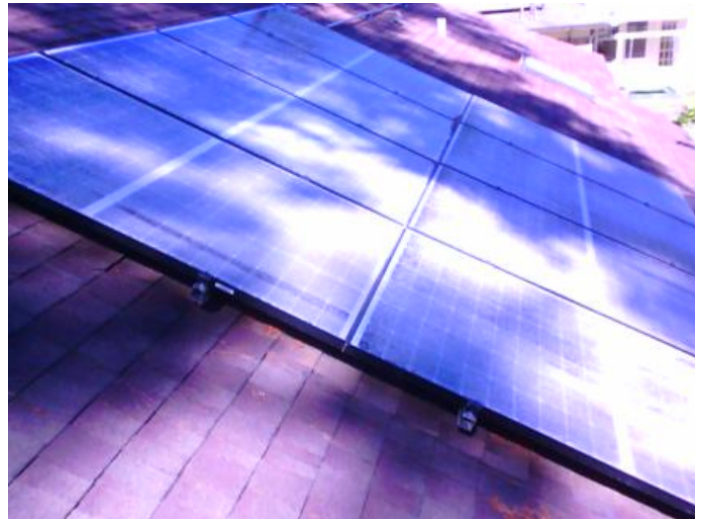
IR - FLIR0219 .jpg

⊗ Sp1	62.0 °F
⊗ Sp2	48.9 °F
⊗ Sp3	122 °F
⊗ Sp4	55.3 °F
⊗ Sp5	44.2 °F

REAR ARRAY. NO VISIBLE DAMAGE OR HOT SPOTS

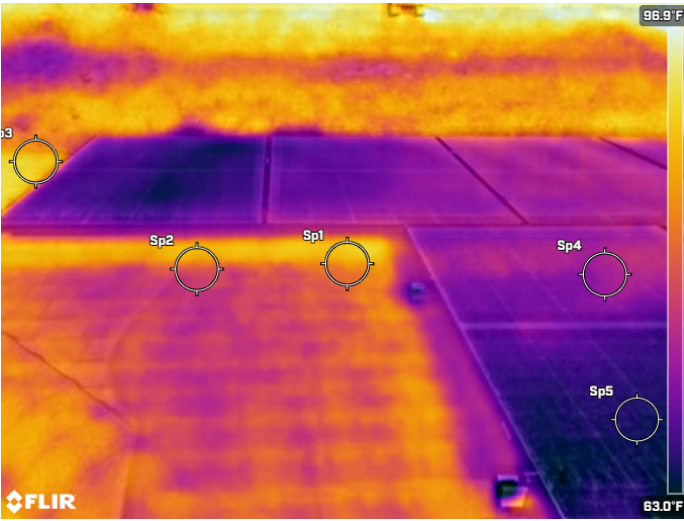
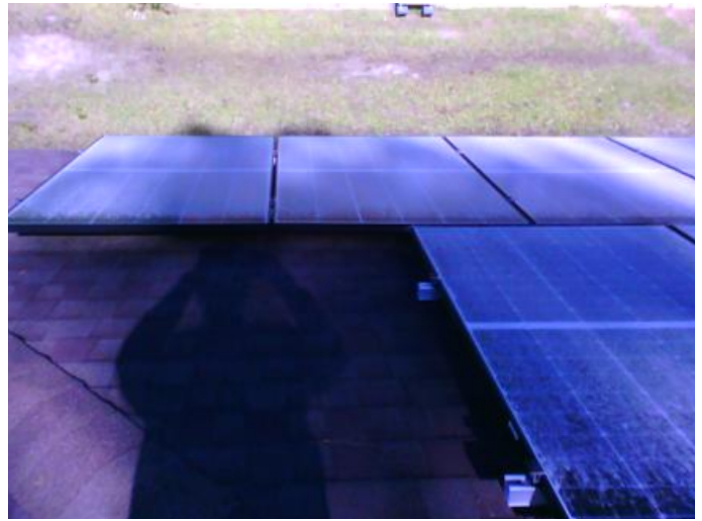
IR - FLIR0220 .jpg

⊗ Sp1	82.0 °F
⊗ Sp2	77.3 °F
⊗ Sp3	87.0 °F
⊗ Sp4	72.7 °F
⊗ Sp5	66.3 °F

LEFT SIDE ARRAY. NO VISIBLE DAMAGE OR HOT SPOTS.

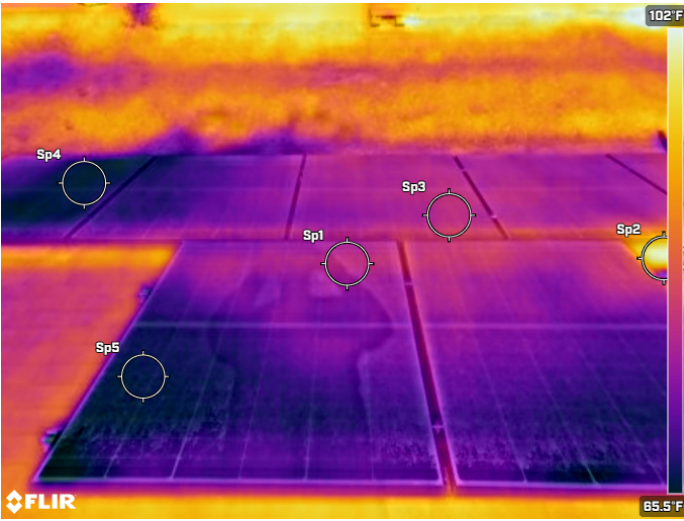
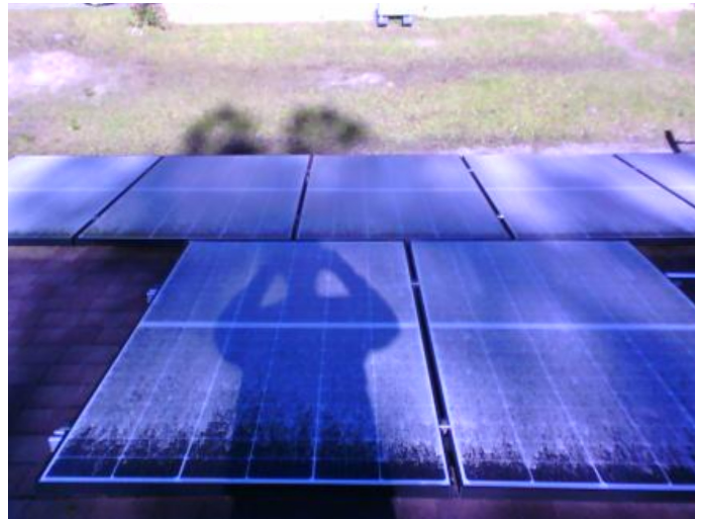
IR - FLIR0221 .jpg

⊗ Sp1	75.7 °F
⊗ Sp2	99.1 °F
⊗ Sp3	75.4 °F
⊗ Sp4	66.3 °F
⊗ Sp5	67.0 °F

LEFT SIDE ARRAY. NO VISBLE DAMAGE OR HOT SPOTS.

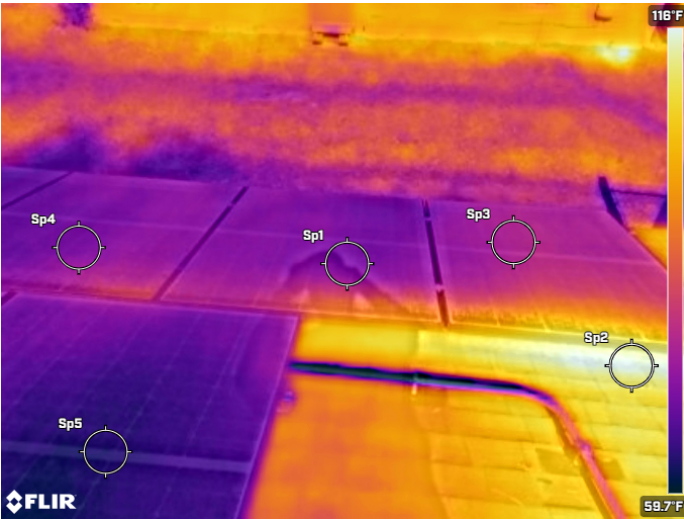
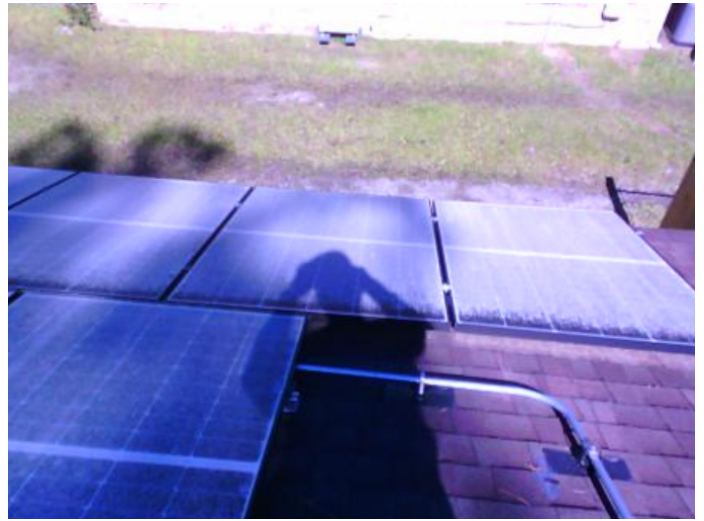
IR - FLIR0222 .jpg

⊕ Sp1	74.7 °F
⊕ Sp2	116 °F
⊕ Sp3	78.7 °F
⊕ Sp4	74.6 °F
⊕ Sp5	67.6 °F

LEFT SIDE ARRAY. NO VISIBLE DAMAGE OR HOT SPOTS.
