WOOD DESTROYING PESTS AND ORGANISMS INSPECTION REPORT

Building Address: 930 Philinda Av., Santa Barbara, 93103		Date of Inspection 07/21/2025	Number of Pages 7
<div style="text-align: center;"> jhonny@jhonnyspestcontrol.com P: 805 685 4848 F: 805 845 4841 2625 Wild Oak Rd., Lompoc, CA 93436 </div>		 <small>AG - 37925 PR - 7204</small>	Report # W16789
		Lic. Registration # PR 7204	
		Escrow #	
Ordered by: <div style="background-color: black; width: 100px; height: 20px; margin: 5px 0;"></div> 930 Philinda Av. Santa Barbara, 93103	Property Owner and/or Party of Interest: <div style="background-color: black; width: 100px; height: 20px; margin: 5px 0;"></div> 930 Philinda Av. Santa Barbara, 93103	Report Sent to: <div style="background-color: black; width: 100px; height: 20px; margin: 5px 0;"></div> 930 Philinda Av. Santa Barbara, 93103	
COMPLETE REPORT <input checked="" type="checkbox"/> LIMITED REPORT <input type="checkbox"/> SUPPLEMENTAL REPORT <input type="checkbox"/> REINSPECTION REPORT <input type="checkbox"/>

General Description: One and two story apartment building, clay tile roof, stucco sided on slab foundation with attached carports		Inspection Tag Posted: Attic	
		Other Tag

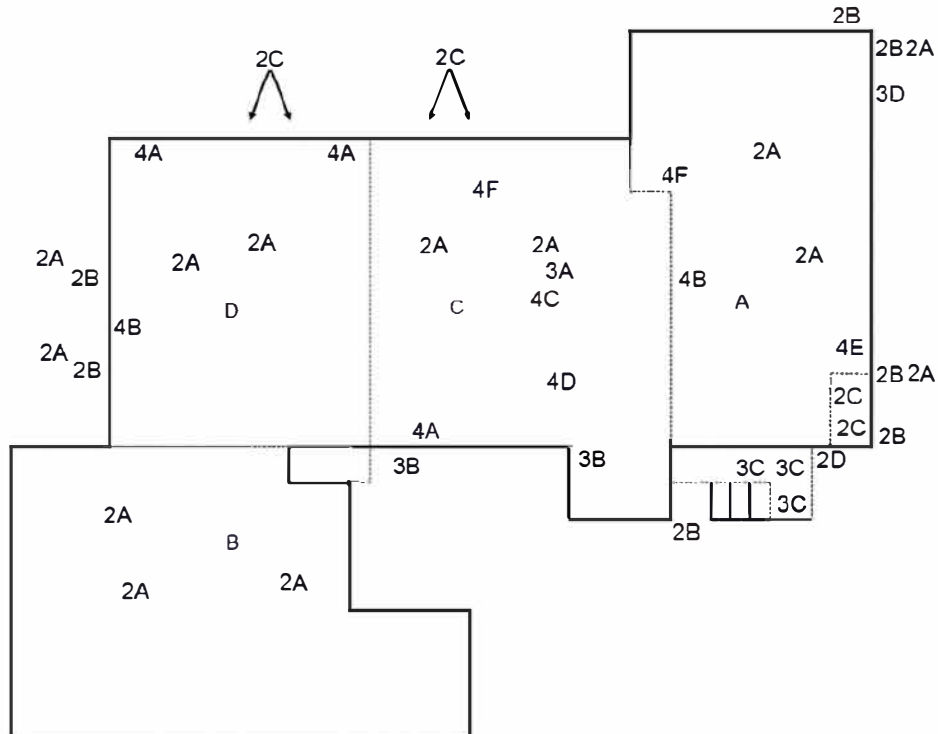
This Diagram is not to scale

2A PRICE: \$5,200.00 (Section I)
FINDINGS: Evidence of dry-wood termite infestations at attic and exterior as indicated on the diagram.
RECOMMENDATION: RECOMMENDATION: Cover and seal the ENTIRE STRUCTURE to fumigate for the control dry wood termites. Zythor gas will be used as the fumigant in combination with chloropicrin as warning agent. Although we take every precaution we can not be responsible for damage to plant, paint, roof, gutters and/or antennas. FUMIGATION HAS A THREE (3) YEAR GUARANTEE.
NOTE: If it is necessary to use masking/glue/adhesive tape on your fumigation, we assume no responsibility for damages caused by peeling paint or paint discoloration.
NOTE: Often properties indicate droppings which we indicate owners to remove or mask over droppings for future reference.
NOTE: Many tiles roof are more lighter weight than traditional tiles. This type is subject to much more breakage than standard tile roof. While all precautions will be taken, Jhonny's Pest Control will not be responsible for damages should they occur, nor will we accept liability. A roof release will be required prior to fumigation. Climbing plants and vines and or trellises must be removed prior to the fumigation crew arrival. To lessen damage to the shrubbery in close proximity to the structure(s), ALL TREES, PLANTS AND FOILAGE, must be cut back at least 6-8 inches from the structure(s) walls. Plants left unattended that are too close to the building to allow proper seal will die or be damaged in the fumigation. Jhonny's Pest Control will not assume responsibility for such damage.

2B PRICE: \$1,465.00 (Section I)
FINDINGS: Evidence of drywood termite damaged wood members noted at time of inspection at eaves, rafter beams, 4x10 balcony header, and corbals as indicated on the diagram.
RECOMMENDATION: Replace, Repair or reinforce termite damaged wood members as necessary. Primer is included in this estimate only if needed. If additional adverse conditions are uncovered during repairs, a further inspection will be recommended and a supplemental report will be issued indicating any infection or additional repairs.

2C PRICE: \$1,684.00 (Section I)
FINDINGS: Evidence of drywood termite damaged wood members noted at time of inspection at balconies and railings as indicated on the diagram.
RECOMMENDATION: Replace, Repair or reinforce termite damaged wood members as necessary. Primer is included in this estimate only if needed. If additional adverse conditions are uncovered during repairs, a further inspection will be recommended and a supplemental report will be issued indicating any infection or additional repairs.

2D PRICE: \$360.00 (Section I)
FINDINGS: Evidence of drywood termite damaged wood members noted at time of inspection at wood trims as indicated on the diagram.
RECOMMENDATION: Replace, Repair or reinforce termite damaged wood members as necessary. Primer is included in this estimate only if needed. If additional adverse conditions are uncovered during repairs, a further inspection will be recommended and a supplemental report will be issued indicating any infection or additional repairs.

- 3A PRICE: \$245.00 (Section I)
FINDINGS: Evidence of fungus damaged wood members noted at time of inspection at bathroom trims floor as indicated on the diagram.
RECOMMENDATION: Replace, Repair or Reinforce fungus damaged wood members as necessary. Primer is included in this estimate if needed. If, during the course of repairs, damage is found to extend into previously inaccessible areas, a supplemental report will be issued with additional findings and costs for further repairs.

- 3B PRICE: \$385.00 (Section I)
FINDINGS: Evidence of fungus damaged wood members noted at time of inspection at door jambs as indicated on the diagram.
RECOMMENDATION: Replace, Repair or Reinforce fungus damaged wood members as necessary. Primer is included in this estimate if needed. If, during the course of repairs, damage is found to extend into previously inaccessible areas, a supplemental report will be issued with additional findings and costs for further repairs.

- 3C PRICE: \$6,100.00 (Section I)
FINDINGS: Evidence of fungus damaged wood members noted at time of inspection at stairway framing as indicated on the diagram.
RECOMMENDATION: Replace stair case framing and damage steps fungus damaged wood members as necessary.

- 3D PRICE: See 2D (Section I)
FINDINGS: Evidence of fungus damaged wood members noted at time of inspection at wood tirms as indicated on the diagram.
RECOMMENDATION: Replace, Repair or Reinforce fungus damaged wood members as necessary. Primer is included in this estimate if needed. If, during the course of repairs, damage is found to extend into previously inaccessible areas, a supplemental report will be issued with additional findings and costs for further repairs.

- 4A PRICE: Unknown (Section II)
FINDINGS: Water stains noted at time of inspection at the door trim, boards as indicated on the diagram.
RECOMMENDATION: Contact proper tradesman to inspect for cause of water stains and correct if needed.

- 4B PRICE: Unknown (Section II)
FINDINGS: Water stains noted at time of inspection underneath the bathroom sink as indicated on the diagram.
RECOMMENDATION: Contact proper tradesman to inspect for cause of water stains and correct if needed.

- 4C PRICE: Unknown (Section II)
FINDINGS: Damaged wall plaster to bathroom.
RECOMMENDATION: Contact proper tradesman to correct as needed.
- 4D PRICE: Unknown (Section II)
FINDINGS: Water stains noted at time of inspection at the interior ceiling as indicated on the diagram.
RECOMMENDATION: Contact proper tradesman to inspect for cause of water stains and correct if needed.

- 4E PRICE: Unknown (Section II)
FINDINGS: Excessive moisture condition noted at time of inspection at and damaged ceiling inside closet as indicated on the diagram.

RECOMMENDATION: We recommend that owner or interested parties contact a tradesperson in this line of work to determine the source of this moisture and make necessary corrections.
- 4F PRICE: Unknown (Section II)
FINDINGS: There are cracks to the bathroom and bedroom floors and/or damaged stucco at the areas indicated which could permit the infiltration of moisture into the structural wood members.
RECOMMENDATION: Owner to contract other party to seal/repair cracked and/or damaged areas to maintain a watertight seal.
-
