STEADFAST HOME INSPECTION

## PROPERTY INSPECTION REPORT

118 Chapala St  
Santa Barbara, CA 93101

11/20/2025

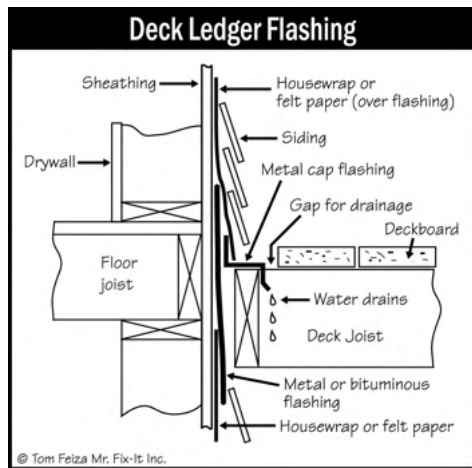
**LEDGER BOARD IMPROPERLY INSTALLED**

The ledger board was not properly attached to the building. This can cause the added structure to pull away from the building and possibly collapse. Recommend that the ledger board be properly attached by qualified contractor.

Common defects include being attached over the siding and not having the proper number or spacing of bolts or lag screws.

Contact a qualified general contractor.

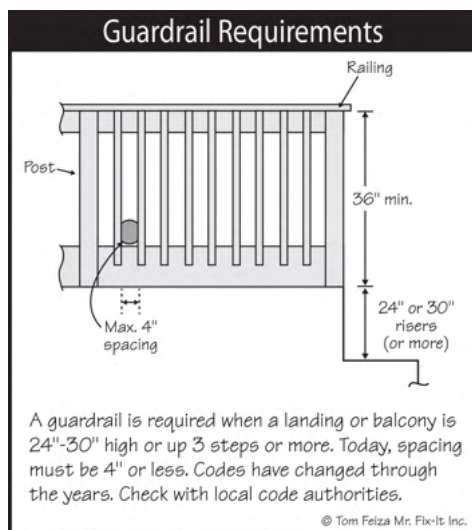
M086

**GUARDRAIL DEFECT**

Guardrail was loose, missing or improperly installed.

Contact a qualified general contractor.

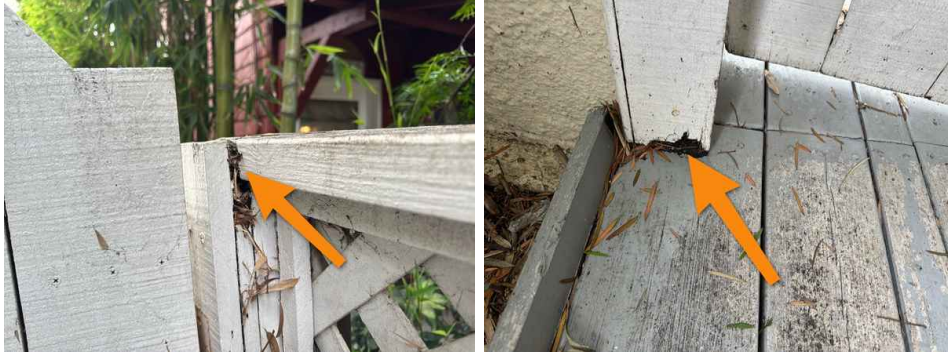
**WOOD DECAY**

Wood decay observed, which should be repaired or replaced to reduce chances of further decay or moisture intrusion. Source of moisture should also be investigated and eliminated.

Contact a qualified carpenter.

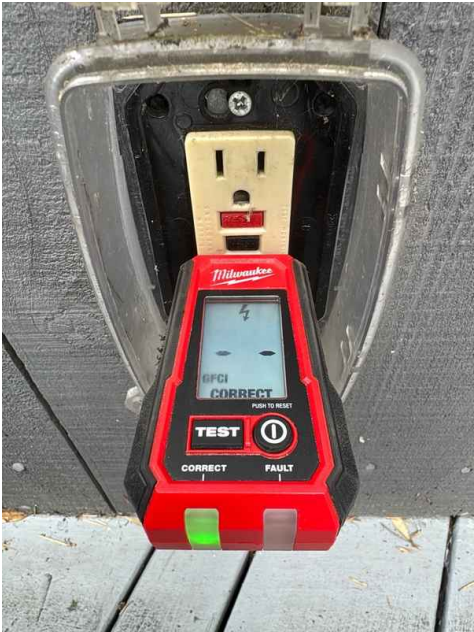
#### GFI DEFECT

GFI device was not functional. It did not trip when tested, would not reset after testing, or was mis-wired. GFI device should be repaired or replaced for occupants' safety.

Contact a qualified electrical contractor.

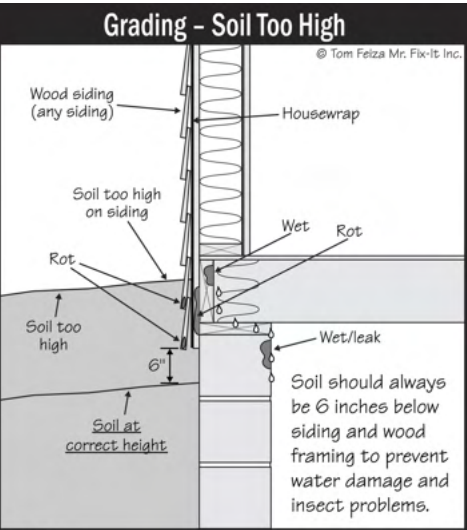
5060

**IMPROPER GROUND CLEARANCE**

Siding material was lower than recommended. Siding should be at least 6 inches above grade in order to minimize chances of water damage and termite infestation.

Contact a qualified siding specialist.

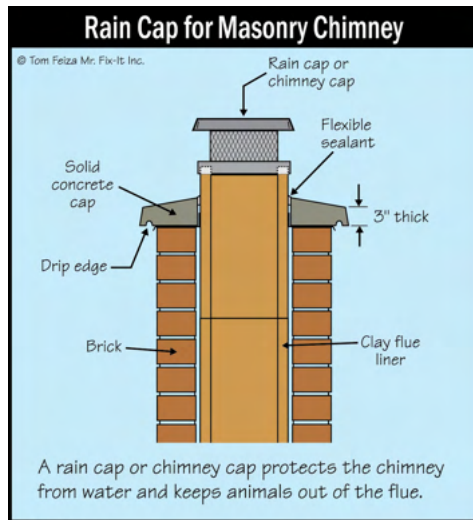
FO30C

**CHIMNEY CAP DEFECT**

Chimney cap was loose, damaged or missing. A cap should be installed to protect the crown of the chimney, as well as to help keep rain and pests out of the flue.

Contact a qualified chimney sweep.

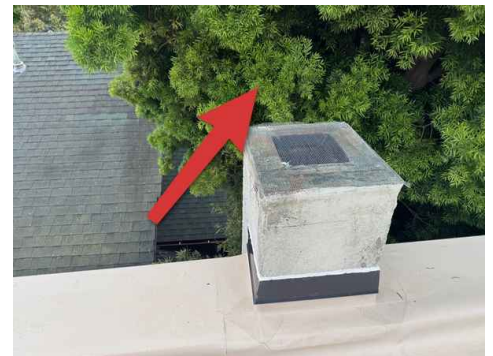
Chimney had tree limbs above it and around it. This can damage the chimney and is a potential fire hazard. Recommend trimming the tree limbs away from the chimney. A general rule is to keep limbs at least 10 feet away and 2 feet below any nearby chimney.

Contact a qualified tree service company.

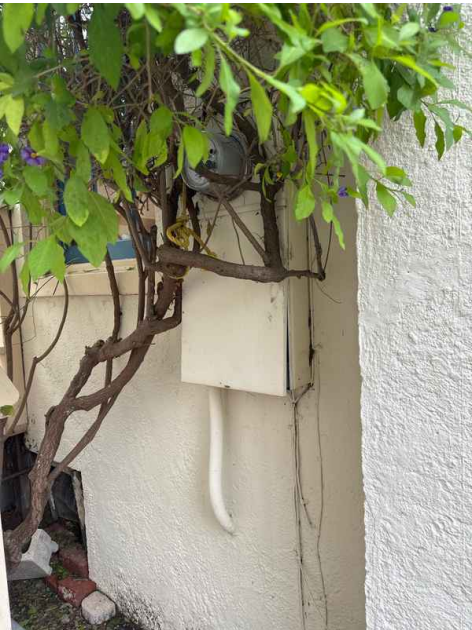
Service Panel Overview  
**COVER NOT REMOVED**

The inspector either could not remove the dead front cover of the panel, or it was not safe to do so at the time of the inspection. Removing this cover is beyond the scope of our Standard of Practice, but is done whenever possible and can often uncover defects within the electrical panel. Recommend evaluation of the panel by a qualified electrician when it is possible to do so.

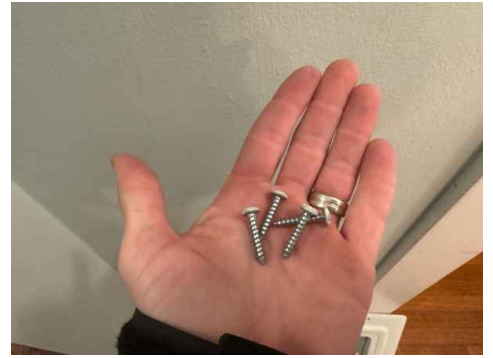
**IMPROPER SCREW**

Incorrect screw used for securing cover. Sharp, coarse-thread screws are more likely to pinch conductors, causing shorts and/or arcing. Recommend replacement with blunt, fine-thread screws.

Contact a qualified electrical contractor.

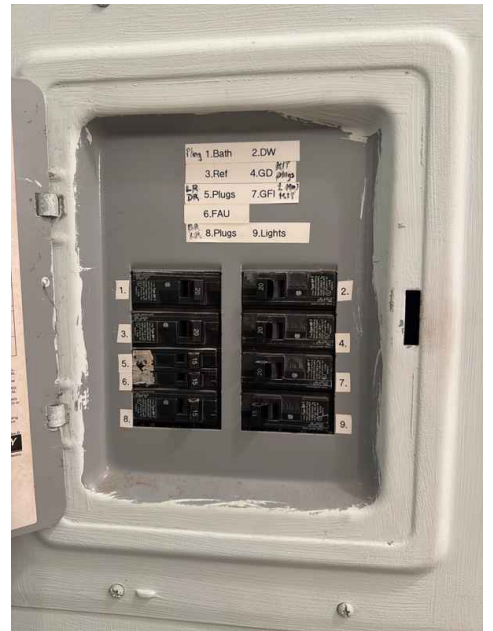
No Arc-Fault Circuit Interrupter (AFCI) devices were installed in the panel (or not at all recommended circuits). Though not required when this home was built, AFCIs are now called for at all circuits feeding lights or receptacles in bedrooms, living rooms and hallways. They help protect against electrical fires caused by electrical arcing both at the installed wiring in the walls and anything plugged into the protected outlets. Recommend installation of AFCI devices as a safety upgrade.

Contact a qualified electrical contractor.
