STEADFAST HOME INSPECTION

## PROPERTY INSPECTION REPORT

4676 Gerona Way  
Santa Barbara, CA 93110

09/10/2024

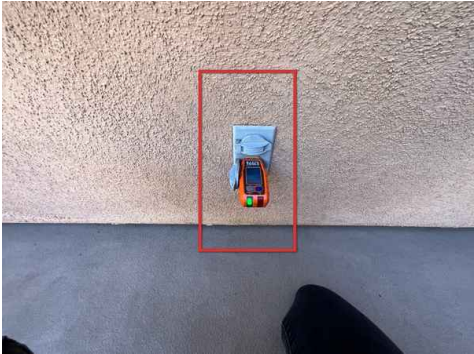
Receptacle outside was not GFI-protected. Current practice calls for all outdoor receptacles to be GFI-protected in order to help reduce the risk of shock in wet areas. Recommend installation for occupants' safety.

Contact a qualified electrical contractor.

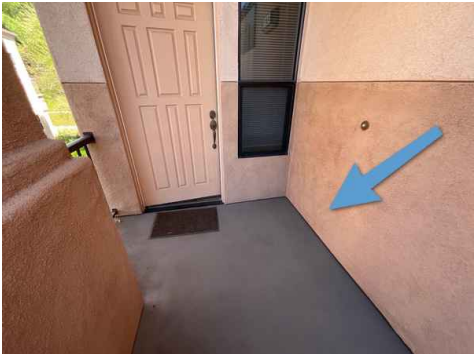
### 5.9.1 Exterior Electrical

#### OUTSIDE RECEPTACLES MISSING

Few electrical receptacles were observed outside the home. This is typical of older homes, but current practice requires at least one GFI receptacle at the front and one at the rear of any home. Additionally, any deck or balcony should have at least one GFI receptacle accessible from the surface.

Contact a qualified electrical contractor.

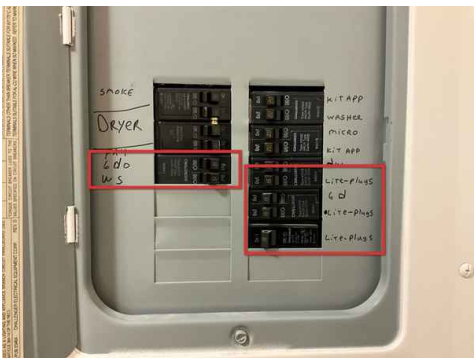
12.2.2 Subpanel

**LEGEND DEFECT**

Distribution panel was lacking a legend or legend was incomplete or outdated. The legend describes each circuit in a way that is clear and unambiguous. Recommend labeling each circuit.

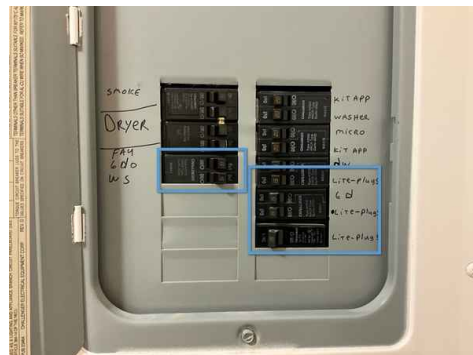
## 12.2.3 Subpanel

No Arc-Fault Circuit Interrupter (AFCI) devices were installed in the panel (or not at all recommended circuits).

Though not required when this home was built, AFCIs are now called for at all circuits feeding lights or receptacles in bedrooms, living rooms and hallways. They help protect against electrical fires caused by electrical arcing both at the installed wiring in the walls and anything plugged into the protected outlets. Recommend installation of AFCI devices as a safety upgrade.

Contact a qualified electrical contractor.

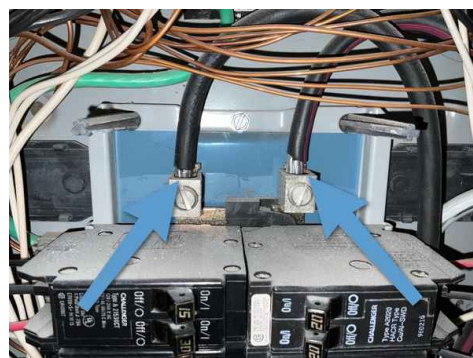
**CONDUCTIVE PASTE NOT OBSERVED**

Conductive paste is recommended out of an abundance of caution where stranded aluminum conductors are used. Though stranded aluminum conductors are not as dangerous as the solid aluminum type, conductive paste could be applied at the lugs to help further reduce the risk of electrical fire.

Contact a qualified electrical contractor.

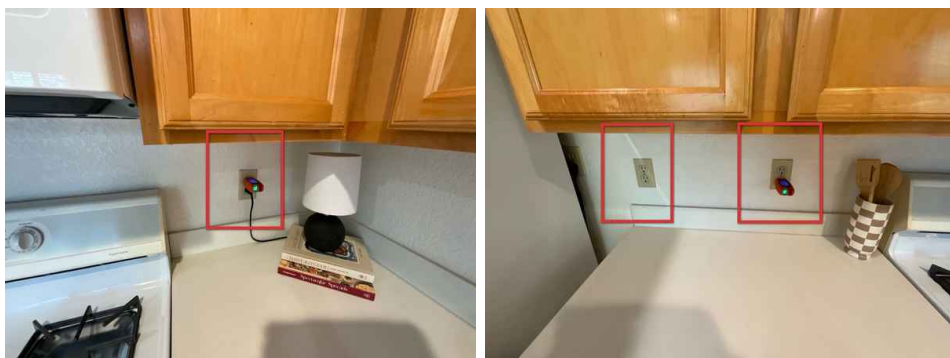
Receptacle at Kitchen counter was not GFI-protected. Current practice calls for all receptacles that serve Kitchen counters to be GFI-protected in order to help reduce the risk of shock in wet areas. Recommend installation for occupants' safety.

Contact a qualified electrical contractor.

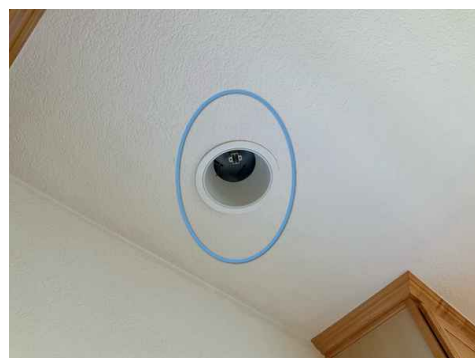
## 13.7.1 Lighting

**BULB OUT**

Light fixture had a bulb **missing** or burnt out. Recommend replacement of bulb and testing of fixture.

Contact a handyman or DIY project

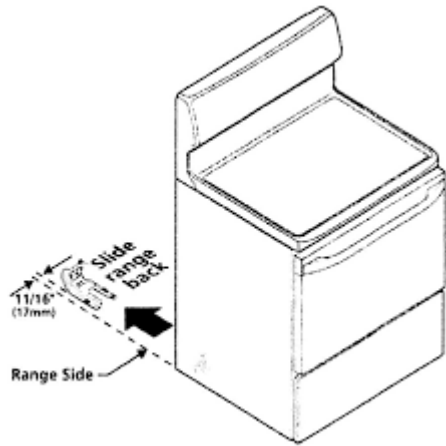
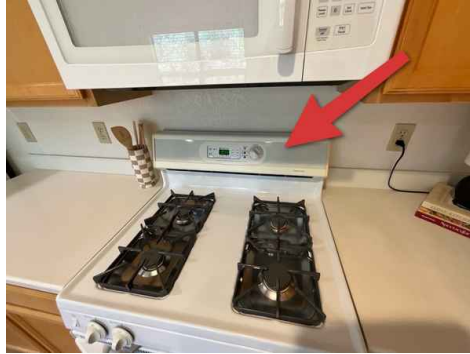
## 13.14.1 Cooking

**ANTI-TIP BRACKET NOT PRESENT**

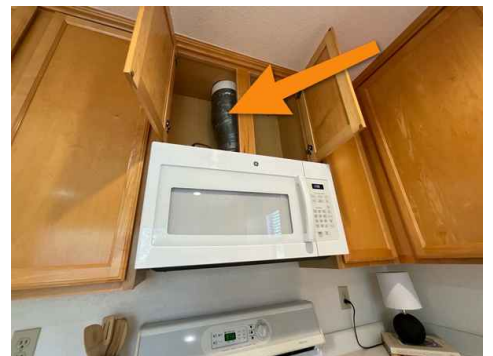
## 13.16.1 Ventilator

**WRONG TAPE AT VENT**

Vent duct was sealed with the wrong type of tape and should be repaired. Heat-resistant aluminum foil duct tape is the only tape that should be used for sealing metal ductwork.

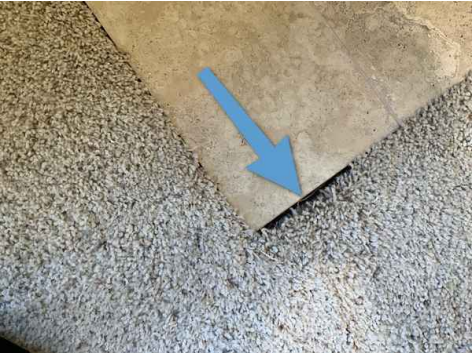
#### CARPET DEFECT

Carpet had a defect, such as a loose seam, ripple(s) or visible wear. Defects can become trip hazards. Recommend monitoring, repairing or replacing carpet.

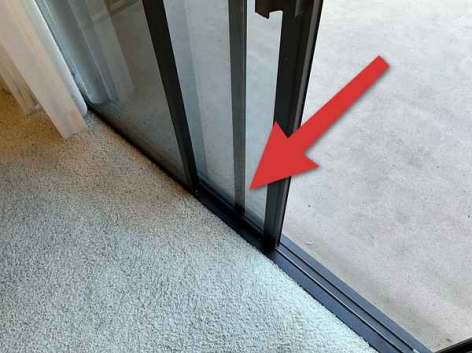
### 14.4.1 Door(s)

#### SLIDING PANE OUTSIDE

Sliding door had the moving pane on the outside. While this is typical of older sliding doors, it is a security risk because the outer pane can be more easily removed, providing entry into the home. Recommend correction for security purposes.

Contact a qualified door repair/installation contractor.

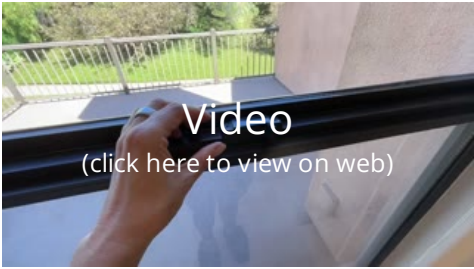
14.5.1 Windows

**HARDWARE DEFECT**

Window hardware was **broken** or missing. Recommend repair or replacement.

Contact a qualified window repair/installation contractor.

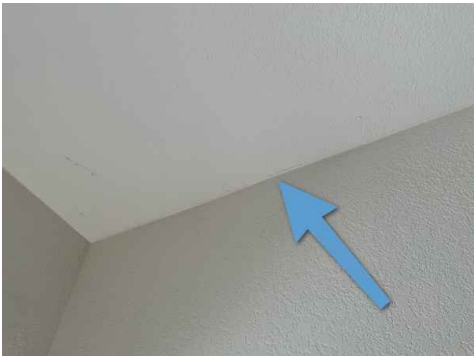
### CRACKS - TYPICAL

Surface was cracked. Crack appeared typical of normal settling and not indicative of a larger problem.

Recommendation  
Recommend monitoring.

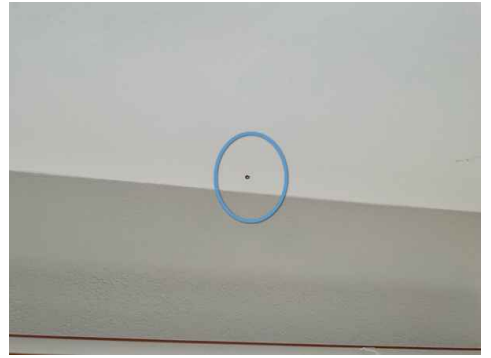
## 15.2.2 Walls &amp; Ceiling

**SURFACE DAMAGE**

Surface had a gap, dent or hole and should be repaired.

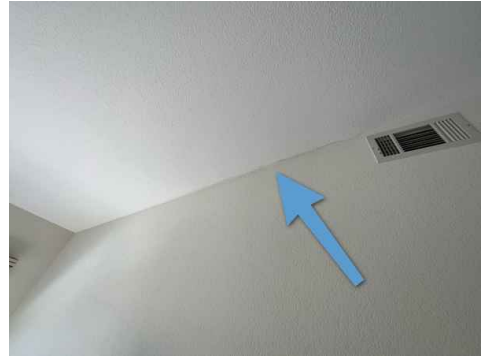
## 15.2.3 Walls &amp; Ceiling

**PATCHED CRACK**

A patched crack was evident at wall or ceiling. While settling and cracks are normal, cracks that grow large or are wider at one end than the other can indicate larger problems. Recommend monitoring.

Recommend monitoring.

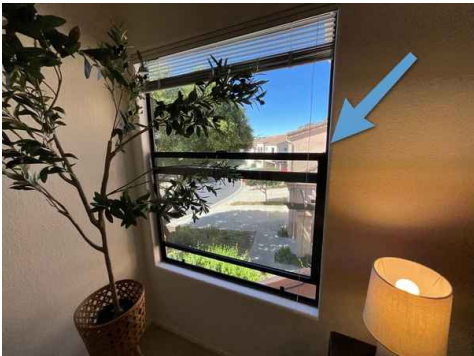
Window was **difficult** or not able to open/close. Recommend repair or adjustment.

Contact a qualified window repair/installation contractor.

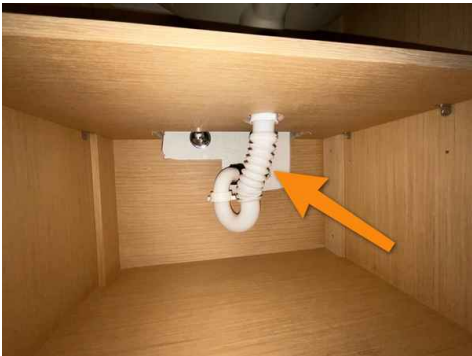
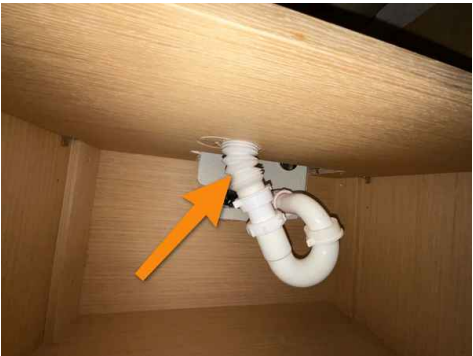
**FLEXIBLE PLUMBING**  
Drain used flexible style pipe. This will likely lead to slow/clogged drains. Recommend replacement with a solid PVC trap.

Recommendation  
Contact a qualified plumbing contractor.

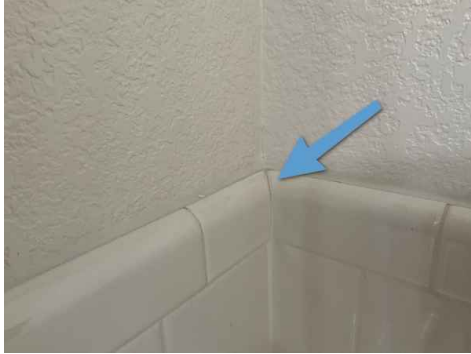
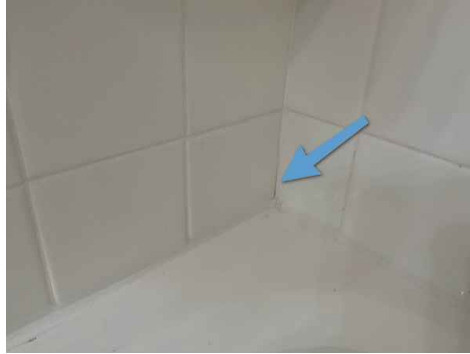
## 18.15.1 Tub / Shower Enclosure

**GROUT DEFECT**

Grout was damaged or missing and should be repaired. Grout holds the tiles in place and helps keep water from penetrating between the tiles.

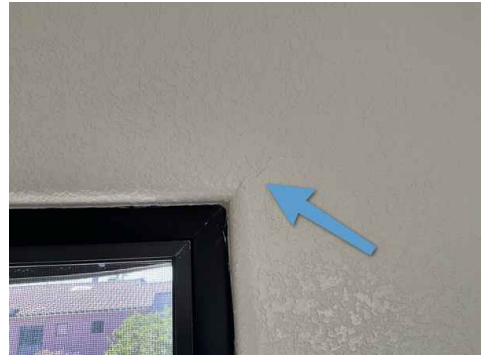
## 19.4.1 Walls &amp; Ceiling

**CRACKS - TYPICAL**

Surface was cracked. Crack appeared typical of normal settling and not indicative of a larger problem.

Recommend monitoring.

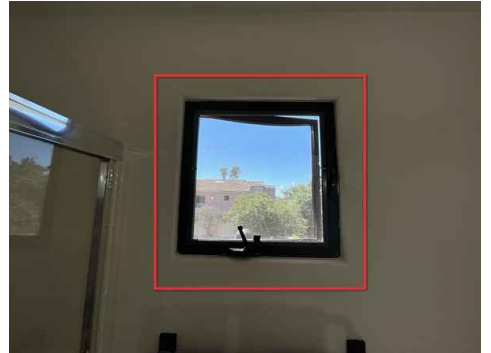
## 19.7.1 Windows

**SAFETY GLASS NOT OBSERVED IN BATHROOM**

Current practice calls for safety glass when used in and around showers and tubs (within 5 feet) when the bottom edge is less than 5 feet above the ground. Recommend correction for occupants' safety.

Safety glass (or tempered glass) can be identified by a marking etched into the glass. In certain cases, it is possible that safety glass is present, but the etching was not observed.

Contact a qualified window repair/installation contractor.

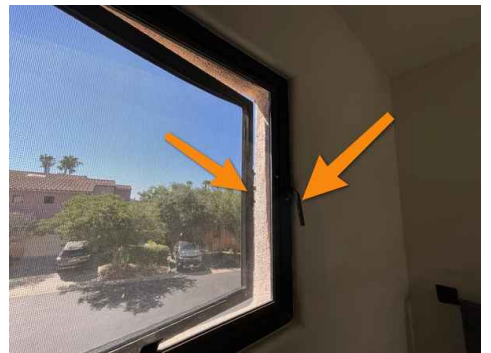
## 19.7.2 Windows

**LATCH DEFECT**

Window did not latch or lock properly and should be repaired for security purposes.

Contact a qualified window repair/installation contractor.

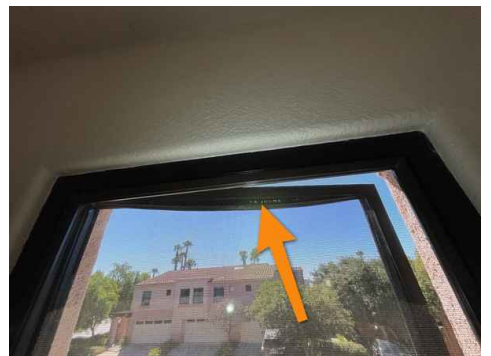
## 19.7.3 Windows

**SEAL DEFECT**

Window seal was **damaged** or deteriorated and may need replacement to help maintain a proper seal.

Contact a qualified window repair/installation contractor.

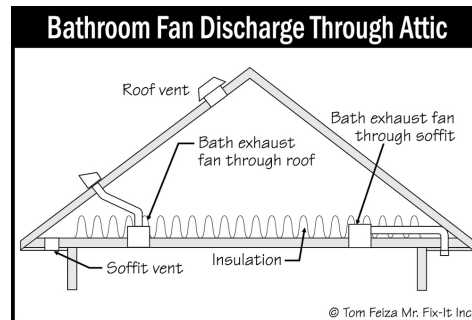
## 19.11.1 Ventilation

**RECOMMEND ADDING VENT FAN**

No ventilation fan was installed. Recommend adding to help remove moisture from the room. Though a window meets code, a fan is more effective and can be used in all seasons.

Contact a qualified general contractor.

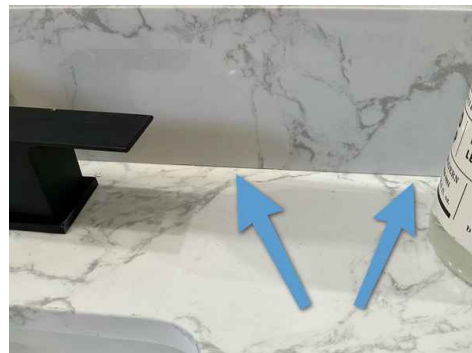
## 19.13.1 Counters

**CAULK DEFECT**

Caulk was damaged or **missing** and should be repaired. Damaged caulk could allow water to damage the cabinets or wall below.

Contact a qualified countertop contractor.

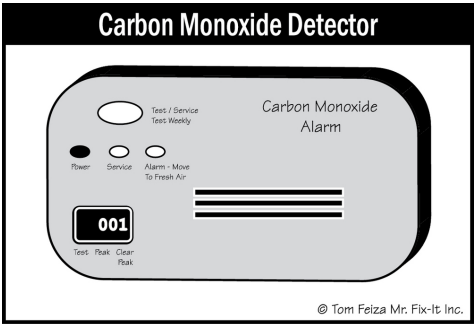
Current practice calls for a Carbon Monoxide (CO) Alarm outside of any sleeping area with at least one on each level of the home. Recommend installation for occupants' safety.

Contact a handyman or DIY project

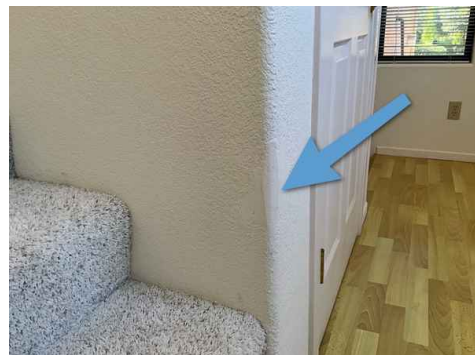
**REPAIRS OBSERVED**

Repairs were observed. This can indicate past damage, possibly moisture intrusion or pest damage. Recommend monitoring.

Recommend monitoring.

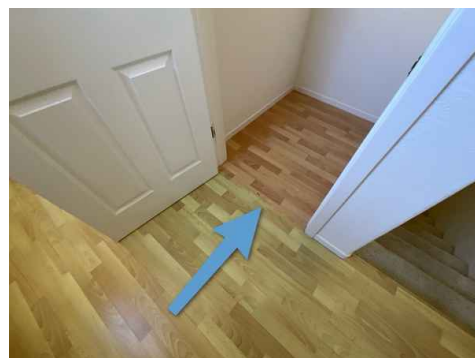
## 21.4.1 Floor

**SUN DAMAGE**

Floor was discolored due to sun damage. Condition is cosmetic in nature, but could be costly to correct.

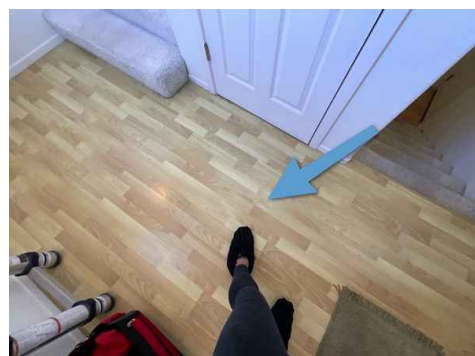
## 21.4.2 Floor

**CREAKY FLOOR**

The floor creaked, which is typically a sign of a loose subfloor. Unless other signs of settling were present, the creaking is unlikely to be a major concern.

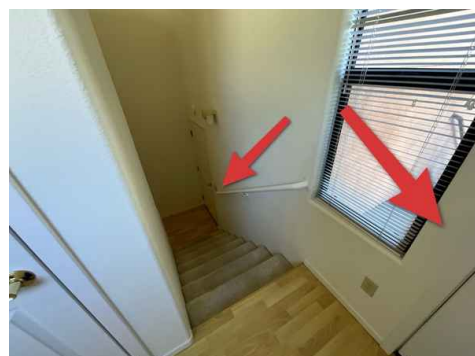
## 21.7.1 Lighting

**HALLWAY 3-WAY SWITCH**

Hall light was not operated by a 3-way switch. Current practice calls for the light in hallways over 6 feet long to be operable from either end of the hallway (via a 3-way switch). Recommend correction for occupants' safety.

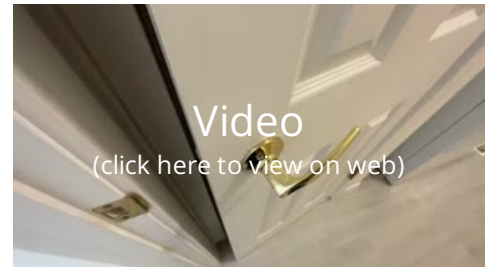
**KNOB DEFECT**

Door knob was **loose**, missing or not functional and should be corrected.

Contact a handyman or DIY project

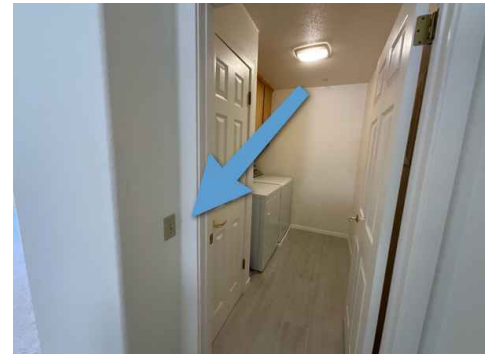
## 22.8.1 Lighting

The switch to operate the lights was located outside of the room, which could become a nuisance. Recommend evaluation by an electrician to determine the best solution.

Contact a qualified electrical contractor.

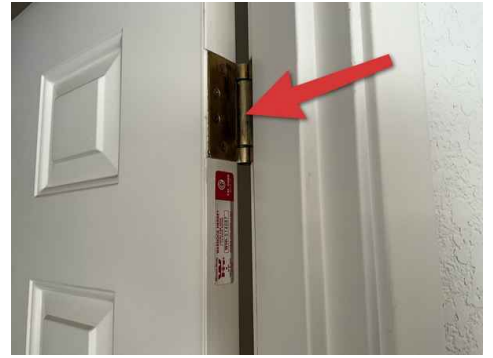
## 23.2.1 Fire Safety

**ADJUST CLOSING DEVICE**

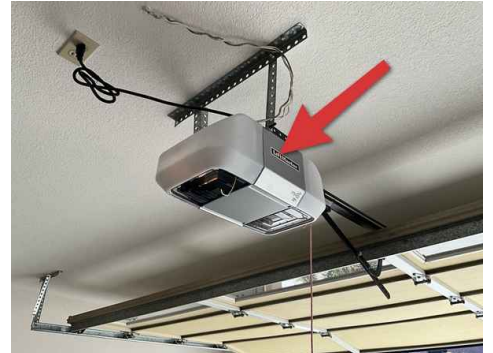
## 23.3.1 Garage Door &amp; Opener

**SAFETY REVERSE**

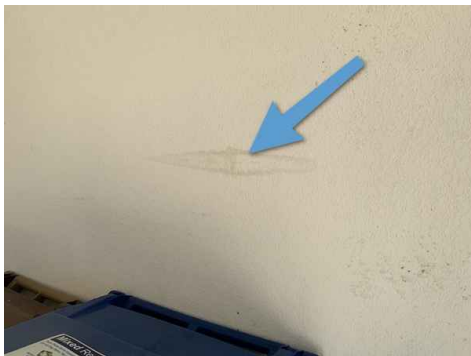
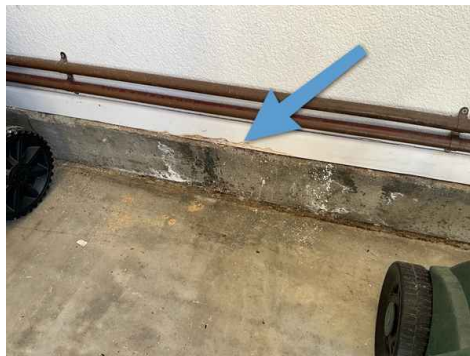
## 23.5.1 Walls &amp; Ceiling

**MOISTURE STAIN**

Surface had a discoloration or stain that was not currently wet. Recommend painting or cleaning and monitoring.

Recommend monitoring.

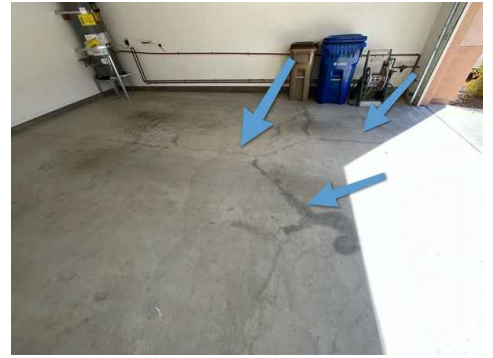
## 23.6.1 Floor

**TYPICAL CRACKING - GARAGE SLAB**

Garage slab had crack(s) that appeared typical. If cracks worsen, correction may be required. Garage slabs are typically poured separate from the home's foundation and do not usually reflect the condition of the home's slab.

Recommend monitoring.

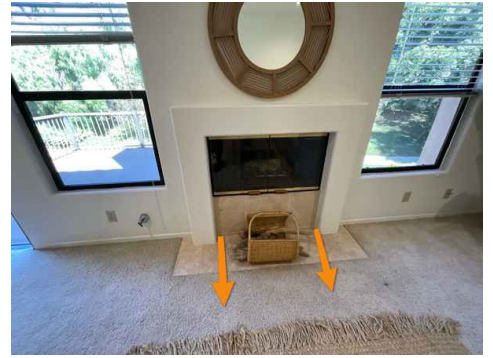
**HEARTH EXTENSION INSUFFICIENT**

Fireplace should have a hearth extension made of non-combustible material that extends at least 16 inches in front of and 8 inches beyond the side of the face of the fireplace.

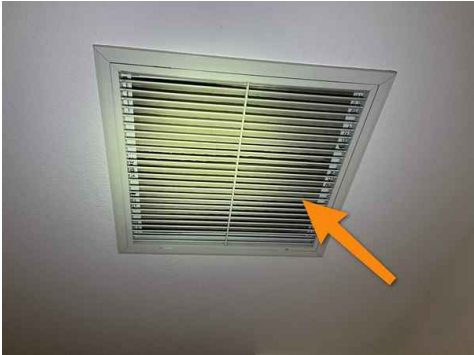
#### FILTER DEFECT

Filter was **dirty** or improperly installed and should be cleaned or replaced. Recommend following manufacturer's recommendations for changing the HVAC system filter(s).

Recommendation  
Recommended DIY Project

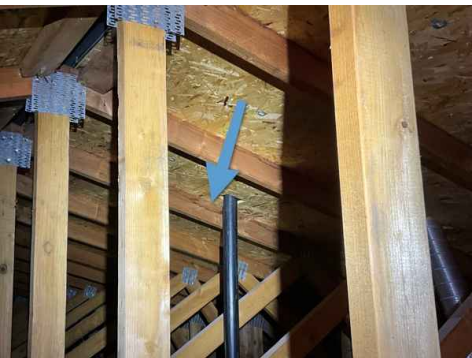
**MOISTURE STAIN**

Stains were noted on the sheathing or framing. No areas were currently wet. Recommend monitoring.

Recommend monitoring.
