# Residential Building Inspection Report

101 Tomahawk Dr, Pittsburgh, PA 15215

**Inspection Date:**  
2026-07-23

**Report Number:**  
0723260003BT

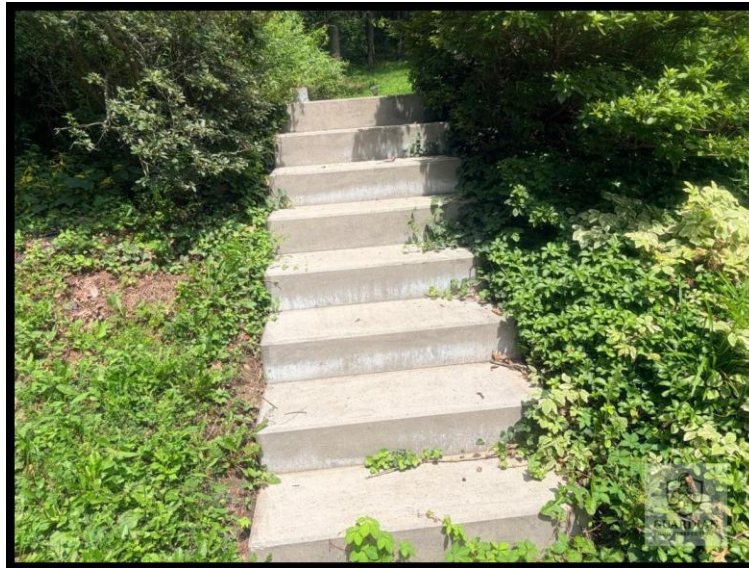
**Safety Concern:** A handrail was not observed at the exterior steps. Missing handrails increase the risk of slips and falls, particularly when steps are wet or debris-covered. A code-compliant handrail should be installed to provide safe support along the stair run. Correction should be performed by a qualified general contractor or handrail/railing contractor. (Figure [1](#))

**Figure 1: A handrail was not observed at the exterior steps.**

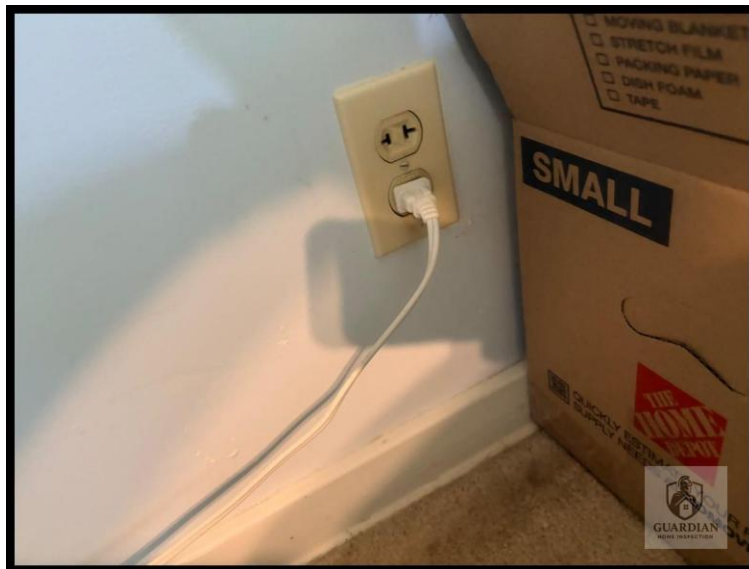
**Safety Concern:** Multiple ungrounded electrical receptacles were observed in the Living Room, Family Room, and Bedroom(s). Ungrounded outlets can increase the risk of electric shock and equipment damage and may indicate older or improperly modified branch-circuit wiring. The affected circuits should be evaluated and corrected by providing a proper equipment grounding conductor or installing approved protection/labeling as applicable. Corrections should be performed by a Licensed Electrician. (Figure [2](#))

**Figure 2: Multiple ungrounded electrical receptacles were observed in the Living Room, Family Room, and Bedroom(s).**

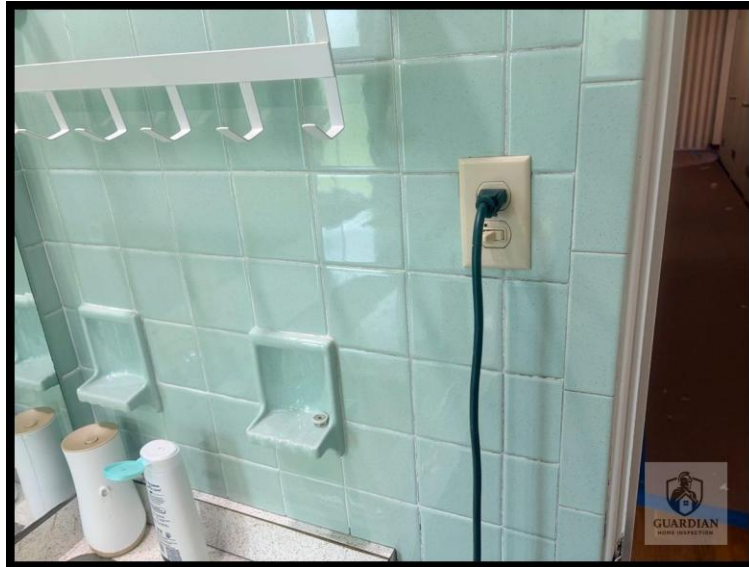
**Safety Concern:** No GFCI-protected outlets were observed in the bathroom. Lack of GFCI protection at bathroom receptacles is a safety concern because it increases the risk of electrical shock in a wet location. GFCI protection should be installed for bathroom receptacles by replacing receptacles with GFCI type and/or providing GFCI protection at the circuit as appropriate. Corrections should be performed by a Licensed Electrician. (Figure [3](#))

**Figure 3: No GFCI-protected outlets were observed in the bathroom.**

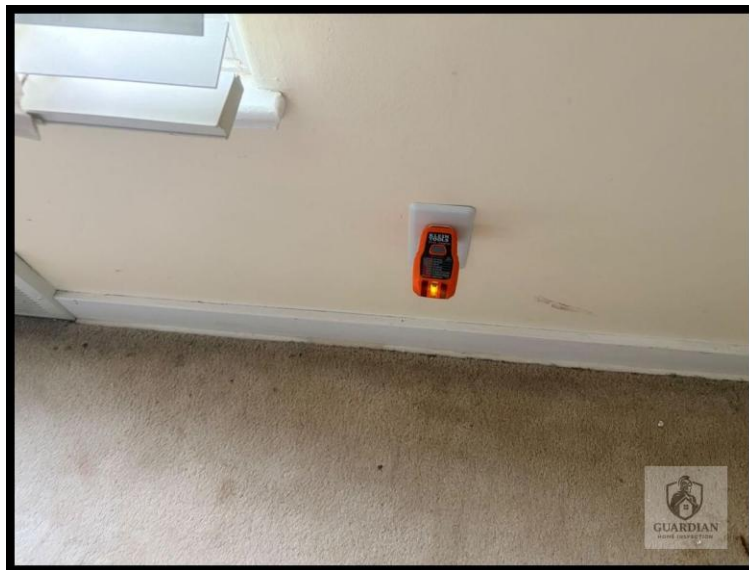
**Safety Concern:** Several receptacles in the bedroom tested as open ground at the time of inspection. An open equipment ground can reduce shock protection and may indicate improper wiring or missing/loose grounding connections. The affected circuit(s) should be evaluated to identify the cause and corrected by restoring an effective equipment grounding path and verifying proper polarity/grounding at all impacted outlets. Repairs and verification testing should be performed by a Licensed Electrician. (Figure [4](#))

**Figure 4: Several receptacles in the bedroom tested as open ground at the time of inspection.**

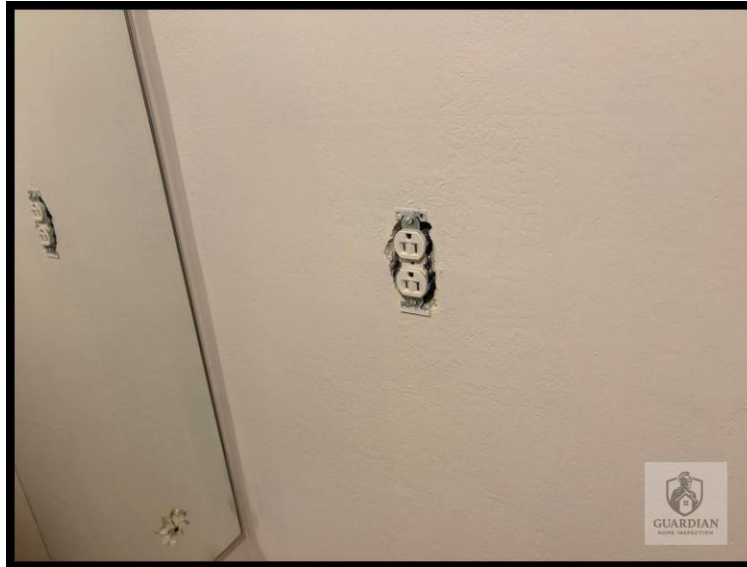
**Safety Concern:** GFCI protection was not present for receptacle(s) in the basement bathroom. Bathrooms are damp/wet locations where lack of GFCI protection increases the risk of electrical shock. GFCI protection should be added by installing a GFCI receptacle and/or providing GFCI protection at the appropriate upstream device (breaker or receptacle) and verifying proper operation. Repairs and verification should be performed by a Licensed Electrician. (Figure [5](#))

**Figure 5: GFCI protection was not present for receptacle(s) in the basement bathroom.**

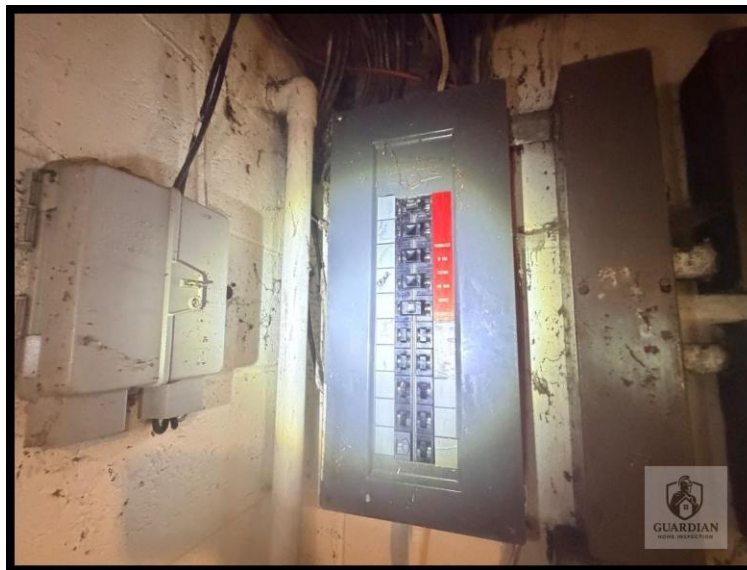
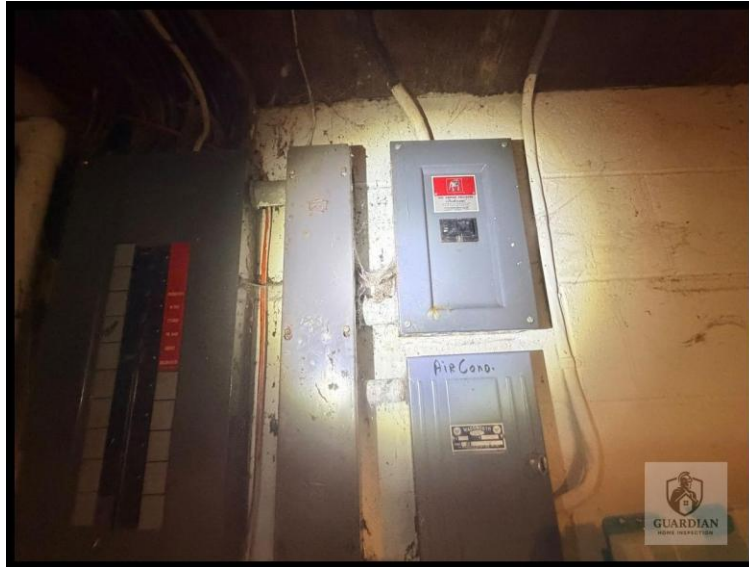
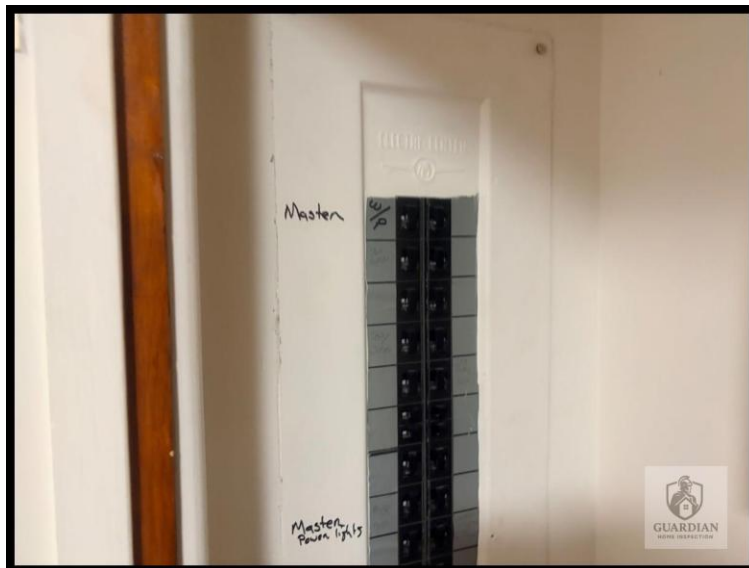
**Safety Concern:** Pushmatic-style breakers were observed at the main electrical panel and the subpanel in the basement. This breaker type is a known safety concern because breakers may not trip reliably, increasing the risk of electrical overheating and fire. Evaluation and correction are recommended, which may include replacement of the panels/breakers with modern equipment as appropriate. Repairs and any panel replacement should be performed by a licensed electrician. (Figures [6](#), [7](#), [8](#))

**Figure 6: Pushmatic-style breakers were observed at the main electrical panel and the subpanel in the basement.**

**Figure 7: Pushmatic-style breakers were observed at the main electrical panel and the subpanel in the basement.**

**Figure 8: Pushmatic-style breakers were observed at the main electrical panel and the subpanel in the basement.**

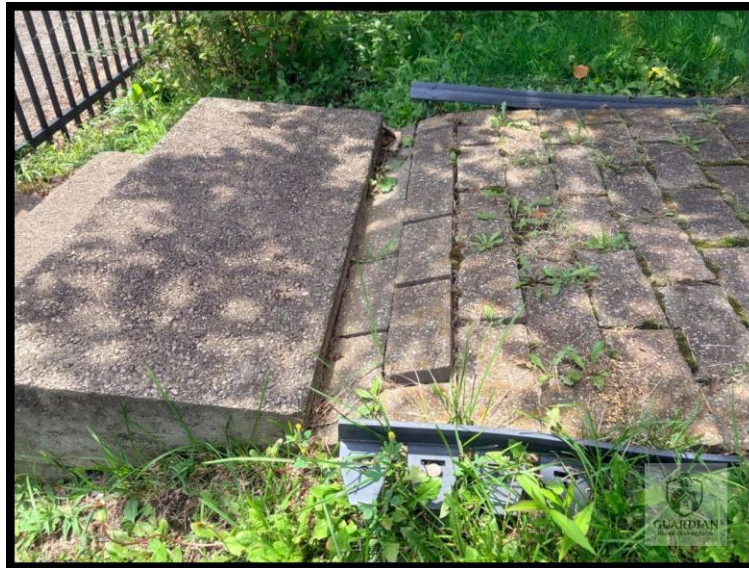
**General Repair:** The exterior paver walkway was observed to be uneven and deteriorated, with gaps between pavers and vegetation growth. This condition can create a trip hazard and may accelerate further displacement and deterioration of the pavers. Re-level and reset the affected pavers, address the base as needed, remove vegetation, and restore joint fill/sand to stabilize the walkway. Corrections should be performed by a qualified hardscape/landscaping contractor. (Figure [9](#))

**Figure 9: The exterior paver walkway was observed to be uneven and deteriorated, with gaps between pavers and vegetation growth.**

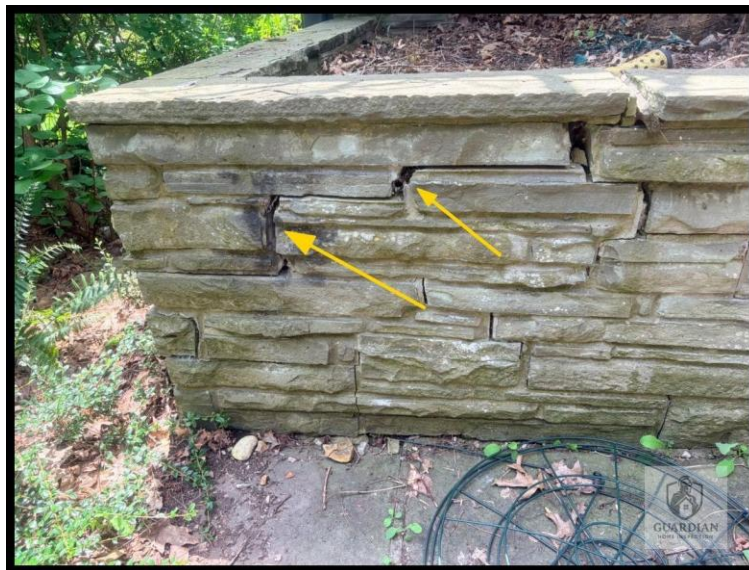
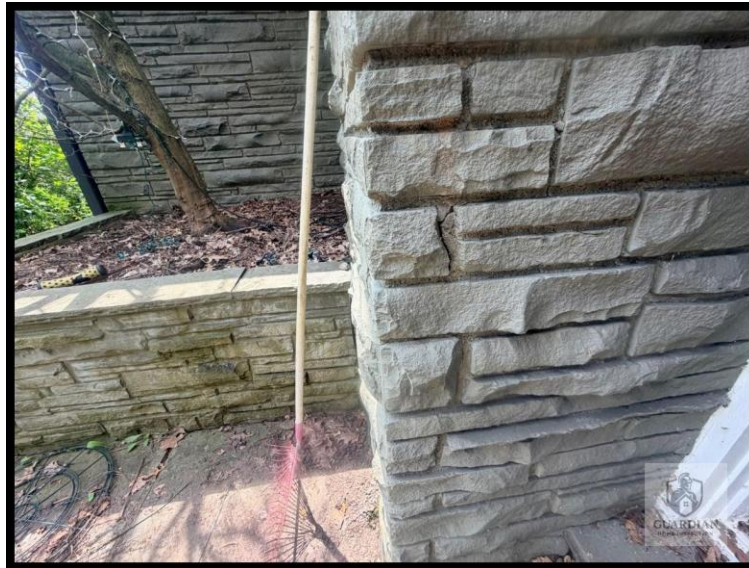
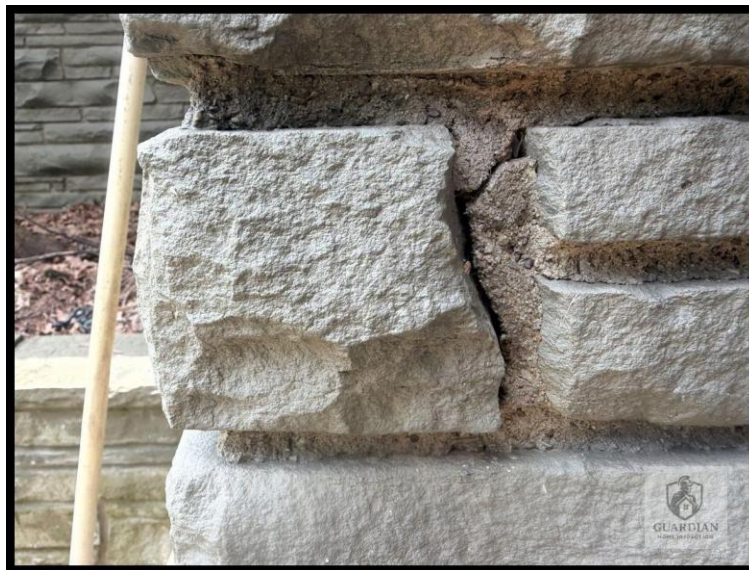
**General Repair:** Cracked and separating stone veneer/masonry was observed at the exterior, with displaced blocks and open joints consistent with movement. This condition can allow water intrusion behind the veneer and may worsen over time, potentially leading to further displacement and damage. Repairs should include evaluation of the affected area, stabilization as needed, and re-setting/repointing and sealing of displaced and separated sections as appropriate. Correction should be performed by a qualified masonry contractor. (Figures [10](#), [11](#), [12](#))

**Figure 10: Cracked and separating stone veneer/masonry was observed at the exterior, with displaced blocks and open joints consistent with movement.**

**Figure 11: Cracked and separating stone veneer/masonry was observed at the exterior, with displaced blocks and open joints consistent with movement.**

**Figure 12: Cracked and separating stone veneer/masonry was observed at the exterior, with displaced blocks and open joints consistent with movement.**

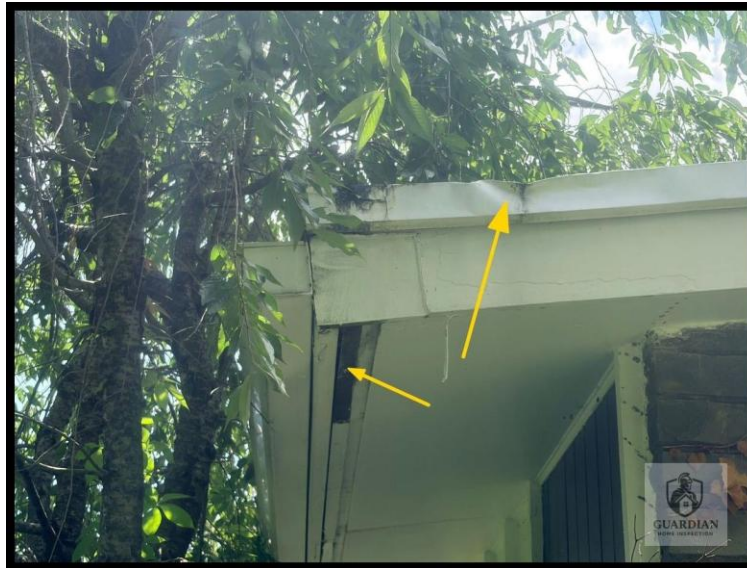
**General Repair:** Damage and missing wood were observed at the fascia/soffit along the roof edge at the exterior. This condition can allow moisture intrusion and pest entry and may contribute to deterioration of adjacent roof-edge components. Repairs are recommended by replacing/repairing the affected fascia/soffit materials and restoring a weather-resistant finish as needed. A qualified exterior carpentry contractor or roofing contractor should perform the repair. (Figure [13](#))

**Figure 13: Damage and missing wood were observed at the fascia/soffit along the roof edge at the exterior.**

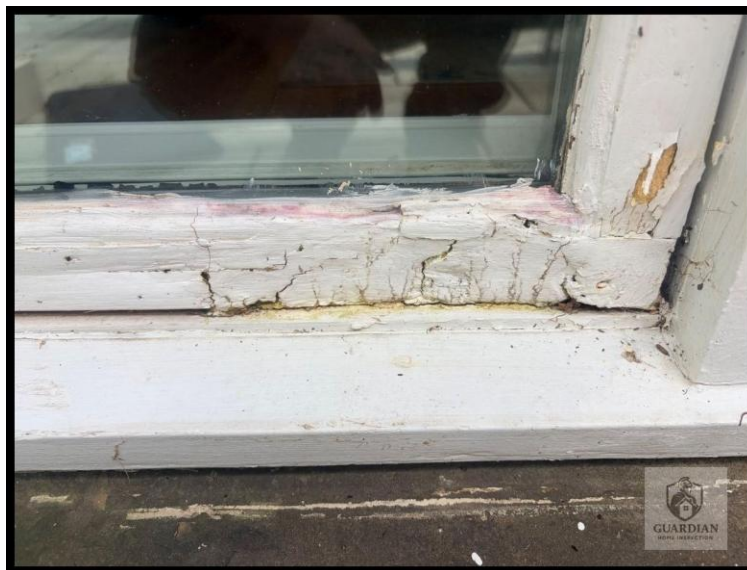
**General Repair:** Peeling paint and deteriorated wood were observed at the exterior window sill/trim, indicating possible moisture damage. This condition can allow additional moisture intrusion and may lead to further wood decay and reduced service life of the window assembly. The affected wood components should be evaluated, repaired or replaced as needed, and the area should be properly sealed and repainted to protect the substrate. Corrections should be completed by a qualified exterior carpenter or general contractor. (Figure [14](#))

**Figure 14: Peeling paint and deteriorated wood were observed at the exterior window sill/trim, indicating possible moisture damage.**

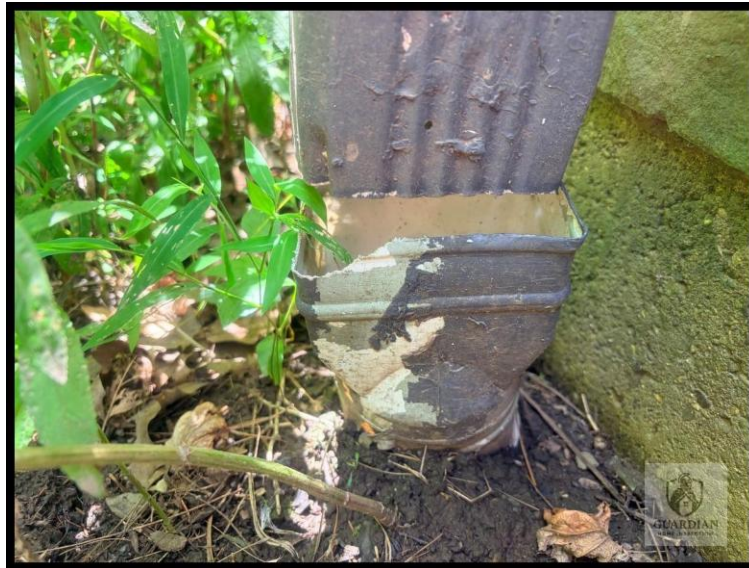
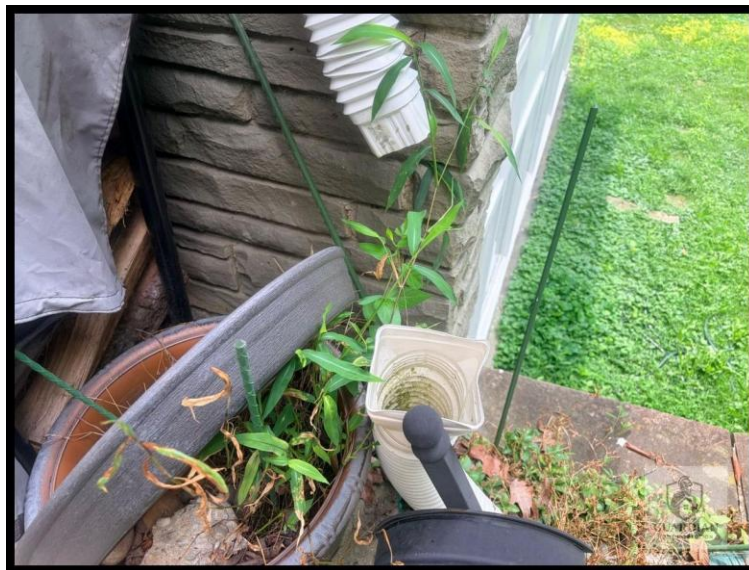
**General Repair:** A downspout extension was observed to be disconnected and/or damaged at the base, resulting in roof runoff discharging near the foundation. Concentrated discharge at the foundation can contribute to moisture intrusion and accelerated deterioration of foundation-adjacent materials. The downspout extension should be repaired/reconnected and configured to discharge away from the foundation. Corrections should be performed by a qualified gutter/downspout contractor or exterior drainage contractor. (Figures [15](#), [16](#))

**Figure 15: A downspout extension was observed to be disconnected and/or damaged at the base, resulting in roof runoff discharging near the foundation.**

**Figure 16: A downspout extension was observed to be disconnected and/or damaged at the base, resulting in roof runoff discharging near the foundation.**

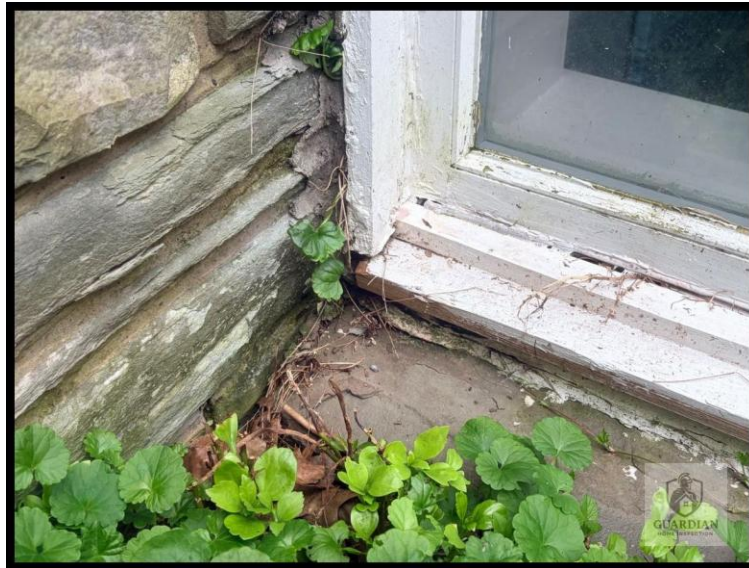
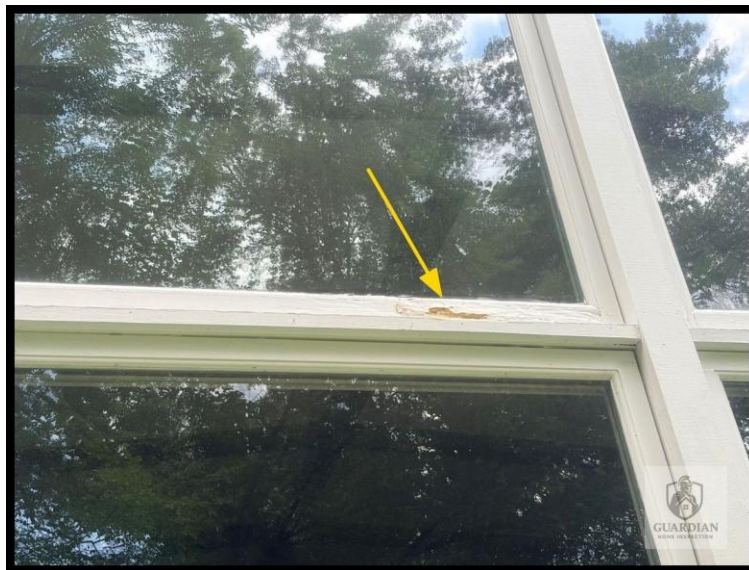
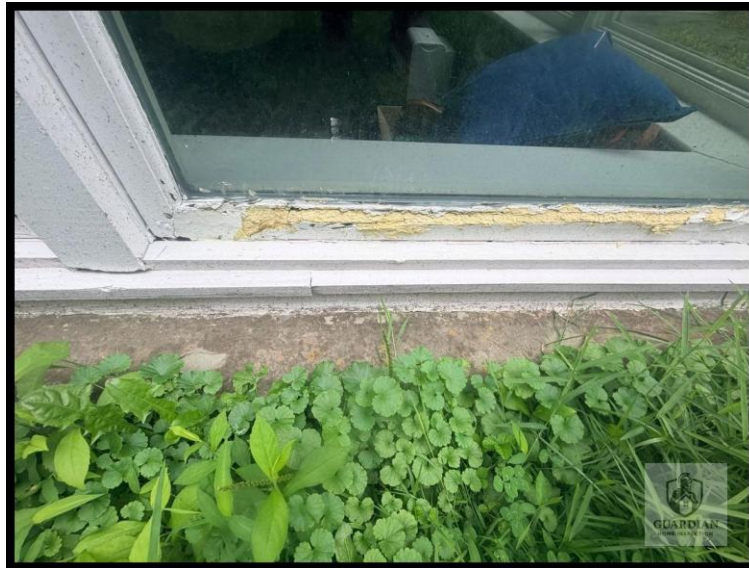
**General Repair:** Deteriorated wood and peeling paint were observed at exterior window trim/sills, indicating moisture exposure and inadequate sealing. This condition can allow continued water intrusion and progressive wood decay, potentially affecting adjacent wall components. Damaged wood should be repaired or replaced as needed and the window perimeter should be properly sealed/caulked and repainted with exterior-grade coatings. Repairs should be performed by a qualified exterior carpenter or window/trim contractor. (Figures [17](#), [18](#), [19](#))

**Figure 17: Deteriorated wood and peeling paint were observed at exterior window trim/sills, indicating moisture exposure and inadequate sealing.**

**Figure 18: Deteriorated wood and peeling paint were observed at exterior window trim/sills, indicating moisture exposure and inadequate sealing.**

**Figure 19: Deteriorated wood and peeling paint were observed at exterior window trim/sills, indicating moisture exposure and inadequate sealing.**

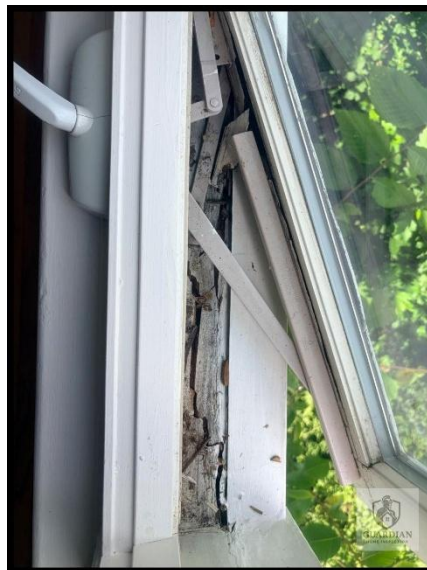
**General Repair:** Significant wood rot and material deterioration were observed at the exterior window frame/sill at the opening. This condition can allow water intrusion, which may lead to concealed damage and continued decay of adjacent materials. The affected wood components should be repaired or replaced as needed and the window perimeter should be properly sealed/flushed to restore a weather-resistant barrier. Repairs should be performed by a qualified window/finish carpenter or exterior remodeling contractor. (Figure [20](#))

**Figure 20: Significant wood rot and material deterioration were observed at the exterior window frame/sill at the opening.**

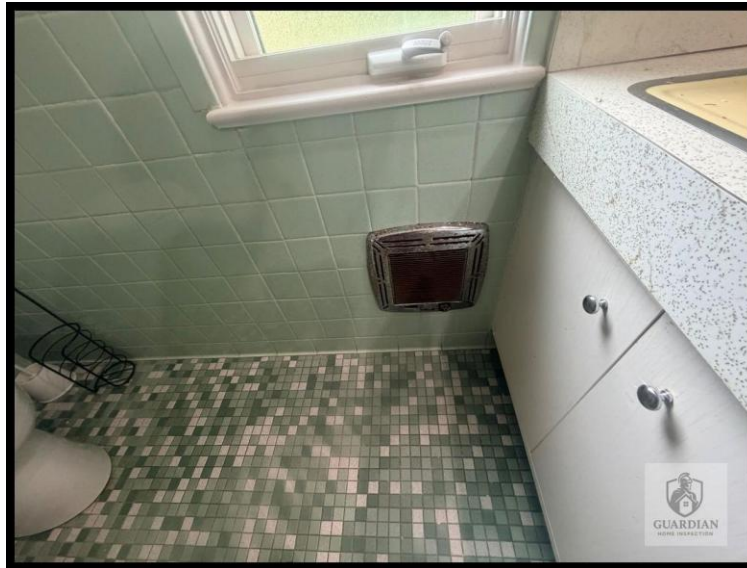
**General Repair:** The bathroom wall-mounted heater was observed to be non-operational at the time of inspection. A non-functioning heater may indicate an electrical or equipment failure and can reduce the ability to adequately heat the space. The unit should be serviced, repaired, or replaced as needed after troubleshooting and verification of safe operation. Evaluation and repairs should be performed by a licensed HVAC contractor. (Figure [21](#))

**Figure 21: The bathroom wall-mounted heater was observed to be non-operational at the time of inspection.**

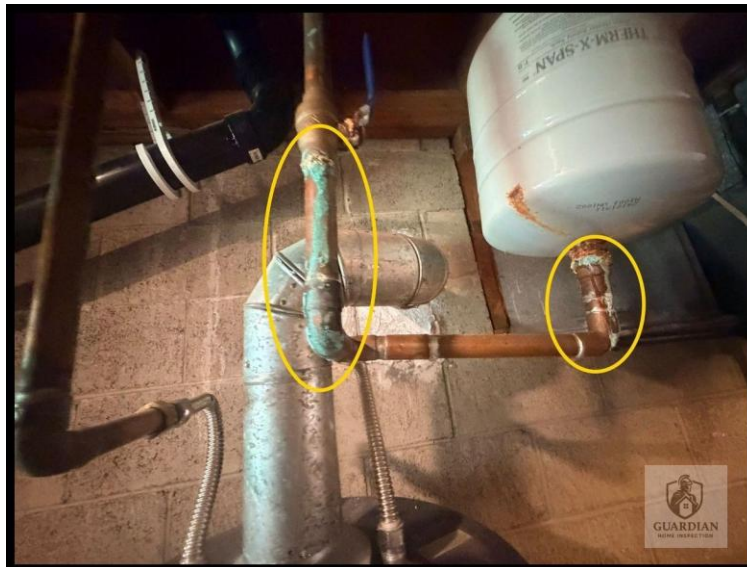
**General Repair:** Corrosion and mineral buildup were observed on the copper plumbing at/near the expansion tank in the basement, suggesting a past or potentially active leak at the connection. Leakage at this location can lead to ongoing water damage and progressive pipe deterioration. The affected joint/connection should be evaluated, leakage verified, and the leaking fitting and/or piping repaired or replaced as needed. Repairs should be performed by a licensed plumber. (Figure [22](#))

**Figure 22: Corrosion and mineral buildup were observed on the copper plumbing at/near the expansion tank in the basement, suggesting a past or potentially active leak at the connection.**

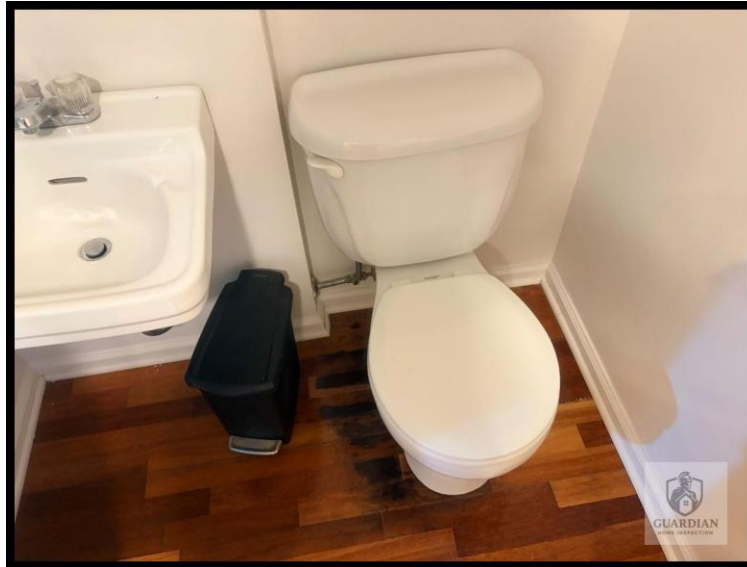
**General Repair:** The toilet in the basement bathroom was observed to be loose at the base. A loose toilet can compromise the wax ring and toilet flange connection, increasing the risk of leakage and damage to the surrounding flooring/subfloor. The toilet should be removed and reset properly, with the flange and wax ring evaluated and replaced as needed, and the bowl secured to the floor. Correction should be performed by a licensed plumber. (Figure [23](#))

**Figure 23: The toilet in the basement bathroom was observed to be loose at the base.**

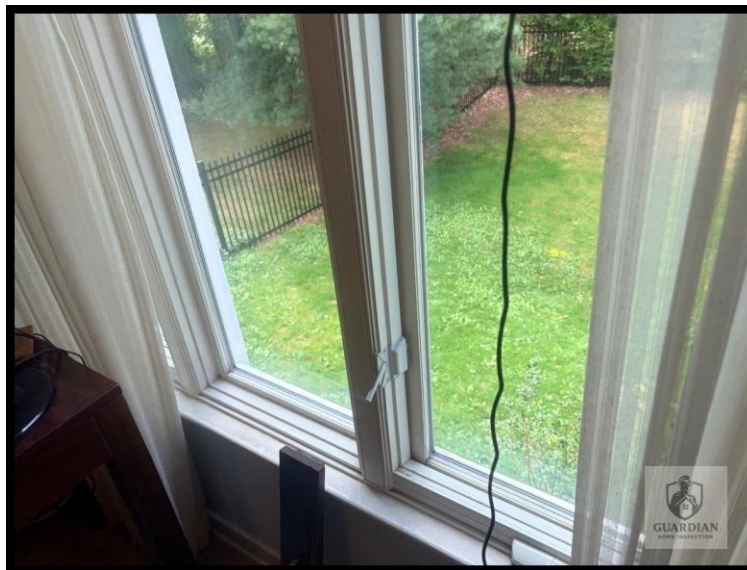
**General Repair:** The bedroom window did not open and close properly at the time of inspection. Inoperable windows may limit emergency egress and ventilation and can indicate failed hardware or binding at the sash/frame. The window should be adjusted, repaired, or replaced as needed to restore smooth operation and proper latching. Repairs should be performed by a qualified window/door contractor or experienced general contractor. (Figure [24](#))

**Figure 24: The bedroom window did not open and close properly at the time of inspection.**

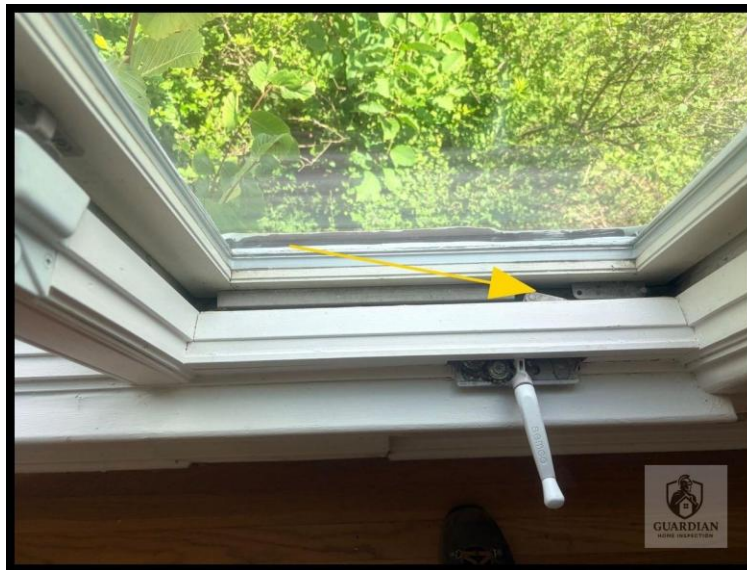
**General Repair:** A bedroom window operator linkage was observed to be broken/disconnected at the time of inspection. This condition can prevent proper operation and secure closure of the window, which may contribute to air/water infiltration and reduced safety/egress functionality. The linkage/hardware should be repaired or replaced and the window should be adjusted to confirm smooth operation and full latching. Correction should be performed by a qualified window repair contractor or experienced carpenter/handyperson. (Figure [25](#))

**Figure 25: A bedroom window operator linkage was observed to be broken/disconnected at the time of inspection.**

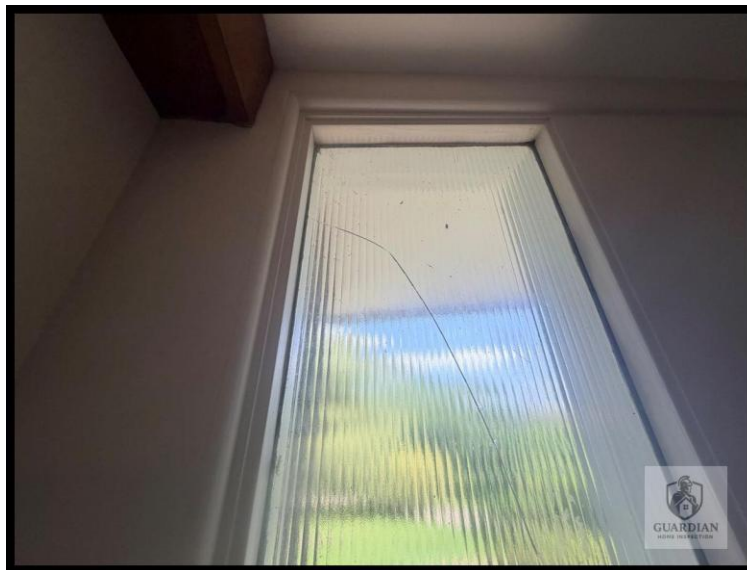
**General Repair:** Cracked window glass was observed beside the main entry door on the first floor. Damaged glazing may present a safety hazard and can allow reduced weather resistance if the crack propagates. The affected glass should be replaced to restore safety and proper performance. Repairs should be completed by a qualified glazier or window/door contractor. (Figure [26](#))

**Figure 26: Cracked window glass was observed beside the main entry door on the first floor.**

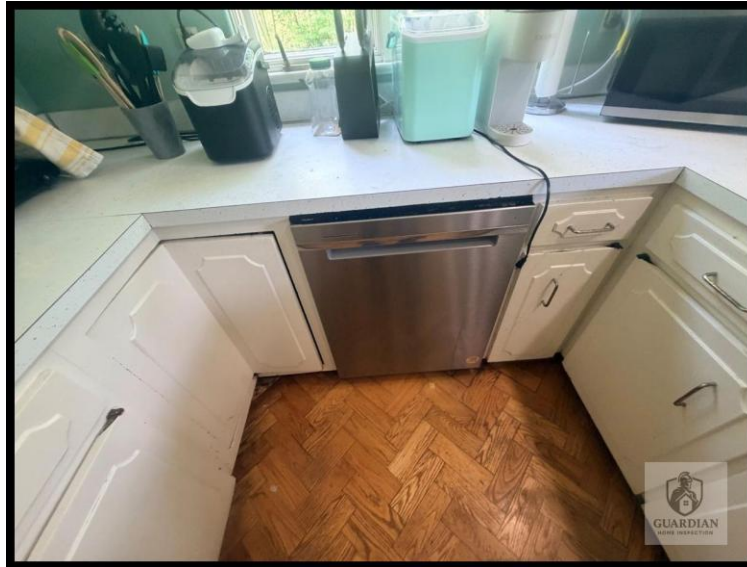
**General Repair:** The kitchen dishwasher did not operate at the time of inspection. An inoperative dishwasher limits normal kitchen function and may indicate an electrical, control, or mechanical failure requiring service. The dishwasher should be evaluated, repaired as needed, or replaced to restore proper operation. Repairs should be performed by a qualified appliance repair technician. (Figure [27](#))

**Figure 27: The kitchen dishwasher did not operate at the time of inspection.**

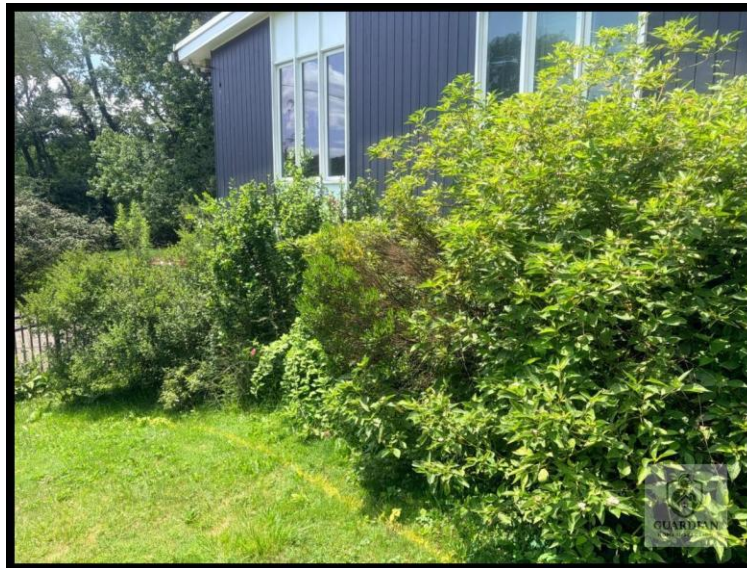
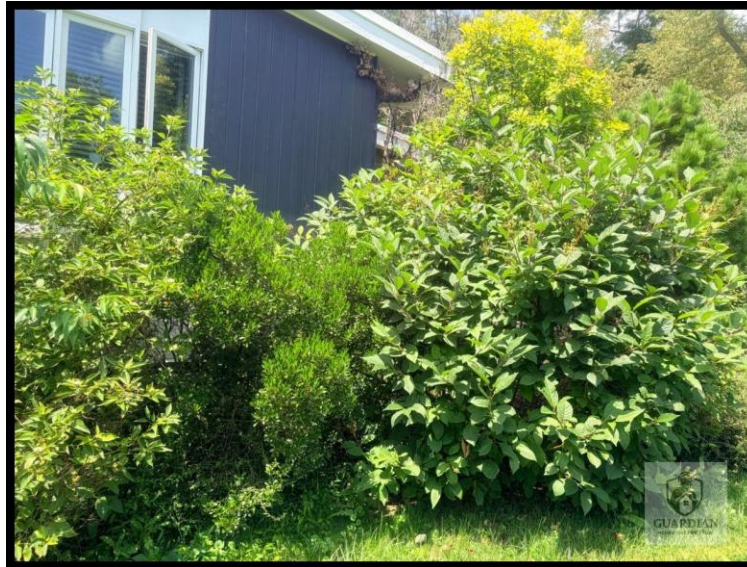
**Improve:** Overgrown shrubs and vegetation were observed in contact with the exterior siding and adjacent to windows. Vegetation contact can trap moisture against building materials and provide a pathway/harborage for pests, which can contribute to deterioration and moisture intrusion concerns. The vegetation should be trimmed back and maintained to provide consistent clearance from the siding and window assemblies. Corrections should be performed by a qualified landscaper or grounds maintenance contractor. (Figures [28](#), [29](#))

**Figure 28: Overgrown shrubs and vegetation were observed in contact with the exterior siding and adjacent to windows.**

**Figure 29: Overgrown shrubs and vegetation were observed in contact with the exterior siding and adjacent to windows.**

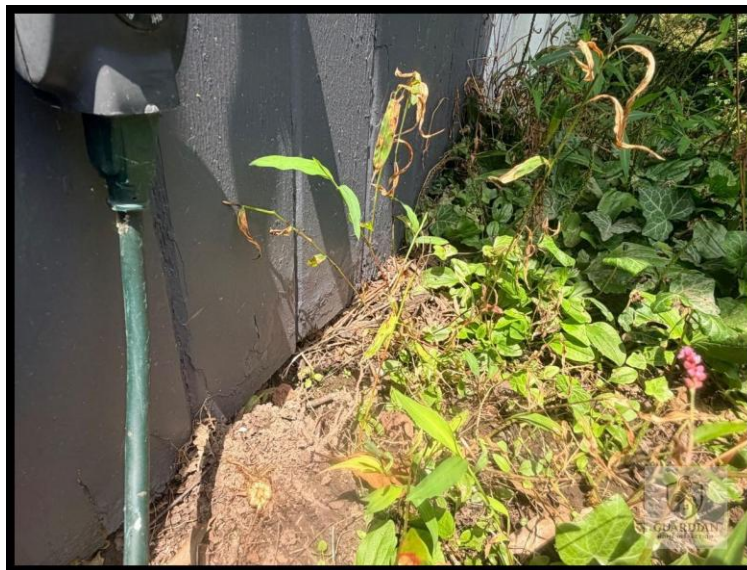
**Improve:** Vegetation and soil were observed in direct contact with the exterior wall. This condition can trap moisture against the wall assembly and can provide a pathway for pests, increasing the likelihood of deterioration and moisture intrusion. Vegetation should be cut back and removed from contact with the wall, and soil/grading should be adjusted to maintain appropriate clearance between grade and exterior wall materials. Corrections should be performed by a qualified landscaping contractor or general contractor. (Figure [30](#))

**Figure 30: Vegetation and soil were observed in direct contact with the exterior wall.**

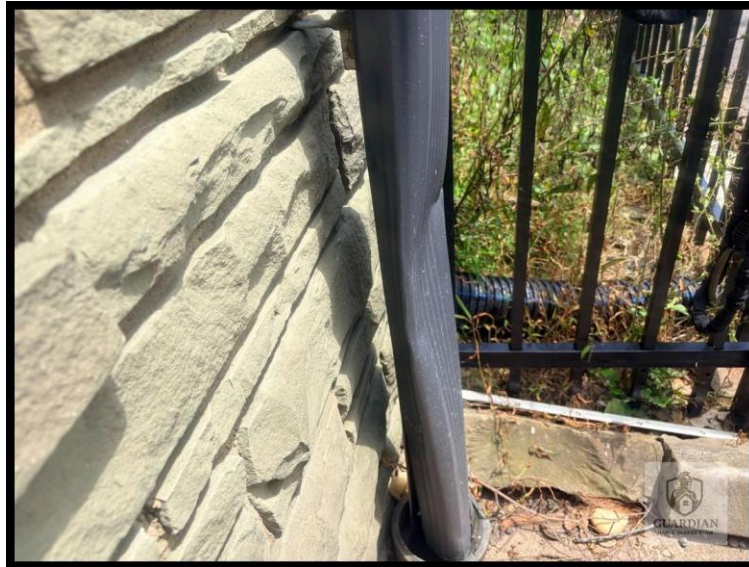
**Improve:** Damage was observed at an exterior downspout, which may restrict or reduce proper gutter drainage. Reduced drainage can contribute to overflow, erosion, and moisture intrusion at adjacent exterior surfaces and the foundation area. The downspout should be repaired or replaced and confirmed to discharge properly away from the structure. Repairs should be performed by a qualified gutter/downspout contractor. (Figure [31](#))

**Figure 31: Damage was observed at an exterior downspout, which may restrict or reduce proper gutter drainage.**

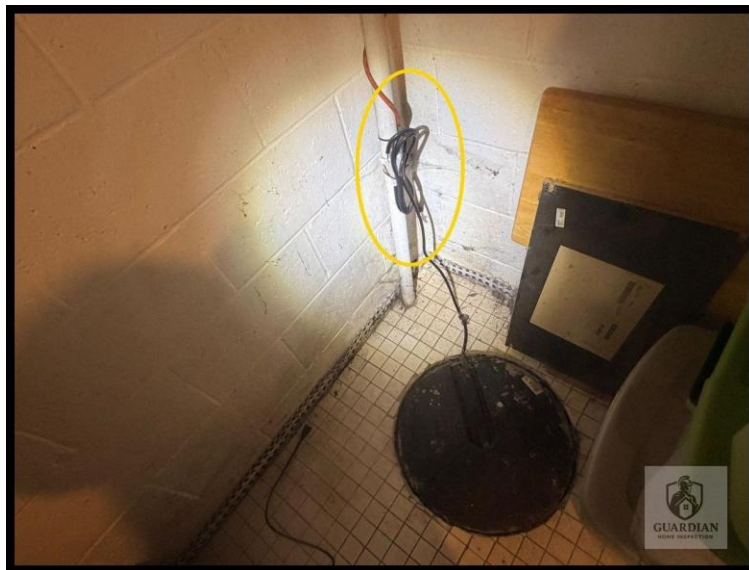
**Improve:** The sump pump in the basement was observed not plugged into a dedicated outlet. Sharing a receptacle/circuit with other loads can lead to nuisance tripping or inadvertent disconnection, which may prevent the pump from operating when needed. A dedicated, properly installed receptacle/circuit should be provided for the sump pump and the pump should be connected accordingly. Corrections should be performed by a Licensed Electrician. (Figure [32](#))

**Figure 32: The sump pump in the basement was observed not plugged into a dedicated outlet.**

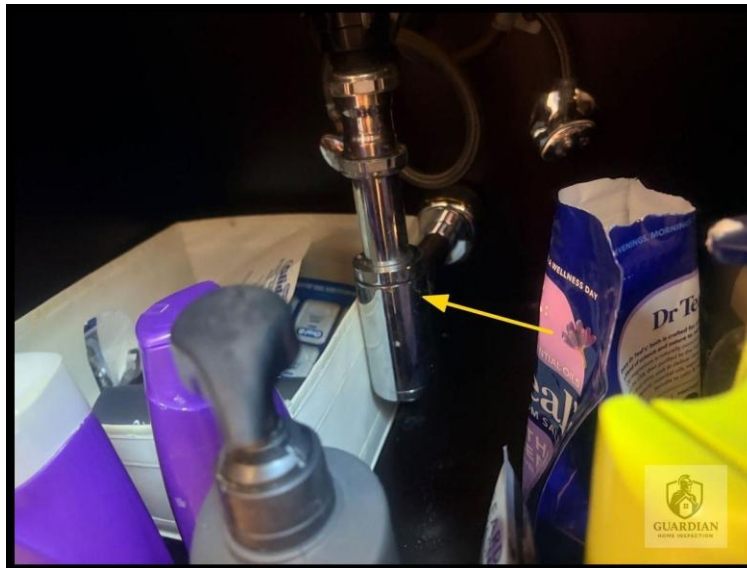
**Improve:** No P-trap was observed installed under the master bathroom sink drain piping at the time of inspection. A missing trap can allow sewer gases to enter the living space and may contribute to drainage and odor concerns. Installation of properly sized P-trap(s) and verification of correct trap arm connection and leak-free operation are recommended. Repairs should be performed by a Licensed Plumber. (Figure [33](#))

**Figure 33: No P-trap was observed installed under the master bathroom sink drain piping at the time of inspection.**

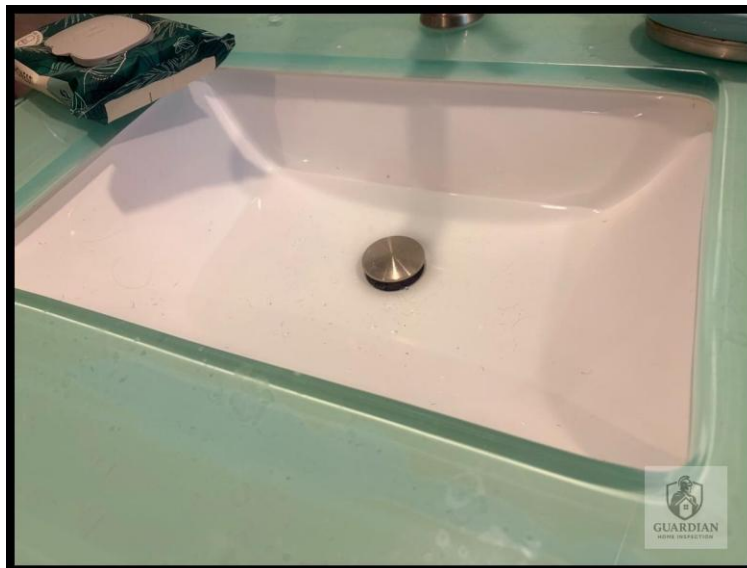
**Improve:** The master bathroom sink was observed to drain very slowly at the time of inspection. Slow drainage can indicate a partial blockage in the fixture drain or trap and may lead to backup, odors, or overflow if the restriction worsens. The sink drain piping should be evaluated and cleared/cleaned as needed to restore normal drainage. Repairs should be performed by a licensed plumber. (Figure [34](#))

**Figure 34: The master bathroom sink was observed to drain very slowly at the time of inspection.**

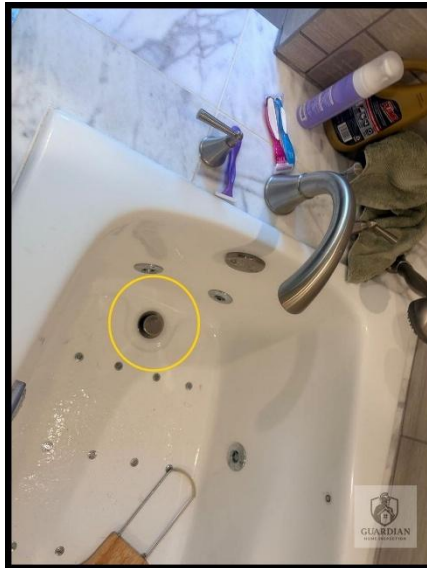
**Improve:** The jet tub drain stopper did not function in the bathroom, which prevented the tub from being filled and the system from being fully tested. This limits evaluation of the tub's watertightness and operation and may allow undetected leakage or functional defects to go unrecognized. The drain stopper and related drain components should be repaired or replaced and the tub should be fully function-tested after corrections are completed. Repairs and testing should be performed by a licensed plumber. (Figure [35](#))

**Figure 35: The jet tub drain stopper did not function in the bathroom, which prevented the tub from being filled and the system from being fully tested.**

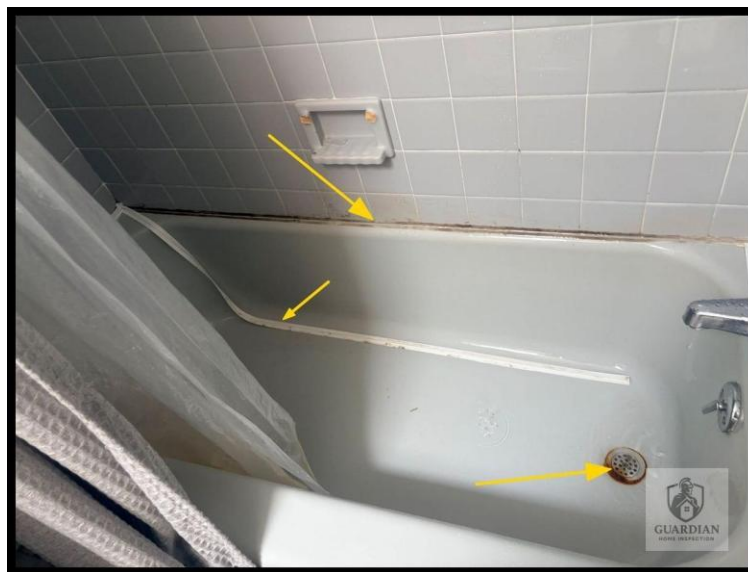
**Improve:** Missing and deteriorated caulk/trim with staining was observed at the bathroom tub surround, and the tub drain was noted to be slow draining. These conditions may allow water intrusion behind the surround and can contribute to hidden moisture damage and potential microbial growth, while the slow drainage may indicate a partial blockage. The tub surround should be properly cleaned, any deteriorated trim repaired/replaced as needed, and all joints re-caulked/sealed; the tub drain should be cleaned/cleared and corrected to restore normal drainage. Repairs should be performed by a qualified plumbing contractor (and a qualified bathroom/tile contractor as needed for trim and sealing). (Figure [36](#))

**Figure 36: Missing and deteriorated caulk/trim with staining was observed at the bathroom tub surround, and the tub drain was noted to be slow draining.**

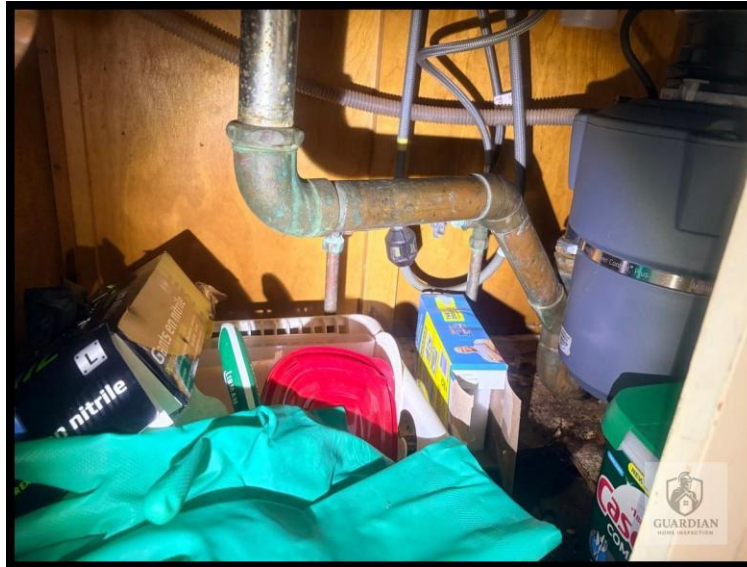
**Improve:** No P-trap was observed under the kitchen sink at the time of inspection. A missing trap can allow sewer gases to enter the living space and may contribute to improper drainage. Installation of a properly sized and configured P-trap (and associated fittings as needed) is recommended to provide an effective trap seal. Correction should be performed by a licensed plumbing contractor. (Figure [37](#))

**Figure 37: No P-trap was observed under the kitchen sink at the time of inspection.**

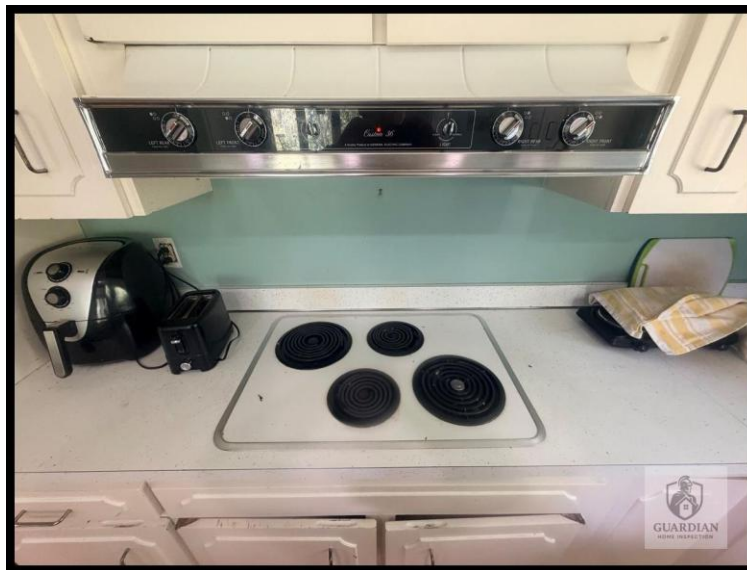
**Improve:** Only one burner on the electric cooktop was observed to function at the time of inspection in the kitchen. This condition limits safe, reliable cooking performance and may indicate failed surface elements, controls, or internal electrical components. The cooktop should be further evaluated and repaired or replaced as needed to restore full burner operation. Corrections should be completed by a qualified appliance repair technician. (Figure [38](#))

**Figure 38: Only one burner on the electric cooktop was observed to function at the time of inspection in the kitchen.**

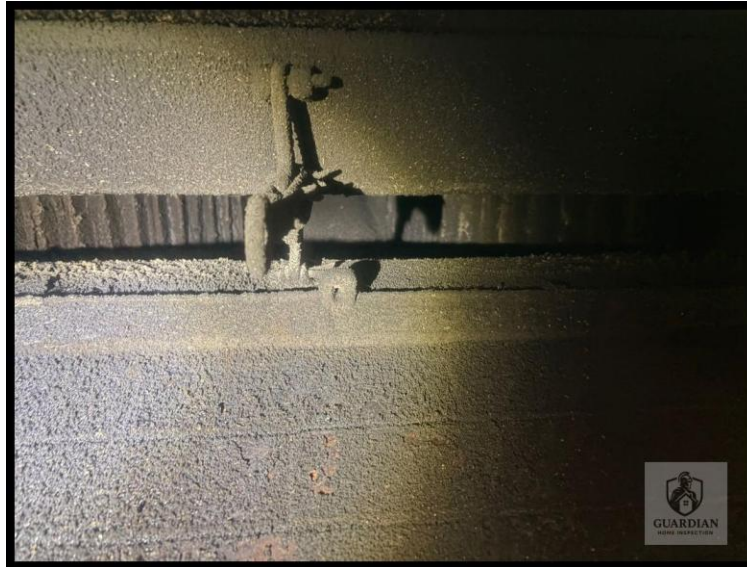
**Figure 39: Heavy soot buildup was observed at the wood-burning fireplace in the Living Room.**

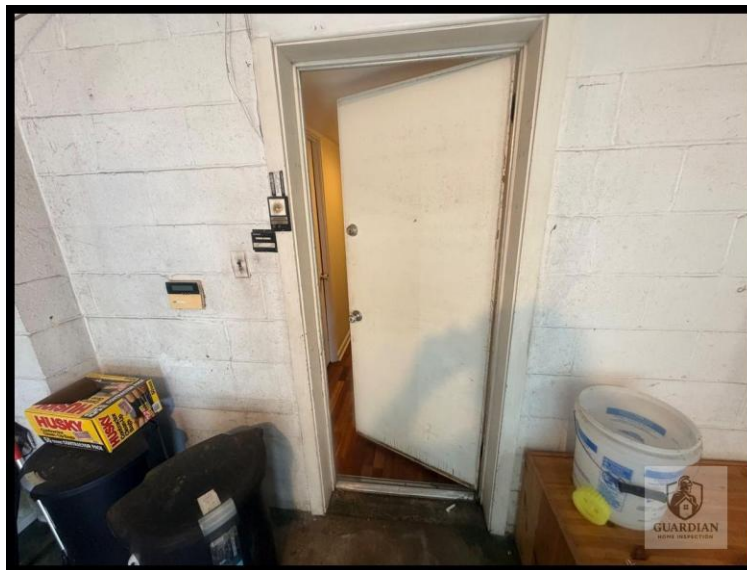
**Figure 40: A hollow-core, non-fire-rated door was observed at the entry between the garage and the dwelling.**
