# Residential Building Inspection Report

5133 5th Ave, Pittsburgh, PA 15232

**Inspection Date:**  
2026-06-17

**Report Number:**  
0617260912CN

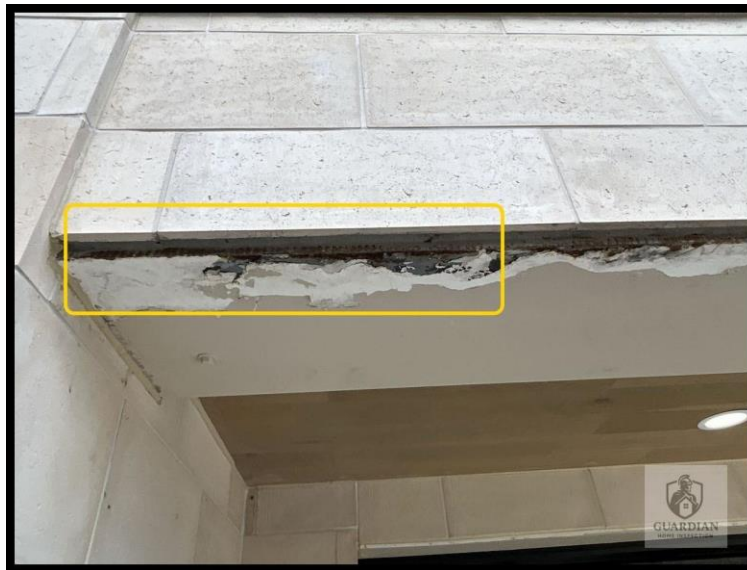
**General Repair:** The lintel above the garage door exhibited visible rust staining and minor deterioration/spalling of the adjacent concrete/finish. Corrosion at a lintel can progress and contribute to cracking, loosening finishes, and reduced long-term durability at the opening. Have the lintel and surrounding concrete evaluated and repaired as needed, including treating corrosion and patching/sealing deteriorated areas to limit further moisture-related damage. Repairs should be performed by a qualified masonry contractor (or concrete repair contractor). (Figure [1](#))

**Figure 1: The lintel above the garage door exhibited visible rust staining and minor deterioration/spalling of the adjacent concrete/finish.**

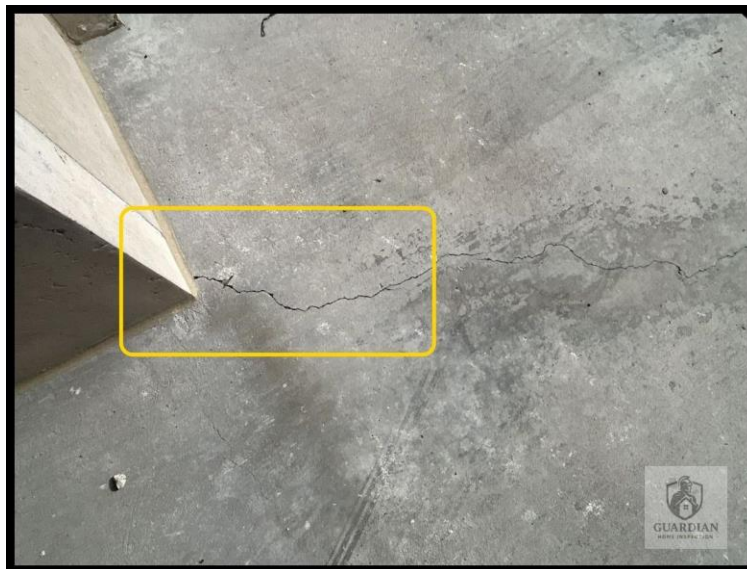
**General Repair:** Minor hairline cracking was observed along the front-facing concrete sidewalk. While common with concrete shrinkage and curing, cracks can allow water intrusion that may contribute to surface deterioration and widening over time. Seal/repair the crack(s) as appropriate and monitor for progression, with further evaluation if movement or displacement is noted. Have a qualified concrete contractor perform the repair. (Figure [2](#))

**Figure 2: Minor hairline cracking was observed along the front-facing concrete sidewalk.**

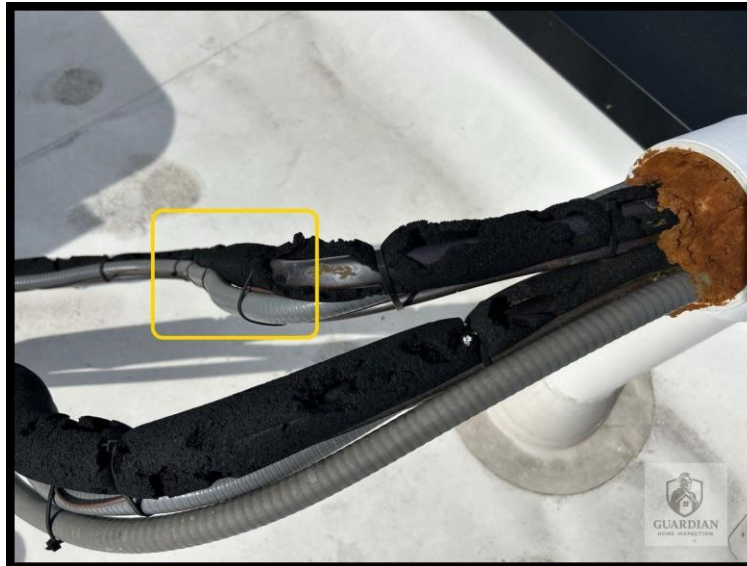
**General Repair:** At the roof, the refrigerator line insulation was observed to be deteriorated with sections missing/exposed. Deteriorated insulation can allow heat gain and condensation on the line, which may reduce system efficiency and contribute to moisture-related issues at the roof area. Replace the damaged insulation with exterior-rated closed-cell insulation and properly secure/protect it where exposed. Repairs should be completed by a qualified HVAC contractor. (Figure [3](#))

**Figure 3: At the roof, the refrigerator line insulation was observed to be deteriorated with sections missing/exposed.**

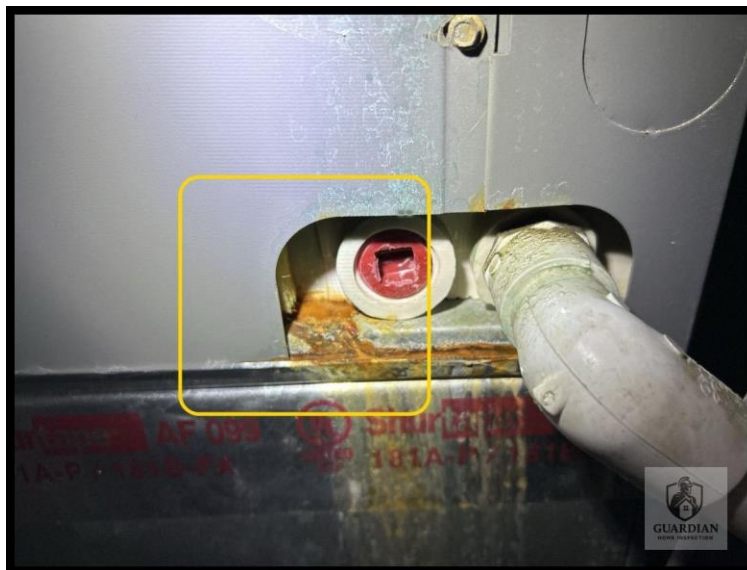
**General Repair:** In the 3rd Floor Utility Room, the air-conditioning overflow knockout was observed actively leaking at the air handler cabinet. Active condensate leakage can damage surrounding materials and promote microbial growth if not corrected. Have the overflow knockout and associated condensate management components repaired/sealed and verify proper condensate drainage operation. Repairs should be performed by a qualified HVAC contractor. (Figure [4](#))

**Figure 4: In the 3rd Floor Utility Room, the air-conditioning overflow knockout was observed actively leaking at the air handler cabinet.**

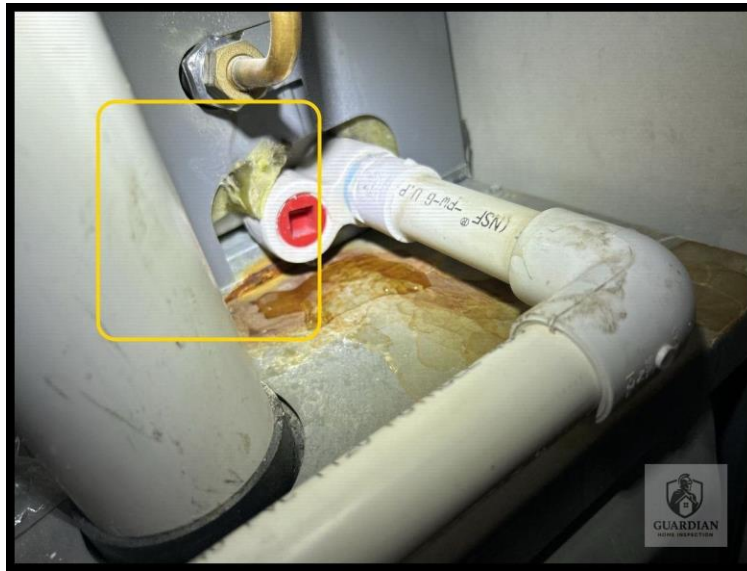
**General Repair:** In the Lower Utility Room, water staining and active moisture were observed at the air conditioner overflow condensate knockout, with leakage running along the basement furnace cabinet. Continued leakage can contribute to corrosion, microbial growth, and water damage to HVAC components and adjacent building materials. Have the condensate overflow/knockout and drain connection corrected and sealed, and verify proper condensate drainage under operation. Repairs should be performed by a qualified HVAC contractor. (Figure [5](#))

**Figure 5:** In the Lower Utility Room, water staining and active moisture were observed at the air conditioner overflow condensate knockout, with leakage running along the basement furnace cabinet.

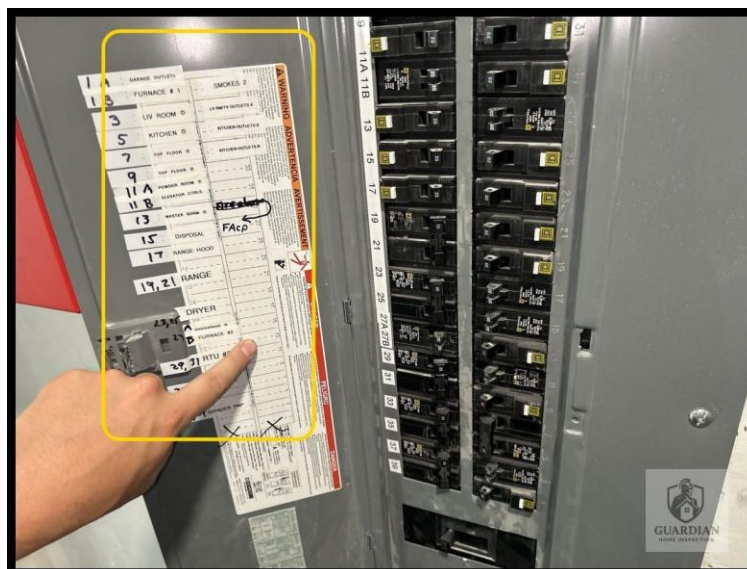
**General Repair:** In the Lower Utility Room, several breakers and portions of the electrical panel circuit directory were not labeled. Missing or incomplete labeling can delay emergency shutoff and increases the chance of turning off the wrong circuit during service. Have all breakers and the panel directory clearly and accurately identified to correspond to the circuits they control. This work should be completed by a Licensed Electrician. (Figure [6](#))

**Figure 6:** In the Lower Utility Room, several breakers and portions of the electrical panel circuit directory were not labeled.

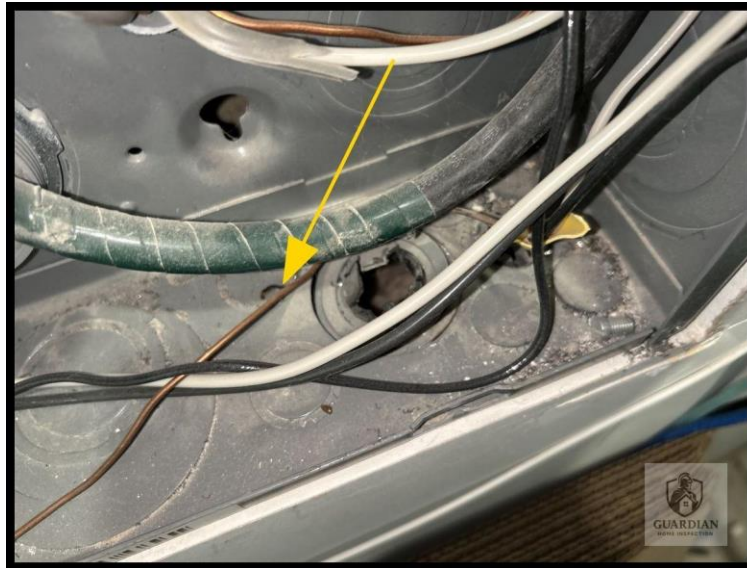
**General Repair:** In the Lower Utility Room, the electrical panel cabinet had missing open knockouts. Open knockouts can allow accidental contact with energized components and permit entry of debris or pests into the panel. Install listed knockout seals/filler plates in all unused openings to restore the panel enclosure integrity. This repair should be completed by a Licensed Electrician. (Figure [7](#))

**Figure 7: In the Lower Utility Room, the electrical panel cabinet had missing open knockouts.**

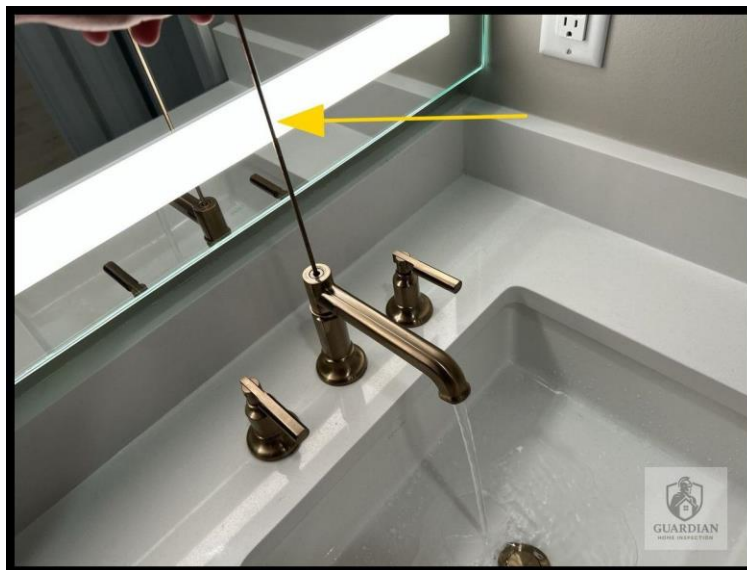
**General Repair:** In the third-floor bathroom, the sink lift rod assembly was observed not connected to the pop-up drain plug/stopper assembly. This condition prevents proper operation of the stopper and can lead to functional issues with the drain. Have the lift rod and linkage reconnected and adjusted so the stopper opens and seals correctly. Repairs should be performed by a licensed plumber. (Figure [8](#))

**Figure 8: In the third-floor bathroom, the sink lift rod assembly was observed not connected to the pop-up drain plug/stopper assembly.**

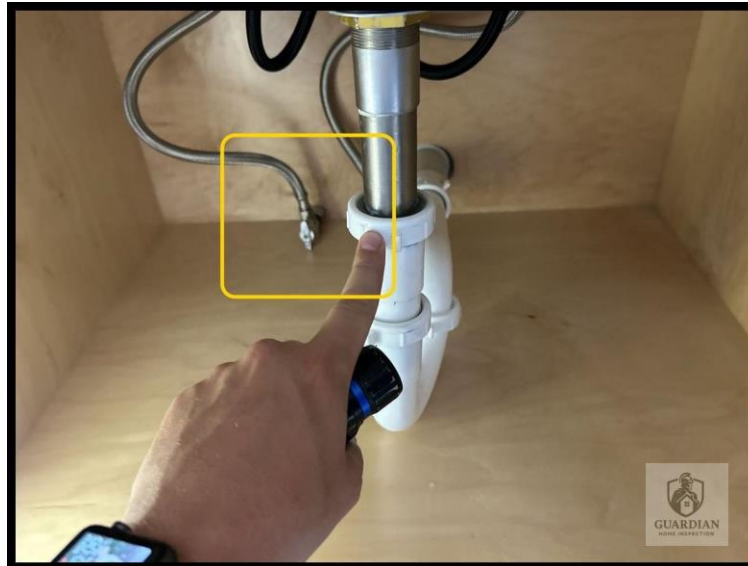
**General Repair:** An active leak was observed at the right-facing sink drain piping in the second-floor primary bathroom (visible at the slip-joint connection under the sink). Active drainage leaks can cause moisture damage to the cabinet, flooring, and adjacent building materials and may promote microbial growth. Have the drain piping/disconnects repaired or reassembled and tested for leaks under normal operation. Repairs should be performed by a Licensed Plumber. (Figure [9](#))

**Figure 9: An active leak was observed at the right-facing sink drain piping in the second-floor primary bathroom (visible at the slip-joint connection under the sink).**

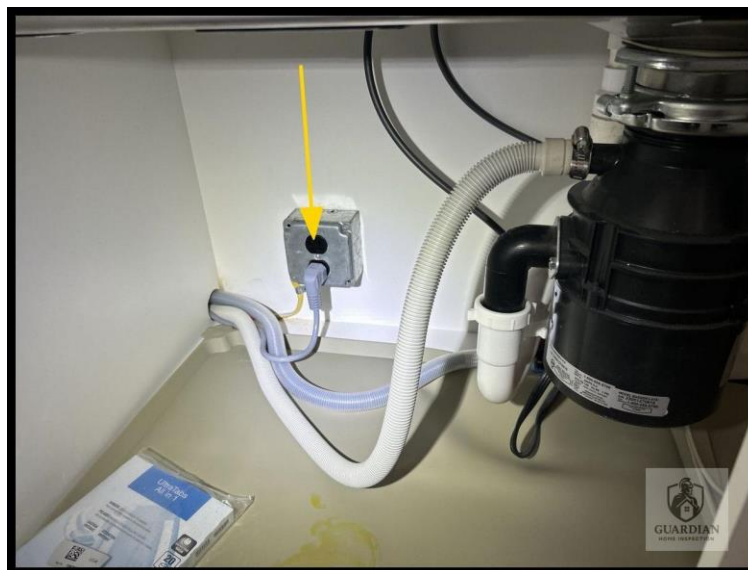
**General Repair:** At the kitchen sink cabinet, the dishwasher drain hose was observed without a high loop secured to the underside of the countertop. A missing high loop can allow wastewater to siphon back into the dishwasher, contributing to unsanitary conditions and potential odors. Install a proper high loop (or code-compliant air gap where required) and secure the hose at the highest practical point before connection to the sink/disposer. Have a qualified plumbing contractor correct this condition. (Figure [10](#))

**Figure 10: At the kitchen sink cabinet, the dishwasher drain hose was observed without a high loop secured to the underside of the countertop.**

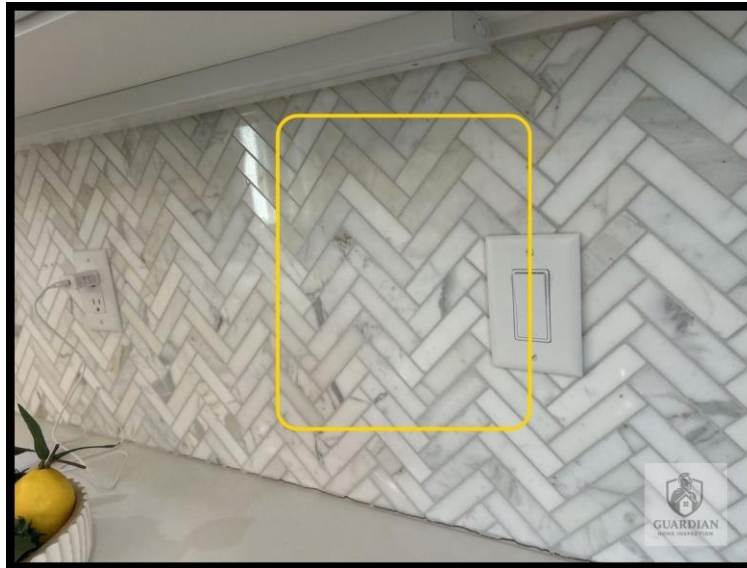
**Investigate:** An electrical wall switch located at the kitchen countertop/backsplash area was present, and its function could not be verified at the time of inspection. Unidentified switching may indicate an improperly labeled, abandoned, or incorrectly wired circuit, which can present a safety and usability concern. Have the switch traced and its controlled load identified, labeled, and corrected as needed. Repairs and verification should be performed by a Licensed Electrician. (Figure [11](#))

**Figure 11: An electrical wall switch located at the kitchen countertop/backsplash area was present, and its function could not be verified at the time of inspection.**

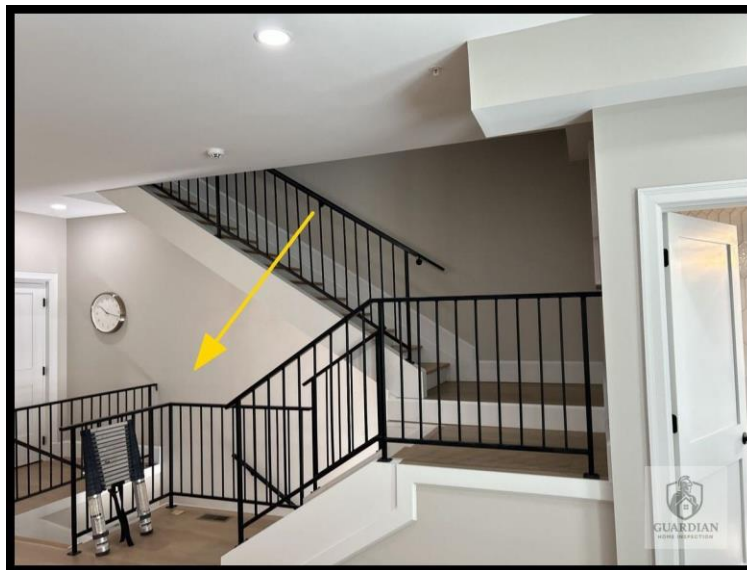
**Improve:** A wall switch was not observed on the first floor for operating the light that illuminates the stairway leading to the second floor. Lack of convenient switching can reduce safe illumination and increase the risk of trips/falls when using the stairs. Install an appropriately located switch (and associated wiring as needed) to control the stairway light from the first-floor level. Have a Licensed Electrician perform the installation and verify proper operation. (Figure [12](#))

**Figure 12: A wall switch was not observed on the first floor for operating the light that illuminates the stairway leading to the second floor.**

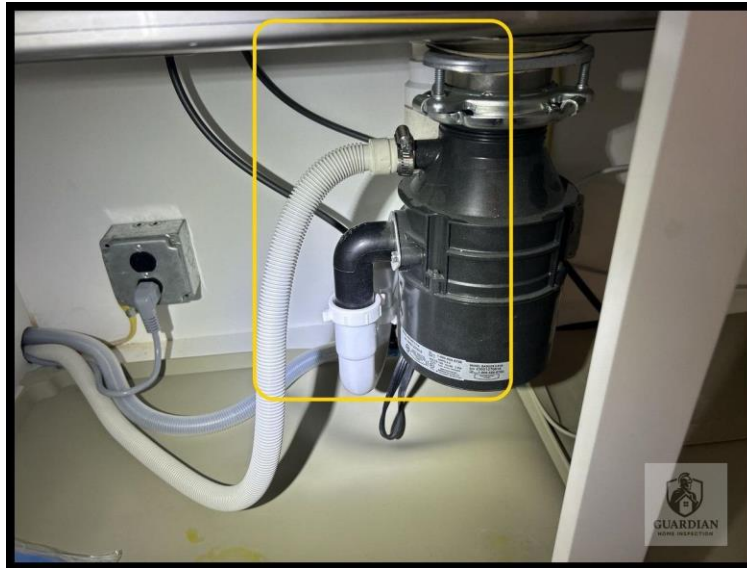
**Improve:** The kitchen waste disposal was observed to operate louder than typical during testing. Excessive noise can indicate a developing mechanical issue or internal obstruction and may lead to premature failure. Have the unit evaluated and serviced (clear obstruction, check mounting/insulation, and repair or replace as needed) to restore normal operation. Corrections should be performed by a qualified plumber or appliance service technician. (Figure [13](#))

**Figure 13: The kitchen waste disposal was observed to operate louder than typical during testing.**

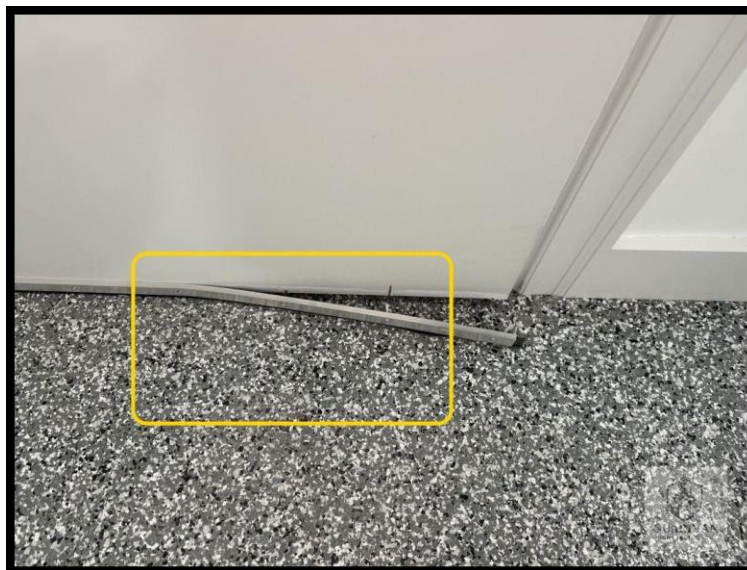
**Improve:** The bottom trimming component/door sweep at the door leading to the lower utility room in the garage was observed damaged and partially detached. This condition can reduce the door's seal, allowing drafts, moisture intrusion, and pest entry and may contribute to premature wear at the door bottom. Replace and properly secure the door bottom trim/sweep to restore an effective seal and ensure proper door operation. Repairs should be performed by a qualified handyman or finish carpenter. (Figure [14](#))

**Figure 14: The bottom trimming component/door sweep at the door leading to the lower utility room in the garage was observed damaged and partially detached.**

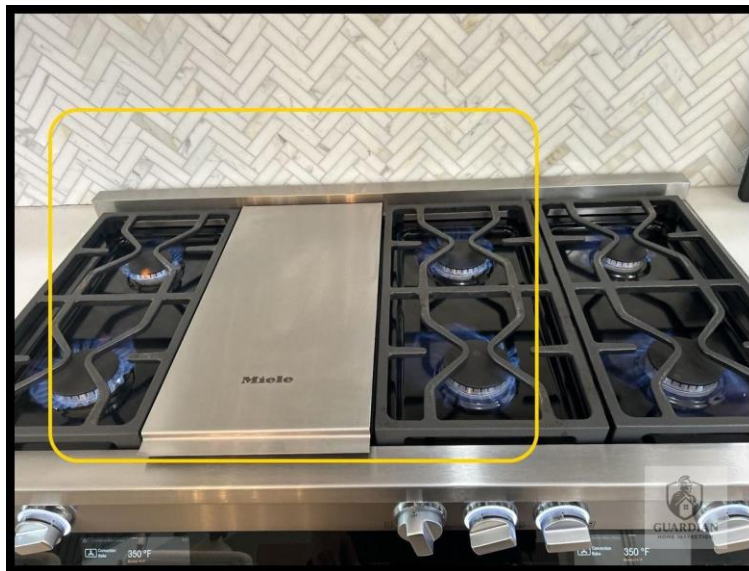
**Figure 15: In the kitchen, operating the exhaust hood on turbo mode was observed to lift the gas range burner flame enough to trigger the spark igniter.**
