# Residential Building Inspection Report

1315 Mississippi Ave, Pittsburgh, PA 15216

0723260003BT

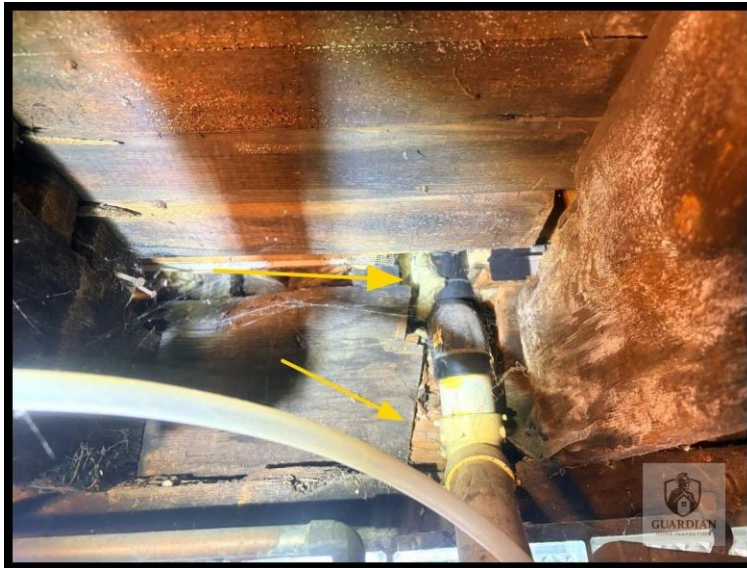
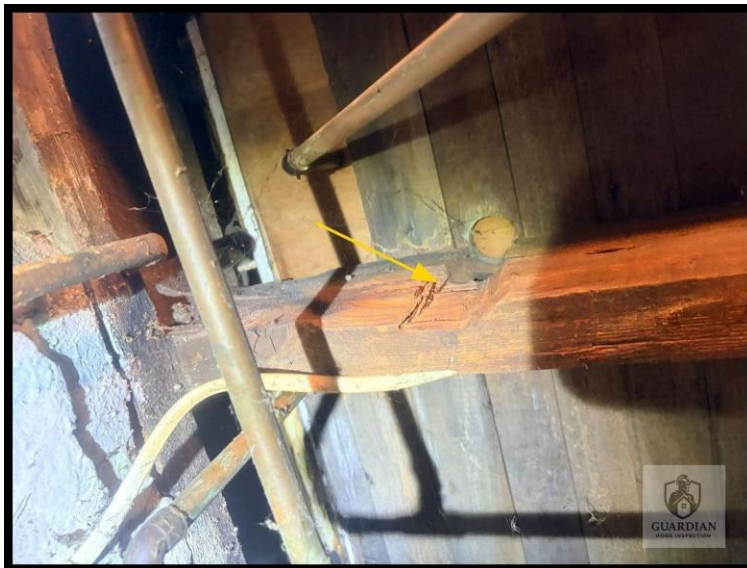
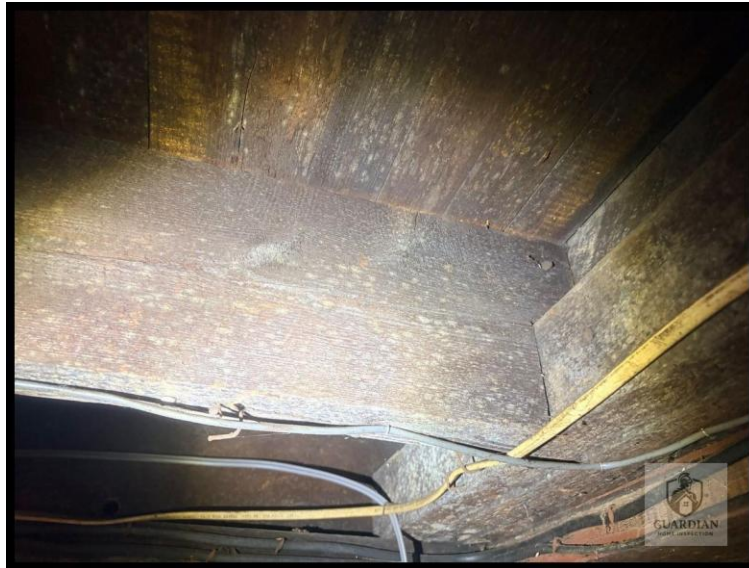
**Major Concern:** Over-notched and poorly constructed floor joists were observed in the basement. Excessive notching and improper framing can reduce the joists' load-carrying capacity and may contribute to floor deflection or structural failure. Evaluation and repair/engineering of the affected framing (e.g., reinforcement, sistering, or other approved corrective methods) should be completed to restore proper structural performance. Repairs should be performed by a qualified structural contractor or licensed structural engineer. (Figures [1, 2, 3](#))

**Figure 1: Over-notched and poorly constructed floor joists were observed in the basement.**

**Figure 2: Over-notched and poorly constructed floor joists were observed in the basement.**

**Figure 3: Over-notched and poorly constructed floor joists were observed in the basement.**

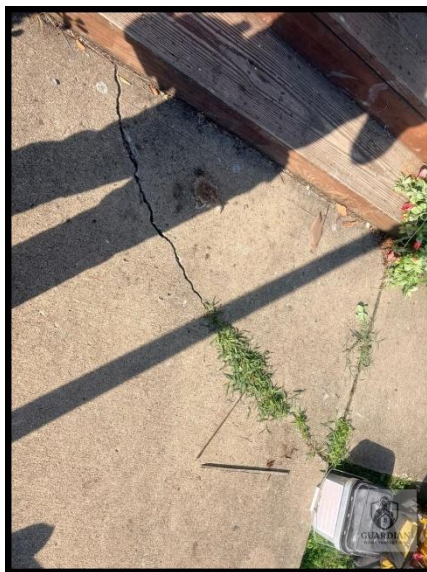
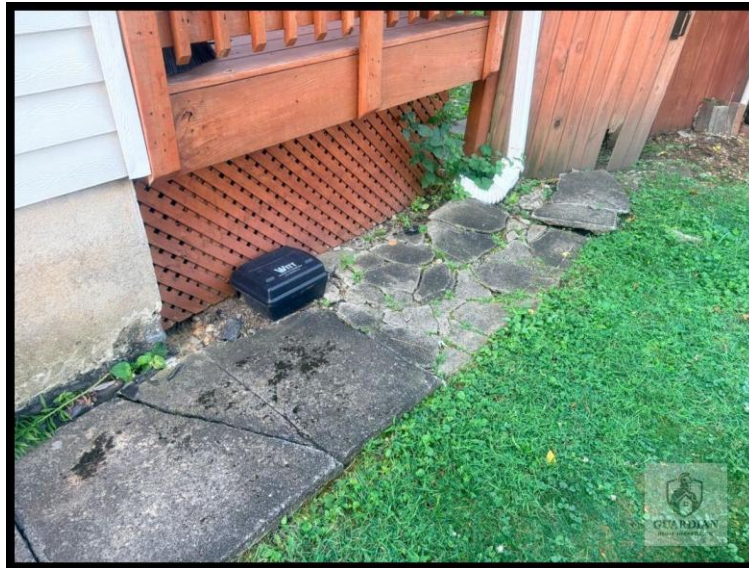
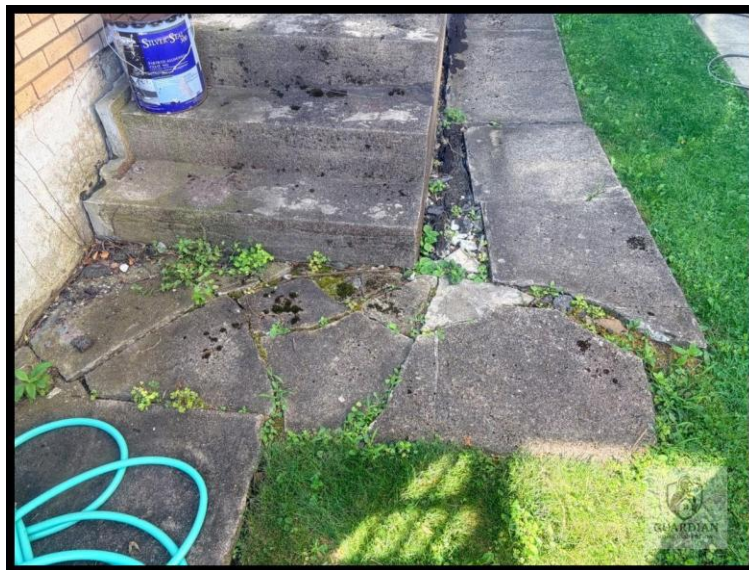
**Safety Concern:** Cracked and broken concrete was observed at the exterior walkway/landing, with vegetation growth through the damaged areas and resulting uneven surfaces. This condition presents a safety concern due to increased trip-and-fall risk. Damaged sections should be repaired or replaced and the surface should be restored to a uniform, stable walking plane, with vegetation removed to help prevent recurrence. Repairs should be performed by a qualified concrete flatwork contractor. (Figures [4, 5, 6](#))

**Figure 4: Cracked and broken concrete was observed at the exterior walkway/landing, with vegetation growth through the damaged areas and resulting uneven surfaces.**

**Figure 5: Cracked and broken concrete was observed at the exterior walkway/landing, with vegetation growth through the damaged areas and resulting uneven surfaces.**

**Figure 6: Cracked and broken concrete was observed at the exterior walkway/landing, with vegetation growth through the damaged areas and resulting uneven surfaces.**

**Safety Concern:** Cracked and broken concrete was observed at the exterior walkway/landing, with vegetation growth through the damaged areas and resulting uneven surfaces. This condition presents a safety concern due to increased trip-and-fall risk. Damaged sections should be repaired or replaced and the surface should be restored to a uniform, stable walking plane, with vegetation removed to help prevent recurrence. Repairs should be performed by a qualified concrete flatwork contractor. (Figures [4](#), [5](#), [6](#))

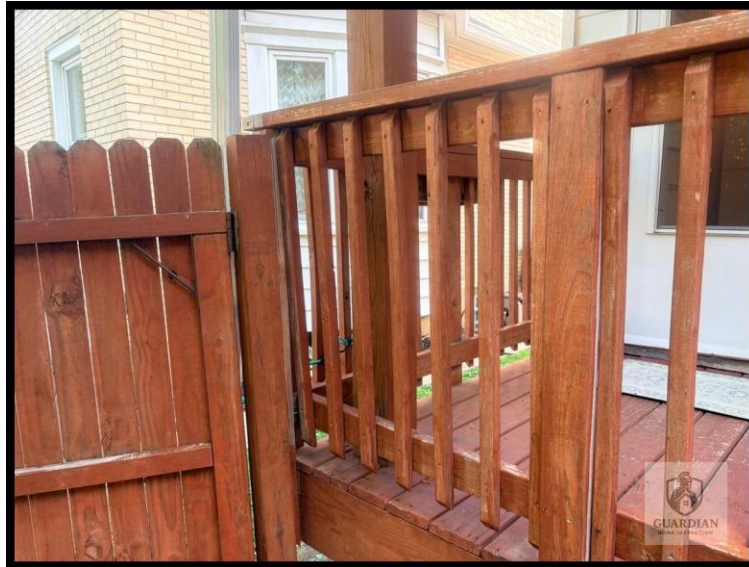
**Safety Concern:** A loose hand railing was observed at the rear porch. This condition is a safety concern because an unstable handhold/guard can contribute to loss of balance and fall risk when using the porch steps/edge. The handrail/guard should be properly re-secured and reinforced with appropriate fasteners and blocking as needed to provide a sturdy, code-compliant installation. Repairs should be performed by a qualified carpenter or deck/porch contractor. (Figure [7](#))

**Figure 7: A loose hand railing was observed at the rear porch.**

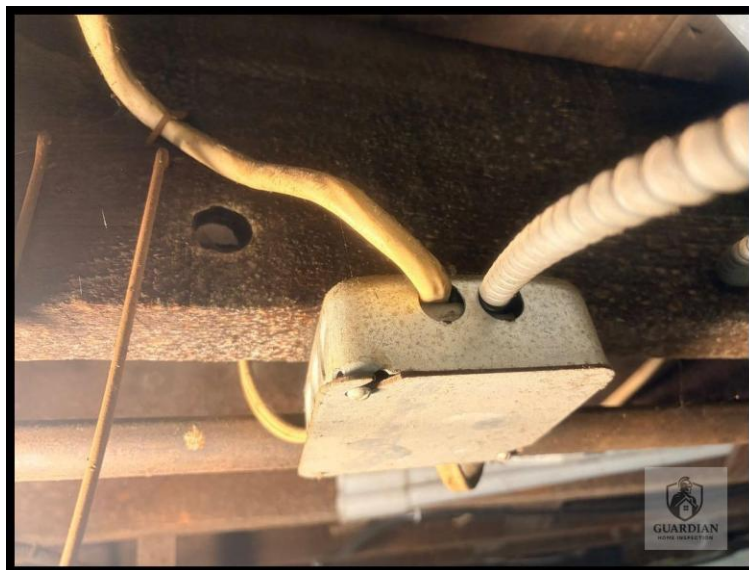
**Safety Concern:** An open knockout was observed in an electrical box cover in the basement, leaving a gap at the enclosure. This condition can allow pest/moisture entry and reduces the protection of wiring, increasing the potential for damage or contact with energized components. The open knockout should be properly sealed using an approved knockout plug/closure and the enclosure should be restored to an intact condition. Corrections should be completed by a Licensed Electrician. (Figure [8](#))

**Figure 8: An open knockout was observed in an electrical box cover in the basement, leaving a gap at the enclosure.**

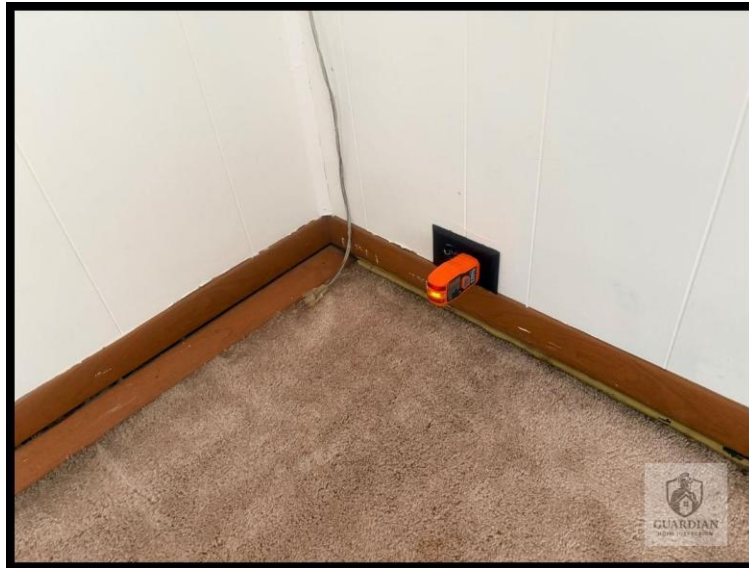
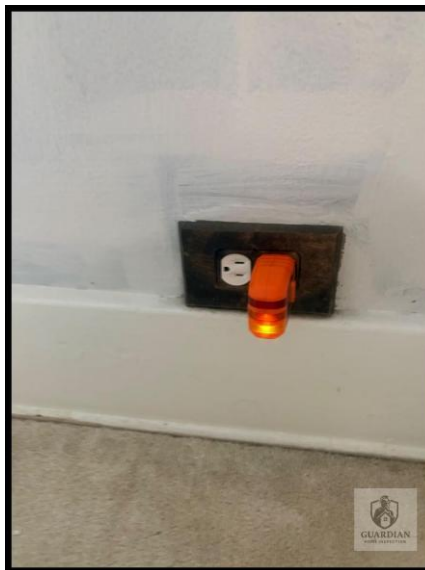
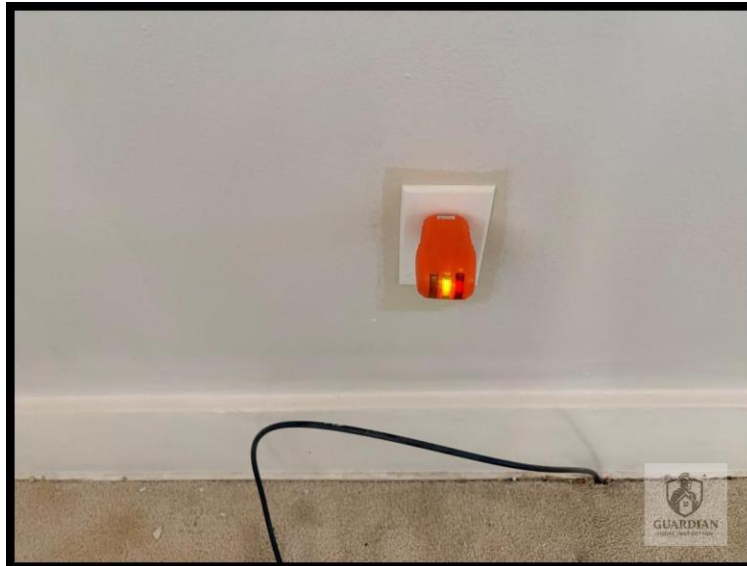
**Safety Concern:** Multiple receptacles in the Living Room and Bedroom indicated open ground conditions and open neutral conditions during testing. These conditions are safety concerns because they can result in shock hazard, improper operation of connected equipment, and increased risk of overheating at loose/failed connections. The affected circuits and receptacles should be traced, evaluated, and corrected by repairing/rewiring connections and restoring a proper equipment grounding path and neutral continuity as required. Repairs and verification testing should be performed by a Licensed Electrician. (Figures [9, 10, 11](#))

**Figure 9: Multiple receptacles in the Living Room and Bedroom indicated open ground conditions and open neutral conditions during testing.**

**Figure 10: Multiple receptacles in the Living Room and Bedroom indicated open ground conditions and open neutral conditions during testing.**

**Figure 11: Multiple receptacles in the Living Room and Bedroom indicated open ground conditions and open neutral conditions during testing.**

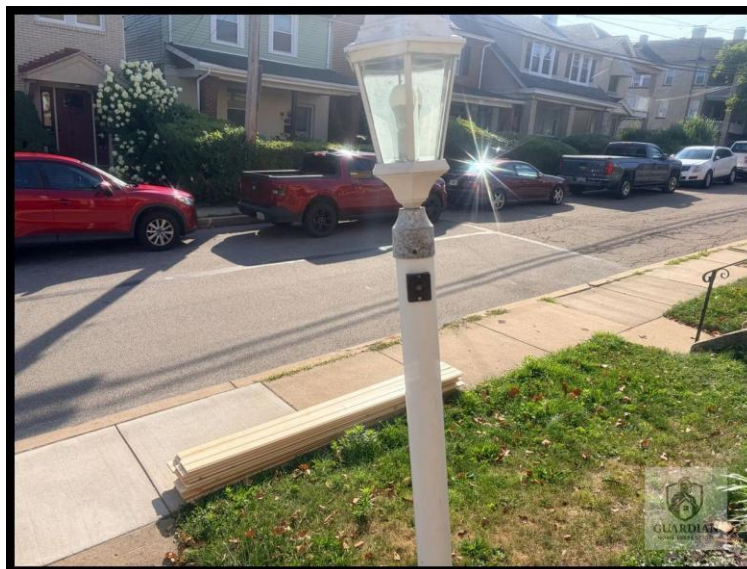
**General Repair:** An exterior lamp post was observed to be loose/unstable. Loose fixtures can tip or become damaged, creating a safety hazard and potentially stressing or damaging the electrical connections. The post should be stabilized by repairing or replacing the mounting/base as needed and verifying the fixture is securely fastened. Repairs should be performed by a qualified electrician or qualified handyman familiar with exterior lighting installations. (Figure [12](#))

**Figure 12: An exterior lamp post was observed to be loose/unstable.**

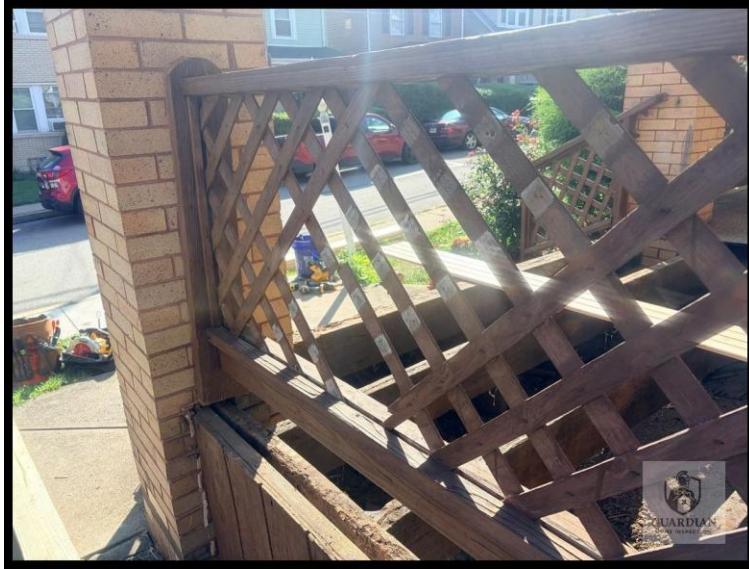
**General Repair:** The exterior wood lattice/porch railing was observed to be broken, loose, and deteriorated, with missing/rotted sections. This condition can create a safety hazard and may allow continued moisture intrusion and accelerated wood decay. Repair or replace the affected lattice/railing sections and ensure the assembly is properly secured and protected from weather exposure. Corrections should be performed by a qualified carpenter or general contractor. (Figure [13](#))

**Figure 13: The exterior wood lattice/porch railing was observed to be broken, loose, and deteriorated, with missing/rotted sections.**

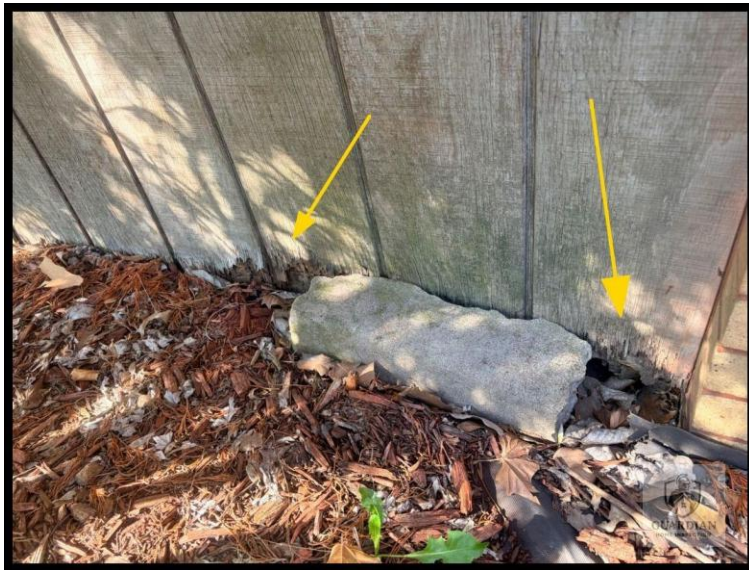
**General Repair:** Rotted and deteriorated wood siding was observed at the bottom edge at the exterior, with a visible gap/opening at the base. This condition can allow moisture intrusion and pest entry and may accelerate concealed decay of adjacent materials. The damaged siding and any affected underlying materials should be repaired or replaced and the base gap should be properly sealed/flushed as appropriate. Repairs should be performed by a qualified siding/wood repair contractor or general contractor. (Figure [14](#))

**Figure 14: Rotted and deteriorated wood siding was observed at the bottom edge at the exterior, with a visible gap/opening at the base.**

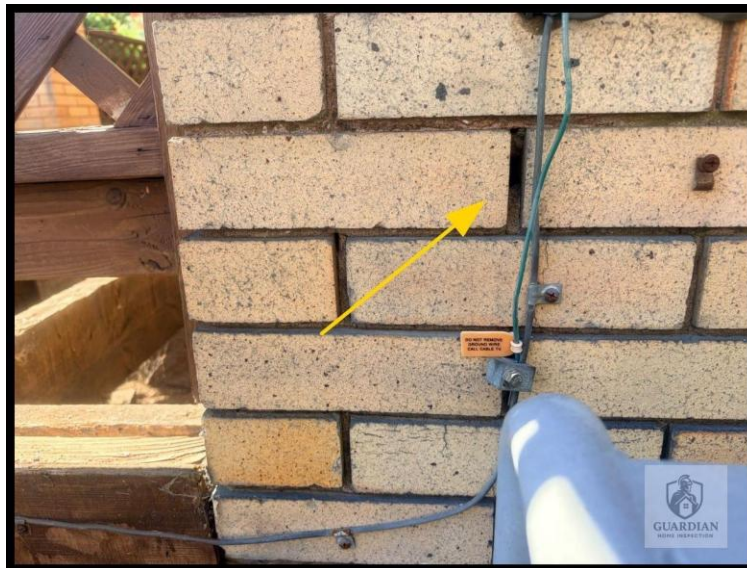
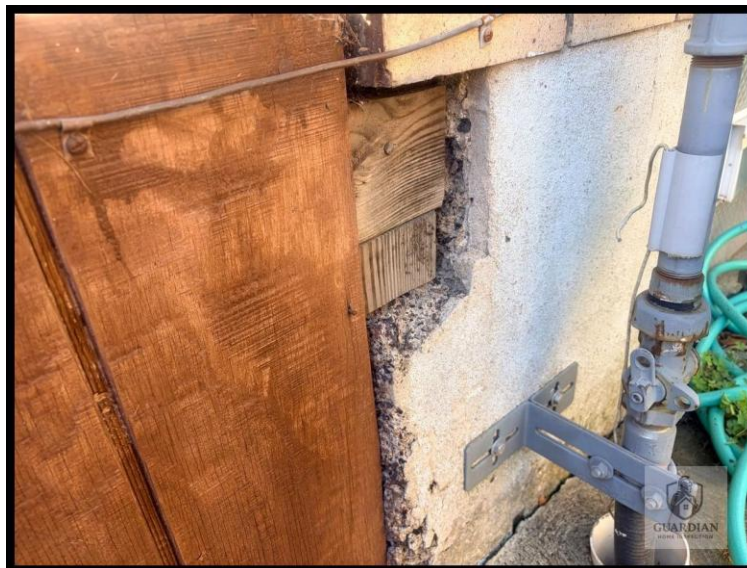
**General Repair:** Open gaps and deteriorated mortar/sealant were observed at an exterior brick-to-wood/stucco corner joint. This condition can allow water intrusion into wall assemblies, which may contribute to concealed moisture damage and decay. The joint should be properly cleaned, repaired (repointed where applicable), and sealed with an appropriate exterior-grade sealant to restore a continuous weather-resistant barrier. Repairs should be performed by a qualified masonry contractor or experienced exterior siding/stucco contractor. (Figures [15](#), [16](#))

**Figure 15: Open gaps and deteriorated mortar/sealant were observed at an exterior brick-to-wood/stucco corner joint.**

**Figure 16: Open gaps and deteriorated mortar/sealant were observed at an exterior brick-to-wood/stucco corner joint.**

**General Repair:** Open gaps and deteriorated mortar/sealant were observed at an exterior brick-to-wood/stucco corner joint. This condition can allow water intrusion into wall assemblies, which may contribute to concealed moisture damage and decay. The joint should be properly cleaned, repaired (repointed where applicable), and sealed with an appropriate exterior-grade sealant to restore a continuous weather-resistant barrier. Repairs should be performed by a qualified masonry contractor or experienced exterior siding/stucco contractor. (Figures [15, 16](#))

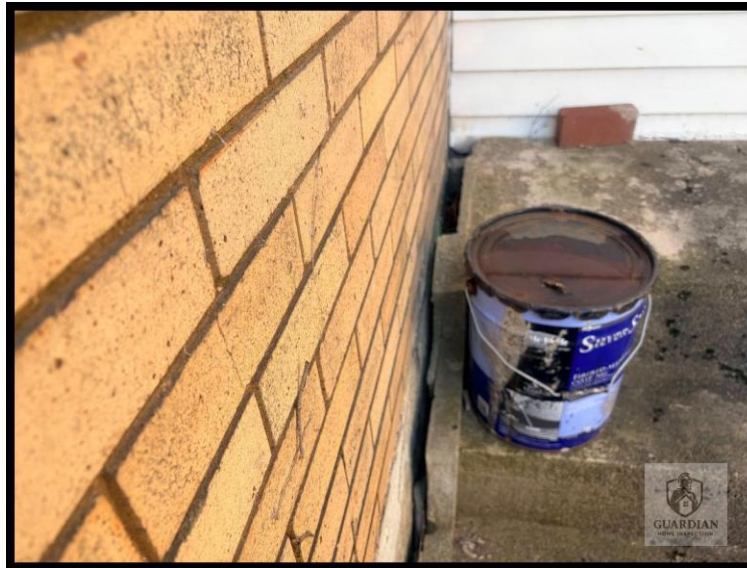
**General Repair:** A gap/opening was observed at the base of the exterior wall/brick veneer, leaving an unsealed area at the wall-to-grade/slab interface. This condition may allow water intrusion and pest entry, which can contribute to concealed deterioration at adjacent materials. The opening should be properly sealed/closed with appropriate materials and detailing compatible with the exterior assembly. Corrections should be performed by a qualified masonry contractor or exterior envelope contractor. (Figure [17](#))

**Figure 17: A gap/opening was observed at the base of the exterior wall/brick veneer, leaving an unsealed area at the wall-to-grade/slab interface.**

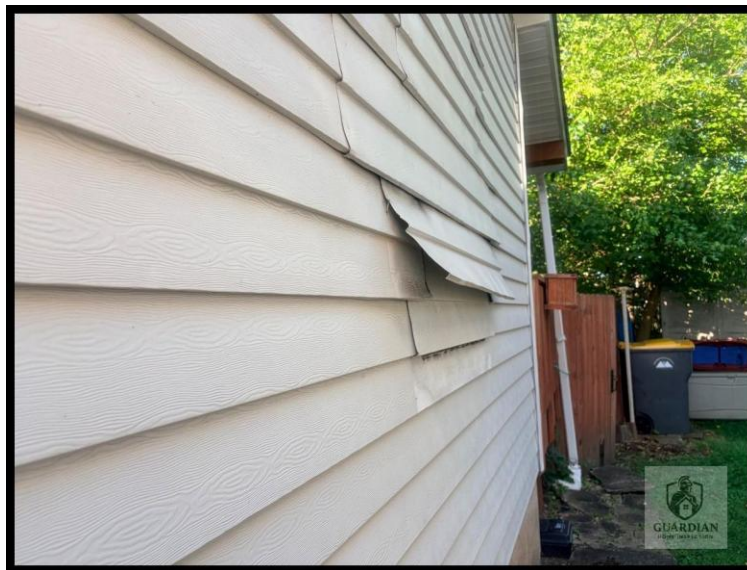
**General Repair:** Exterior lap siding was observed to be broken/warped and pulling loose, leaving visible gaps at the exterior wall. This condition can allow water intrusion behind the cladding, which may contribute to concealed moisture damage and deterioration of underlying materials. Repair or replace the affected siding sections and properly secure and seal joints to restore a weather-resistant exterior envelope. Corrections should be performed by a qualified siding contractor or exterior general contractor. (Figure [18](#))

**Figure 18: Exterior lap siding was observed to be broken/warped and pulling loose, leaving visible gaps at the exterior wall.**

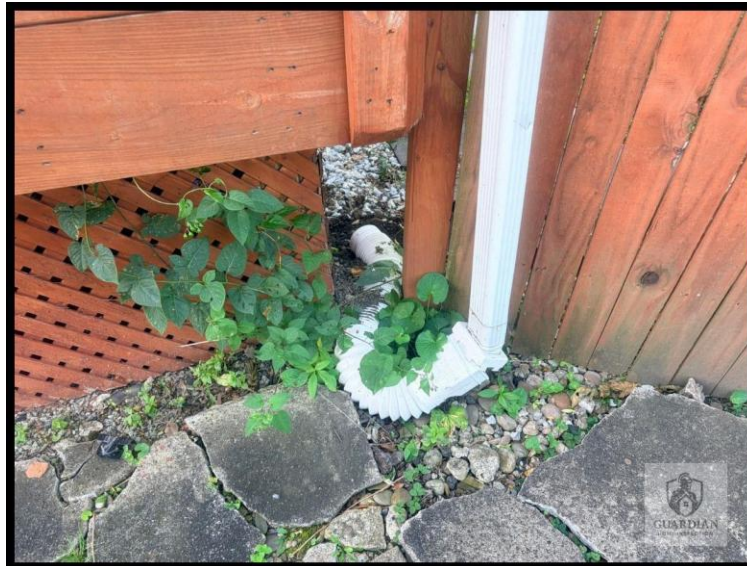
**General Repair:** A downspout extension was observed to be disconnected/loose and discharging roof runoff at the foundation, with vegetation overgrowth around the discharge area. Concentrated water at the foundation can contribute to moisture intrusion and foundation movement and may accelerate deterioration of adjacent materials. The downspout extension should be reconnected/secured and adjusted to discharge water away from the foundation, and vegetation should be trimmed/removed to maintain proper drainage. Repairs should be completed by a qualified gutter contractor or exterior drainage contractor. (Figure [19](#))

**Figure 19: A downspout extension was observed to be disconnected/loose and discharging roof runoff at the foundation, with vegetation overgrowth around the discharge area.**

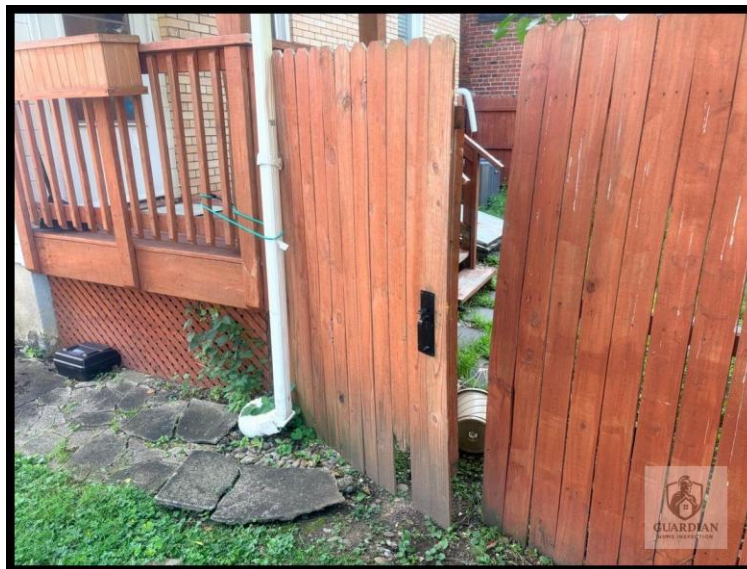
**General Repair:** The exterior privacy gate was observed to be damaged and difficult to open/close. Impaired operation can create a pinch/safety concern and may limit secure access/egress. Repair or replace the gate and adjust/secure the hinges and latch hardware so the gate operates smoothly and closes/latches properly. Repairs should be performed by a qualified fencing contractor or carpenter. (Figure [20](#))

**Figure 20: The exterior privacy gate was observed to be damaged and difficult to open/close.**

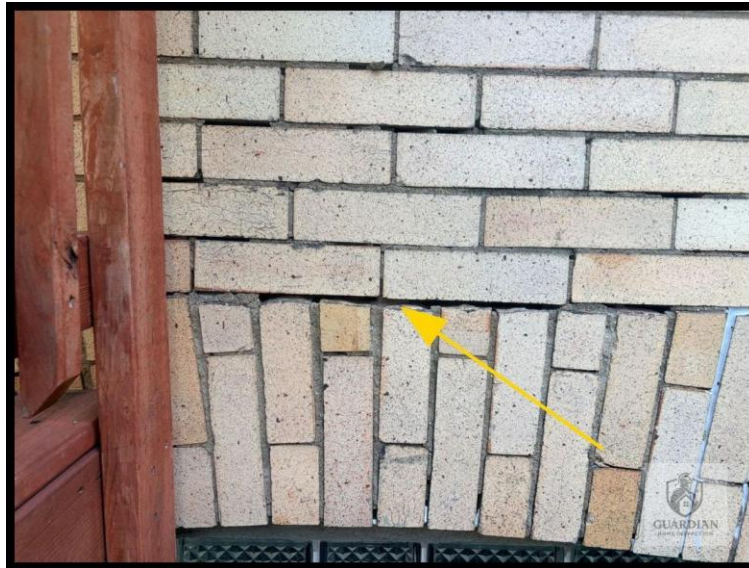
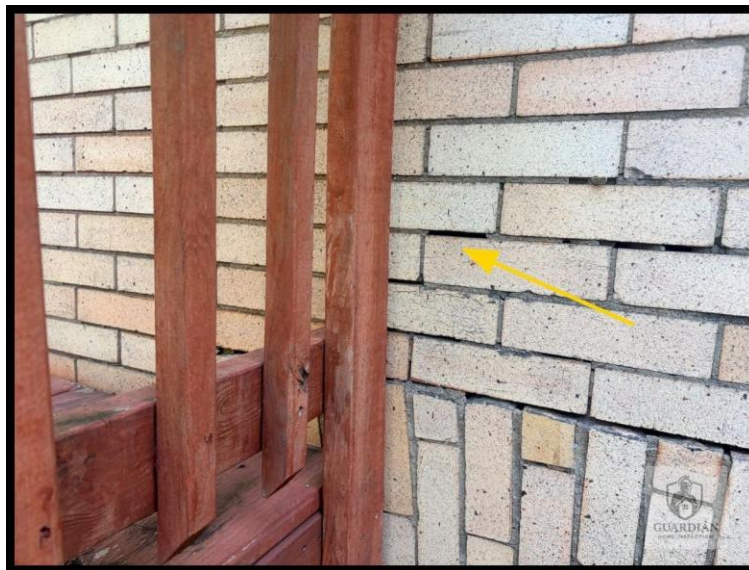
**General Repair:** Stepped cracking and mortar joint separation were observed in the exterior brick veneer, consistent with possible building movement/settlement. This condition can allow moisture intrusion and may indicate underlying structural displacement that could worsen if not addressed. Evaluation should be performed and repairs completed as needed, which may include repointing and localized masonry reconstruction after the cause of movement is identified. A qualified masonry contractor should perform the assessment and repairs; if movement is confirmed or suspected to be ongoing, a structural engineer should be consulted for further evaluation and repair guidance. (Figures [21](#), [22](#))

**Figure 21: Stepped cracking and mortar joint separation were observed in the exterior brick veneer, consistent with possible building movement/settlement.**

**Figure 22: Stepped cracking and mortar joint separation were observed in the exterior brick veneer, consistent with possible building movement/settlement.**

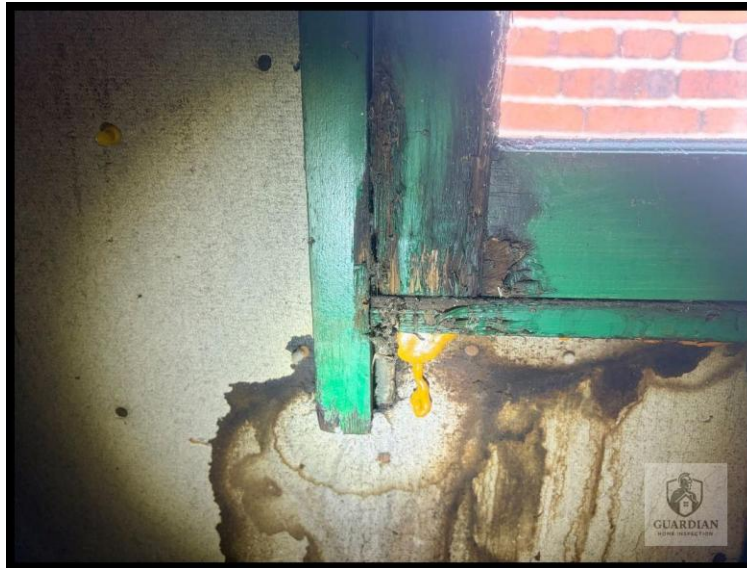
**General Repair:** Severe wood rot was observed at an exterior window frame/sill, with peeling paint and moisture staining consistent with active or prior water intrusion. This condition can allow continued water entry and concealed deterioration of surrounding materials. The window sill/frame components should be repaired or replaced as needed and the window perimeter should be properly sealed/flushed to control moisture intrusion. Repairs should be performed by a qualified exterior carpentry contractor or window installation contractor. (Figure [23](#))

**Figure 23: Severe wood rot was observed at an exterior window frame/sill, with peeling paint and moisture staining consistent with active or prior water intrusion.**

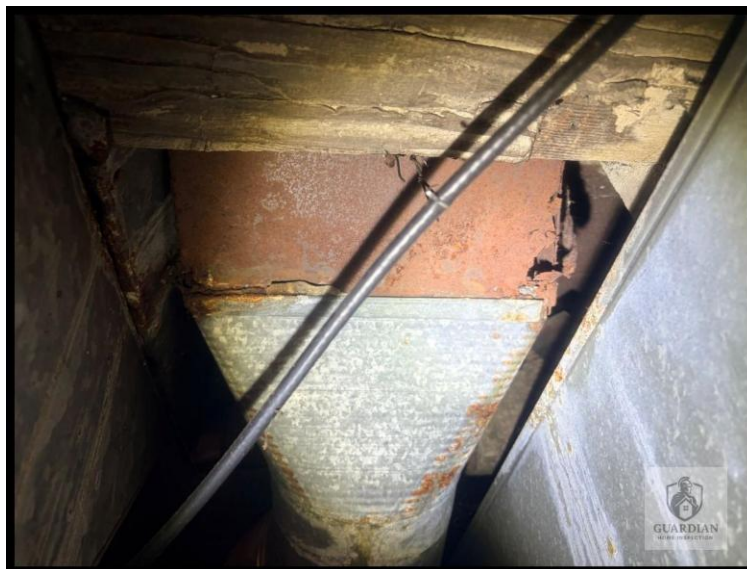
**General Repair:** Ductwork in the basement was observed to be heavily rusted in areas. Corrosion can reduce duct integrity over time and may contribute to air leakage and reduced heating system efficiency. The affected duct sections should be evaluated and repaired or replaced as needed, and any contributing moisture conditions should be addressed to help prevent recurrence. Corrections should be performed by a qualified HVAC contractor. (Figure [24](#))

**Figure 24: Ductwork in the basement was observed to be heavily rusted in areas.**

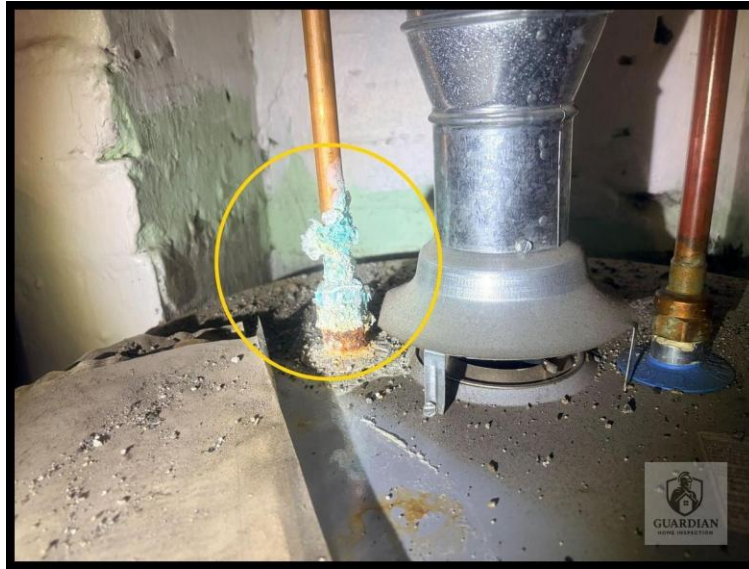
**General Repair:** Severe corrosion and mineral buildup were observed on a copper pipe/connection at the water heater in the basement, indicating a possible active or past leak. This condition can lead to pipe deterioration, active leakage, and resultant water damage. The affected piping/connection should be evaluated, the leak source confirmed, and the corroded components repaired or replaced as necessary. Corrections should be performed by a licensed plumber. (Figure [25](#))

**Figure 25: Severe corrosion and mineral buildup were observed on a copper pipe/connection at the water heater in the basement, indicating a possible active or past leak.**

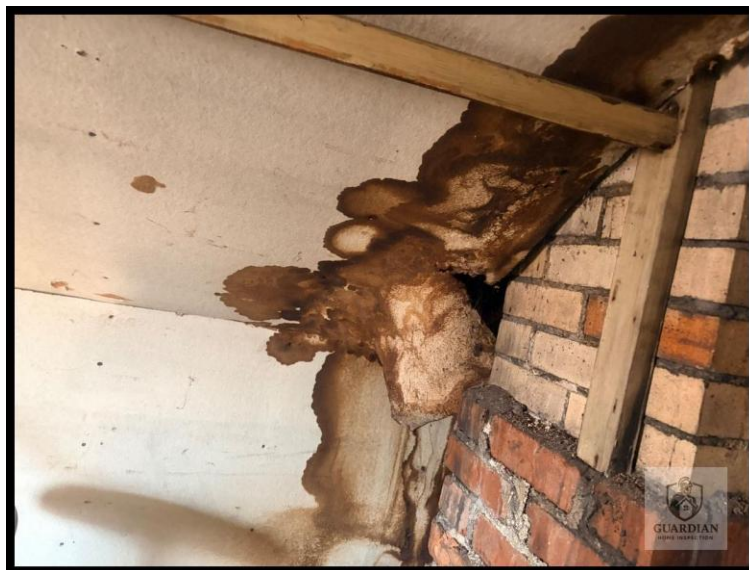
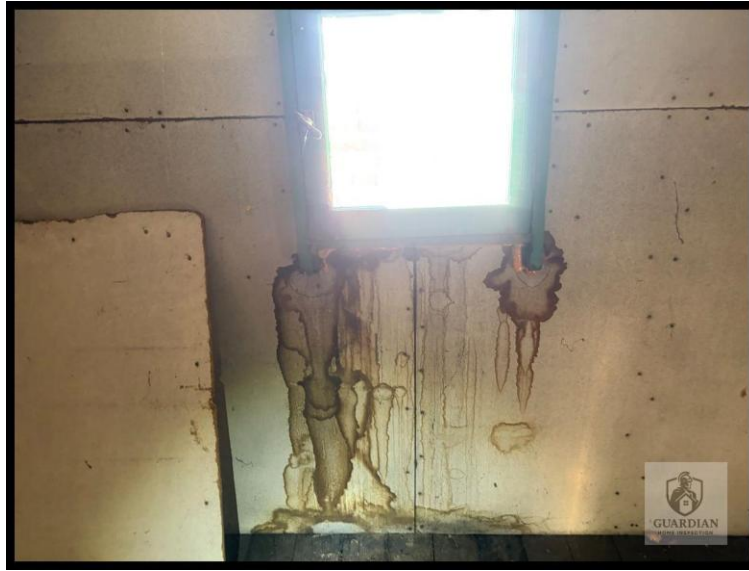
**General Repair:** Significant water intrusion staining and damaged sheathing/drywall were observed in the attic around the chimney and a window, with evidence consistent with a past leak. This condition is important because moisture intrusion can lead to concealed material deterioration and ongoing damage if the source is still active. The leak source should be located and corrected, and all damaged materials should be repaired or replaced as needed after the area has been allowed to dry. Repairs should be performed by a qualified roofing contractor for the leak correction and a qualified contractor for interior/attic material repairs. (Figures [26, 27](#))

**Figure 26: Significant water intrusion staining and damaged sheathing/drywall were observed in the attic around the chimney and a window, with evidence consistent with a past leak.**

**Figure 27: Significant water intrusion staining and damaged sheathing/drywall were observed in the attic around the chimney and a window, with evidence consistent with a past leak.**

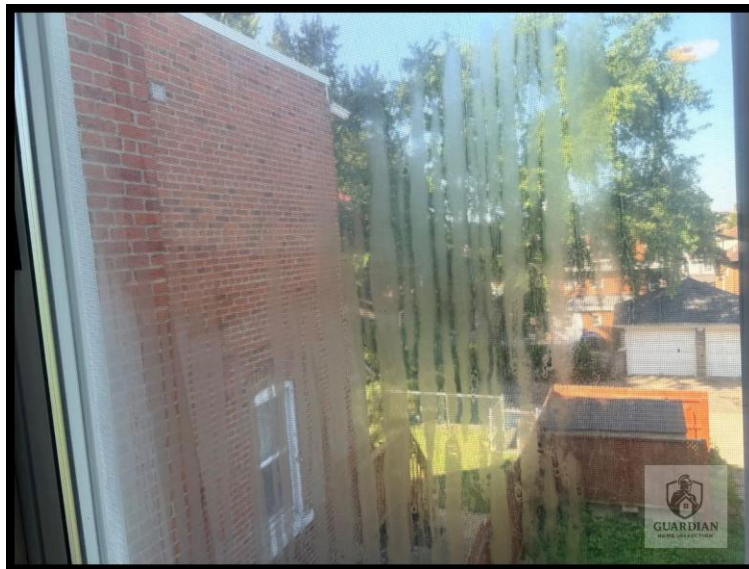
**General Repair:** Heavy condensation and water streaking were observed between the window panes in the bedroom, consistent with a likely failed insulated glass seal. This condition reduces insulating performance and visibility and can contribute to moisture-related deterioration of adjacent window components over time. Replacement of the insulated glass unit or the affected window assembly is recommended to restore proper performance. Repairs should be completed by a qualified window and glass contractor. (Figure [28](#))

**Figure 28: Heavy condensation and water streaking were observed between the window panes in the bedroom, consistent with a likely failed insulated glass seal.**

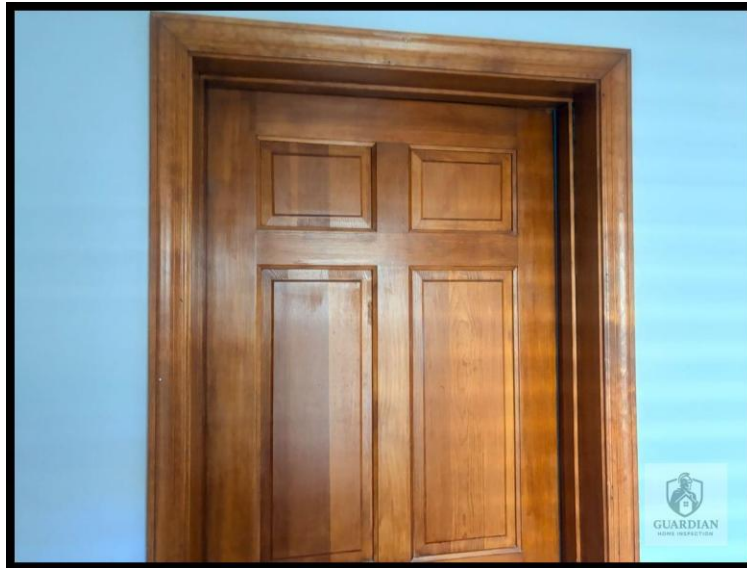
**General Repair:** The bedroom door was observed to not close properly. This condition can impede privacy and egress and may indicate misalignment at the hinges, latch, or door frame. Adjustment and/or repair of the door, hinges, latch/strike plate, and frame should be completed to allow proper latching and smooth operation. Repairs should be performed by a qualified carpenter or door/trim contractor. (Figure [29](#))

**Figure 29: The bedroom door was observed to not close properly.**

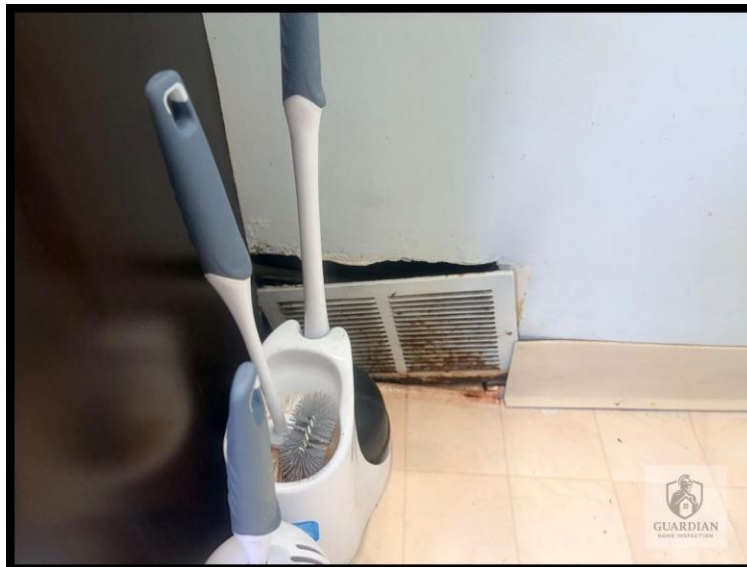
**General Repair:** Damaged drywall was observed around the bathroom HVAC return vent, including a visible gap at the wall opening and water staining/rust at the return grille and adjacent baseboard area. This condition may indicate moisture intrusion and can lead to continued material deterioration and potential indoor air quality concerns if not corrected. The return grille and surrounding finishes should be repaired/replaced as needed and the wall opening should be properly sealed and finished after the moisture source is identified and corrected. Repairs should be performed by a qualified drywall/finish contractor, with evaluation and correction of the moisture source by a licensed HVAC contractor if related to the return duct/grille or air movement/condensation. (Figure [30](#))

**Figure 30: Damaged drywall was observed around the bathroom HVAC return vent, including a visible gap at the wall opening and water staining/rust at the return grille and adjacent baseboard area.**

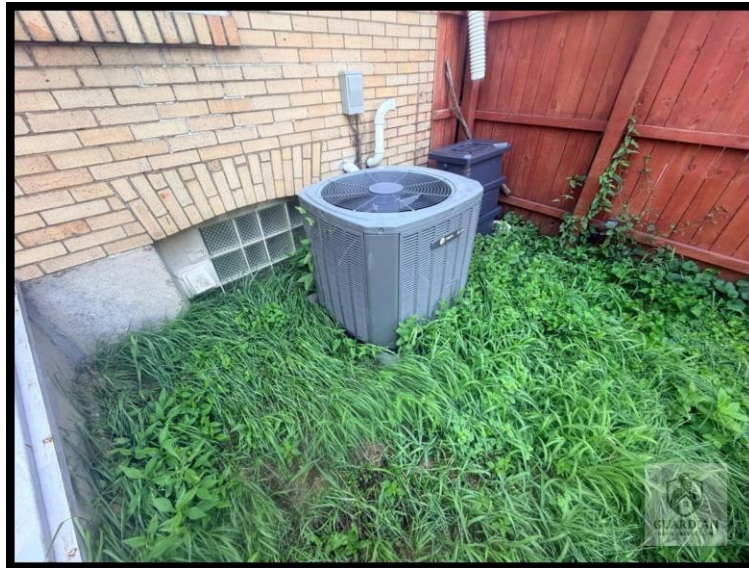
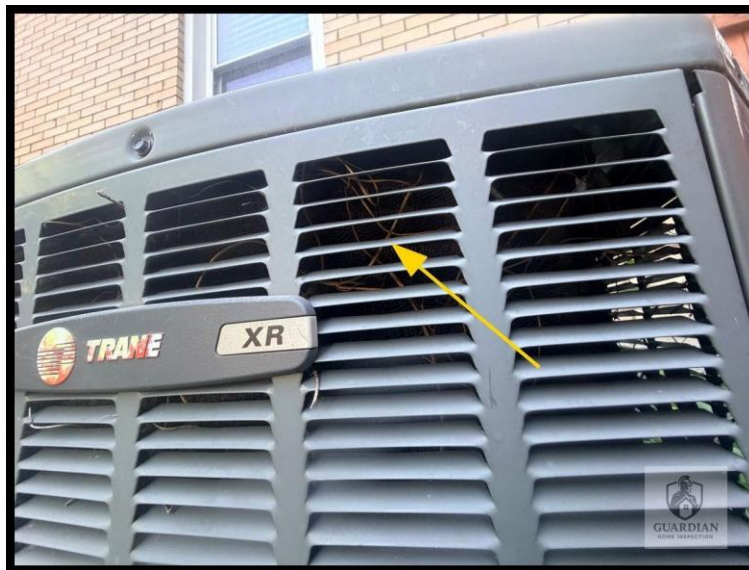
**Improve:** Overgrown vegetation and debris were observed inside and around the outdoor A/C condenser, restricting airflow through the coil area and limiting service access. This condition can reduce cooling efficiency, contribute to overheating and premature equipment wear, and impede proper maintenance. Vegetation and debris should be removed and a continuous clearance zone should be maintained around the condenser in accordance with the manufacturer's requirements. Corrections should be performed by a qualified HVAC contractor or landscaping professional as appropriate, with care taken to avoid damaging the coil fins and wiring. (Figures [31](#), [32](#))

**Figure 31: Overgrown vegetation and debris were observed inside and around the outdoor A/C condenser, restricting airflow through the coil area and limiting service access.**

**Figure 32: Overgrown vegetation and debris were observed inside and around the outdoor A/C condenser, restricting airflow through the coil area and limiting service access.**

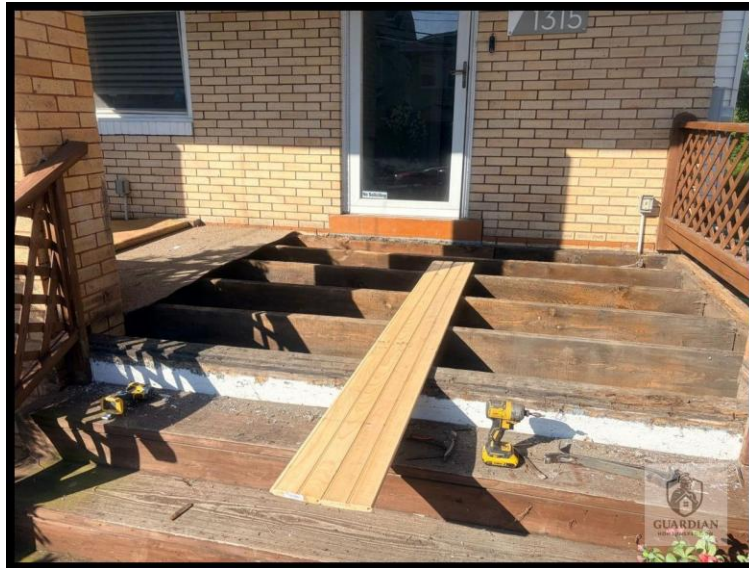
**Figure 33: The front porch/deck was under construction at the time of the inspection, and portions of the walking surface were not installed, limiting evaluation of the complete assembly.**

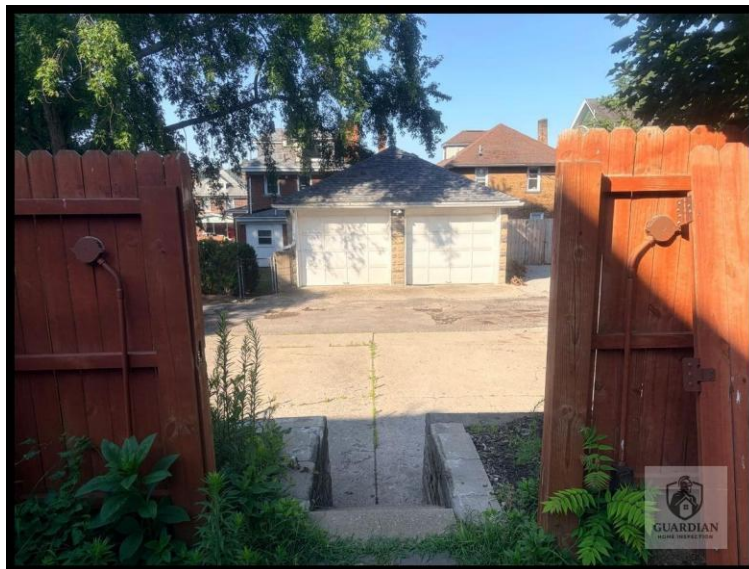
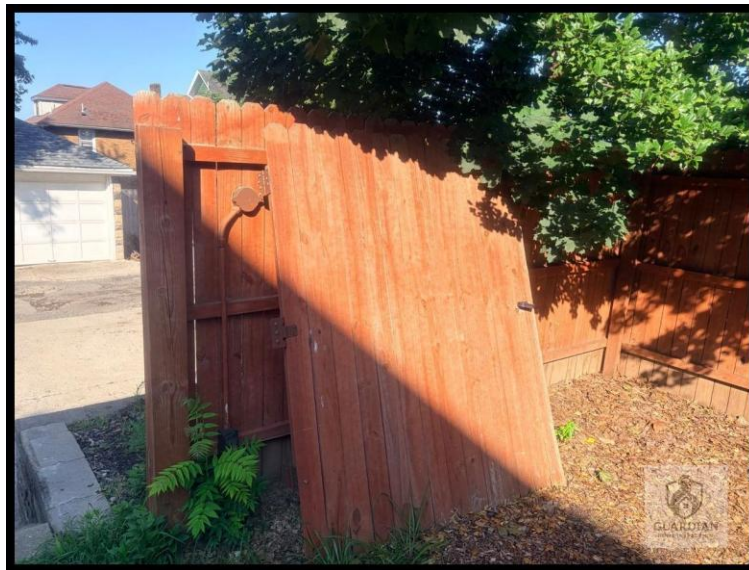
**Figure 34: The rear privacy gate was observed to be dismantled at the time of inspection.**

**Figure 35: The rear privacy gate was observed to be dismantled at the time of inspection.**
