# Residential Building Inspection Report

**238 Grant Ave, Pittsburgh, PA 15237**

**Inspection Date:**  
2026-06-10

**Report Number:**  
0610260912CN

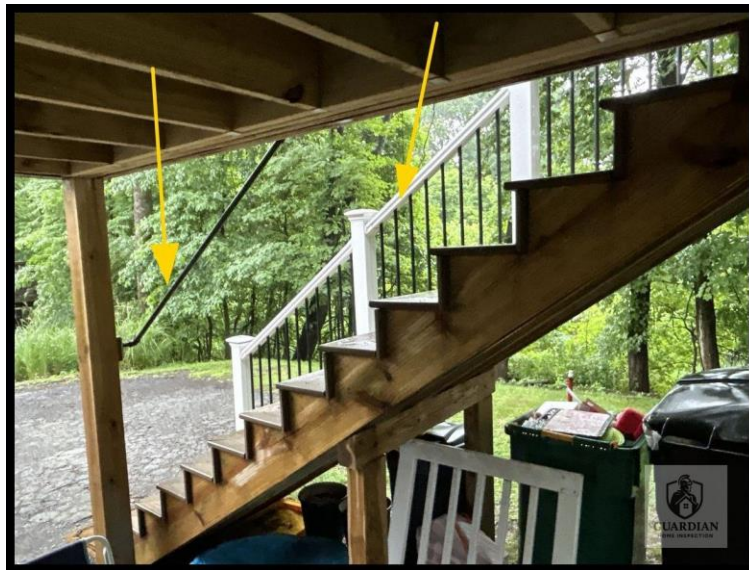
**Figure 1: The rear exterior deck stairway has an open side where a step railing/handrail is not installed.**

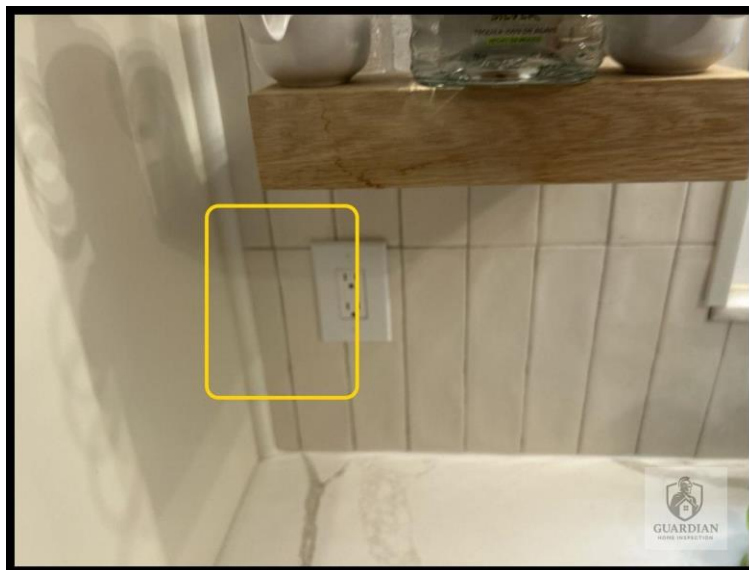
**Safety Concern:** A receptacle located along the kitchen countertop was observed without GFCI protection. Countertop outlets are subject to moisture exposure, and lack of GFCI protection increases the risk of electric shock. Have GFCI protection installed (via a GFCI receptacle, GFCI breaker, or upstream GFCI protection as appropriate) and verify proper operation. This repair should be performed by a Licensed Electrician. (Figure [2](#))

**Figure 2: A receptacle located along the kitchen countertop was observed without GFCI protection.**

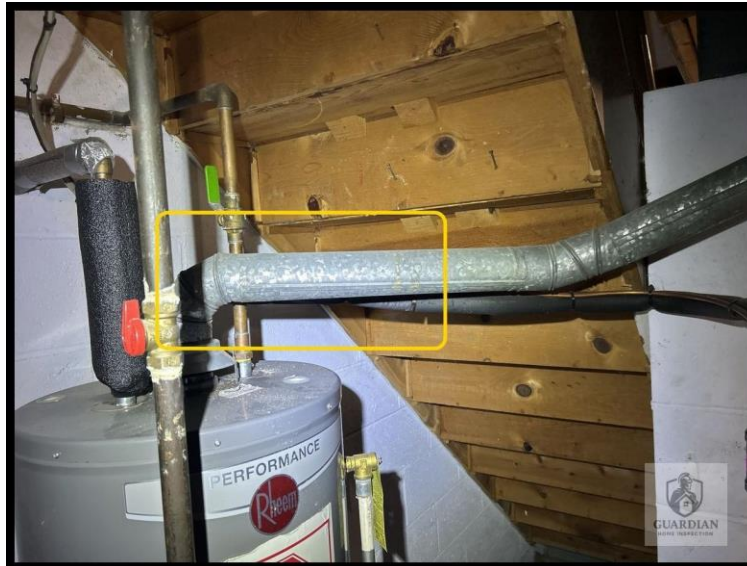
**Safety Concern:** In the basement, the hot water heater vent flue/connector did not have adequate upward slope back toward the unit. Insufficient slope can impede proper draft and may allow combustion gases, including carbon monoxide, to spill into the home, which is a safety concern. Have the vent connector evaluated and reconfigured to maintain proper pitch and secure connections in accordance with the water heater manufacturer's instructions and applicable codes. Repairs should be performed by a qualified HVAC contractor or licensed plumber experienced with fuel-fired appliance venting. (Figure [3](#))

**Figure 3: In the basement, the hot water heater vent flue/connector did not have adequate upward slope back toward the unit.**

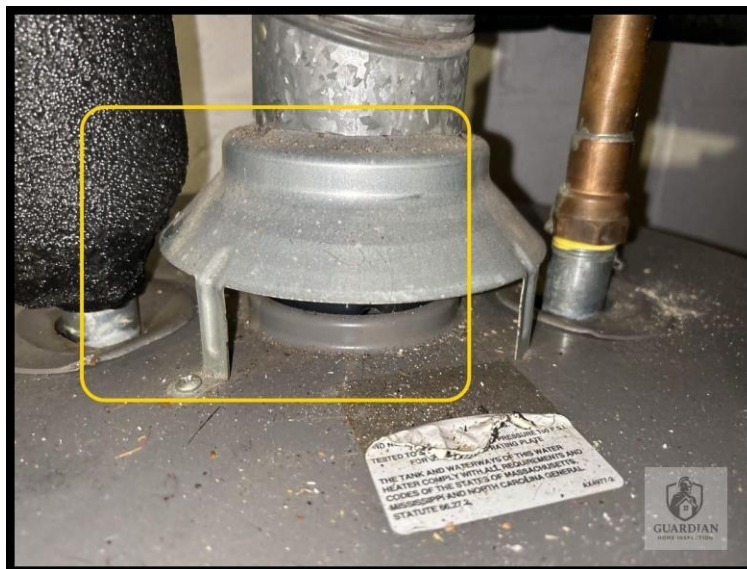
**Safety Concern:** The water heater draft hood in the basement was observed to be backdrafting. Backdrafting can allow combustion gases, including carbon monoxide, to spill into the living space and represents a safety concern. Have the venting system and combustion air provisions evaluated and corrected as needed to establish proper draft and safe operation. Repairs and verification should be performed by a licensed plumbing/HVAC contractor qualified in gas-fired appliance venting. (Figure [4](#))

**Figure 4: The water heater draft hood in the basement was observed to be backdrafting.**

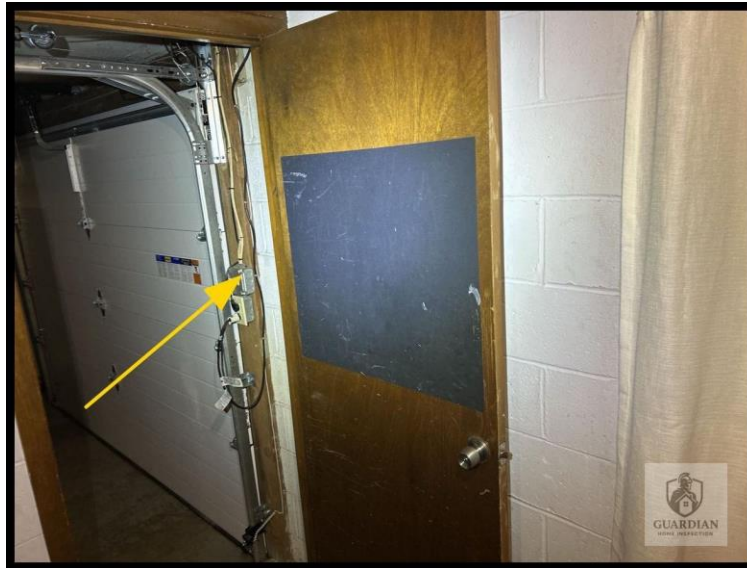
**Safety Concern:** The door between the garage and the home (Garage/Basement area) was observed to be a wood door that is not fire-rated. This condition can reduce the intended fire and smoke separation between the garage and living areas, increasing life-safety risk. Replace the door assembly with an approved fire-rated door (and proper self-closing/latching hardware as required) to restore the separation. Have the correction performed by a qualified door installer or general contractor familiar with fire-separation requirements. (Figure [5](#))

**Figure 5: The door between the garage and the home (Garage/Basement area) was observed to be a wood door that is not fire-rated.**

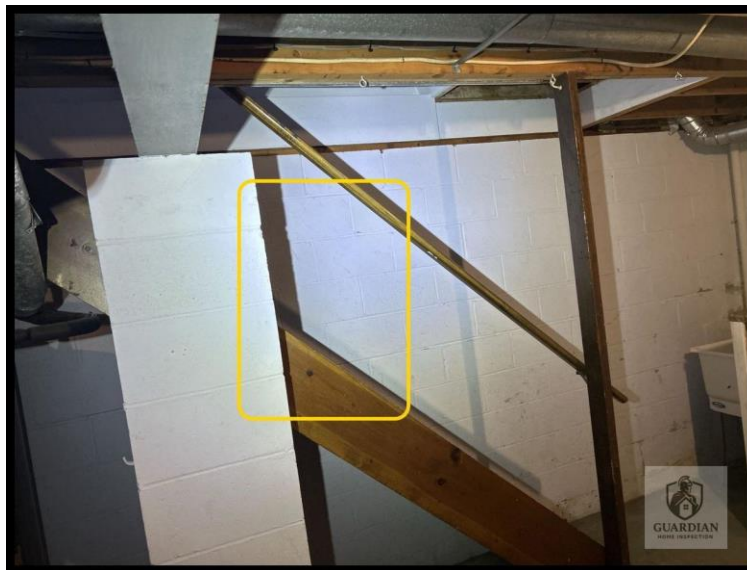
**Figure 6: The open side of the basement stairway lacked a step railing/guard, as evidenced by the exposed edge along the stair run.**

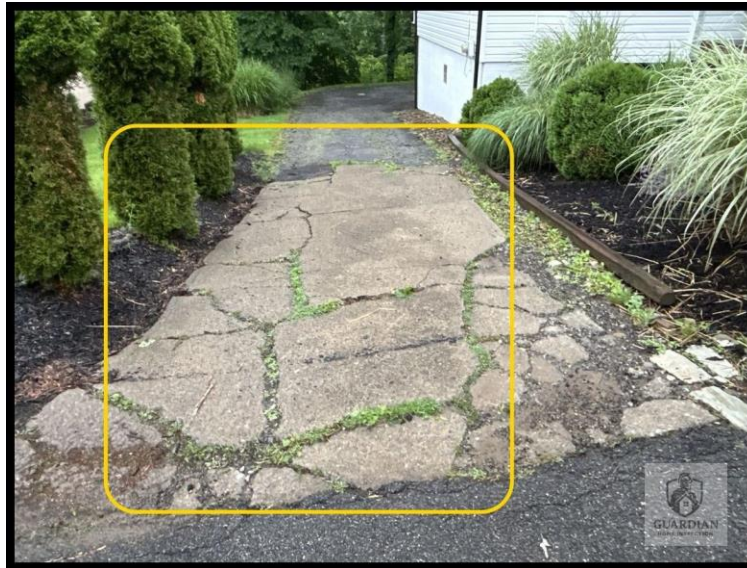
**General Repair:** The concrete and asphalt driveway was observed to be in poor condition with widespread cracking, deteriorated/patched areas, and uneven surfaces. This condition can worsen with freeze-thaw cycles and water intrusion, creating trip hazards and potentially accelerating settlement and drainage issues. Have the driveway evaluated and repaired or resurfaced as needed, with replacement of failed sections where deterioration is extensive. Repairs should be performed by a qualified paving/driveway contractor. (Figure [7](#))

**Figure 7: The concrete and asphalt driveway was observed to be in poor condition with widespread cracking, deteriorated/patched areas, and uneven surfaces.**

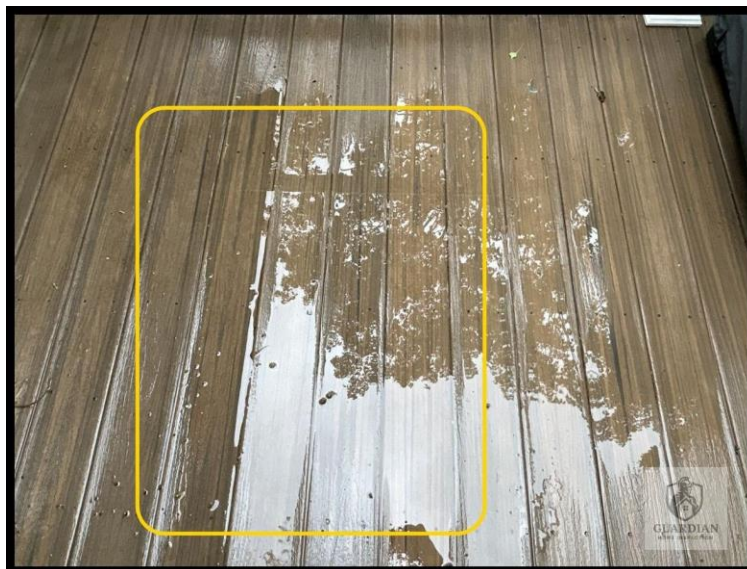
**General Repair:** Inadequate spacing was observed along the rear exterior deck planking. Insufficient gaps can trap moisture and debris, contributing to premature deterioration, slippery conditions, and potential distortion of the decking. Correct by re-spacing and/or replacing affected deck boards to provide consistent drainage and drying gaps per manufacturer and best-practice guidelines. Repairs should be performed by a qualified deck contractor or carpenter. (Figure [8](#))

**Figure 8: Inadequate spacing was observed along the rear exterior deck planking.**

**General Repair:** Inadequate spacing was observed along the rear exterior deck planking. Insufficient gaps can trap moisture and debris, contributing to premature deterioration, slippery conditions, and potential distortion of the decking. Correct by re-spacing and/or replacing affected deck boards to provide consistent

drainage and drying gaps per manufacturer and best-practice guidelines. Repairs should be performed by a qualified deck contractor or carpenter. (Figure [8](#))

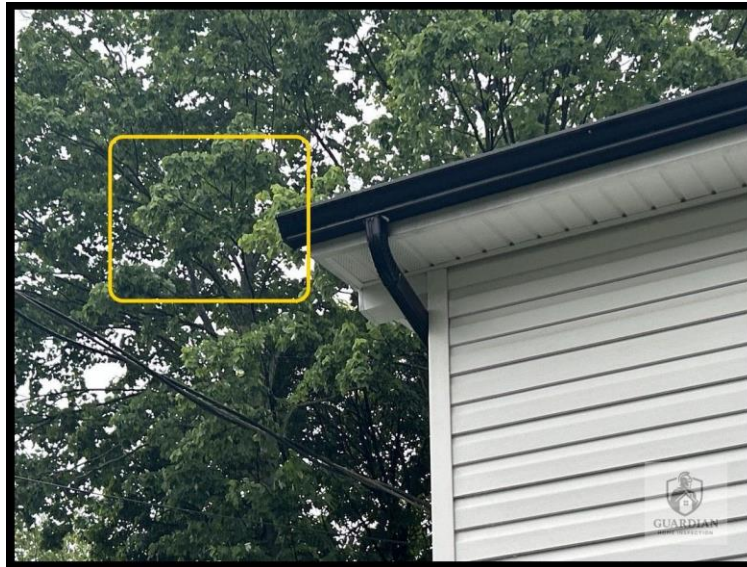
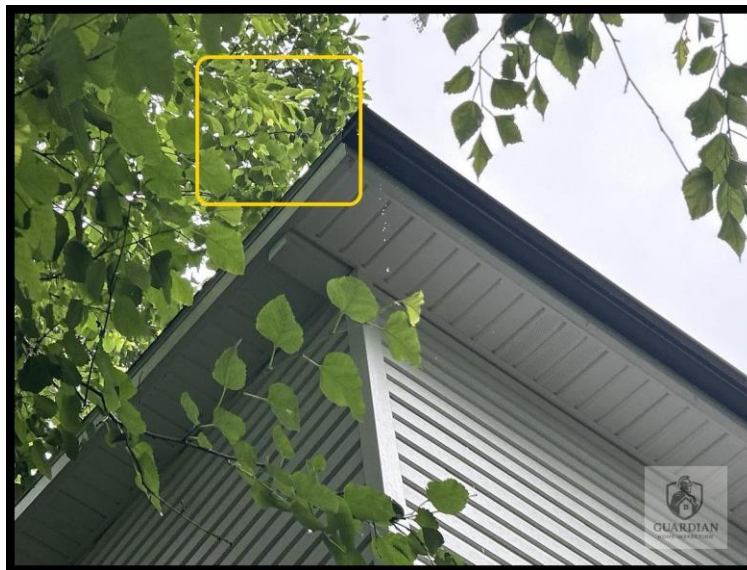
**General Repair:** Several gutter corner seams at the roofline were observed leaking at the time of inspection. Leaking seams can allow water to run behind the gutter and wet fascia/soffit materials, increasing the risk of deterioration and moisture intrusion. Have the affected corner joints cleaned and resealed or repaired, and replace any damaged sections as needed. Repairs should be performed by a qualified gutter contractor. (Figures [9](#), [10](#))

**Figure 9: Several gutter corner seams at the roofline were observed leaking at the time of inspection.**

**Figure 10: Several gutter corner seams at the roofline were observed leaking at the time of inspection.**

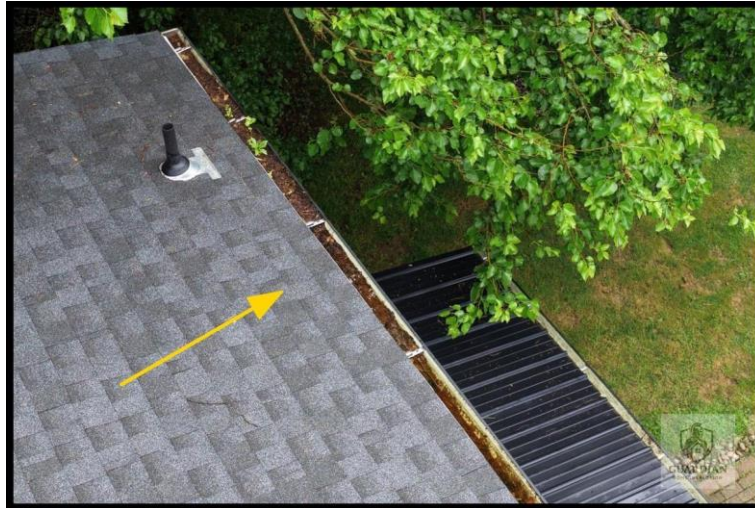
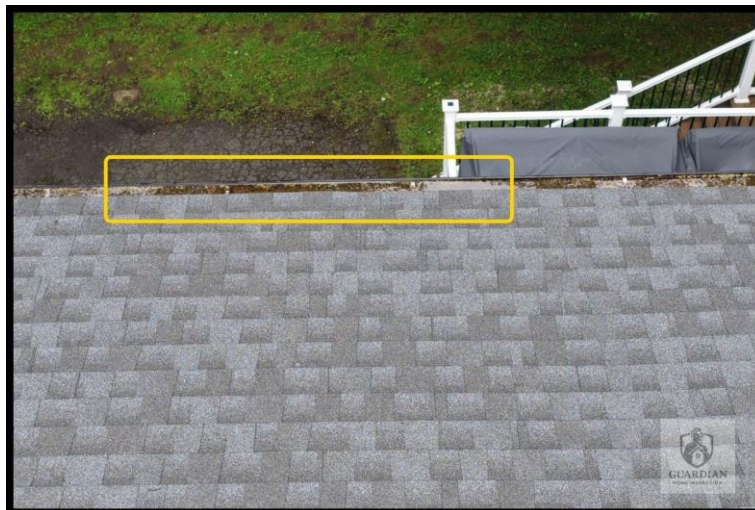
**General Repair:** The roof gutters were observed to be full of debris and spilling over along the eaves. Overflowing gutters can lead to improper roof drainage and increased risk of water intrusion and exterior deterioration. Clean the gutters and downspouts and verify proper drainage and flow at all sections. This work should be performed by a qualified gutter cleaning/maintenance contractor or roofing contractor. (Figures [11](#), [12](#))

**Figure 11: The roof gutters were observed to be full of debris and spilling over along the eaves.**

**Figure 12: The roof gutters were observed to be full of debris and spilling over along the eaves.**

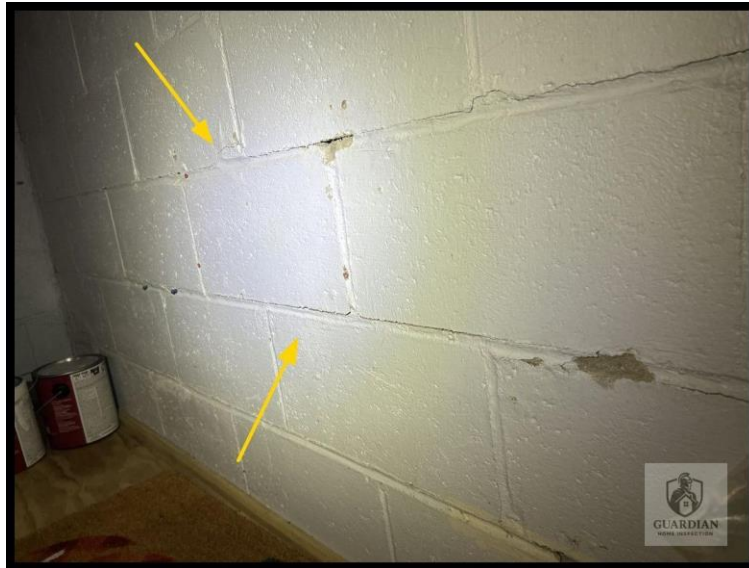
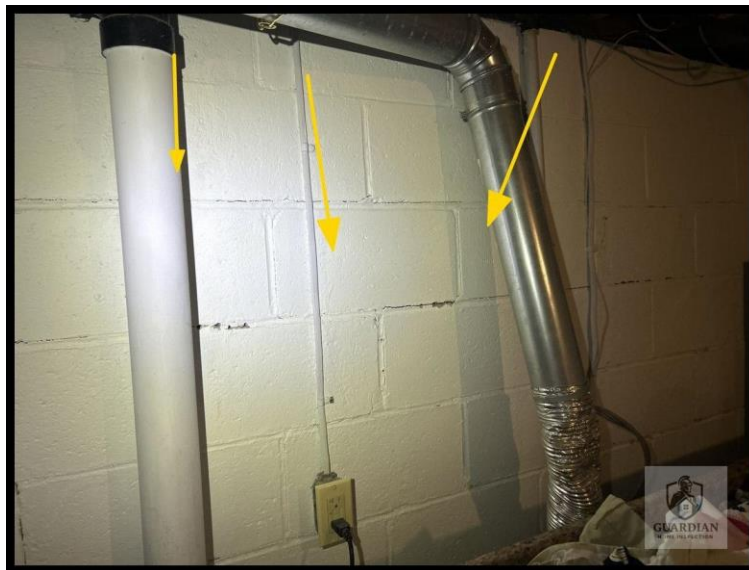
**General Repair:** Moderate step and horizontal cracking was observed along the front-facing foundation wall in the basement, as shown in the photos. This condition may indicate differential movement or lateral pressure and can allow moisture intrusion and further structural deterioration if not addressed. Consult a foundation specialist to evaluate the cracking, determine the cause, and provide repair/monitoring options as needed. Repairs and any required stabilization should be performed by a qualified foundation repair contractor/structural specialist. (Figures [13, 14](#))

**Figure 13: Moderate step and horizontal cracking was observed along the front-facing foundation wall in the basement, as shown in the photos.**

**Figure 14: Moderate step and horizontal cracking was observed along the front-facing foundation wall in the basement, as shown in the photos.**

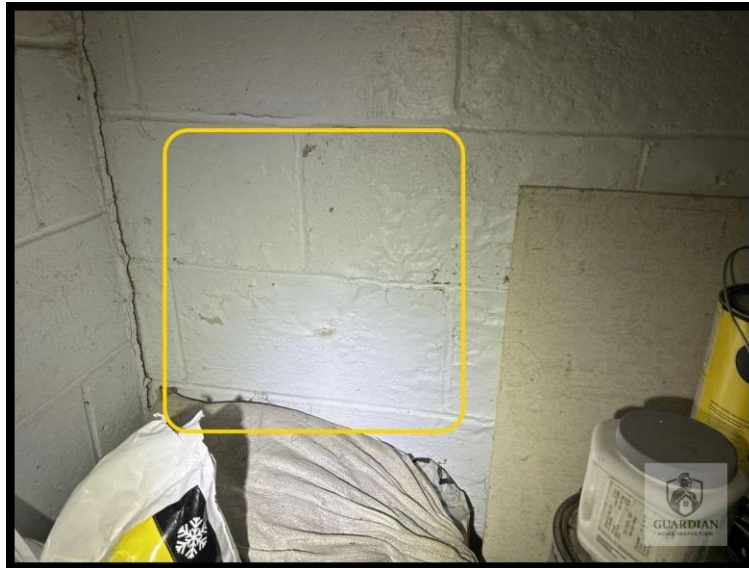
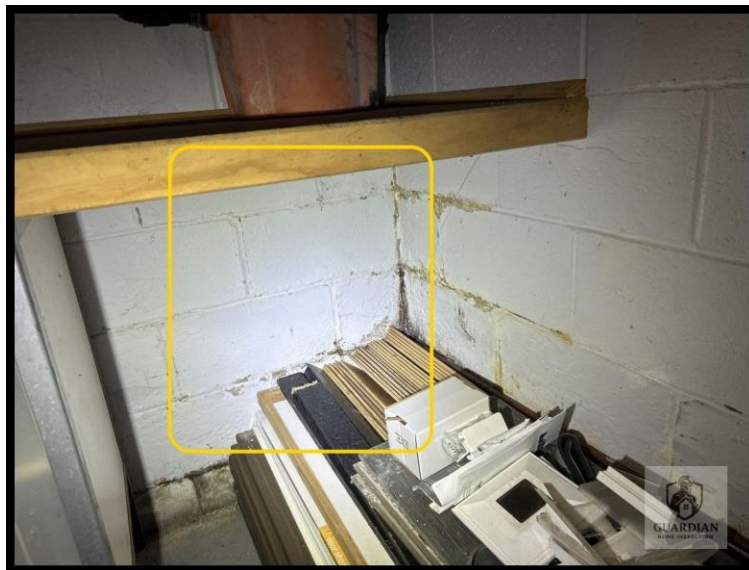
**General Repair:** Moisture intrusion was noted along the front-facing basement foundation wall, with visible staining/efflorescence on the masonry surface. Ongoing moisture can contribute to deterioration of foundation materials and can promote mold growth and elevated indoor humidity. Have the moisture source evaluated and corrected, which may include improving exterior drainage/grading and sealing/waterproofing as needed to prevent continued water entry. Repairs and corrective measures should be performed by a qualified basement waterproofing contractor or foundation/drainage specialist. (Figures [15, 16](#))

**Figure 15: Moisture intrusion was noted along the front-facing basement foundation wall, with visible staining/efflorescence on the masonry surface.**

**Figure 16: Moisture intrusion was noted along the front-facing basement foundation wall, with visible staining/efflorescence on the masonry surface.**

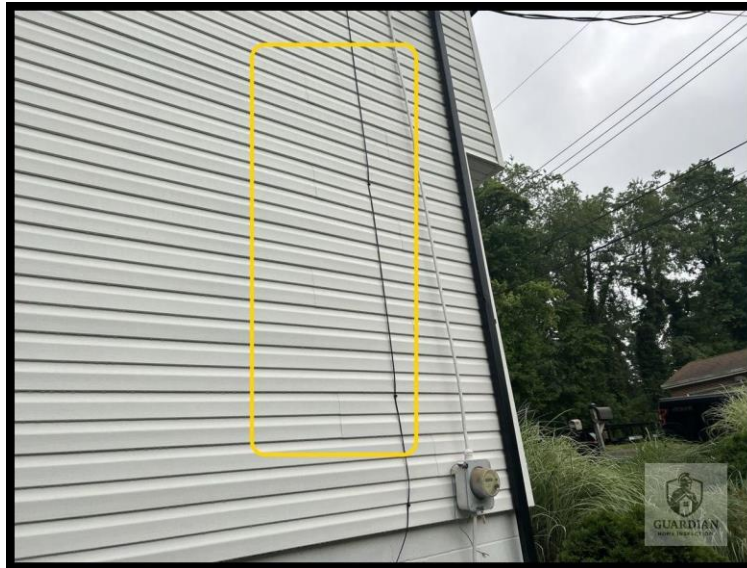
**General Repair:** The electrical service cable along the left-facing exterior side of the home was observed to be loose and not adequately secured to the wall. Loose service conductors can be damaged by wind movement or abrasion, increasing the risk of insulation damage and electrical hazards. Have the cable properly supported and fastened with approved hardware and verify the service attachment is secure and protected from physical damage. Repairs should be performed by a Licensed Electrician. (Figure [17](#))

**Figure 17: The electrical service cable along the left-facing exterior side of the home was observed to be loose and not adequately secured to the wall.**

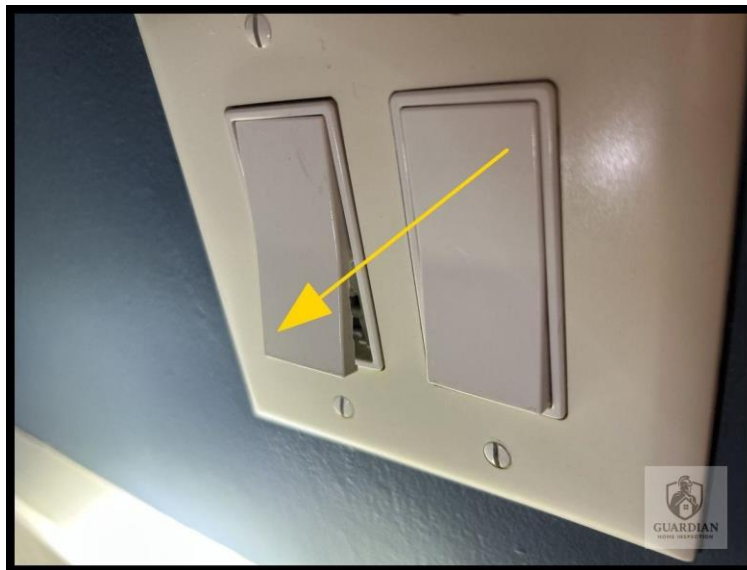
**General Repair:** A switch in the first-floor powder room bathroom was observed to be damaged, with a broken/loose rocker visible at the switch opening. Damaged switches can expose internal components and may present a shock or fire hazard if the device or wiring is compromised. Replace the damaged switch and verify the integrity of the device box and wiring connections. Repairs should be completed by a Licensed Electrician. (Figure [18](#))

**Figure 18: A switch in the first-floor powder room bathroom was observed to be damaged, with a broken/loose rocker visible at the switch opening.**

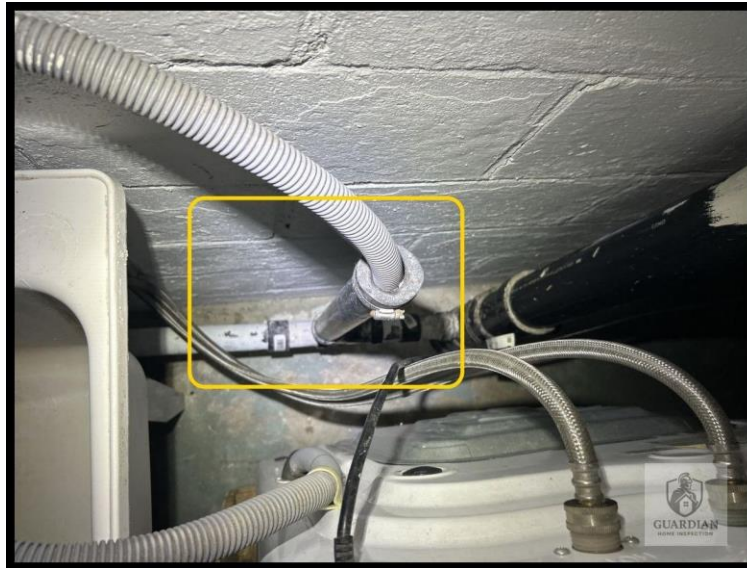
**General Repair:** In the basement, the clothes washer standpipe drain line was observed to lack adequate P-trap protection. An improperly trapped/vented standpipe can allow sewer gases to enter the home and may contribute to improper draining. Have the standpipe drain and trap assembly corrected to provide proper P-trap configuration and protection consistent with current standards. Repairs should be performed by a licensed plumber. (Figure [19](#))

**Figure 19: In the basement, the clothes washer standpipe drain line was observed to lack adequate P-trap protection.**

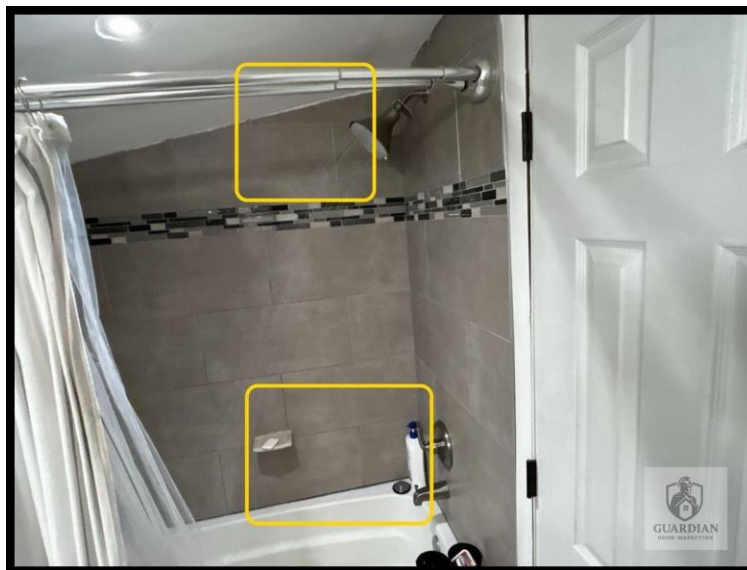
**General Repair:** The second floor bathroom bathtub faucet and showerhead were observed loose from the tub/shower enclosure. Loose plumbing trim can allow movement that may damage supply connections and

can permit water intrusion behind the wall finish, leading to concealed moisture damage. Have the faucet and showerhead assemblies properly secured to the enclosure and verify the connections are sound and leak-free, with appropriate sealing at wall penetrations as needed. Repairs should be performed by a Licensed Plumber. (Figure [20](#))

**Figure 20: The second floor bathroom bathtub faucet and showerhead were observed loose from the tub/shower enclosure.**

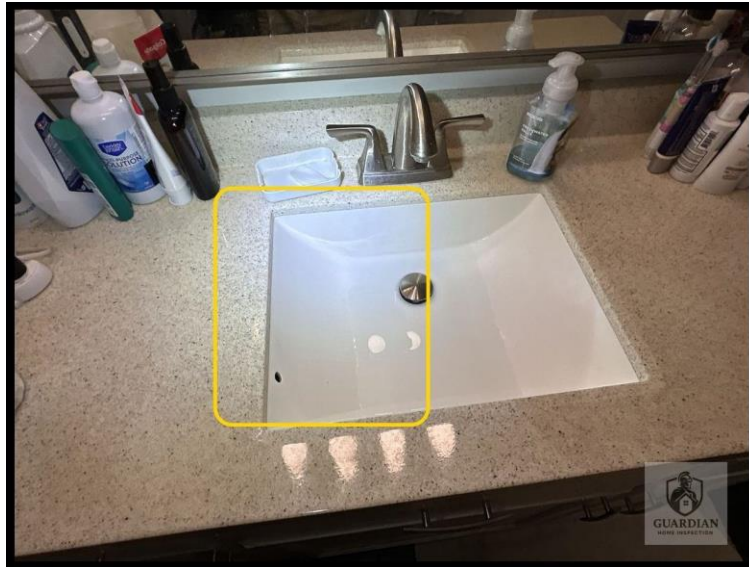
**General Repair:** The second floor bathroom sink was observed to drain slowly at the time of inspection. Slow drainage can indicate a partial blockage or venting issue and may lead to backups or leakage at fittings if the condition worsens. Have the drain piping and trap evaluated and cleared/cleaned as needed, and confirm proper drainage/venting and leak-free operation after repairs. This work should be performed by a Licensed Plumber. (Figure [21](#))

**Figure 21: The second floor bathroom sink was observed to drain slowly at the time of inspection.**

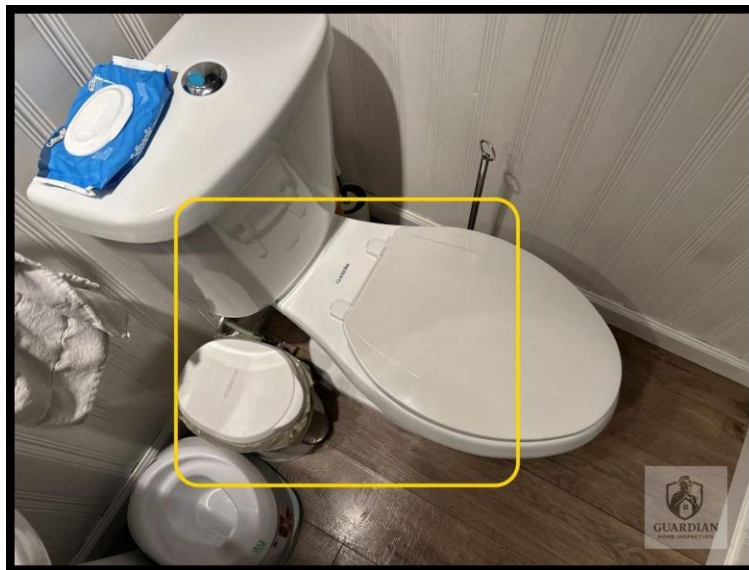
**General Repair:** The toilet in the first-floor powder room was observed to be loose at the floor. A loose toilet can damage the wax ring and flange and may allow leakage that can deteriorate the subfloor and create unsanitary conditions. Have the toilet removed and reset, the wax ring/flange and subfloor condition evaluated, and the toilet properly secured and sealed as needed. Repairs should be performed by a licensed plumber. (Figure [22](#))

**Figure 22: The toilet in the first-floor powder room was observed to be loose at the floor.**

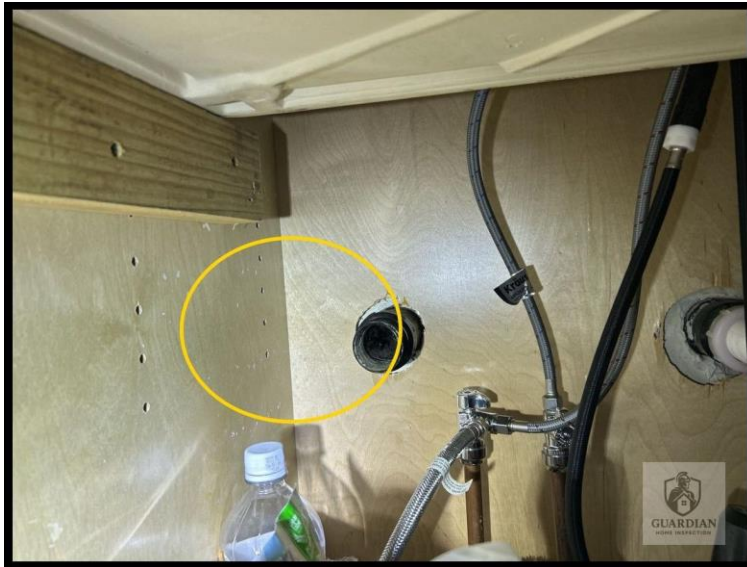
**General Repair:** An abandoned waste pipe opening was observed in the kitchen cabinet area and it was not properly capped. Uncapped waste piping can allow sewer gases, odors, and pests to enter the home and may contribute to moisture-related damage. Have the abandoned line properly sealed with an approved cap/plug (or removed back to an accessible connection as appropriate) and verify the system is gas-tight. This work should be performed by a Licensed Plumber. (Figure [23](#))

**Figure 23: An abandoned waste pipe opening was observed in the kitchen cabinet area and it was not properly capped.**

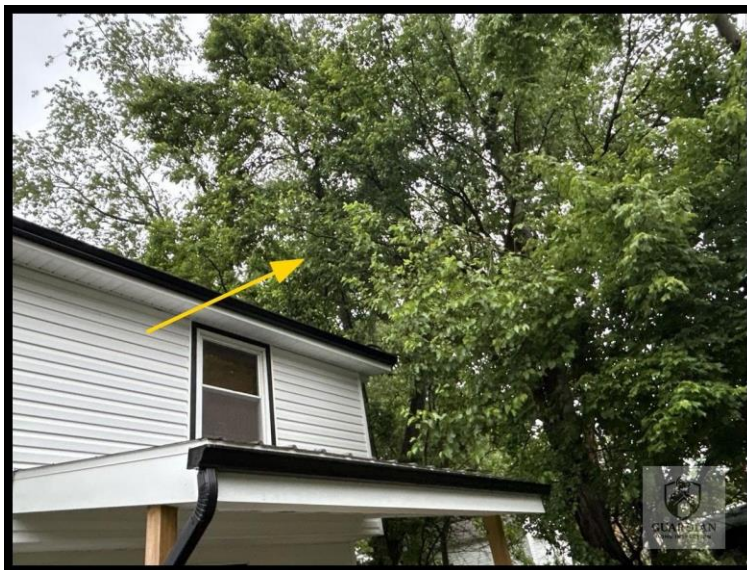
**Improve:** Tree branches were observed overhanging the roofline. Overhanging vegetation can abrade roofing materials, deposit debris that accelerates wear, and provide a pathway for pests to access the structure. Trim back branches to provide adequate clearance from the roof and gutters to reduce damage potential and improve drainage performance. Have a qualified arborist or tree service perform the trimming to avoid injury and prevent damage to the roof and exterior finishes. (Figure [24](#))

**Figure 24: Tree branches were observed overhanging the roofline.**

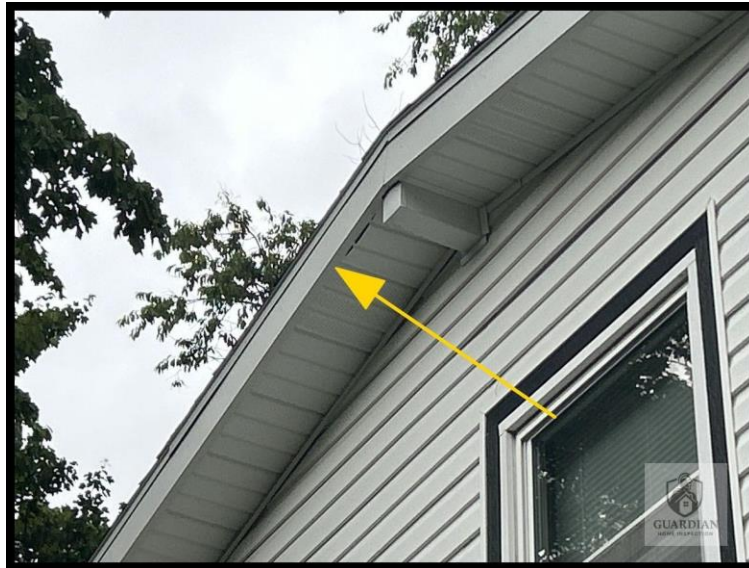
**Improve:** A minorly loose soffit piece was observed along the left exterior eave. Loose soffit panels can allow wind-driven rain and pests to enter the soffit/eave area and may worsen with wind exposure. Have the soffit properly re-secured and any damaged fasteners or panels replaced as needed. Repairs should be performed by a qualified siding/soffit contractor. (Figure [25](#))

**Figure 25: A minorly loose soffit piece was observed along the left exterior eave.**

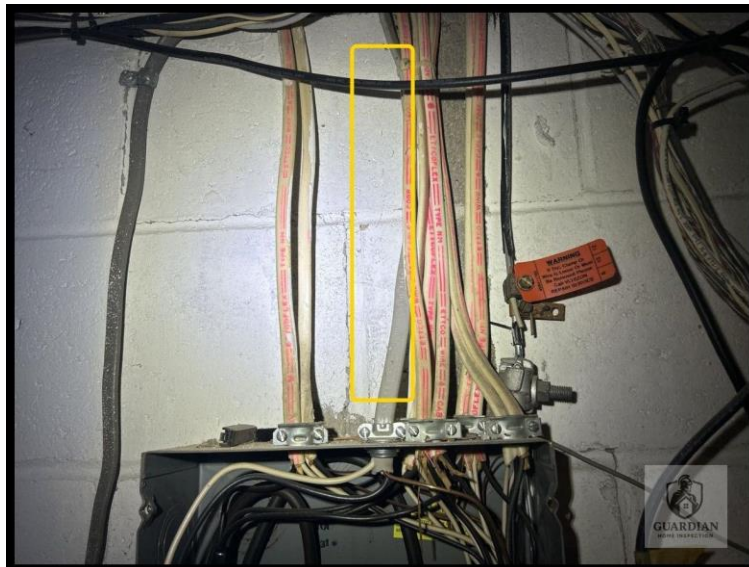
**Improve:** At the main electrical panel in the garage, only one grounding conductor routed to the water line was observed, with no second grounding connection (typically to an exterior ground rod) visible. An incomplete grounding electrode system can reduce the effectiveness of fault clearing and increase shock and equipment damage risk. Have the grounding electrode system evaluated and corrected as needed, including verifying required grounding electrodes and bonding connections. Repairs and any additions should be performed by a licensed electrician. (Figure [26](#))

**Figure 26: At the main electrical panel in the garage, only one grounding conductor routed to the water line was observed, with no second grounding connection (typically to an exterior ground rod) visible.**

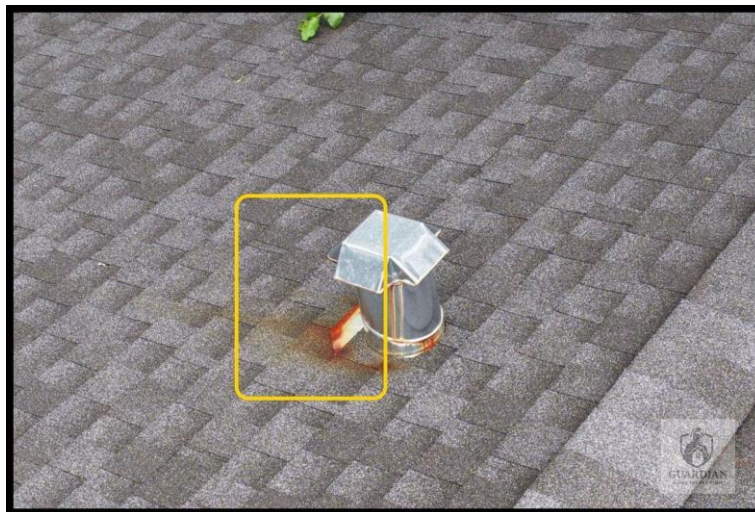
**Figure 27: The caulking/sealant around the metal chimney/flue penetration on the roof should be monitored for deterioration or separation.**

• **FYI:** The caulking/sealant around the metal chimney/flue penetration on the roof should be monitored for deterioration or separation. Failed sealant at roof penetrations can allow moisture intrusion and result in roof deck and interior water damage. Maintain a weathertight seal by resealing/repairing the caulked joint as needed and ensuring the penetration is properly flashed and sealed. Have a qualified roofing contractor perform the evaluation and any necessary resealing/repairs.
