Annual Termite Inspection Report

210 Wild Cedar PI

Simpsonville SC 29681

11/03/2025

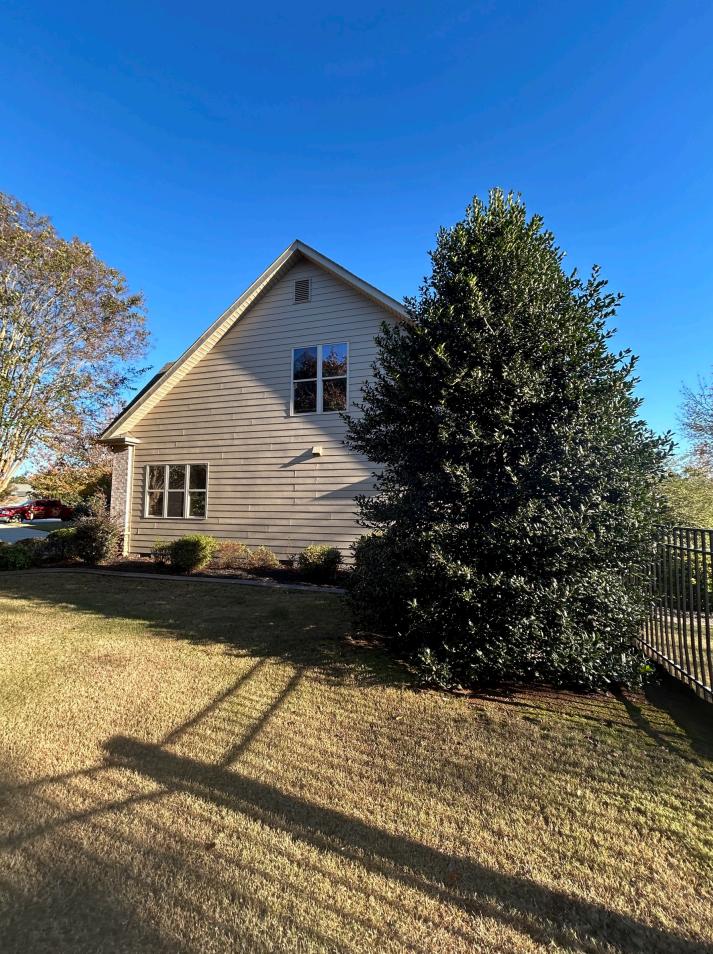
| Picture # | Photo | Caption |
|---|--|---|
| 1 | | Right side |

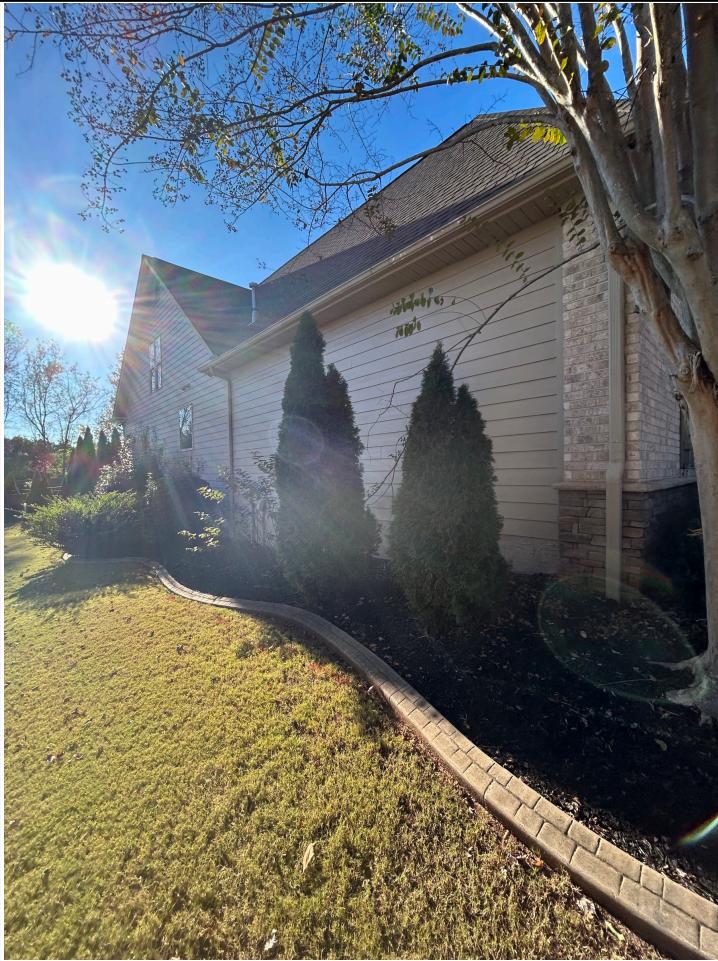
| Picture # | Photo | Caption |
|---|--|---|
| 2 | | Left side |

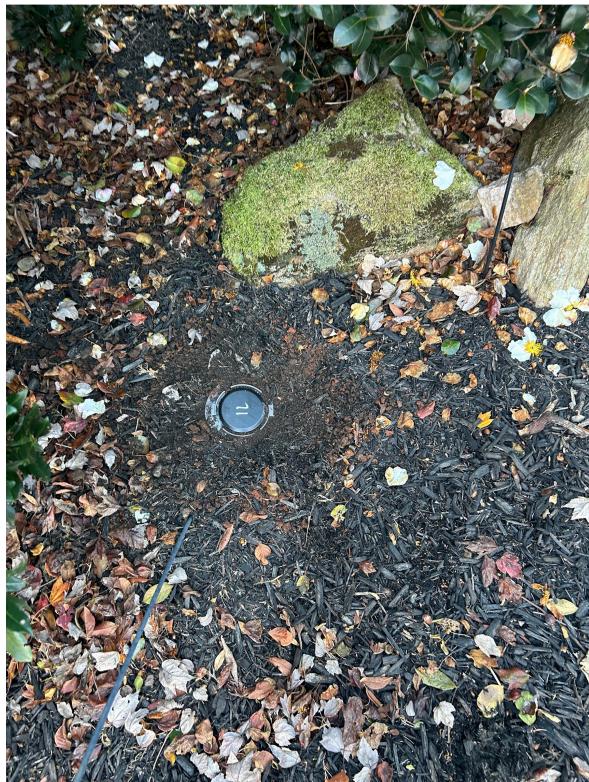
Treatment Photos

| Name of Product | EPA Number | Amount | Unit of Measurement | % | Location of Treatment | Other location |
|---|---|---|---|---|---|---|
| ATBS Station | | 12 | Stations | | Ext. Perimeter | |
