September 1, 2026

On 8/31/2026, Cities' Inspection Service, Inc. completed a home inspection of the property located at 11700 Galtier Drive, Burnsville, Minnesota for you. Doug Hastings did all the fieldwork related to this project. Doug used the national home inspection protocol; the American Society of Home Inspectors (ASHI) Standards of Practice.

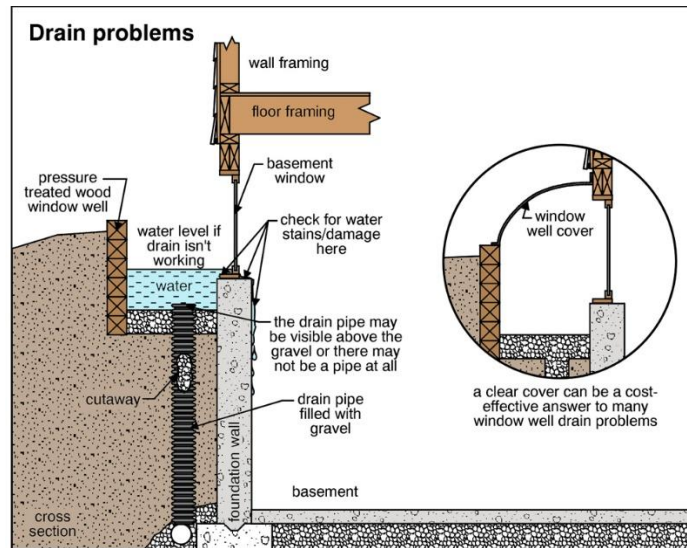
retaining wall \_\_\_\_\_ ⊗.... egress window fills with water

- ✓ grounds \_\_\_\_\_ medium (egress window well)
- ✓ walls \_\_\_\_\_ low
- ✓ roof \_\_\_\_\_ low

- ✓ Egress window well does not drain (dome required).
- ✓ Unstained porch walls (interior also).
- ✓ Loose piece of wall siding. Ivy growing on siding, overhangs, and trim.
- ✓ Verify all windows have screens.
- ✓ Tree too close to roof shingles.
- ✓ Missing piece of roof to wall kickout flashing.

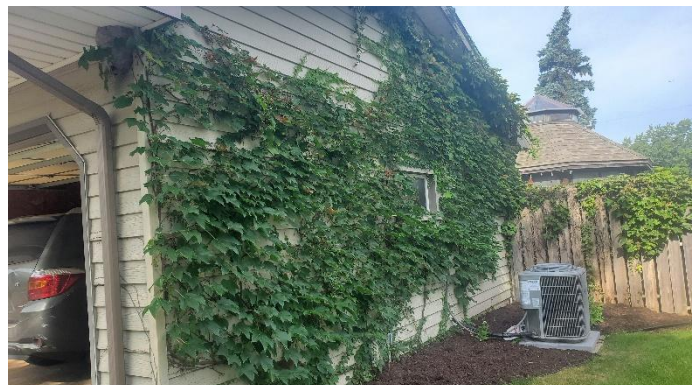
East side

- siding \_\_\_\_\_ ⦿... loose piece siding (west side) / ivy (east side)
- windows \_\_\_\_\_ ⚠️... verify all windows have screens
- doors \_\_\_\_\_ ⦿
- overhangs \_\_\_\_\_ ⦿
- gutters \_\_\_\_\_ ⦿

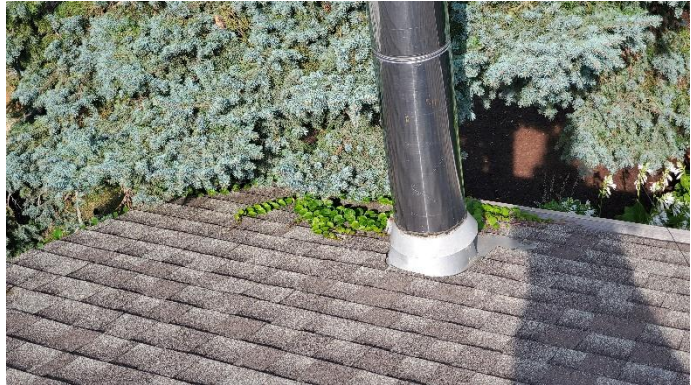
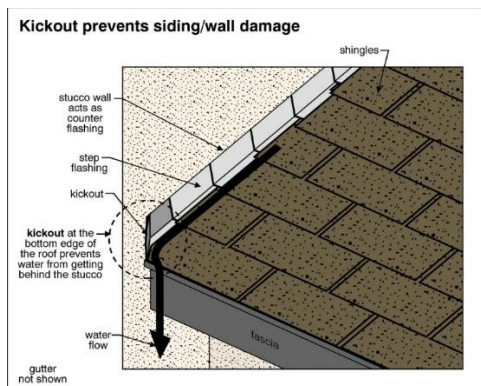
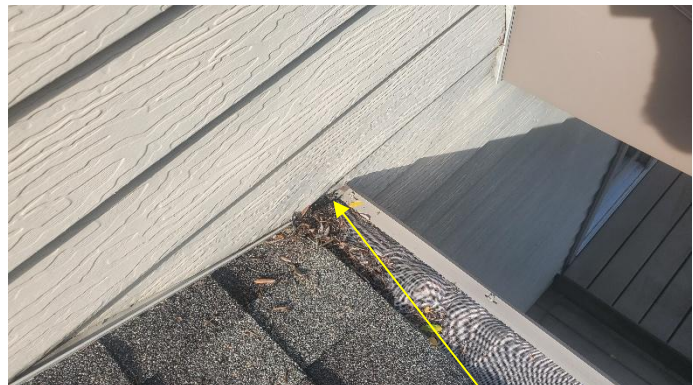
- steep slope \_\_\_\_\_ ●
- shingles \_\_\_\_\_ ○.... trees too close
- flashing \_\_\_\_\_ ✗.... missing kickout flashing
- skylight \_\_\_\_\_ ●
- flue pipe \_\_\_\_\_ ●

No kickout flashing

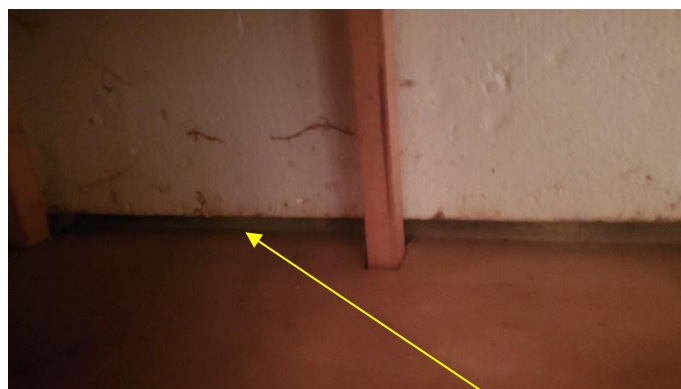
Northeast corner

walls\_\_\_\_\_ ⚠.... limited view / wall & floor stains (northeast corner, west, & north sides)

- ✓ foundation \_\_\_\_\_ medium (wall & floor stains)
- ✓ floors \_\_\_\_\_ low
- ✓ walls \_\_\_\_\_ low
- ✓ roof \_\_\_\_\_ low

- ✓ Water stained basement walls and floor (west, north, and east sides).

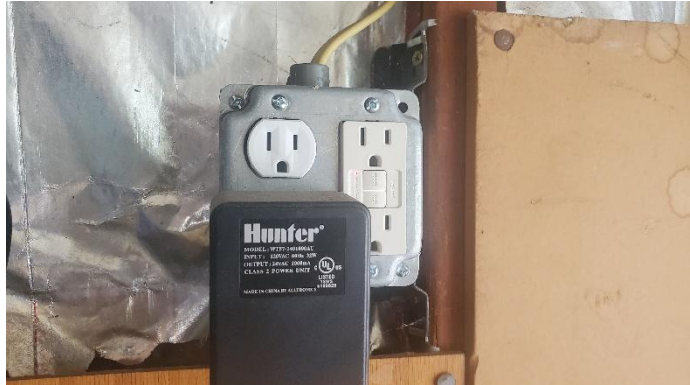
garage\_\_\_\_\_ ○.... inoperable GFI

Garage outlet

- ✓ Inoperable garage GFI receptacle.
- ✓ Broken basement sink outlet. Unsupported storage room outlet.
- ✓ Missing basement smoke detector. No main level hallway CO detector.
- ✓ Ungrounded basement bath 3 prong outlet. No GFI receptacle.

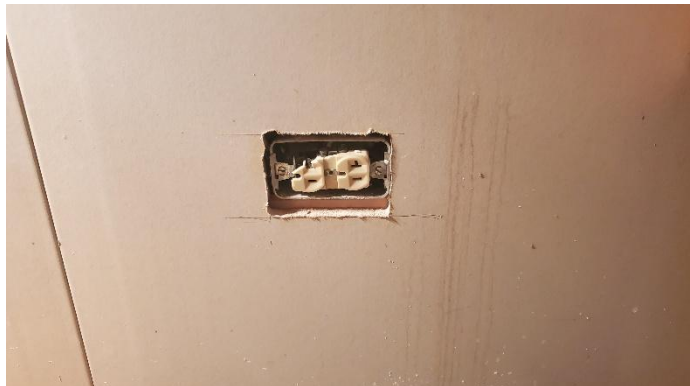
basement\_\_\_\_\_ ○.... broken sink outlet / loose outlet

Basement sink outlet

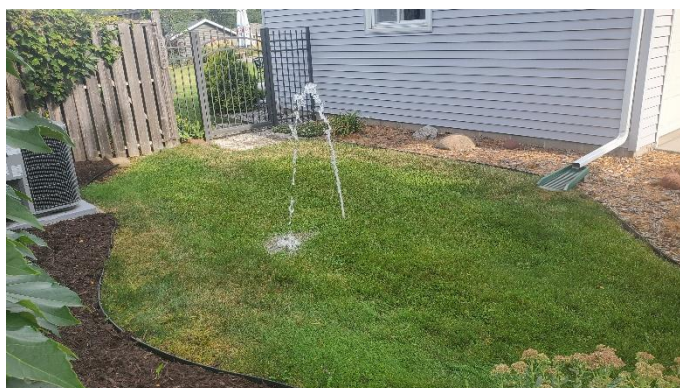
yard sprinkler \_\_\_\_\_ ○ .... missing head / no heads adjacent to east side driveway

- ✓ No exterior water spigot interior shutoff valves.
- ✓ One missing yard sprinkler head.
- ✓ Corroded laundry tub drain pipe. Broken tub faucet handle.
- ✓ Leaking basement bath shower faucet. Corroded sink drain pipe.
- ✓ No dishwasher drain pipe air gap.

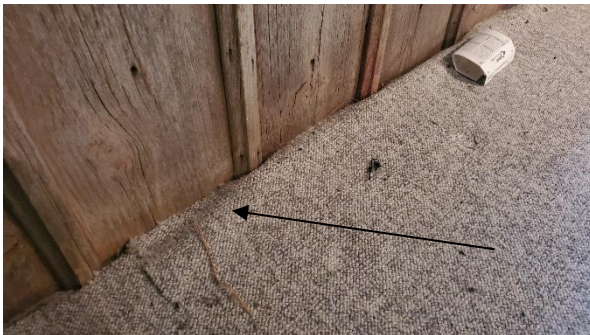
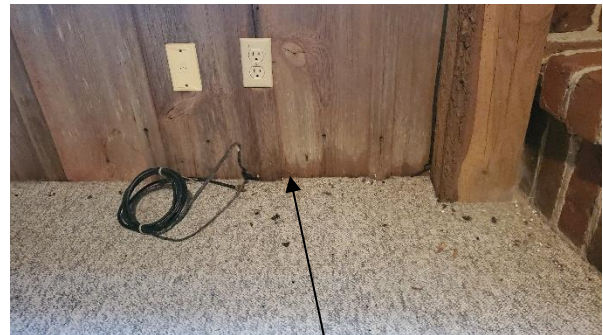
wall, ceiling, floor \_\_\_\_\_ ✗.... wall & floor stains (north & west sides)  
window and door \_\_\_\_\_ ✗.... blocked window sash / water stained frame  
outlet and fixture \_\_\_\_\_ ●  
sink \_\_\_\_\_ ✗.... unapproved wet vent  
heat \_\_\_\_\_ ●  
wood stove \_\_\_\_\_ ✗.... unlisted appliance / vent pipe too close to ceiling / clearances unknown

West wall – water damage

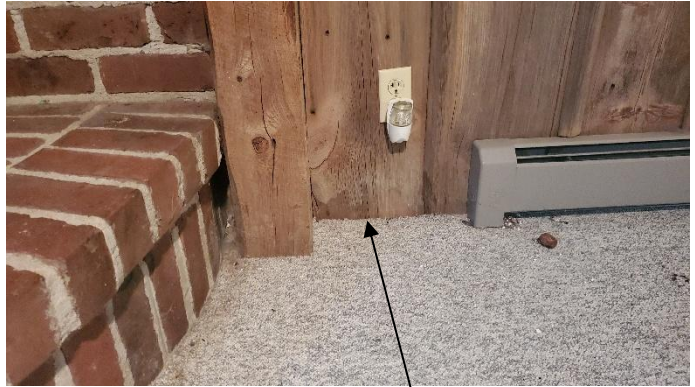
North wall – water stained

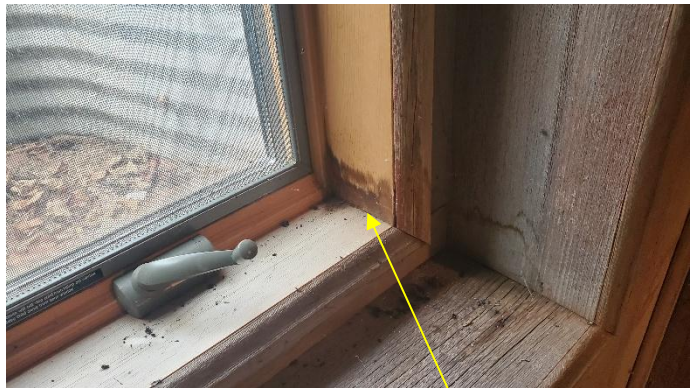
Water stained window

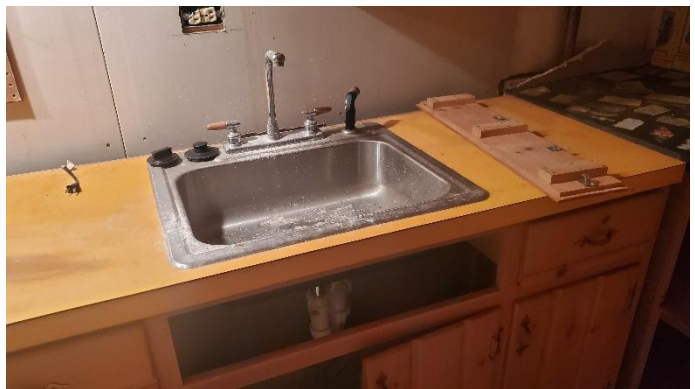
Sink – wet vented

- ✓ Wet vented basement sink.
- ✓ Plugged basement bath sink. No shower faucet escutcheon.

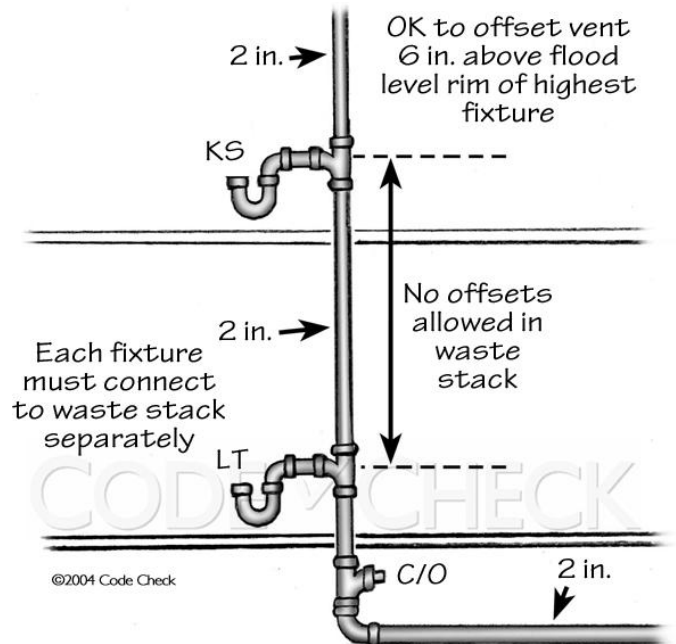
Wet vent

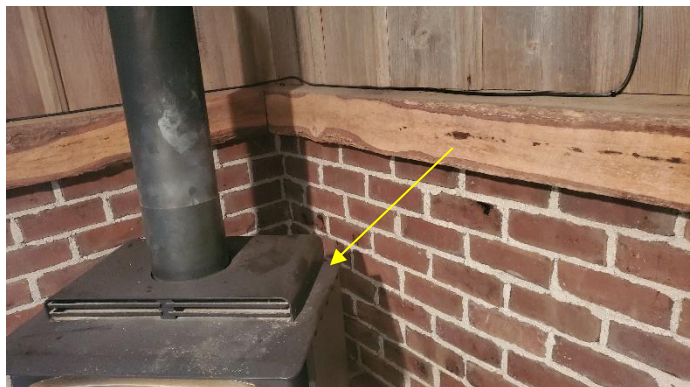
Too close to wall

- ✓ Unlisted rec room wood stove. Stove too close to walls and ceiling.
- ✓ Inoperable basement bath exhaust fan. Vent pipe does not extend to the outside.

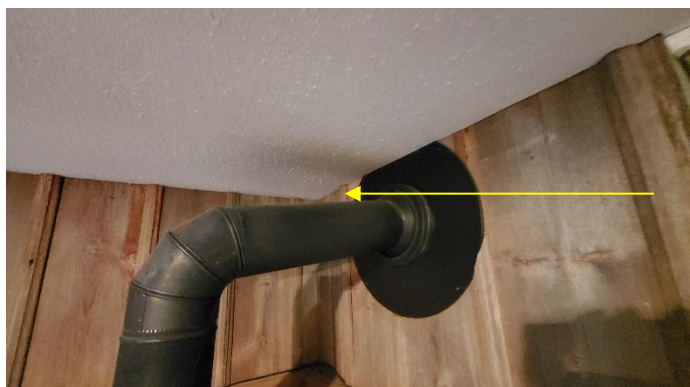
Too close to ceiling

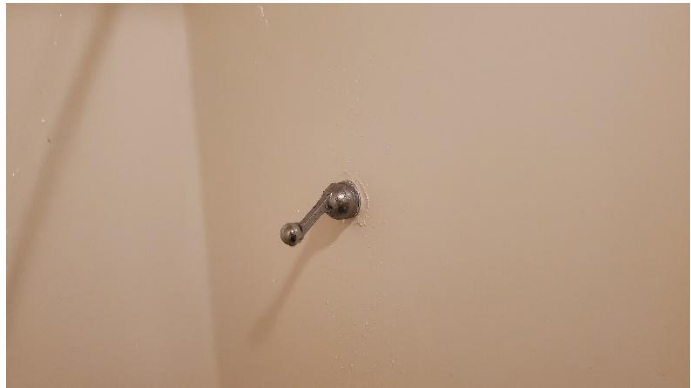
No escutcheon

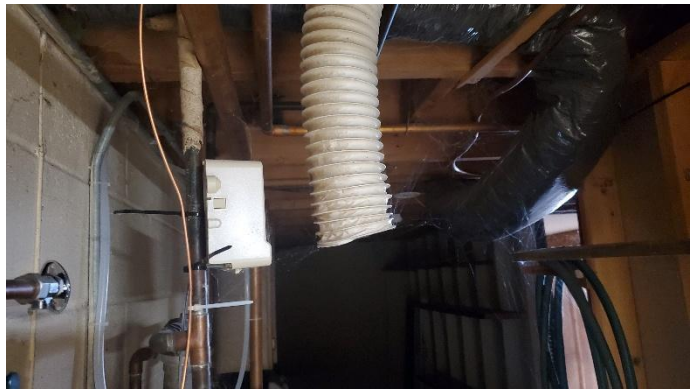
Unvented fan

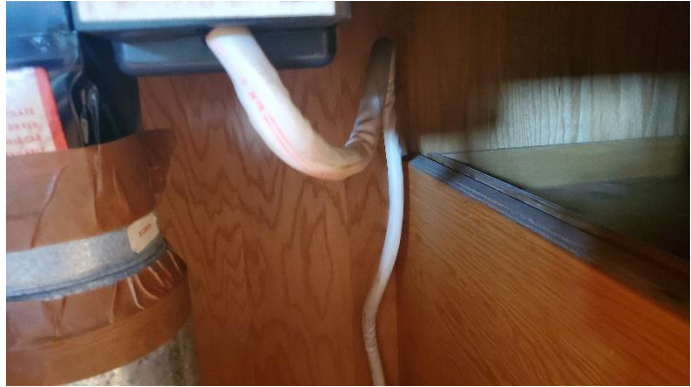
Unprotected wiring

- ✓ Unprotected kitchen cooktop wiring.
