# Your Inspection Report

184 Wright Avenue  
Toronto, ON M6R 1L2

RE: Report No. 4568, v.2  
184 Wright Avenue  
Toronto, ON  
M6R 1L2

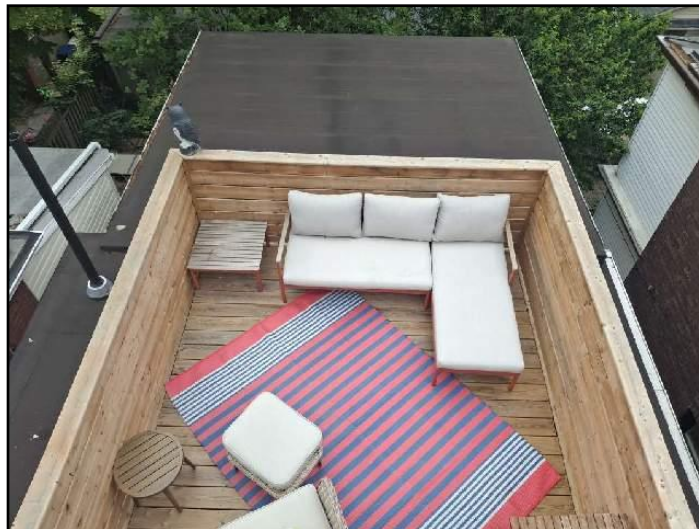
5.

• Deck, could not inspect roof membrane below.

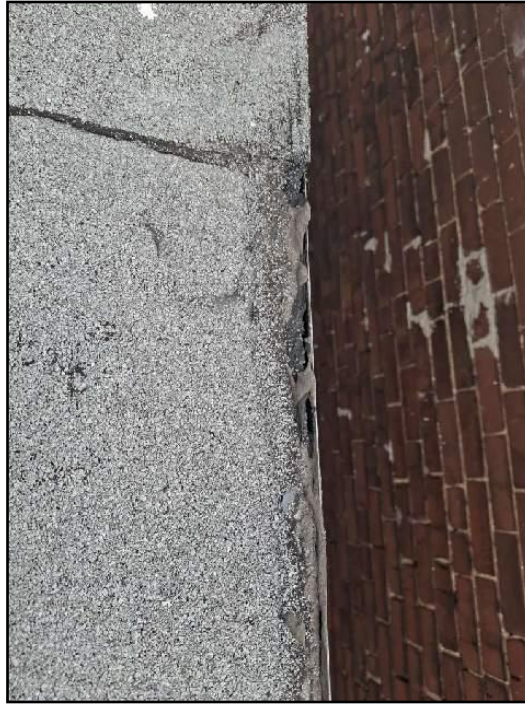
6.

**1. Condition:** • [Openings at seams or flashings](#)

**Implication(s):** Chance of water damage to structure, finishes and contents

Reseal perimeter of upper flat roof.

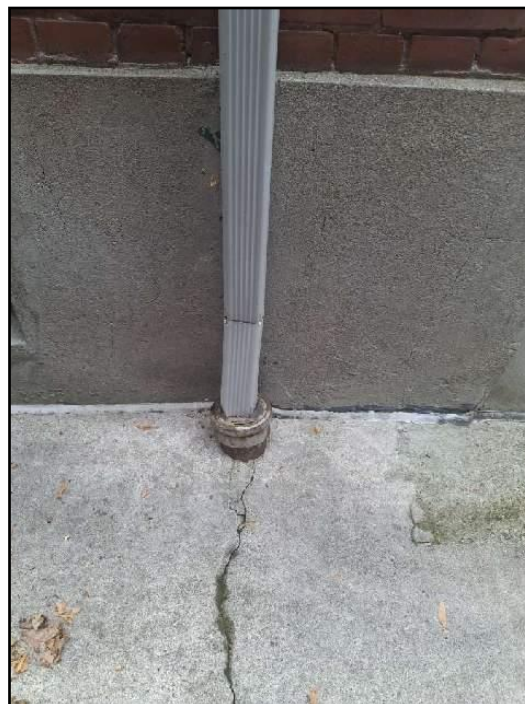
7.

2. Condition: • [Discharge below grade](#)

**Implication(s):** Chance of water damage to structure, finishes and contents

**Location:** East Exterior

Disconnect downspout and route well away from foundation.

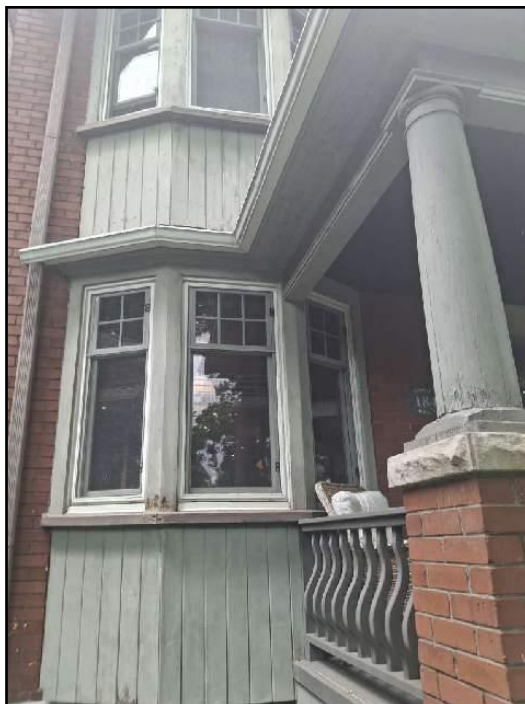
8.

**3. Condition:** • Typical paint and caulking maintenance needed.

**Location:** Throughout Exterior

Seller to have wood prep and paint completed at exterior.

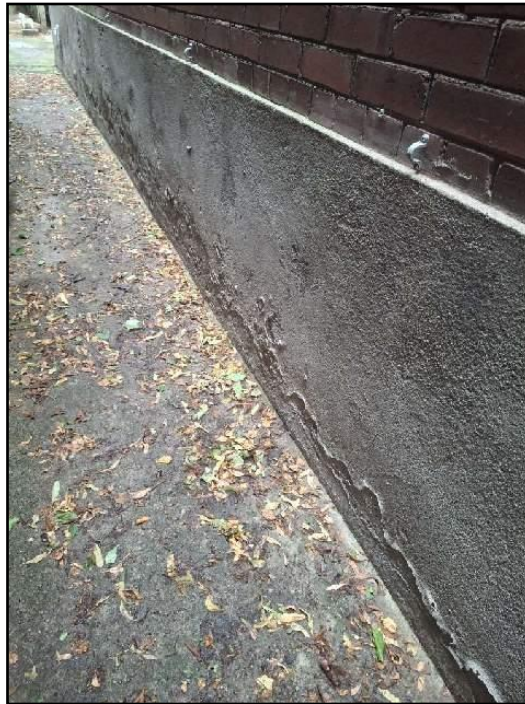
9.

**4. Condition:** • [Parging damaged or missing](#)

**Implication(s):** Chance of damage to structure | Shortened life expectancy of material

**Location:** West Exterior

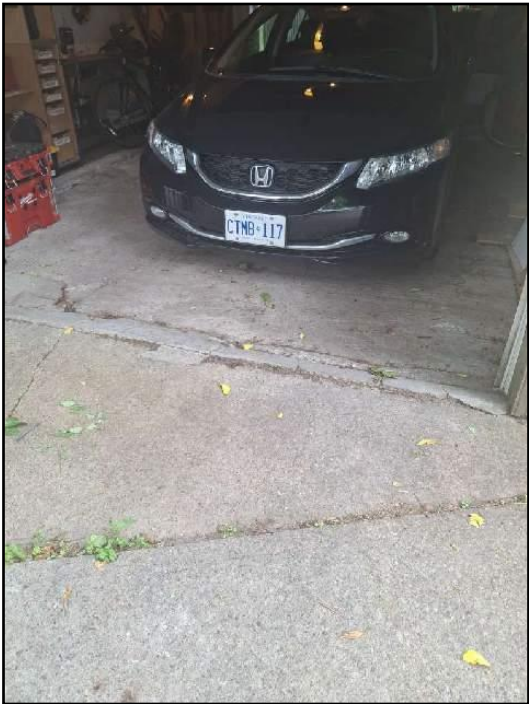
10.

**5. Condition:** • Garage floor is below lane level, monitor for water entry and need to install drainage.

**Location:** Garage

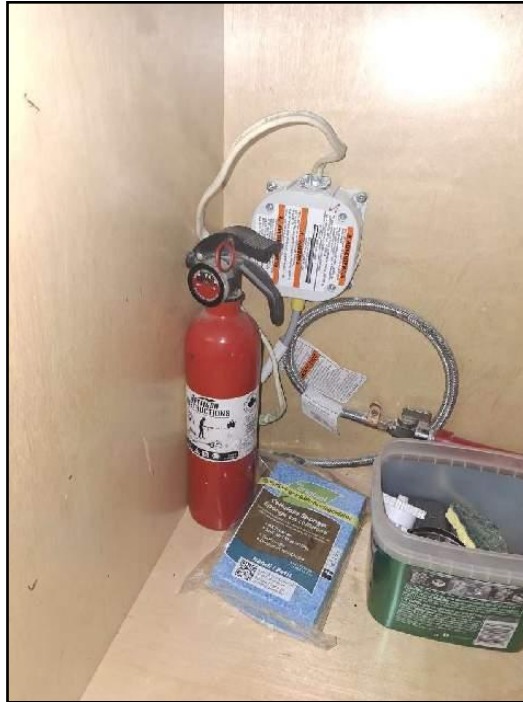
12.

**8. Condition:** • Cover exposed wiring with conduit.

**Location:** Kitchen

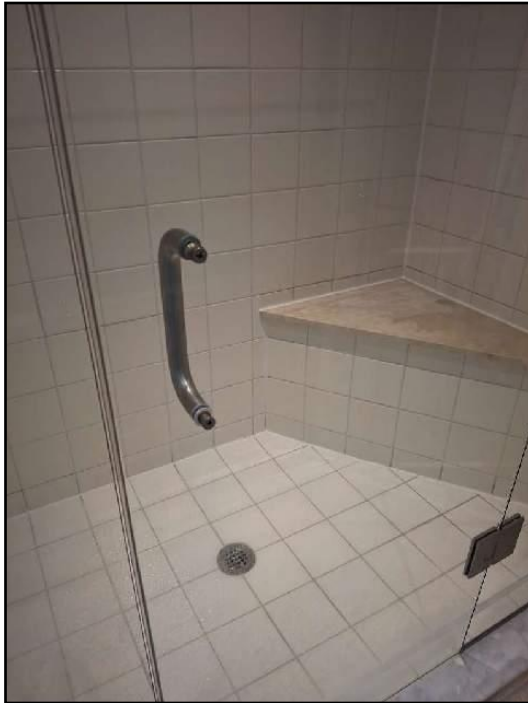
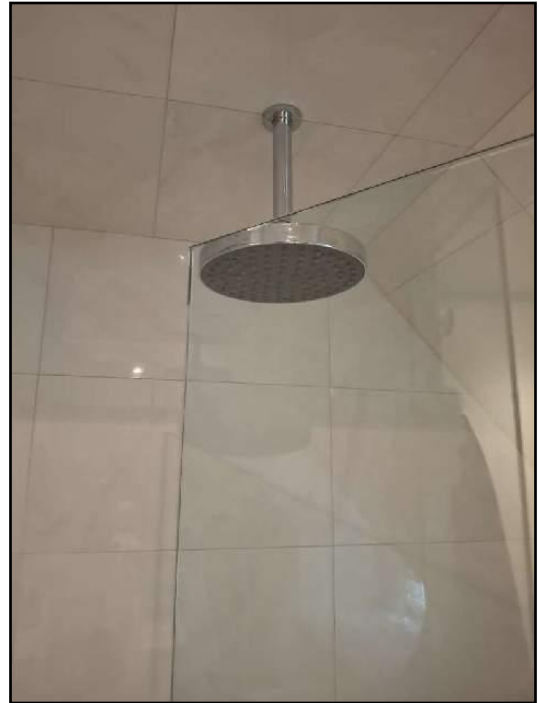
- 14. Condition:** • [Entrance problems](#)

**Implication(s):** Difficult access

**Location:** Second Floor Third Floor

Replace missing handle at second floor, add door stop to prevent contact of glass with shower head.
