# Your Inspection Report

48 Galley Avenue  
Toronto, ON M6R 1G8

Thursday, September 10, 2026

RE: Report No. 4608, v.2  
48 Galley Avenue  
Toronto, ON  
M6R 1G8

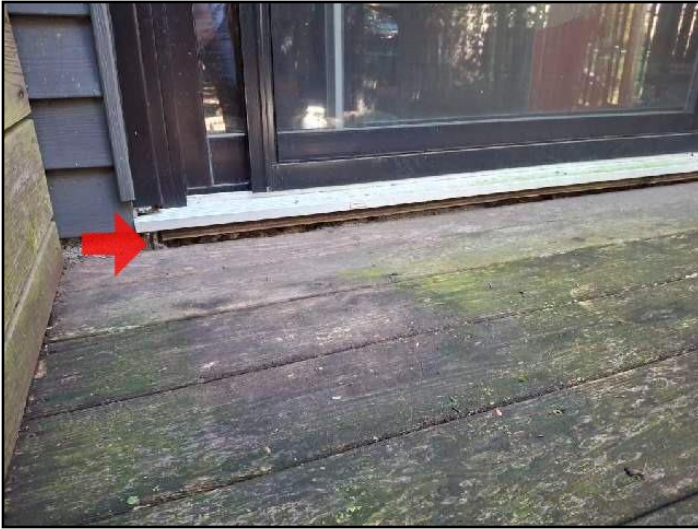
7.

5. Condition: • Siding - incomplete / missing

Replace damaged siding below deck and add flashing below sliding door. Terminate siding (including vinyl) several inches above grade.

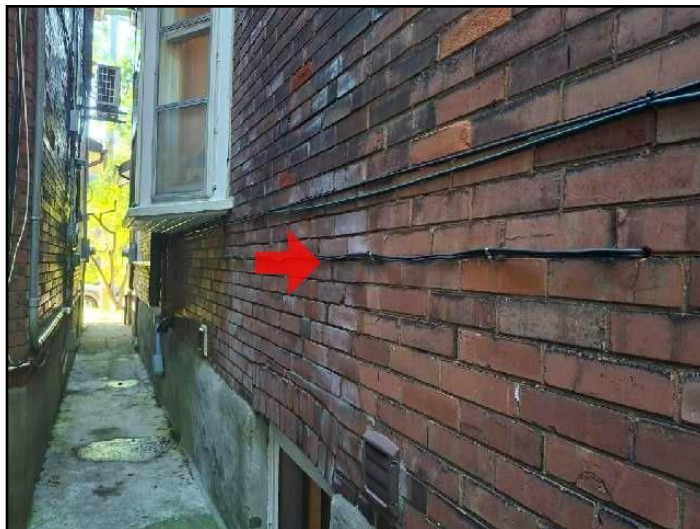
15.

**12. Condition:** • Cover exposed wiring with conduit.

**Location:** East Exterior Wall

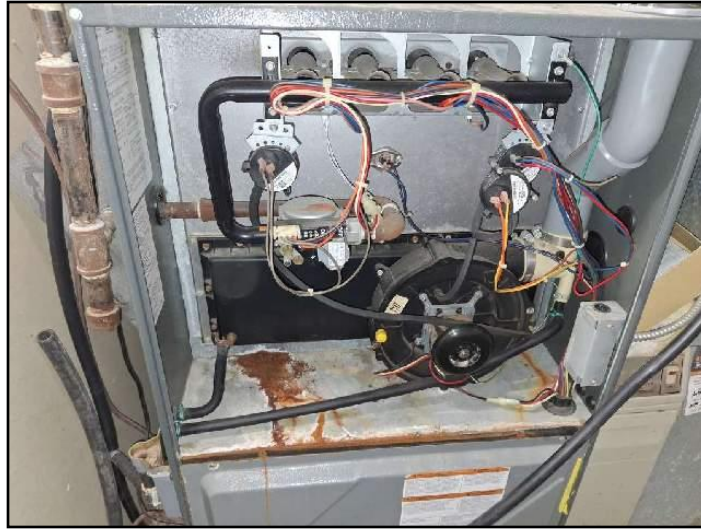
23.

**14. Condition:** • [Near end of life expectancy](#)

Furnace is 18 years old and rusted. Budget for replacement.

**Implication(s):** Equipment failure | No heat for building

**Task:** Replace

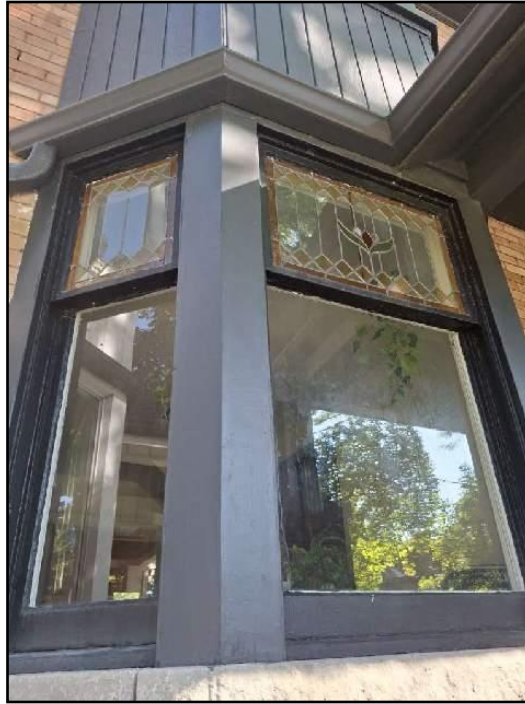
25.

**22. Condition:** • [Original lower quality units](#)

**Task:** Replace

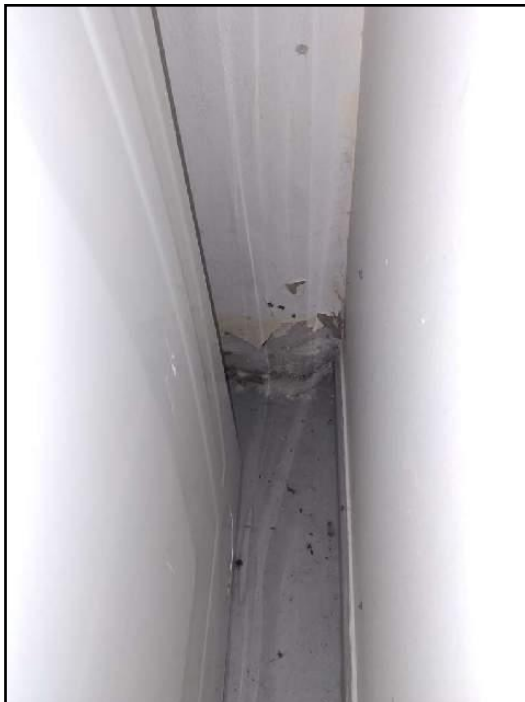
26.

**23. Condition:** • [Crumbling plaster, dry wall or concrete walls](#)

Some seepage evident at basement laundry area and near door. Consider interior or exterior foundation membrane system.

**Implication(s):** Chance of water damage to structure, finishes and contents | Material deterioration
