# Your Inspection Report

184 Wright Avenue  
Toronto, ON M6R 1L2

Monday, June 22, 2026

RE: Report No. 4568  
184 Wright Avenue  
Toronto, ON  
M6R 1L2

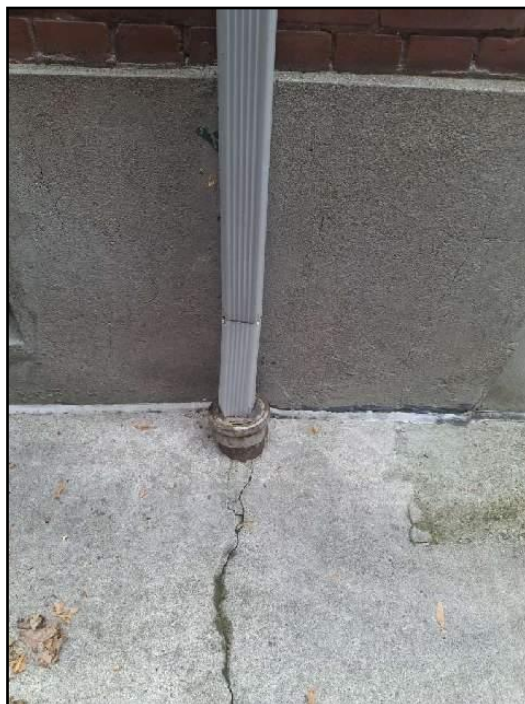
7.

2. Condition: • [Discharge below grade](#)

**Implication(s):** Chance of water damage to structure, finishes and contents

**Location:** East Exterior

Disconnect downspout and route well away from foundation.

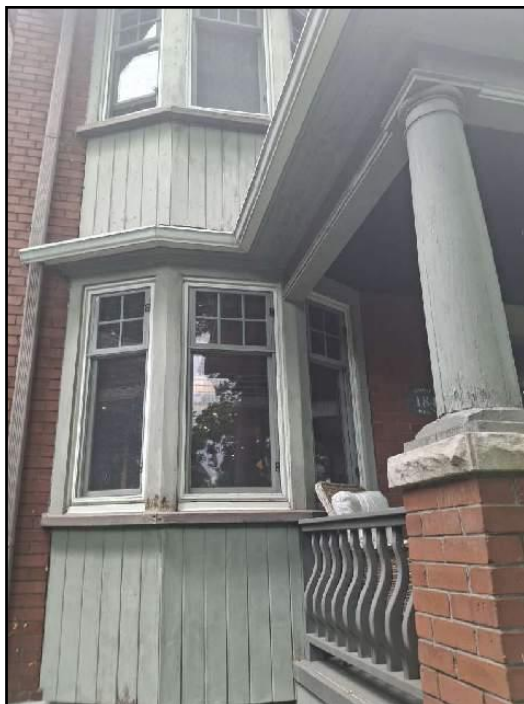
8.

**3. Condition:** • Typical paint and caulking maintenance needed.

**Location:** Throughout Exterior

Seller to have wood prep and paint completed at exterior.

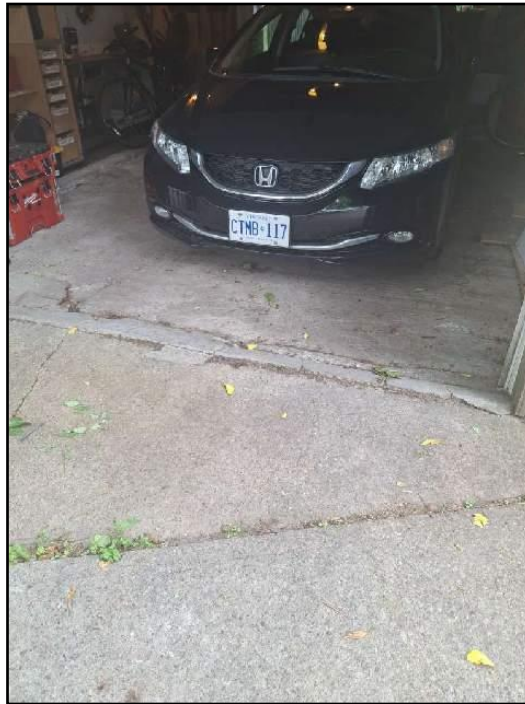
10.

**5. Condition:** • Garage floor is below lane level, monitor for water entry and need to install drainage.

**Location:** Garage

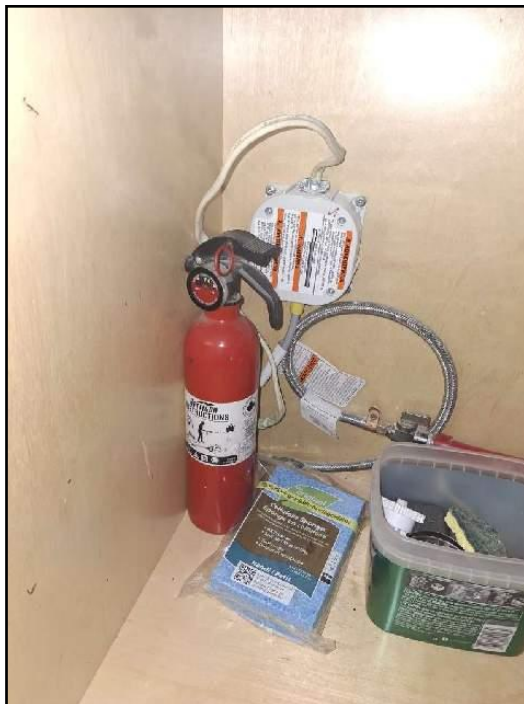
12.

**8. Condition:** • Cover exposed wiring with conduit.

**Location:** Kitchen

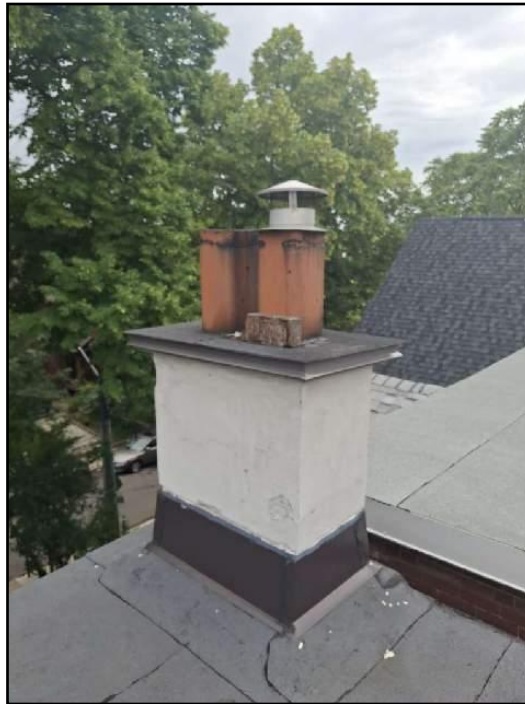
14. Not in use
