April 16, 2021

Re: Structural Health Check of Home  
3150 E Copper Ridge Loop  
Billings, MT

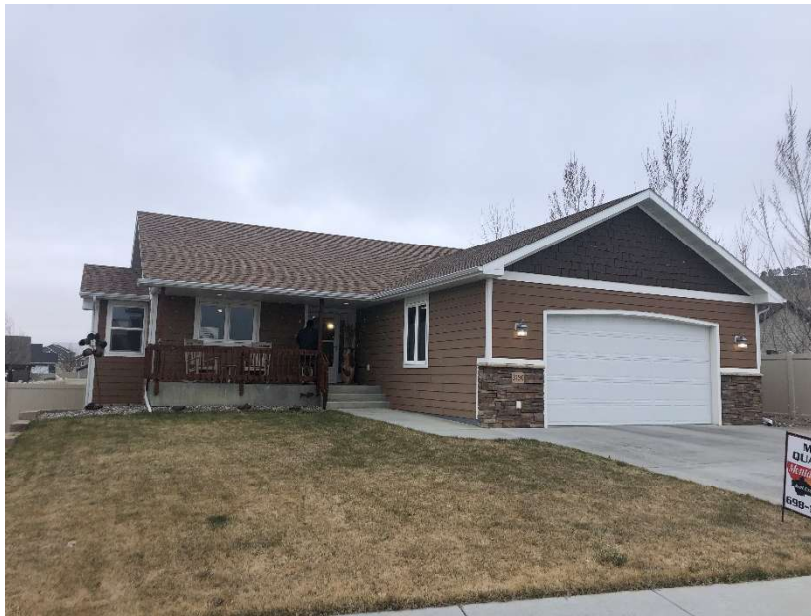
*Photo 1:*

*Exterior profile*

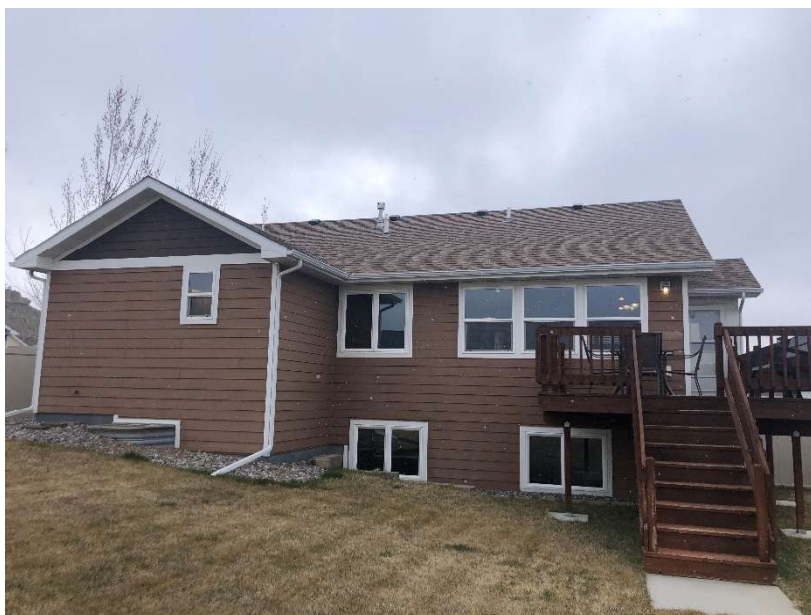
*Photo 2:*

*Exterior Profile*

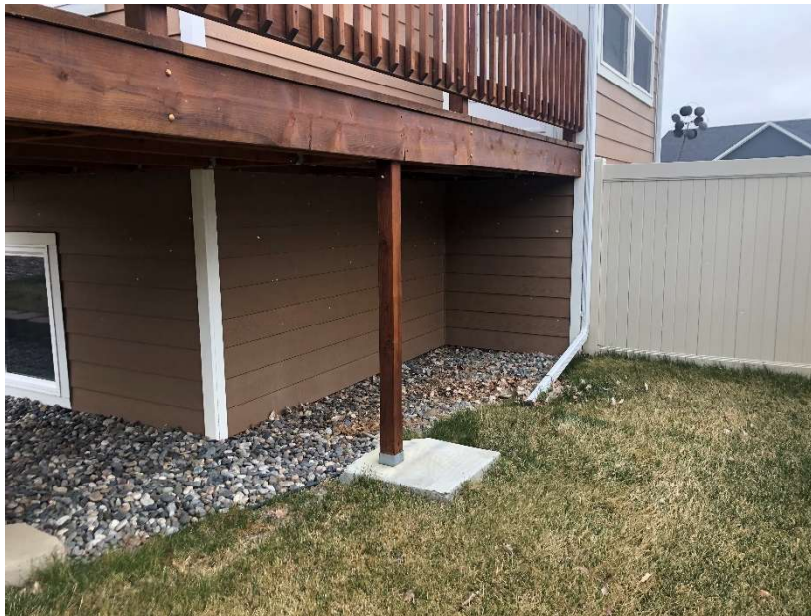
*Photo 3:*

*Minor drainage improvements  
needed adjacent to foundation*

Some minor drainage improvements should be performed on the south side of the house to ensure adequate positive drainage away from the foundation. Additionally, it appears the gutter on the northeast corner of the garage may allow some water to saturate the subgrade adjacent to the foundation; this downspout should be monitored to ensure all released water drains away from the garage.

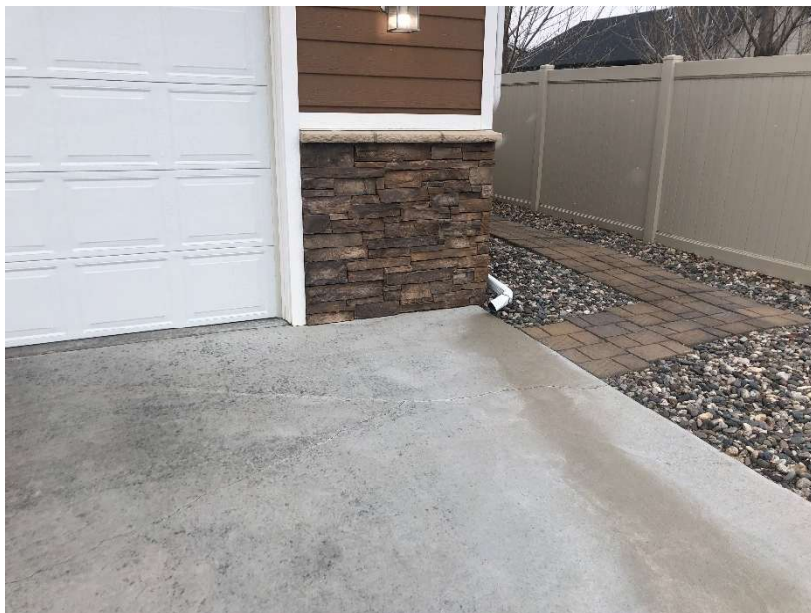
*Photo 4:*

*Ensure water released from  
gutter does not saturate  
subgrade.*
