**23 S 16th St**

**RE: Pittsburgh, PA 15203**

**Inspection #: 527-062026-6912**

### *HOME INSPECTION REPORT*

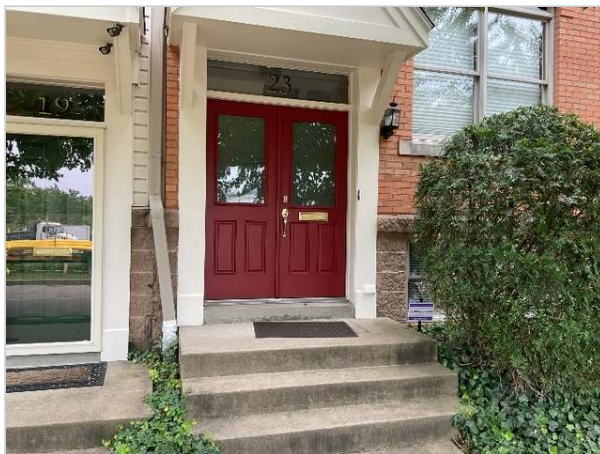
### *NOTE: EXTERIOR HANDRAILS:*

There were no handrails on the steps in the front. Local codes may require the installation of handrails in location where three or more steps are present.

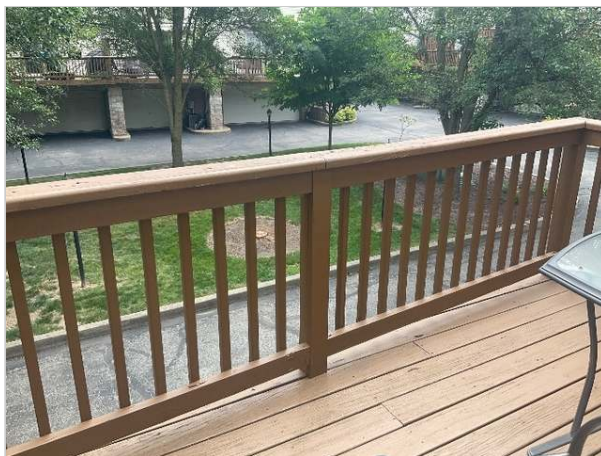
**NOTE: LOOSE EXTERIOR HANDRAIL:**

The handrail on the on the rear deck is loose. The handrails should be properly secured by a qualified contractor.

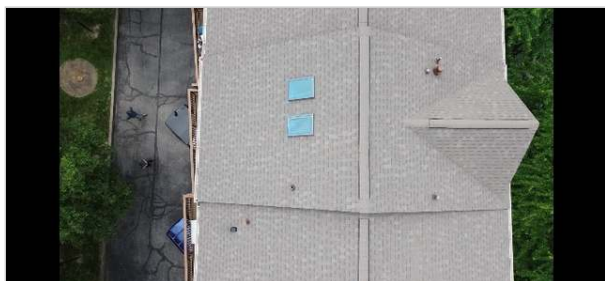
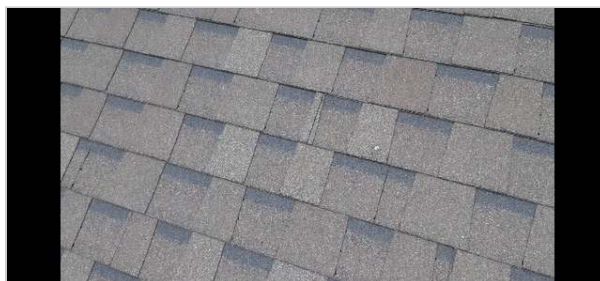
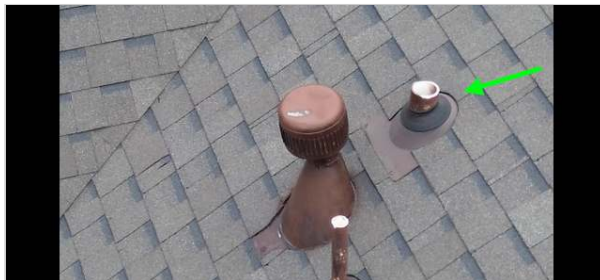
A roof vent pipe was noted to have insufficient height above the roof surface. Plumbing vent pipes should typically extend at least 6 inches above the roof (or higher in areas with heavy snowfall) to allow proper venting and prevent blockages or backflow of sewer gases. Correction by a qualified roofing or plumbing professional is recommended

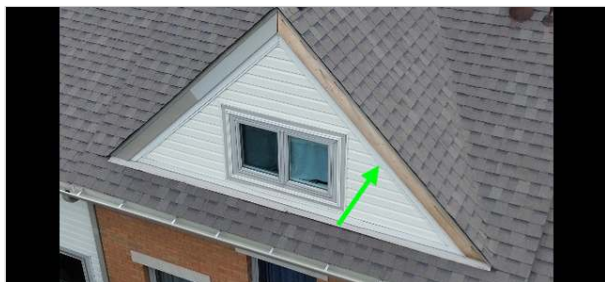
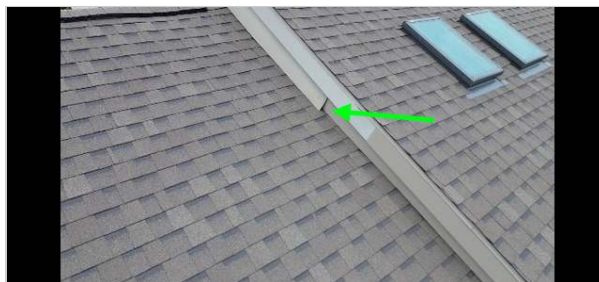
**NOTE: SOFFIT & FASCIA:**

The aluminum soffit and fascia was inspected and was in need of repair.

Loose and missing fascia was noted on the front and right sides. Consult with a qualified contractor for repair.

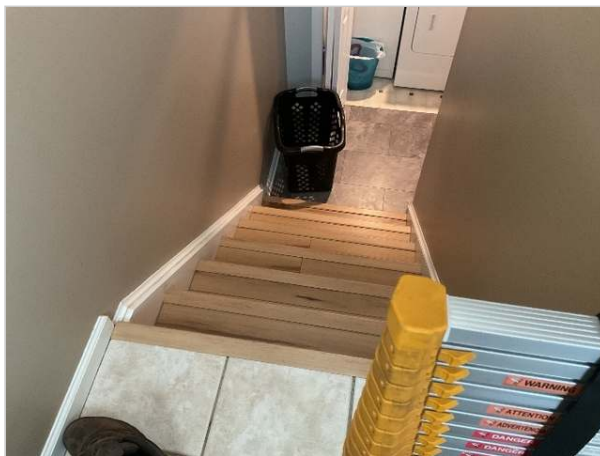
### ***SAFETY NOTE: MISSING HANDRAIL:***

There was no handrail on the stairs leading to the basement. This can be a safety concern. Local building codes may also require the installation of a handrail.

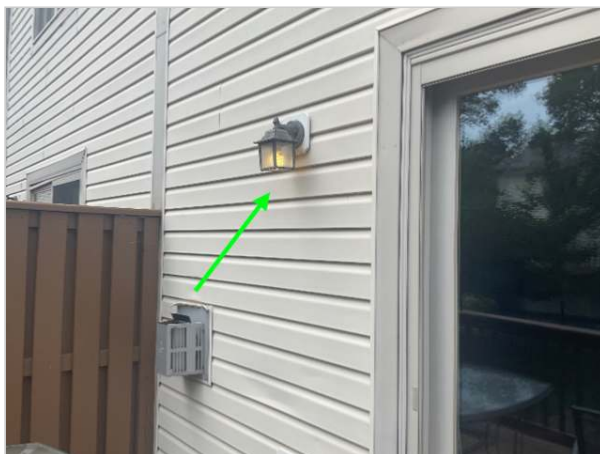
### ***SAFETY NOTE: LOOSE ELECTRICAL FIXTURE:***

A loose electrical fixture was noted on the exterior. All electrical fixtures should be properly secured. Consult with a qualified electrical contractor for further evaluation and repair recommendations.

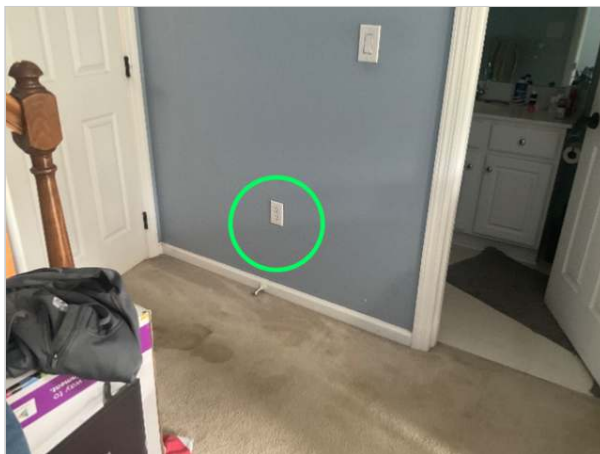
### ***SAFETY NOTE: LOOSE OUTLET:***

A loose outlet was noted in the master bedroom. This could be a shock hazard due to exposed electrical contacts. The affected outlet(s) should be secured by a qualified contractor.

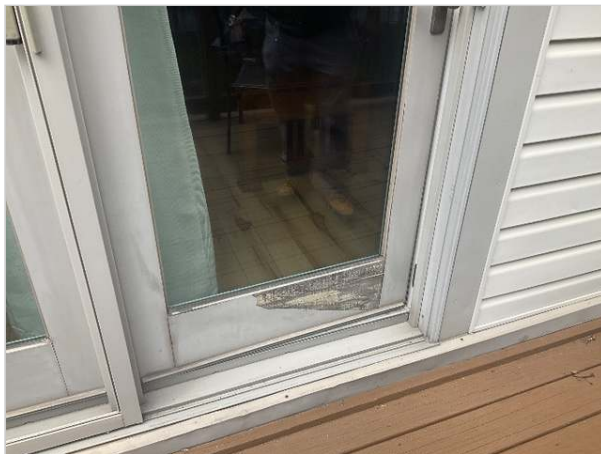
**NOTE: DAMAGED DOOR CLADDING:**

The cladding on the exterior doors located on the back is damaged. The doors was operable at the time of the inspection. Evaluation and repair should be made by a qualified contractor.

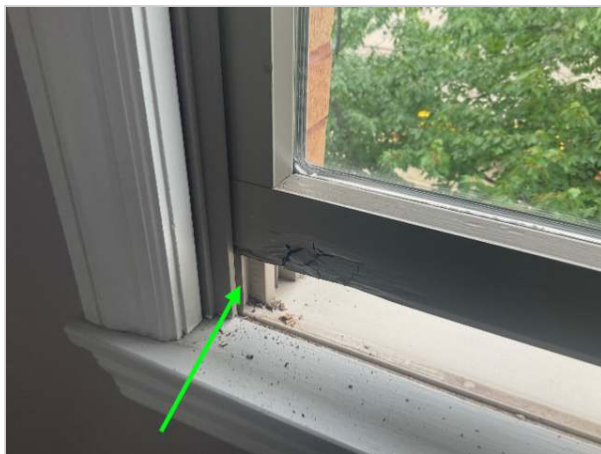
**NOTE: DAMAGED CLADDING:**

The cladding on the exterior window located on the front is damaged. The window was not operable at the time of the inspection. Evaluation and repair should be made by a qualified contractor.

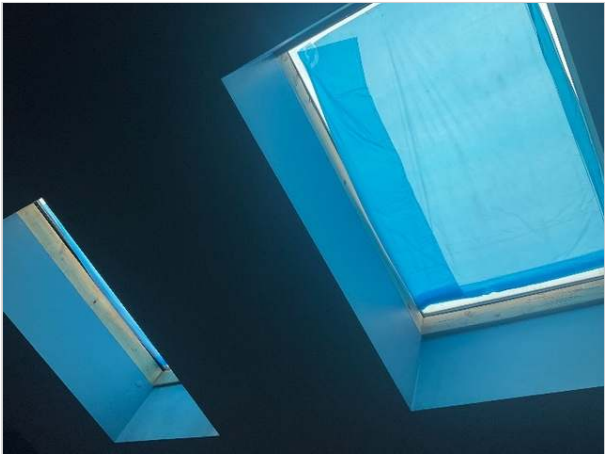
**INFORMATIONAL NOTE: WINDOWS COVERED WITH PLASTIC:**

One or more of the windows were covered with plastic. This is generally done to prevent wind and draft intrusion. The plastic prevents opening and full view of the windows. Consequently, we could not test any plastic covered windows for proper operation. Consult with the current property owner for information on the condition and operation of the windows.

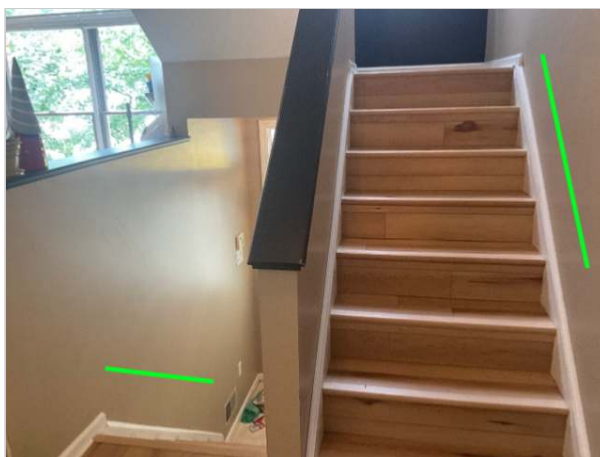
### ***SAFETY NOTE: MISSING HANDRAIL:***

There was no handrail on the stairs leading to the second floor. This can be a safety concern. Local building codes may also require the installation of a handrail.

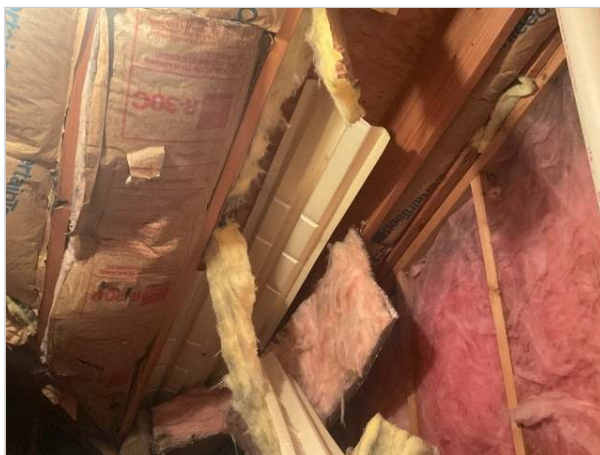
**NOTE: MISSING INSULATION:**

There are areas of missing insulation installed in the attic. This could affect the overall comfort level in the affected area. Insulation should be installed.
