**HomeTeam**<sup>®</sup>  
INSPECTION SERVICE

**886 N Meadowcroft Ave**  
**RE: Pittsburgh, PA 15216**  
**Inspection #: 527-072025-6406**

### *HOME INSPECTION REPORT*

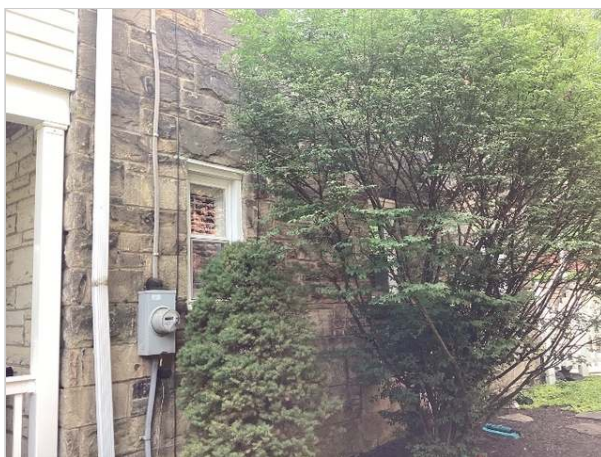
Extensive plant growth was observed against the home, in the right side area of the house. Recommend removing this growth away from the siding to prevent possible damage including insect infestation.

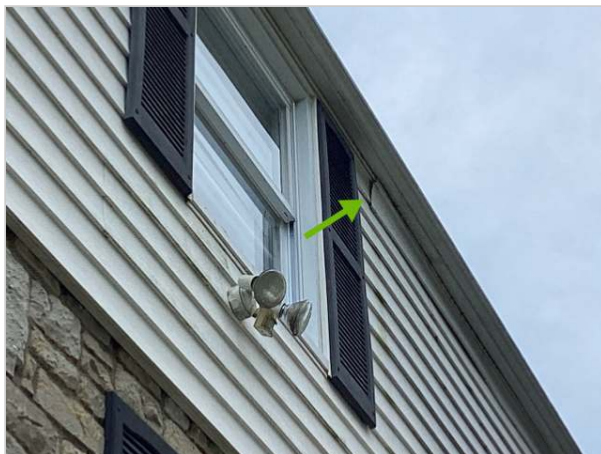
### *NOTE: LOOSE SIDING:*

Loose siding was noted on the front of the home. The siding should be reattached.

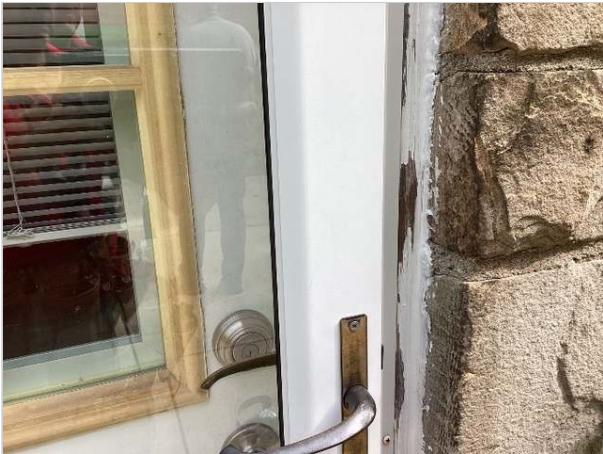
### *MAINTENANCE NOTE: PEELING PAINT:*

Peeling paint was noted on the exterior doors. In order to preserve the life of the exterior surfaces and materials, all areas should be scraped and painted.

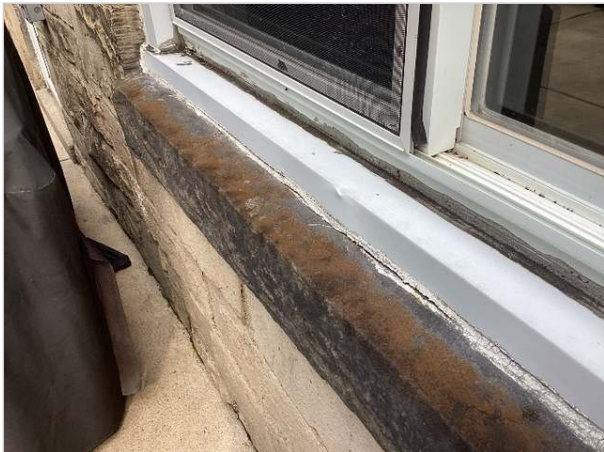
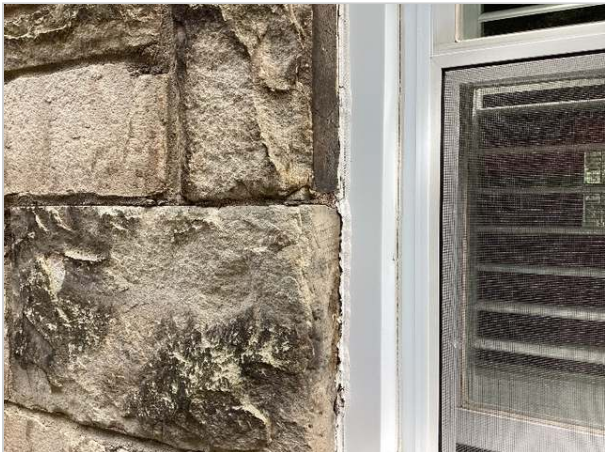
**MAINTENANCE NOTE: EXTERIOR CAULKING:**

The exterior caulking around the windows is cracked or missing on all sides of the home. The caulking should be replaced to ensure the exterior of the home remains weather and water tight.

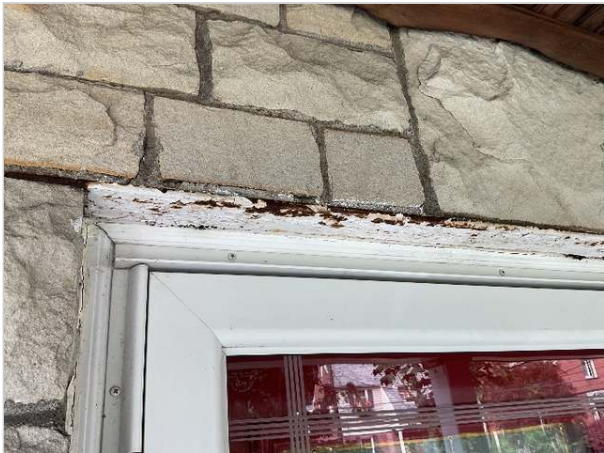
Front

One or more of the steel lintels above the windows on the exterior of the home were noted to be rusting. Lintels support masonry materials above doors and windows. Keeping the lintels sealed and painted will prevent rusting and expansion. Expanded lintels can lead to cracks in the masonry on the exterior of the home.

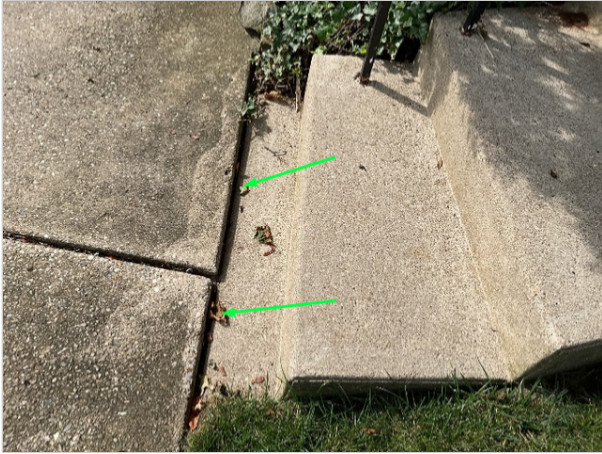
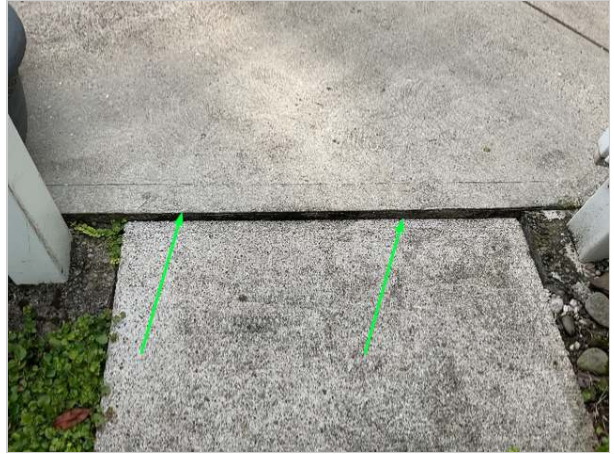
### ***SAFETY NOTE: TRIP HAZARDS:***

There were several trip hazards found on the walkways around the house. The hazards can be repaired using a suitable or similar surfacing material to "feather" the out-of-level condition to make a smooth transition.

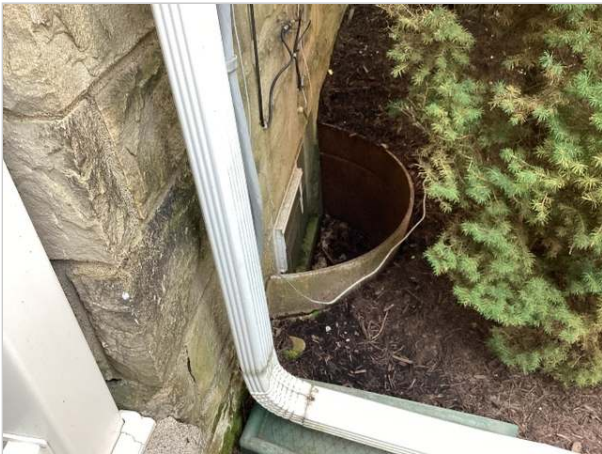
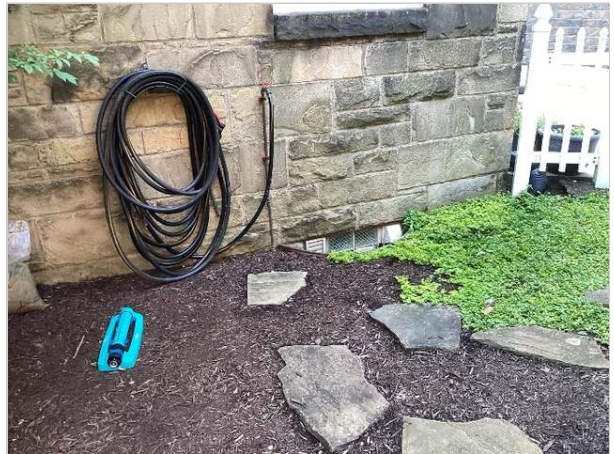
***SAFETY NOTE: FALL HAZARD:***

There is no barrier installed at the window wells. The absence of a proper rail or barrier constitutes a fall hazard and should be corrected. Consult with a qualified contractor for installation of a proper barrier.

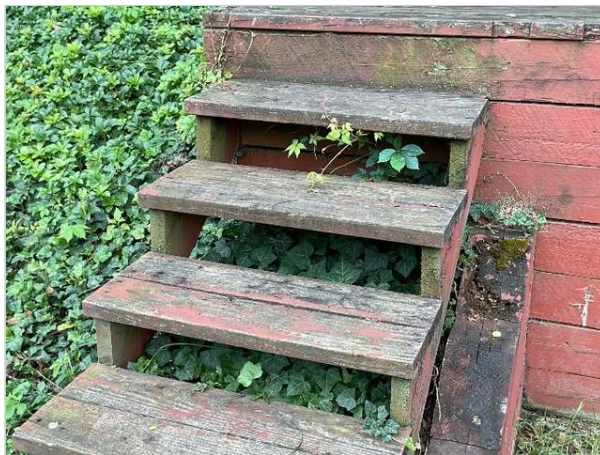
***SAFETY NOTE: OPEN BACK STAIR RISERS:***

The risers or backs of the rear retaining wall stairs are open. This could be a fall hazard for small children. Consult with a qualified contractor for evaluation and recommendations.

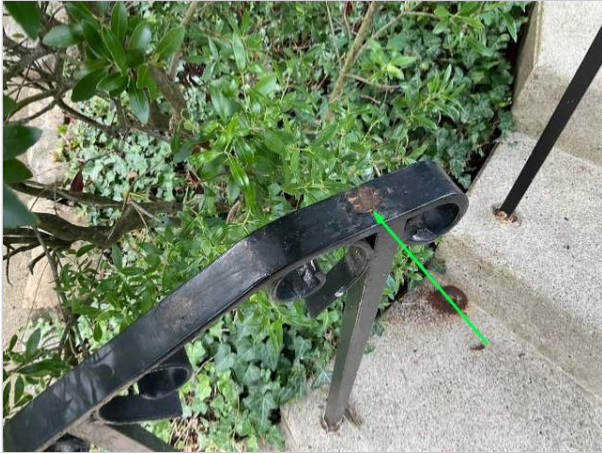
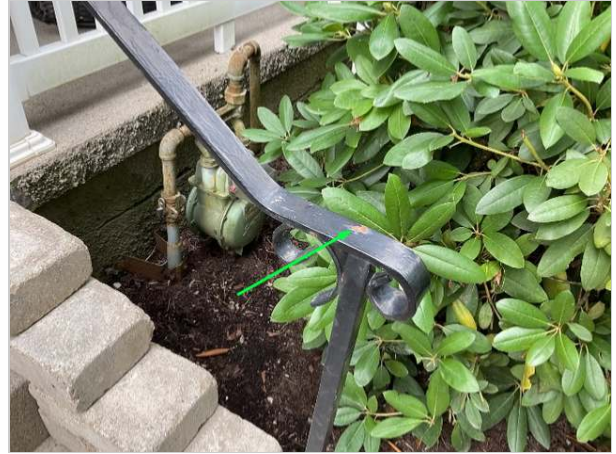
***MAINTENANCE NOTE: RUSTY RAILINGS:***

The front railings are rusted. The railings should be scraped and painted.

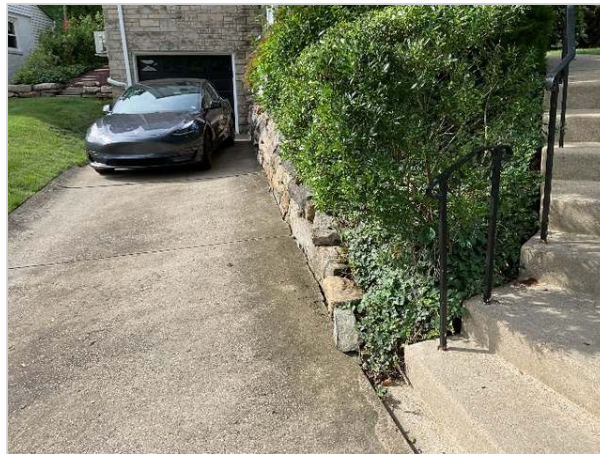
The front retaining wall is leaning inward. There were vertical earth pressure type cracks observed in the wall. This condition is most often associated with soil and /or water pressure. The displacement occurs incrementally as the wall yields to horizontal earth pressure. The wall was stable at the time of the inspection. Repairs to the wall are not required at this time.

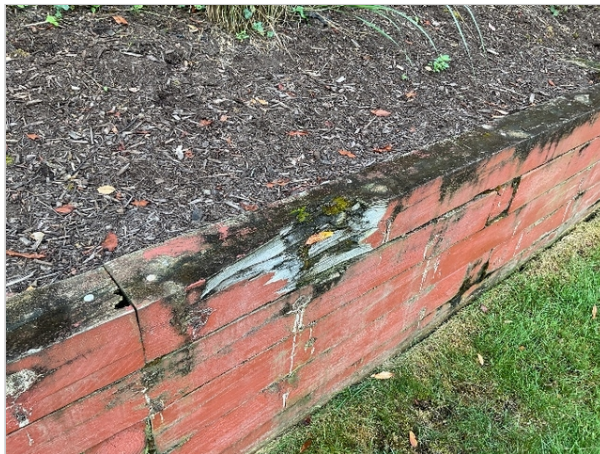
### ***NOTE: EXTERIOR WOOD ROT:***

Rotted wood was noted on the retaining wall . The areas should be repaired and sealed by a qualified contractor.

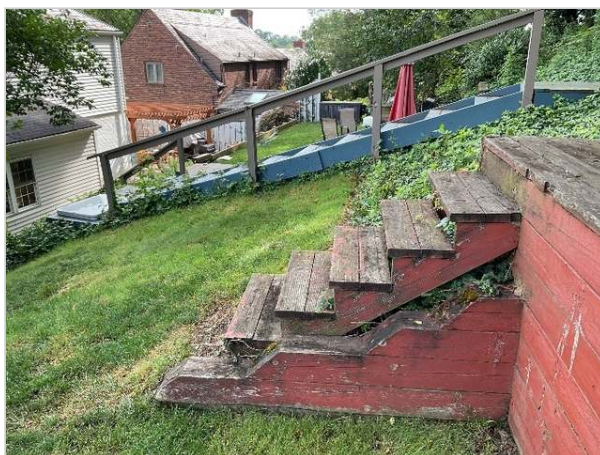
**NOTE: EXTERIOR HANDRAILS:**

There were no handrails on the steps on the rear retaining wall. Local codes may require the installation of handrails in location where three or more steps are present.

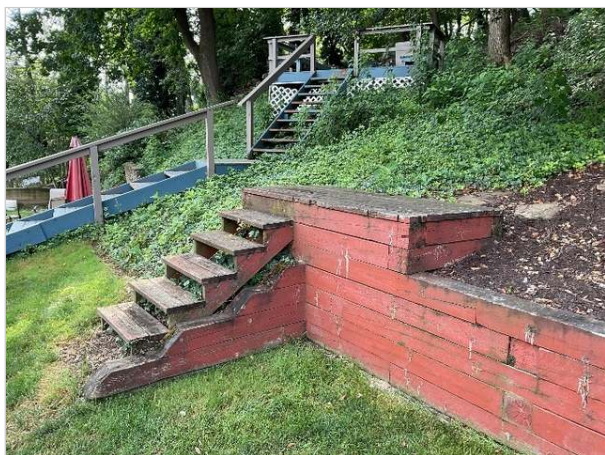
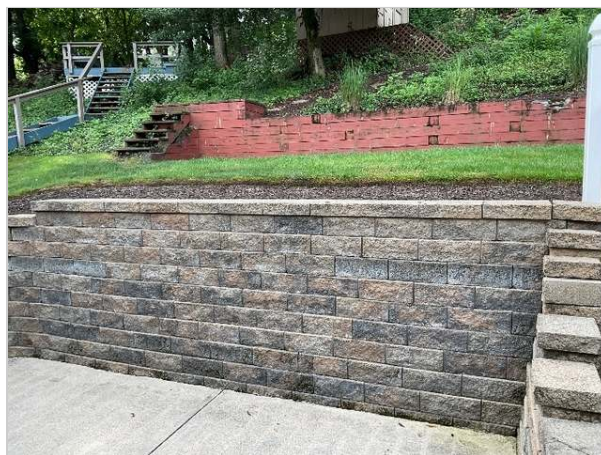
**SAFETY NOTE: FALL HAZARD:**

There are no barriers installed on the rear retaining walls. The absence of a proper rail or barrier constitutes a fall hazard and should be corrected. Consult with a qualified contractor for installation of a proper barrier.

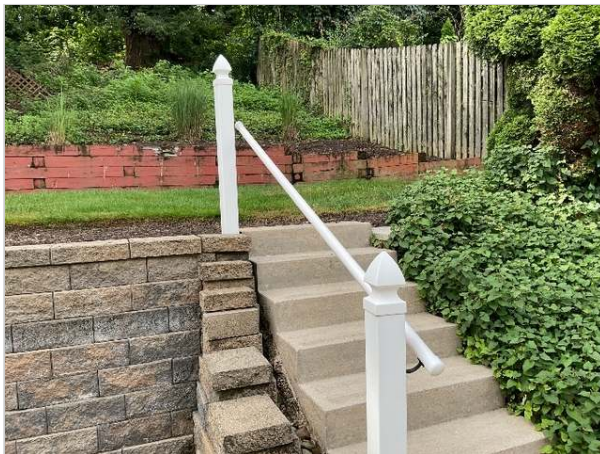
**NOTE: LOOSE EXTERIOR HANDRAIL:**

The handrail on the steps in the back is loose. The handrails should be properly secured by a qualified contractor.

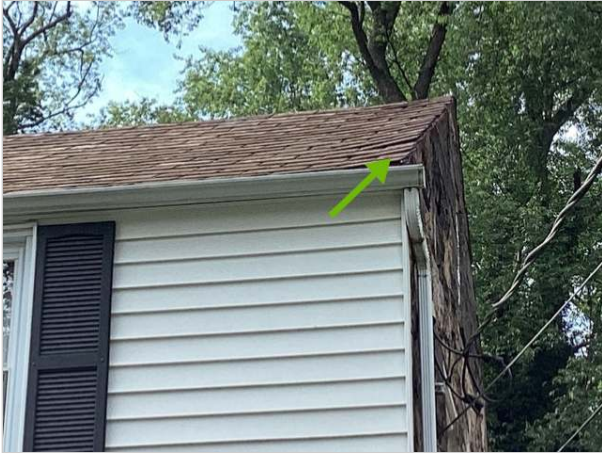
Front

There were damaged slate noted on on all sides of the roof. Consult with a qualified slate roofer for evaluation and repair.

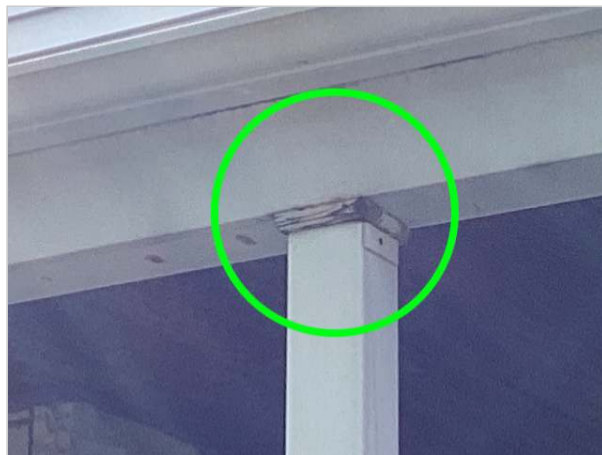
**NOTE: EXTERIOR WOOD ROT:**

Rotted wood was noted on the front porch pillars . The areas should be repaired and sealed by a qualified contractor.

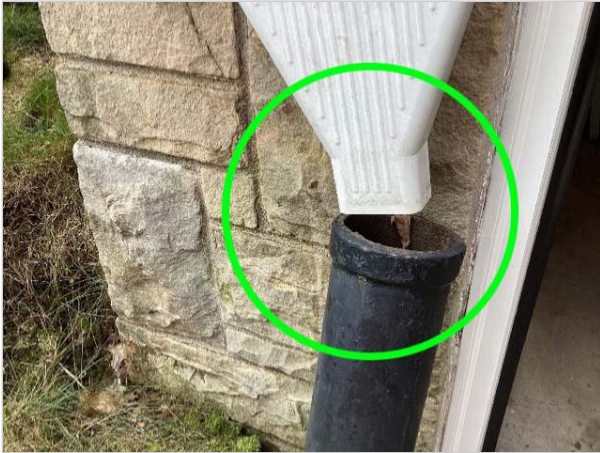
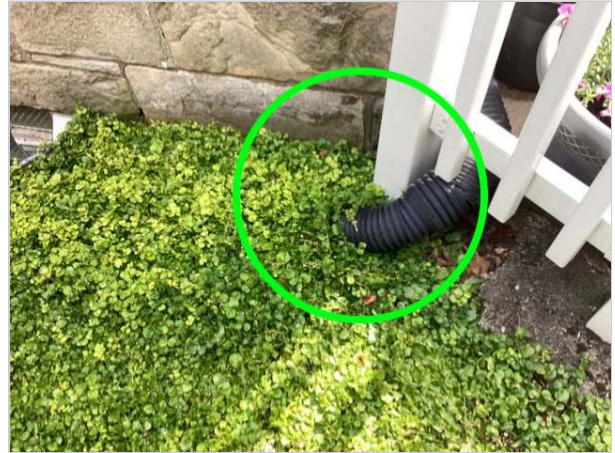
Several draining at or too close to the base of the foundation. All roof drainage should be directed at least six feet from the base of the foundation.

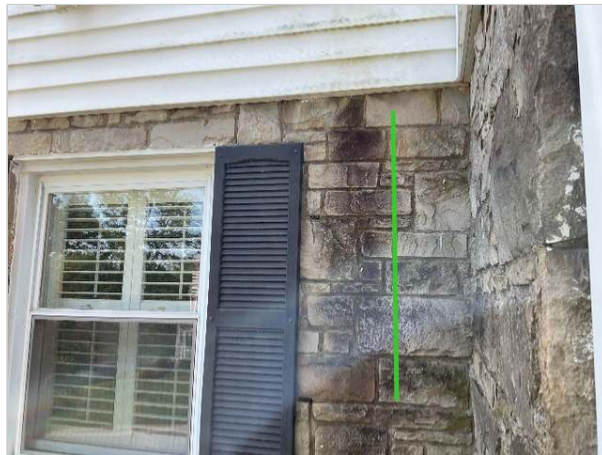
**NOTE: LEAKING GUTTERS:**

The front gutter appears to be leaking from behind. Note comments under moisture evidence on interior walls. The seams should be sealed with an appropriate gutter sealant by a qualified contractor.

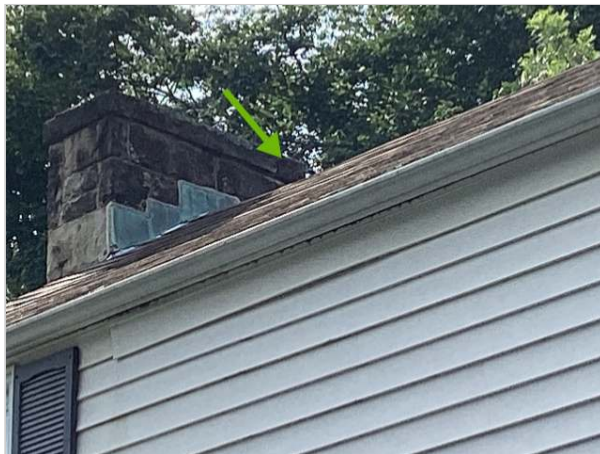
There was missing mortar on the chimney and repairs should be made to prevent further deterioration. Consult with a qualified masonry contractor for repair.

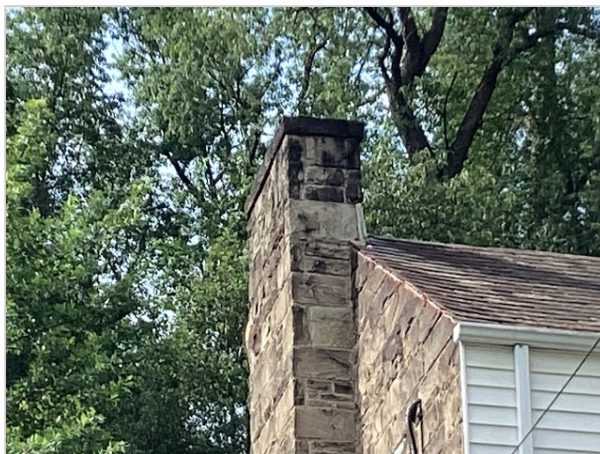
**NOTE: RAIN HAT:**

The rain hat on top of the chimney is missing. Repairs should be made by a qualified roofer.

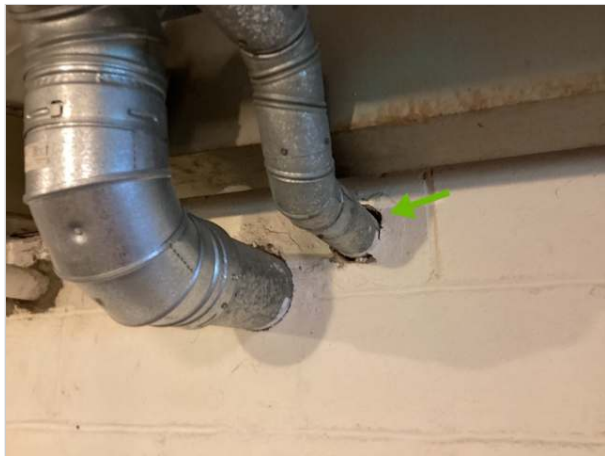
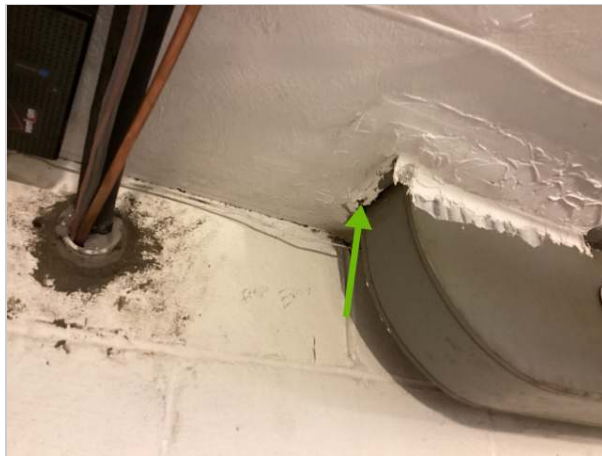
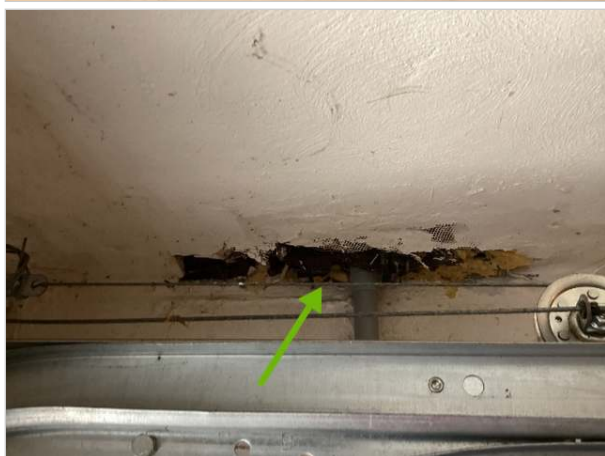
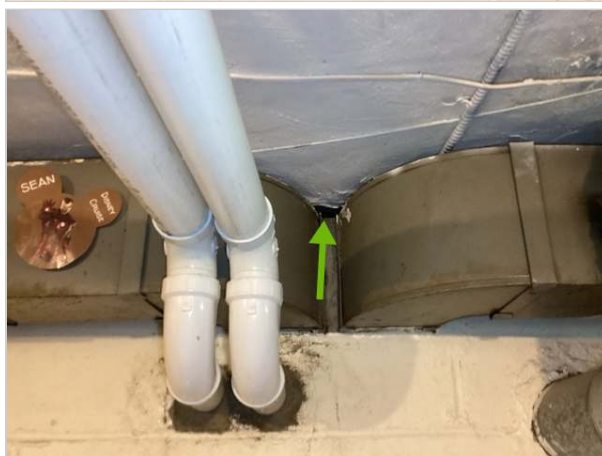
The finish on the garage ceiling and any partition walls between the garage and basement or living space is designed to provide a barrier between the garage and living space in the event of a fire. One or more openings were noted in the garage ceiling. Repairs should be made to the ceiling to maintain the integrity of this important safety feature.

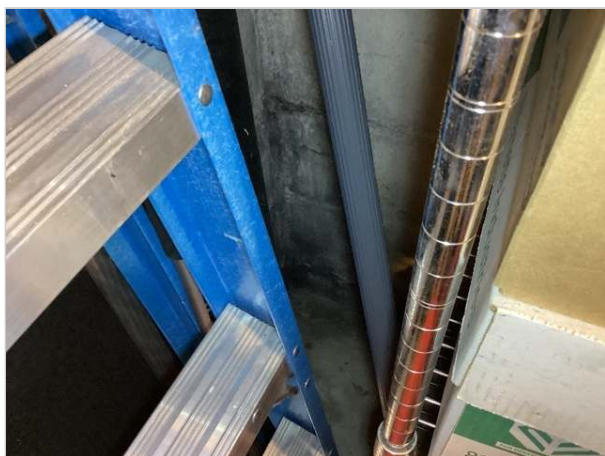
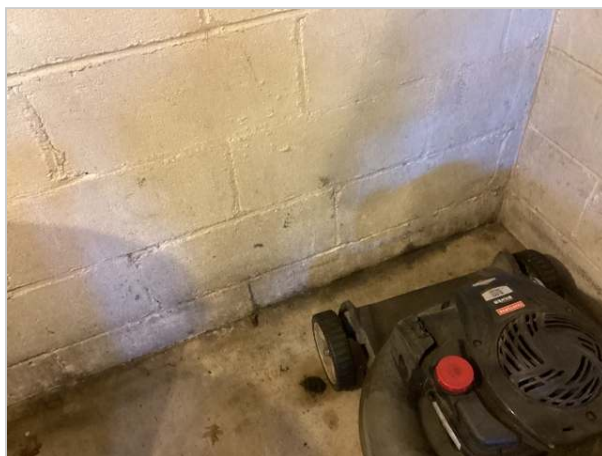
A substance with the characteristics of mold is visible in one or more areas of the property. The EPA (<http://www.epa.gov/mold/moldresources.html>) advises consumers that areas less than ten square feet of coverage can usually be controlled using readily available household products. In the event the substance cannot be controlled, a certified mold testing and remediation firm should be contacted for a recommended course of action.

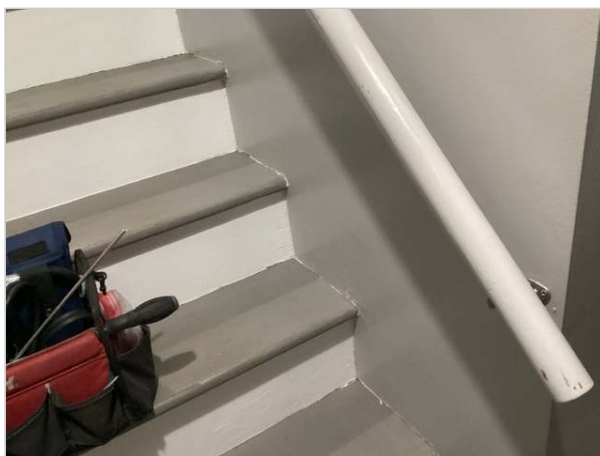
### ***SAFETY NOTE: LOOSE HANDRAIL:***

The handrail on the stairs leading to the basement is loose or otherwise insecure. The handrail should be properly secured for safety.

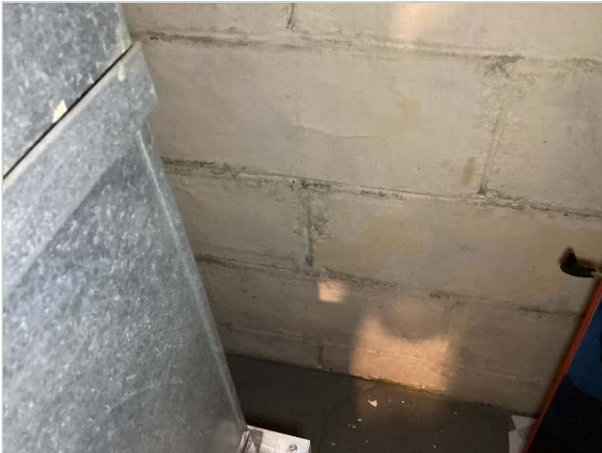
Behind furnace

There were signs of moisture on the front, back and right basement walls. The area was dry at the time of the inspection. Dampness on basement walls is not always a sign of water intrusion. The dampness can be the result of warm humid air making contact with cool walls. In many cases the humid air condenses on the wall and forms a layer of moisture. It is important to assess whether moisture on the basement walls is the result of water intrusion or condensation. In this case, the efflorescence noted on the wall appears to be the result of moisture buildup on the exterior side of the foundation. The exterior grading in the affected area is questionable. Many water intrusion problems can be controlled by improving the drainage on the exterior of the home. It is important that all roof drainage and surface water is directed away from the foundation. Any concern about this condition should be referred to a qualified contractor for evaluation and recommendations.

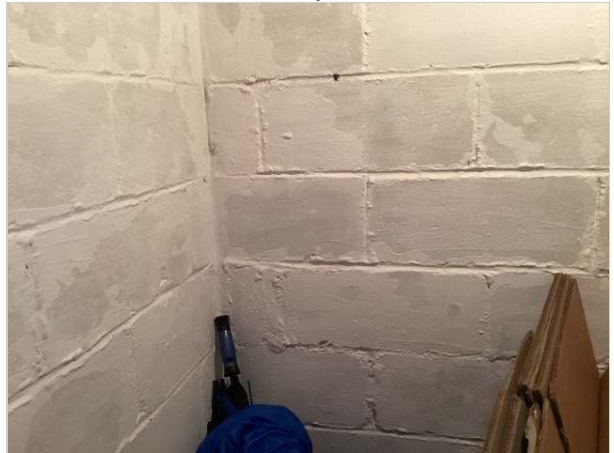
Evidence of moisture under front porch

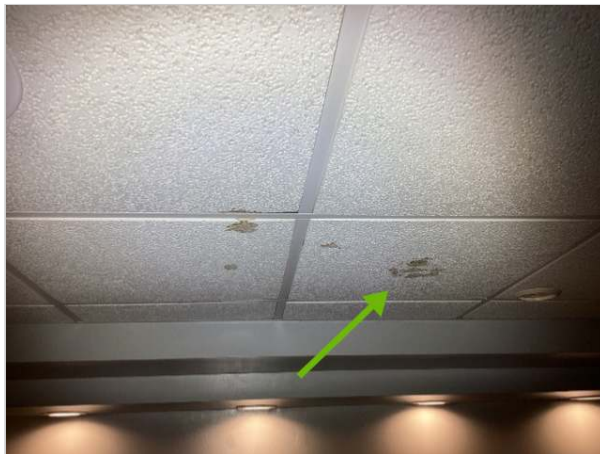
The basement ceiling is water marked below the living area from what appears to be a previous leak. The area was dry at the time of the inspection. No immediate action is required. The area should be monitored for evidence of new leaks. Consult with a qualified contractor for repair if required.

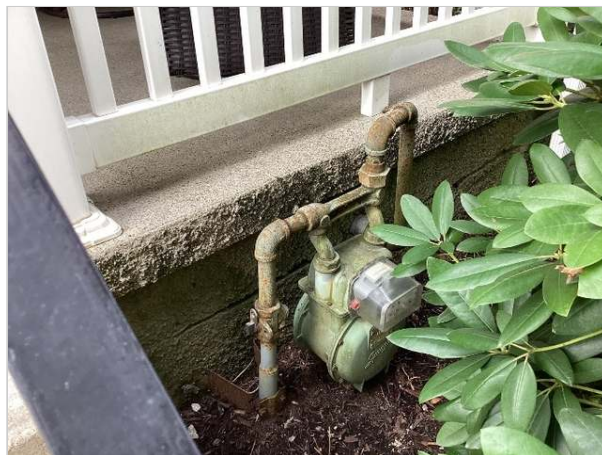
The exterior gas supply lines were *rusted*. *No leaks were found*. We recommend the gas supplier be contacted to inspect further.

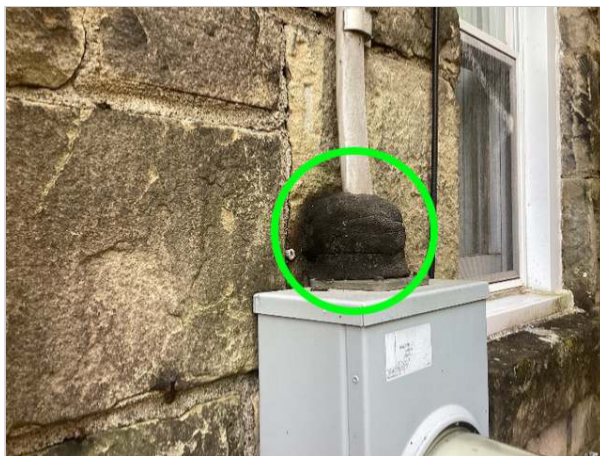
The sealant at the top of the electric meter box is cracked. The sealant should be replaced to ensure that water does not enter the electric service panel.

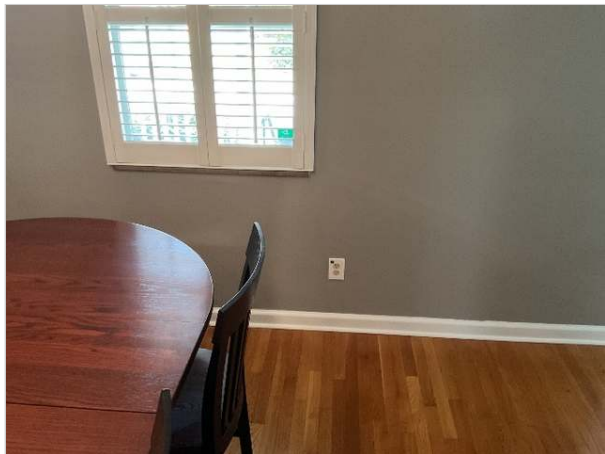
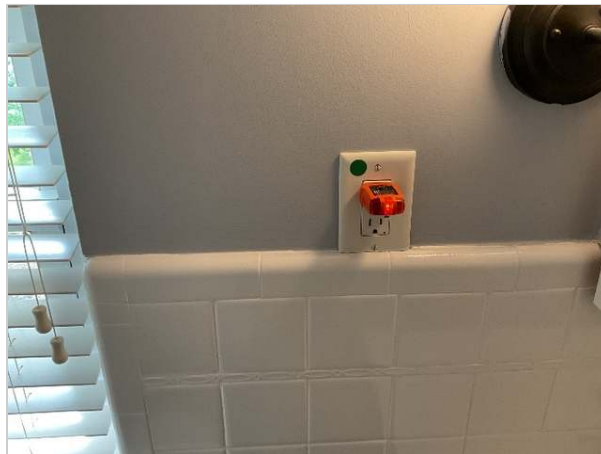
One or more three prong type outlets in the home tested as having an open ground. This means that the third prong, also known as the ground prong is not doing its job. This is usually caused by a missing ground connection at an electrical device in the circuit. This condition is usually easily correctable by an electrician. Open grounds in wet locations is considered a safety issue and should be corrected. The outlets that tested with this condition were marked with a **"GREEN"** dot for easy identification. The affected outlets were located in the dining room. Please note that we only test outlets that are visible and readily accessible at the time of the inspection.

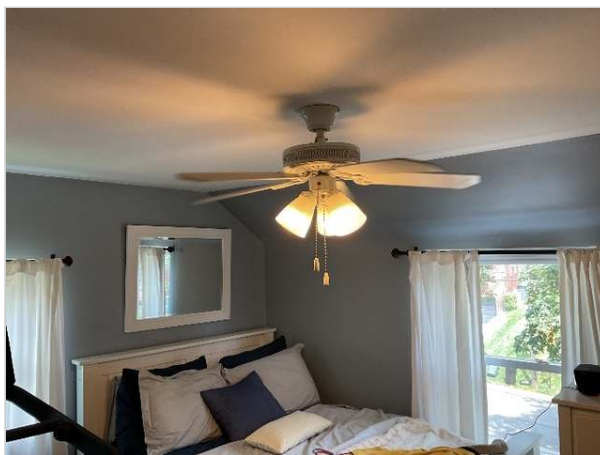
**NOTE: PADDLE FAN OUT OF BALANCE:**

The paddle fan in the front bedroom appears to be out of balance because it is loose in the ceiling box. The fan wobbles when turning. The fan could be improperly installed or the mounting screws are loose. Consult with a qualified contractor for evaluation and repair.

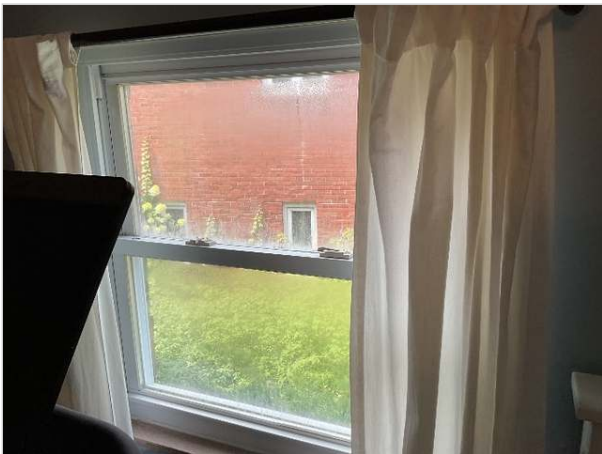
front bedroom

Three or more of the insulated window panes throughout the home had a defective thermal seal. The windows were located in the bedrooms. A defective thermal seal can be identified when fogging is observed between the panes of glass. This statement should not be considered all inclusive. Our ability to identify defective thermal seals is affected by dirty glass, the angle by which we can view the windows, window coverings and the direction of the sun. It is not possible to identify mild cases of fogging between glass panes given the conditions that affect our view. Repair of the thermal seal can be accomplished by replacing the affected glass panel.

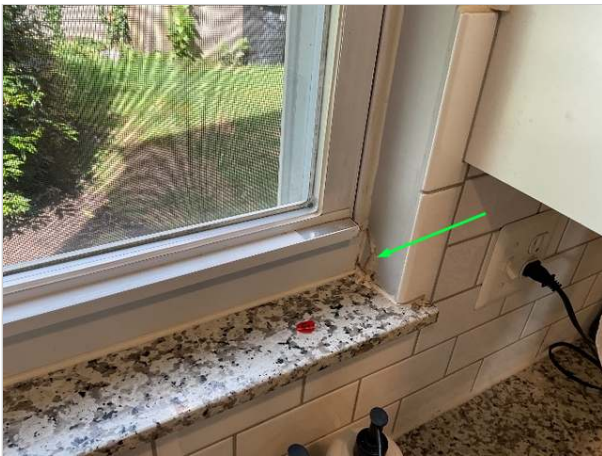
kitchen

Elevated levels of moisture with no surface damage was noted on the walls in the living room and kitchen. The moisture appeared to be the result of active leaks. Consult with a qualified contractor for evaluation and repairs as required.

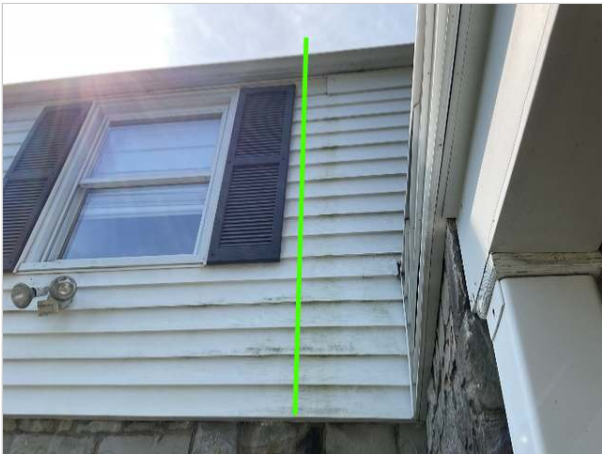
Evidence of leak from behind

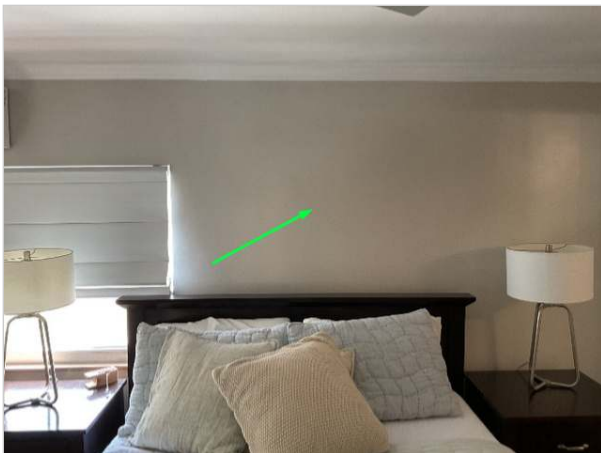
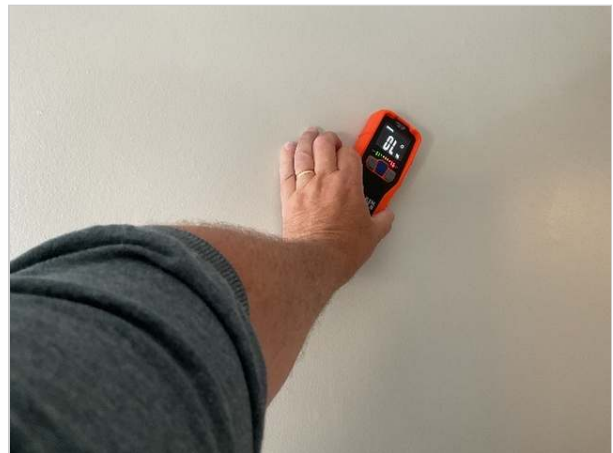
detection area

Elevated levels of moisture with no surface damage was noted on the wall in the master bedroom. The moisture appeared to be the result of active leaks. Consult with a qualified contractor for evaluation and repairs as required.

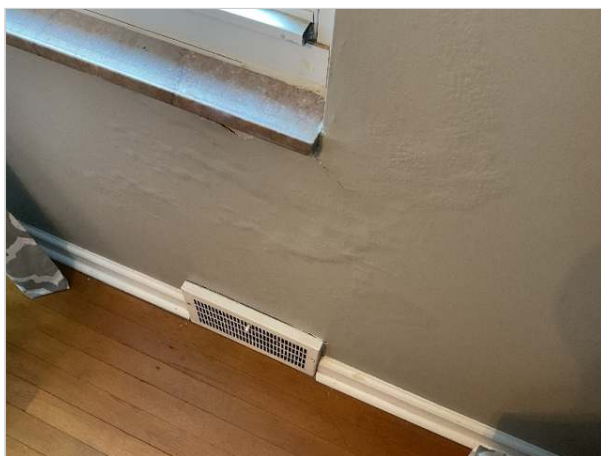
rear bedroom

Cracked or bubbling paint was noted on the walls around the windows. This condition appeared to be caused by water. There was evidence of an active leak at the time of the inspection. Any damaged areas should be scraped, repaired, leveled and primed prior to applying a finish coat of paint.

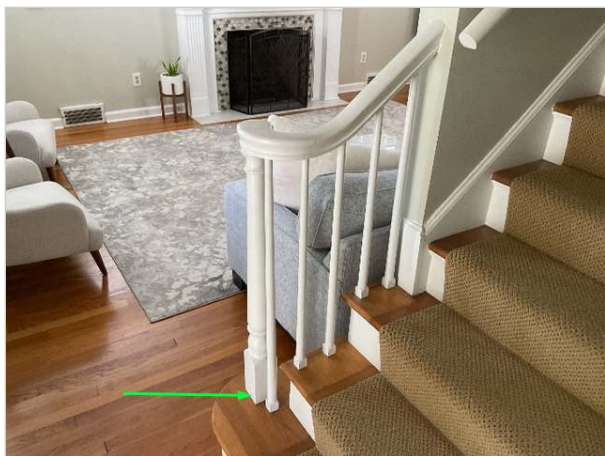
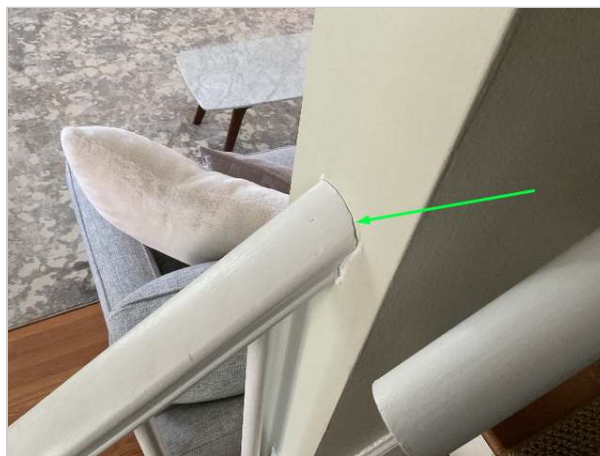
The handrail on the stairs leading to the second floor is loose or otherwise insecure. The handrail should be properly secured for safety.

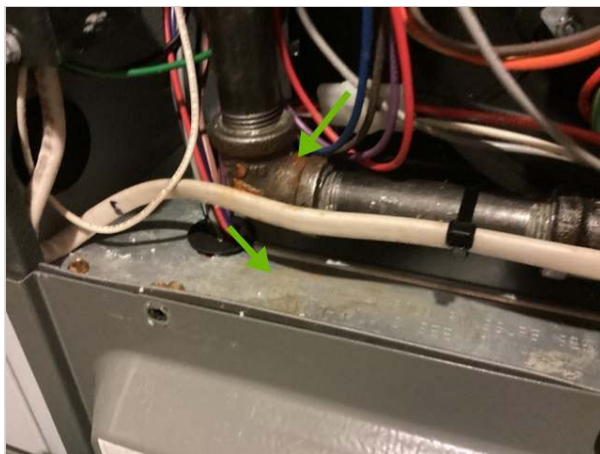
Evidence of water was noted inside the furnace compartment. The condition is most likely caused by a condensate leak in the furnace and/or air conditioning condensate drain lines. The water can also be caused by a leaking humidifier if one is installed. Water inside the furnace compartment can damage the furnace cabinet or other operational components and should be repaired. The furnace compartment was dry at the time of the inspection. The unit should be monitored for evidence of active leaks and repaired by a qualified contractor as required. Please also note that due to the seasonal use of heating and air conditioning systems, wet and dry conditions can change based on whether the inspection is performed during the heating or cooling season. The observation at the time of the inspection can be limited to seasonal conditions.

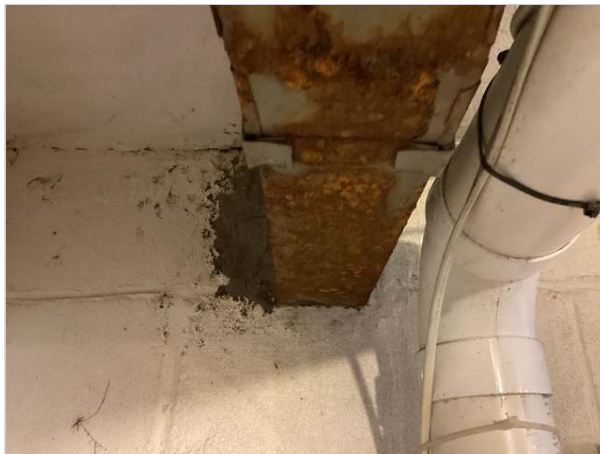
Rusting ductwork was noted in the garage. We recommend the ducts be replaced to prevent further deterioration. Consult with a qualified contractor for repair.
