# Home Inspection Report

**694 Valleyview Rd, Pittsburgh, PA 15243**

251103-01

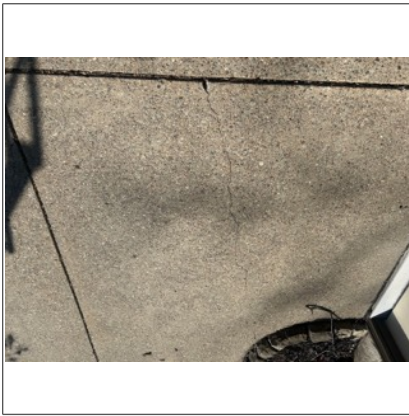
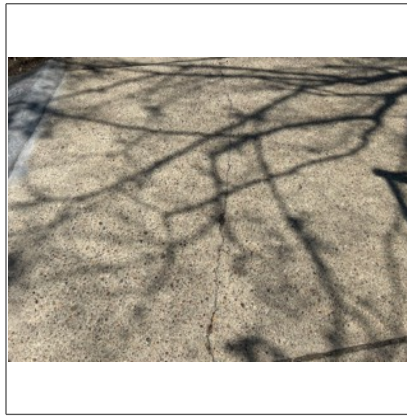
☐ None ☐ Not Visible  
**Material** ☒ Concrete ☐ Asphalt ☐ Gravel/Dirt ☐ Brick Other: \_\_\_\_\_  
**Condition** ☒ Satisfactory ☐ Marginal ☐ Poor ☐ Settling Cracks ☒ Typical cracks ☐ Pitched towards home  
☐ Trip hazard ☒ Fill cracks and seal  
**Comments** At the time of inspection, typical cracking was observed. Recommend sealing crack with concrete crack filler to prevent water from penetrating and causing further deterioration.

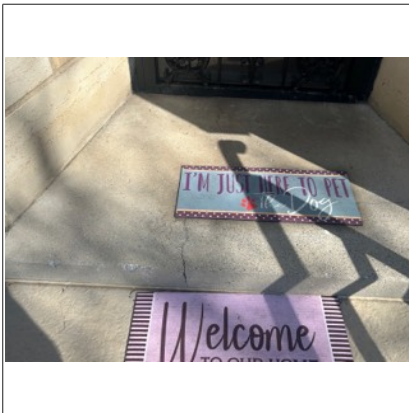
☐ None  
**Material** ☒ Concrete ☒ Stone Other: ☐ Railing/Balusters recommended  
**Condition** ☒ Satisfactory ☐ Marginal ☐ Poor ☐ Safety Hazard ☐ Uneven risers ☐ Rotted/Damaged  
☒ Cracked ☐ Settled  
**Comments** At the time of inspection, typical cracking was observed. Recommend sealing crack with concrete crack filler to prevent water from penetrating and causing further deterioration.

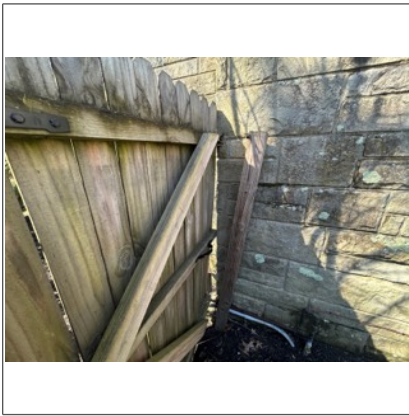
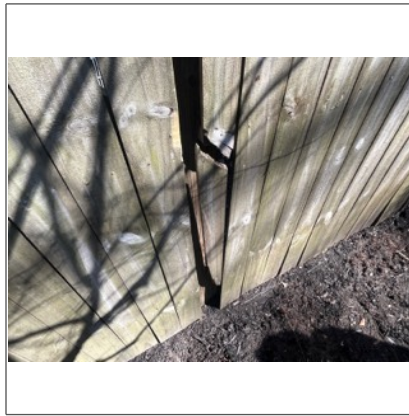
Type ☐ Not evaluated ☐ None  
☐ Brick ☐ Block ☒ Wood ☒ Metal ☐ Chain Link ☐ Rusted ☐ Vinyl  
 Condition ☒ Satisfactory(Metal) ☒ Marginal (Wood) ☐ Poor ☐ Typical cracks ☐ Loose Blocks/Caps  
 Comments At the time of inspection, loose post was observed at wood gate. Recommend resecuring post.

At the time of inspection, damaged wood flanking was observed. If deemed necessary, recommend replacing damaged wood pickets to preserve the wood fence. It is recommended to pressure wash and seal or stain every 3 to 5 years to protect the wood from the exterior elements.

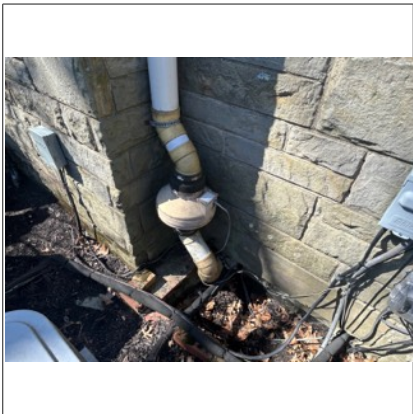
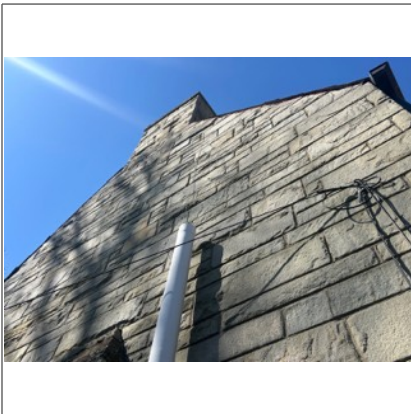
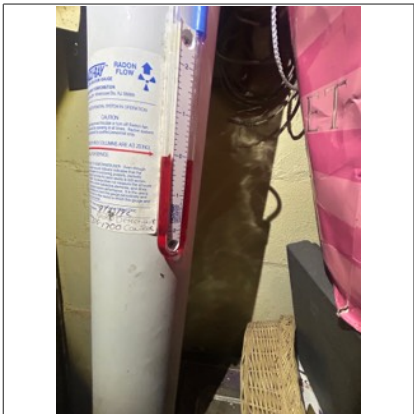
At the time of inspection, radon mitigation system was not properly functioning. Recommend having radon mitigation company evaluate and make the necessary repairs to resolve this potential safety hazard. It is also recommended that the exhaust pipe be vented past the roofline.

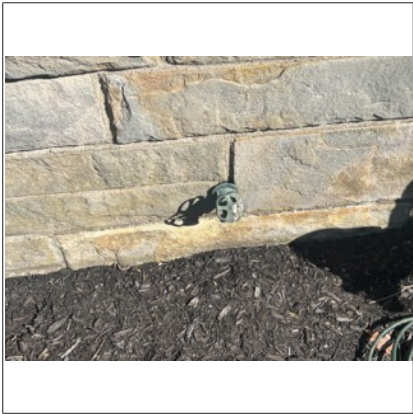
- ☐ N/A
- ☐ Satisfactory ☒ Marginal ☐ Poor ☒ Recommend Anti-siphon valve
- ☒ Yes ☒ No(1) ☐ Not Tested
- At the time of inspection, hose bib in the photo would not turn. Recommend having plumber evaluate, make the necessary repairs to resolve this issue.

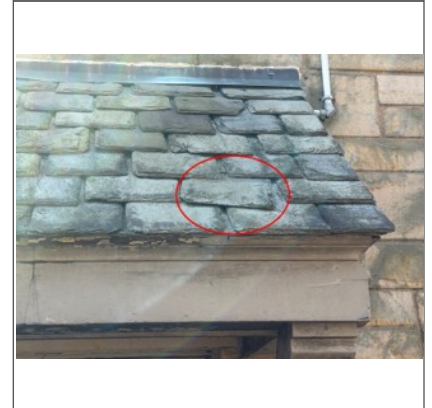
**Comments** At the time of the inspection, overall condition of the slate tiles were good. However, loose and broken tiles were observed throughout the roof. Recommend having a licensed slate roofer evaluate and make the necessary repairs to prevent potential water infiltration points.

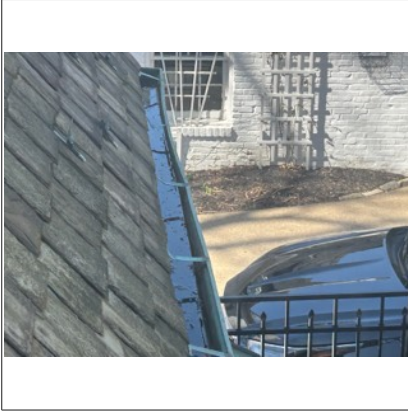
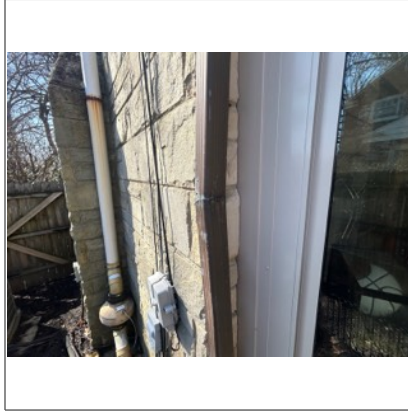
**Condition** ☐ None ☒ Satisfactory ☐ Marginal ☐ Poor ☐ Rusting ☐ Downspouts needed ☐ Recommend repair/replace  
☒ Needs to be cleaned  
**Material** ☐ Copper ☐ Vinyl/Plastic ☒ Galvanized/Aluminum Other: \_\_\_\_\_  
**Comments** At the time of inspection, gutter was holding water. Recommend cleaning gutters to maximize drainage and monitoring.

At the time of inspection, loose downspout was observed. Recommend resealing.

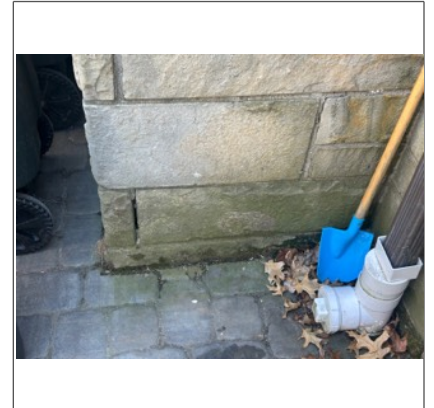
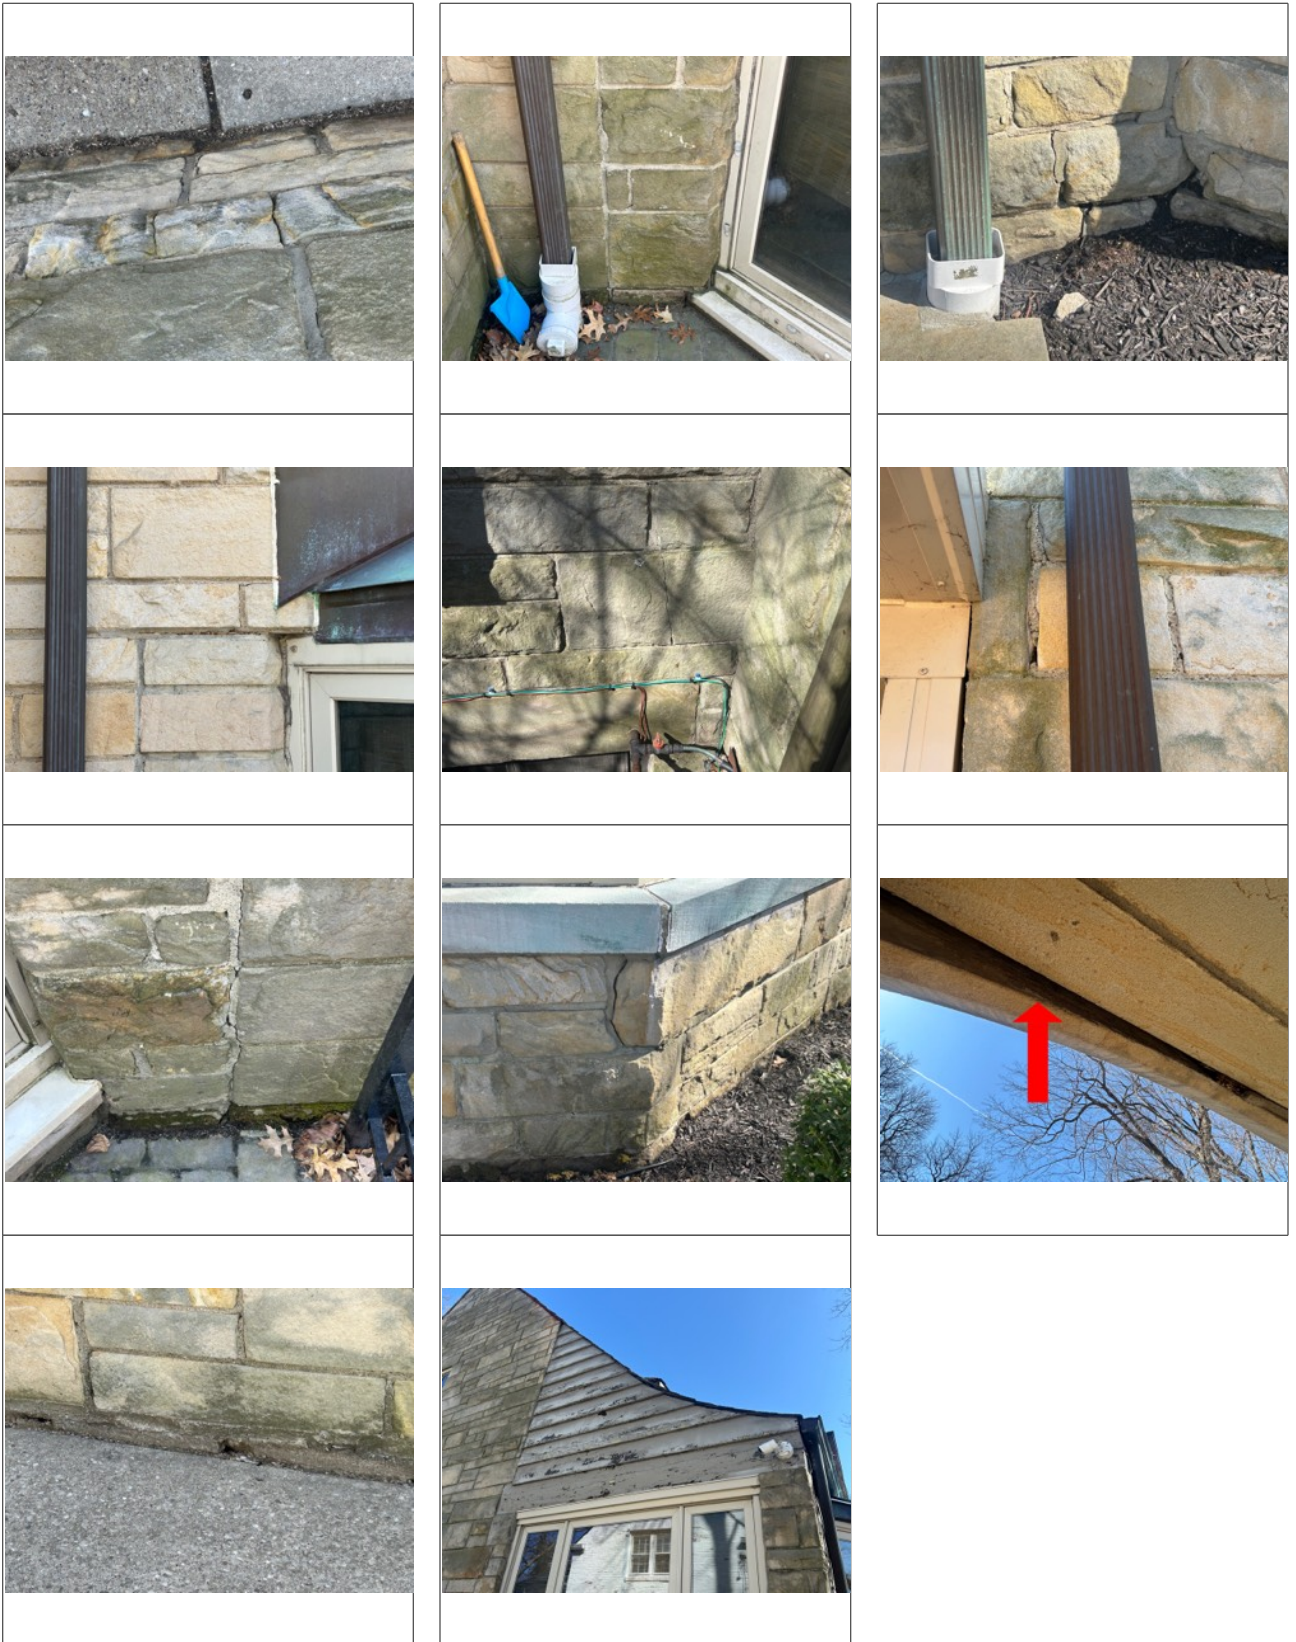
**Material** ☒ Stone ☐ Slate ☐ Block/Brick ☐ Fiberboard ☐ Fiber-cement ☐ Stucco ☐ EIFS\* Not Inspected  
☐ Asphalt ☒ Wood ☐ Metal/Vinyl Other: \_\_\_\_\_ ☐ Typical cracks ☐ Peeling paint ☐ Monitor ☐ Wood rot  
☐ Loose/Missing/Holes  
**Condition** ☐ Satisfactory ☒ Marginal ☐ Poor ☒ Recommend repair/painting  
**Comments** At the time of inspection, cracking and mortar deterioration was observed at stonework. Recommend having a mason re-point these areas to prevent water from penetrating and causing further deterioration.

At the time of inspection, peeling paint was observed at wood siding. Recommend removing any loose paint, sanding, priming, then painting to protect the wood from the exterior elements.

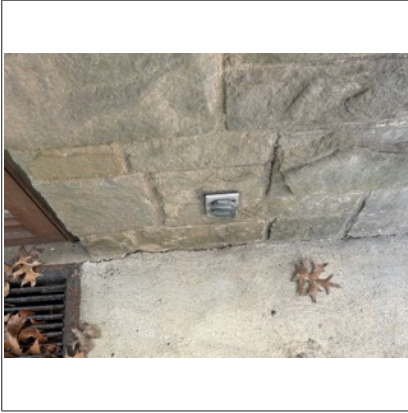
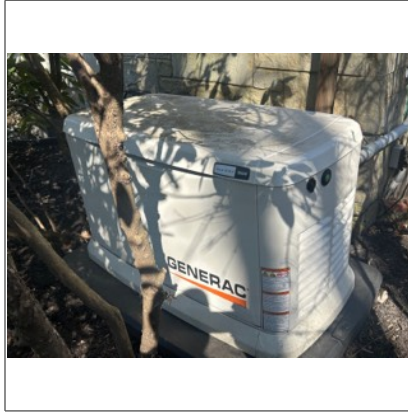
**Comments** At the time of inspection, the majority of exterior receptacles were GFCI protected. However, one receptacle is not GFCI protected. Recommend having electrician install a GFCI protected receptacle to prevent potential safety hazard.

At the time of inspection, generator was not inspected. This is a small engine. If deemed necessary, recommend having serviced to ensure that the unit is properly functioning.

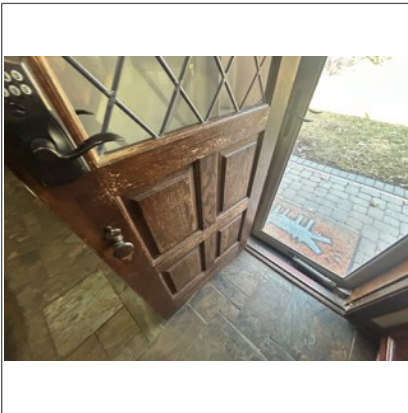
**Comments** At the time of inspection, stain deterioration was observed at door. Recommend lightly sanding and re-staining to protect the wood from the exterior elements.

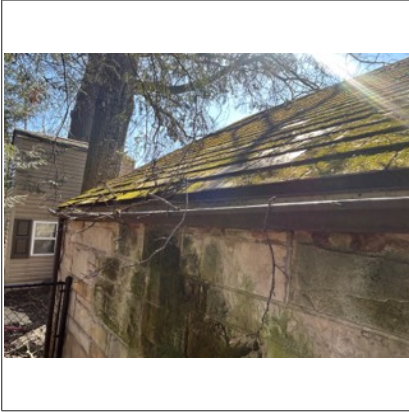
**Condition** ☒ Satisfactory ☐ Marginal ☐ Poor ☐ Same as house  
**Comments** At the time of inspection, loose gutter was observed. Recommend resealing gutter.

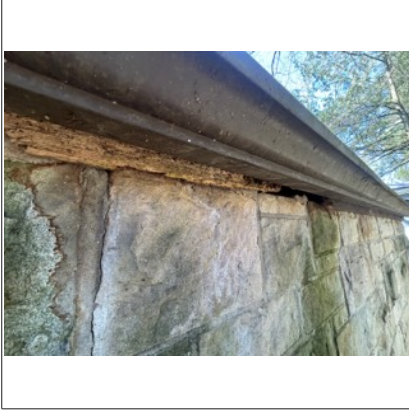
**Comments** At the time of inspection, damaged wood trim was observed at the fascia. It appears water is entering behind the gutter into missing drip edge. Recommend installing a drip edge to properly divert water into the gutters and replace fascia board.

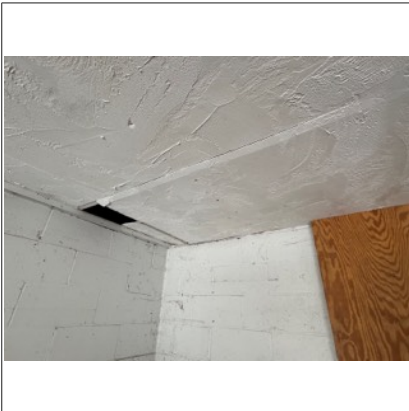
**Condition** ☒ Satisfactory ☐ Poor ☐ Safety hazard  
**Comments** At the time of inspection, typical cracking and missing drywall was observed. This is cosmetic only. If deemed necessary, recommend cosmetic drywall repairs.

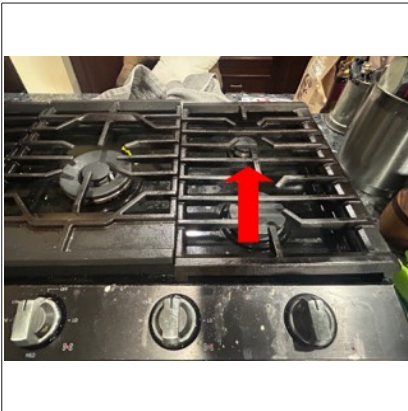
**Comments** At the time of inspection, one of the burners would not light. Recommend repairs to the burner to resolve this issue.

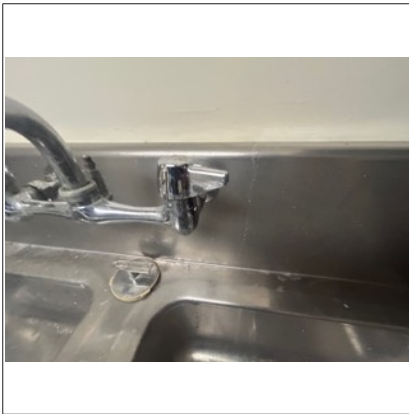
**Comments** At the time of inspection, cold water shut off at kitchen faucet was leaking. Recommend having plumber make the necessary repairs to resolve this issue.

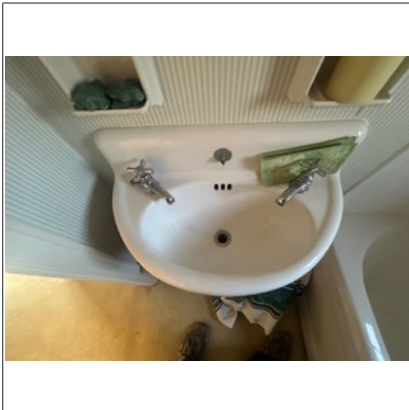
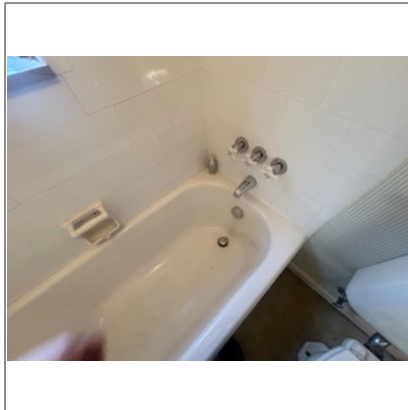
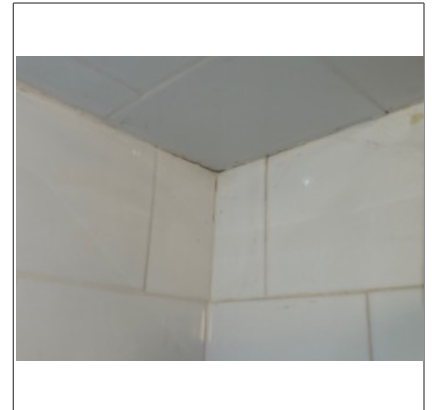
**Open ground/Reverse polarity** ☒ Yes ☐ No ☒ Potential Safety Hazard  
**Exhaust fan** ☐ Yes ☒ No Operable: ☐ Yes ☐ No  
**Comments** At the time of inspection, cold water faucet would not turn on. Recommend having a plumber evaluate and make the necessary repairs to resolve this issue.

At the time of inspection, water at tub/shower would not turn on. Recommend having plumber evaluate and make the necessary repairs to resolve this issue.

At the time of inspection, cracking was observed at shower surround. Recommend caulking with a tub/tile caulking to protect grout and prevent potential leaking.

At the time of inspection, loose toilet was observed. Recommend resecuring toilet to prevent leak at the wax ring.

At the time of inspection, missing GFCI receptacle was observed at bathroom. Recommend installing a GFCI receptacle to prevent potential safety hazard.

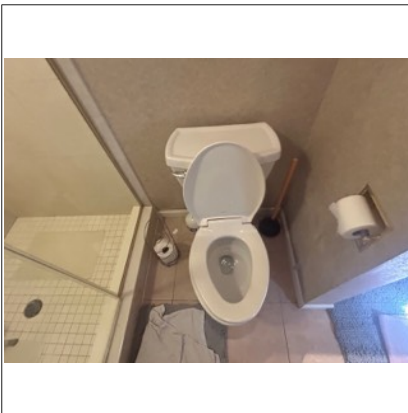
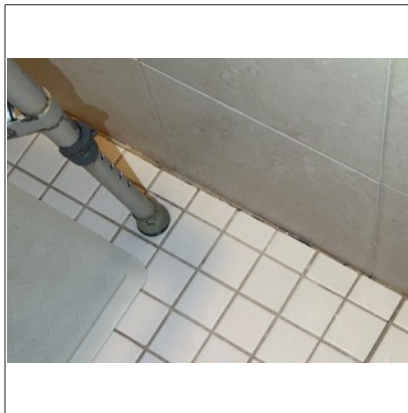
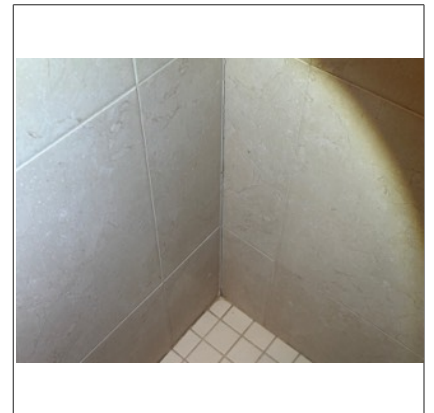
**Exhaust fan** ☒ Yes ☐ No Operable: ☒ Yes ☐ No  
**Comments** At the time of inspection, loose toilet was observed. Recommend resealing toilet to prevent leak at the wax ring.

At the time of inspection, cracking was observed at shower surround. Recommend caulking with a tub/tile caulking to protect grout and prevent potential leaking.

At the time of inspection, typical cracking was observed. If deemed necessary, recommend cosmetic repair and repainting.

At the time of inspection, mold like sporing was observed at ceiling. It is important to run the bathroom exhaust fan or open the window when showering to remove moisture buildup and prevent mold. Recommend having treated for mold removal.

At the time of inspection, peeling paint was observed at door. Recommend removing any loose paint, priming and repainting.

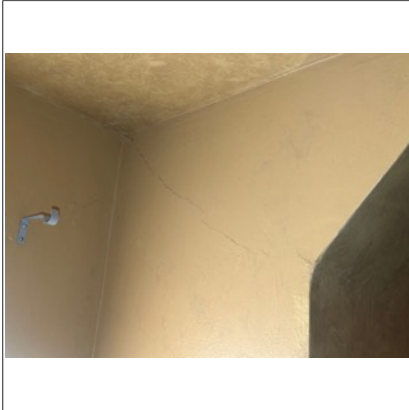
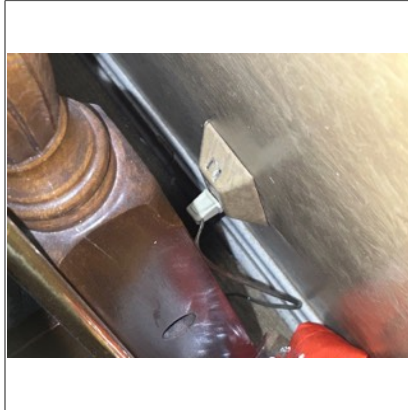
At the time of inspection, open ground receptacles were observed. This is a potential safety hazard. Recommend having electrician make necessary repairs to resolve this issue.

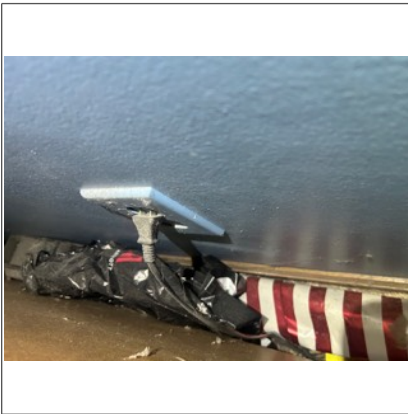
**Comments** At the time of inspection, open ground receptacles were observed. This is a potential safety hazard. Recommend having an electrician make necessary repairs to resolve this issue.

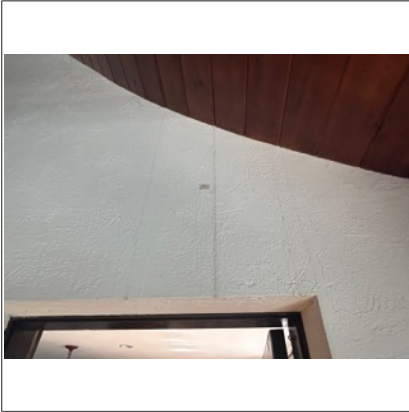
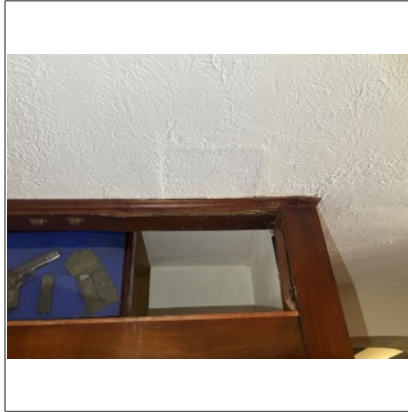
**Comments** At the time of inspection, moisture stains were observed at wall, ceiling and cabinet. These areas were probed with a moisture meter and found no active traces of moisture, and appear to be a past issue. If deemed necessary, recommend cosmetic repairs.

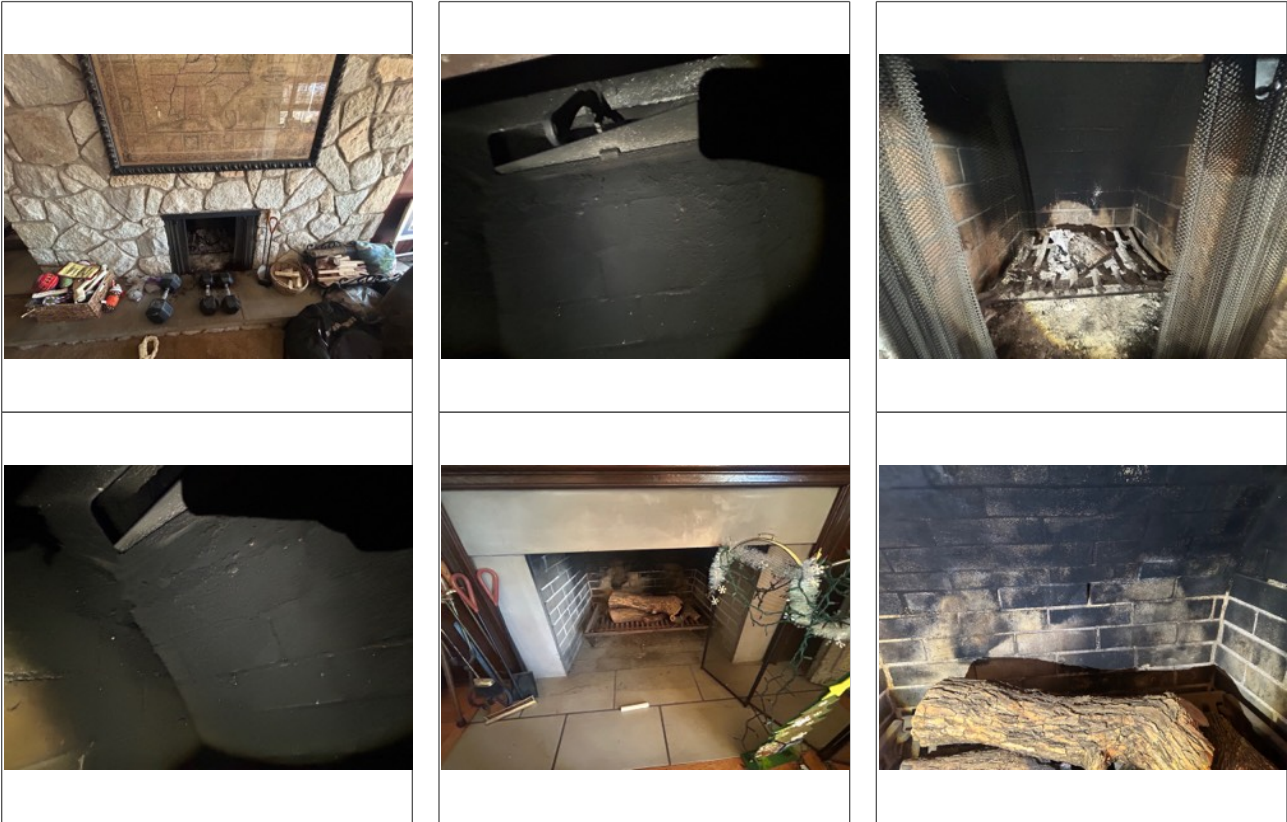
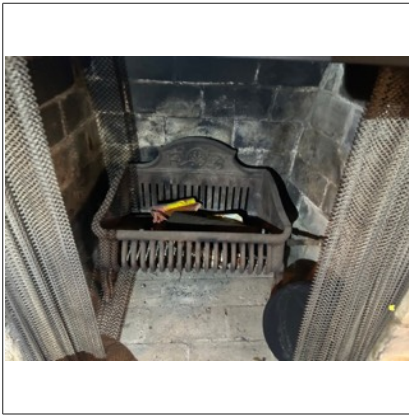
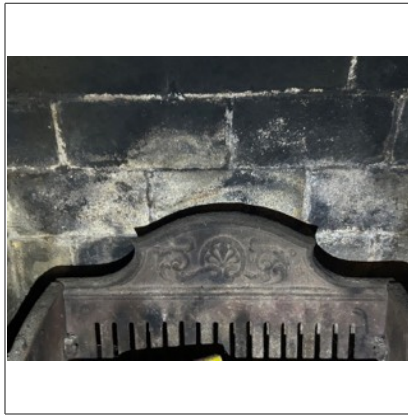
At the time of inspection, mortar deterioration was observed at gameroom fireplace. Recommend having firebrick repointed then cleaning firebox, and paint with a heat paint to protect the brick and mortar joints.

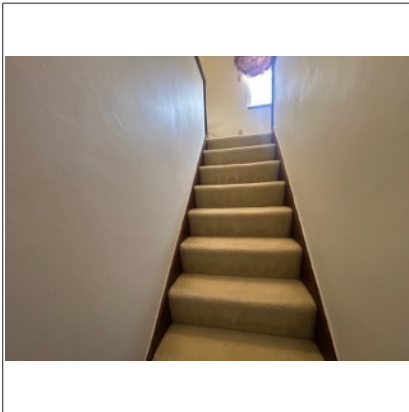
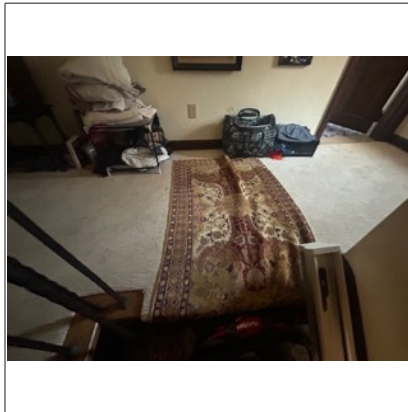
☐ None  
**Condition** ☒ Satisfactory ☐ Marginal ☐ Poor  
**Handrail** ☒ Satisfactory ☐ Marginal ☐ Poor ☒ Hand Rail recommended  
**Risers/Treads** ☒ Satisfactory ☐ Marginal ☐ Poor ☐ Risers/Treads uneven  
**Comments** At the time of inspection, missing handrail was observed at third-floor stairs. Recommend installing handrail to prevent potential safety hazard.

At the time of inspection, carpet runner was extended past the stairs and was loose. This could be a potential trip hazard. Recommend trimming carpet runner at the top riser of stairs to resolve this issue.

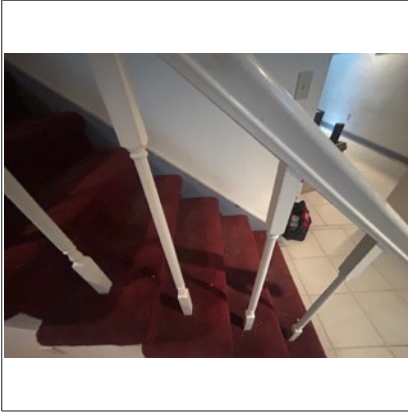
**Comments** At the time of inspection, balusters were greater than 4 inches apart. This is typical with the age of the home. However could be a potential safety hazard with small children. If deemed necessary, recommend installing additional balusters to resolve this issue.

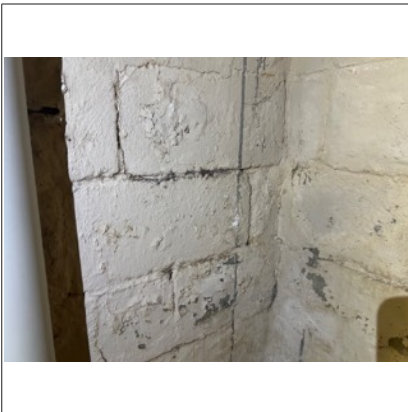
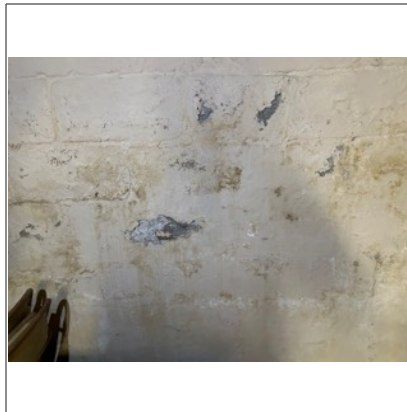
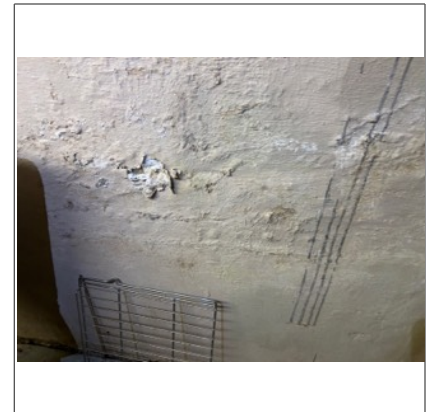
At the time of inspection, cracking was observed by foundation. This is caused by limited settling. No repairs are necessary at this time.

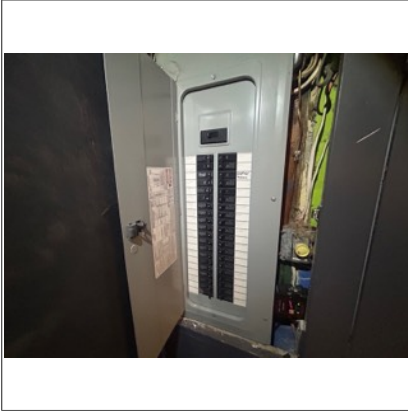
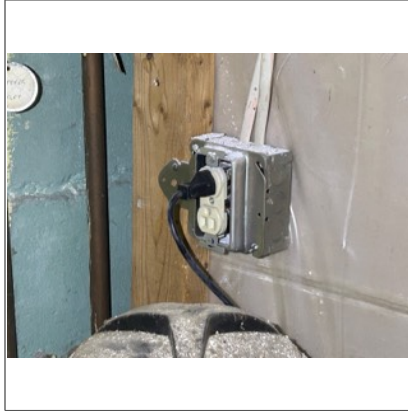
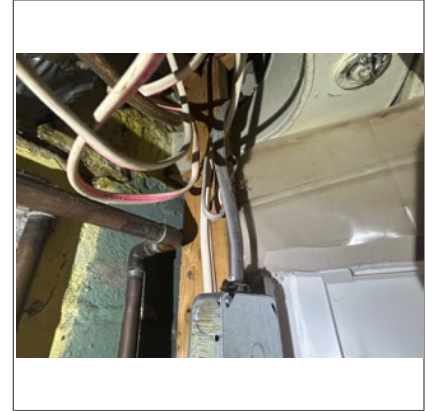
At the time of inspection, loose wiring was observed. This is in the furnace/water heater closet. Recommend installing junction box with cover plate to prevent potential safety hazard.

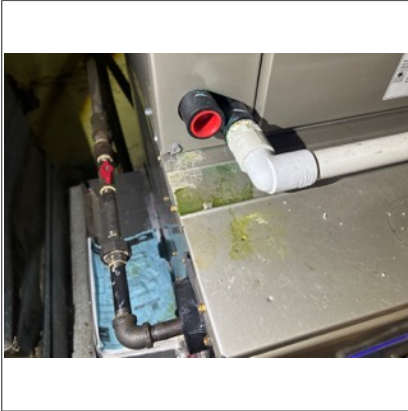
☐ N/A  
**General** ☒ Central system ☐ Wall unit  
**Condensate line/drain** ☐ To exterior ☐ To pump ☒ Floor drain Other: .  
**Condition** ☒ Satisfactory ☐ Marginal ☐ Poor  
**Comments** At the time of inspection, unit appears to be leaking at condensing line. Recommend having HVAC technician evaluate and make the necessary repairs, as over time this could cause the furnace box to rust and damage the furnace.
