**337 Snowberry Cir**

**RE: Venetia, PA 15367**

**Inspection #: 527-072026-6967**

### *HOME INSPECTION REPORT*

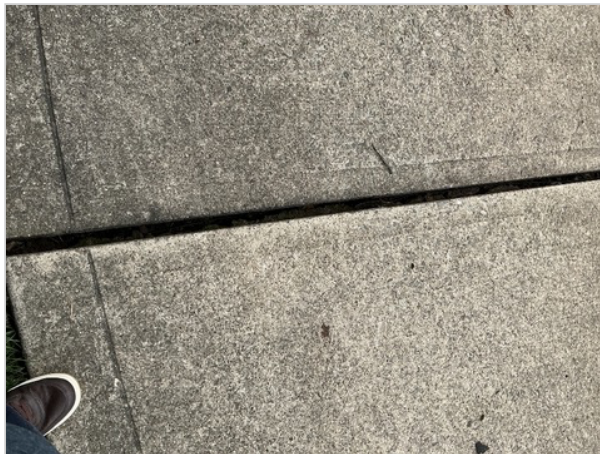
### ***NOTE: CONCRETE SETTLEMENT:***

Settlement was noted on the front driveway slab. The settlement does not appear to be active. Settlement of concrete slabs is common and is usually not a problem. If the settlement causes the concrete slab to pitch toward the foundation of the home, it is possible that water will drain into the basement. In this case the slab was not pitched toward the foundation. It is not possible for us to positively determine if active settlement is occurring during a home inspection. The area should be monitored for evidence of new or continued settlement. Consult with a qualified contractor for further evaluation if required.

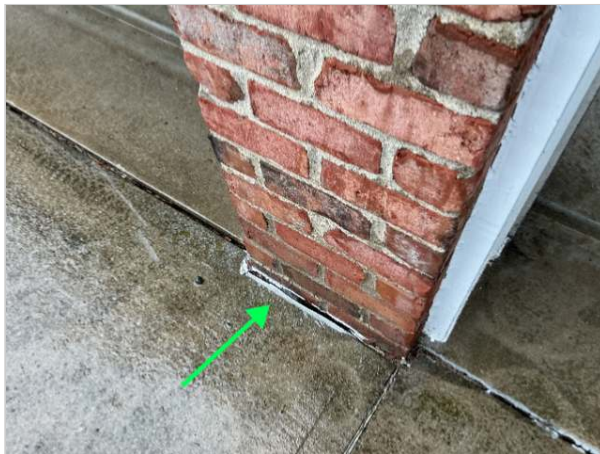
garage entryway

### ***MAINTENANCE NOTE: EXTERIOR SEALANT:***

The exterior sealant around the doors is cracked or missing on the left side of the home. The caulking should be replaced to ensure the exterior of the home remains weather and water tight.

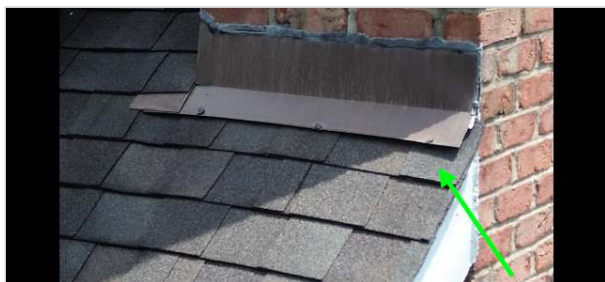
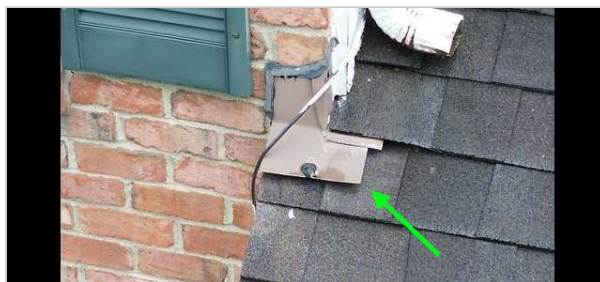
### NOTE: LOOSE FLASHING:

Loose flashing was noted on the front of the roof. Loose flashing could be a leak source. We cannot always determine if active leaks exist. Consult with a qualified roofer for further evaluation and repair.

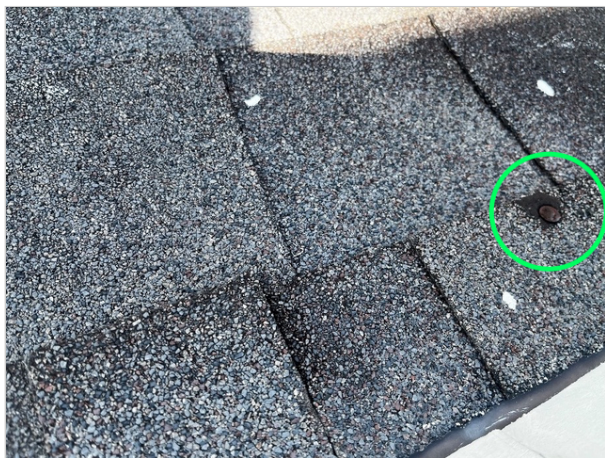
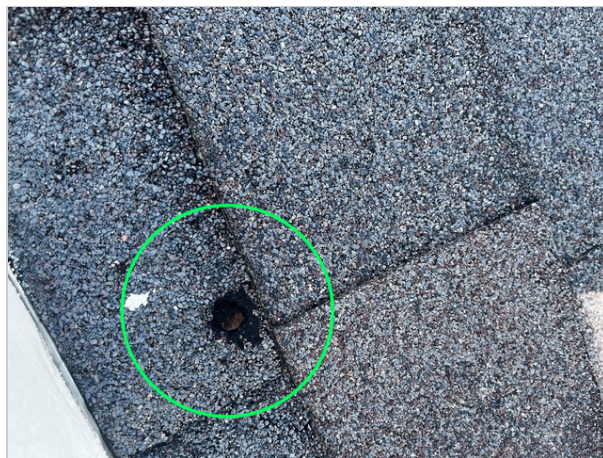
base of front dormers

### NOTE: EXPOSED NAILS ON ROOF:

One or more exposed/unsealed nail(s) were noted on the roof. Consult with a qualified roofer for repair.

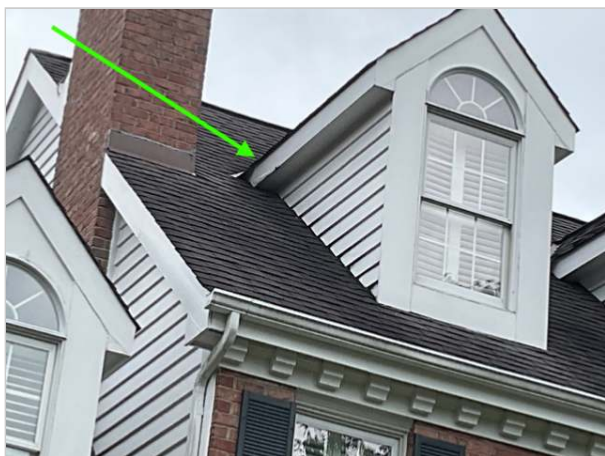
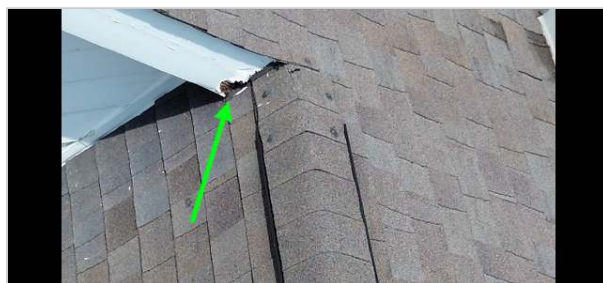
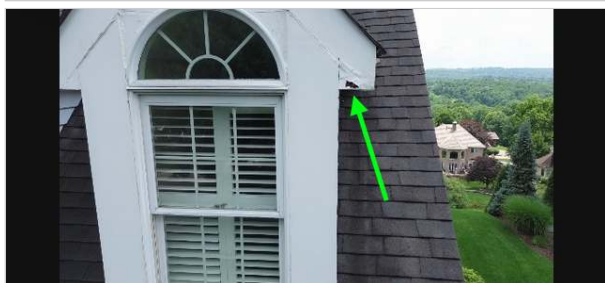
The wood soffit and fascia was inspected and was rotted in one or more areas.

**NOTE: EXTERIOR WOOD ROT:**

Rotted wood was noted on the wood fascia . The areas should be repaired and sealed by a qualified contractor.

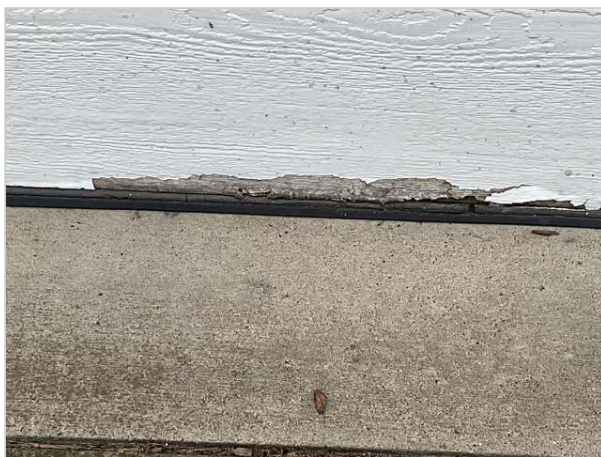
### **NOTE: ROTTED WOOD ON GARAGE DOOR:**

Rotted or weather damaged wood was noted on the garage door. Repairs should be made by a qualified contractor.

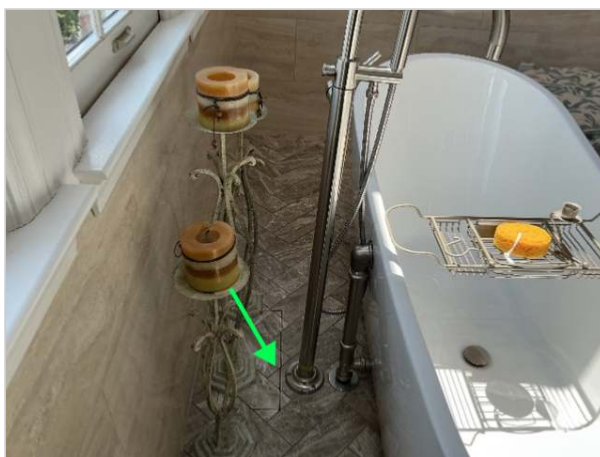
Minor plumbing issues were noted during the inspection. This is not intended to be an all inclusive list. Concealed, latent or intermittent plumbing issues may not be apparent during the testing period. Consult with a qualified plumber for further evaluation and repairs as required.

- Exterior bar sink No hot water at bar sink
- Basement bath shower hot and cold water supply lines are reversed.
- Master bath tub faucet fixture is loose.
- 
-

Loose in floor

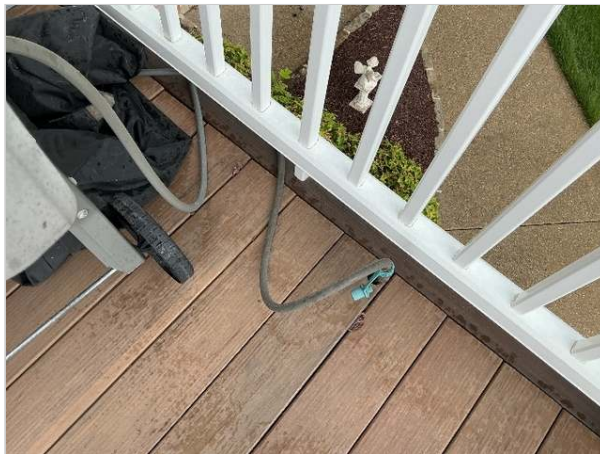
**NOTE: SOFT COPPER TUBING:**

Some of the gas appliances in the home are plumbed with soft copper tubing. The tubing was observed on the gas line (s) feeding the gas grill. This may or may not be an issue based on the local jurisdiction. Some areas permit the use of soft copper tubing while others do not. Consult with a qualified plumber for further evaluation and recommendations.

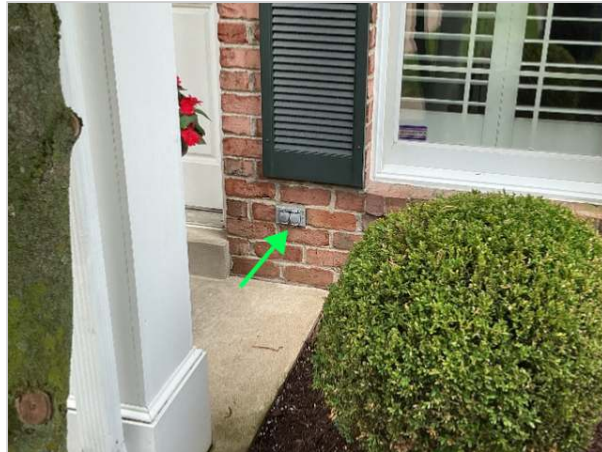
***SAFETY NOTE: LOOSE OUTLET:***

A loose outlet was noted in the exterior. This could be a shock hazard due to exposed electrical contacts. The affected outlet(s) should be secured by a qualified contractor.

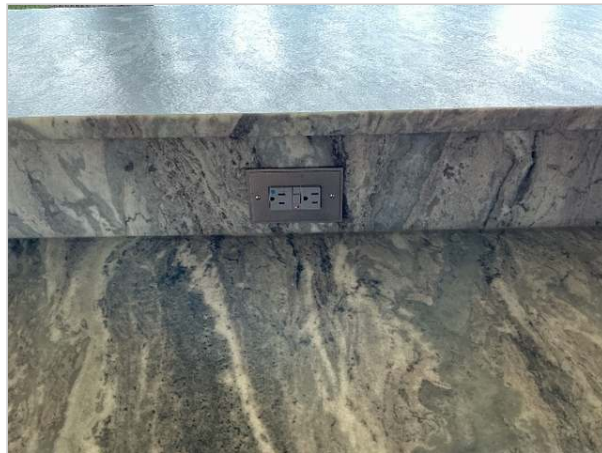
Rear bar sink

***SAFETY NOTE: DEFECTIVE GFCI:***

The GFCI outlet located on the exterior is defective and should be replaced by a qualified electrician.

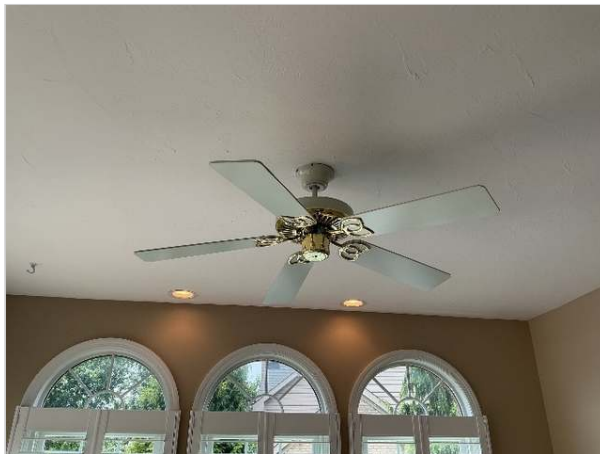
***NOTE: PADDLE FAN:***

The paddle fan located in the sunroom is not operable. Consult with a qualified contractor for repair.

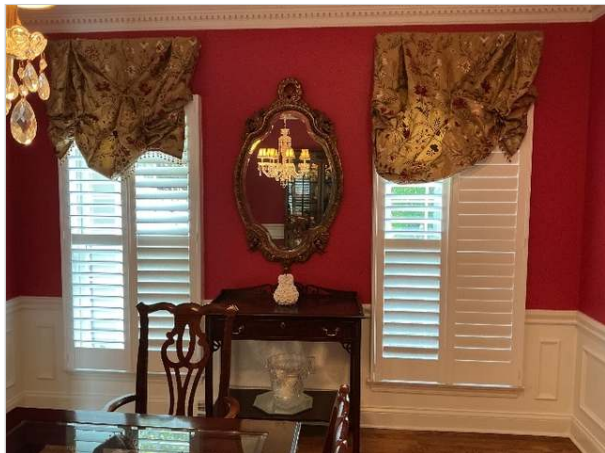
Both windows

**SAFETY NOTE: WINDOW BALANCERS:**

One or more of the windows would not stay in its placed position without support. This condition is usually caused by a defective balancer mechanism. Window balancers can be a rope and weight inside the window frame of older windows, or a combination of springs and ropes in newer windows. The window (s) were located in the dining room. A defective balancer can be considered a safety issue if the sash falls rapidly. Repair or replacement of the balancer system may be required in order for the windows to stay in place without additional support.

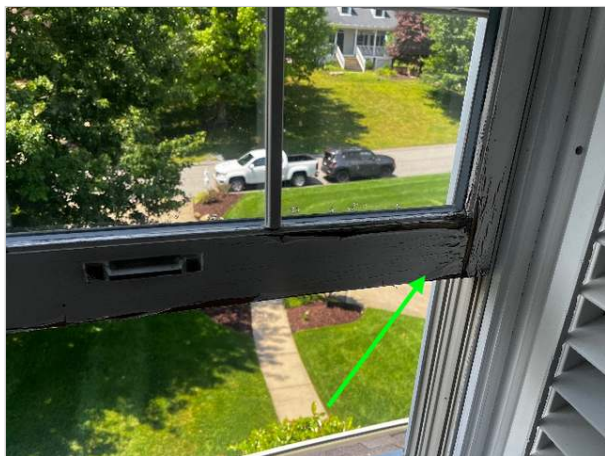
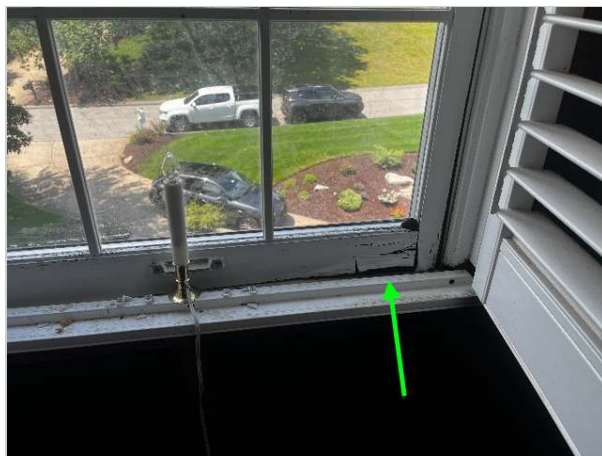
**NOTE: INTERIOR WOOD ROT:**

Rotted wood was noted on the attic windows. The affected area should be repaired by a qualified contractor.

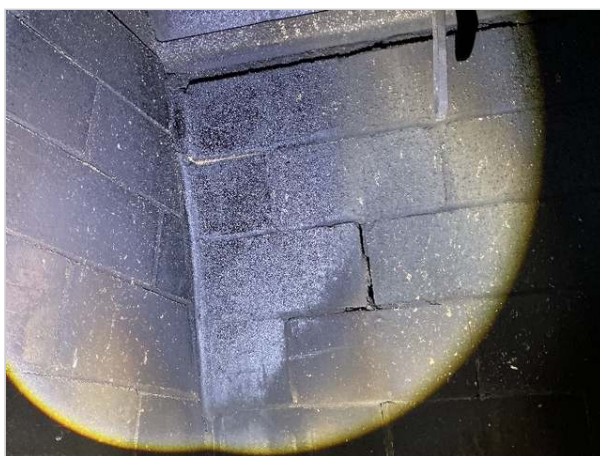
***NOTE: CRACKS IN FIREBOX:***

Cracks were noted in the firebox of the fireplace located in the living room. The bricks and mortar inside the firebox are designed to act as a heat and spark shield and should be free of any voids. Consult with a qualified, reputable chimney and fireplace service for evaluation and repair.

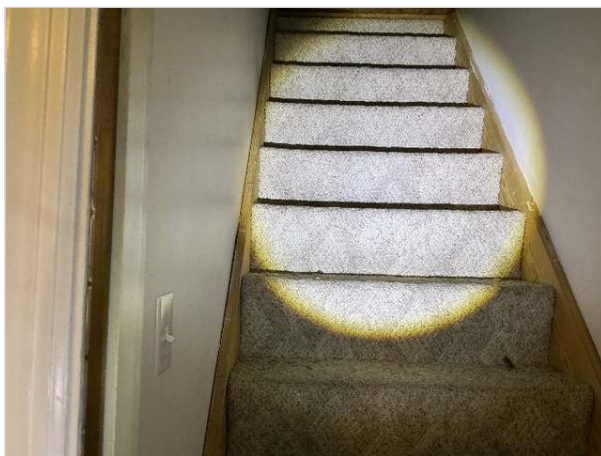
### ***SAFETY NOTE: MISSING HANDRAIL:***

There is a missing handrail on the stairs to the attic. This can be a safety concern. Local building codes may also require the installation of a handrail.

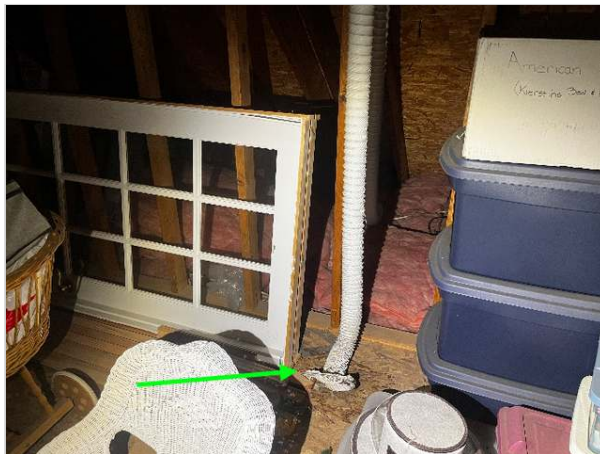
### ***NOTE: BATHROOM FAN:***

The second floor full bath fan is discharging into the attic. Excessive moisture can build up in the insulation, creating a condition for mold growth. A duct should be installed from the fan exhaust to a roof vent.

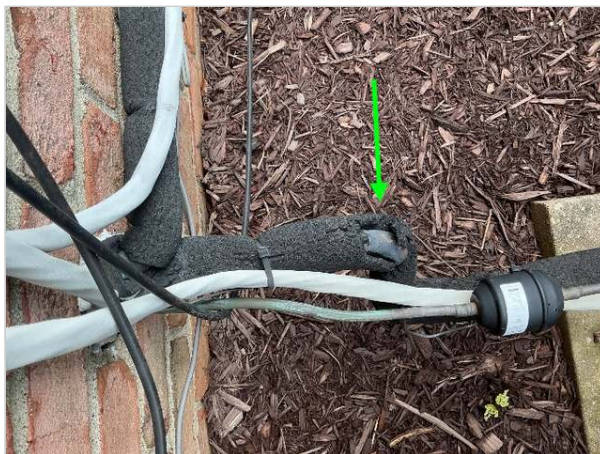
**NOTE: A/C LINE SET INSULATION:**

The insulation on the exterior air conditioning line set is damaged. This could affect the efficiency of the system and should be replaced.

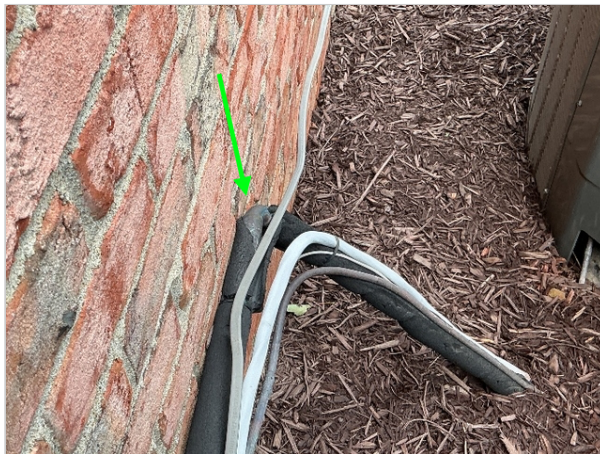
**NOTE: A/C LINE SET INSULATION:**

The insulation on the exterior air conditioning line set is damaged. This could affect the efficiency of the system and should be replaced.

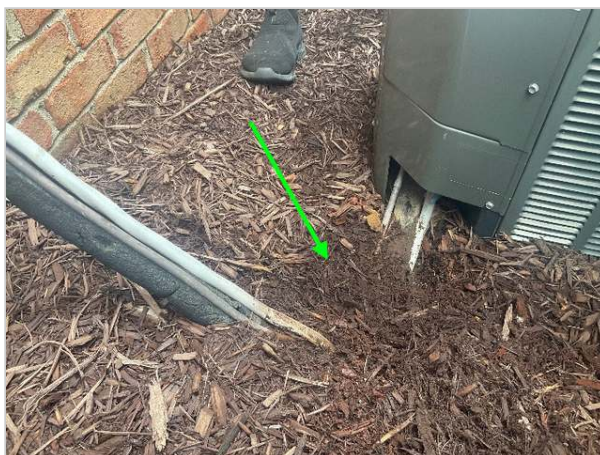
**NOTE: A/C LINE ELECTRIC SUPPLY:**

The electrical supply wiring serving the air conditioning condenser was observed buried below grade without an approved protective conduit. Exposed direct-burial cable or improperly protected wiring is susceptible to physical damage and may not meet current installation standards. Recommend evaluation and correction by a qualified electrical contractor to provide appropriate protection for the wiring.
