**244 E Jefferson St**

**RE: Pittsburgh, PA 15212**

**Inspection #: 527-062026-6907**

### *HOME INSPECTION REPORT*

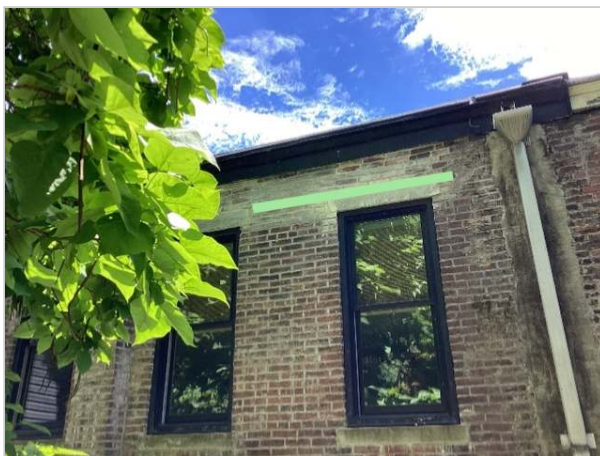
One or more of the steel lintels above the windows on the exterior of the home were noted as being repaired. Lintels support masonry materials above doors and windows. Keeping the lintels sealed and painted will prevent rusting and expansion. Expanded lintels can lead to cracks in the masonry on the exterior of the home.

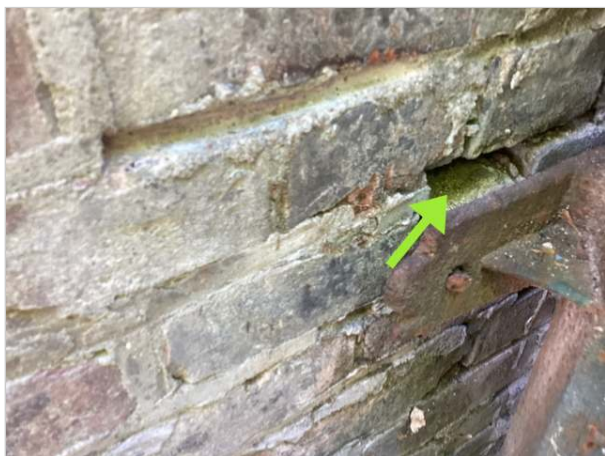
Rear

Missing mortar was noted on the brickwork on several areas of the home. There were no loose bricks noted. Small amounts of missing mortar are usually inconsequential. Extensive amounts of missing mortar can permit water intrusion. Consult with a qualified masonry contractor for repair estimates.

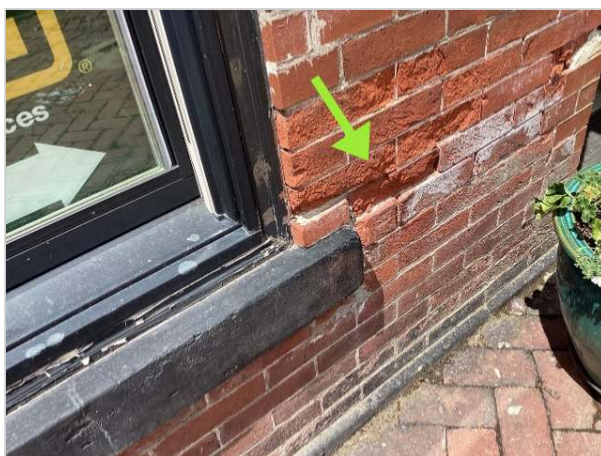
Some spalling was noted on the brick of the home. Spalling is usually caused by moisture accumulation behind the surface. In cold weather, the moisture freezes and pushes the face off. In some cases the condition can be controlled by sealing the face with an appropriate masonry sealer. Consult with a qualified masonry contractor for recommendations.

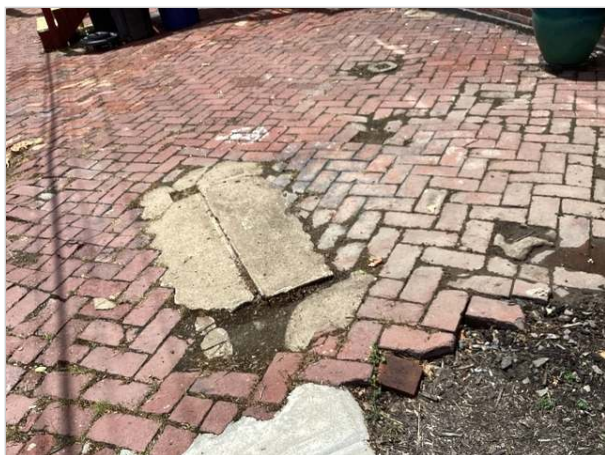
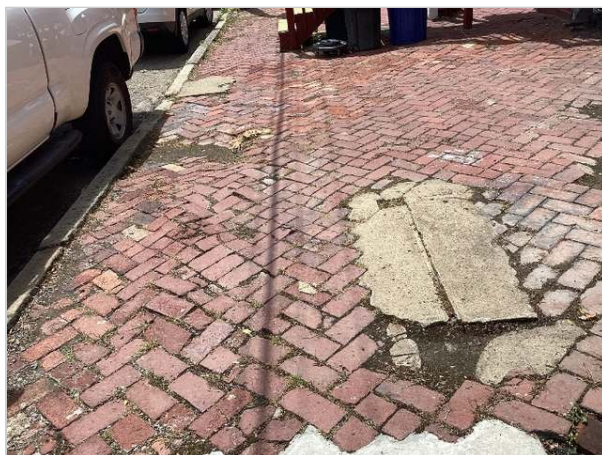
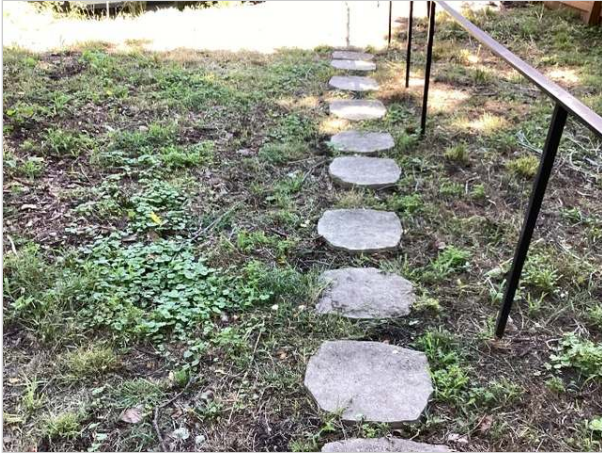
There were several trip hazards found on the walkways around the house. The hazards can be repaired using a suitable or similar surfacing material to "feather" the out-of-level condition to make a smooth transition.

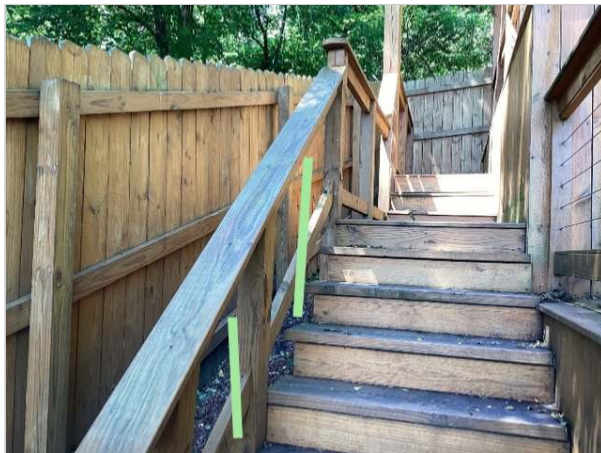
The balusters on the deck rail were installed horizontally rather than vertically. Generally accepted construction techniques provide for balusters to be installed vertically and spaced no greater than four inches apart. Larger baluster spacing can be a safety concern, and horizontally mounted balusters permit climbing. Local codes may require modification and / or installation of additional balusters. Consult with a general contractor for cost estimates for additional balusters.

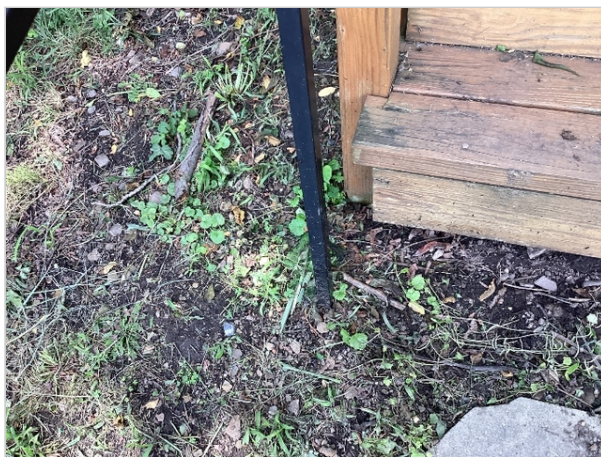
The *deck* support post(s) are making direct contact with the landscaping. Common practice is to mount support posts on concrete piers. The post is an important structural component and should be monitored for deterioration. A qualified contractor should be contacted for further evaluation and recommendations if desired.

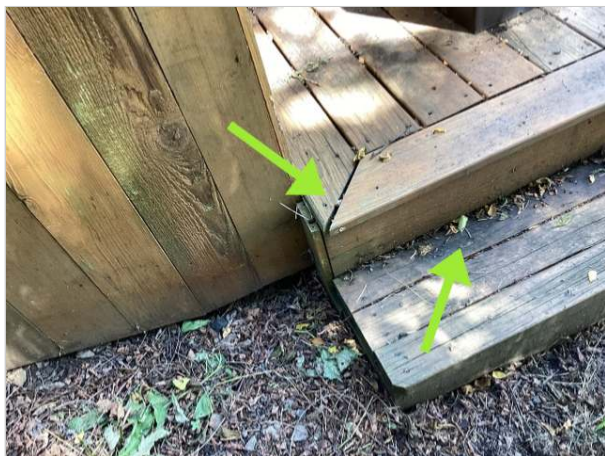
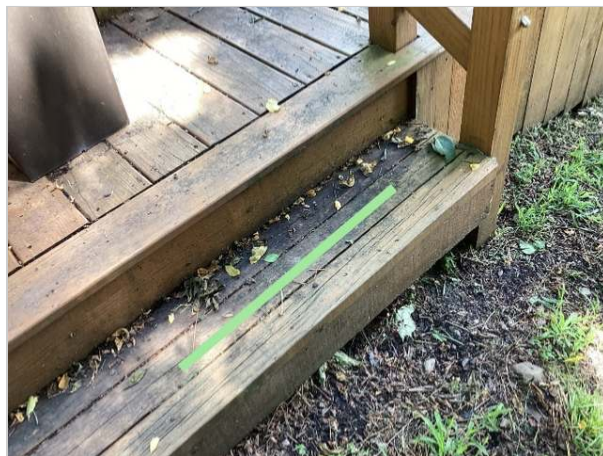
A few deck boards were deteriorated at the time of the inspection. Consult with a qualified contractor for replacement estimates.

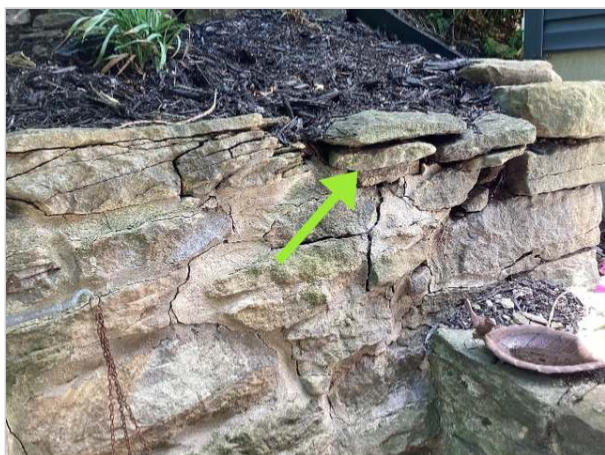
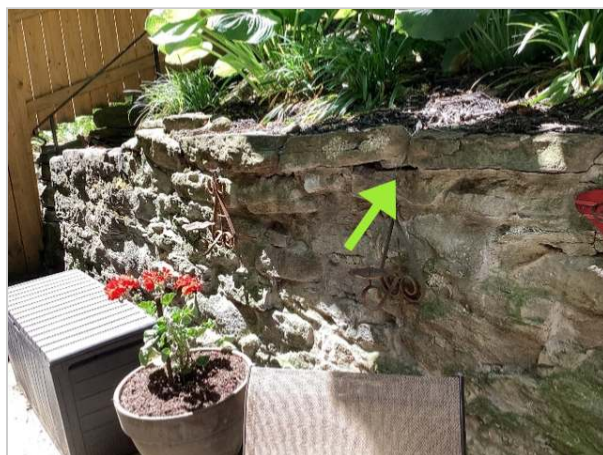
Missing mortar was noted on the rear retaining wall of the home. There were no loose bricks noted. Small amounts of missing mortar are usually inconsequential. Extensive amounts of missing mortar can permit water intrusion. Consult with a qualified masonry contractor for repair estimates.

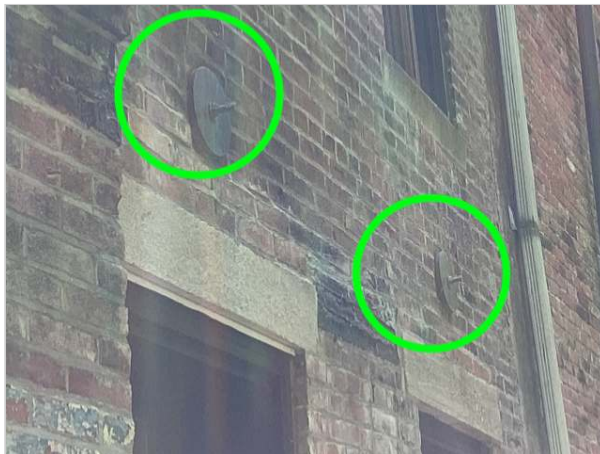
Repairs to the brick veneer have been made in the form of wall anchors. Any significant change in the characteristic of the cracks or repairs should be referred to the company that made the repairs.

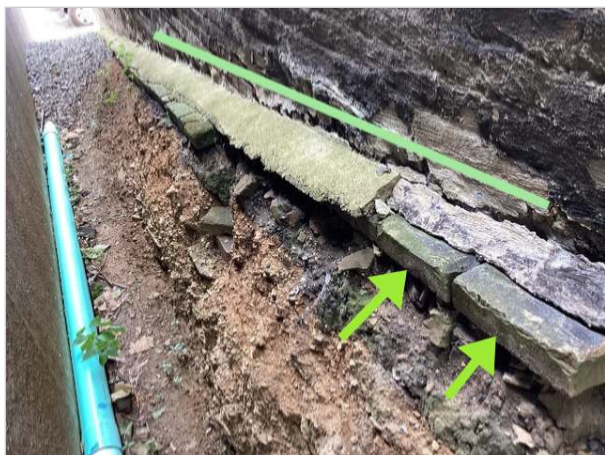
Right side exterior

Missing mortar was noted on the block on several areas of the home. There were also loose block noted. Small amounts of missing mortar are usually inconsequential. Extensive amounts of missing mortar can permit water intrusion. Consult with a qualified masonry contractor for repair estimates.

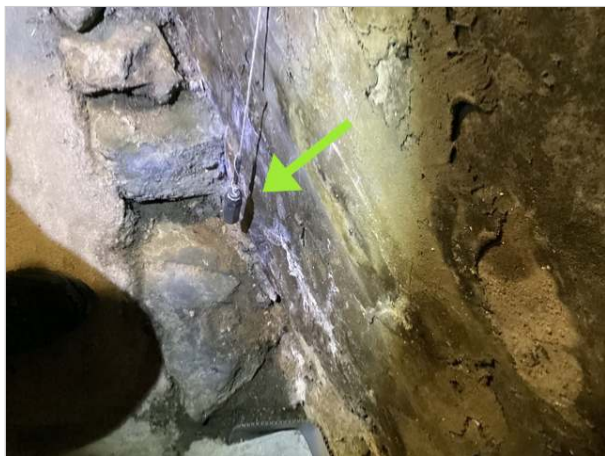
There was also an inward bulge observed on the right side foundation wall. The deflection on the wall was measured using a plumb line and found to be approximately 2-inches. The wall was considered stable at the time of the inspection. Consult with a company specializing in foundation repair for further evaluation and recommendations.. This condition is most often associated with soil and / or water pressures. The displacement occurs incrementally as the wall yields to horizontal earth pressure. Surface grading around the foundation is questionable. Proper grading should be maintained to prevent foundation damage and water penetration.

Approximately 2 inch offset

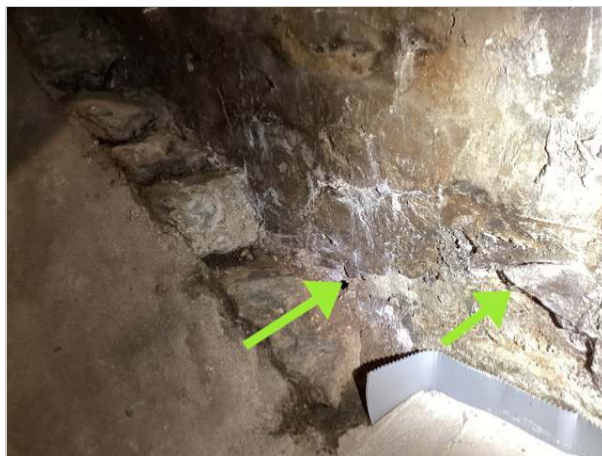
Open mortar and crack

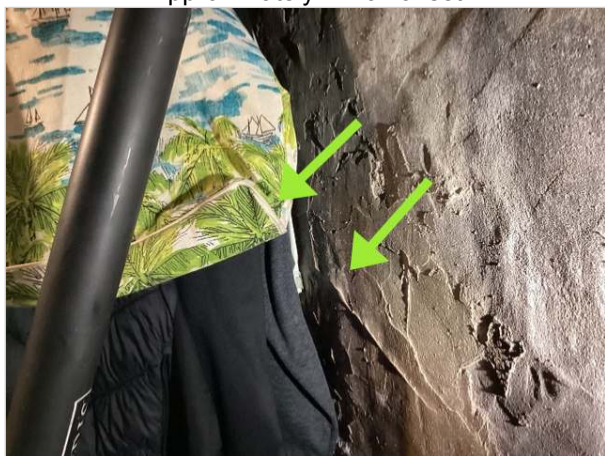
Bulged

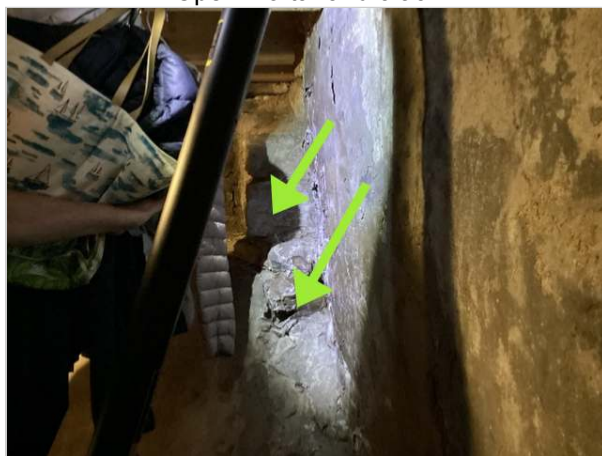
Evidence of deterioration

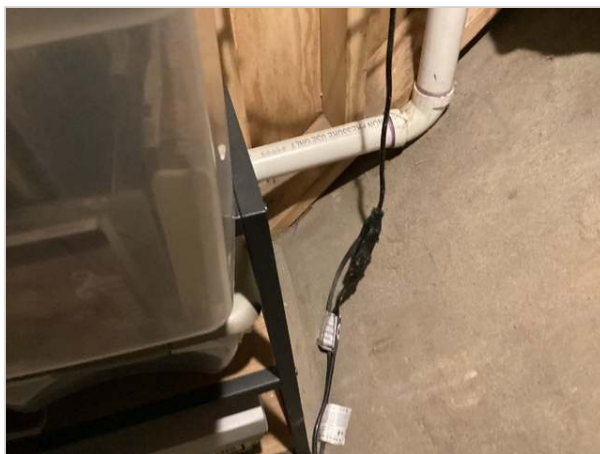
The sump pump is not properly wired. The pump should be connected to a permanently wired, grounded outlet that is located close to the sump. Consult with a qualified electrician for installation.

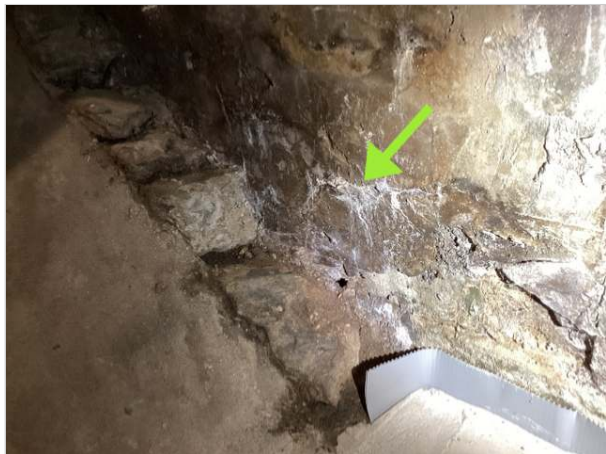
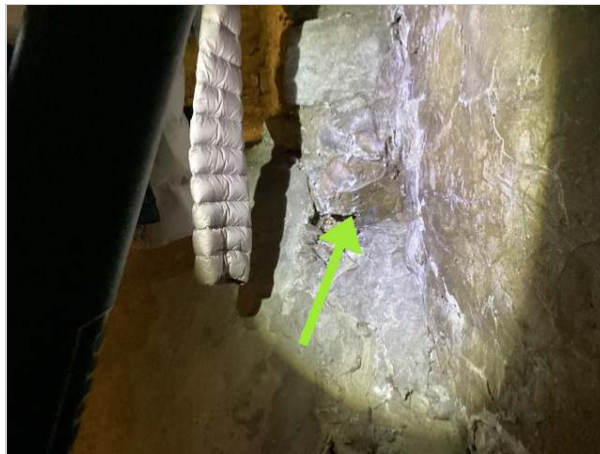
There were signs of moisture on the right crawl space wall. The area was dry at the time of the inspection. Excessive moisture buildup in the crawl space can lead to mold conditions. Dampness on crawl space walls is not always a sign of water intrusion. The dampness can be the result of warm humid air making contact with cool walls. In many cases the humid air condenses on the wall and forms a layer of moisture. It is important to assess whether moisture on the walls is the result of water intrusion or condensation. In this case, the efflorescence noted on the wall appears to be the result of moisture buildup on the exterior side of the foundation. The exterior grading in the affected area is questionable. Many water intrusion problems can be controlled by improving the drainage on the exterior of the home. It is important that all roof drainage and surface water is directed away from the foundation. Any concern about this condition should be referred to a qualified contractor for evaluation and recommendations.

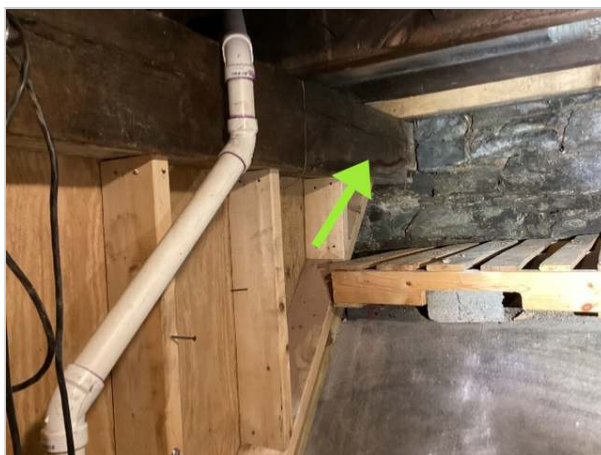
The floor joists and sub floor are water marked in multiple areas of the basement floor structure. The area was dry at the time of the inspection. The wood on the affected area was not rotted. Repairs to the affected area does not appear to be necessary.No immediate action is required.

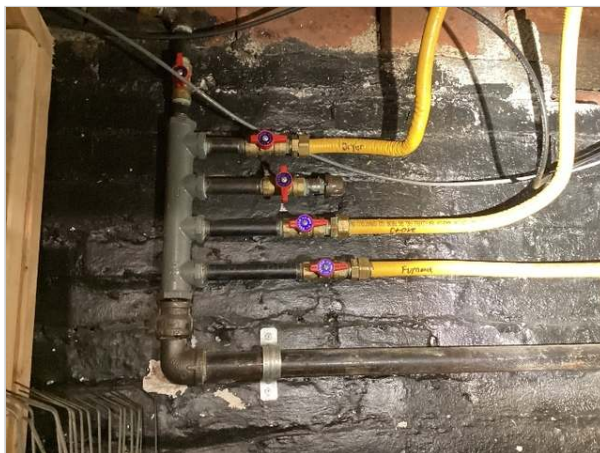
There was no apparent bonding on the interior gas line at the time of the inspection. Direct bonding is required for all yellow corrugated stainless steel gas-piping systems. More information is available at [www.csstsafety.com](http://www.csstsafety.com). Consult with a qualified electrician to ensure that the gas lines are appropriately bonded.

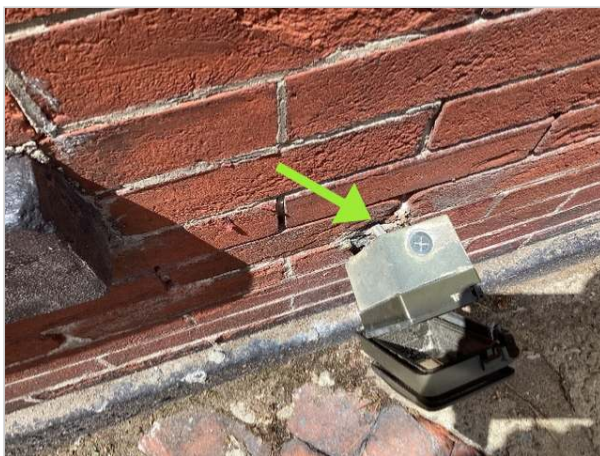
A loose outlet was noted in the exterior. This could be a shock hazard due to exposed electrical contacts. The affected outlet(s) should be secured by a qualified contractor.

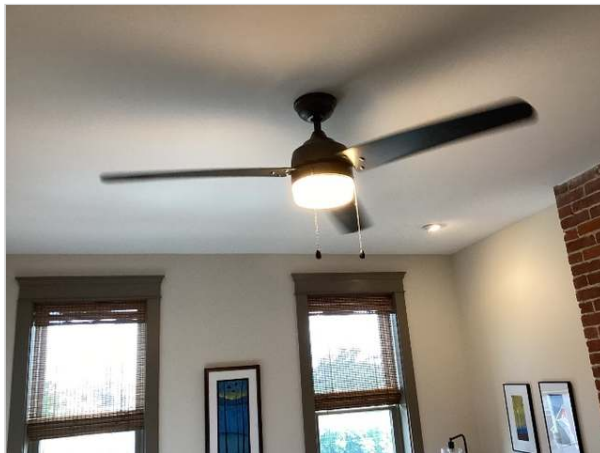
The paddle fan in the living room appears to be out of balance because it is loose in the ceiling box. The fan wobbles when turning. The fan could be improperly installed or the mounting screws are loose. Consult with a qualified contractor for evaluation and repair.

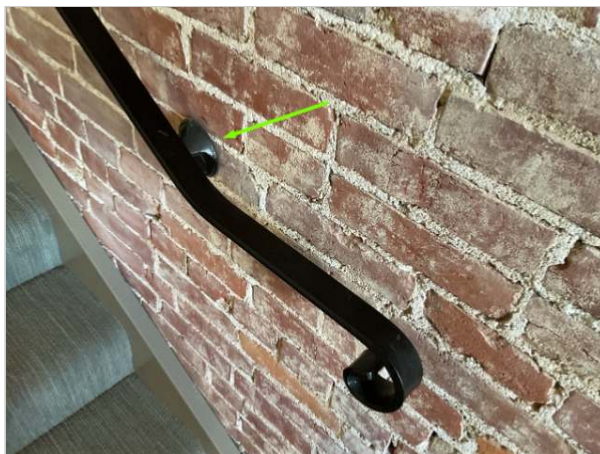
The handrail on the stairs leading to the second floor is loose or otherwise insecure. The handrail should be properly secured for safety.

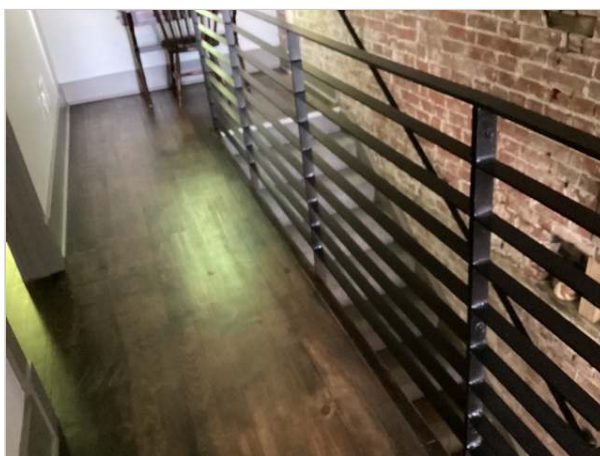
The balusters on the second floor handrail are installed horizontally. Generally accepted construction techniques provide for balusters to be installed vertically and spaced no greater than four inches apart. Larger baluster spacing can also be a safety concern. Local codes may require the installation of additional balusters. Consult with a general contractor for cost estimates for additional balusters.

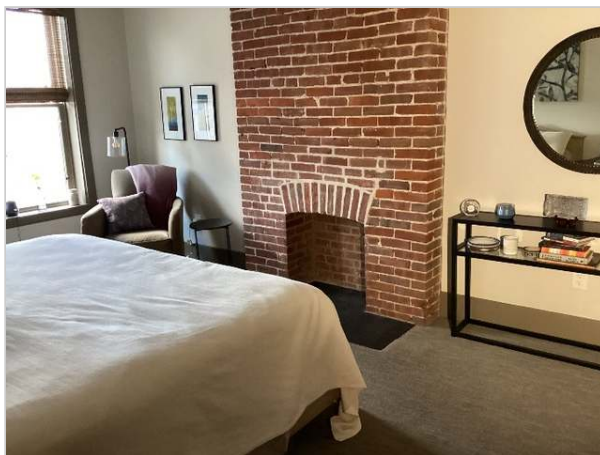
A decorative fireplace was located in the master bedroom. The unit is not suitable for burning. No attempt should be made to burn any type of fuel in the unit. Consult with a qualified, reputable chimney and fireplace service for additional advice.

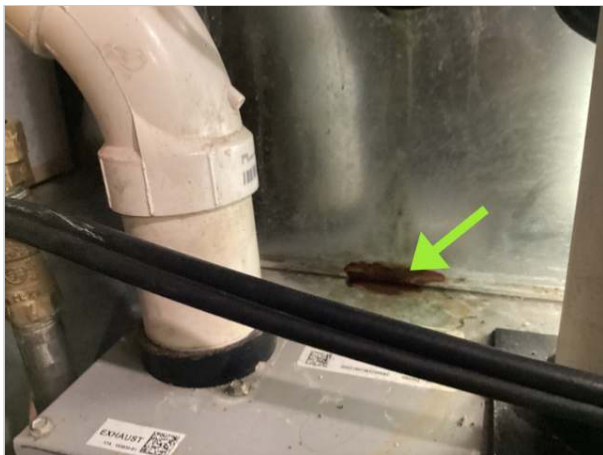
A condensate leak was noted on the furnace exhaust line. Repairs should be made by a qualified contractor.

Water

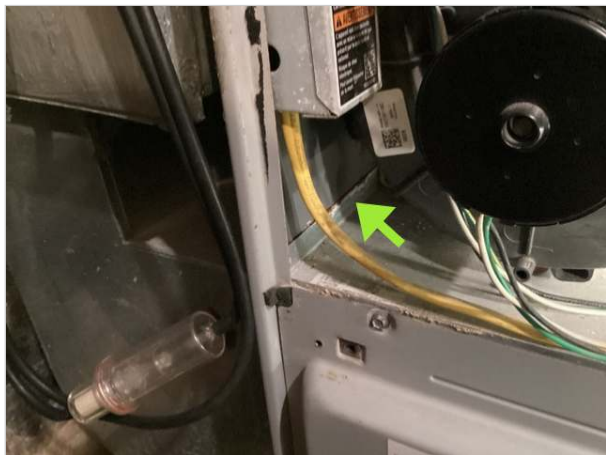
Evidence of water was noted inside the furnace compartment. The condition is most likely caused by a condensate leak in the furnace and/or air conditioning condensate drain lines. The water can also be caused by a leaking humidifier if one is installed. Water inside the furnace compartment can damage the furnace cabinet or other operational components and should be repaired. The furnace compartment was dry at the time of the inspection. Consult with a qualified heating contractor to determine the source of the water and correct the issue. Please also note that due to the seasonal use of heating and air conditioning systems, wet and dry conditions can change based on whether the inspection is performed during the heating or cooling season. The observation at the time of the inspection can be limited to seasonal conditions.

Rust

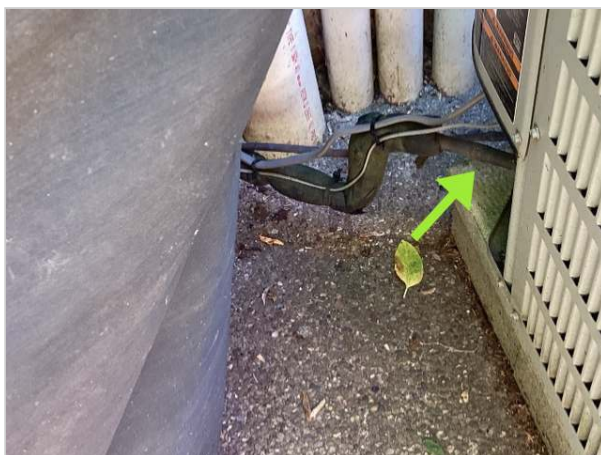
The insulation on the exterior air conditioning line set is damaged. This could affect the efficiency of the system and should be replaced.
