**1012 Biltmore Ave**

**RE: Pittsburgh, PA 15216**

**Inspection #: 527-042026-6791**

### HOME INSPECTION REPORT

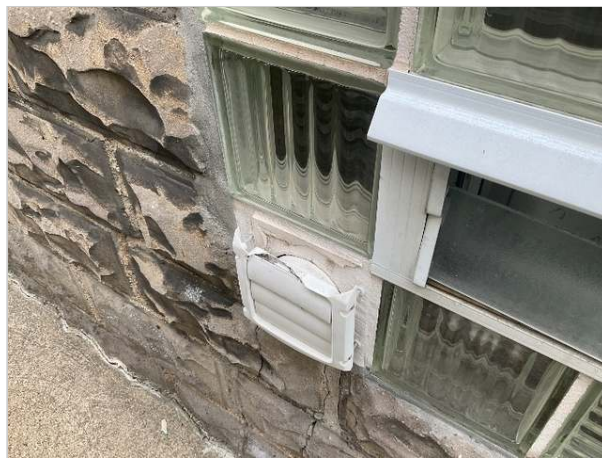
### *NOTE: MISSING VENT COVER:*

The dryer vent cover on the right side of the home is damaged. Repairs should be made by a qualified contractor to help prevent water and pest intrusion.

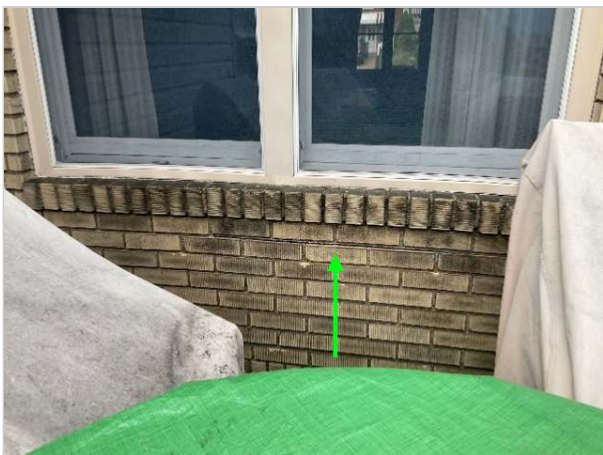
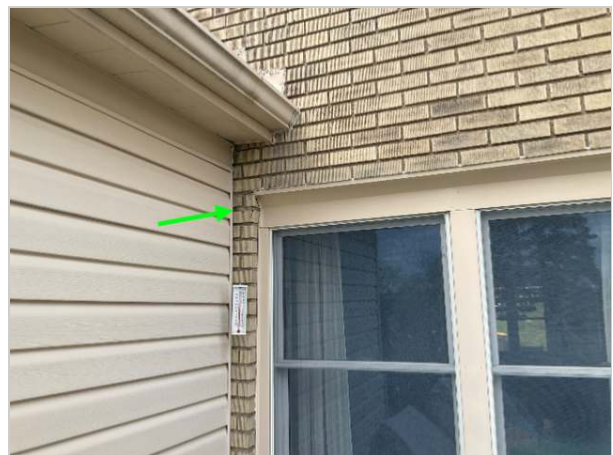
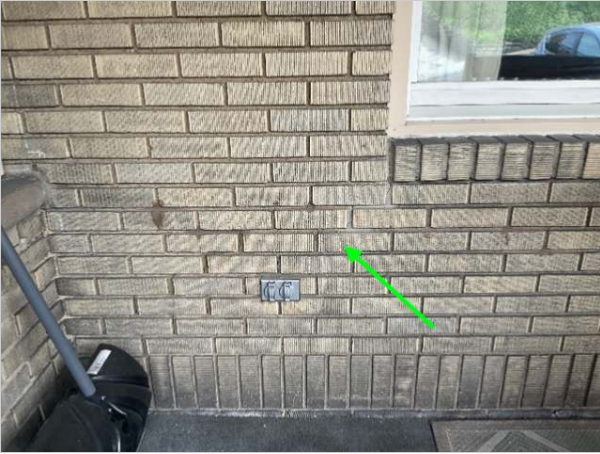
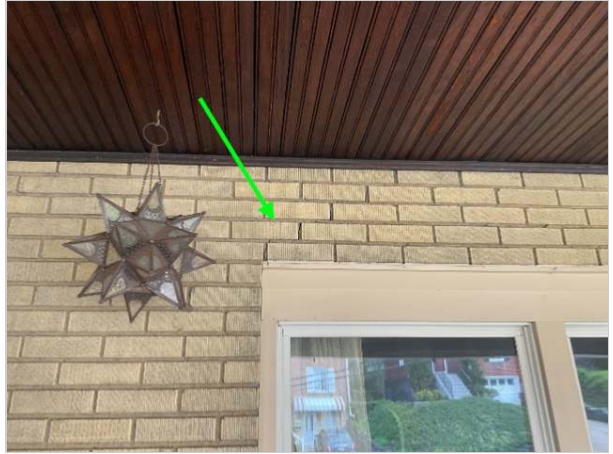
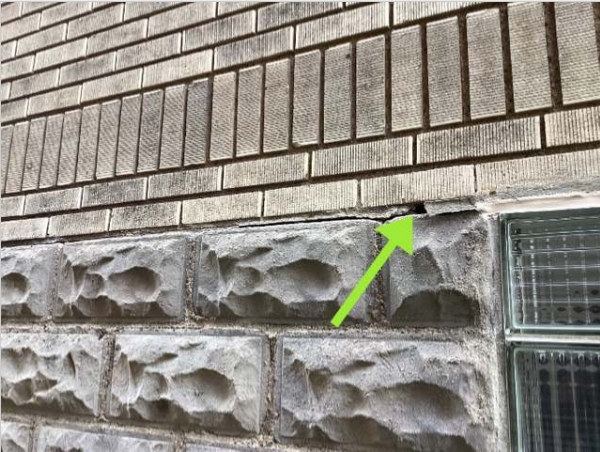
### *NOTE: MASONRY/MORTAR CRACKS:*

One or more cracks were noted on the brick veneer of the home. The cracks were located on the back and left side. The cracks appear to have been caused by expansion and contraction, are common and do not usually have any structural significance. No structural concern on the brickwork was noted at the time of the inspection. All cracks should be monitored for significant changes in characteristics. Corrective action is required. Consult with a qualified masonry contractor for repair estimates.

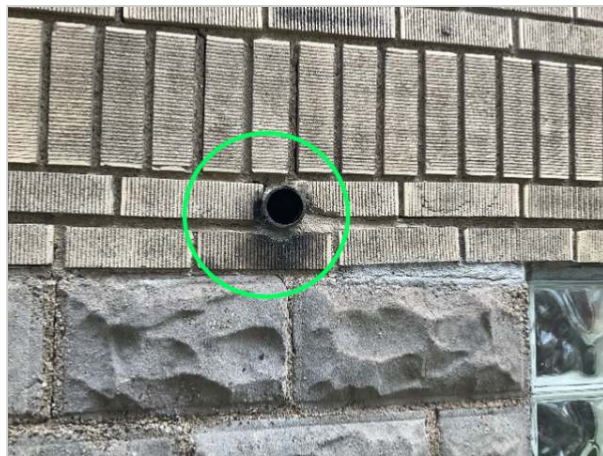
**MAINTENANCE NOTE: EXTERIOR SEALANT:**

The exterior sealant around an opening is cracked or missing on the left side of the home. The sealant should be replaced to ensure the exterior of the home remains weather and water tight.

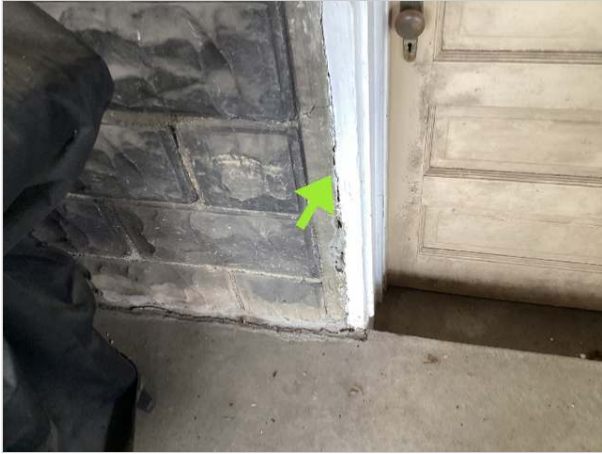
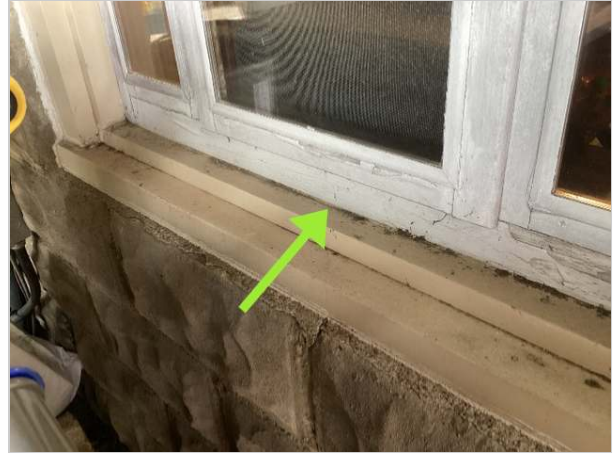
**MAINTENANCE NOTE: EXTERIOR SEALANT:**

The exterior caulking around the windows and doors is cracked or missing on all sides of the home. The caulking should be replaced to ensure the exterior of the home remains weather and water tight.

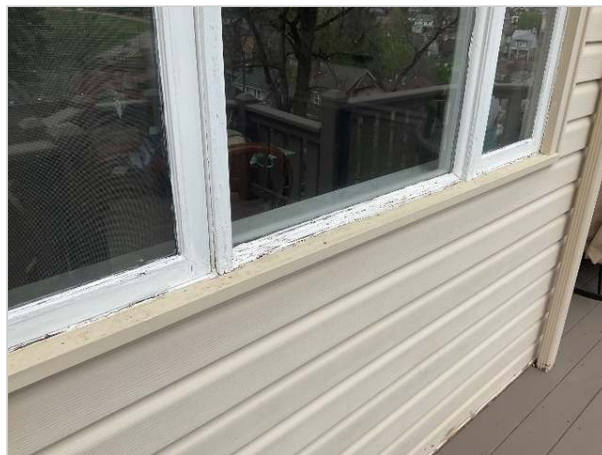
**MAINTENANCE NOTE: PEELING PAINT:**

Peeling paint was noted on the wood windows. In order to preserve the life of the exterior surfaces and materials, all areas should be scraped and painted.

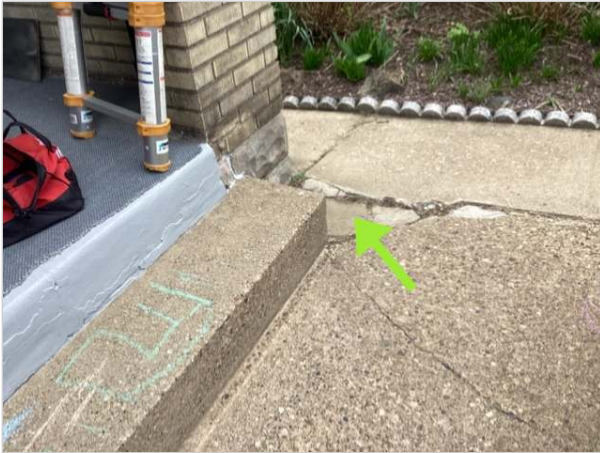
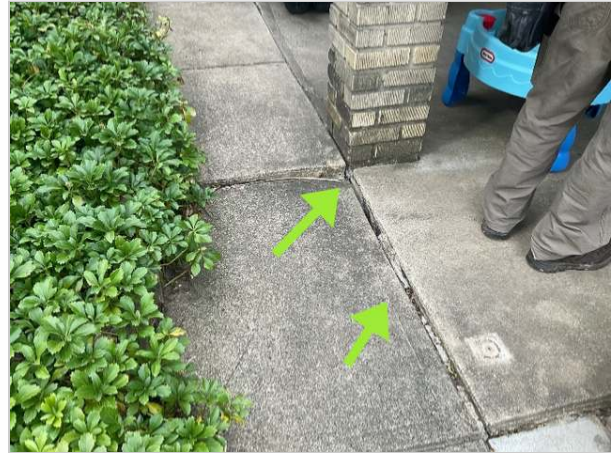
Front

Settlement was noted on the front and rear walkway slab. The settlement does not appear to be active. Settlement of concrete slabs is common and is usually not a problem. If the settlement causes the concrete slab to pitch toward the foundation of the home, it is possible that water will drain into the basement. In this case the slab was pitched toward

the foundation. It is not possible for us to positively determine if active settlement is occurring during a home inspection. The area should be monitored for evidence of new or continued settlement. Consult with a qualified contractor for further evaluation if required.

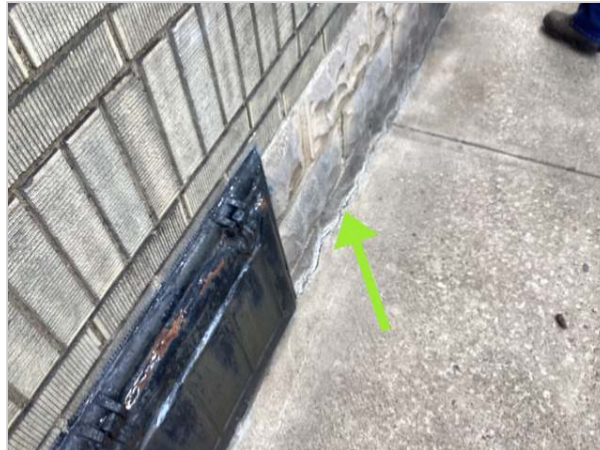
**MAINTENANCE NOTE: EXTERIOR SEALANT:**

The exterior sealant around the foundation is cracked or missing on the right side of the home. The caulking should be replaced to ensure the exterior of the home remains weather and water tight.

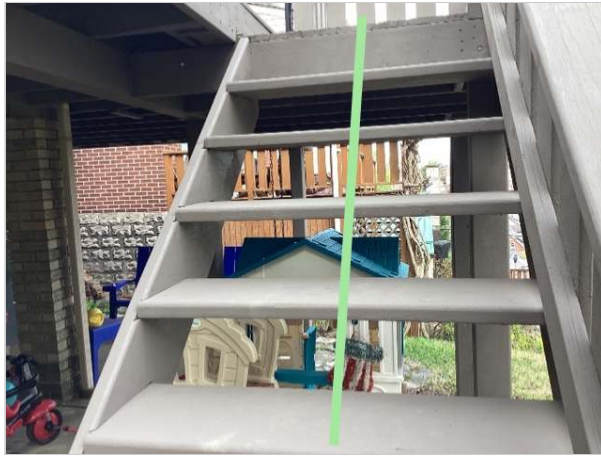
The risers or backs of the deck stairs are open. This could be a fall hazard for small children. Consult with a qualified contractor for evaluation and recommendations.

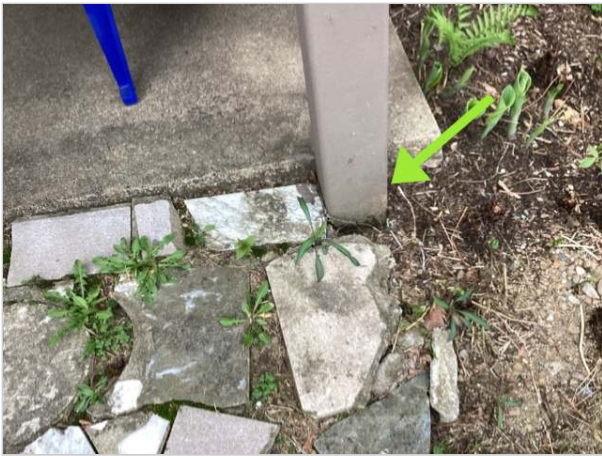
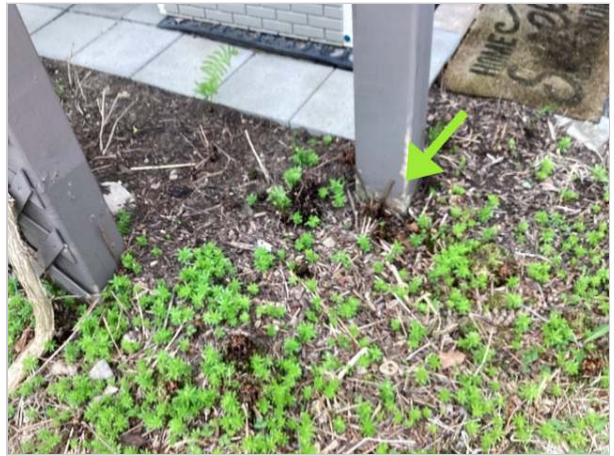
**NOTE: DECK SUPPORT POST:**

The deck support post(s) are making direct contact with the landscaping. Common practice is to mount support posts on concrete piers. The post is an important structural component and should be monitored for deterioration. A qualified contractor should be contacted for further evaluation and recommendations if desired.

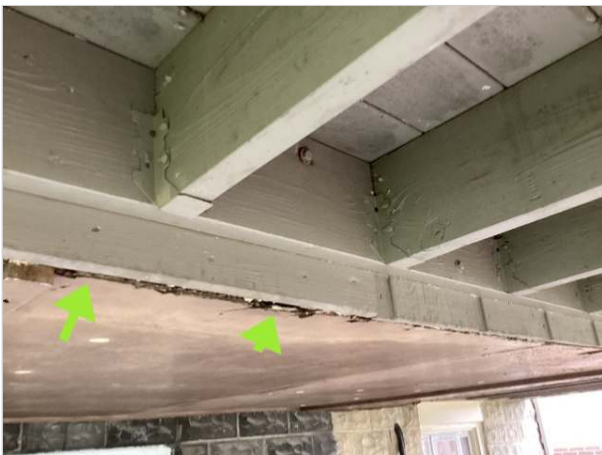
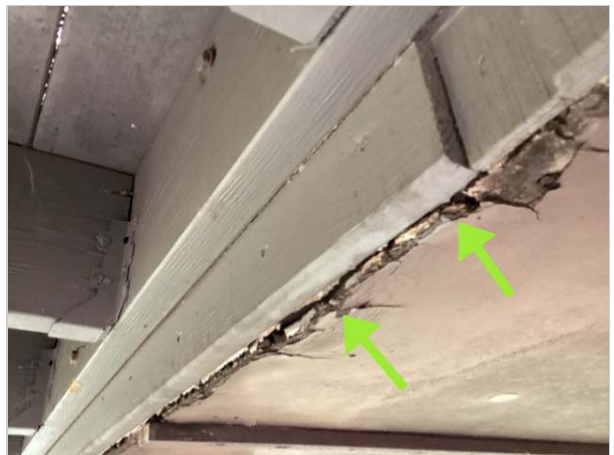
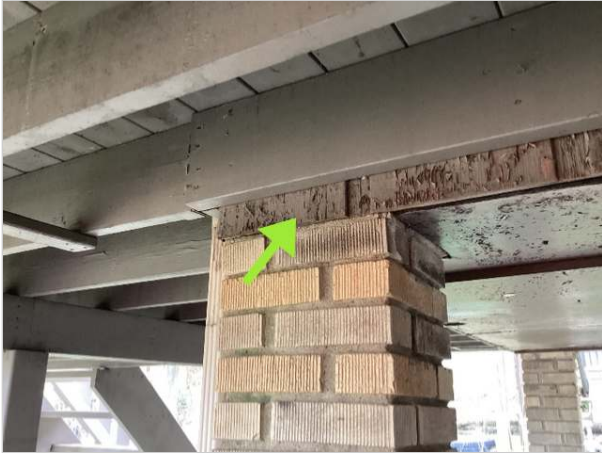
**NOTE: EXTERIOR WOOD ROT:**

Rotted wood was noted on the back porch. The areas should be repaired and sealed by a qualified contractor.

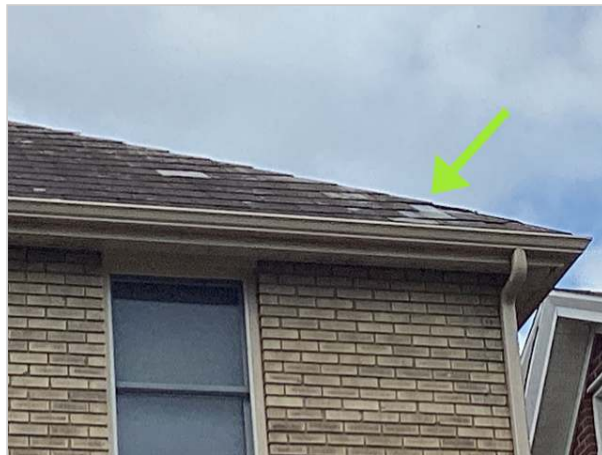
### *NOTE: ROOF REPAIR:*

An adequate roof repair was noted on the back. The repair appeared to be made correctly. There was no evidence of an active roof leak noted at the time of inspection. it is recommended that a qualified roofing contractor be consulted for further evaluation and recommendations.

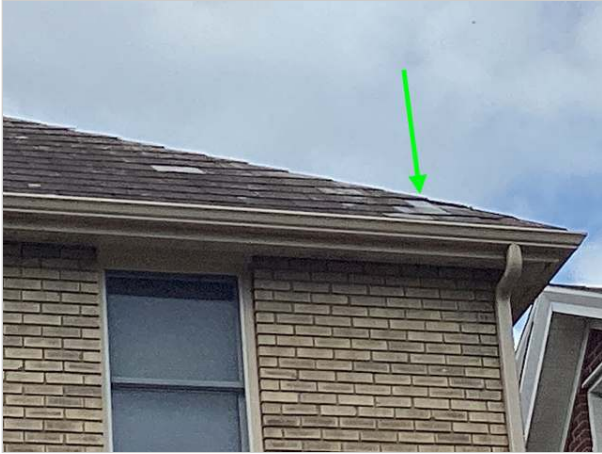
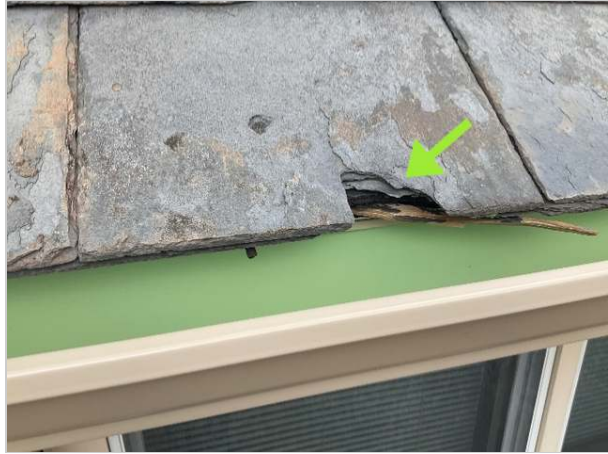
### *NOTE: MISSING SLATE:*

There were missing and damaged slate noted on the front and back of the roof. Consult with a qualified slate roofer for evaluation and repair.

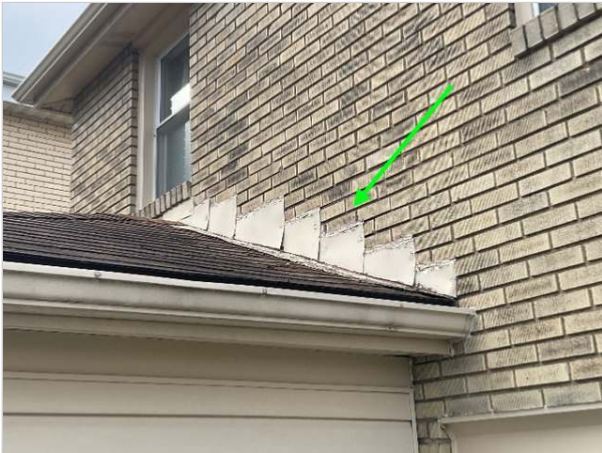
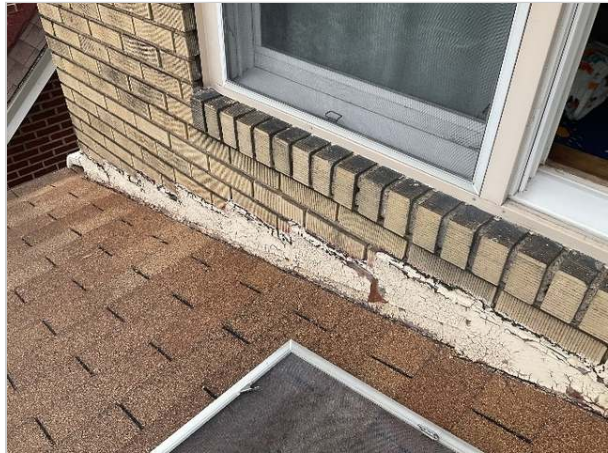
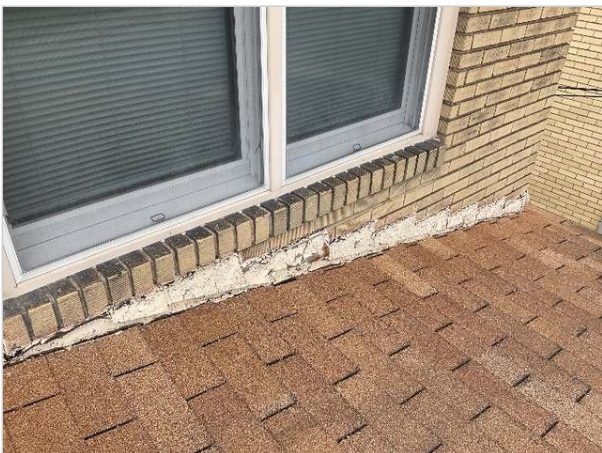
**NOTE: FLASHING SEALANT:**

The flashing sealant on the front and rear roof is deteriorated. Loose flashing was noted. This is not necessarily the source of a leak. Evidence of any leak may be isolated to periods of heavy or extended rain. Consult with a qualified roofer for evaluation and repair as required.

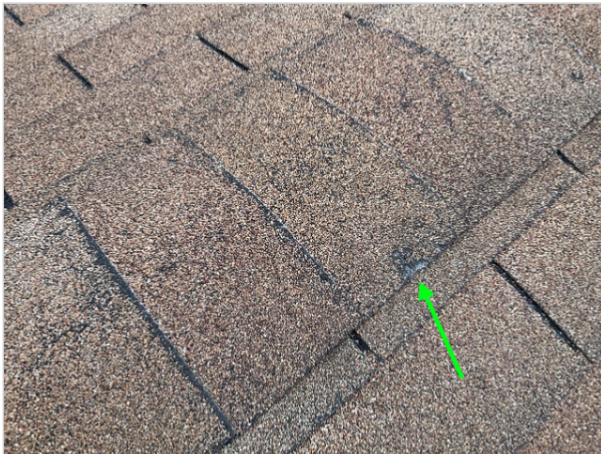
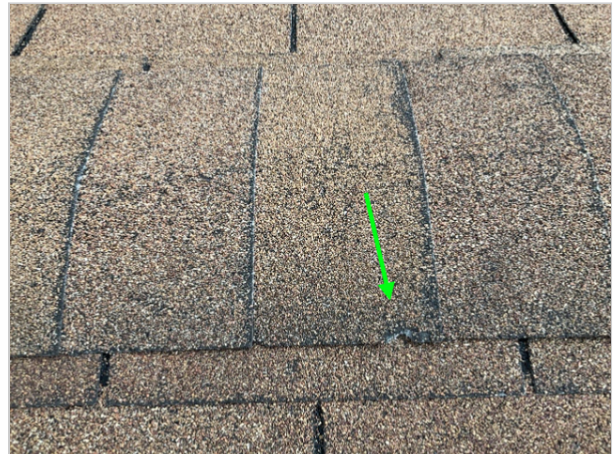
**NOTE: ROOF SHINGLES:**

Three shingles were damaged on the front of the roof at the time of the inspection. While this condition is not necessarily an indication of a leak, repairs should be made. Consult with a qualified roofer for repair.

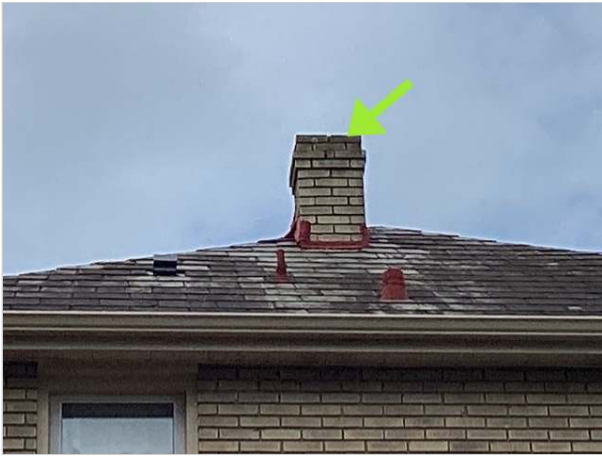
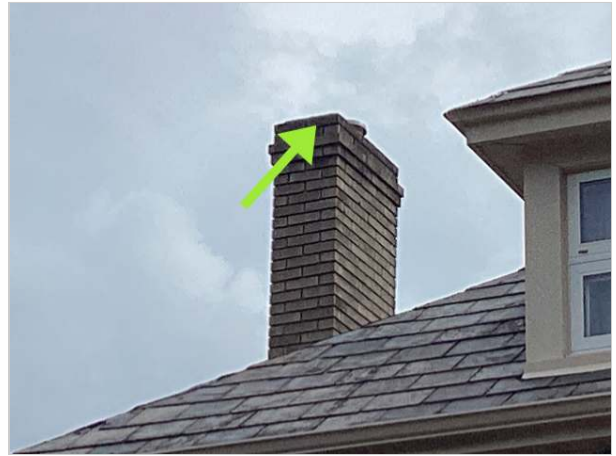
There were cracks on the top cap(s) of the chimney and repairs should be made to prevent further deterioration. Consult with a qualified masonry contractor for repair.

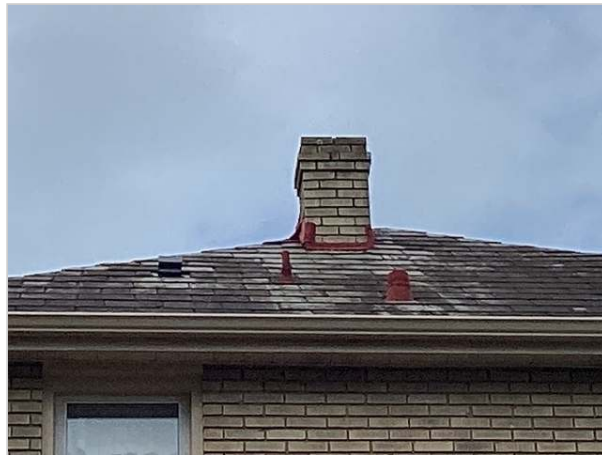
**NOTE: RAIN HAT:**

The rain hat on top of the chimney is missing. Repairs should be made by a qualified roofer.

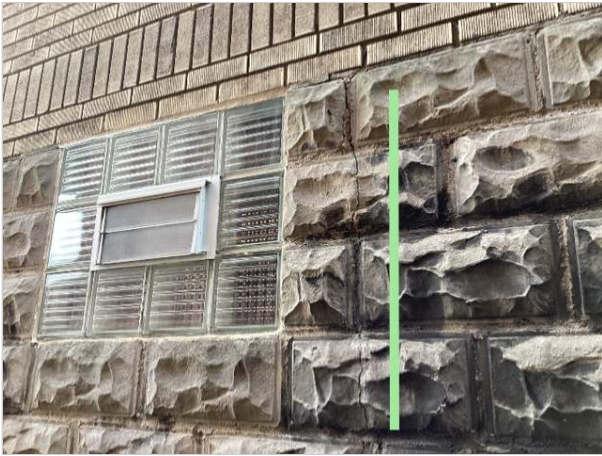
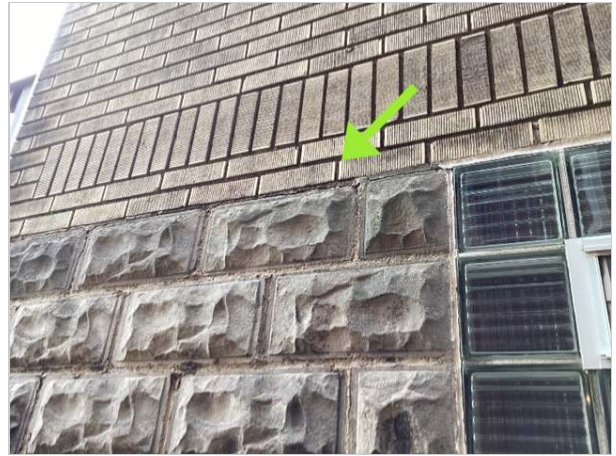
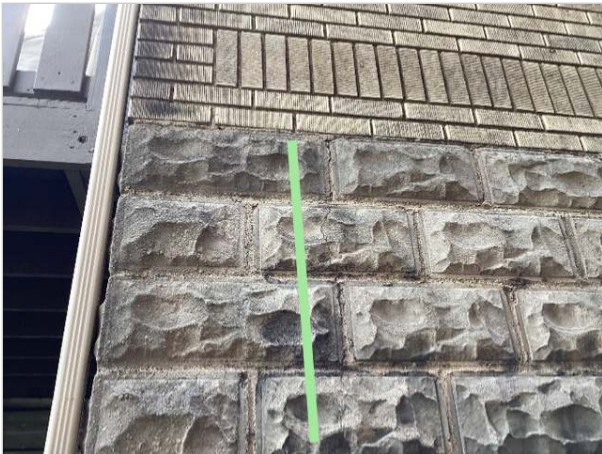
**NOTE: FOUNDATION CRACKS:**

One or more cracks were noted on the foundation walls. The cracks were located on the left rear. The cracks appear to have been caused by settlement. There was no evidence of active movement at the time of the inspection. Corrective action did not appear to be necessary. All cracks should be monitored for significant changes in characteristic. Consult with a contractor if the cracks change significantly or you desire another opinion on this condition.

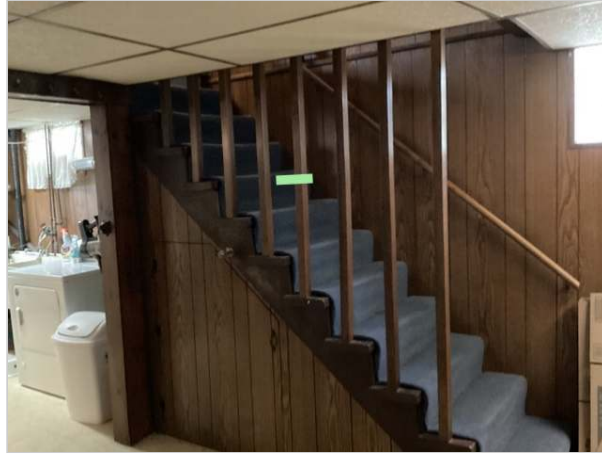
The balusters on the basement rail were installed horizontally rather than vertically and spaced greater than four inches apart. Generally accepted construction techniques provide for balusters to be installed vertically and spaced no greater than four inches apart. Larger baluster spacing can be a safety concern, and horizontally mounted balusters permit climbing. Local codes may require modification and / or installation of additional balusters. Consult with a general contractor for cost estimates for additional balusters.

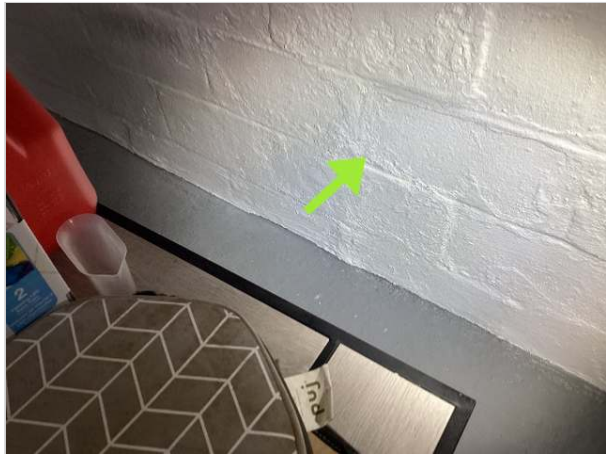
Under front porch

*NOTE: BASEMENT MOISTURE EVIDENCE:*

There were signs of moisture on the front basement wall. The area was dry at the time of the inspection. Dampness on basement walls is not always a sign of water intrusion. The dampness can be the result of warm humid air making contact with cool walls. In many cases the humid air condenses on the wall and forms a layer of moisture. It is important to assess whether moisture on the basement walls is the result of water intrusion or condensation. In this case, the efflorescence noted on the wall appears to be the result of moisture buildup on the exterior side of the foundation. The exterior grading in the affected area is questionable. Many water intrusion problems can be controlled by improving the drainage on the exterior of the home. It is important that all roof drainage and surface water is directed away from the foundation. Any concern about this condition should be referred to a qualified contractor for evaluation and recommendations.

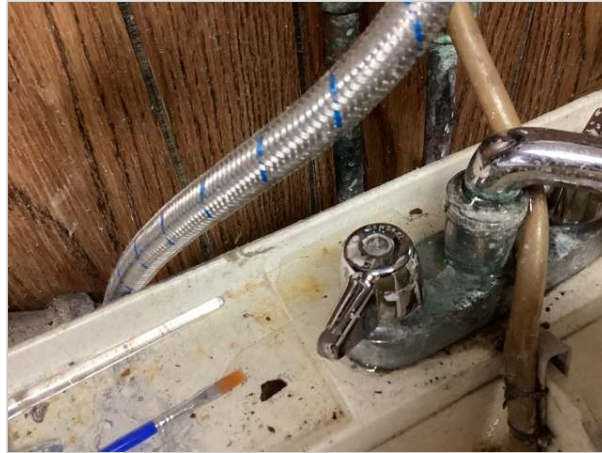
- Basement faucet leaks at the base of the spigot.
- Second floor full bath tub drains slow.

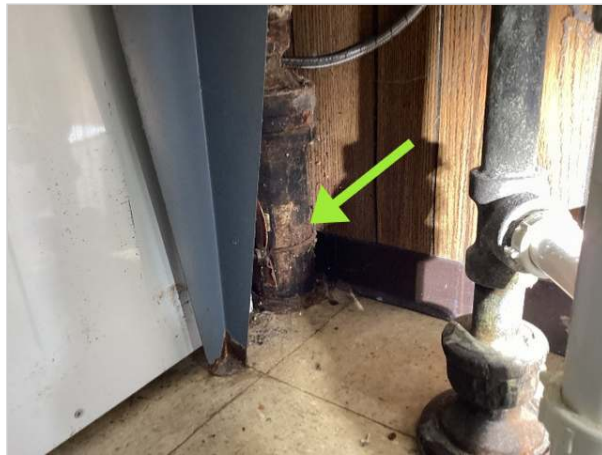
Rust

**NOTE: DRAIN STACK:**

The drain stack near the right basement wall was rusted at the time of the inspection. Consult with a qualified plumber for repair.

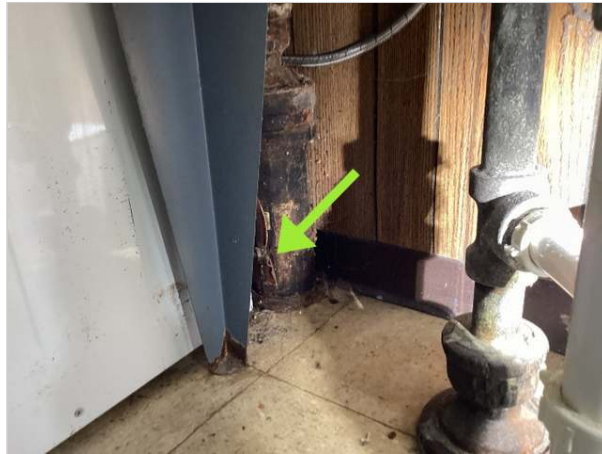
Repair

**NOTE: PIPE REPAIR:**

The drain stack drain line has been repaired with Clamp and gasket. The drain was not leaking at the time of the inspection. This type of amateur repair is generally temporary and should be repaired by a qualified plumber.

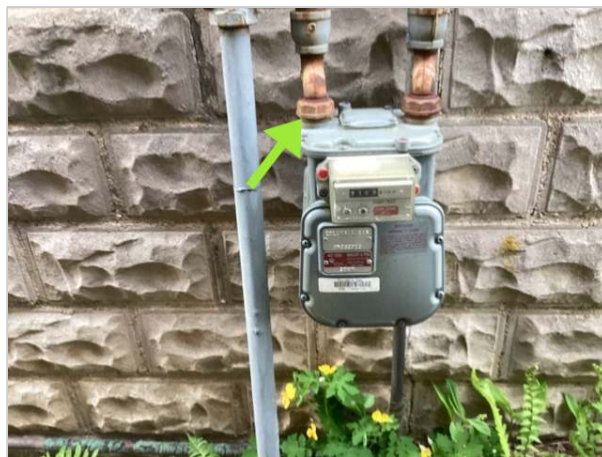
The exterior gas supply lines were *rusted*. *No leaks were found*. We recommend the gas supplier be contacted to inspect further.

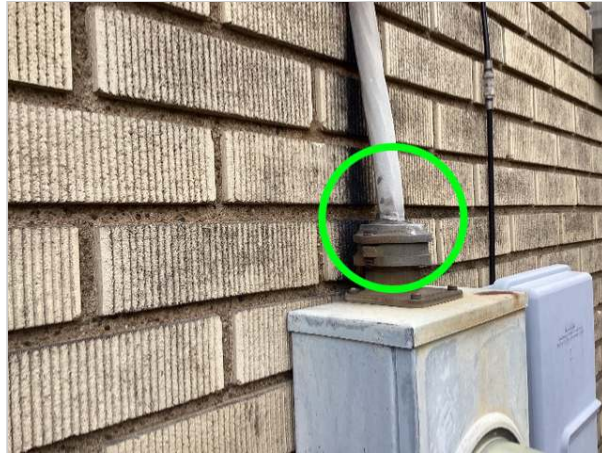
The sealant at the top of the electric meter box is missing. The sealant should be replaced to ensure that water does not enter the electric service panel.

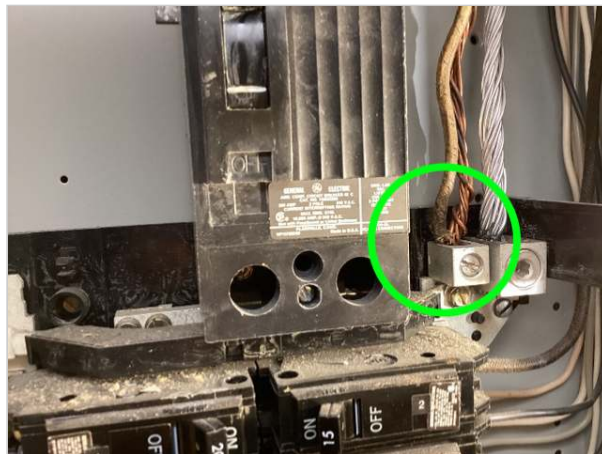
### *NOTE: DOUBLE LUGGED NEUTRAL WIRE:*

One or more neutral wires were double lugged to the neutral bus bar. The screws that secure neutral wires to the bus bar are designed to secure one wire per screw. Double lugging can compromise the electrical connection and lead to overheating. Consult with a qualified electrician for evaluation and repair.

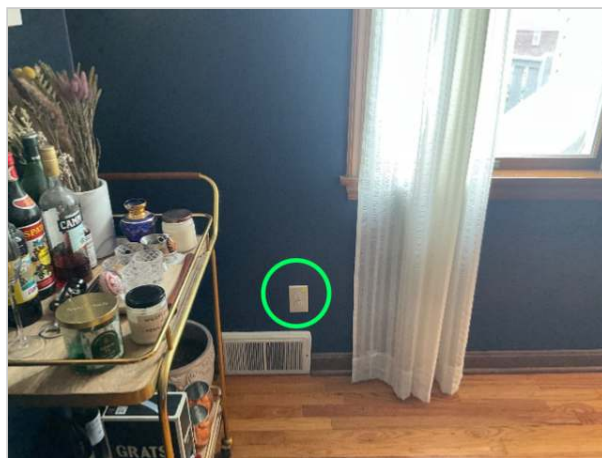
**NOTE: HOT NEUTRAL REVERSE:**

There were one or more receptacles in the home where the presence of hot and neutral wires were reversed. This is a safety concern and should be repaired by a licensed electrician. The outlets that tested with this condition were marked with a "YELLOW" dot for easy identification. The affected outlets were located in the dining room. Please note that we only test outlets that are visible and readily accessible at the time of the inspection.

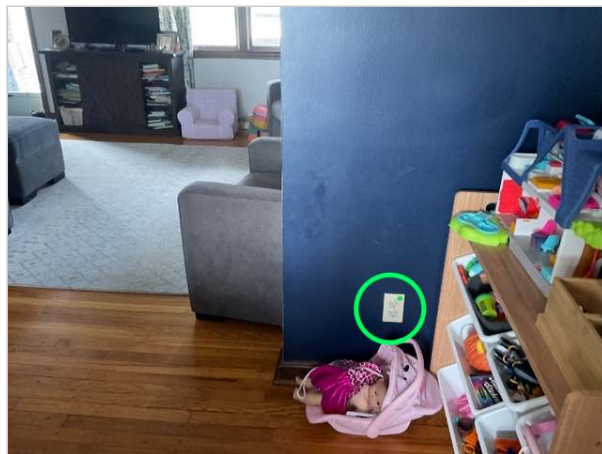
**NOTE: THREE PRONG OUTLET WITH OPEN GROUND:**

One or more three prong type outlets in the home tested as having an open ground. This means that the third prong, also known as the ground prong is not doing its job. This is usually caused by a missing ground connection at an electrical device in the circuit. This condition is usually easily correctable by an electrician. Open grounds in wet locations is considered a safety issue and should be corrected. The outlets that tested with this condition were marked with a "GREEN" dot for easy identification. The affected outlets were located in the dining room. Please note that we only test outlets that are visible and readily accessible at the time of the inspection.

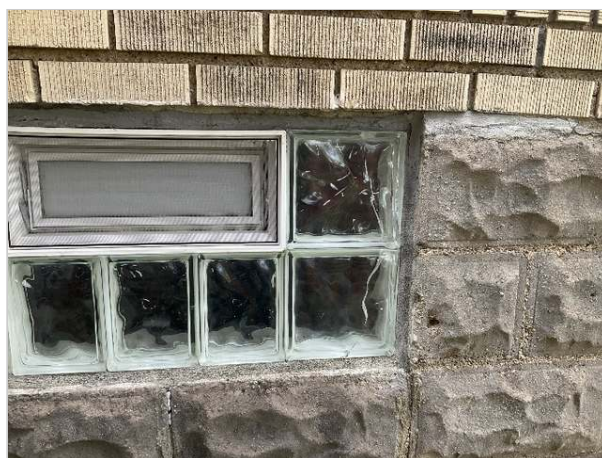
### ***SAFETY NOTE: CRACKED OR BROKEN GLASS:***

Cracked glass was noted on the basement window (s). For safety and security all cracked and broken glass should be replaced.

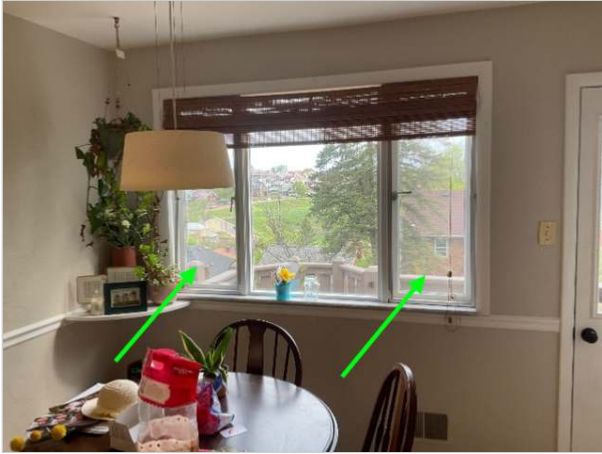
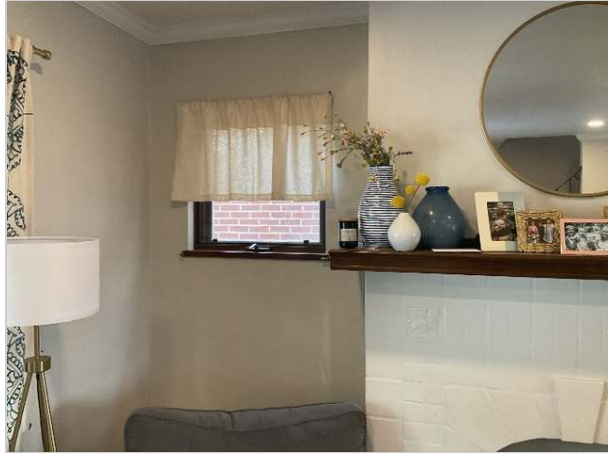
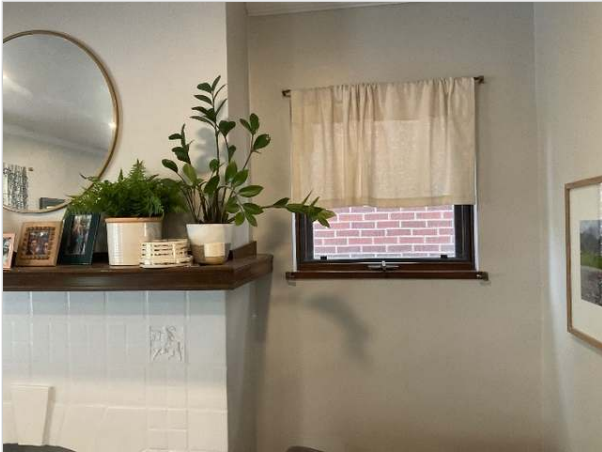
### ***NOTE: WINDOWS WON'T OPEN:***

One or more windows could not be opened using reasonable force at the time of the inspection. The window (s) were located in the first level. This condition could be caused by paint, obstructions or lack of use. Repairs or adjustments may be required. For safety reasons, it is important that at least one window opens in each room of the home.

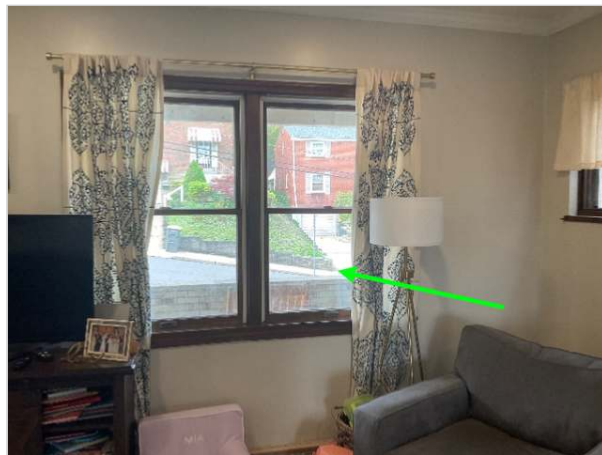
**SAFETY NOTE: WINDOW BALANCERS:**

One or more of the windows would not stay in its placed position without support. This condition is usually caused by a defective balancer mechanism. Window balancers can be a rope and weight inside the window frame of older windows, or a combination of springs and ropes in newer windows. The window (s) were located in the living room. A defective balancer can be considered a safety issue if the sash falls rapidly. Repair or replacement of the balancer system may be required in order for the windows to stay in place without additional support.

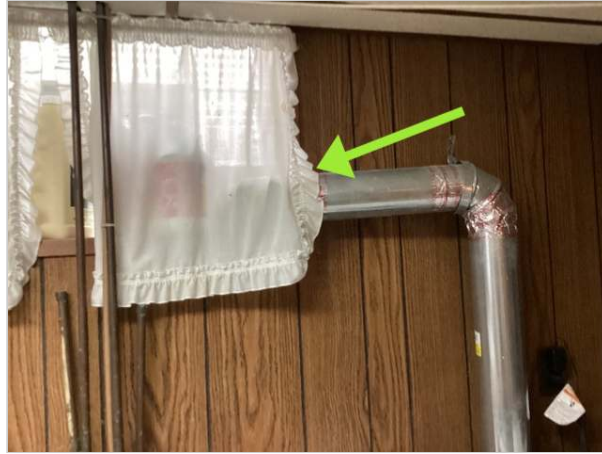
The vent pipe should rise from the dryer to its exhaust point. The flue pipe should be modified to rise toward the exhaust point to ensure proper exhaust of the gases. Consult with a qualified plumber for additional information and repair estimates.

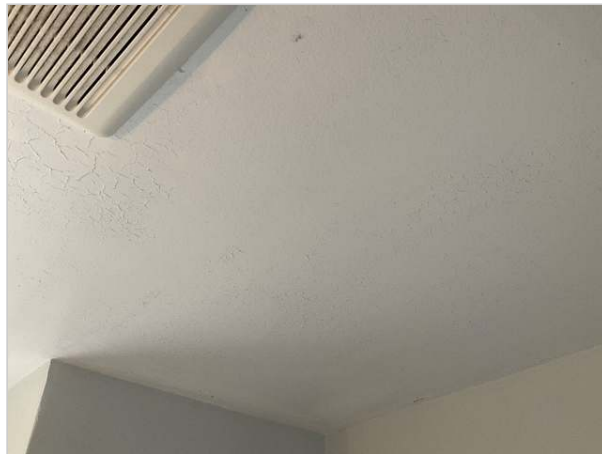
### *NOTE: CRACKED / BUBBLING PAINT:*

Cracked or bubbling paint was noted on the ceiling in the bathroom. This condition appeared to be caused by condensation. There was no evidence of an active leak at the time of the inspection. Any damaged areas should be scraped, repaired, leveled and primed prior to applying a finish coat of paint.

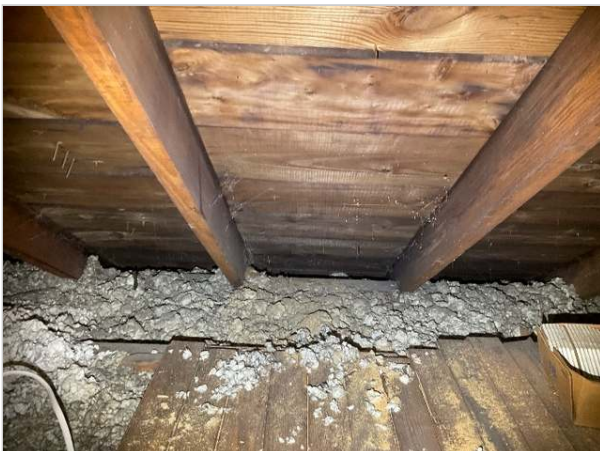
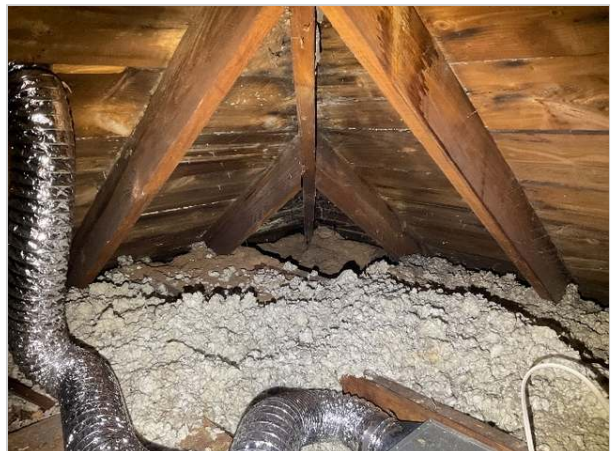
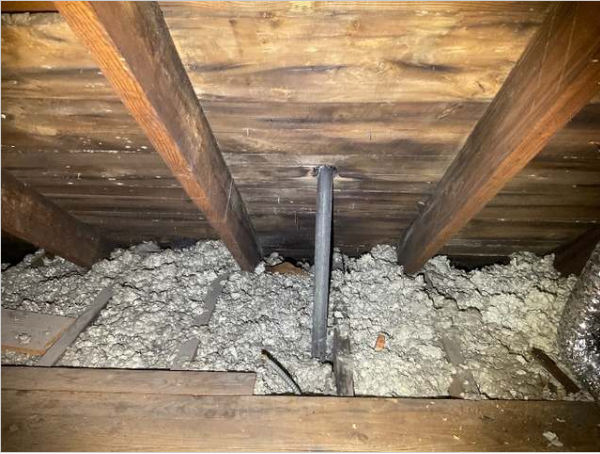
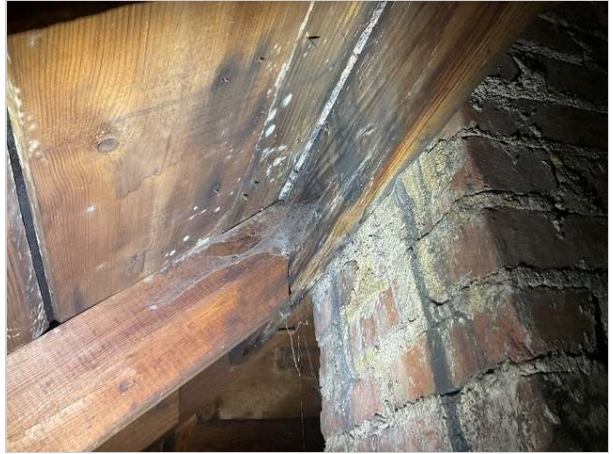
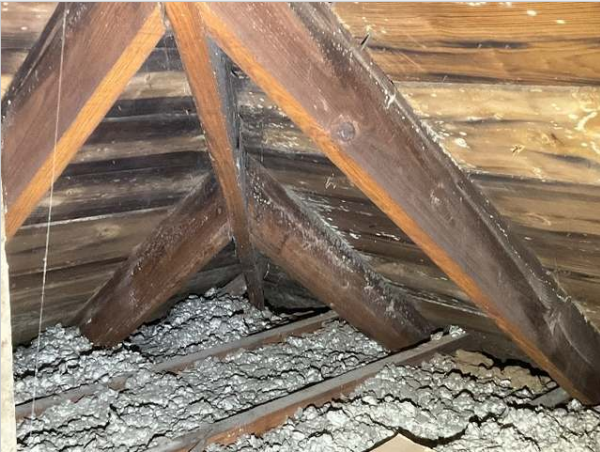
The presence of certain mold and mold spores in housing can result in mild to severe health effects in humans and can deteriorate the structure of the dwelling resulting in structural damage. Health effects include, but are not limited to: asthma, allergy symptoms, watery eyes, sneezing, wheezing, difficulty breathing, sinus congestion, blurry vision, sore throat, dry cough, aches and pains, skin irritation, bleeding of the lungs, headaches, memory loss and fever. As humans vary greatly in their chemical make-up, so does the individual's reaction to mold exposure. For some people, a small number of mold spores can cause ill effects. In others it may take many more. A substance with the characteristics of mold is visible in the attic. Since the attic is not a part of the living space, the condition may not have any affect on those that are sensitive to mold. The EPA (<http://www.epa.gov/mold/moldresources.html>) advises consumers that areas less than ten square feet of coverage can usually be controlled using readily available household products. In the event the substance cannot be controlled, a certified mold testing and remediation firm should be contacted for a recommended course of action.

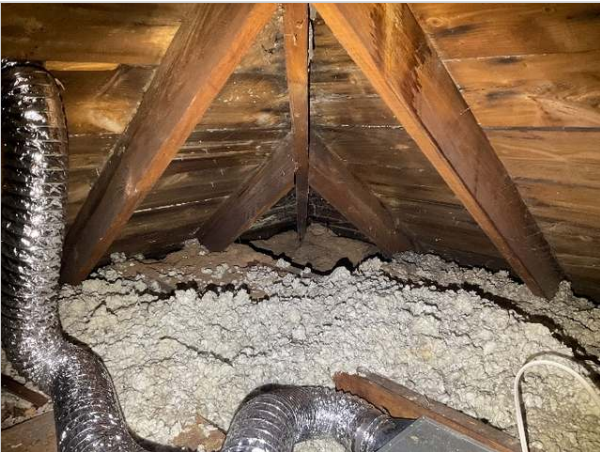
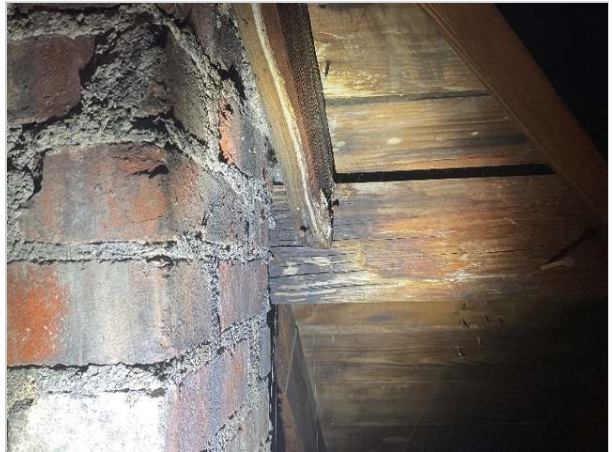
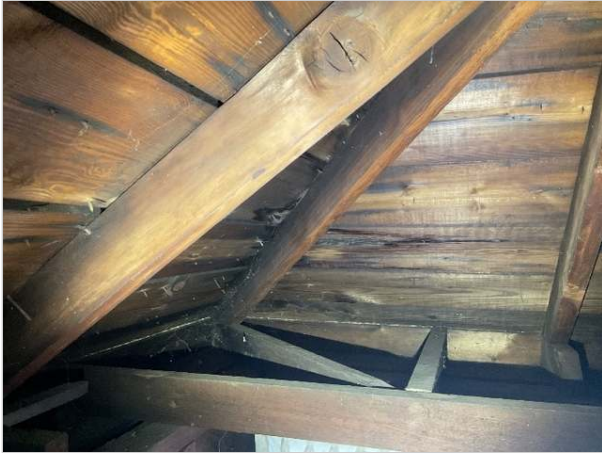
**NOTE: ROOF DECK:**

The roof deck as viewed from the attic is water marked. The cause of condition appears to be the result of questionable ventilation and previous leaks. Repairs to the affected areas are not required. Areas should be monitored during times of heavy rains for any changes or new watermarks.
