HomeTeam[®]

257 Lincoln Dr

Inspection #: 527-052026-6875

HOME INSPECTION REPORT

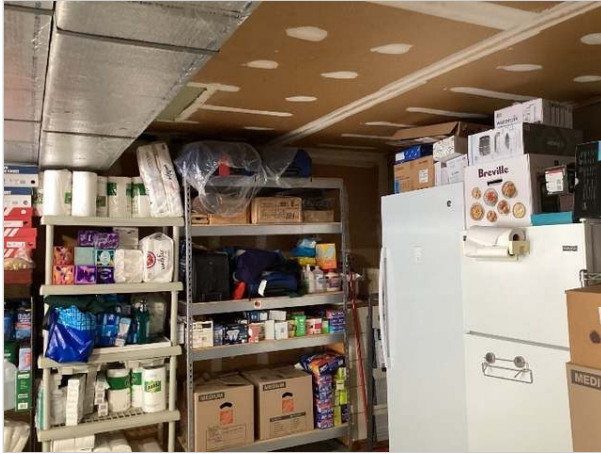
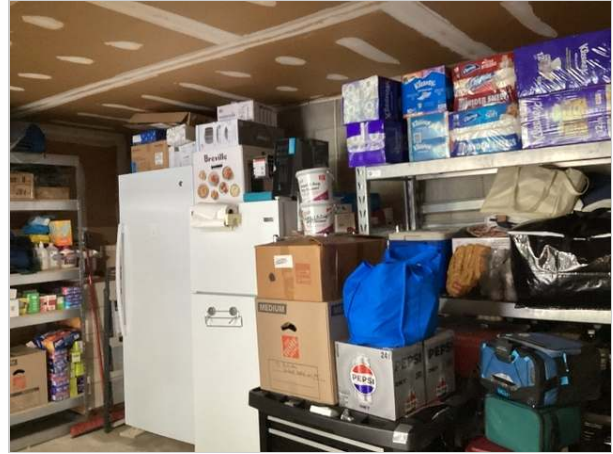
The garage was cluttered with many stored items and/or shelves at the time of inspection, therefore several areas were unable to be inspected.

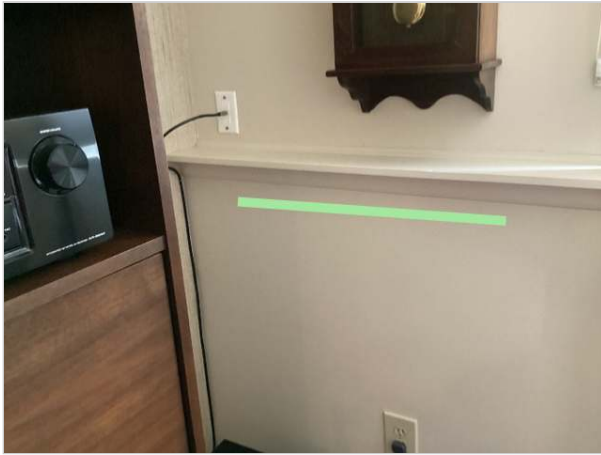
There were signs of moisture on the front basement wall. The area was dry at the time of the inspection. Dampness on basement walls is not always a sign of water intrusion. The dampness can be the result of warm humid air making contact with cool walls. In many cases the humid air condenses on the wall and forms a layer of moisture. It is important

to assess whether moisture on the basement walls is the result of water intrusion or condensation. In this case, the efflorescence noted on the wall appears to be the result of moisture buildup on the exterior side of the foundation. The exterior grading in the affected area is adequate. Many water intrusion problems can be controlled by improving the drainage on the exterior of the home. It is important that all roof drainage and surface water is directed away from the foundation. Any concern about this condition should be referred to a qualified contractor for evaluation and recommendations.

Area of high moisture

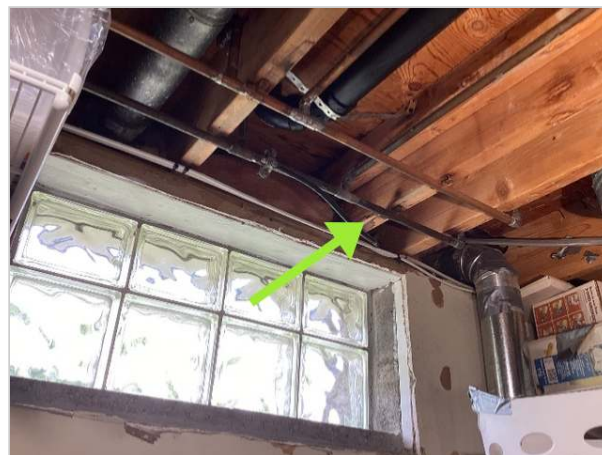
The floor joists and sub floor are water marked below the kitchen basement floor structure. The area was dry at the time of the inspection. The wood on the affected area was not rotted. Repairs to the affected area does not appear to be necessary.No immediate action is required.

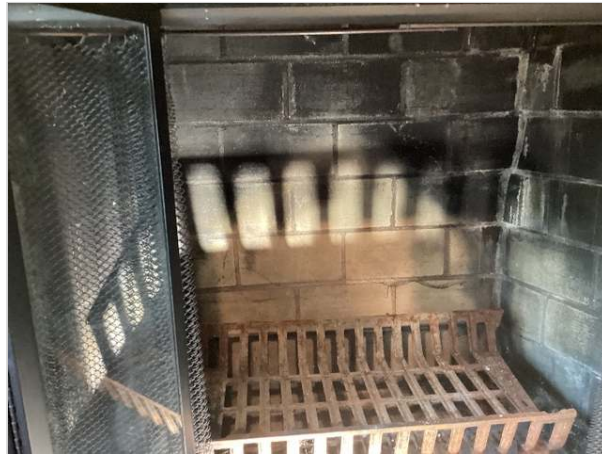
A buildup of soot and / or creosote was noted in the chimney of the basement fireplace. The chimney should be cleaned by a qualified, reputable chimney and fireplace service prior to using the unit.

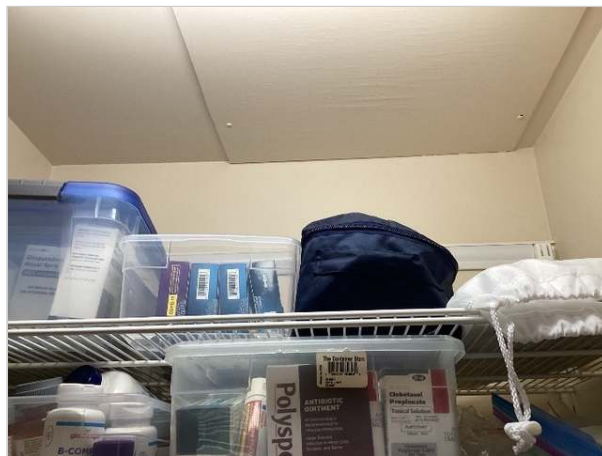
INFORMATIONAL NOTE: NO ATTIC ACCESS: There was no access to the attic area at the time of the inspection. As a result, it was not possible to inspect any part of the underside of the roof for signs of leaks, or to determine the type of roof construction. Additionally, it was not possible to determine if insulation was installed in the attic. Special attention was paid to the visible finished ceiling surfaces for evidence of active leaks. There was no evidence of active leaks at the time of the inspection.

Fixed shelves
