## **HomeTeam<sup>®</sup>** INSPECTION SERVICE

**1281 Washington Rd  
RE: Pittsburgh, PA 15228  
Inspection #: 527-062026-6954**

### *HOME INSPECTION REPORT*

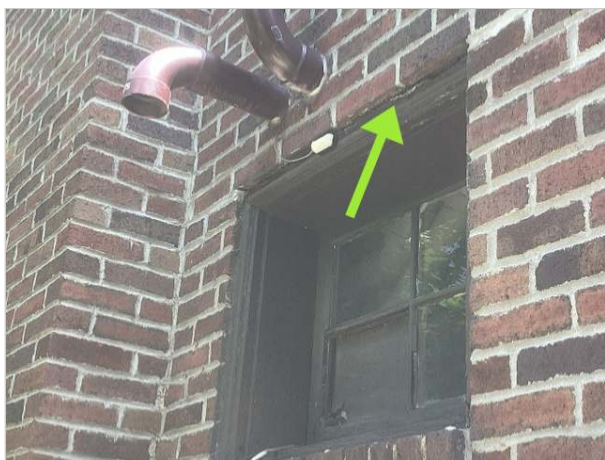
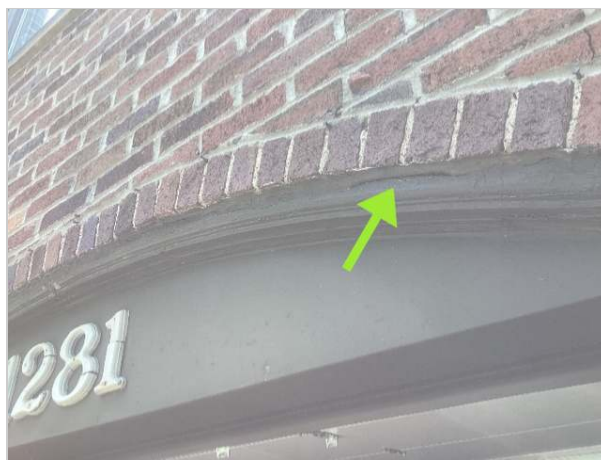
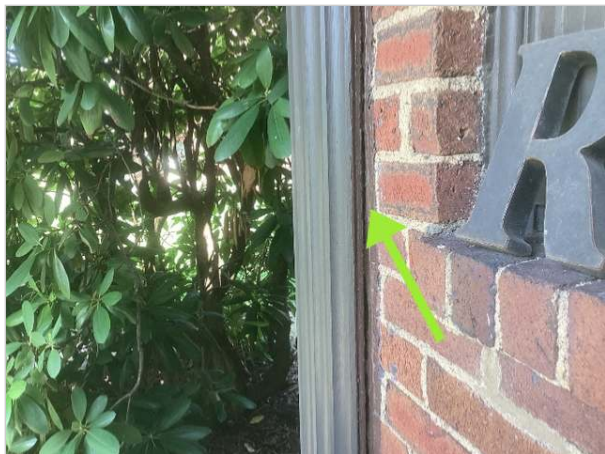
The exterior caulking around the windows and doors is cracked or missing on all sides of the home. The caulking should be replaced to ensure the exterior of the home remains weather and water tight.

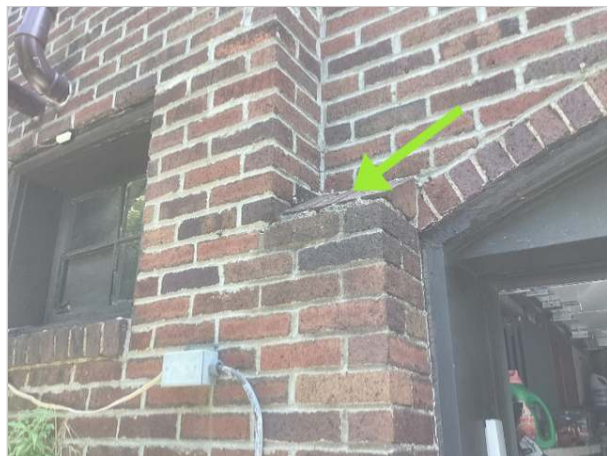
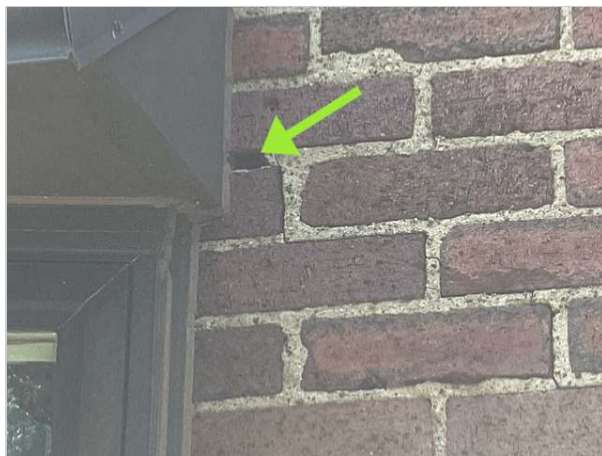
### *NOTE: MISSING MORTAR:*

Missing mortar was noted on the brickwork on several areas of the home. There were no loose bricks noted. Small amounts of missing mortar are usually inconsequential. Extensive amounts of missing mortar can permit water intrusion. Consult with a qualified masonry contractor for repair estimates.

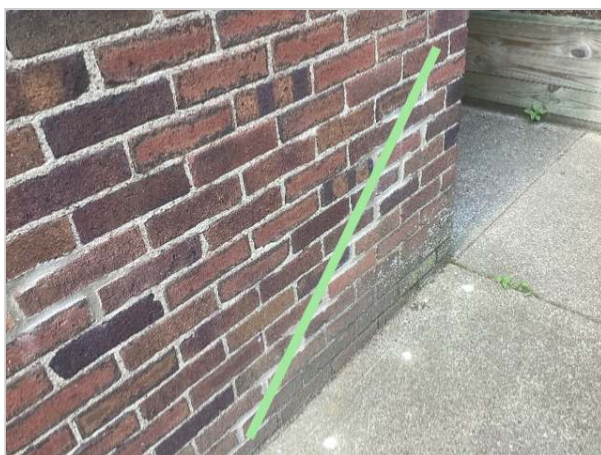
**NOTE: MASONARY/MORTAR CRACKS:**

One or more cracks were noted on the brick veneer of the home. The cracks were located on the back. The cracks appear to have been caused by expansion and contraction, are common and do not usually have any structural significance. No structural concern on the brickwork was noted at the time of the inspection. All cracks should be monitored for significant changes in characteristics. Corrective action has been taken. No additional action appeared to be necessary at the time of the inspection.

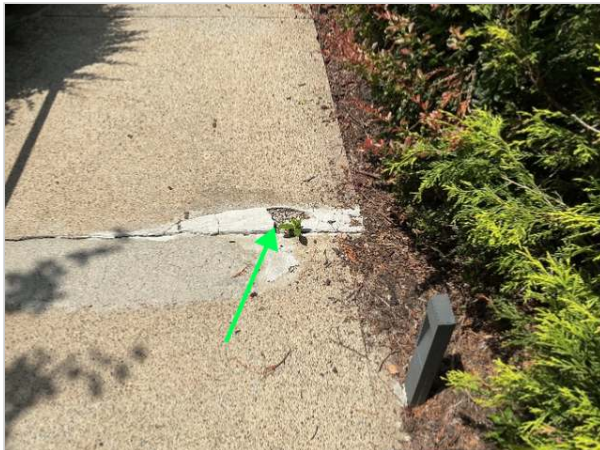
**SAFETY NOTE: TRIP HAZARDS:**

There were several trip hazards found on the walkways around the house. The hazards can be repaired using a suitable or similar surfacing material to "feather" the out-of-level condition to make a smooth transition.

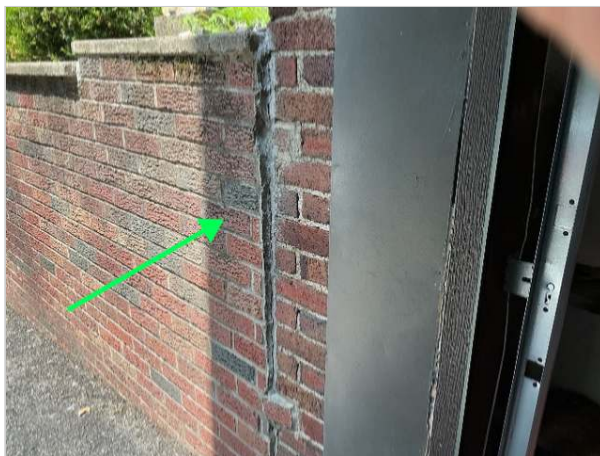
The front left retaining wall is leaning inward. There were significant vertical earth pressure type cracks observed in the wall. This condition is most often associated with soil and /or water pressure. The displacement occurs incrementally as the wall yields to horizontal earth pressure. The wall was stable at the time of the inspection. Repairs to the wall may be required. Consult with a qualified contractor for repair estimates

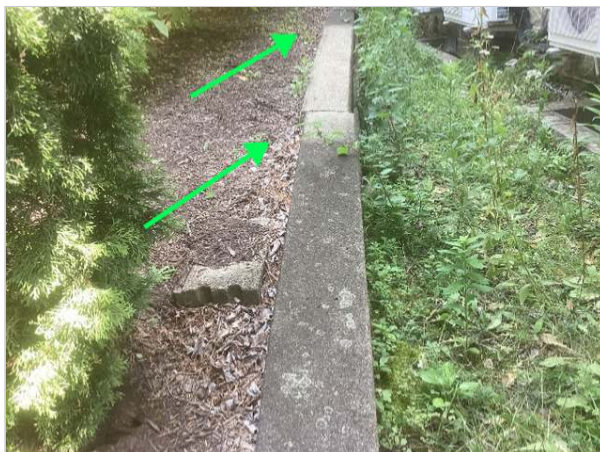
**NOTE: RETAINING WALL:**

The right retaining wall is cracked and leaning inward. There were significant vertical earth pressure type cracks observed in the wall. This condition is most often associated with soil and /or water pressure. The displacement occurs incrementally as the wall yields to horizontal earth pressure. The wall was stable at the time of the inspection. Repairs to the wall may be required. Consult with a qualified contractor for repair estimates

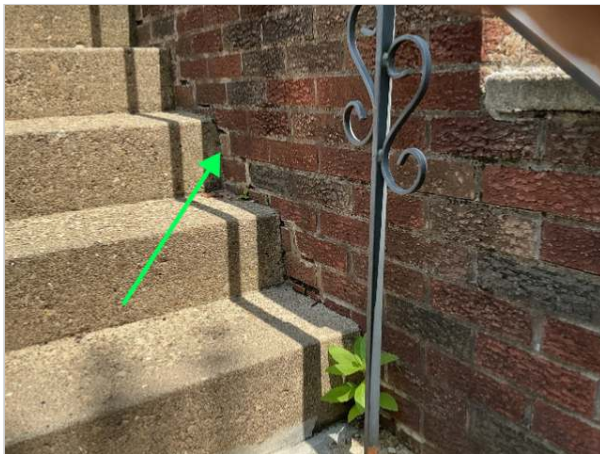
**NOTE: MISSING MORTAR:**

Missing mortar was noted on the brickwork on the front retaining wall of the home. There were no loose bricks noted. Small amounts of missing mortar are usually inconsequential. Extensive amounts of missing mortar can permit water intrusion. Consult with a qualified masonry contractor for repair estimates.

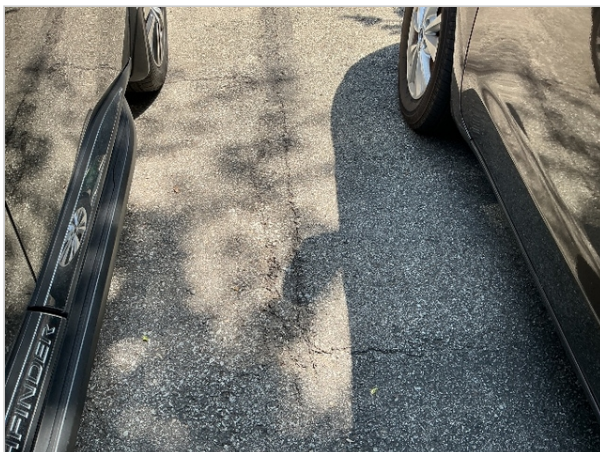
There was an asphalt driveway in the front of the home which led to the integral garage. There were many cracks and spalled areas noted on the driveway. Surface defects in driveways develop and progress with age and are considered normal as long as they do not create a safety hazard. There were no material defects observed in the driveway. Sealing the driveway with an asphalt driveway sealer will help extend the life of the driveway.

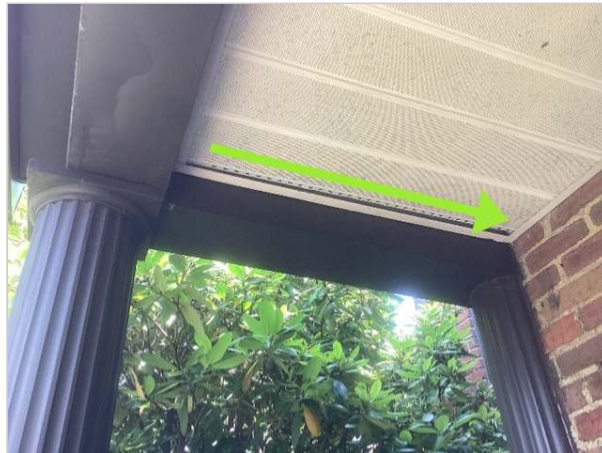
*NOTE: SOFFIT & FASCIA:*

Missing fascia was noted on the front. Consult with a qualified contractor for repair.

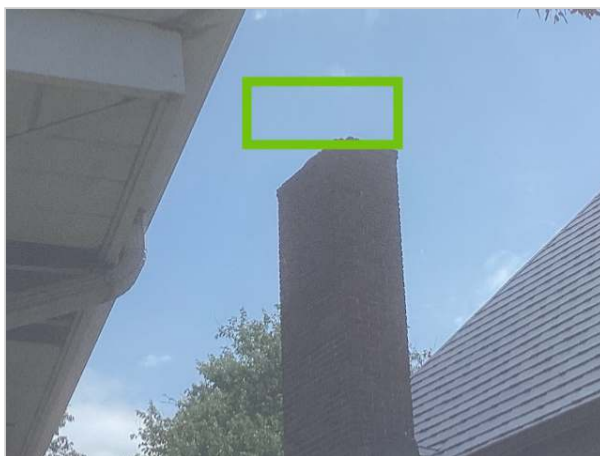
Left side chimney

The rain hat on top of the chimney is missing. Repairs should be made by a qualified roofer.

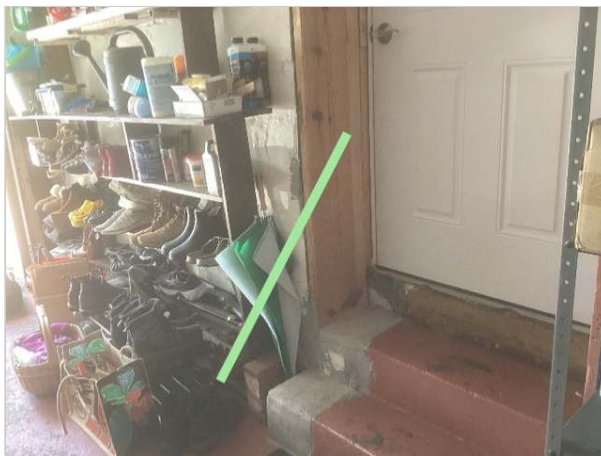
**SAFETY NOTE: MISSING HANDRAIL:**

There was no handrail on the stairs leading from the garage. This can be a safety concern. Local building codes may also require the installation of a handrail.

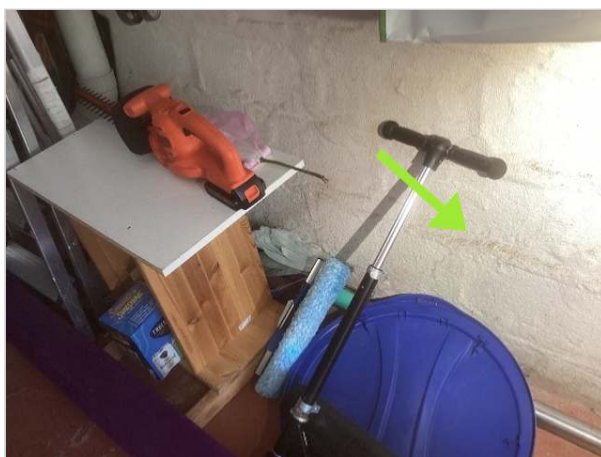
**NOTE: GARAGE MOISTURE EVIDENCE:**

There were signs of moisture on the right garage wall. The area was dry at the time of the inspection. Dampness on garage walls is not always a sign of water intrusion. The dampness can be the result of warm humid air making contact with cool walls. In many cases the humid air condenses on the wall and forms a layer of moisture. It is important to assess whether moisture on the walls is the result of water intrusion or condensation. In this case, the efflorescence noted on the wall appears to be the result of moisture buildup on the exterior side of the foundation. The exterior grading in the affected area is questionable. Many water intrusion problems can be controlled by improving the drainage on the exterior of the home. It is important that all roof drainage and surface water is directed away from the foundation. The area should be monitored during periods of heavy rain to better assess the cause.

Efflorescence

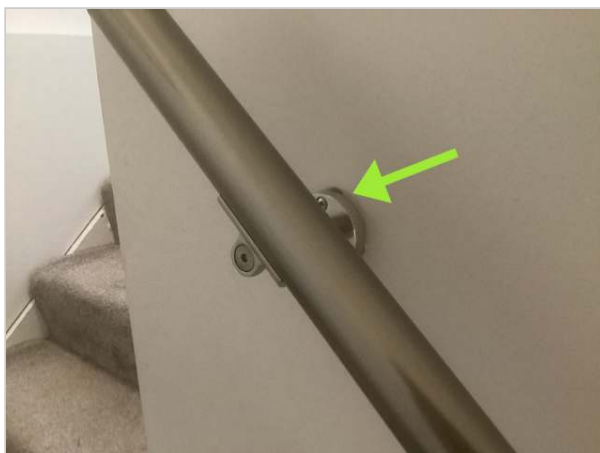
### ***SAFETY NOTE: LOOSE HANDRAIL:***

The handrail on the stairs leading to the basement is loose or otherwise insecure. The handrail should be properly secured for safety.

Bolt loose

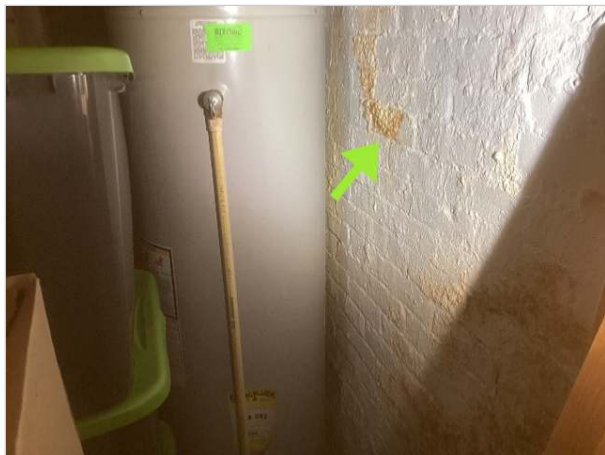
Left

There were signs of moisture on the left basement wall. The area was dry at the time of the inspection. Dampness on basement walls is not always a sign of water intrusion. The dampness can be the result of warm humid air making contact with cool walls. In many cases the humid air condenses on the wall and forms a layer of moisture. It is important to assess whether moisture on the basement walls is the result of water intrusion or condensation. In this case, the efflorescence noted on the wall appears to be the result of moisture buildup on the exterior side of the foundation. The exterior grading in the affected area is questionable. Many water intrusion problems can be controlled by improving the drainage on the exterior of the home. It is important that all roof drainage and surface water is directed away from the foundation. Any concern about this condition should be referred to a qualified contractor for evaluation and recommendations.

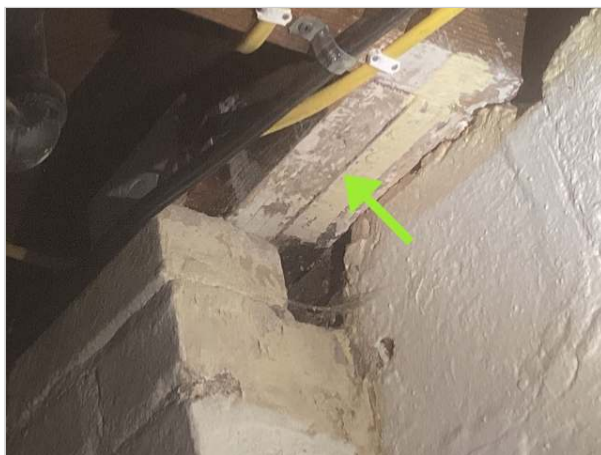
Tunnel

Evidence of termite activity was noted on the basement floor joists. The visible damage noted was insignificant and did not appear to have any structural significance. Repairs to the affected area (s) did not appear to be necessary. Please note too that any assessment as to the extent of damage caused by termites is limited to the visible and readily accessible areas of the home. We are not able to determine the presence or extent of concealed damage.

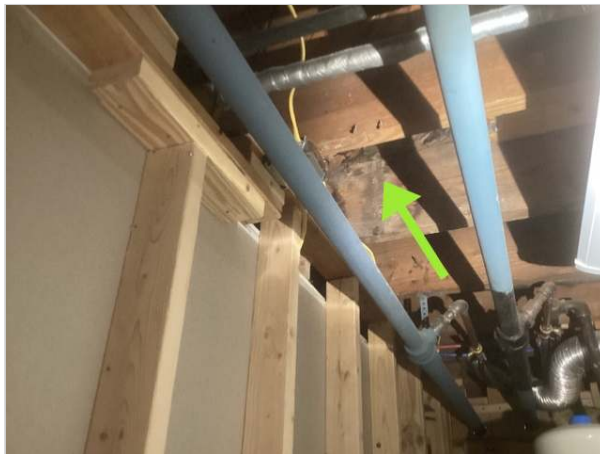
### *NOTE: WATER MARKED FLOOR STRUCTURE:*

The floor joists are water marked below the kitchen basement floor structure. The area was dry at the time of the inspection. The wood on the affected area was not rotted. Repairs to the affected area does not appear to be necessary.No immediate action is required.

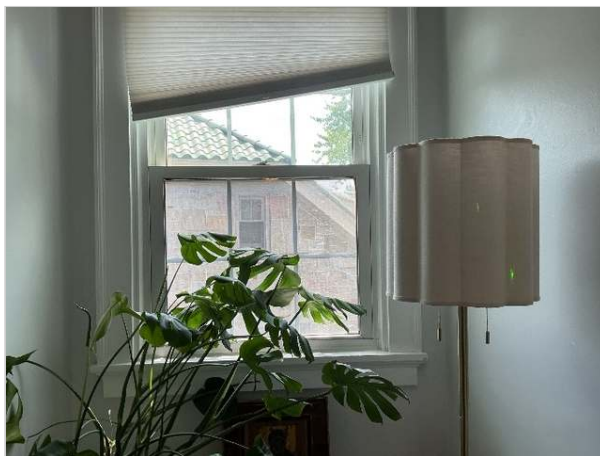
### ***NOTE: DEFECTIVE TILT LATCH:***

One or more defective tilt latches were noted on the windows. The tilt latch facilitates easier cleaning by permitting the window to tilt inward when the latches are released. Defective latches permit the window to tilt or fall inward during normal opening. The latches should be replaced.

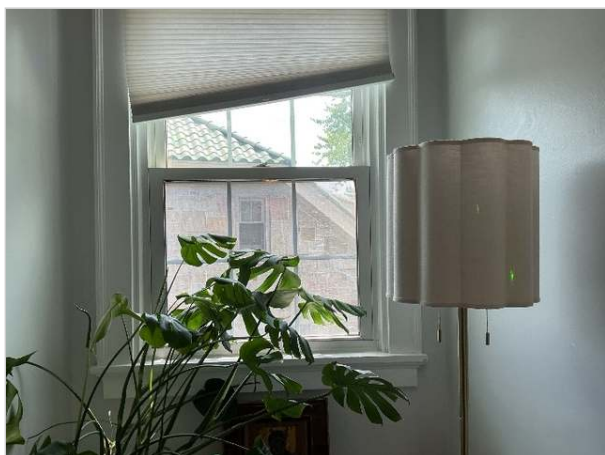
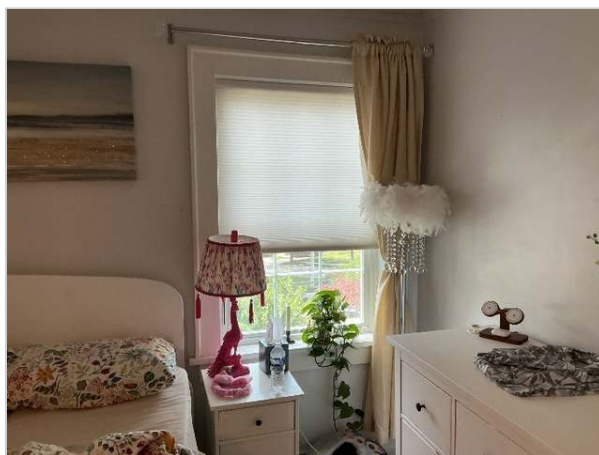
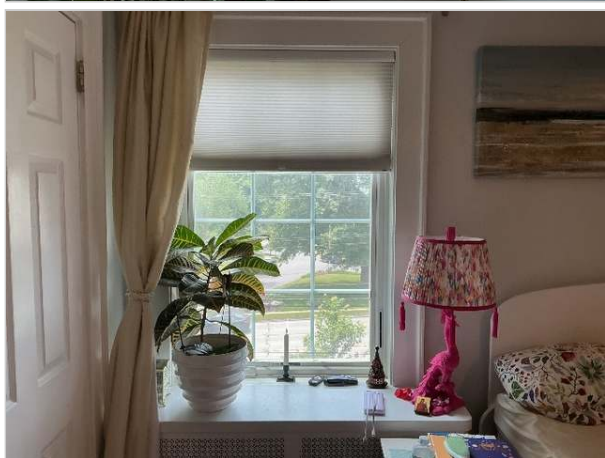
**SAFETY NOTE: WINDOW LOCKS:**

3 window (s) would not lock. The window (s) were located in the master bedroom For personal security all windows should properly lock.

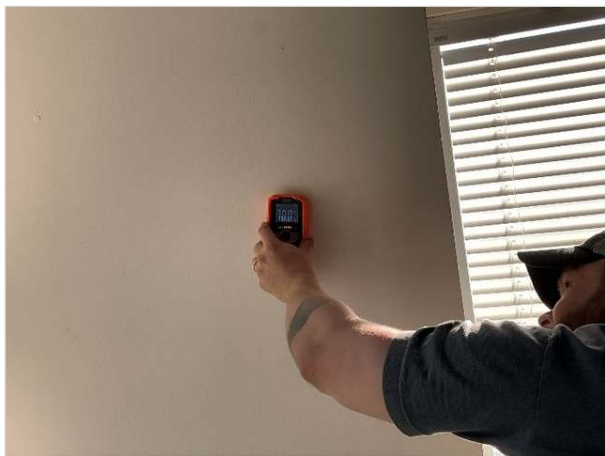
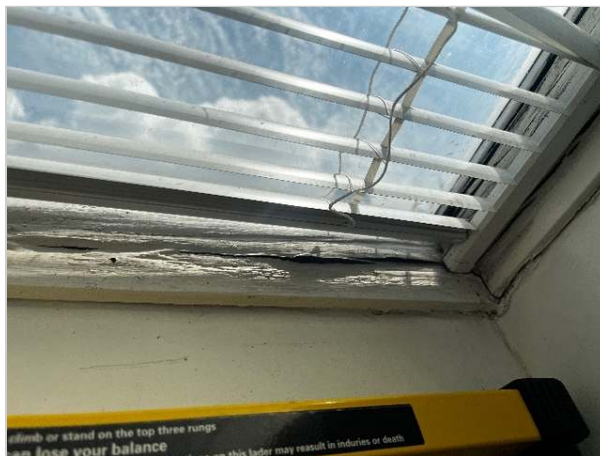
moisture meter reading

Water marks with some surface damage was noted on the ceiling at a skylight. The water marks appeared to be the result of active leaks. Consult with a qualified roofer for evaluation and repair.

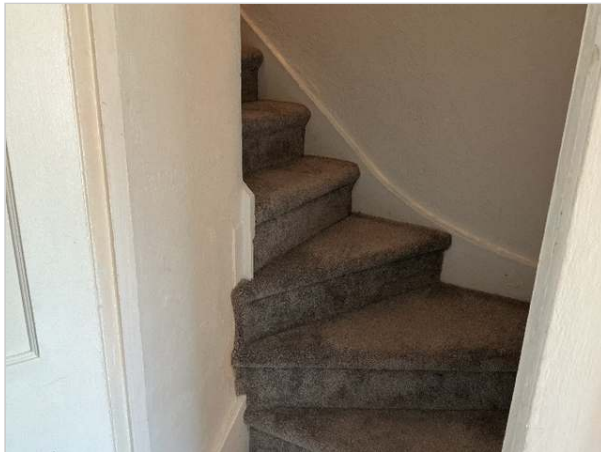
**SAFETY NOTE: MISSING HANDRAIL:**

There is a missing handrail on the stairs leading to the 3rd floor. This can be a safety concern. Local building codes may also require the installation of a handrail.

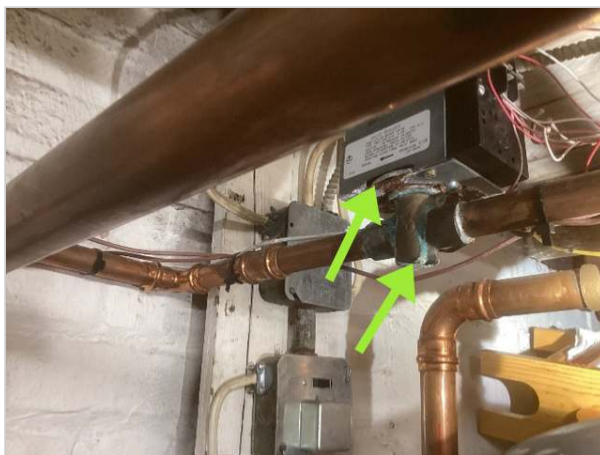
**NOTE: LEAKY CONTROLLER:**

There was evidence the boiler control was leaking. Consult with a qualified plumber for repair.

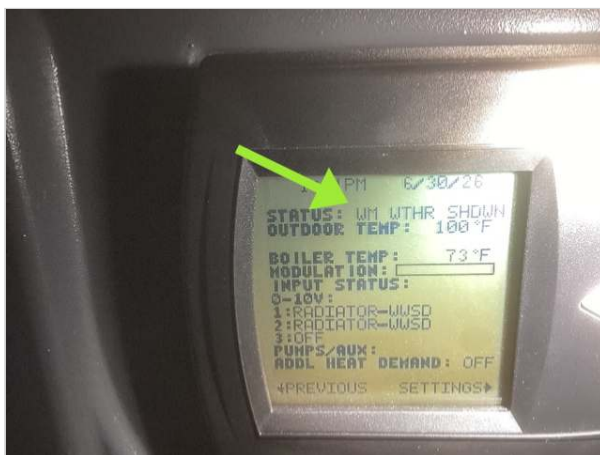
**NOTE: INOPERABLE BOILER:**

The boiler was not functional at the time of the inspection. The unit was in shut down mode due to high outside temperatures. Consult with a qualified heating contractor to confirm operation if desired.

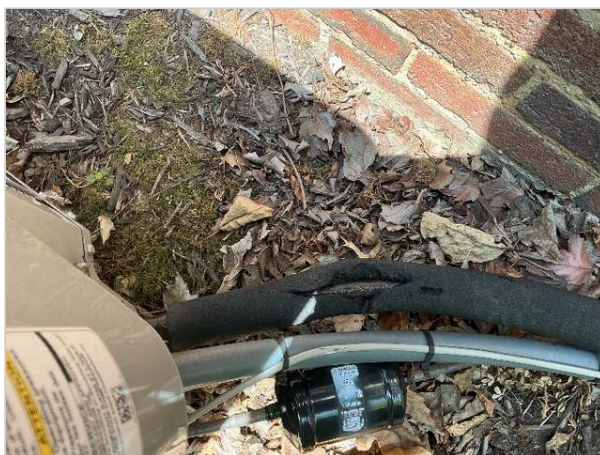
**NOTE: A/C LINE SET INSULATION:**

The insulation on the exterior air conditioning line set is damaged. This could affect the efficiency of the system and should be replaced.

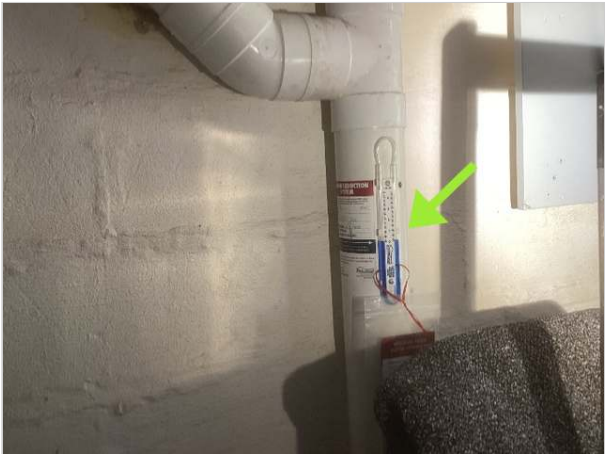
The radon mitigation system installed in the home did not appear to be working properly at the time of the inspection. Consult with the original installer whose name is usually located on a label affixed to the system in the basement for evaluation and repair.
