**1140 Franklin St**

**RE: White Oak, PA 15131**

**Inspection #: 527-072025-6431**

### *HOME INSPECTION REPORT*

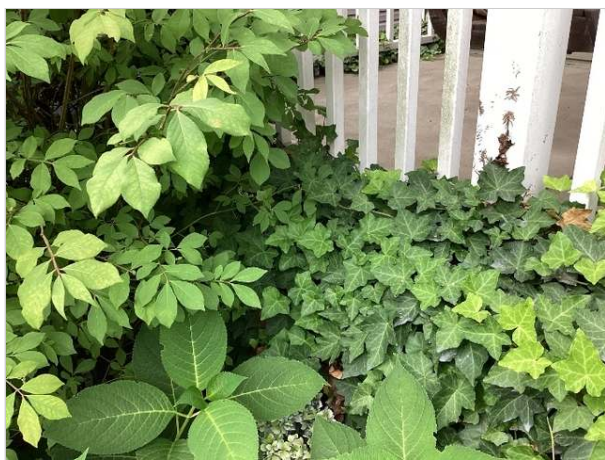
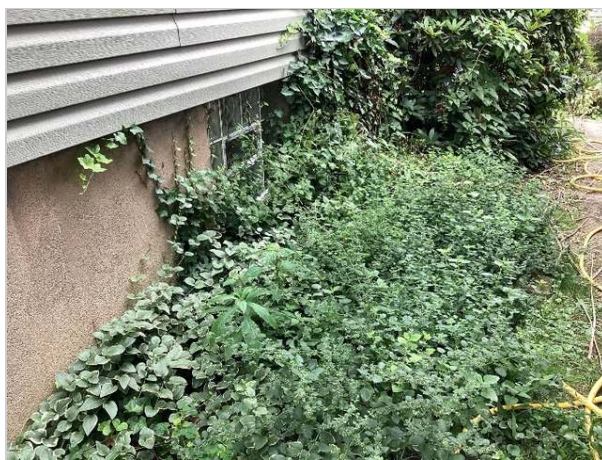
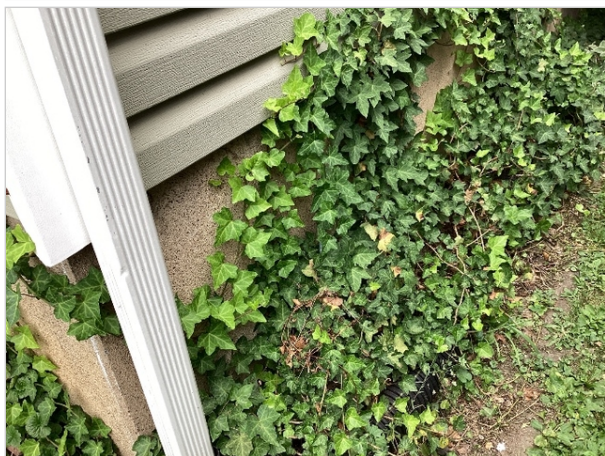
Extensive plant growth was observed against the home, in the front and left side area of the house. Recommend removing this growth away from the siding to prevent possible damage including insect infestation.

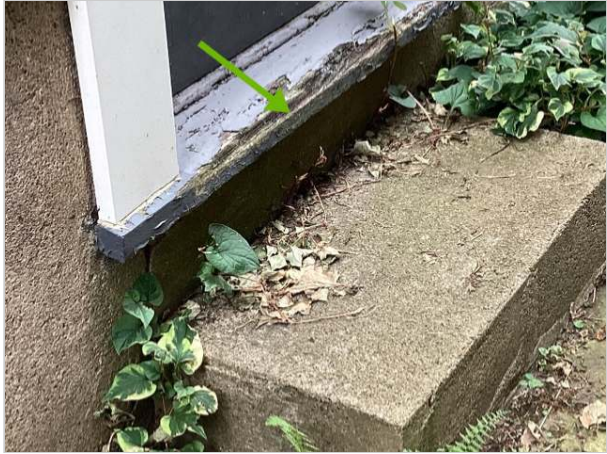
### *NOTE: EXTERIOR WOOD ROT:*

Rotted wood was noted at the side threshold . The areas should be repaired and sealed by a qualified contractor.

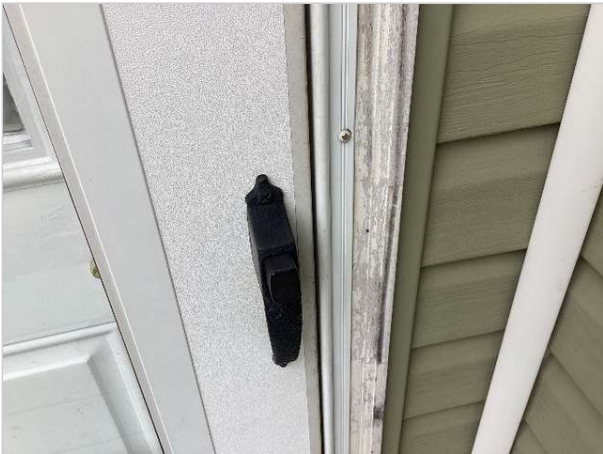
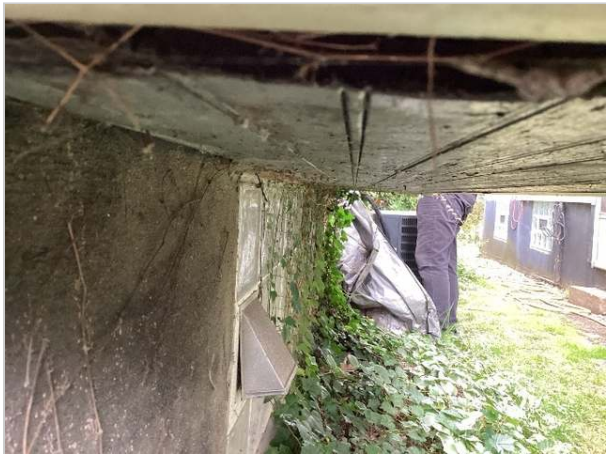
Right side bump out

Peeling paint was noted on one or more areas of the exterior. In order to preserve the life of the exterior surfaces and materials, all areas should be scraped and painted.

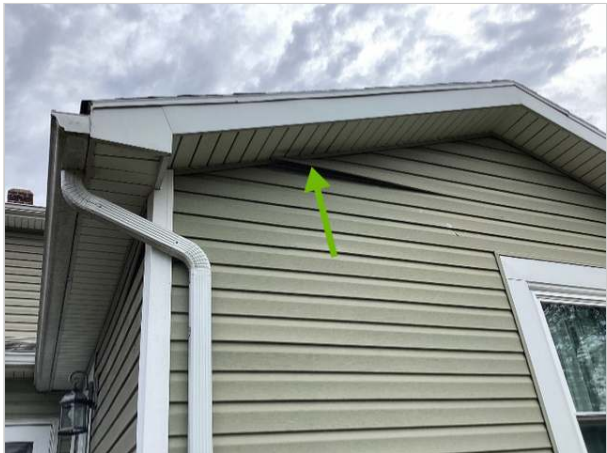
**NOTE: LOOSE SIDING:**

Loose siding was noted on the back of the home. The siding should be reattached.

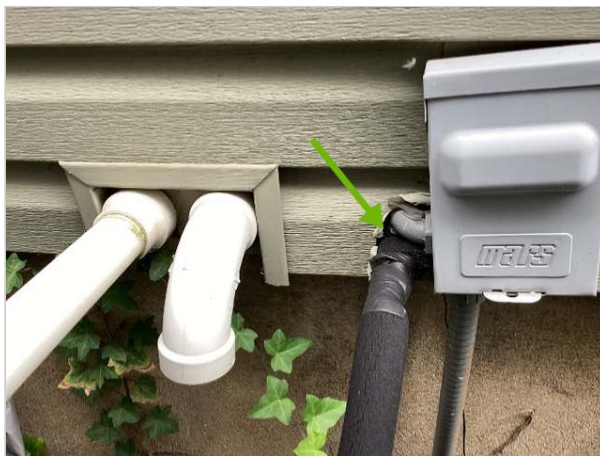
**NOTE: SIDING:**

A hole was noted in the siding on the left side. This condition does not impact the structural integrity of the building, but can lead to water intrusion. Repairs should be made by a qualified contractor.

Recommend sealant

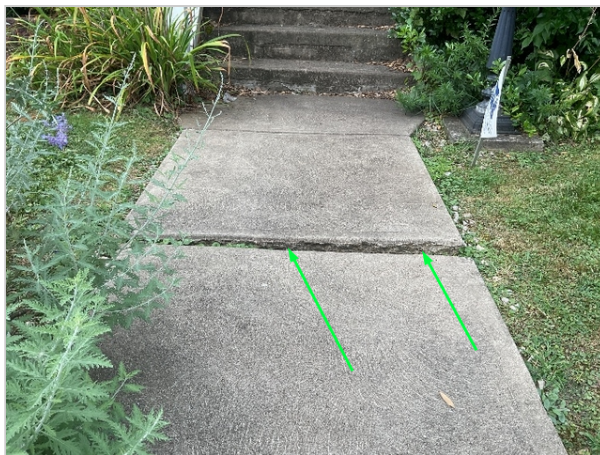
### *SAFETY NOTE: TRIP HAZARDS:*

There were several trip hazards found on the walkways around the house. The hazards can be repaired using a suitable or similar surfacing material to "feather" the out-of-level condition to make a smooth transition.

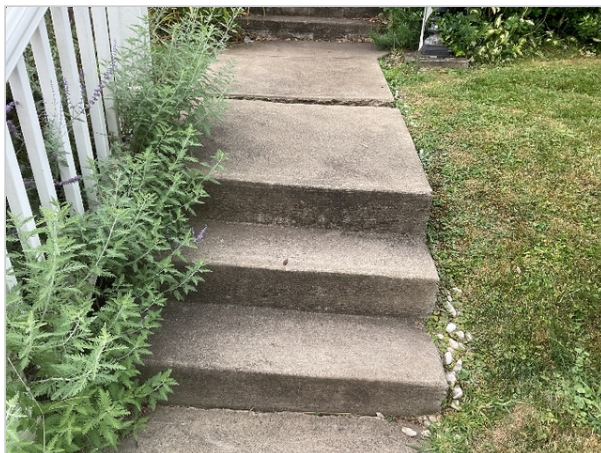
### *NOTE: STEP SETTLEMENT:*

Settlement was noted on the front step slab. The settlement does not appear to be active. Settlement of concrete slabs is common and is usually not a problem. It is not possible for us to positively determine if active settlement is occurring

during a home inspection. The area should be monitored for evidence of new or continued settlement. Consult with a qualified contractor for further evaluation if required.

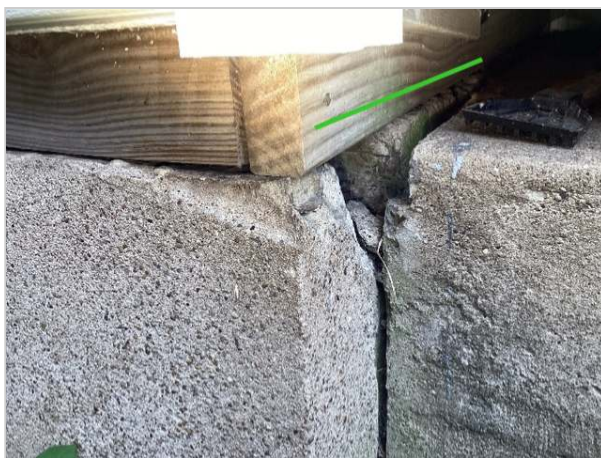
The ledger board for the deck is nailed to the main structure of the home rather than bolted. Generally accepted deck construction techniques require the deck to be bolted to the main structure of the home at regular intervals. Consult with a qualified contractor to anchor the deck to the home with bolts.

No bolts

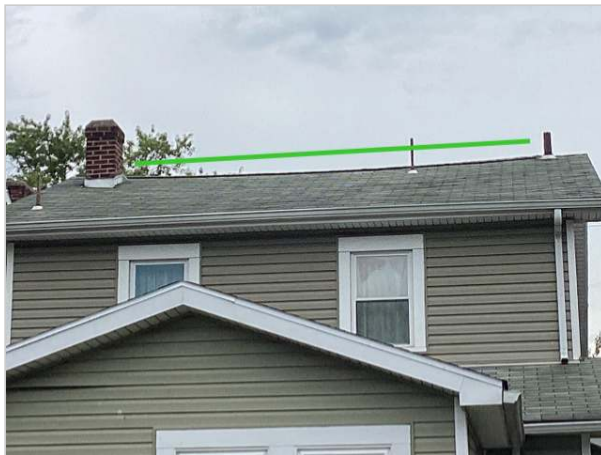
A depression in the roofing was noted on the ridge. This condition is usually caused by settlement of the roof framing and is generally insignificant. Consult with a qualified roofer for further evaluation if desired.

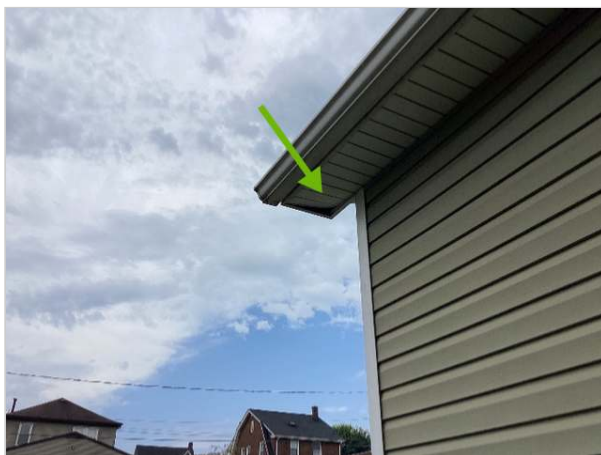
### *NOTE: SOFFIT & FASCIA:*

Loose soffit was noted on the back. Consult with a qualified contractor for repair.

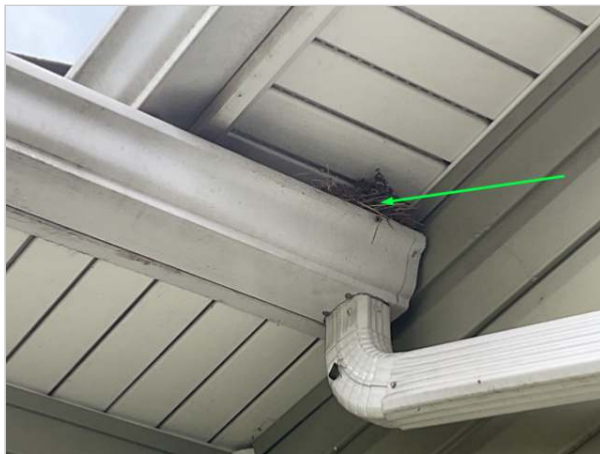
The left side gutters were in need of cleaning at the time of the inspection. Clogged gutters can cause roof drainage water to drain at the base of the foundation, causing basement water problems. The gutters should be cleaned.

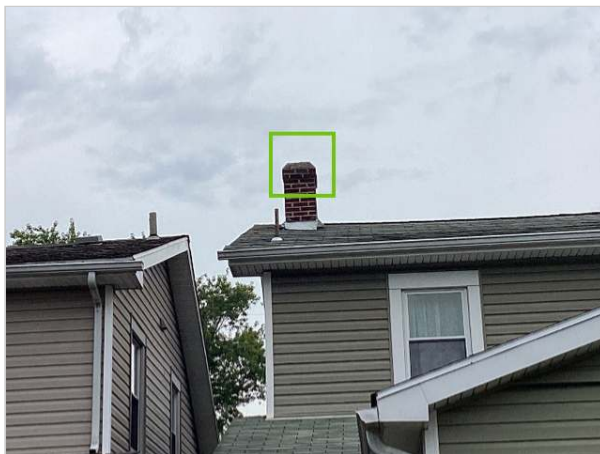
**NOTE: RAIN HAT:**

The rain hat on top of the chimney is missing. Repairs should be made by a qualified roofer.

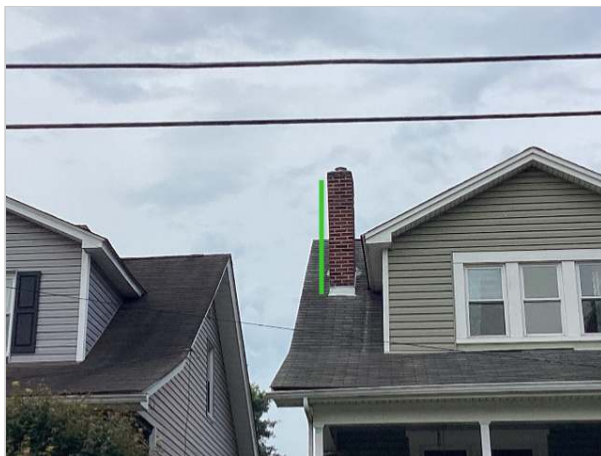
**NOTE: CHIMNEY LEANING:**

The front chimney is leaning from the main structure of the home. We were not able to determine if the condition is active or dormant. Consult with a structural engineer for evaluation and recommendations.

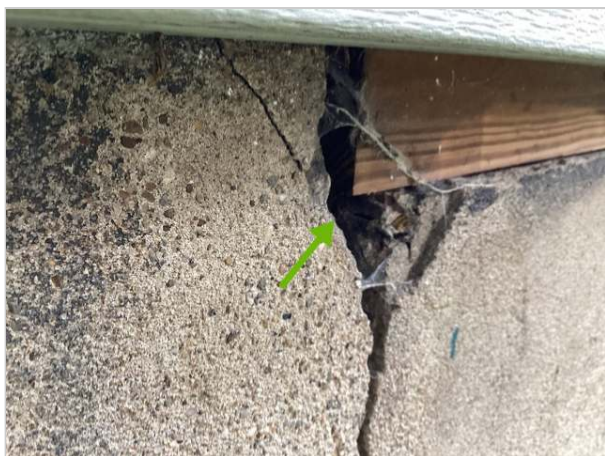
Rear addition

One or more cracks were noted on the exterior foundation walls. The cracks were located on the right side. The cracks appear to have been caused by settlement. There was no evidence of active movement at the time of the inspection. Corrective action did appear to be necessary. We do recommend sealing cracks. All cracks should be monitored for significant changes in characteristic. Consult with a contractor if the cracks change significantly or you desire another opinion on this condition.

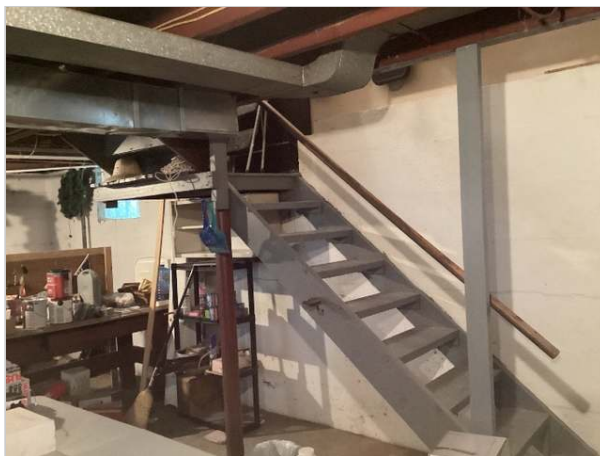
The balusters on the basement rail were installed horizontally rather than vertically and spaced greater than four inches apart. Generally accepted construction techniques provide for balusters to be installed vertically and spaced no greater than four inches apart. Larger baluster spacing can be a safety concern, and horizontally mounted balusters permit climbing. Local codes may require modification and / or installation of additional balusters. Consult with a general contractor for cost estimates for additional balusters.

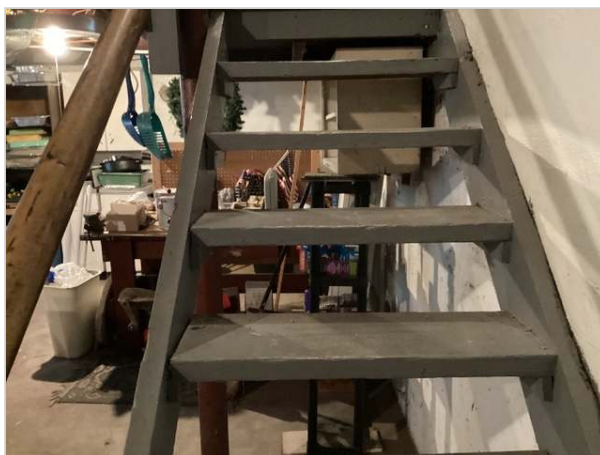
The risers or backs of the basement stairs are open. This could be a fall hazard for small children. Consult with a qualified contractor for evaluation and recommendations.

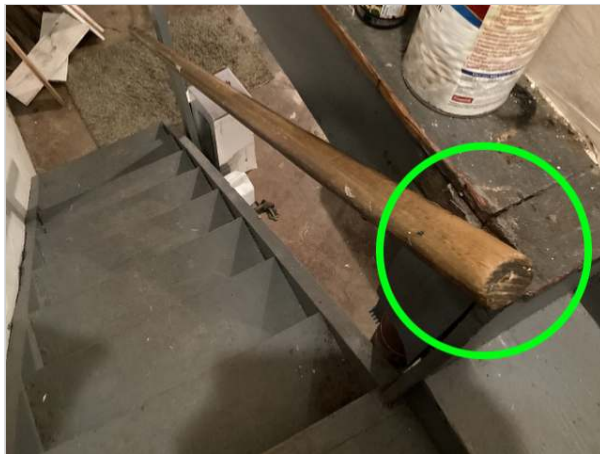
***SAFETY NOTE: LOOSE LANDING RAIL:***

The rail at the top of the basement stairs is loose or otherwise insecure. The rail should be properly secured by a qualified contractor.

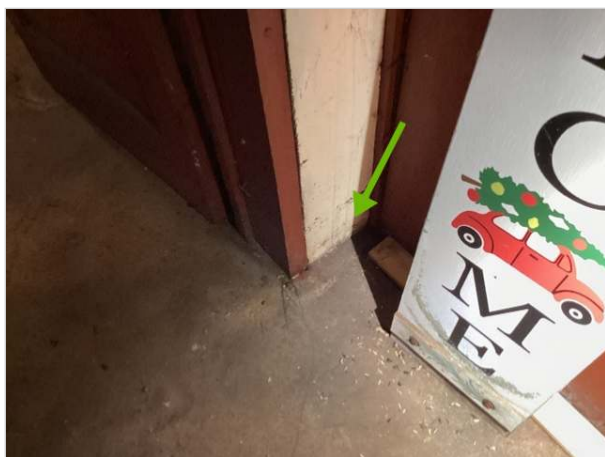
Under front porch

There were signs of moisture on the front and left basement walls. The area was dry at the time of the inspection. Dampness on basement walls is not always a sign of water intrusion. The dampness can be the result of warm humid air making contact with cool walls. In many cases the humid air condenses on the wall and forms a layer of moisture. It is important to assess whether moisture on the basement walls is the result of water intrusion or condensation. In this case, the efflorescence noted on the wall appears to be the result of moisture buildup on the exterior side of the foundation. The exterior grading in the affected area is questionable. Many water intrusion problems can be controlled by improving the drainage on the exterior of the home. It is important that all roof drainage and surface water is directed away from the foundation. Any concern about this condition should be referred to a qualified contractor for evaluation and recommendations.

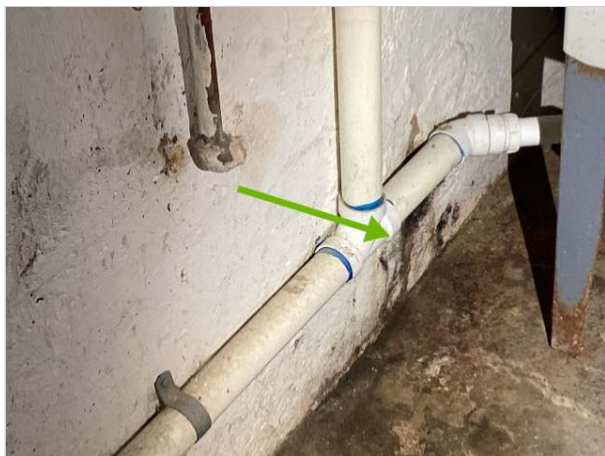
Behind laundry moisture and mold like substance

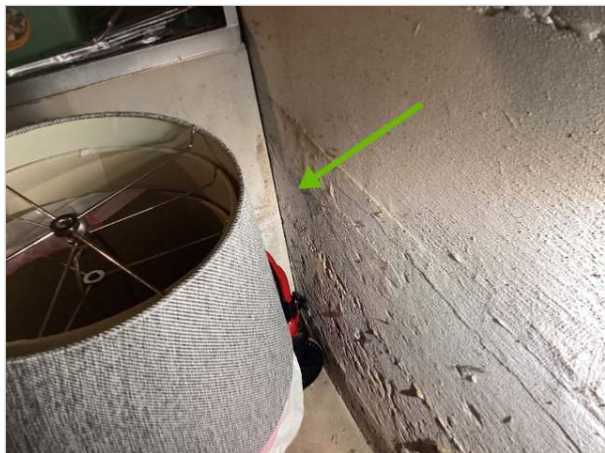
Right rear

A substance with the characteristics of mold is visible in one or more areas of the property. The EPA (<http://www.epa.gov/mold/moldresources.html>) advises consumers that areas less than ten square feet of coverage can usually be controlled using readily available household products. In the event the substance cannot be controlled, a certified mold testing and remediation firm should be contacted for a recommended course of action.

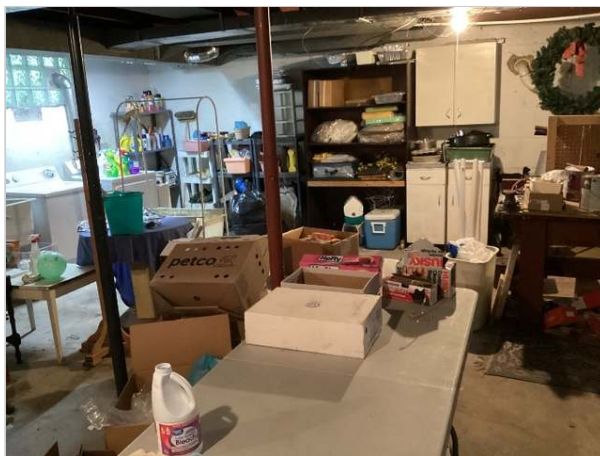
The basement was cluttered with many stored items and/or shelves at the time of inspection, therefore several areas were unable to be inspected.

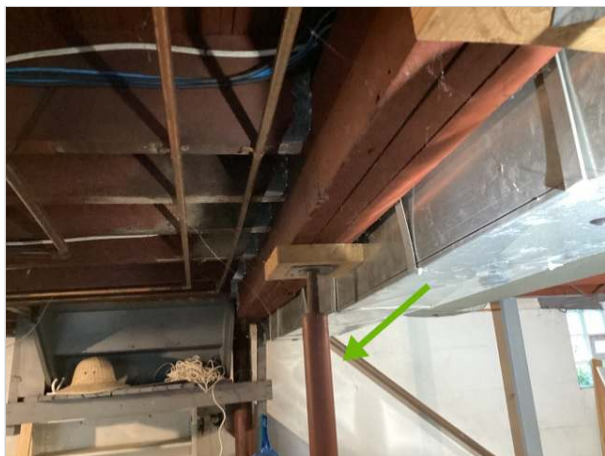
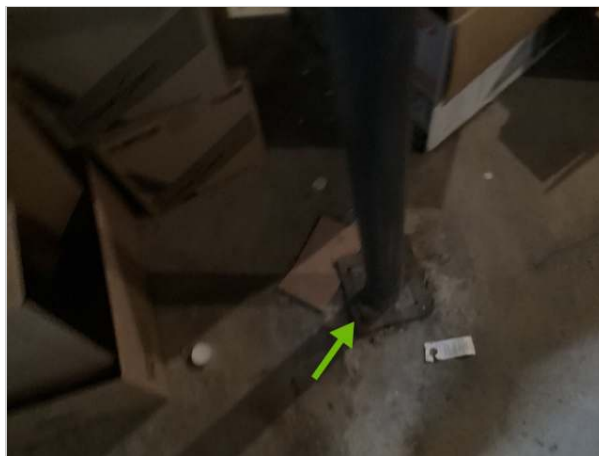
The adjustable support post installed to provide vertical support to the main beam is not designed for permanent installation. These posts are designed to provide temporary support during repair and are not meant to support the weight of the structure on a long term basis. Additionally, a proper vertical support post should be installed on a concrete footing, usually located below the floor. Consult with a qualified contractor or structural engineer for evaluation and recommendations.

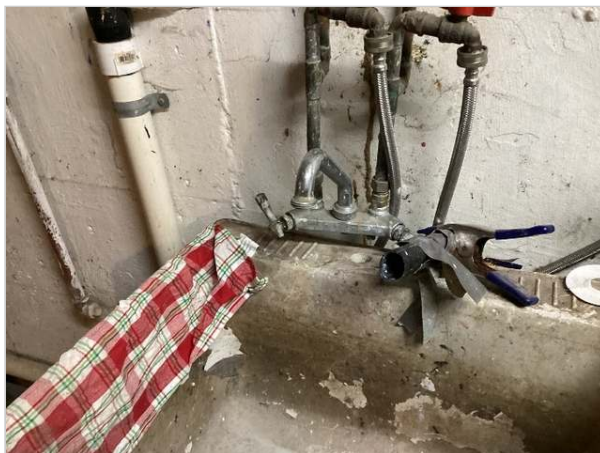
- Basement laundry tub loose and faucet in disrepair
- Full bath tub stop and waste valve is inoperable. Full bath tub hot and cold water supply lines are reversed.

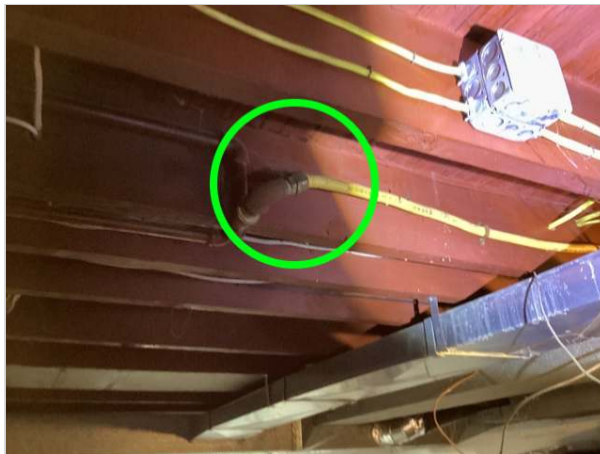
There was no apparent bonding on the interior gas line at the time of the inspection. Direct bonding is required for all yellow corrugated stainless steel gas-piping systems. More information is available at [www.csstsafety.com](http://www.csstsafety.com). Consult with a qualified electrician to ensure that the gas lines are appropriately bonded.

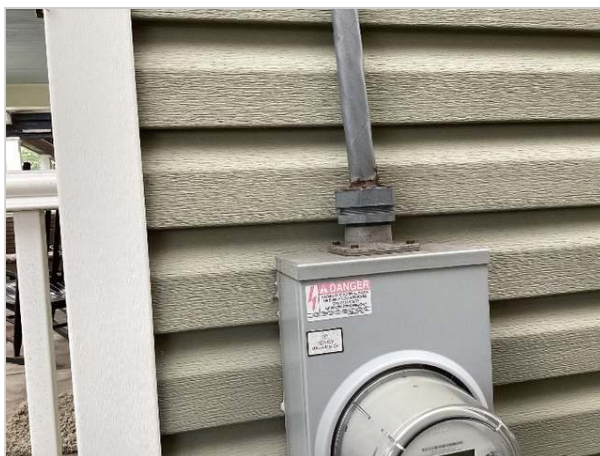
The sealant at the top of the electric meter box is missing. The sealant should be replaced to ensure that water does not enter the electric service panel.

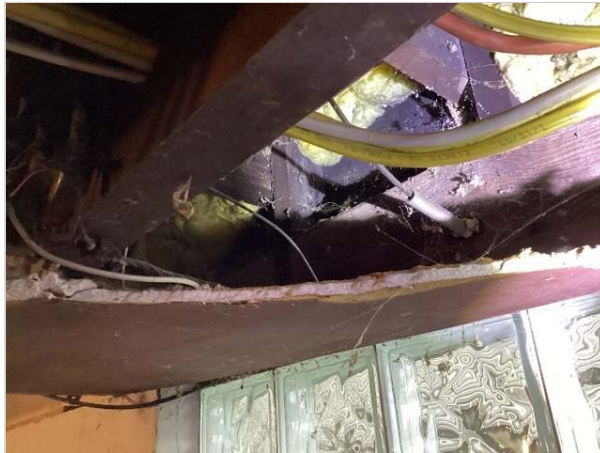
**NOTE: INACTIVE KNOB & TUBE WIRING:**

Inactive knob and tube wiring was observed in the home. All visible sections of the knob and tube wiring were tested and found to be inactive. Most of this wiring is concealed in walls, ceilings and insulation where its condition cannot be completely evaluated.

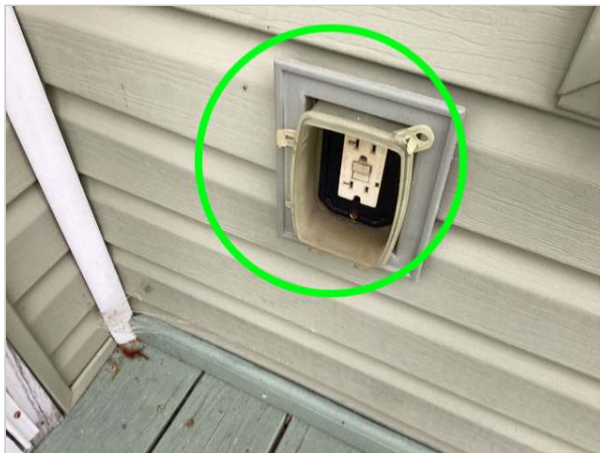
**NOTE: MISSING EXTERIOR OUTLET COVER:**

One or more exterior outlets were not properly covered. Outlet covers designed for use in wet locations should be installed on all exterior outlets.

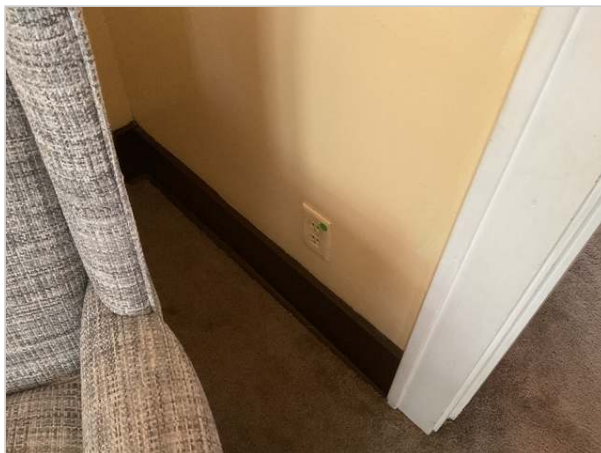
**NOTE: THREE PRONG OUTLET WITH OPEN GROUND:**

with a "**GREEN**" dot for easy identification. The affected outlet is located in the living room. Please note that we only test outlets that are visible and readily accessible at the time of the inspection.

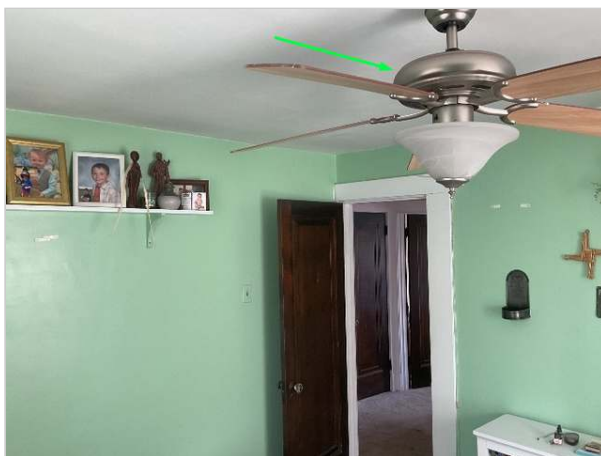
**NOTE: PADDLE FAN:**

The paddle fan located in the rear bedroom is not operable. Consult with a qualified contractor for repair.

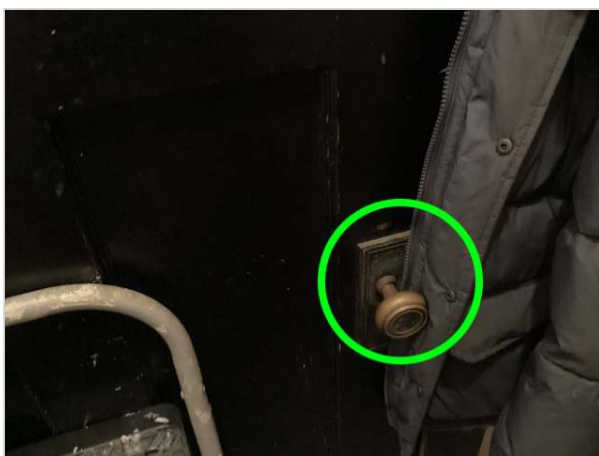
The basement landing door lock is inoperable or otherwise in need of repair. For personal security consult with a qualified locksmith for repair.

No lock

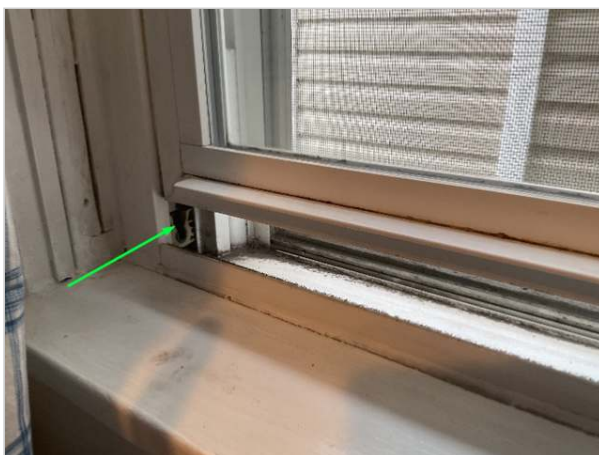
The kitchen window would not close. Repairs should be made by a qualified contractor.

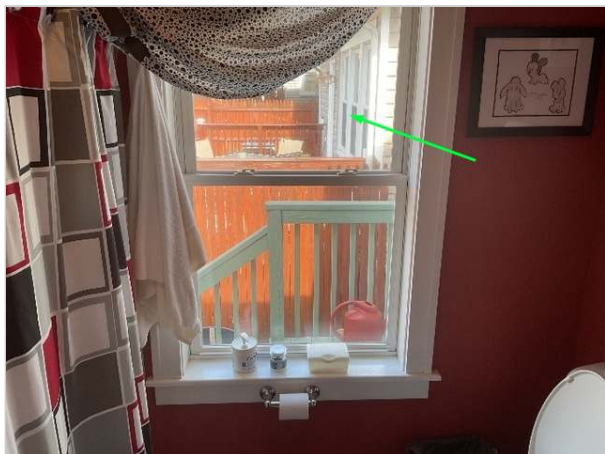
first level bath

the thermal seal can be accomplished by replacing the affected glass panel.

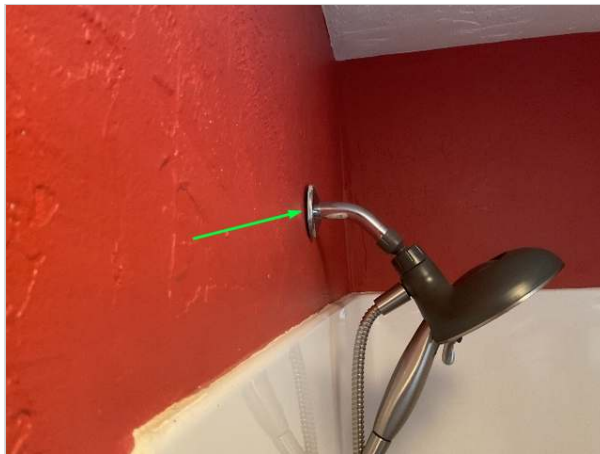
Failure to keep walls sealed can cause deterioration and extensive moisture damage including mold growth to the interior walls, which is not always visible at the time of the inspection. Some of the caulk was missing from around the shower head . These areas should be caulked to help prevent moisture penetration.

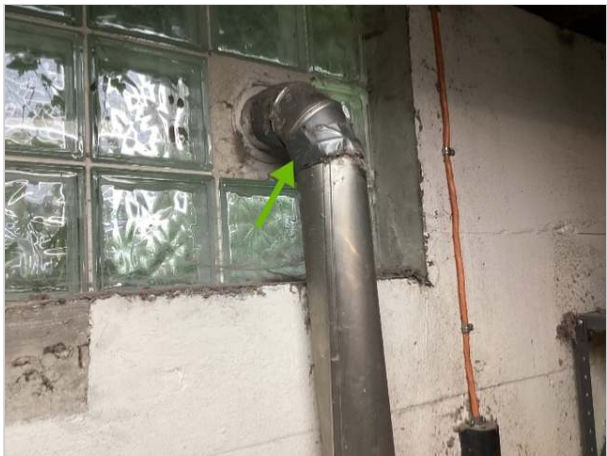
A dryer vent was installed. The visible portions of the dryer vent was inspected and did appear to be functional. The venting was adequate to vent the dryer to the exterior of the home.

Recommend foil tape versus duct tape

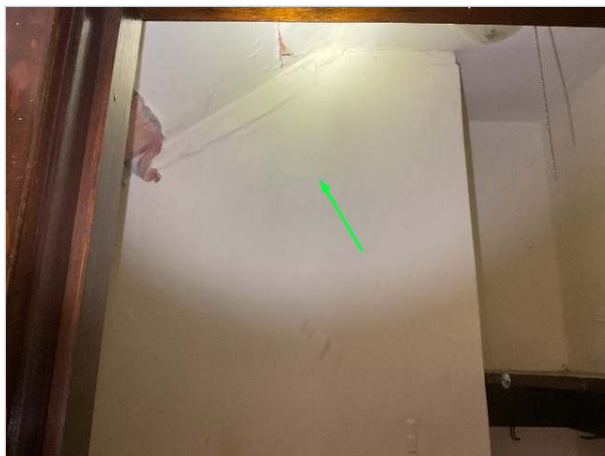
detection area - front chimney

Elevated levels of moisture with no surface damage was noted on the wall and ceiling in the left bedroom. The moisture appeared to be the result of previous leaks. No immediate action is required. The affected area (s) should be monitored for evidence of new leaks. Consult with a qualified contractor for repair if required.

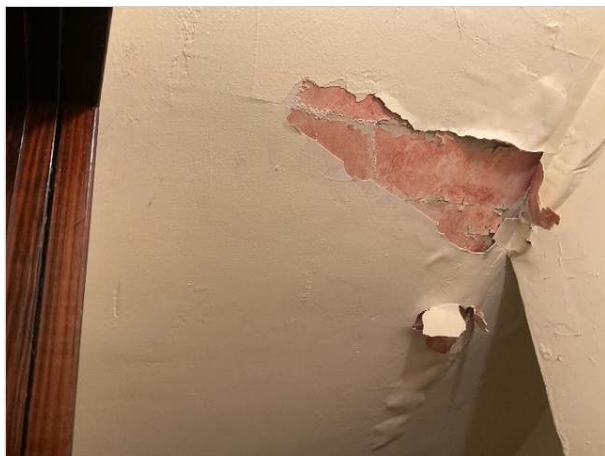
front bedroom closet

Cracked or bubbling paint was noted on the walls and ceilings in the bedrooms. This condition did not appear to be caused by water. There was no evidence of an active leak at the time of the inspection. Any damaged areas should be scraped, repaired, leveled and primed prior to applying a finish coat of paint.

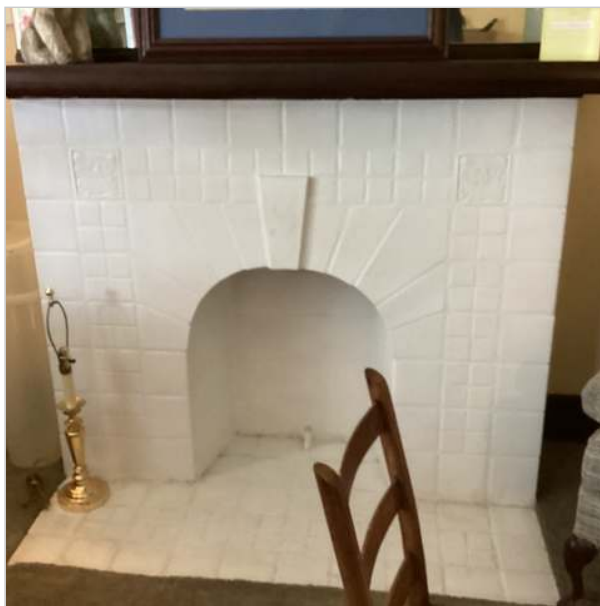
A decorative fireplace was located in the living room. The unit is not suitable for burning. No attempt should be made to burn any type of fuel in the unit. Consult with a qualified, reputable chimney and fireplace service for additional advice.

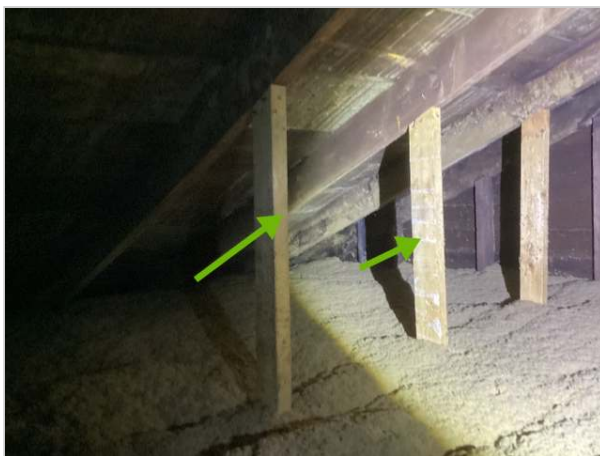
Evidence of previous adequate reinforcement

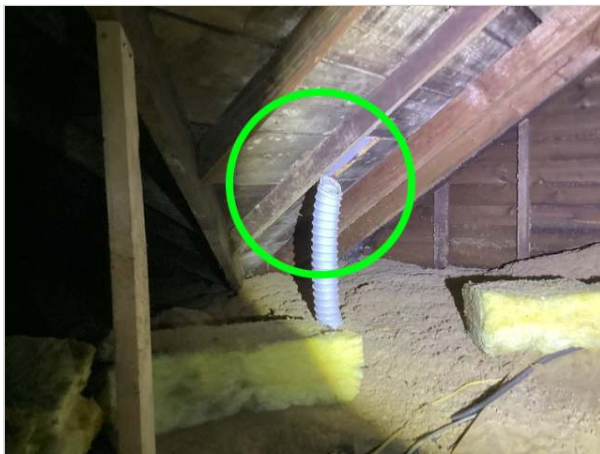
The full bath fan is discharging into the attic. Excessive moisture can build up in the insulation, creating a condition for mold growth. A duct should be installed from the fan exhaust to a roof vent.

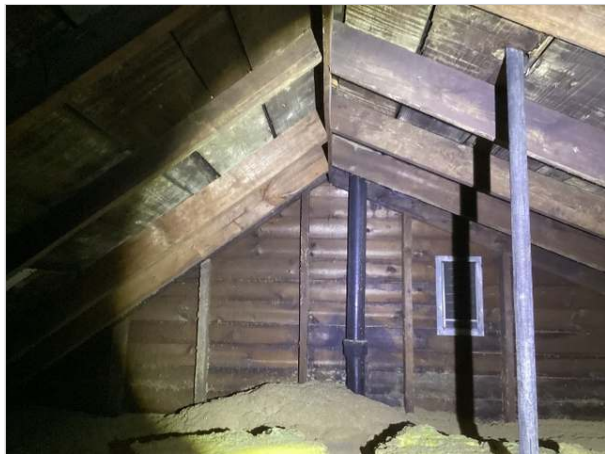
**NOTE: ROOF DECK:**

The roof deck as viewed from the attic is water marked. The cause of condition appears to be the result of questionable ventilation. Repairs to the affected areas are not required. Areas should be monitored during times of heavy rains for any changes or new watermarks.

Recommend upgrading ventilation at next roof replacement
