Property Inspection Report

1393 Washington Road, Pittsburgh, PA

DATE OF INSPECTION: 2/18/2026

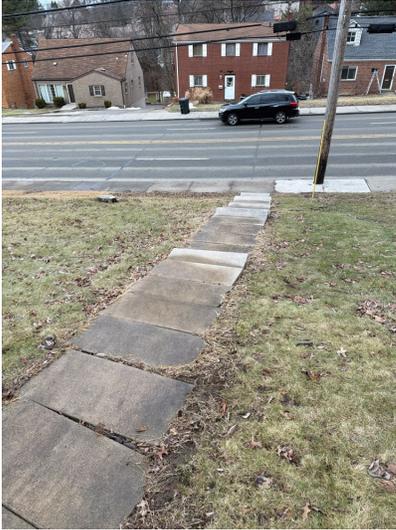
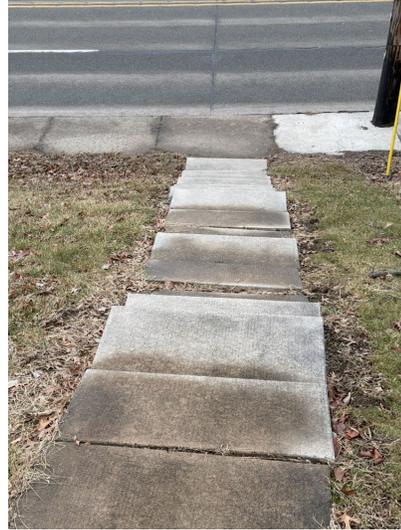
- Steps in front yard are damaged and need repaired or replaced by a contractor.

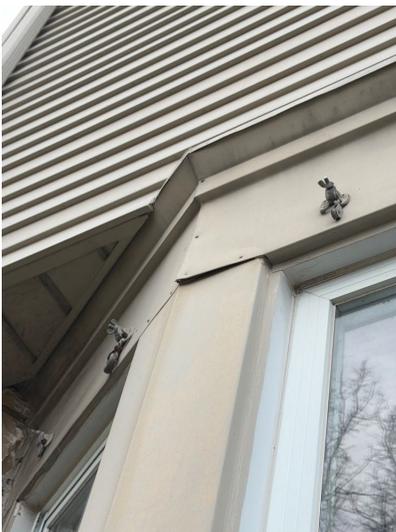
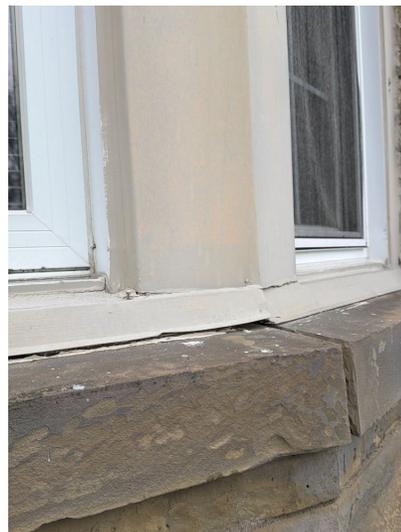
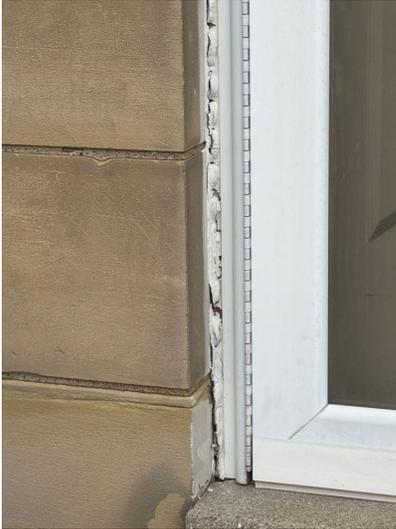
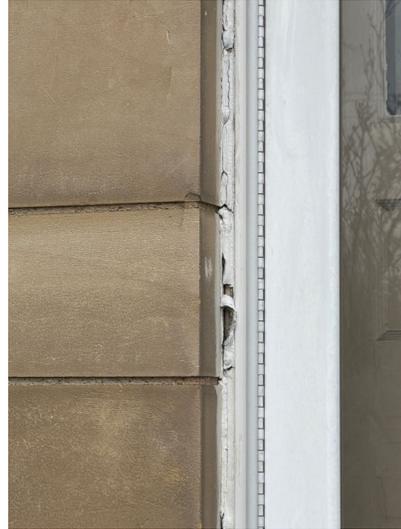
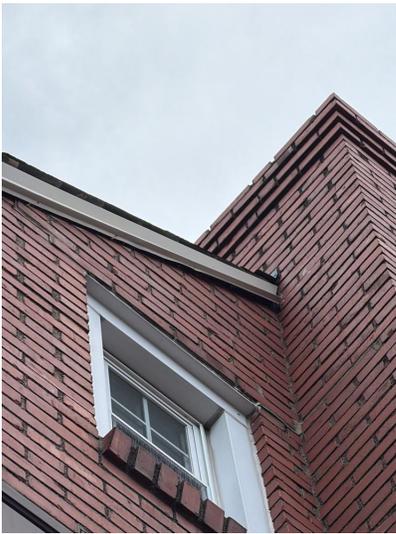
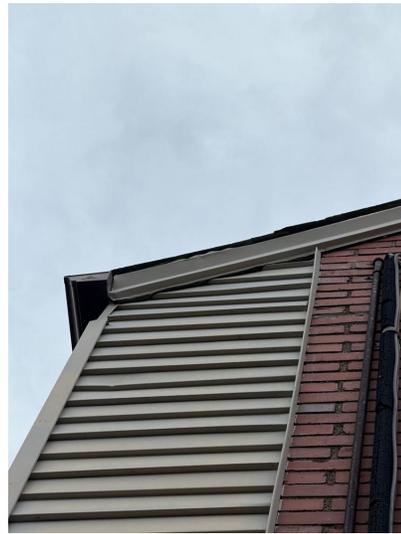
6. Exterior Trim

- There are areas of peeling paint and wood-rot visible on exterior of house. The peeling paint should be scraped and re-painted. Any areas of wood rot should be replaced.
- There are areas of damaged fascia or soffit that need repaired or replaced. A contractor should make repairs.
- Areas of trim are loose around several windows at the front of the house. Repairs should be made as needed.

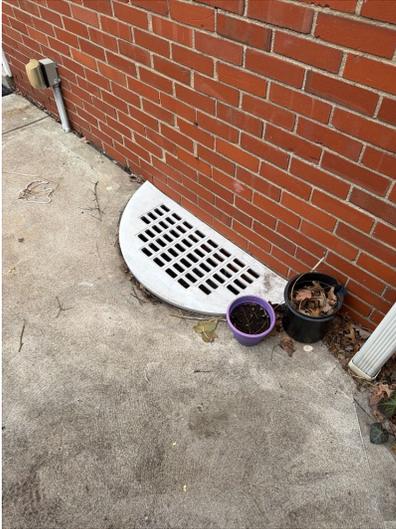
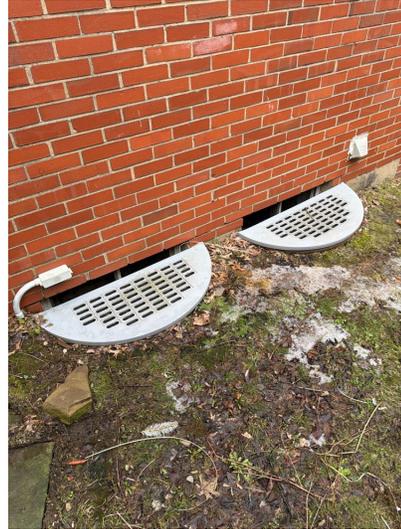
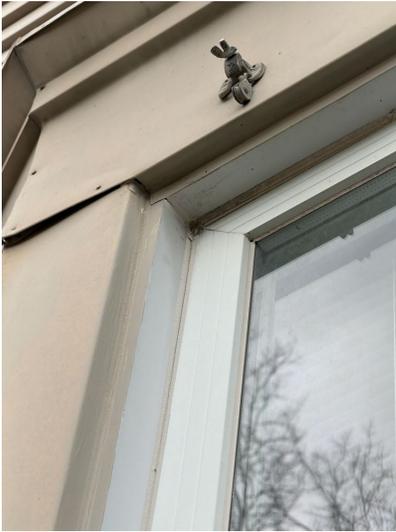
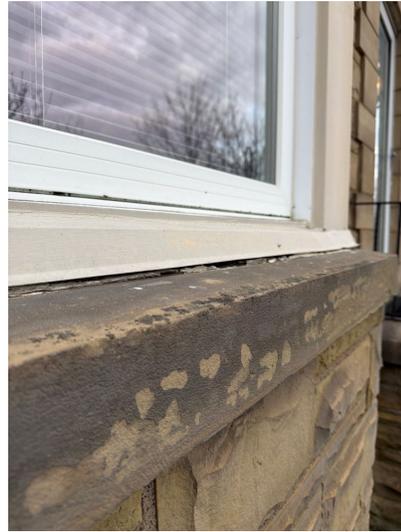
- We test every window that we can get to. You should be aware that the windows on this house are either original or at least very old.
- Some windows need to be recaulked in areas. This is a common maintenance repair that should be done to help with energy efficiency and to help prevent moisture penetration.
- There are areas of windows that are on or below grade that could allow water into the structure. You should consider adding a window well to these windows that are below grade, if they do not have one. If there is a window well, the well should be high enough so that the surrounding dirt slopes away from it.

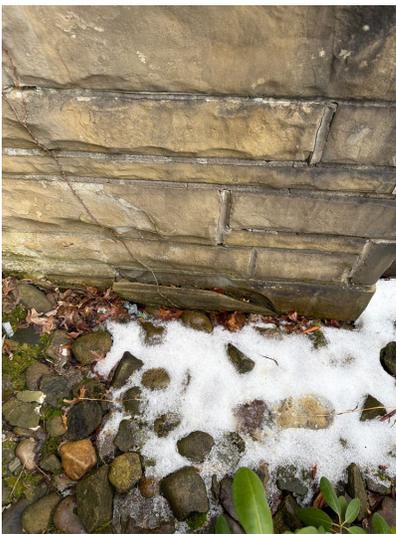
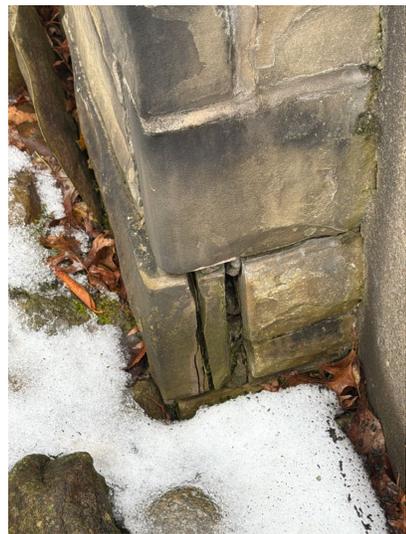
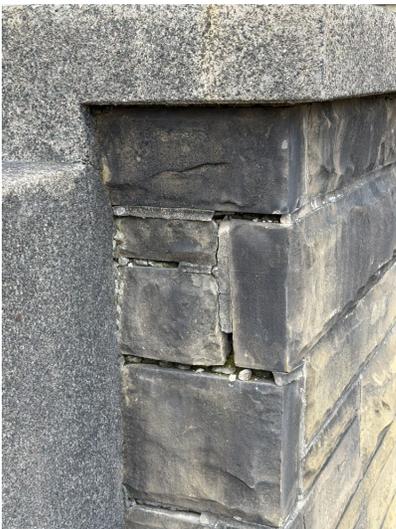
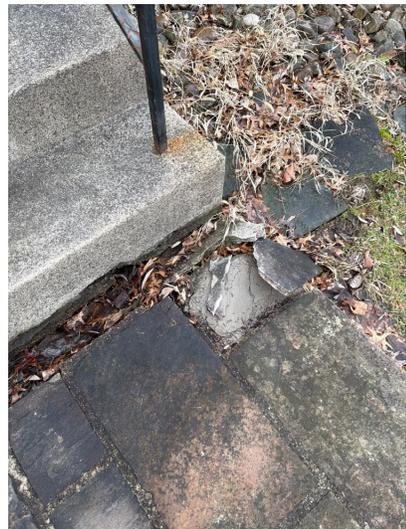
- The stem wall under front porch and landing has some missing mortar and damaged stone which should be repaired by a contractor.

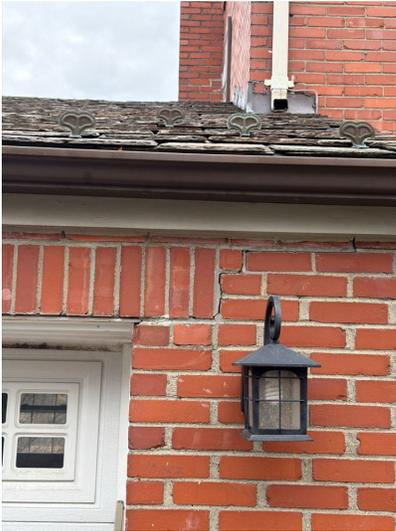
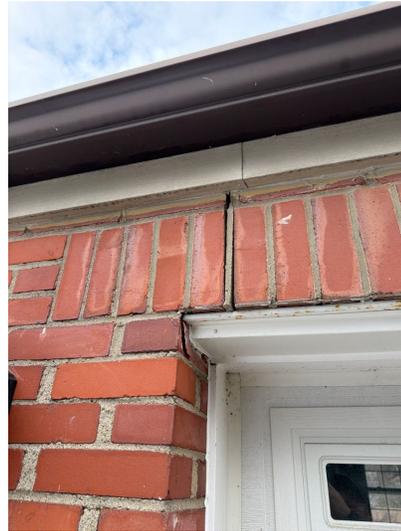
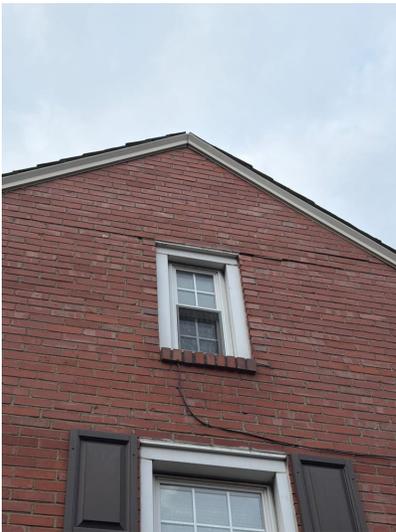
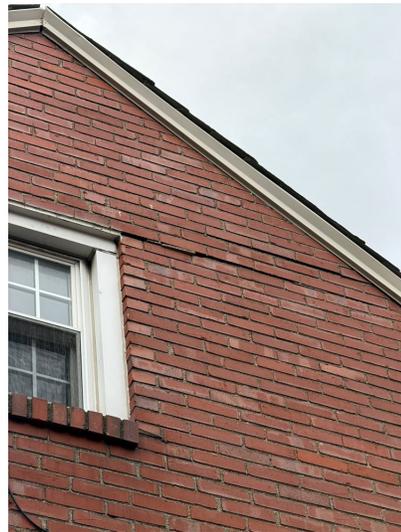
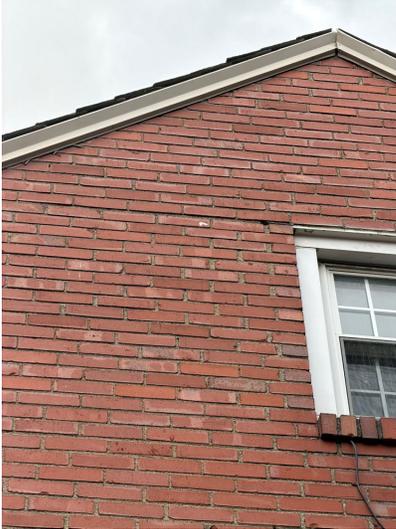
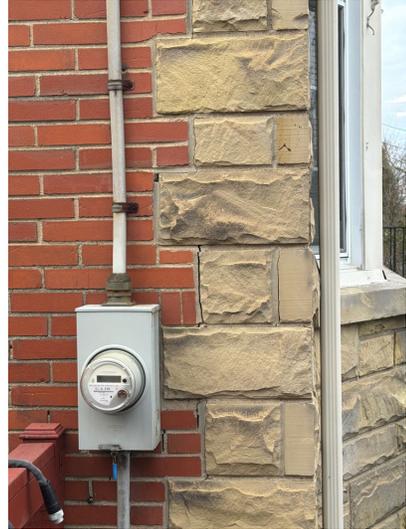
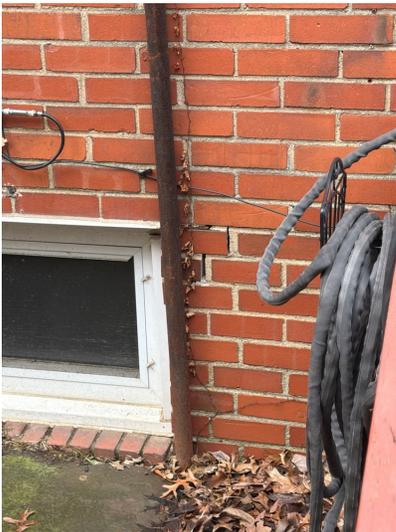
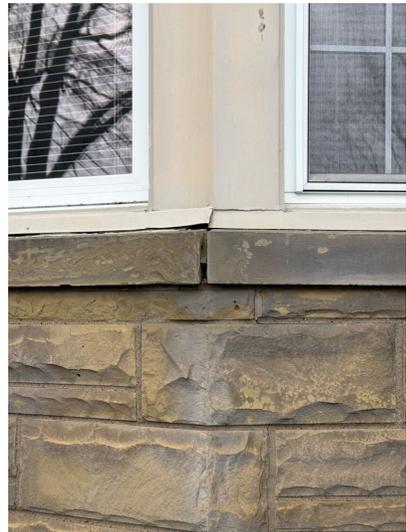
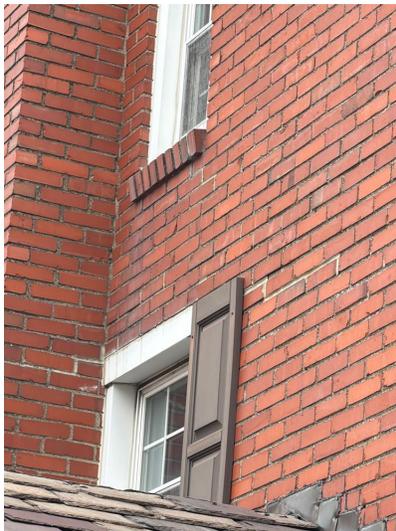
2. Wall Covering Condition

- Areas of missing mortar need repaired to help prevent further damage. A mason should evaluate the entire house and make all repairs needed.

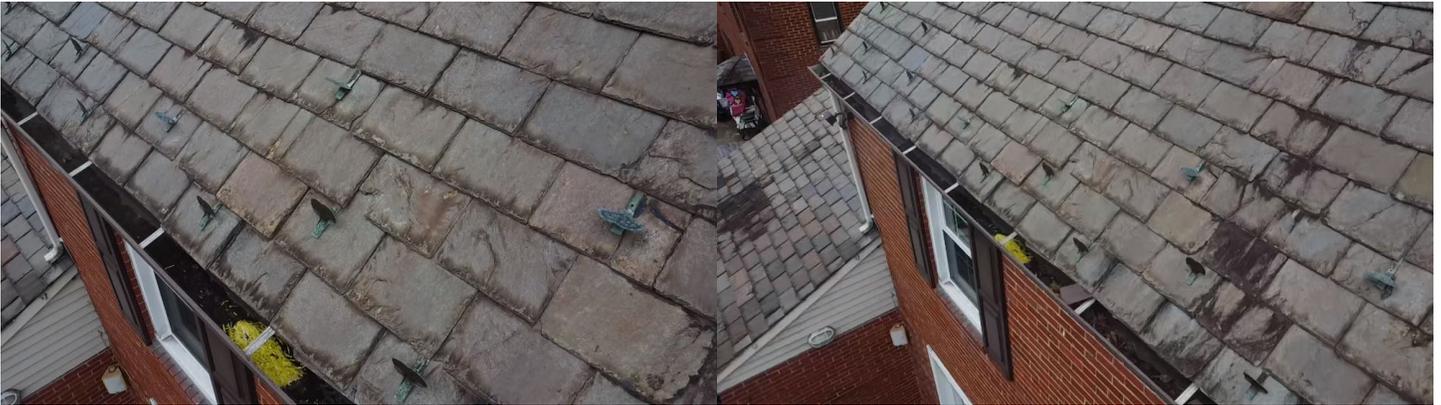
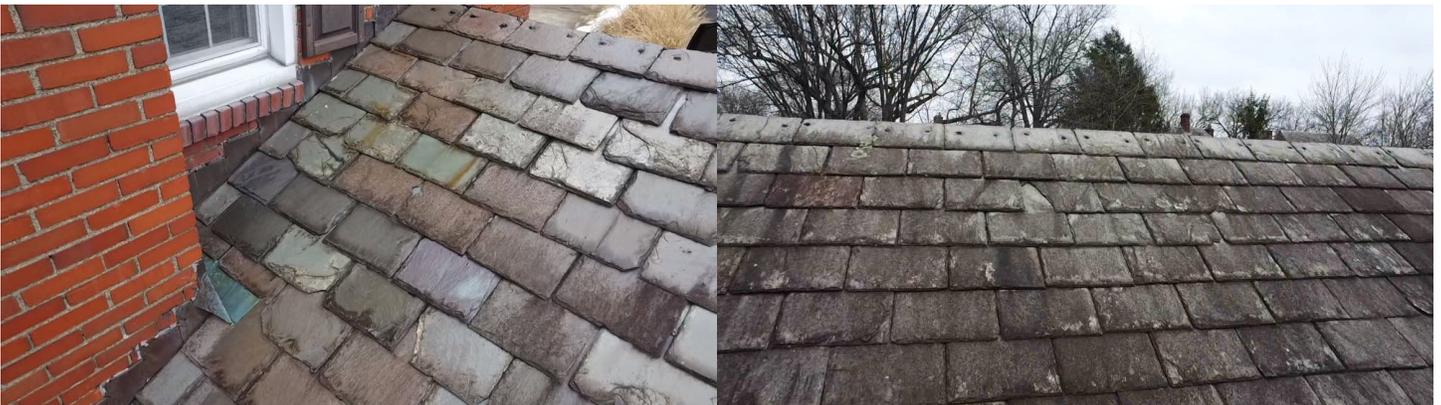
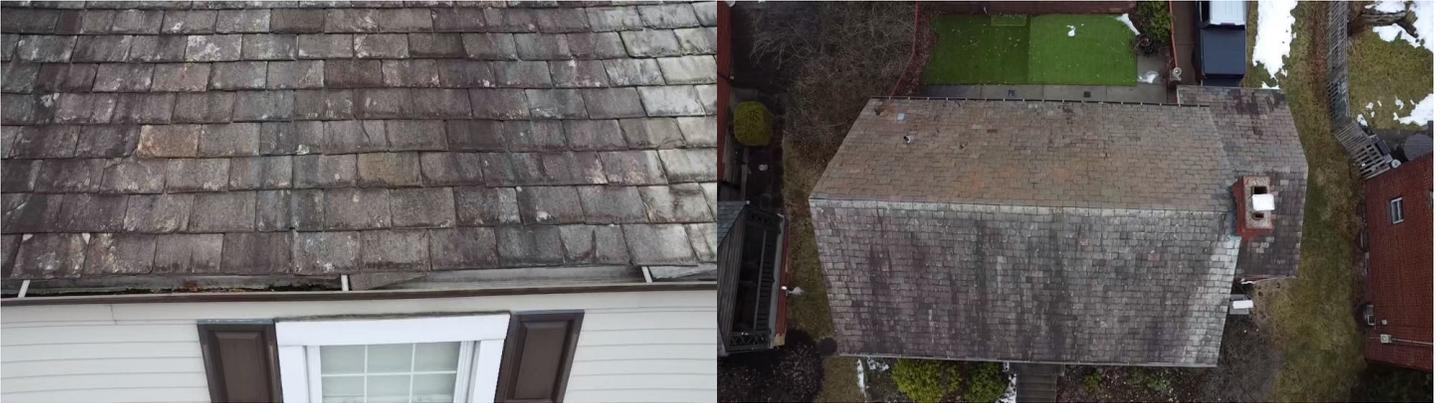
- The slate roof has areas of damaged, misplaced, or deteriorated slates and should be further evaluated by a specialist. A roofing contractor should further evaluate the entire roof system and its components. Repairs and regular maintenance are very important on a slate roof. A roofer should further evaluate and make repairs now and then evaluate annually and our inspection does not include any guarantee against leaks.

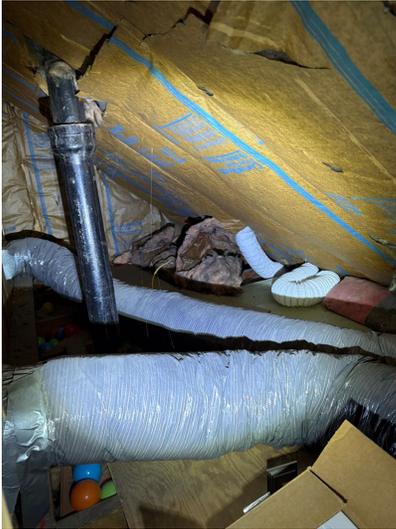
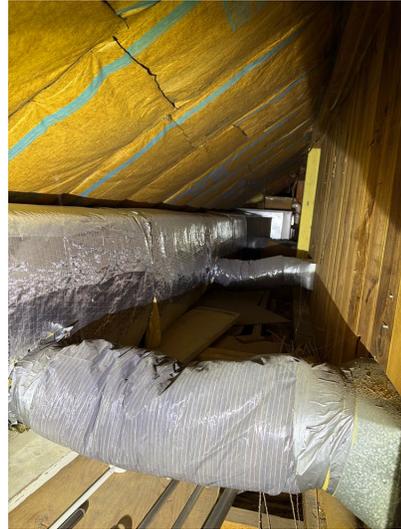
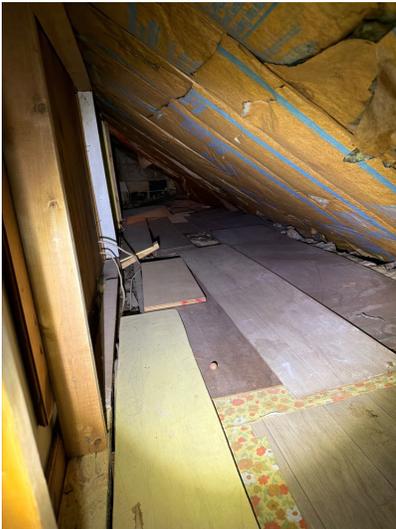
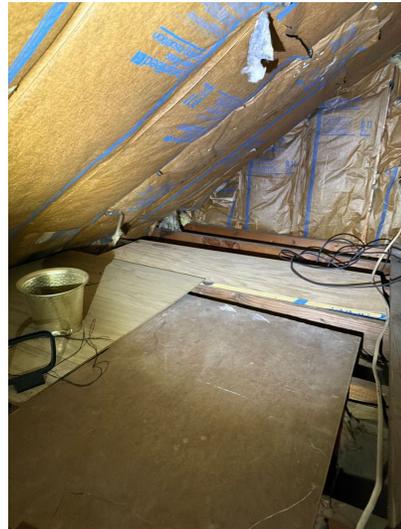
- The visible portions of the framing are in acceptable condition, and would conform to the standards of the year in which they were constructed.
- There are moisture stains or evidence of damage or past leakage to the roof sheathing. We did not feel that the stains were active at this time, although they should be monitored.

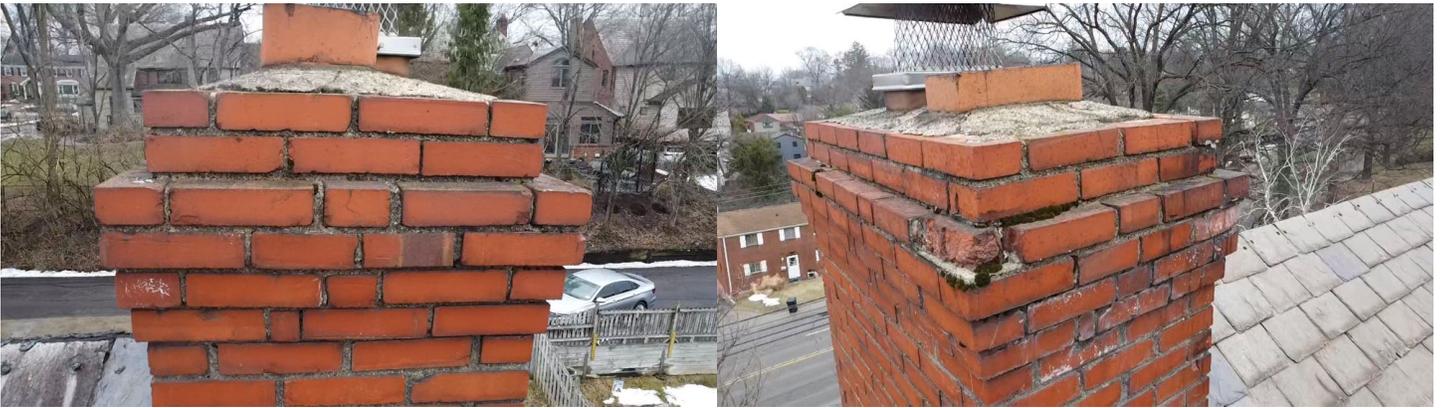
- The chimney has areas of missing mortar that should be repointed. A chimney sweep or qualified contractor should further evaluate each chimney and make repairs as needed.

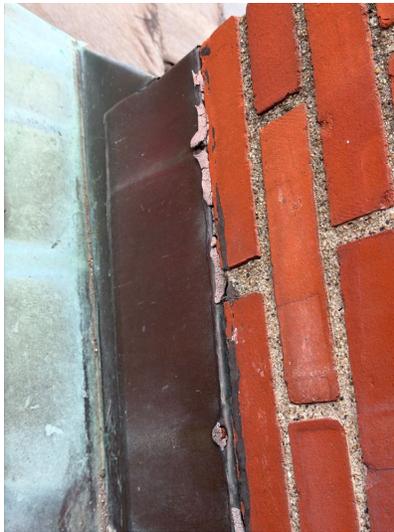
2. Chimney Flashing

- The flashing of the chimney has areas that need to be resealed to help prevent moisture penetration, a roofer should evaluate.

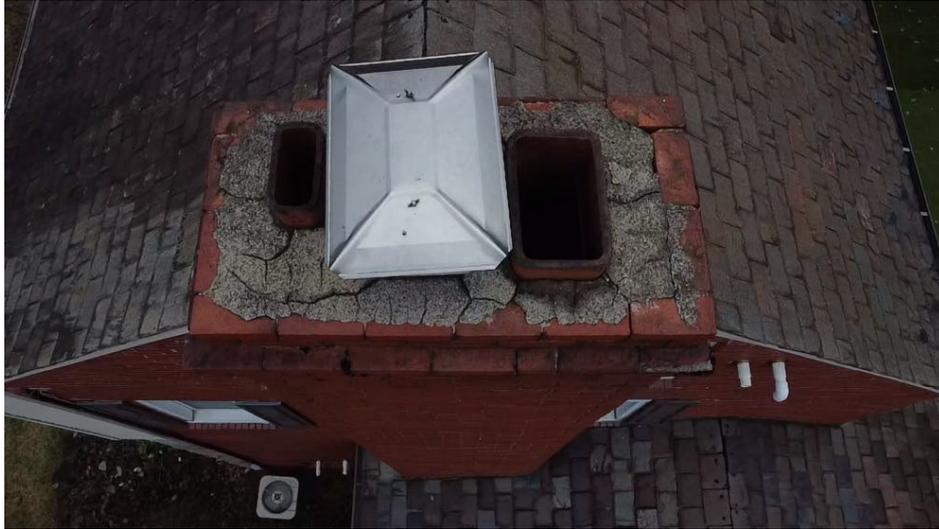
3. Chimney Crown

- The chimney crown, which is designed to seal the chimney wall and divert rainwater, is cracked and should be repaired to help prevent moisture penetration. A qualified contractor or chimney sweep should further evaluate and make repairs as needed.

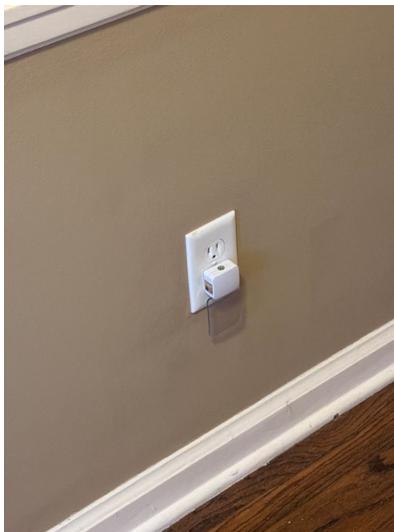
- One of the outlets, on the second floor, is wired with an open ground and should be repaired by an electrician.

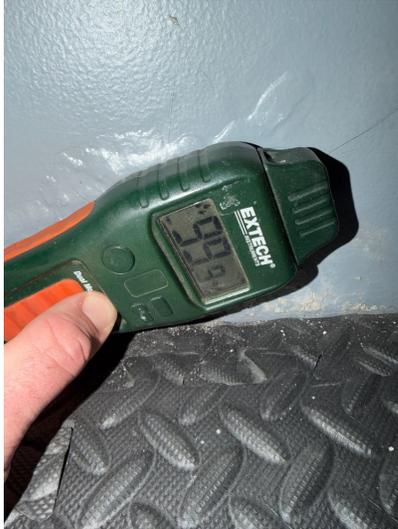
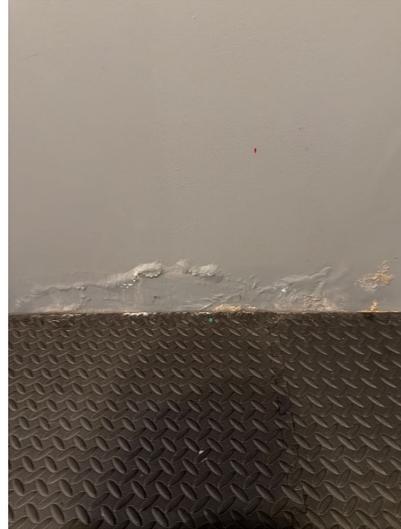
- There is a moisture stain on the wall that showed to be active and should be further evaluated by a contractor. The source of the stain should be repaired.

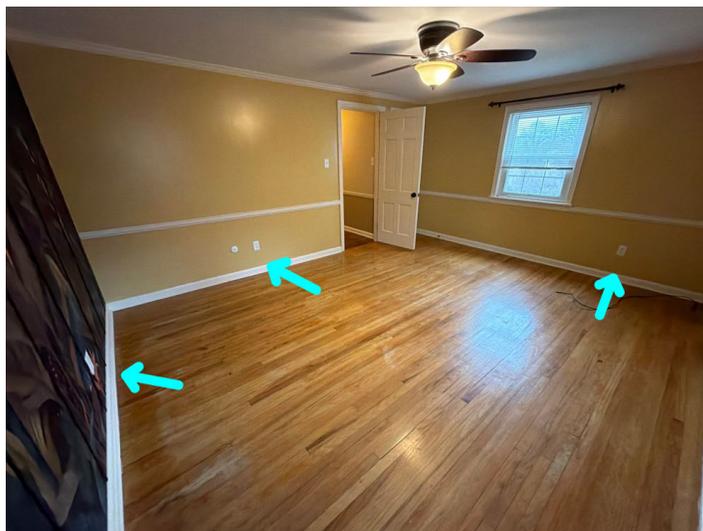
- Several of the outlets are wired with an open ground and should be repaired by an electrician.

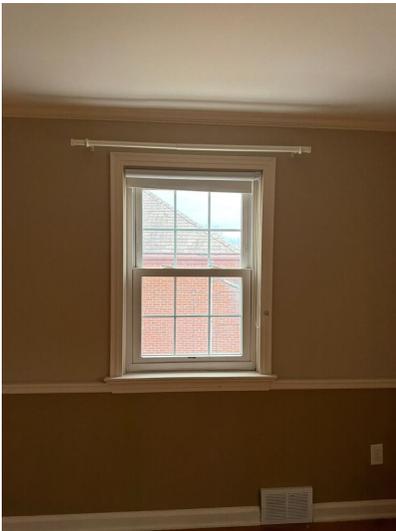
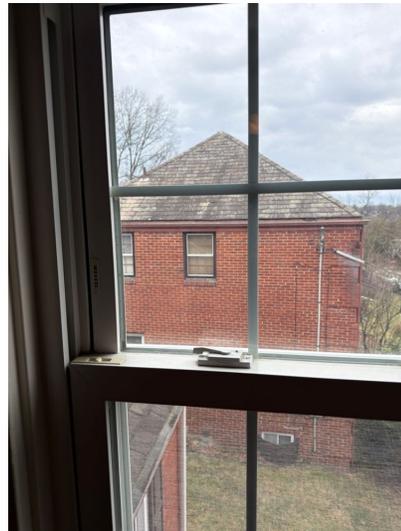
- The windows in this room are dual glazed.
- A dual-glazed window has a broken hermetic seal that has fogged the glass.

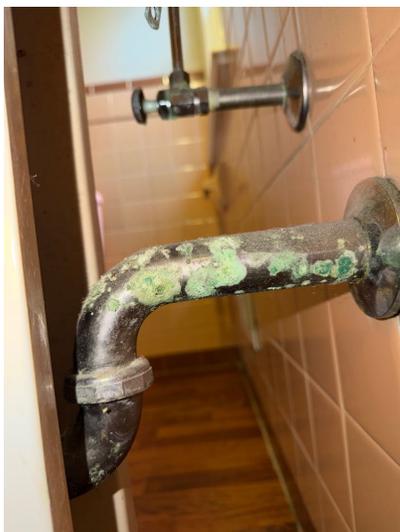
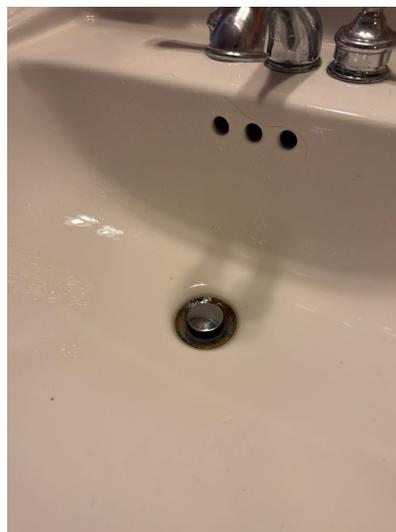
- The sink drain, although not leaking, is corroded. You should consider replacing this drain before a leak occurs.
- The mechanical sink stopper does not function properly and should be repaired or replaced by a plumber.

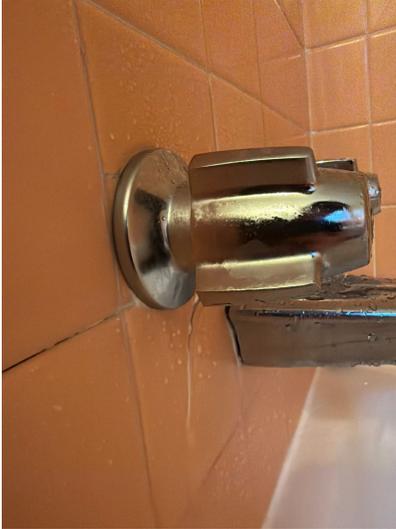
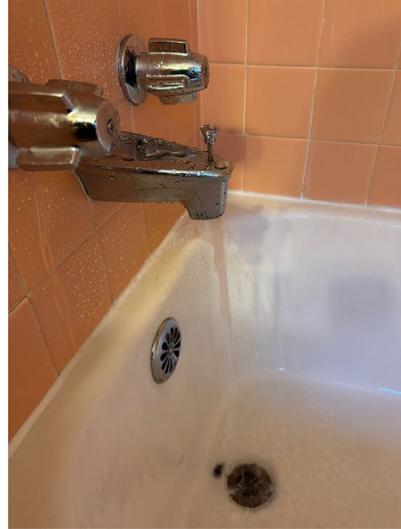
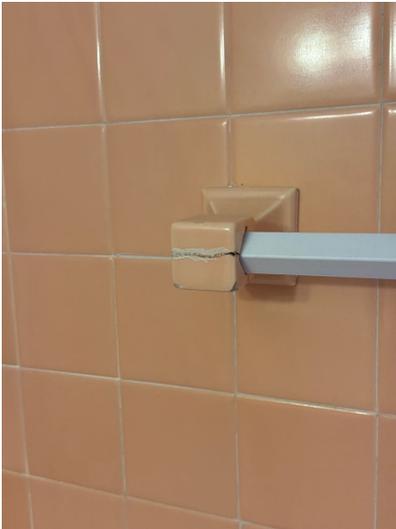
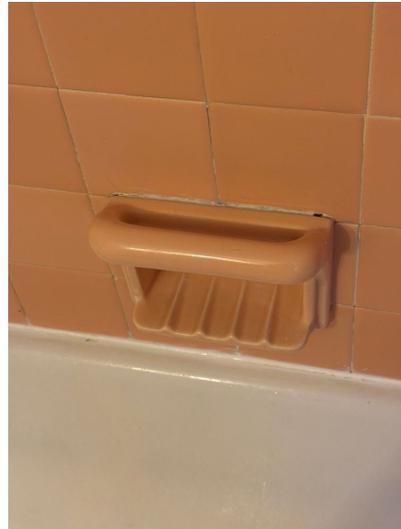
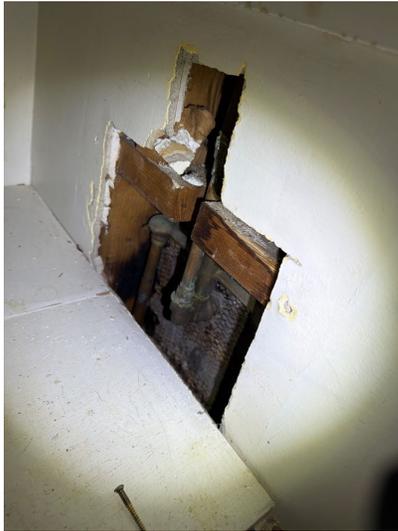
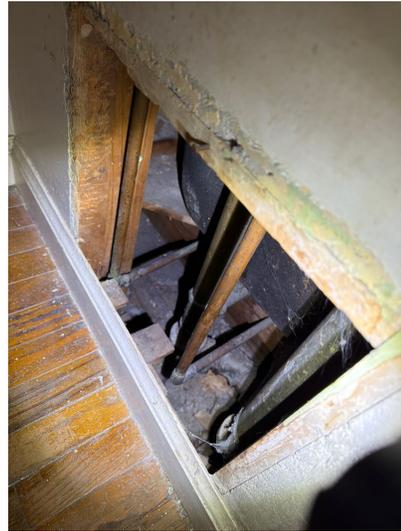
7. Bathtub/Shower

- The access area behind the tub was evaluated and there were no visible leakage at the time of the inspection.
- There are cracked or damaged tiles around the tub area that should be repaired to prevent moisture damage. A contractor should further evaluate and make repairs as needed.
- The tub/shower handles leak and should be serviced. A plumber should further evaluate and make repairs.
- The shower diverter does not divert the water fully to the shower head while engaged. A plumber should further evaluate and make repairs as needed.
- Tub should be caulked to help prevent water damage at the tub-wall and tub-floor joint.

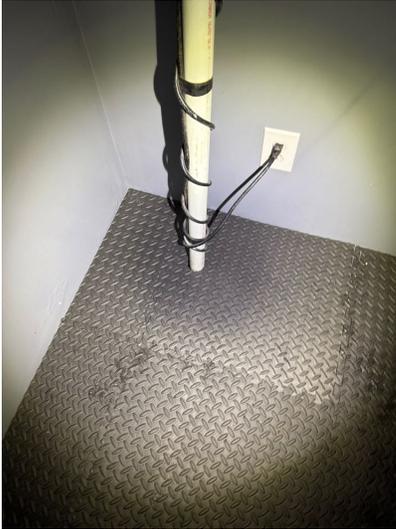
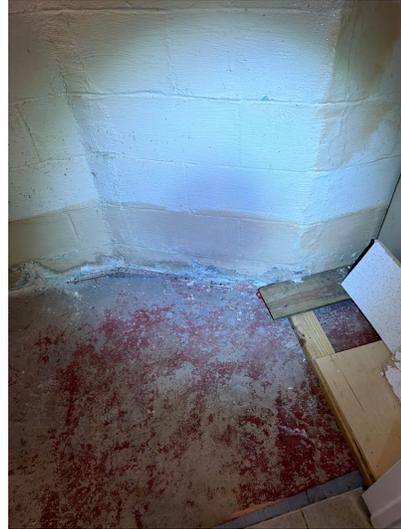
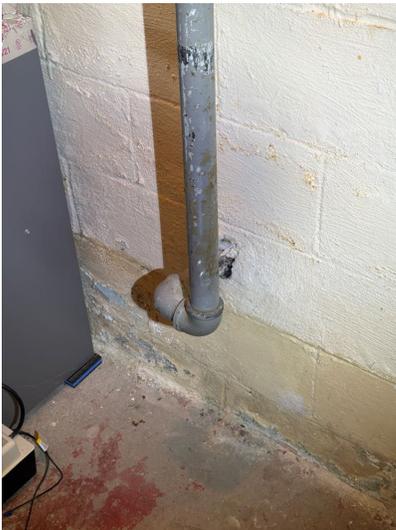
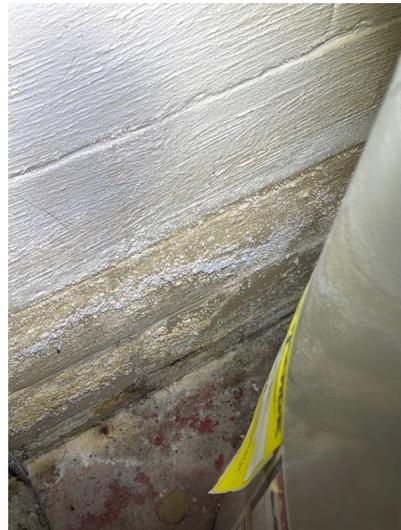
2. Moisture or Dampness

- In this basement, there is a switch activated sump pump. It was tested and found to be functional. I recommend asking the current homeowner for more information on this system such as date of install, location and distance covered by a french-drain or system serving the sump pit, and also if there is a current warranty.
- There is efflorescence or staining on the basement or lower level walls, which is caused by moisture intrusion. This in our area is not uncommon, however, it should be controlled. The exterior grading around the house should be built up to slope away from the house at a drop of 5 inches over 5 feet. As with most basements, you should know that future moisture penetration is possible.

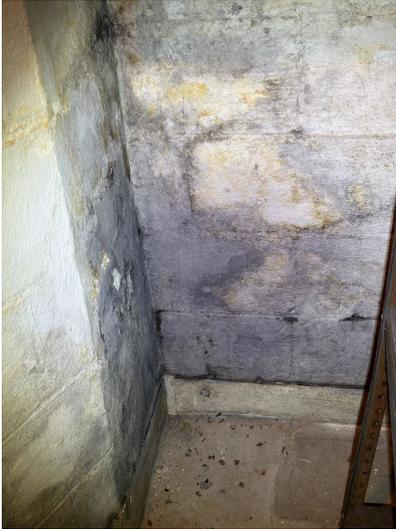
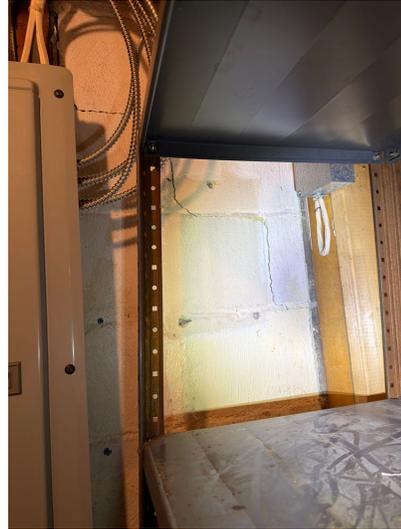
5. Foundation

- The foundation is made of block.
- Most of the foundation is covered with drywall or other finish material, which limited my ability to inspect for moisture or structural movement.
- There are areas of cracking or movement in the foundation walls. In most cases this is from moisture freezing against the wall, expanding, which is causing a shift at the wall. This is also called hydrostatic pressure. There are areas of movement at some walls at this property however, I do not feel that they are necessarily an issue that need repaired or evaluated by a certified contractor at this time. However, you may wish to have a specialist evaluate. If the moisture is not controlled, as noted in the grading section of the report, then future repairs should be expected in these areas of the basement.

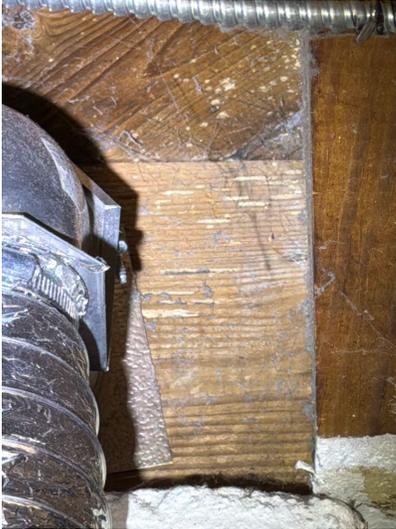
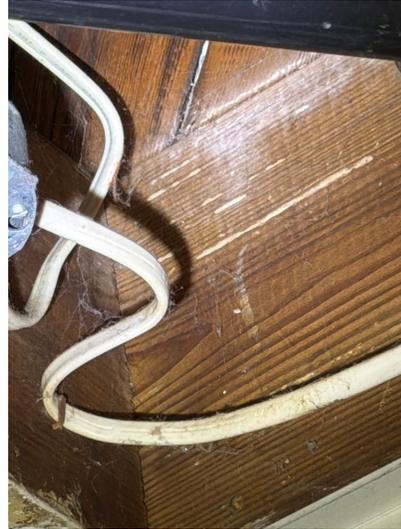
Floor Framing Style		
Page 41 Item: 1	General Comments and Description	<ul style="list-style-type: none"> There is visible termite evidence to floor structure in basement. In my opinion structural repairs are not necessary at this time. It should be treated, if recommended by the pest inspector, and kept under an active warranty to help control the termites and closely monitored.

- The floor structure includes structural steel beams and conventional lumber sheathed with wood.
- There is visible termite evidence to floor structure in basement. In my opinion structural repairs are not necessary at this time. It should be treated, if recommended by the pest inspector, and kept under an active warranty to help control the termites and closely monitored.

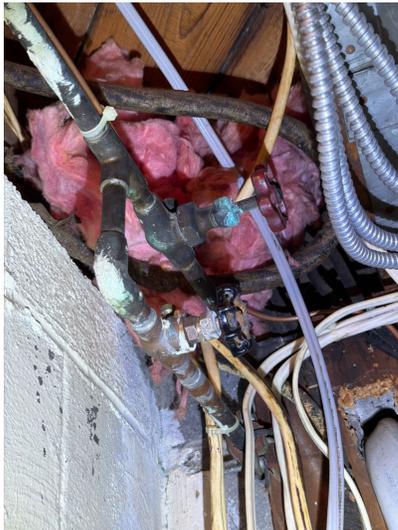
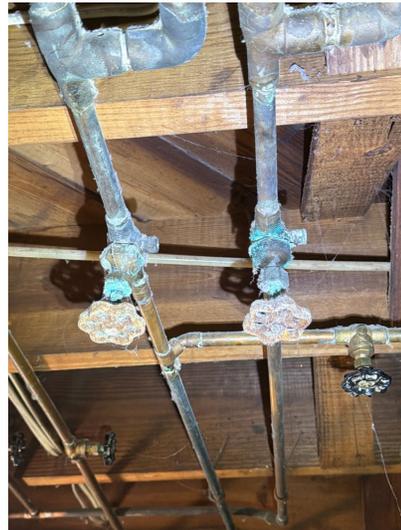
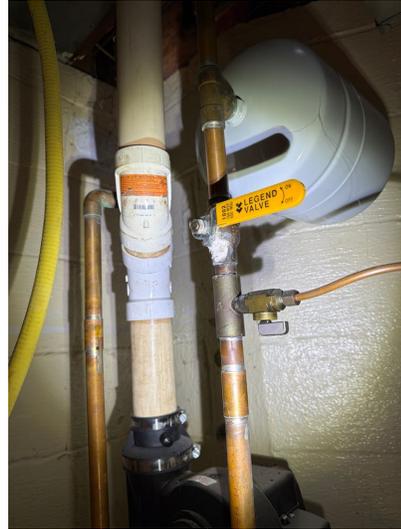
3. Water Pipe Condition

- There are valves in basement that are significantly corroded. Although not leaking now, these corroded pipes should be replaced by a plumber.

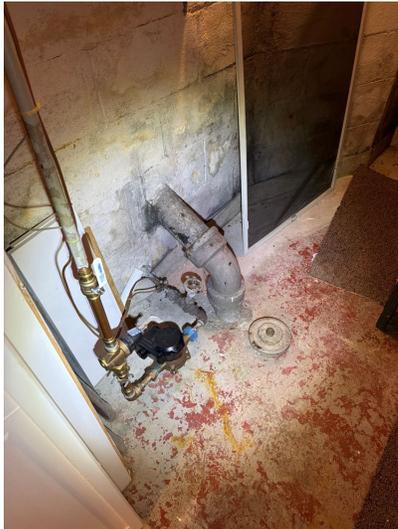
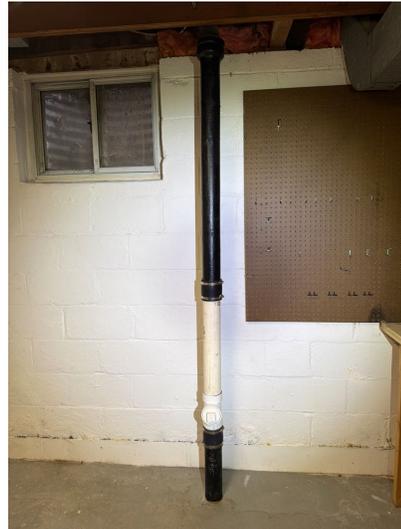
3. Drain Pipe Condition

- The basement floor drains were tested and found to be functioning satisfactory. We dump a large amount of water down each accessible drain to ensure that water does flow properly past these drains.
- Areas of the plumbing drains have been updated to plastic.
- Plumbing drains are older in areas and should be monitored, repairs may be needed in the future.
- All areas of the main stack or other components of the plumbing drain system were not visible for inspection. Some areas were behind walls and buried.
- We strongly recommend carrying underground pipe insurance on your home. This can help cover costly repairs to the home underground sewer lines and utilities. In most cases, you own all utilities from the house out to where it ties in at the main/street.

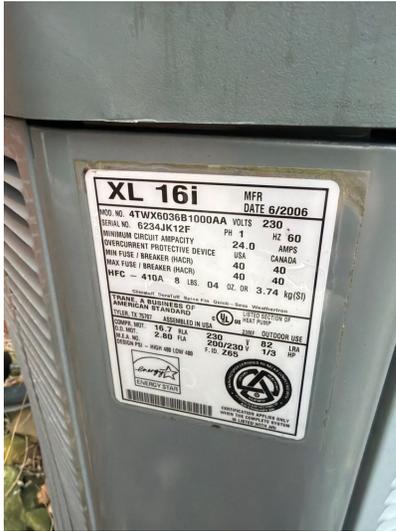
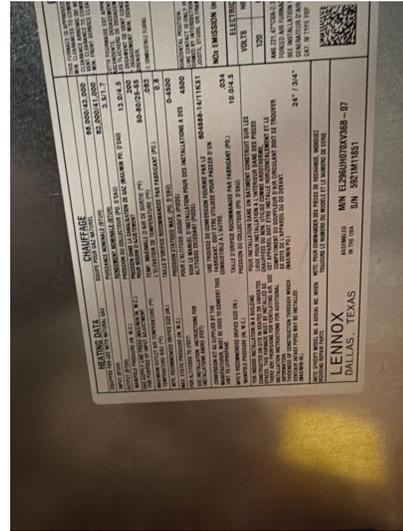
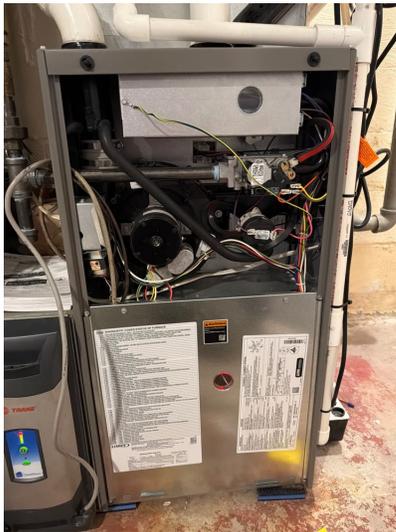
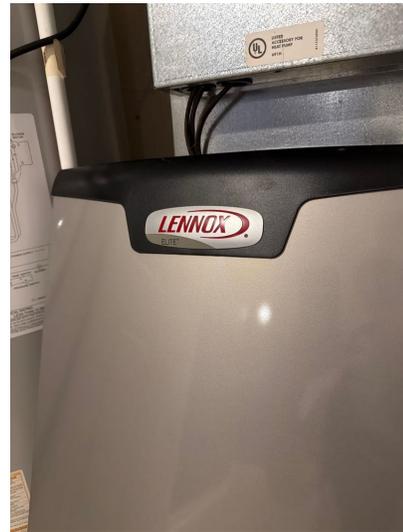
• Central heat and air-conditioning is provided by a 20 year-old heat pump, that is located outside, with an air-handler located in . It responded to the request for heating, but was not tested on the cooling cycle because the ambient temperature is too low and to do so could have damaged the coil.

• This heat pump system includes an additional heat source, which is considered "Emergency Heat". It is a forced air gas furnace and was tested and found to be functioning at the time of the inspection.

This furnace is a 5 years old and 66,000 btu's.

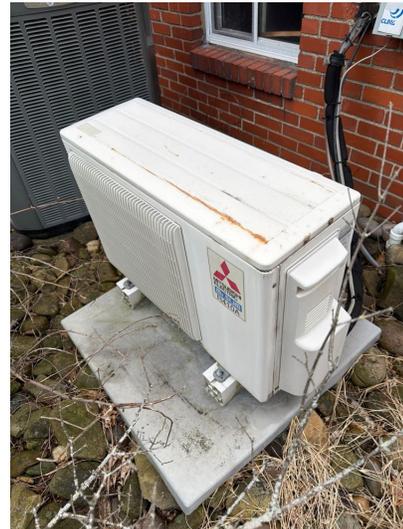
- There was a 23 year old split system air conditioner installed. This system was tested and appeared to function properly at the time of the inspection.

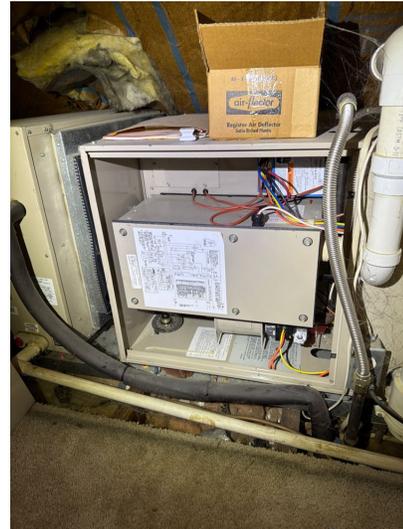
- The furnace is functional. However, it is beyond the commonly accepted design life of twenty years, and will need to be monitored more closely for evidence of metal fatigue. Future repairs or replacement should be expected and budgeted for.

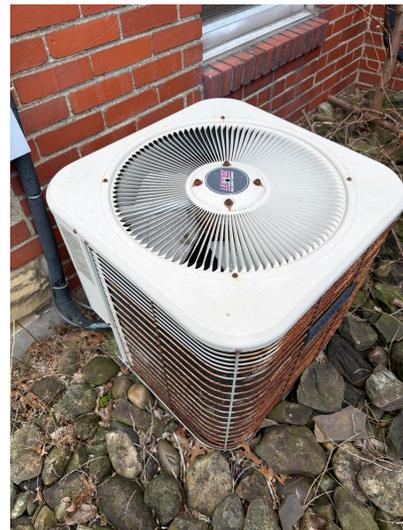
- The condensing coil is beyond its designed life and should be monitored in the future. You should expect that repairs or replacements will be in the close future.

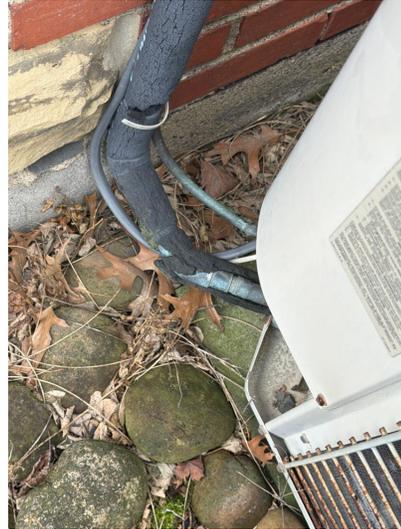
9. Refrigerant Lines

- Insulation is missing from the refrigerant lines, which will allow condensation to form and drip as well as lessen the efficiency of the system, and should be installed.
