**1240 Hillsdale Ave**

**RE: Pittsburgh, PA 15216**

**Inspection #: 527-082025-6463**

### *HOME INSPECTION REPORT*

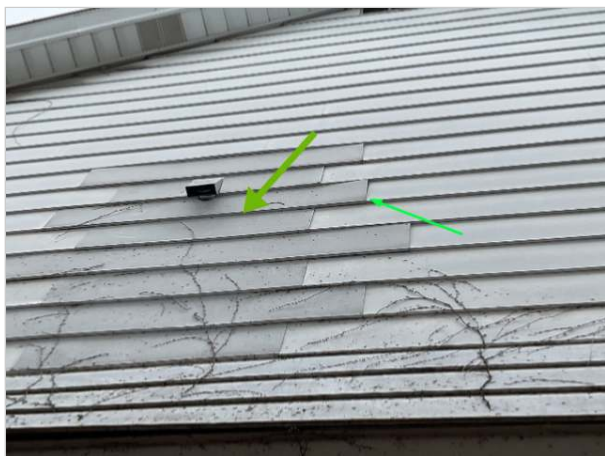
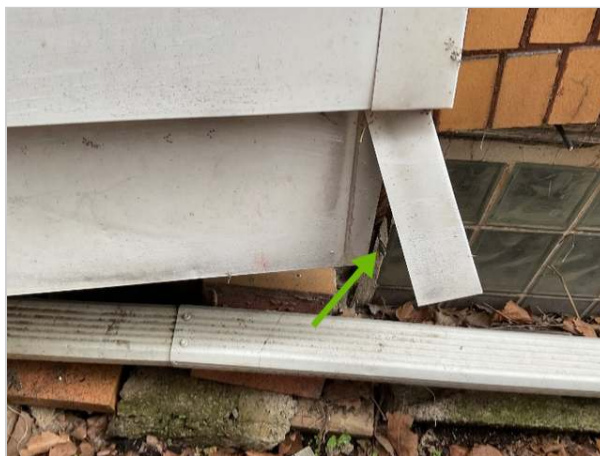
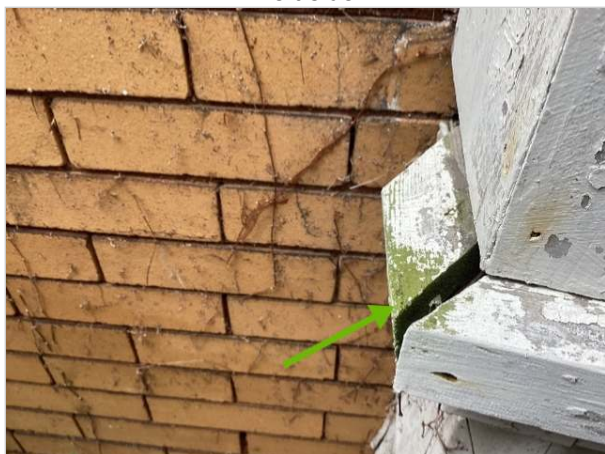
Loose siding was noted on the left side of the home. The siding should be reattached.

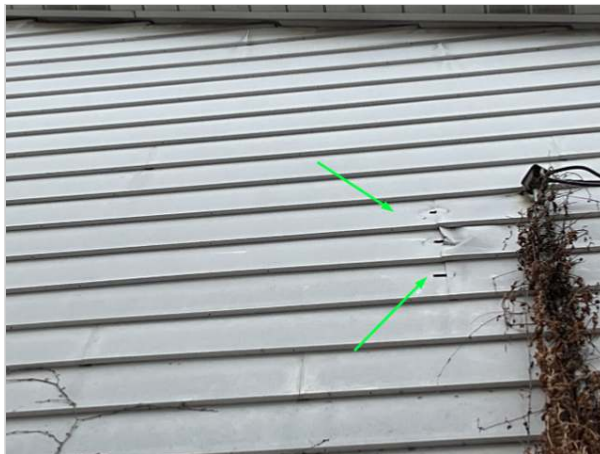
Holes were noted in the siding on the left side. This condition does not impact the structural integrity of the building, but can lead to water intrusion. Repairs should be made by a qualified contractor.

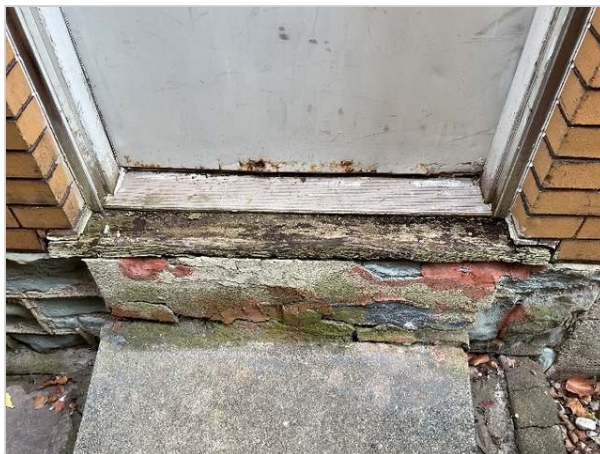
Rotted wood was noted on several areas . The areas should be repaired and sealed by a qualified contractor.

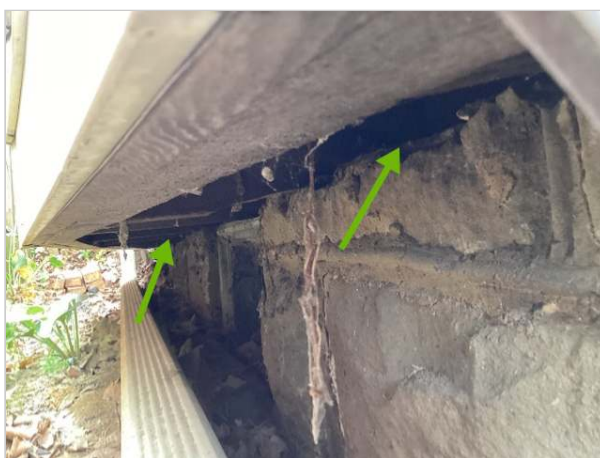
The underside of the build out on the left side is not sealed. This can lead to cold weather intrusion. Repairs should be made by a qualified contractor.

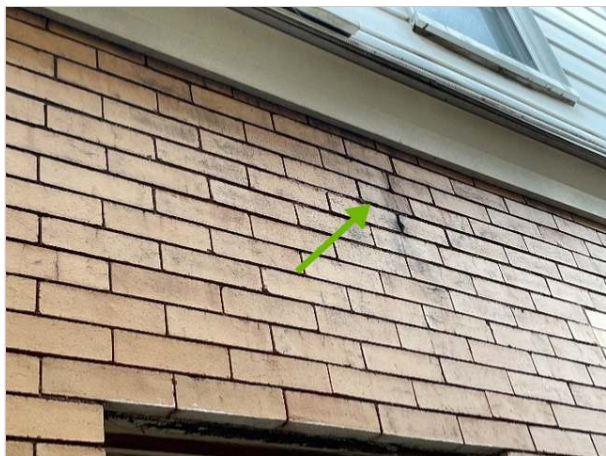
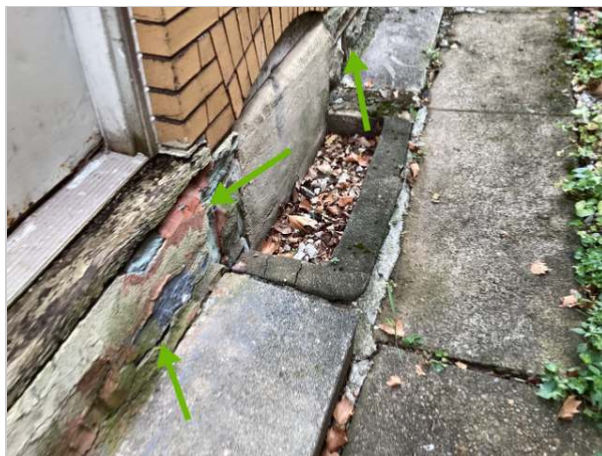
Missing mortar was noted on the brickwork on several areas of the home. There were no loose bricks noted. Small amounts of missing mortar are usually inconsequential. Extensive amounts of missing mortar can permit water intrusion. Consult with a qualified masonry contractor for repair estimates.

Recommend feeling along right side foundation wall

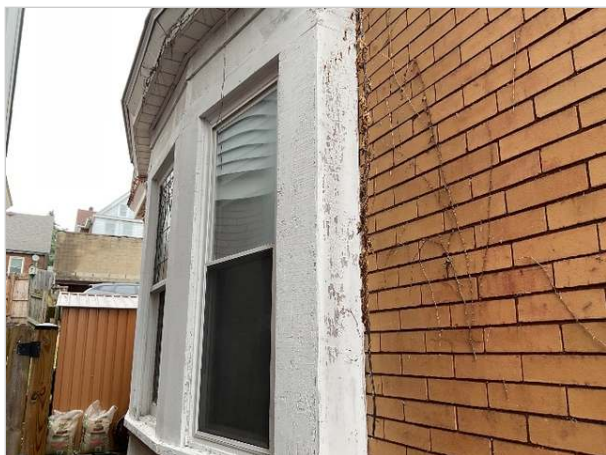
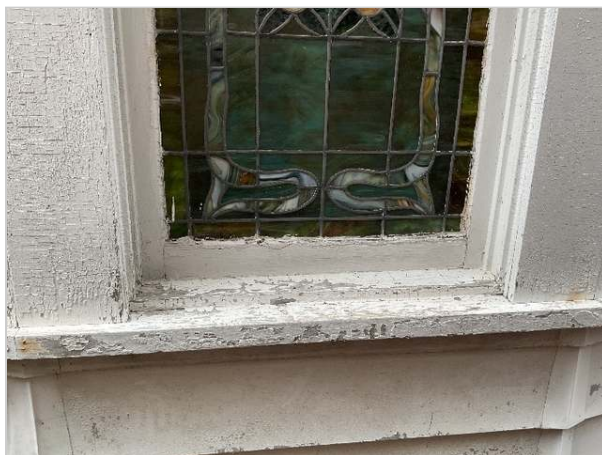
Peeling paint was noted on many areas of the exterior. In order to preserve the life of the exterior surfaces and materials, all areas should be scraped and painted.

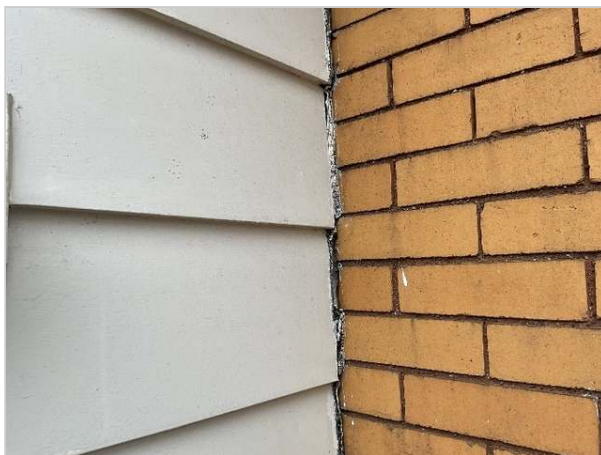
The exterior caulking around the windows and doors is cracked or missing on all sides of the home. The caulking should be replaced to ensure the exterior of the home remains weather and water tight.

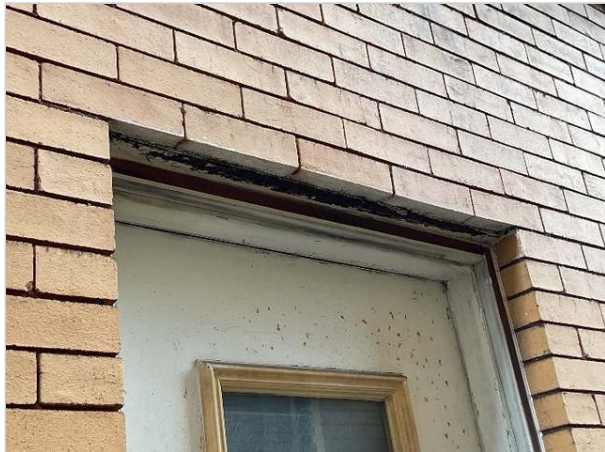
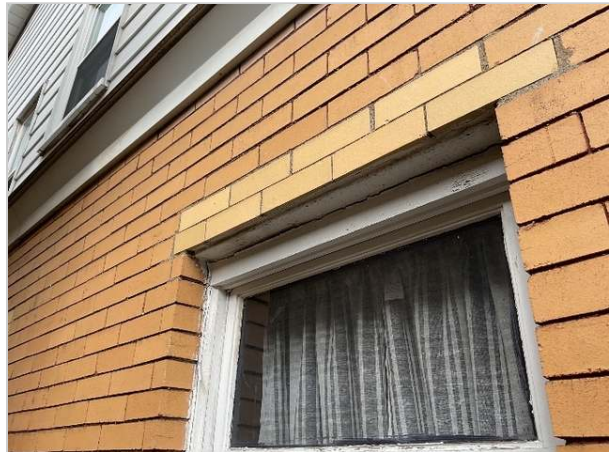
One or more of the steel lintels above the windows on the exterior of the home were noted to be rusting. Lintels support

masonry materials above doors and windows. Keeping the lintels sealed and painted will prevent rusting and expansion. Expanded lintels can lead to cracks in the masonry on the exterior of the home.

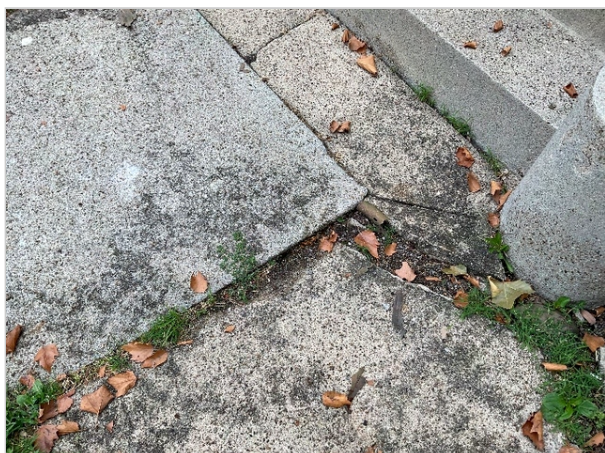
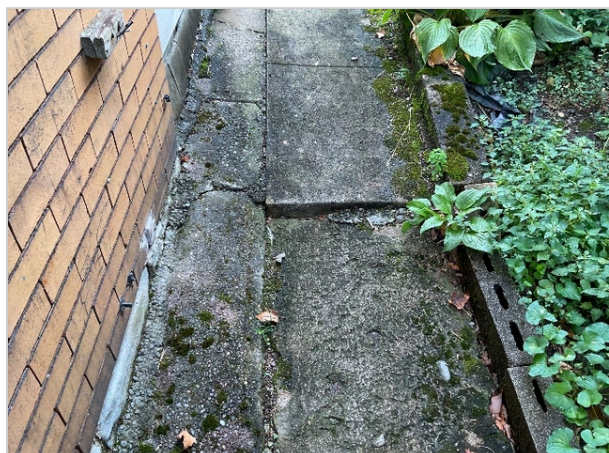
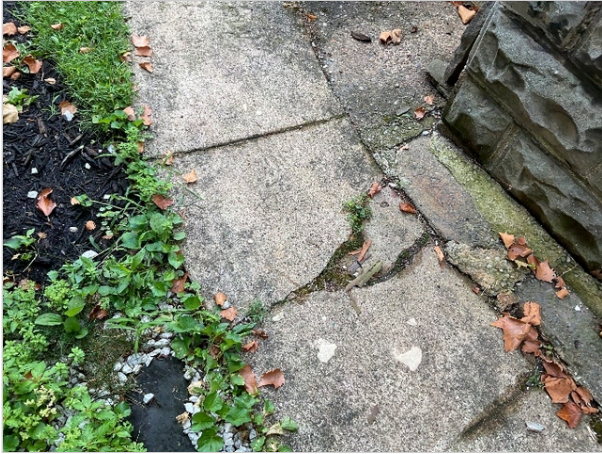
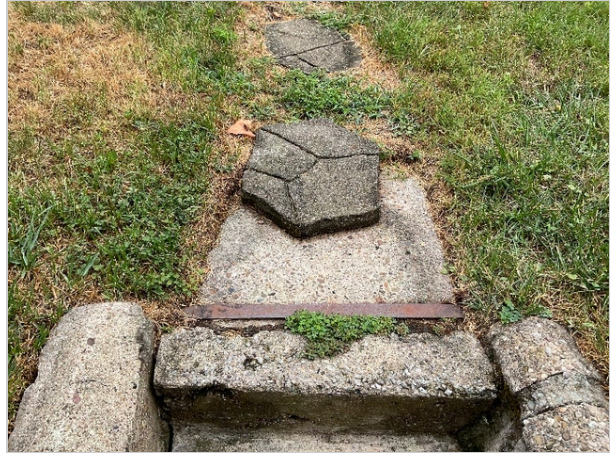
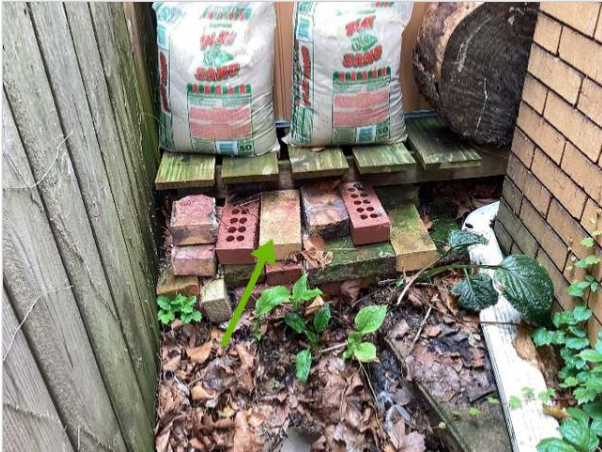
There were several trip hazards found on the walkways around the house. The hazards can be repaired using a suitable or similar surfacing material to "feather" the out-of-level condition to make a smooth transition.

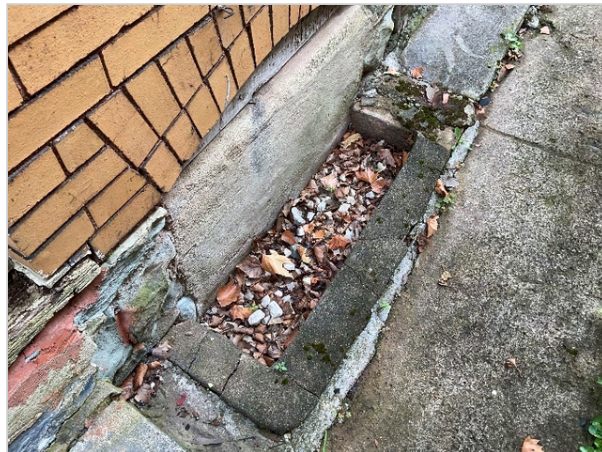
There is no barrier installed at the window wells. The absence of a proper rail or barrier constitutes a fall hazard and should be corrected. Consult with a qualified contractor for installation of a proper barrier.

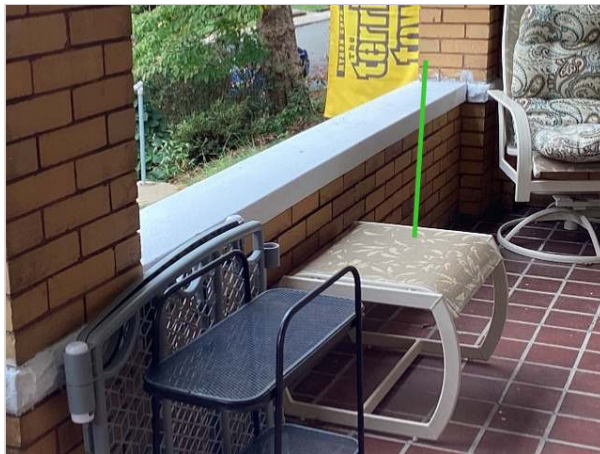
The front porch rail is too low in height by today's standards. The rail should be a minimum height of of 36 inches with vertically mounted balusters spaced no greater than 4-inches apart. Consult with a qualified contractor for repair estimates.

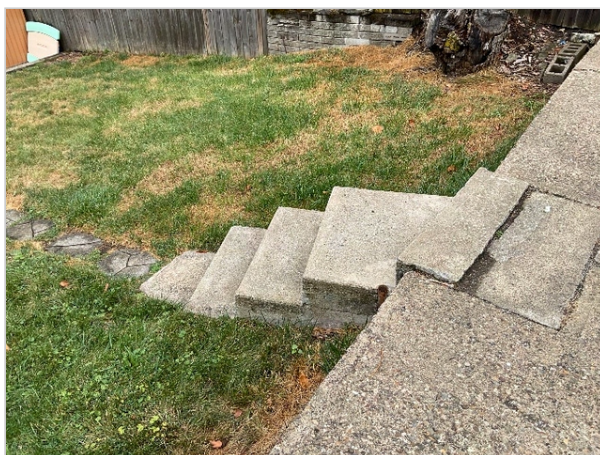
There were no handrails on the steps leading to the parking pad. Local codes may require the installation of handrails in location where three or more steps are present.

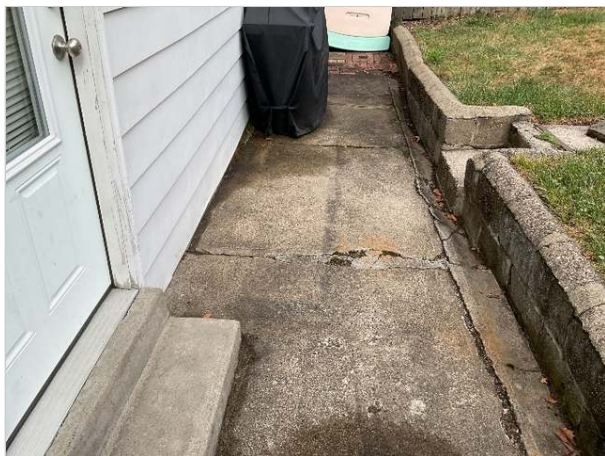
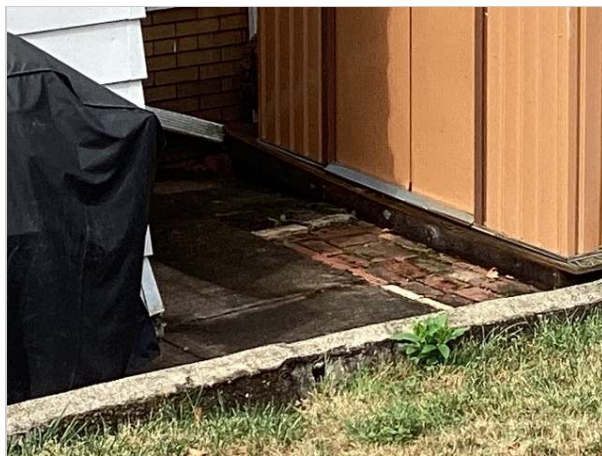
Settlement was noted on the back patio slab. The settlement does not appear to be active. Settlement of concrete slabs is common and is usually not a problem. If the settlement causes the concrete slab to pitch toward the foundation of the home, it is possible that water will drain into the basement. In this case the slab was pitched toward the foundation. It is not possible for us to positively determine if active settlement is occurring during a home inspection. The area should be monitored for evidence of new or continued settlement. Consult with a qualified contractor for further evaluation if required.

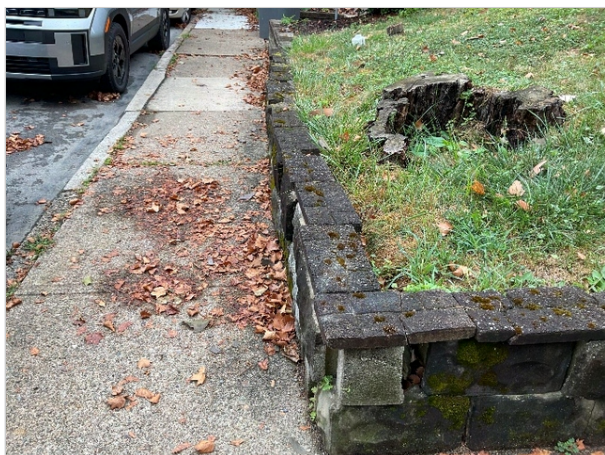
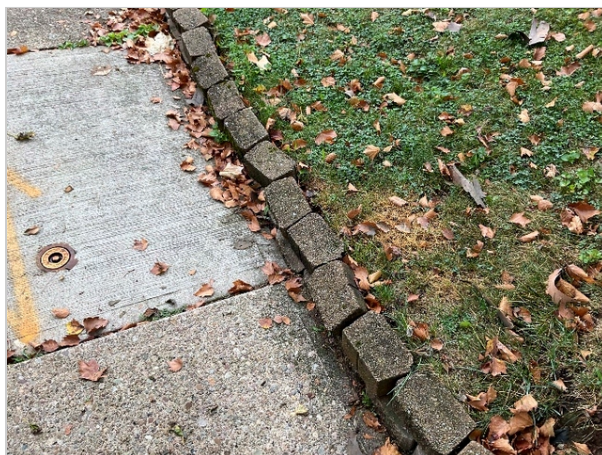
The front left retaining wall is pushed. There were significant vertical earth pressure type cracks observed in the wall. This condition is most often associated with soil and /or water pressure. The displacement occurs incrementally as the wall yields to horizontal earth pressure. The wall was stable at the time of the inspection. Repairs to the wall may be required. Consult with a qualified contractor for repair estimates

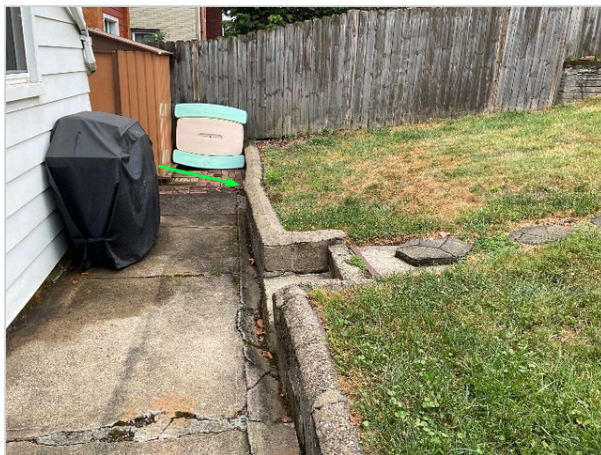
The rear retaining wall is pushed. There were significant vertical earth pressure type cracks observed in the wall. This condition is most often associated with soil and /or water pressure. The displacement occurs incrementally as the wall yields to horizontal earth pressure. The wall was stable at the time of the inspection. Repairs to the wall may be

required. Consult with a qualified contractor for repair estimates

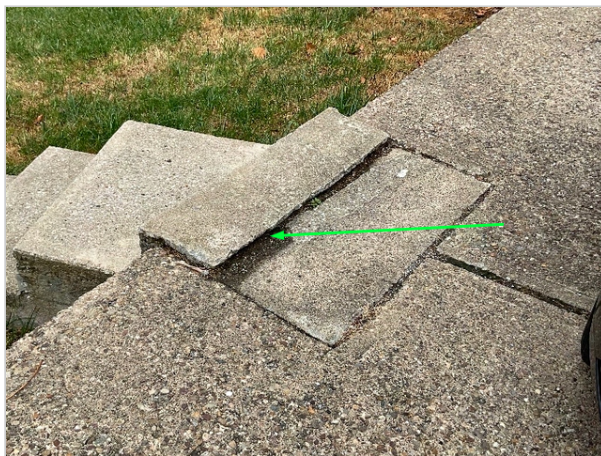
There were several trip hazards found on the driveway. The hazards can be repaired using a suitable or similar surfacing material to "feather" the out-of-level condition to make a smooth transition.

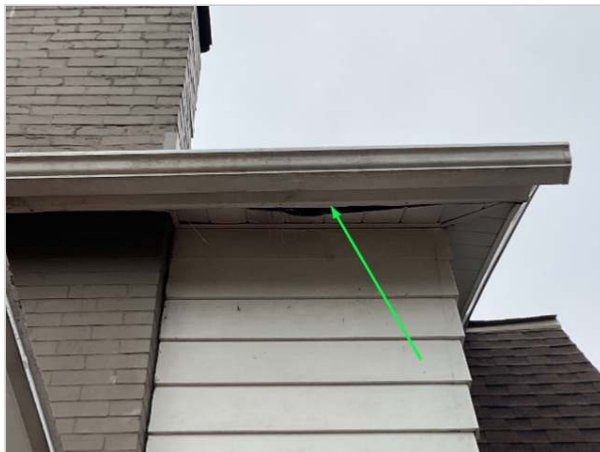
Loose soffit was noted on the back. Consult with a qualified contractor for repair.

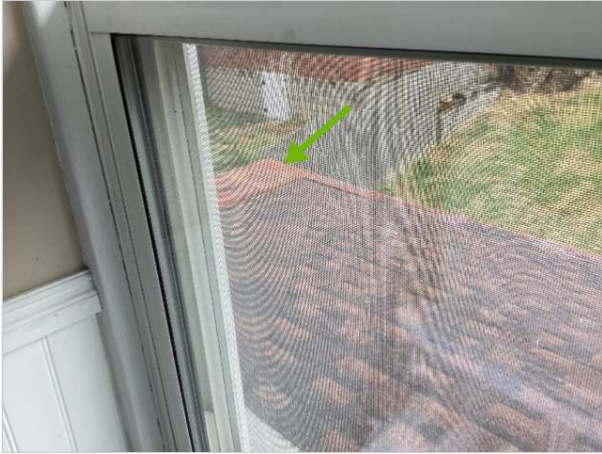
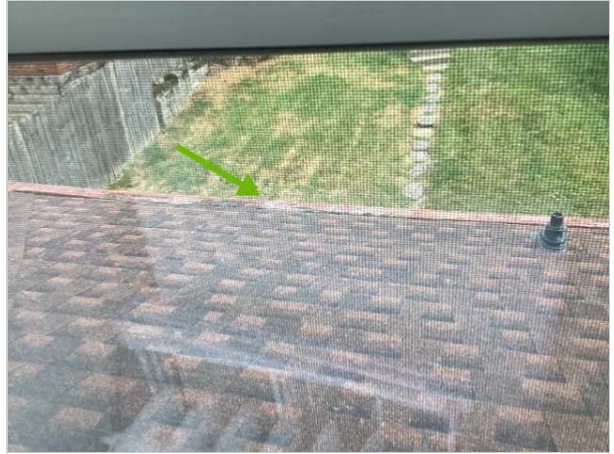
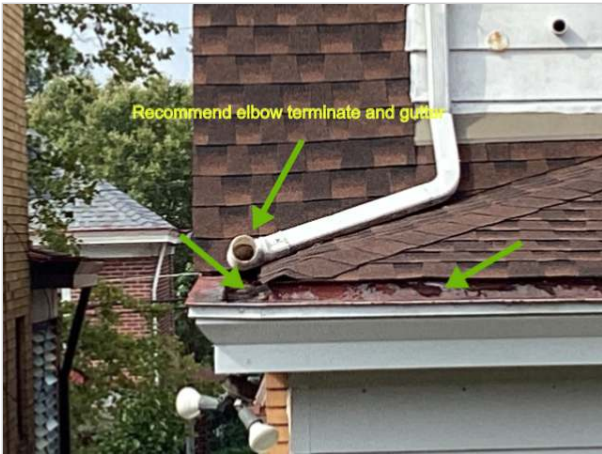
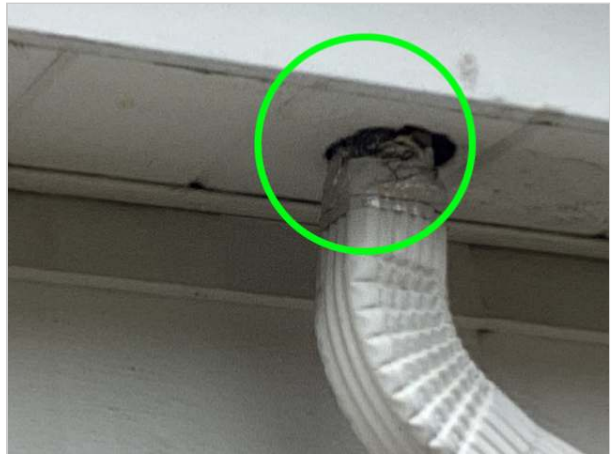
Damaged gutters were noted on the front and rear. The woodbox gutters were showing signs of deterioration . Gutters and downspouts help facilitate proper drainage of roof water away from the foundation of the home. Consult with a qualified, reputable contractor to install proper roof drainage.

Evidence of deterioration

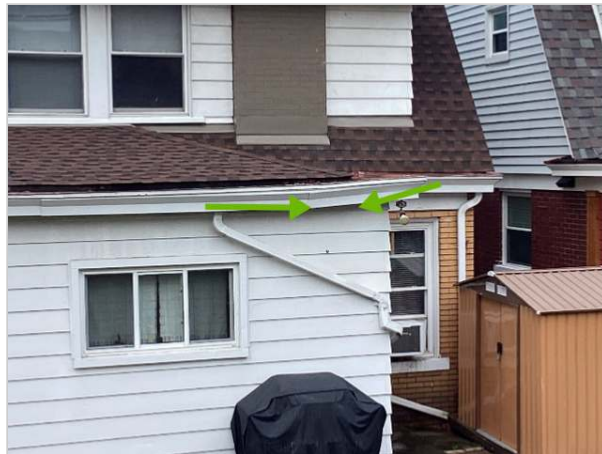
A low spot was noted in the rear gutter. This will affect proper drainage of roof water and could cause roof water to flow over the top of the gutter at the low spot. Consult with a qualified contractor for repair.

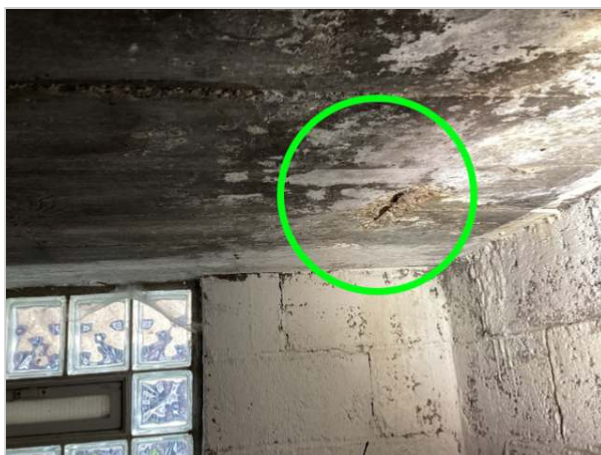
The underside of the front porch slab as viewed from the under the porch is cracked and spalling. This condition is common with structural concrete and is rarely a structural concern. The steel reinforcements that are closest to the bottom of the slab rust and expand with age and exposure to moisture. The expansion pushes against the thin layer of concrete and fractures the bottom surface. The condition is cosmetic and should not affect the structural integrity of the slab. Be aware also, that any concrete slab that is exposed to weather will develop hairline cracks which may not be visible to the naked eye and will leak. Care should be taken to assess the interior conditions during periods of extended rain before storing anything that could be damaged by water. As with all opinions offered by a home inspector, feel free to consult with a qualified engineer for further evaluation.

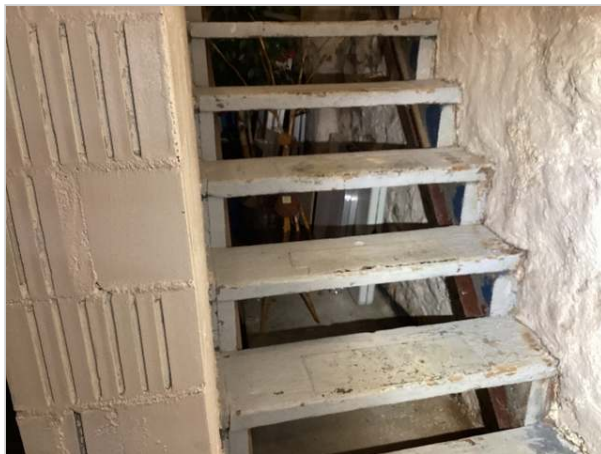
The risers or backs of the basement stairs are open. This could be a fall hazard for small children. Consult with a qualified contractor for evaluation and recommendations.

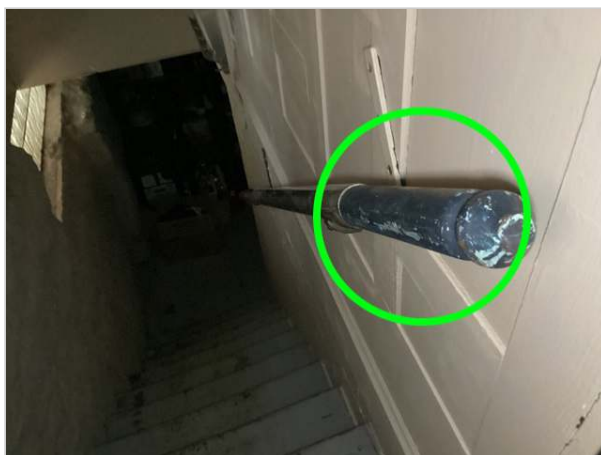
The rail at the top of the basement stairs is loose or otherwise insecure. The rail should be properly secured by a qualified contractor.

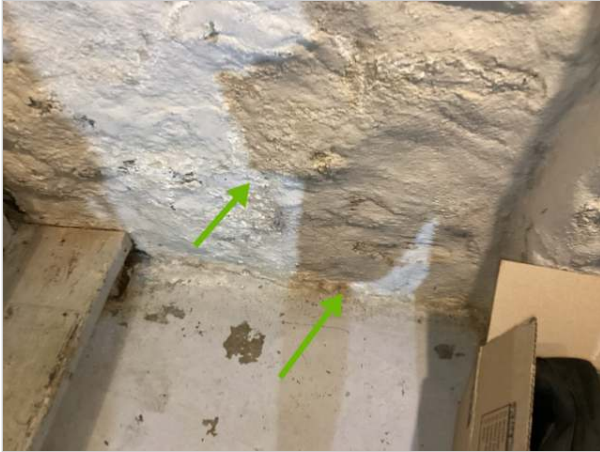
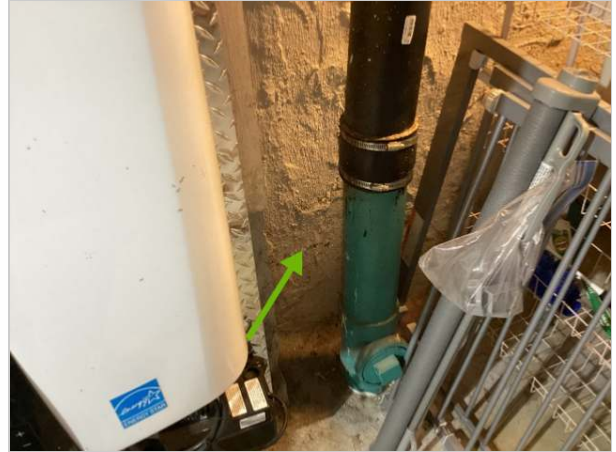
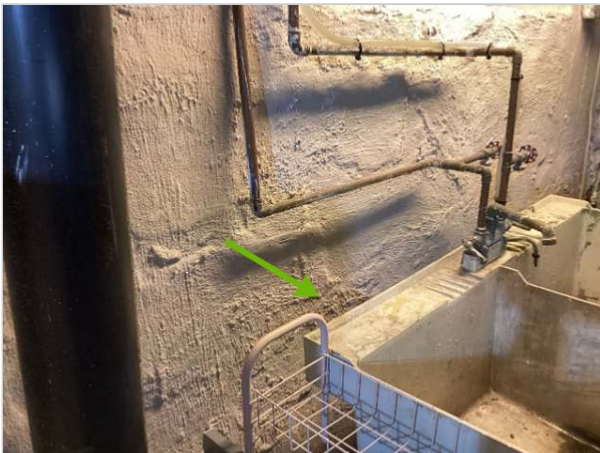
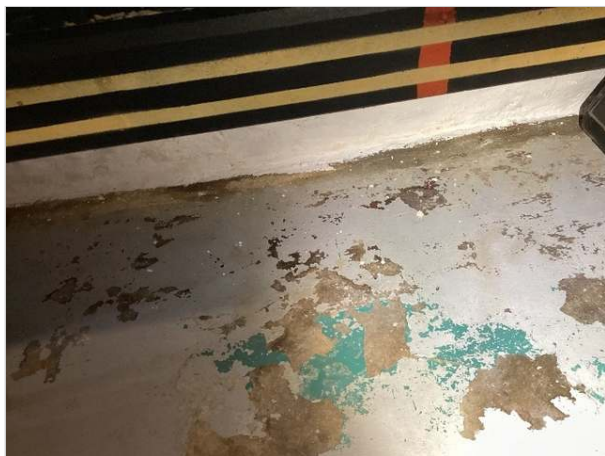
There were signs of moisture on all of the basement walls. The area was dry at the time of the inspection. Dampness on basement walls is not always a sign of water intrusion. The dampness can be the result of warm humid air making contact with cool walls. In many cases the humid air condenses on the wall and forms a layer of moisture. It is important to assess whether moisture on the basement walls is the result of water intrusion or condensation. In this case, the efflorescence noted on the wall appears to be the result of moisture buildup on the exterior side of the foundation. The exterior grading in the affected area is questionable. Many water intrusion problems can be controlled by improving the drainage on the exterior of the home. It is important that all roof drainage and surface water is directed away from the foundation. Any concern about this condition should be referred to a qualified contractor for evaluation and recommendations.

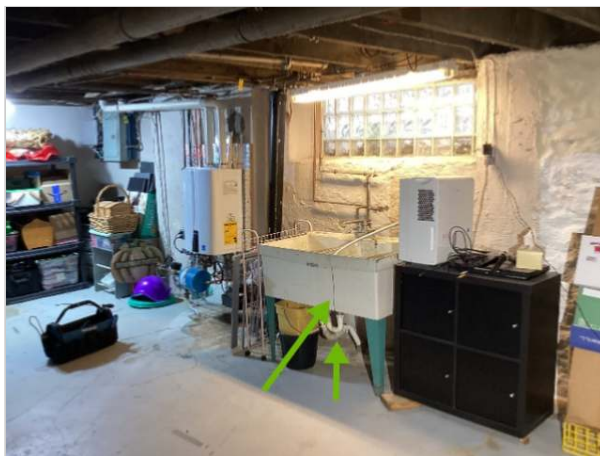
- Basement laundry tub loose
- Basement flex line on trap

Tub loose and flex line on trap

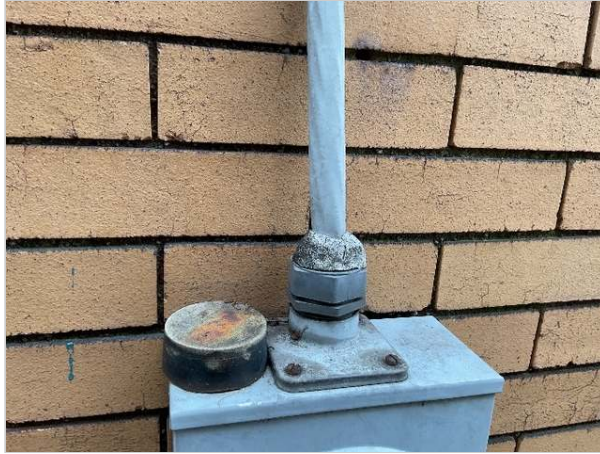
The sealant at the top of the electric meter box is cracked and decayed. The sealant should be replaced to ensure that water does not enter the electric service panel.

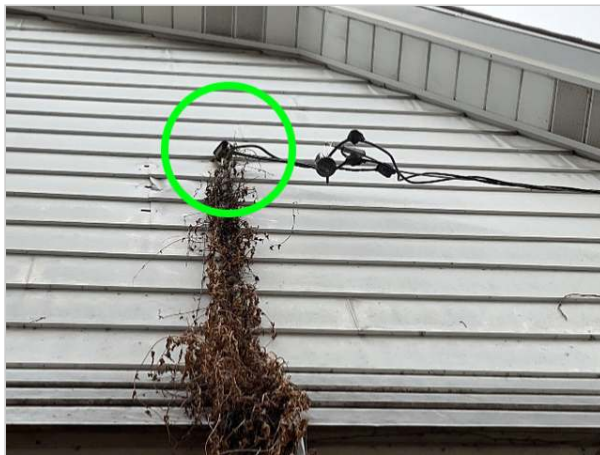
The weatherhead at the top of the electric service entrance cable is not attached. Consult with a qualified electrician for repair.

Loose weather head with overgrowth

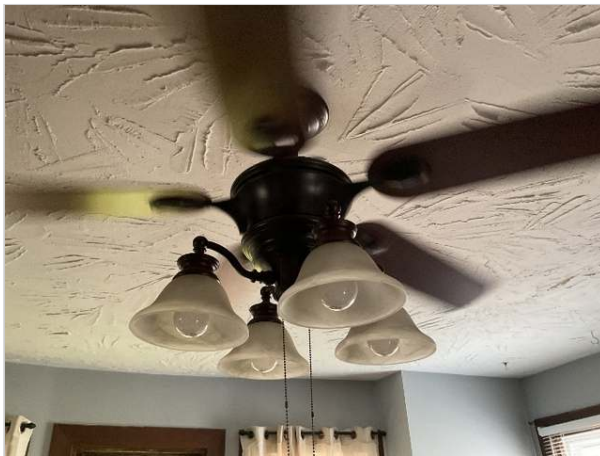
The paddle fan in the dining room appears to be out of balance because it is loose in the ceiling box. The fan wobbles when turning. The fan could be improperly installed or the mounting screws are loose. Consult with a qualified contractor for evaluation and repair.

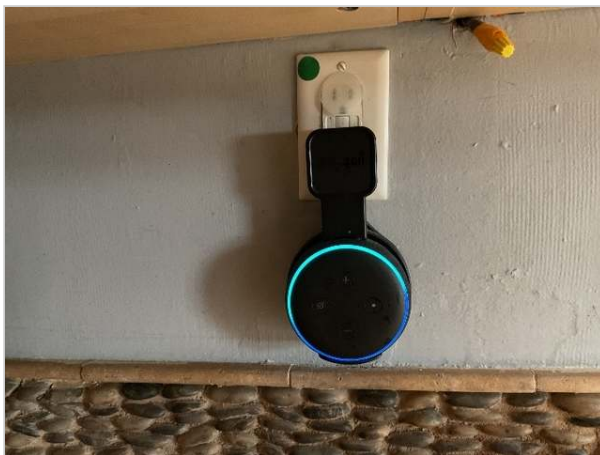
One or more three prong type outlets in the home tested as having an open ground. This means that the third prong, also known as the ground prong is not doing its job. This is usually caused by a missing ground connection at an electrical device in the circuit. This condition is usually easily correctable by an electrician. Open grounds in wet locations is considered a safety issue and should be corrected. The outlets that tested with this condition were marked with a "GREEN" dot for easy identification. The affected outlets were located in the kitchen. Please note that we only test outlets that are visible and readily accessible at the time of the inspection.

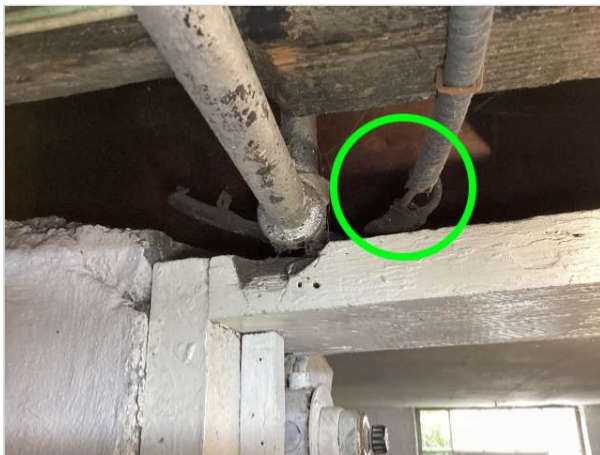
Open electrical splices were noted in the basement. All electrical splices should be enclosed in an approved and covered electrical box. Electrical related repairs should be performed by a qualified electrician.

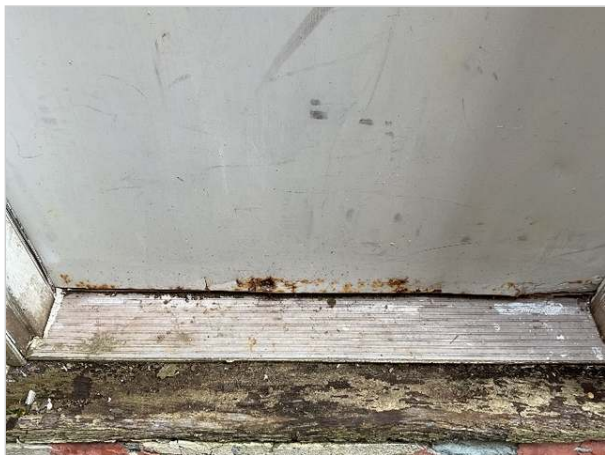
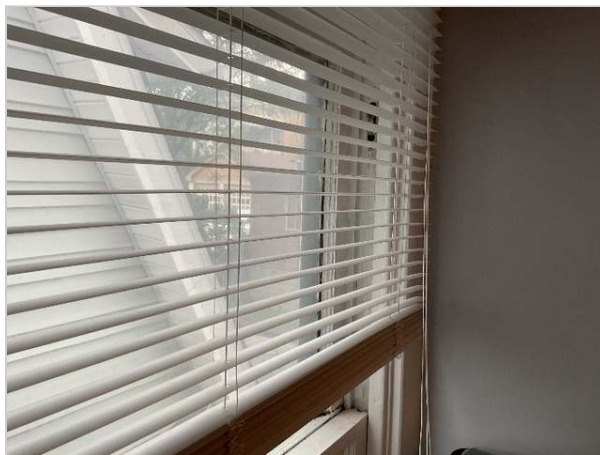
The cladding on the exterior doors located on the right side is rusted. The door was operable at the time of the inspection. Evaluation and repair should be made by a qualified contractor.

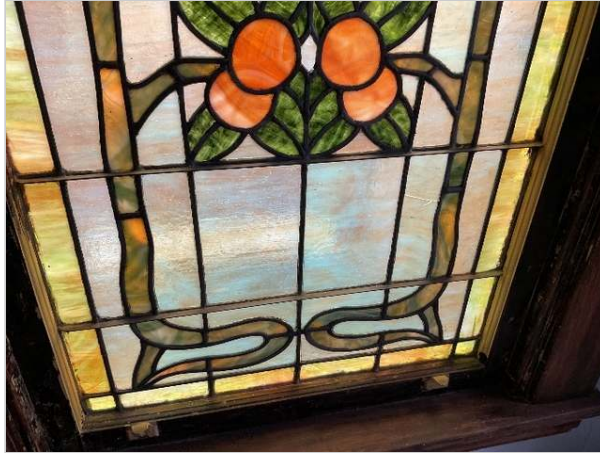
Cracked glass was noted on the dining room window (s). For safety and security all cracked and broken glass should be replaced.

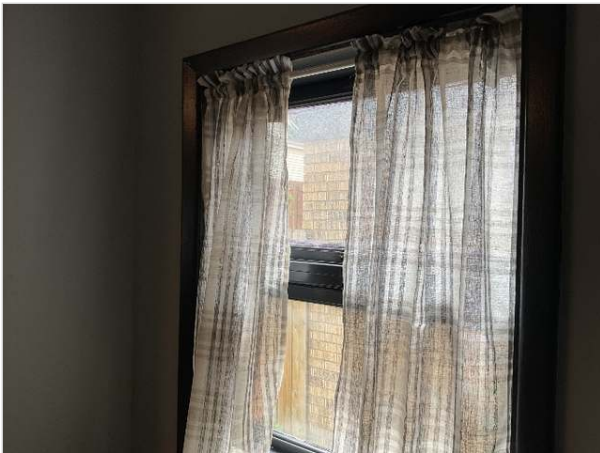
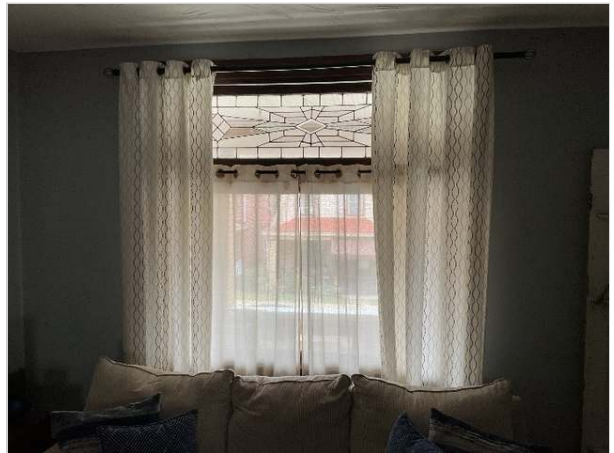
One or more windows could not be opened using reasonable force at the time of the inspection. The windows were located in the first level. This condition could be caused by paint, obstructions or lack of use. Repairs or adjustments may be required. For safety reasons, it is important that at least one window opens in each room of the home.

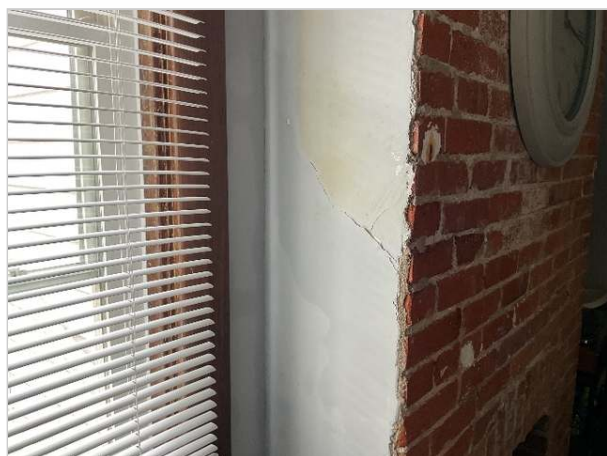
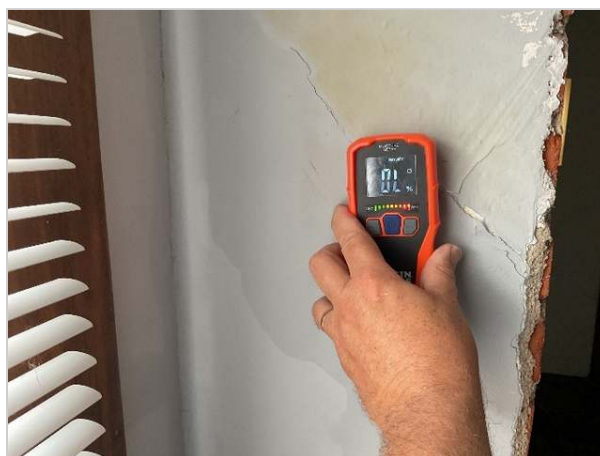
Elevated levels of moisture with no surface damage was noted on the chimney in the dining room. The moisture appeared to be the result of previous leaks. No immediate action is required. The affected area (s) should be monitored for evidence of new leaks. Consult with a qualified contractor for repair if required.

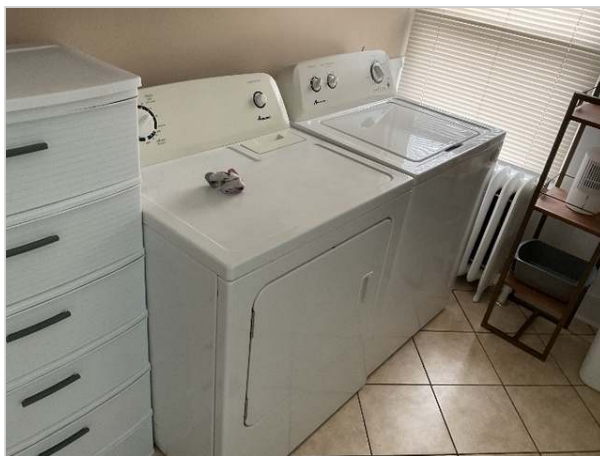
There is no water collection pan installed under the washer in the laundry. The collection pan will capture water from the washer in the event of a leak. A collection pan should be installed by a qualified contractor.

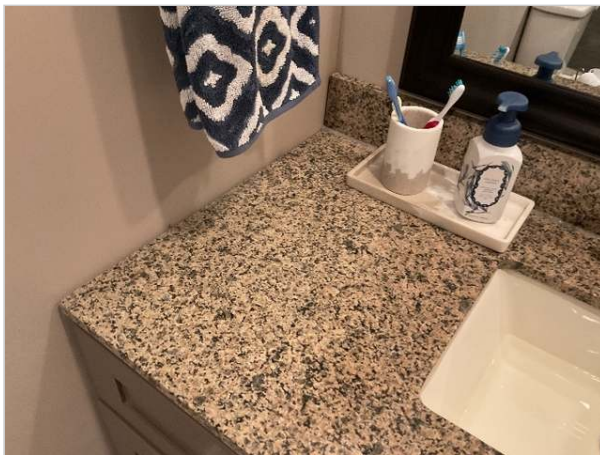
Failure to keep walls sealed can cause deterioration and extensive moisture damage including mold growth to the interior walls, which is not always visible at the time of the inspection. Some of the caulk was missing from around the sink top . These areas should be caulked to help prevent moisture penetration.
