310 Cola St

RE: Pittsburgh, PA 15203

Inspection #: 527-032026-6753

HOME INSPECTION REPORT

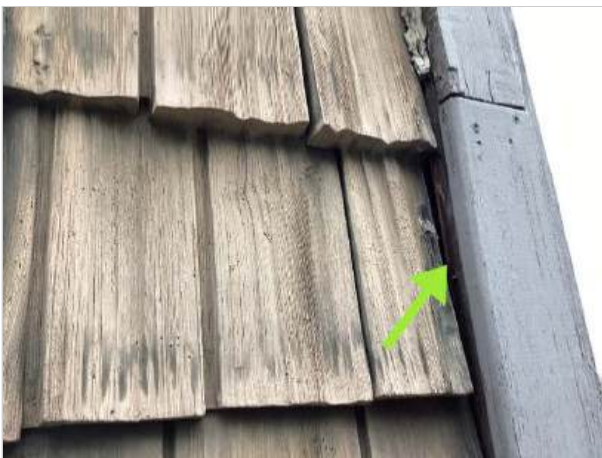
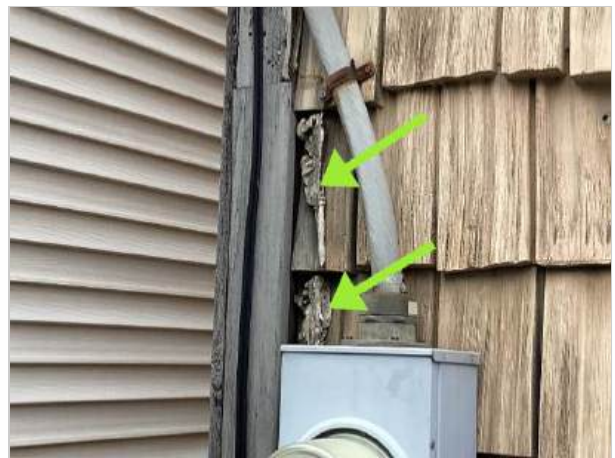
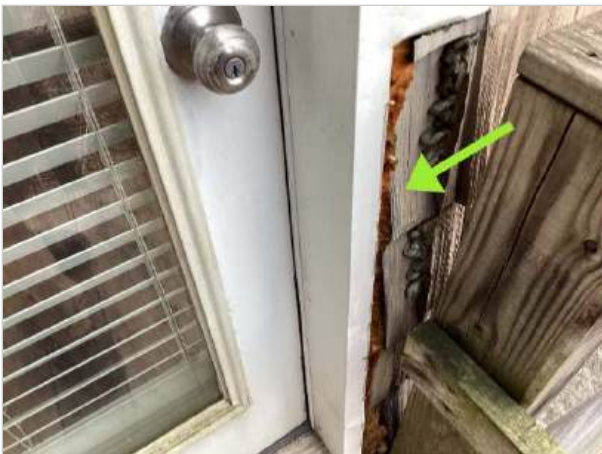
Damaged siding was noted in the siding on the left and right sides. This condition does not impact the structural integrity of the building, but can lead to water intrusion. Repairs should be made by a qualified contractor.

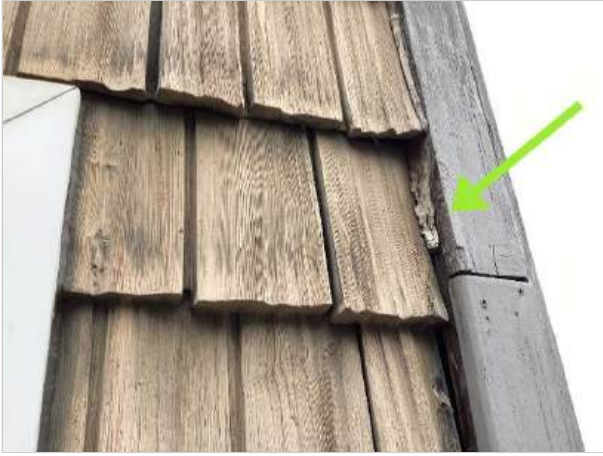
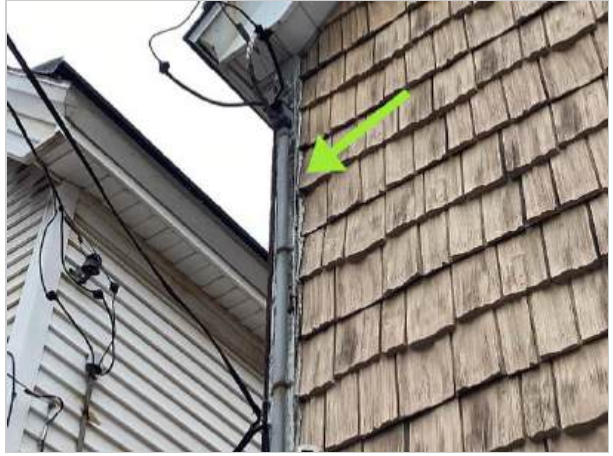
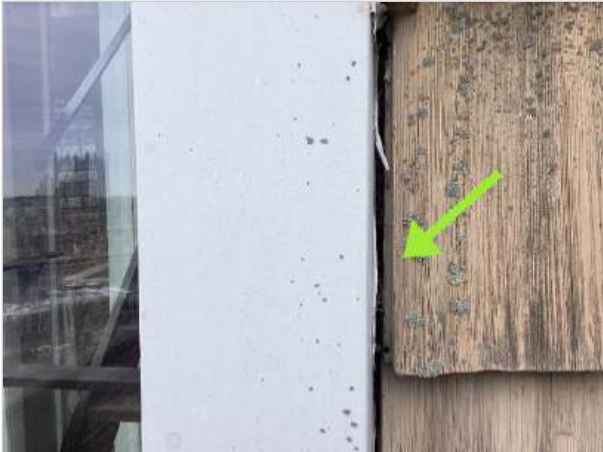
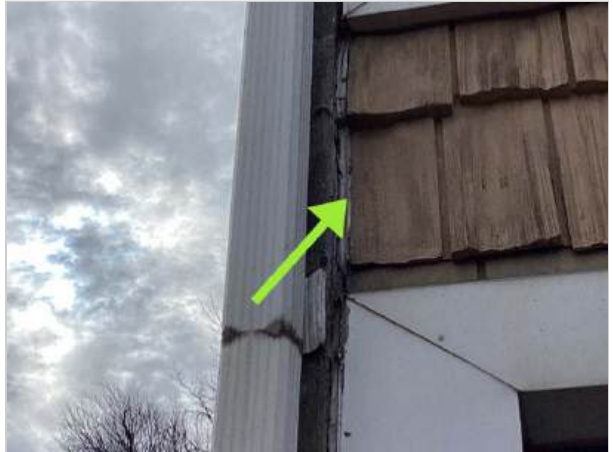
The exterior caulking around the multiple areas is cracked or missing on all sides of the home. The caulking should be replaced to ensure the exterior of the home remains weather and water tight.

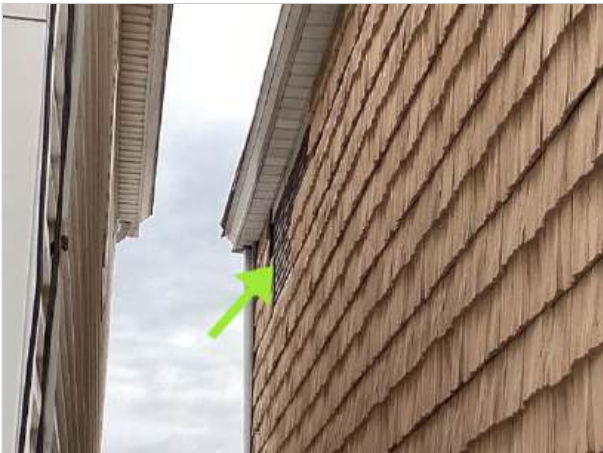
Left rear

Missing siding was noted on several areas of the home. Consult with a qualified contractor for replacement.

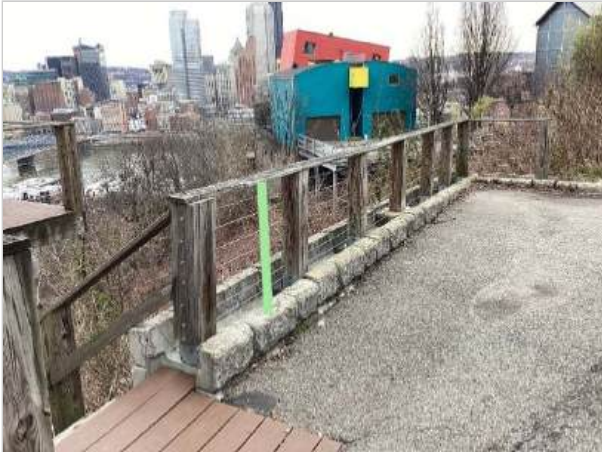
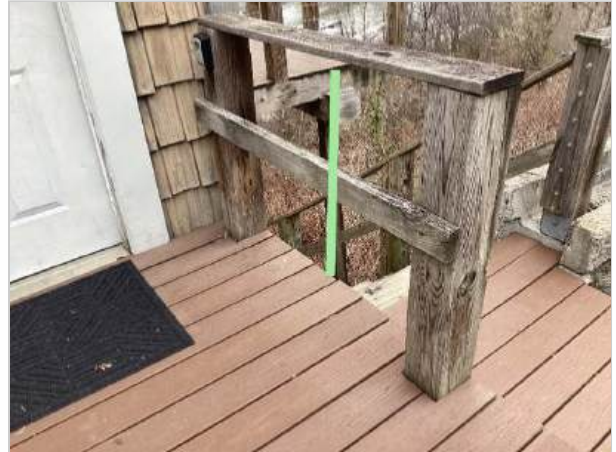
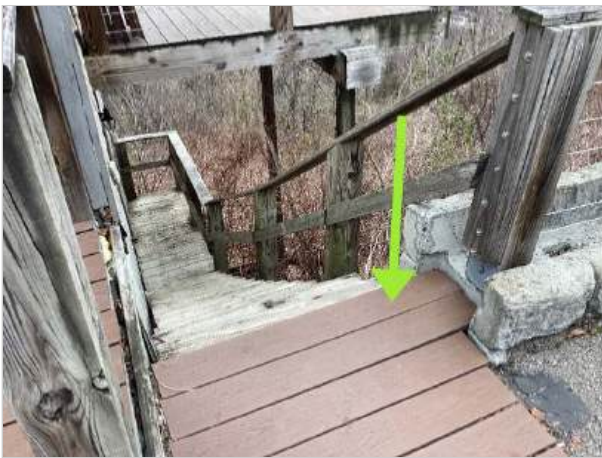
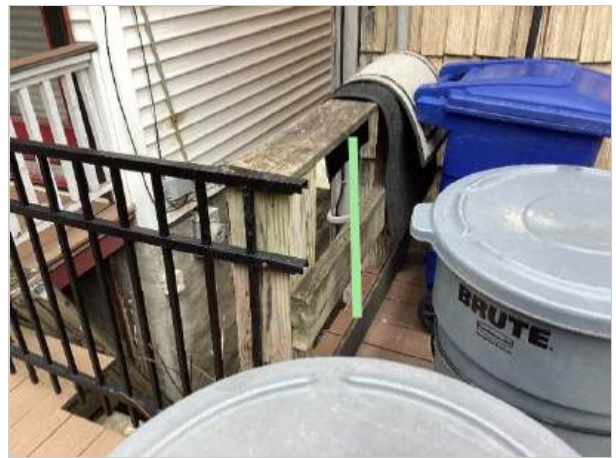
modification and / or installation of additional balusters. Consult with a general contractor for cost estimates for additional balusters.

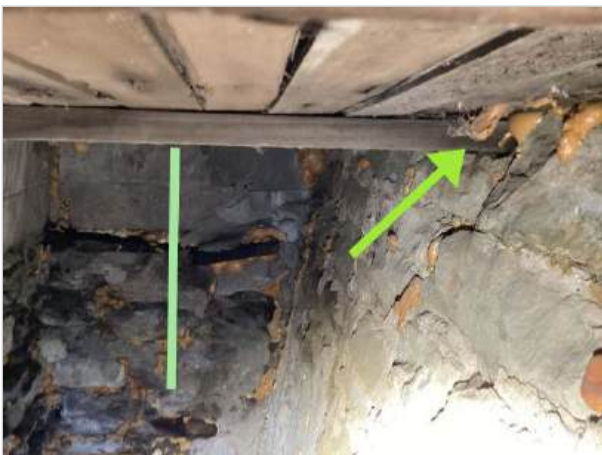
The middle vertical support post on the front porch is not installed. The post is an important structural component and should be repaired. Consult with a qualified contractor for recommendations.

No center support

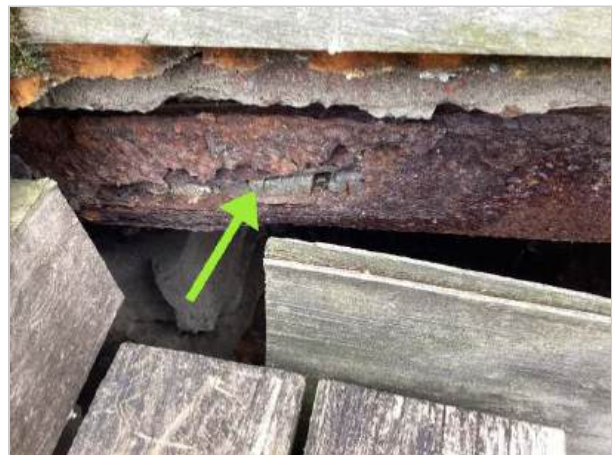
Rusted horizontal support

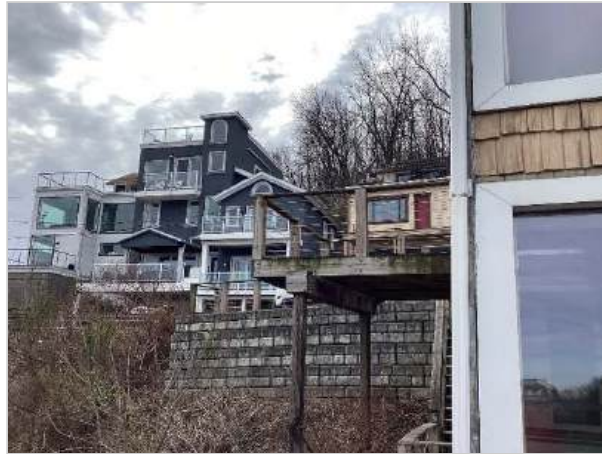
The balusters on the upper right deck rail were installed horizontally rather than vertically. Generally accepted construction techniques provide for balusters to be installed vertically and spaced no greater than four inches apart. Larger baluster spacing can be a safety concern, and horizontally mounted balusters permit climbing. Local codes may require modification and / or installation of additional balusters. Consult with a general contractor for cost estimates for additional balusters.

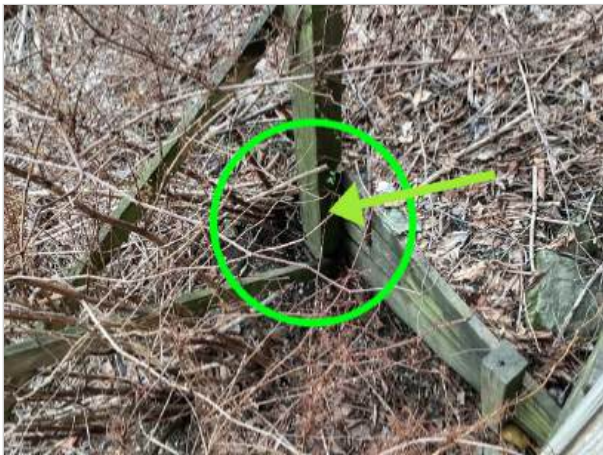
The vertical support posts on the right upper deck have several deficiencies. The post are not mounted on concrete piers with a bottom saddle to prevent rot. The front post has a retaining wall leaning on it's base. The post is an important structural component and should be repaired. Consult with a qualified contractor for recommendations.

Earth mounted post with retaining wall at base

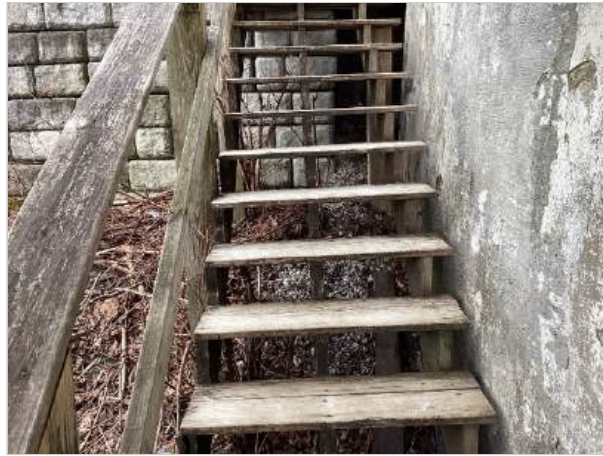
The risers or backs of the right exterior stairs are open. This could be a fall hazard for small children. Consult with a qualified contractor for evaluation and recommendations.

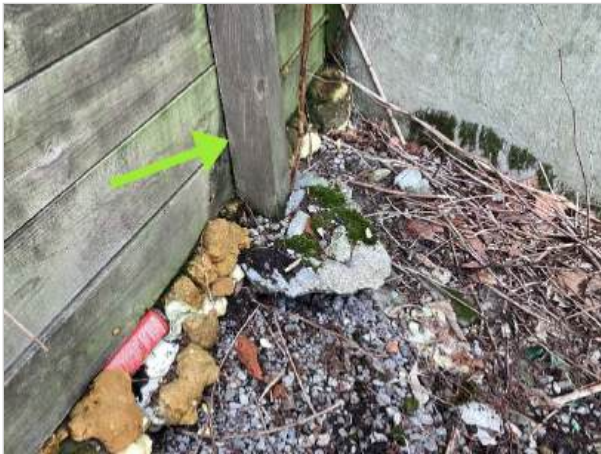
The vertical support posts on the lower right deck have several deficiencies. The post are not mounted on concrete piers with a bottom saddle to prevent rot. The front post has a retaining wall leaning on it's base. One post is detached and falling. The post is an important structural component and should be repaired. Consult with a qualified contractor for recommendations.

Pressure at base

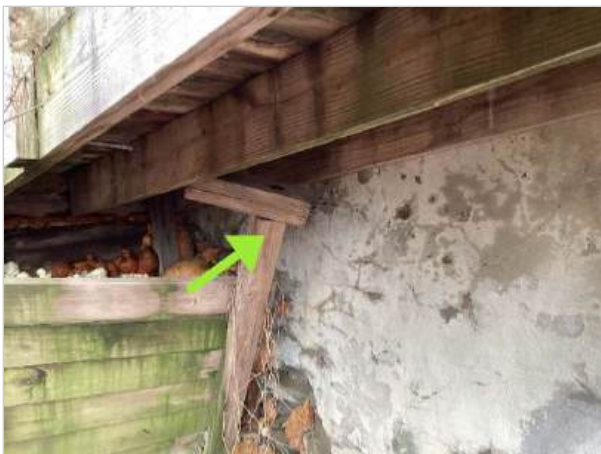
Loose support post

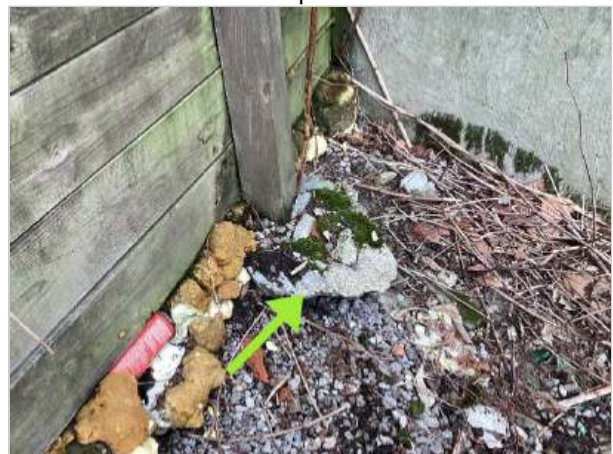
Erosion evidence

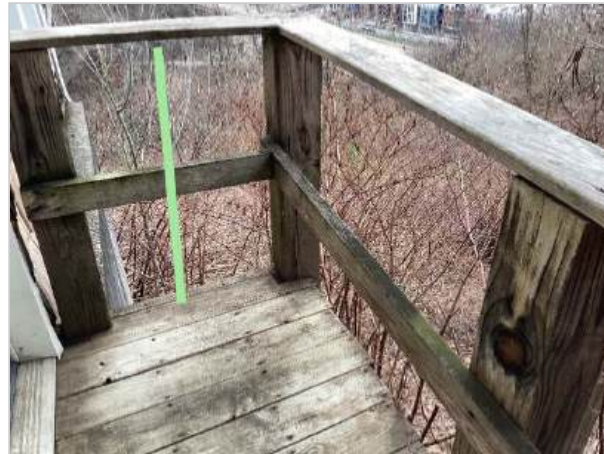
The balusters on the deck rail were installed horizontally rather than vertically. Generally accepted construction techniques provide for balusters to be installed vertically and spaced no greater than four inches apart. Larger baluster spacing can be a safety concern, and horizontally mounted balusters permit climbing. Local codes may require modification and / or installation of additional balusters. Consult with a general contractor for cost estimates for additional balusters.

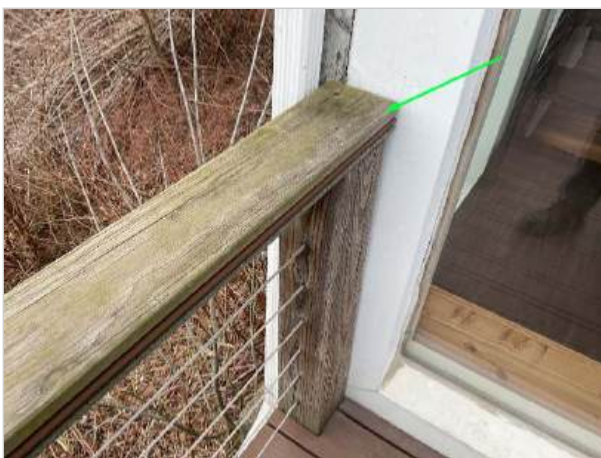
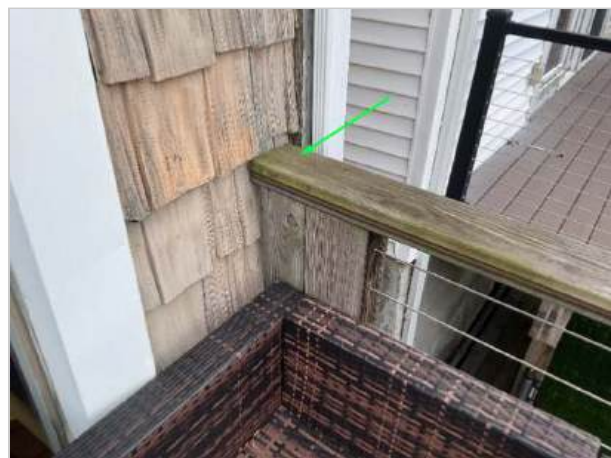
The deck rail on the rear deck is loose. The rail should be secured for safety by a qualified contractor.

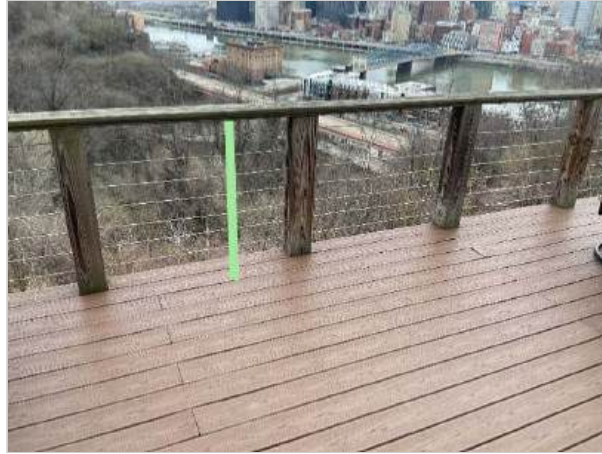
The balusters on the deck rail were installed horizontally rather than vertically and spaced greater than four inches apart. Generally accepted construction techniques provide for balusters to be installed vertically and spaced no greater than four inches apart. Larger baluster spacing can be a safety concern, and horizontally mounted balusters permit climbing. Local codes may require modification and / or installation of additional balusters. Consult with a general contractor for cost estimates for additional balusters.

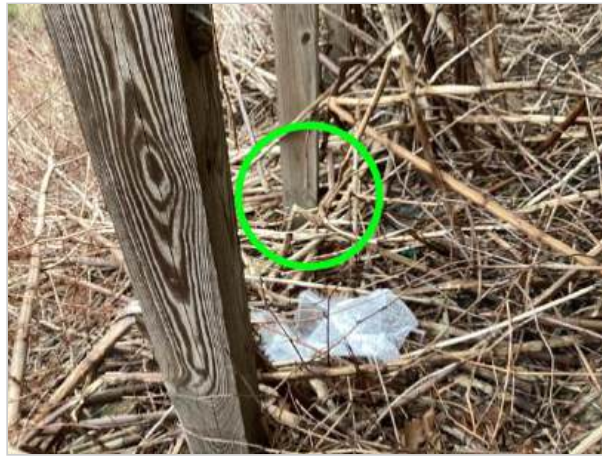
The *deck* support post(s) are making direct contact with the landscaping. Common practice is to mount support posts on concrete piers. The post is an important structural component and should be monitored for deterioration. A qualified contractor should be contacted for further evaluation and recommendations if desired.

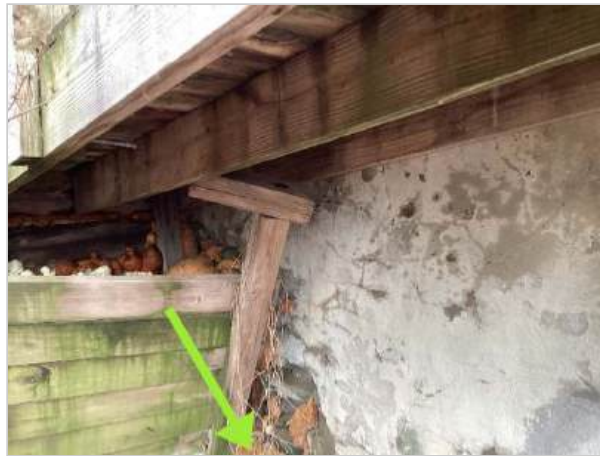
The right retaining wall is failing. There were significant vertical earth pressure type cracks observed in the wall. This condition is most often associated with soil and /or water pressure. The displacement occurs incrementally as the wall yields to horizontal earth pressure. The wall was not stable at the time of the inspection. Repairs to the wall are required. Consult with a qualified contractor for repair estimates.

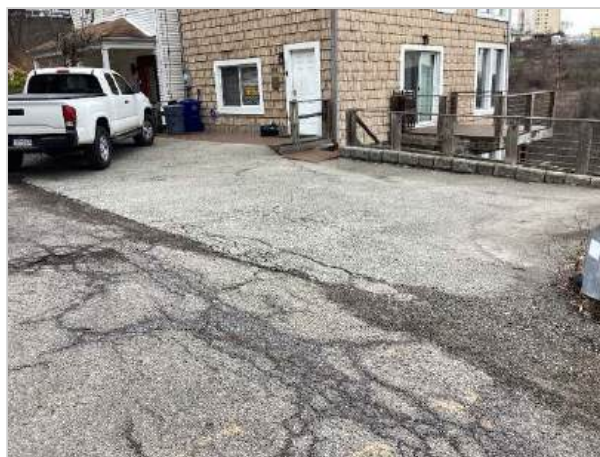
There was an asphalt driveway in the front of the home which led to the off street parking. There were minor cracks and spalling noted on the driveway. Surface defects in driveways develop and progress with age and are considered normal as long as they do not create a safety hazard. There were no material defects observed in the driveway. Sealing the driveway with an asphalt driveway sealer will help extend the life of the driveway.

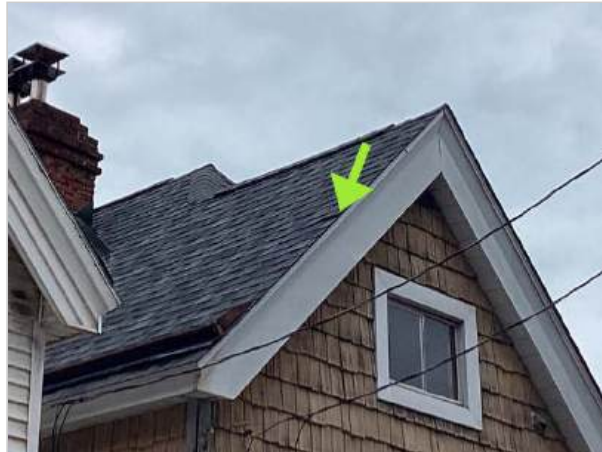
One or more popped nails were noted on the roof at the time of the inspection. A popped nail can be identified by a lifted corner on a shingle. The heating and cooling of the roof will often cause roofing nails to lift under the shingles, causing the corner to lift. While it is not likely that the condition is causing a leak, the nails should be reset and sealed to prevent wind from getting under the shingle and possibly lifting the shingle off the roof. Consult with a qualified roofer for repair.

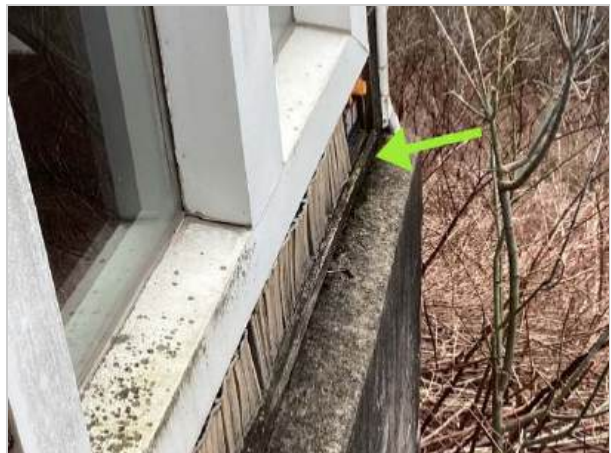
Rotted wood was noted on the wood fascia . The areas should be repaired and sealed by a qualified contractor.

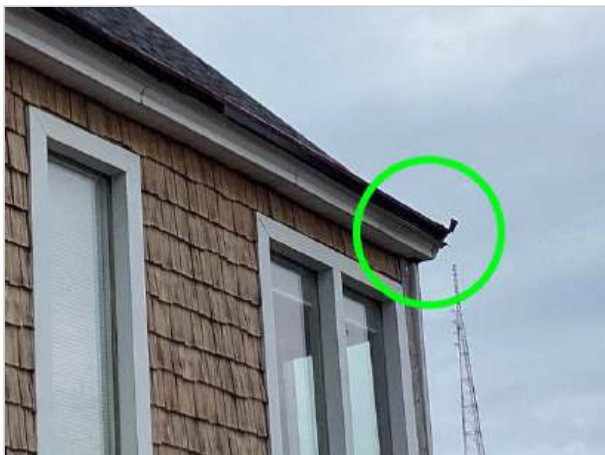
Damaged gutters were noted on the right. Gutters and downspouts help facilitate proper drainage of roof water away from the foundation of the home. Consult with a qualified, reputable contractor to install proper roof drainage.

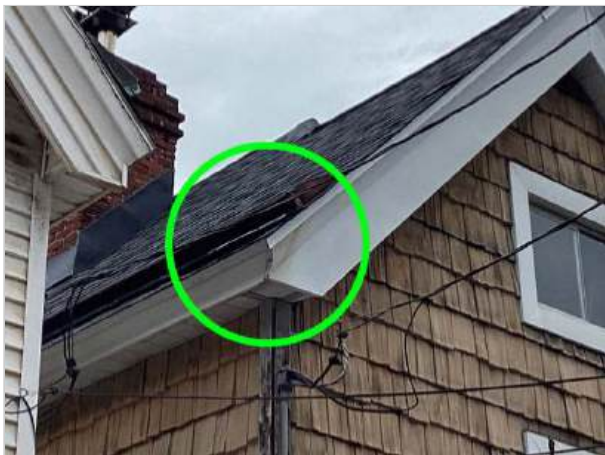
The left gutter appears to be leaking at the corners. The seams should be sealed with an appropriate gutter sealant by a qualified contractor.

Evidence of leak

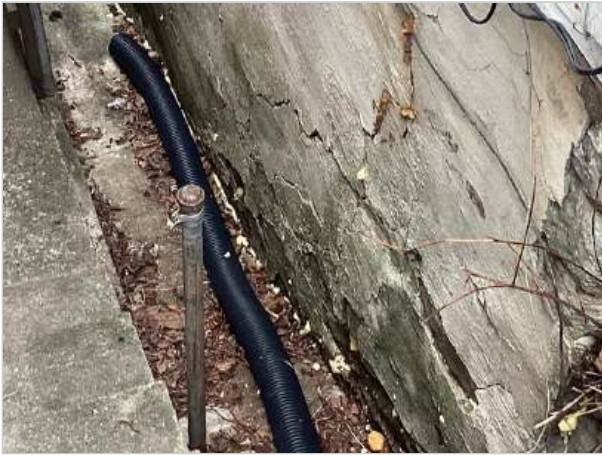
Left side

Some spalling was noted on the concrete of the home. Spalling is usually caused by moisture accumulation behind the surface. In cold weather, the moisture freezes and pushes the face off. In some cases the condition can be controlled by sealing the face with an appropriate masonry sealer. Consult with a qualified masonry contractor for recommendations.

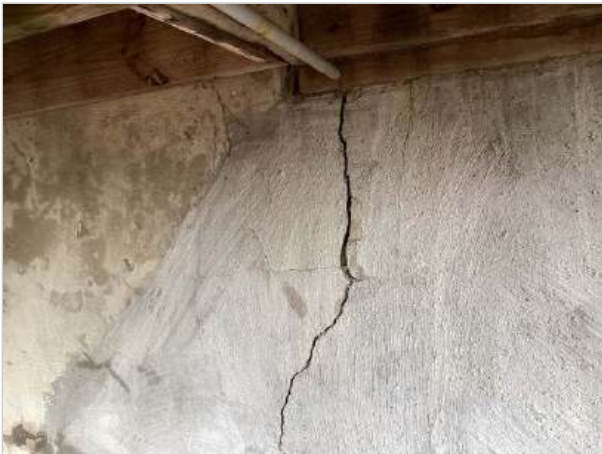
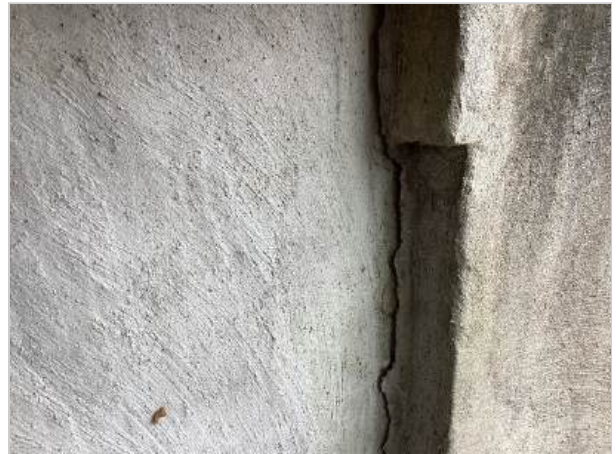
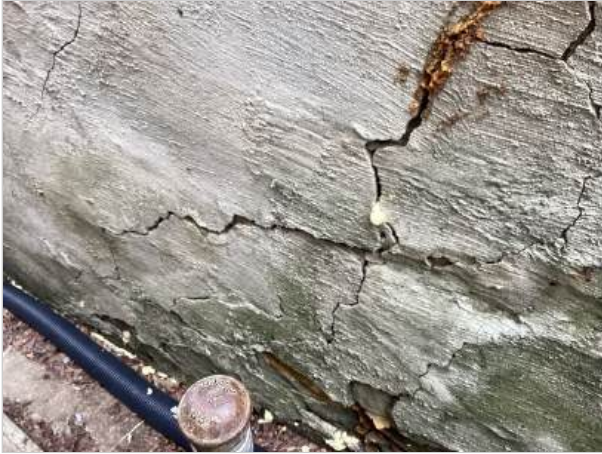
One or more cracks were noted on the foundation walls. The cracks were located on the right and left. The cracks appear to have been caused by settlement. There was no evidence of active movement at the time of the inspection. Corrective action did appear to be necessary. All cracks should be monitored for significant changes in characteristic. Consult with a contractor if the cracks change significantly or you desire another opinion on this condition.

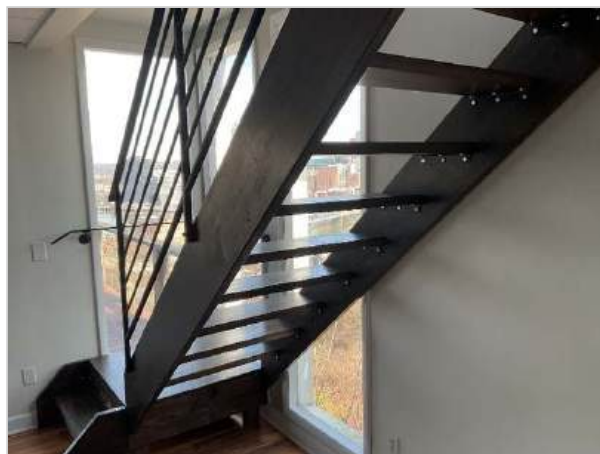
The risers or backs of the basement stairs are open. This could be a fall hazard for small children. Consult with a qualified contractor for evaluation and recommendations.

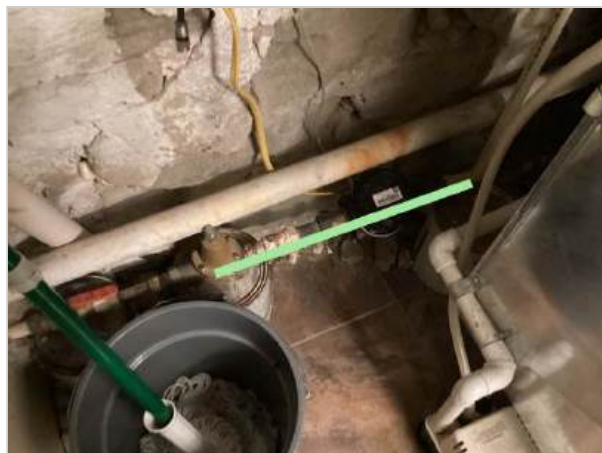
Generally accepted wiring methods, as well as some local codes require the installation of a ground jumper from one side of the water meter to the other. The purpose of the jumper is to ensure the integrity of the cold water ground connection. The water meter ground jumper was not installed at the time of the inspection. Installation of a ground jumper is recommended. Consult with a qualified electrician.

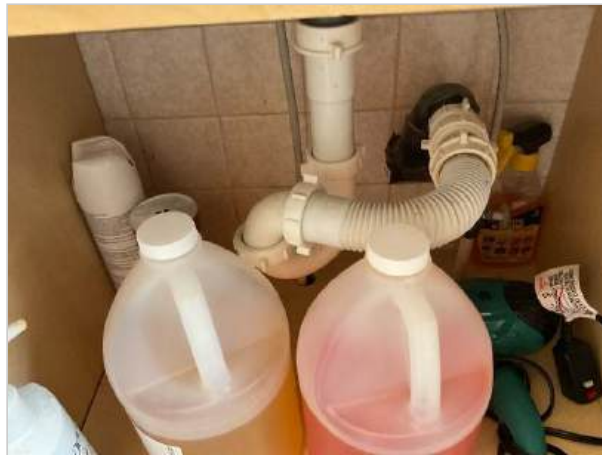
The full bath sink drain line has been repaired with flexible drain pipe . The drain was not leaking at the time of the inspection. This type of amateur repair is generally temporary and should repaired by a qualified plumber.

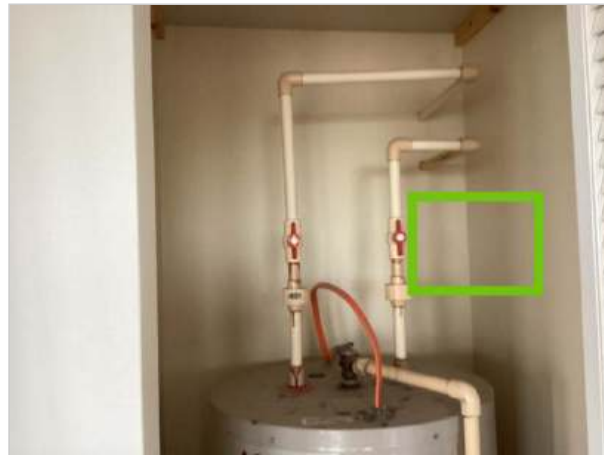
There is no expansion tank installed on the water heater. Expansion tanks relieve excessive pressure in the plumbing system and help lengthen the life of the water heater. These devices are installed on most newer water heaters. We recommend consulting with a qualified plumber for installation of an expansion tank. Depending on the terms, the lack of an expansion tank could affect any remaining manufacturer's warranty on the water heater.

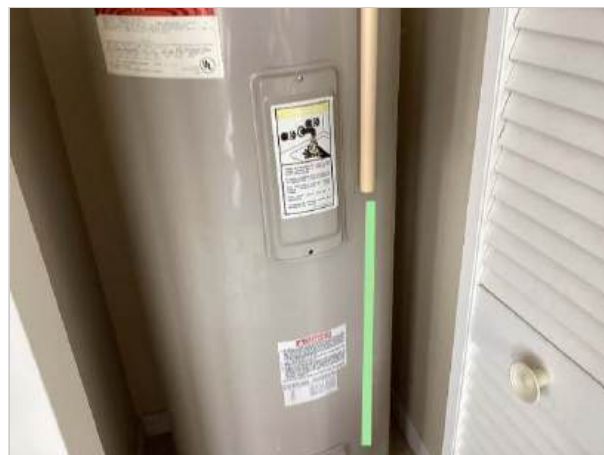
There was no drip leg installed on the T&P valve of the water heater. The drip leg directs water from the T&P valve toward the floor. A drip leg terminating within six-inches of the floor should be installed.

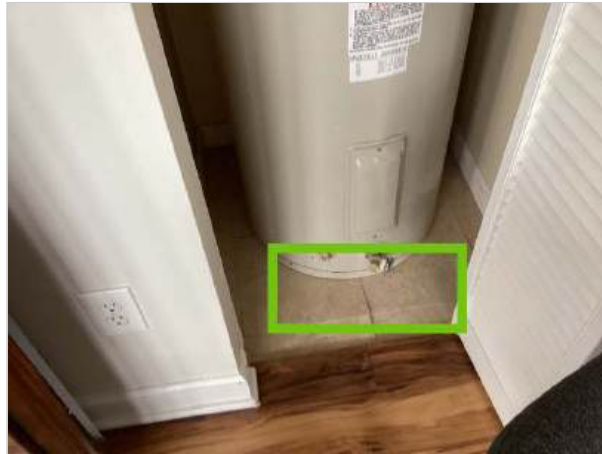
There is no water collection pan installed under the water heater. The collection pan will capture water from the unit in the event of a leak. A collection pan should be installed by a qualified contractor.

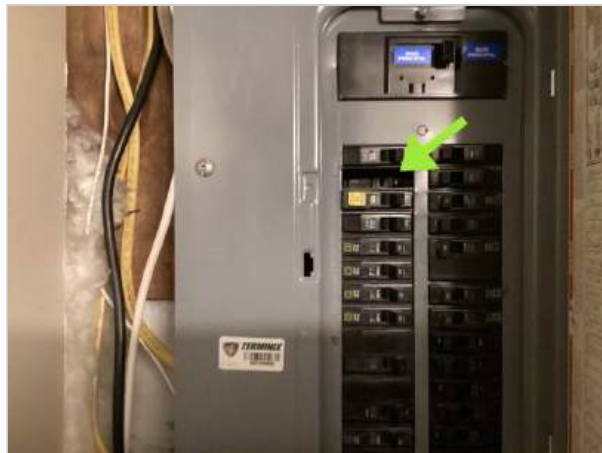
One or more electrical fixture knockout(s) was noted in the electric service panel. All service panel openings should be covered to prevent access to high voltage and risk of electrical shock. Electrical related repairs should be performed by a qualified electrician.

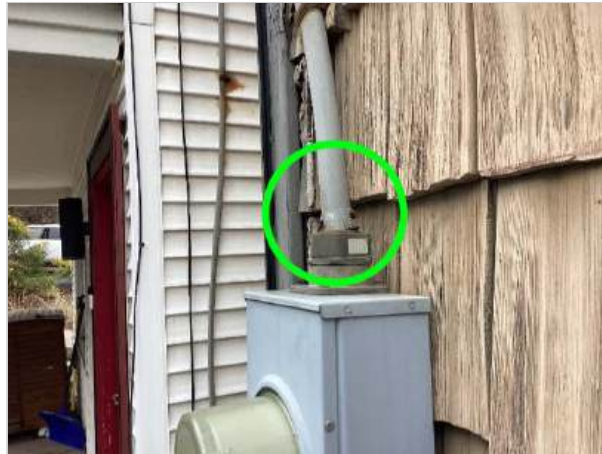
The sealant at the top of the electric meter box is cracked and decayed. The sealant should be replaced to ensure that water does not enter the electric service panel.

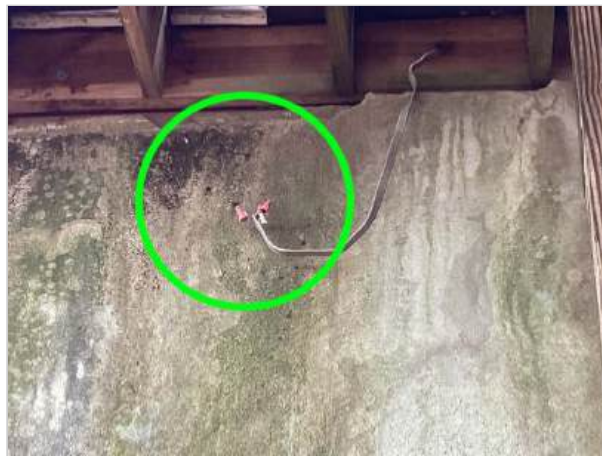
Rear

Exposed or un-terminated live wires were noted on the exterior. The wires should either be disconnected at the source or properly terminated in an approved, covered electrical box. Consult with a qualified electrician for repair.

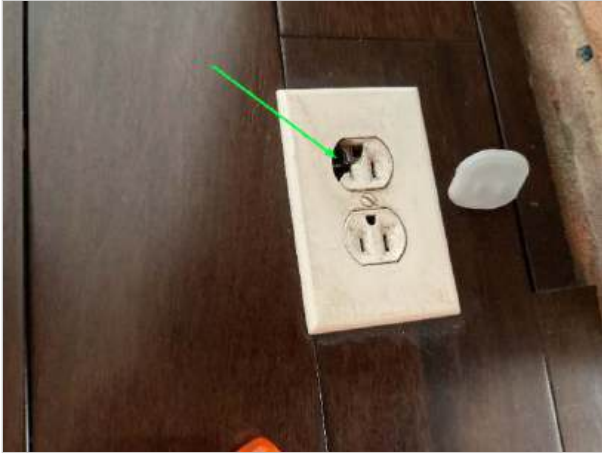
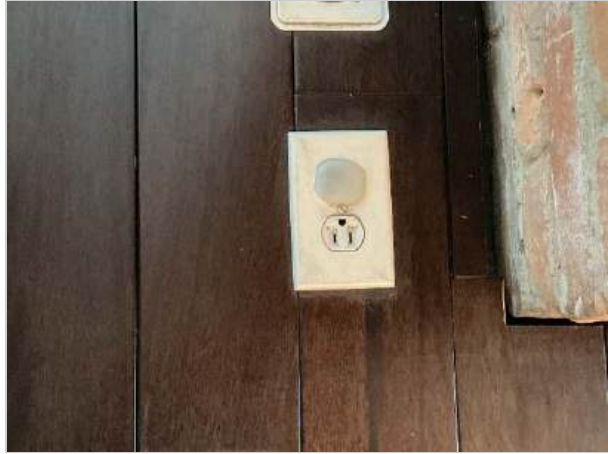
A broken outlet was noted in the kitchen. This could be a shock hazard due to exposed electrical contacts. The affected outlet(s) should be replaced by a qualified contractor.

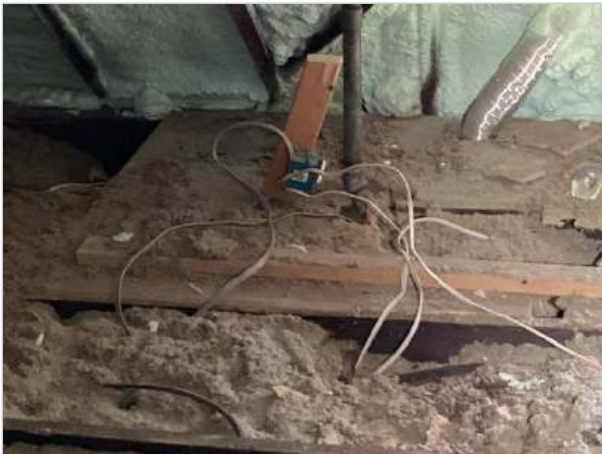
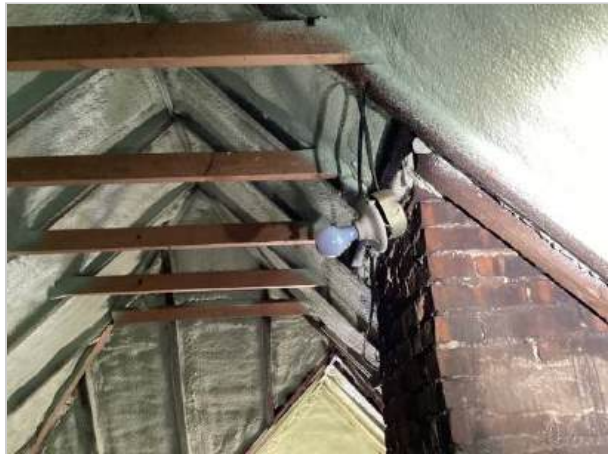
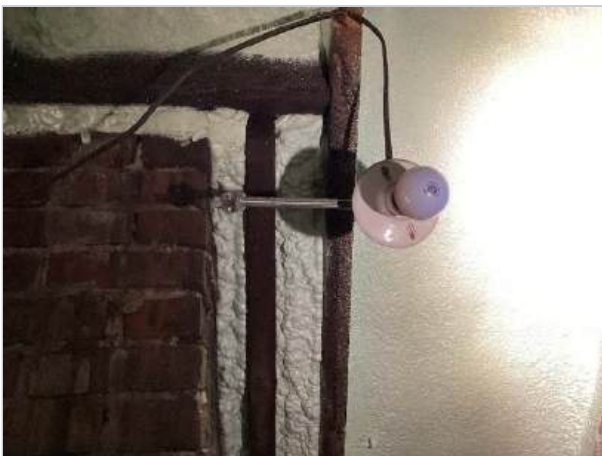
One or more sections of unsupported electrical wiring was noted in the attic. All electrical wiring should be supported at regular intervals.

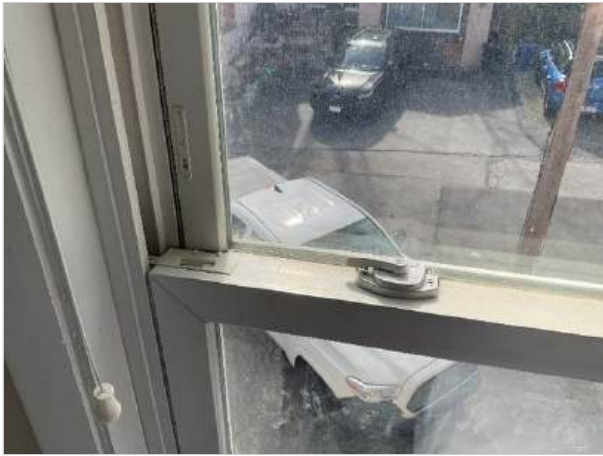
rear bedroom

One or more defective tilt latches were noted on the windows. The tilt latch facilitates easier cleaning by permitting the window to tilt inward when the latches are released. Defective latches permit the window to tilt or fall inward during normal opening. The latches should be replaced.

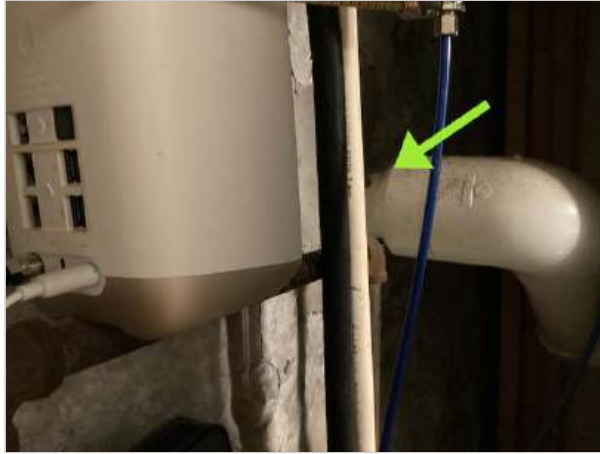
4 inch to 2 inch reduction
