2516 Highland Cir

RE: Bethel Park, PA 15102

Inspection #: 527-032026-6736

HOME INSPECTION REPORT

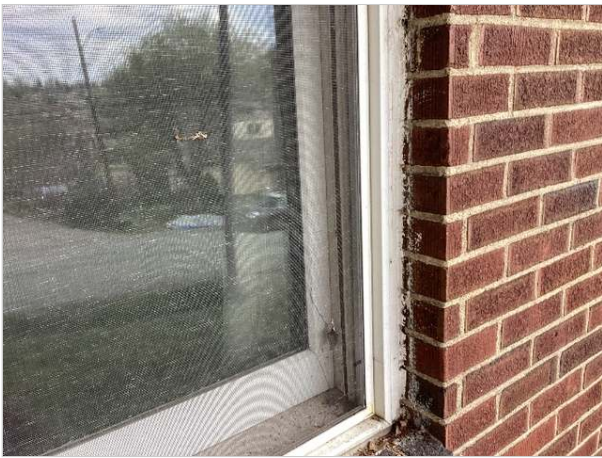
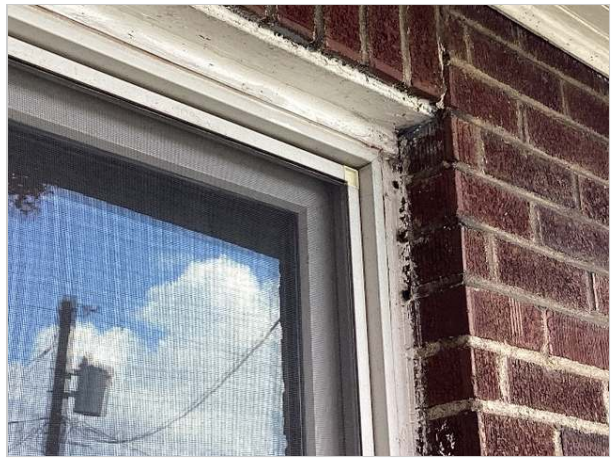
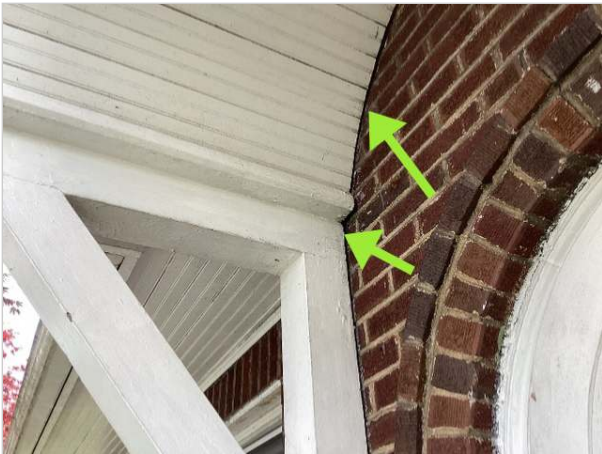
The exterior caulking around the windows and doors is cracked or missing on all sides of the home. The caulking should be replaced to ensure the exterior of the home remains weather and water tight.

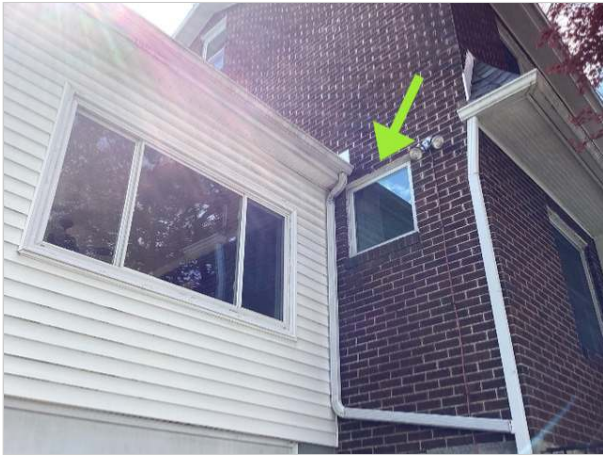
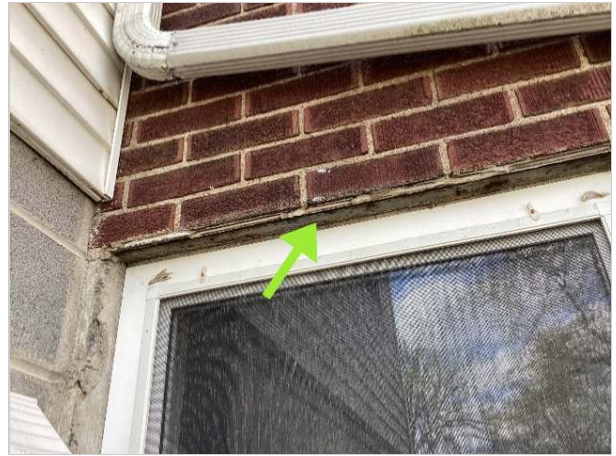
MAINTENANCE NOTE: LINTELS:

One or more of the steel lintels above the windows on the exterior of the home were noted to be rusting. Lintels support masonry materials above doors and windows. Keeping the lintels sealed and painted will prevent rusting and expansion. Expanded lintels can lead to cracks in the masonry on the exterior of the home.

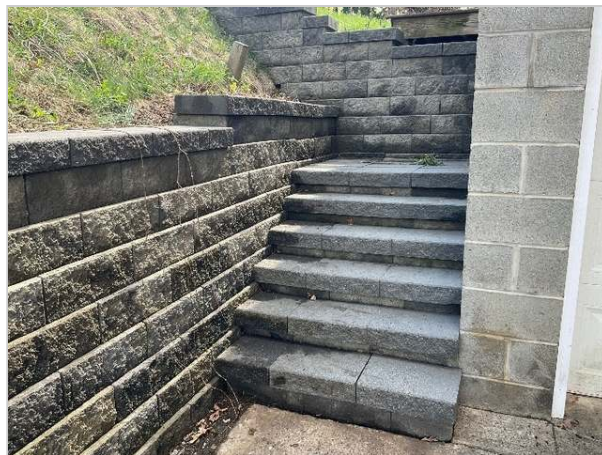
There were no handrails on the steps in the front. Local codes may require the installation of handrails in location where three or more steps are present.

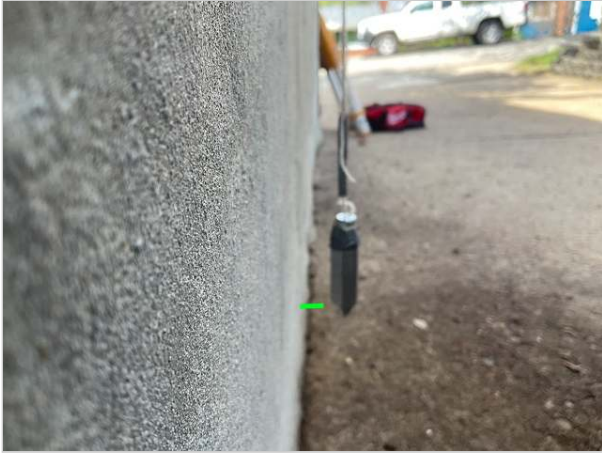
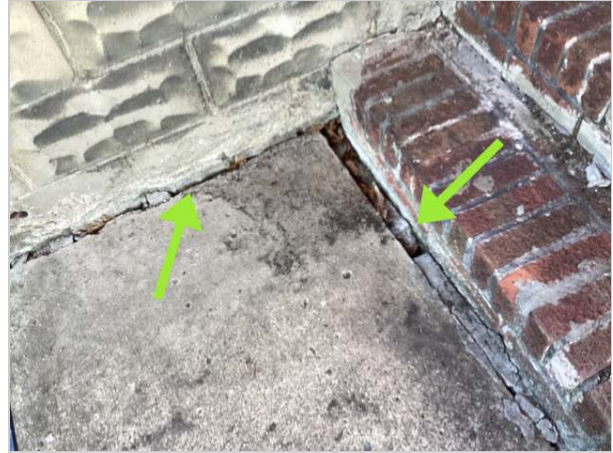
NOTE: CONCRETE SETTLEMENT:

Settlement was noted on the front porch slab. The settlement does not appear to be active. Settlement of concrete slabs is common and is usually not a problem. If the settlement causes the concrete slab to pitch toward the foundation

of the home, it is possible that water will drain into the basement. In this case the slab was pitched toward the foundation. It is not possible for us to positively determine if active settlement is occurring during a home inspection. The area should be monitored for evidence of new or continued settlement. Consult with a qualified contractor for further evaluation if required.

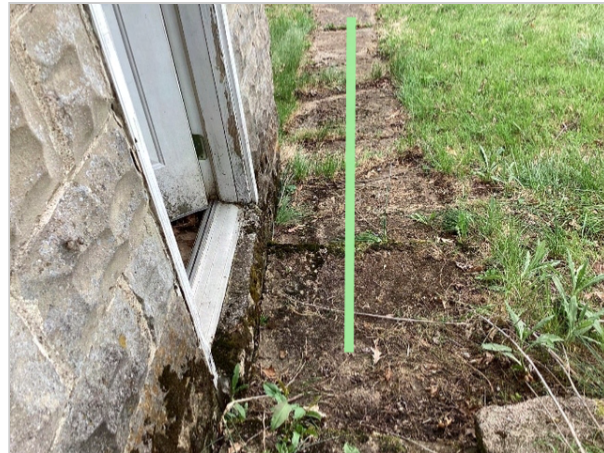
NOTE: CONCRETE SETTLEMENT:

Settlement was noted on the back walkway slab. The settlement does not appear to be active. Settlement of concrete slabs is common and is usually not a problem. If the settlement causes the concrete slab to pitch toward the foundation of the home, it is possible that water will drain into the basement. In this case the slab was not pitched toward the foundation. It is not possible for us to positively determine if active settlement is occurring during a home inspection. The area should be monitored for evidence of new or continued settlement. Consult with a qualified contractor for further evaluation if required.

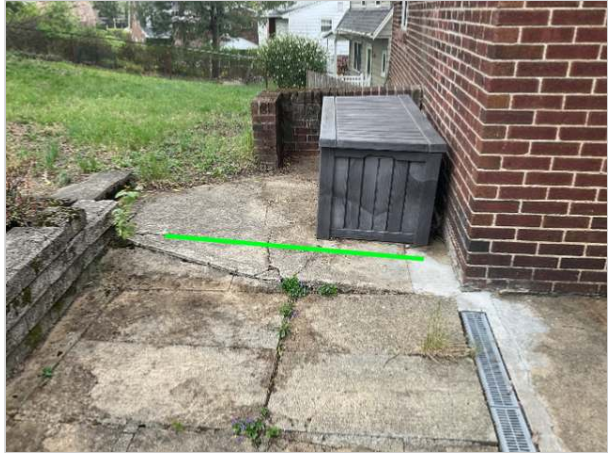
NOTE: CONCRETE SETTLEMENT:

Settlement was noted on the back patio slab. The settlement does not appear to be active. Settlement of concrete slabs is common and is usually not a problem. If the settlement causes the concrete slab to pitch toward the foundation of the home, it is possible that water will drain into the basement. In this case the slab was pitched toward the foundation. It is not possible for us to positively determine if active settlement is occurring during a home inspection. The area should be monitored for evidence of new or continued settlement. Consult with a qualified contractor for further evaluation if required.

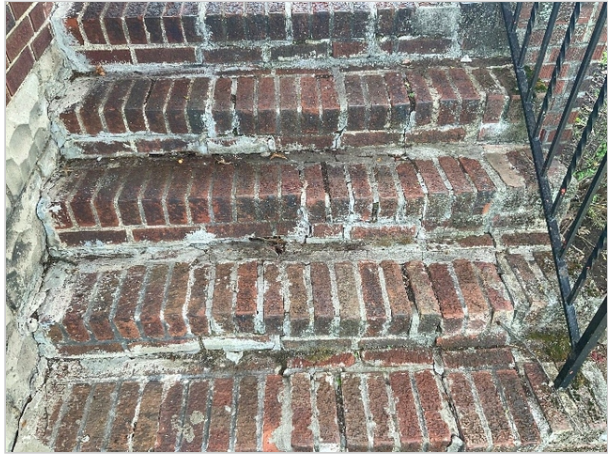
NOTE: STEPS SETTLEMENT:

The front porch steps are cracked and settled. We are not able to determine if the condition is active. The steps appeared to be stable at the time of the inspection. Consult with a qualified contractor for evaluation and recommendations.

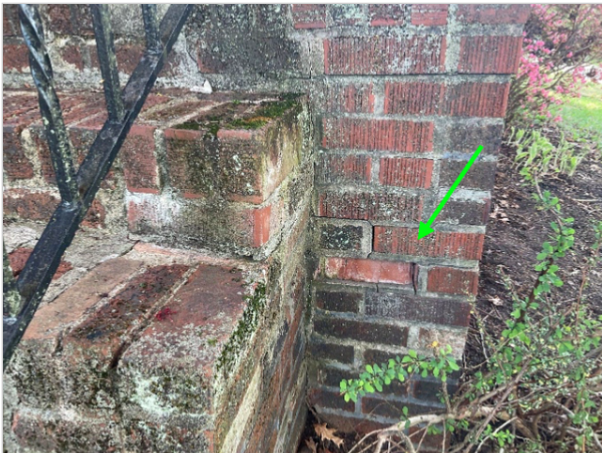
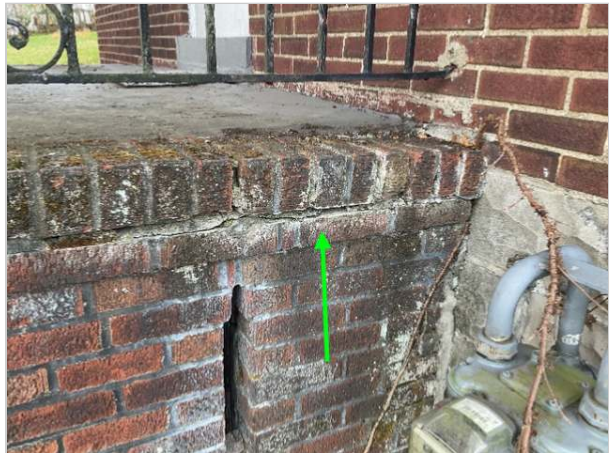
NOTE: MASONRY/MORTAR CRACKS:

One or more cracks and spalling were noted on the brick veneer of the home. The cracks were located on the front. The cracks appear to have been caused by settlement, are common and do not usually have any structural significance. No structural concern on the brickwork was noted at the time of the inspection. All cracks should be monitored for significant changes in characteristics. Corrective action is required. Consult with a qualified masonry contractor for repair estimates.

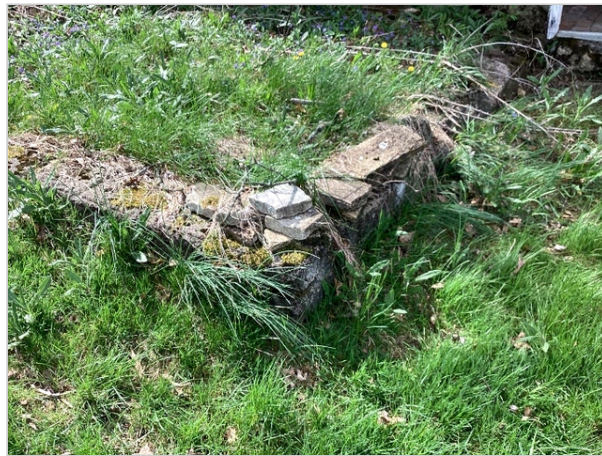
The rear detached garage retaining wall is in a general state of disrepair. There were significant vertical earth pressure type cracks observed in the wall. This condition is most often associated with soil and /or water pressure. The displacement occurs incrementally as the wall yields to horizontal earth pressure. The wall was stable at the time of the inspection. Repairs to the wall are required. Consult with a qualified contractor for repair estimates.

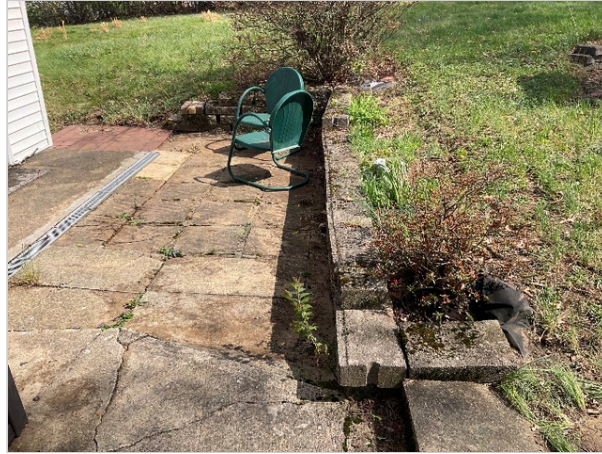
The rear patio retaining wall is pushed. There were significant vertical earth pressure type cracks observed in the wall. This condition is most often associated with soil and /or water pressure. The displacement occurs incrementally as the wall yields to horizontal earth pressure. The wall was stable at the time of the inspection. Repairs to the wall may be required. Consult with a qualified contractor for repair estimates

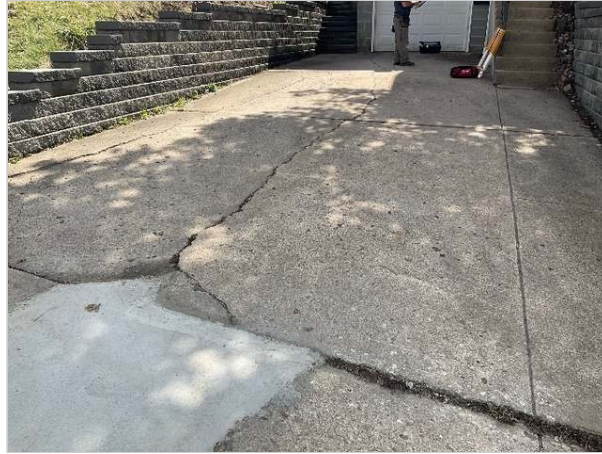
There was a concrete driveway in the front of the home which led to the integral garage. There were many cracks and spalled areas noted on the driveway. Surface defects in driveways develop and progress with age and are considered normal as long as they do not create a safety hazard. There were no material defects observed in the driveway.

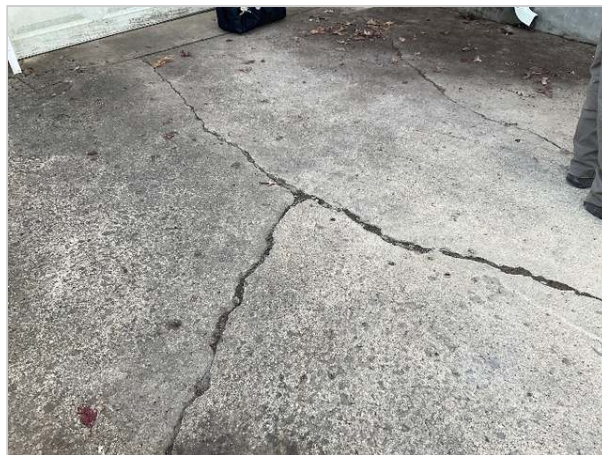
Settlement was noted on the front driveway slab. The settlement does not appear to be active. Settlement of concrete slabs is common and is usually not a problem. If the settlement causes the concrete slab to pitch toward the foundation of the home, it is possible that water will drain into the basement. In this case the slab was not pitched toward the foundation. It is not possible for us to positively determine if active settlement is occurring during a home inspection. The area should be monitored for evidence of new or continued settlement. Consult with a qualified contractor for further evaluation if required.

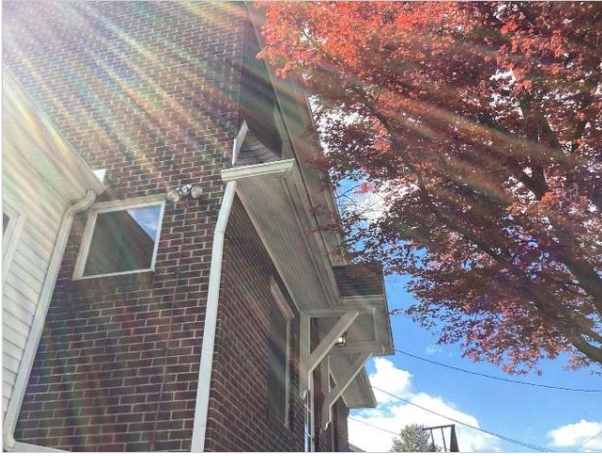
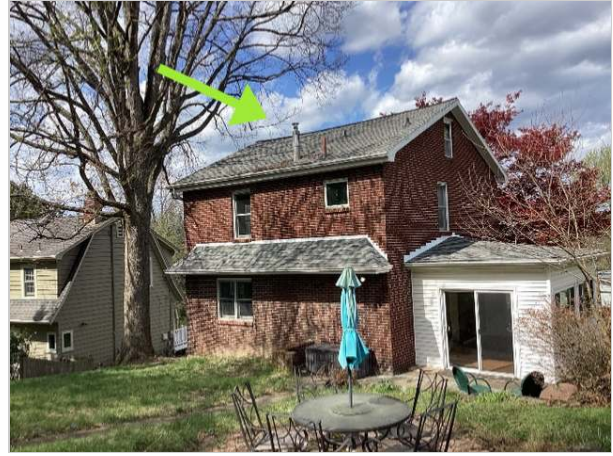
Tree branches were hanging over, or making contact with the roof. The trees should be cut back away from the roof to avoid damage to the roofing material.

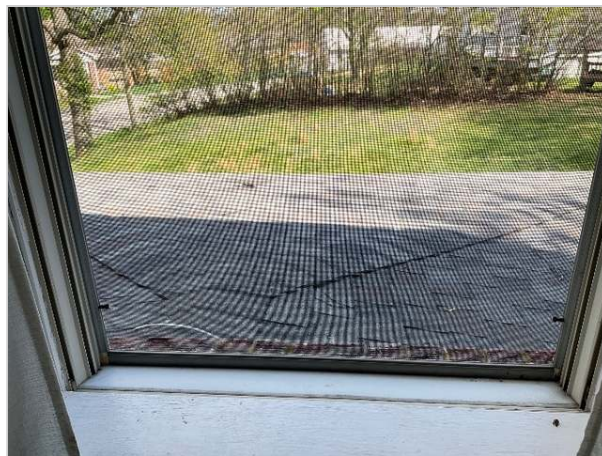
NOTE: ROOF PITCH:

The addition roof does not appear to have sufficient pitch for installation of standard shingles. Water can back under the shingles and leak to the interior. Asphalt shingles should not be used on roofs with less than a 2:12 pitch and require special application procedures for pitches less than 4:12. It is not within the scope of the home inspection to determine if special application steps were taken prior to the installation of the shingles. Consult with a qualified roofing contractor for further evaluation and recommendations.

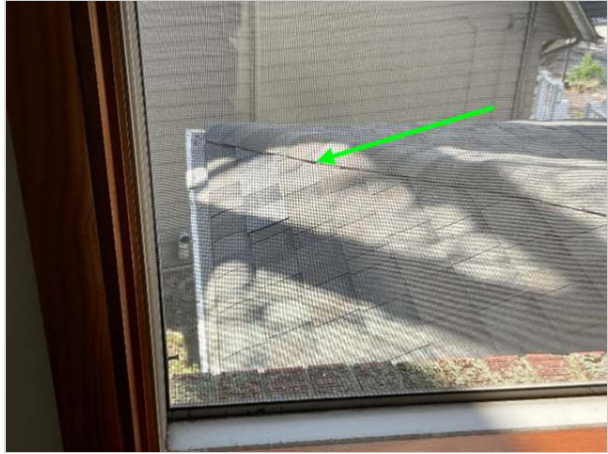
NOTE: ROOF REPAIR:

A questionable roof repair was noted on the right side. The long term effectiveness of the repair is doubtful as it appears sealant was applied directly to the asphalt shingle surface. There was no evidence of an active roof leak noted at the time of inspection. It is recommended that a qualified roofing contractor be consulted for further evaluation and recommendations.

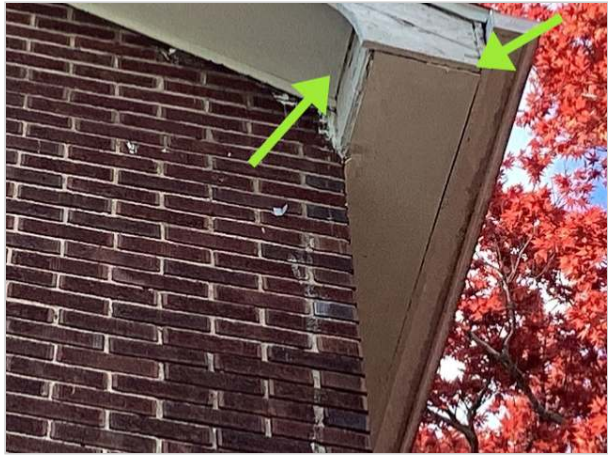
NOTE: EXTERIOR WOOD ROT:

Rotted wood was noted on the soffit and fascia . The areas should be repaired and sealed by a qualified contractor.

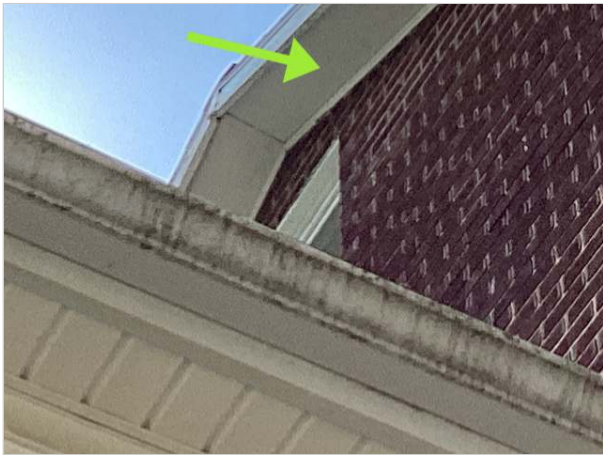
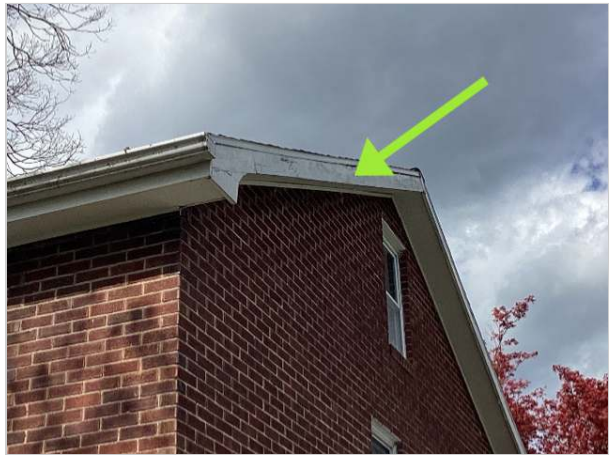
MAINTENANCE NOTE: PEELING PAINT:

Peeling paint was noted on many areas of the exterior. In order to preserve the life of the exterior surfaces and materials, all areas should be scraped and painted.

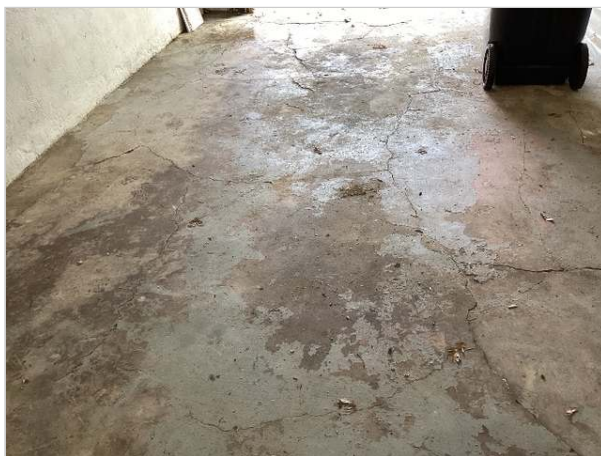
Settlement was noted on the integral garage floor slab. The settlement does not appear to be active. Settlement of concrete slabs is common and is usually not a problem, as there is no connection between the floor and structure of the home. It is not possible for us to positively determine if active settlement is occurring during a home inspection. The area should be monitored for evidence of new or continued settlement. Consult with a qualified contractor for further evaluation if required. Certain instances of settlement can damage floor or drain plumbing. Plumbing issues below floor level are not visible for inspection and therefore cannot be evaluated. Consult with a qualified plumber to have a sewer camera inspection performed if desired.

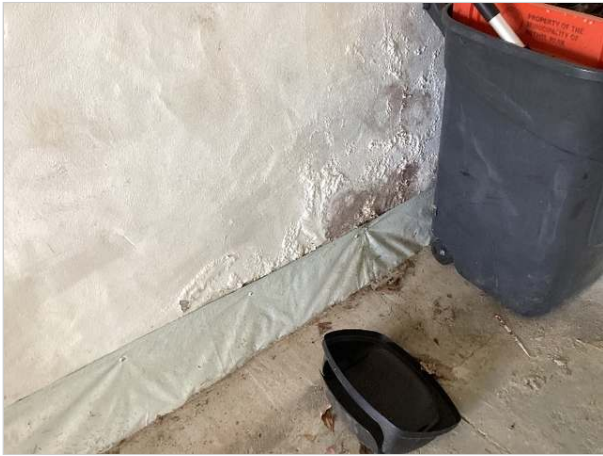
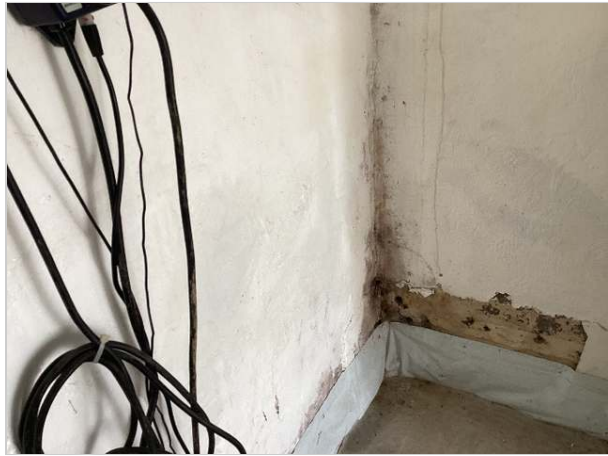
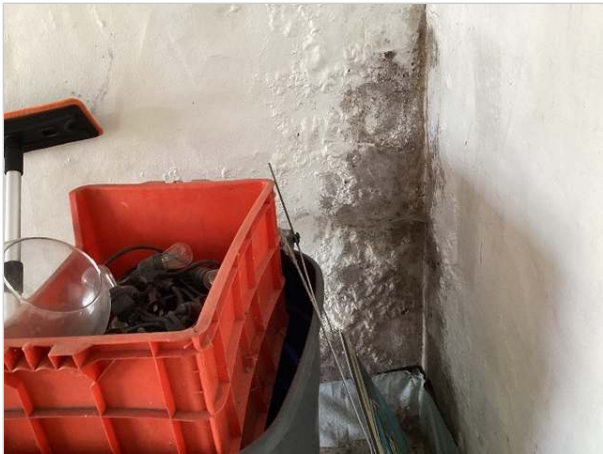
NOTE: GARAGE MOISTURE EVIDENCE:

There were signs of moisture on the left and rear garage walls of the integral garage. The area was dry at the time of the inspection. Dampness on garage walls is not always a sign of water intrusion. The dampness can be the result of warm humid air making contact with cool walls. In many cases the humid air condenses on the wall and forms a layer of moisture. It is important to assess whether moisture on the walls is the result of water intrusion or condensation. In this case the condition appears to be the result of water intrusion. The exterior grading in the affected area is questionable. Many water intrusion problems can be controlled by improving the drainage on the exterior of the home. It is important that all roof drainage and surface water is directed away from the foundation. Any concern about this condition should be referred to a qualified contractor for evaluation and recommendations.

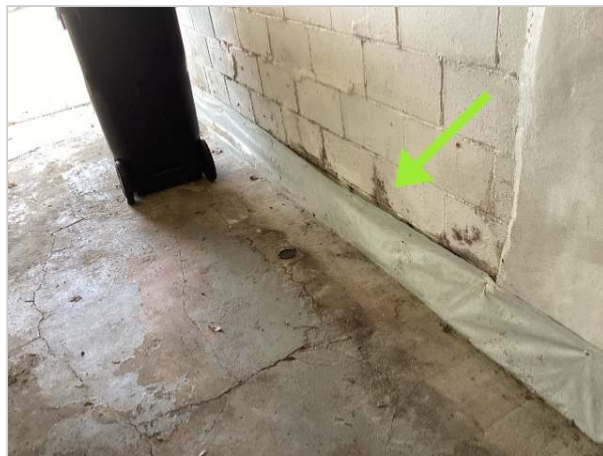
A substance with the characteristics of mold is visible in one or more areas of the integral garage. The EPA (<http://www.epa.gov/mold/moldresources.html>) advises consumers that areas less than ten square feet of coverage can usually be controlled using readily available household products. In the event the substance cannot be controlled, a certified mold testing and remediation firm should be contacted for a recommended course of action.

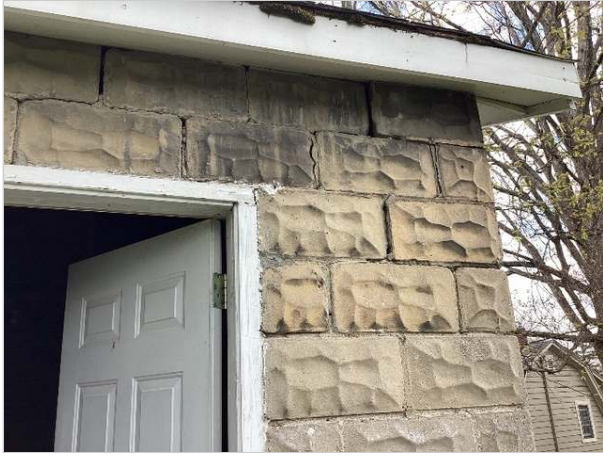
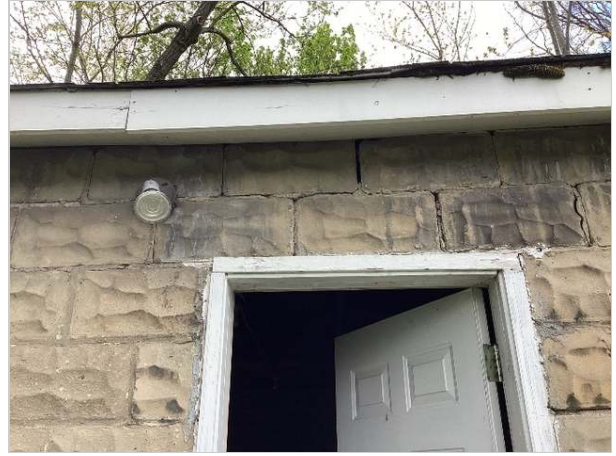
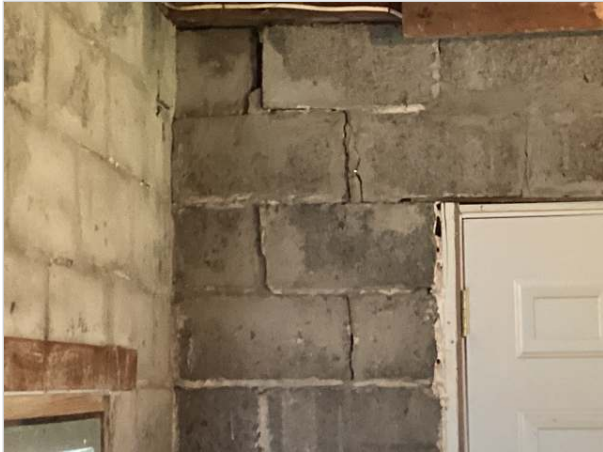
NOTE: MISSING MORTAR:

Missing mortar was noted on the brickwork on the back of the garage. There were also loose bricks noted. Small amounts of missing mortar are usually inconsequential. Extensive amounts of missing mortar can permit water intrusion. Consult with a qualified masonry contractor for repair estimates.

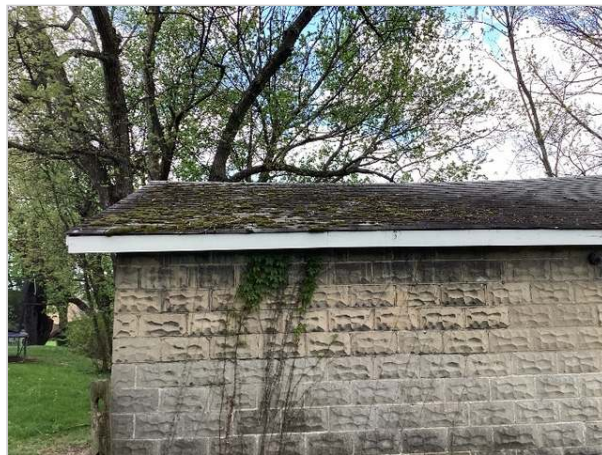
NOTE: MOSS GROWTH ON ROOF:

Moss growth was noted on the garage roof. This condition is usually caused by a lack of sunlight on the roof due to trees or other cover. While the moss on the roof presents no hazard, advanced growth can cause the roof to hold moisture and debris. The consequences of moss growth on roofs is widely debated. While cleaning products are available for moss removal, simply cutting back trees can remove the conditions that cause moss growth. Consult with a qualified contractor for further evaluation if desired.

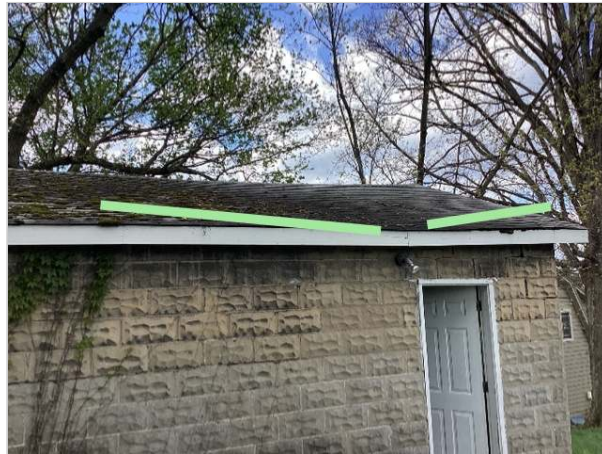
NOTE: LOW SPOT ON ROOF:

A depression in the roofing was noted on the garage. This condition is usually caused by settlement of the roof framing and is generally insignificant. Consult with a qualified roofer for further evaluation if desired.

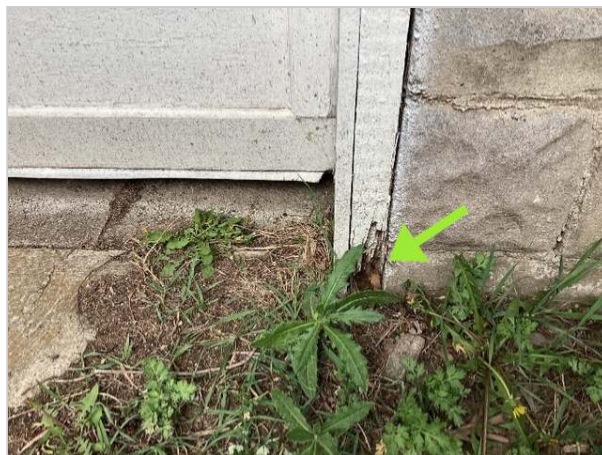
NOTE: EVIDENCE OF TERMITE ACTIVITY:

Evidence of termite activity was noted on the garage door frame. The visible damage noted was insignificant and did not appear to have any structural significance. Repairs to the affected area (s) may be necessary. Consult with a qualified contractor for further evaluation. Please note too that any assessment as to the extent of damage caused by termites is limited to the visible and readily accessible areas of the home. We are not able to determine the presence or extent of concealed damage.

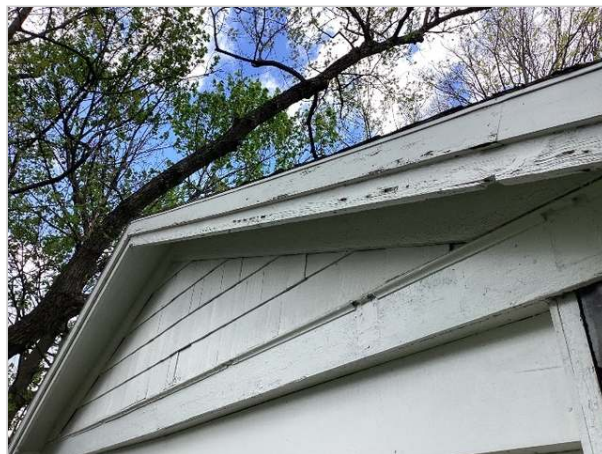
NOTE: CARPENTER BEES

Carpenter bee damage was noted on the fascia. The affected areas should be repaired and sealed by a qualified contractor.

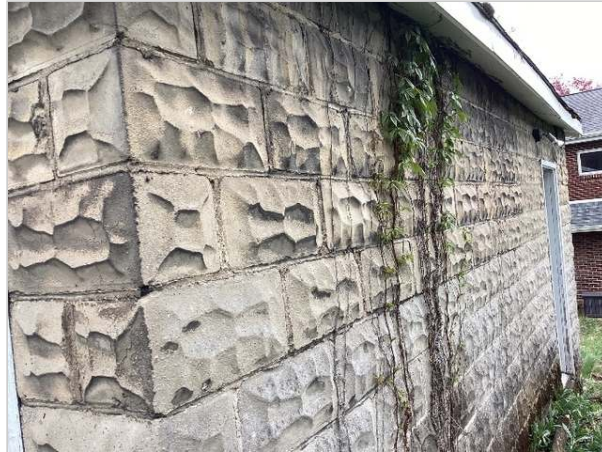
NOTE: OVER GROWTH:

Extensive plant growth was observed against the garage , on the left side area of the house. Recommend removing this growth away from the siding to prevent possible damage including insect infestation.

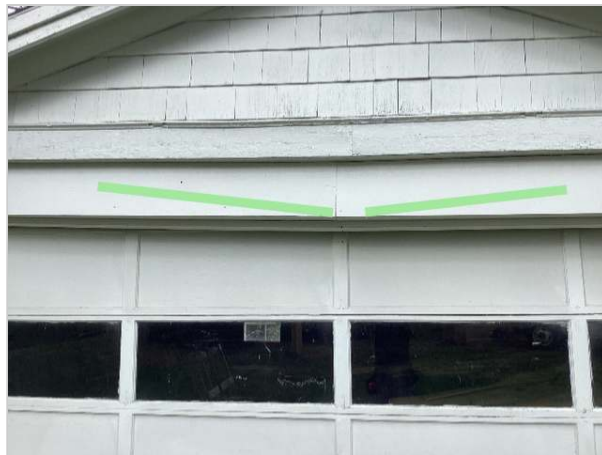
NOTE: LINTELS/HEADER:

The header on the garage is deflected. Headers support structure materials above doors and windows and lintel failure will lead to brick cracks or other damage to the masonry exterior. Consult with a qualified contractor for evaluation and recommendations.

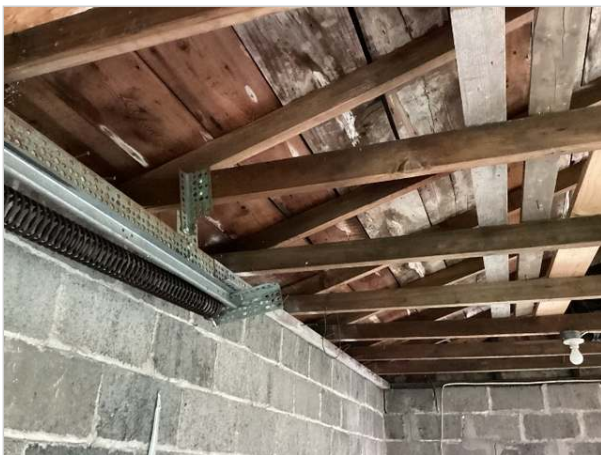
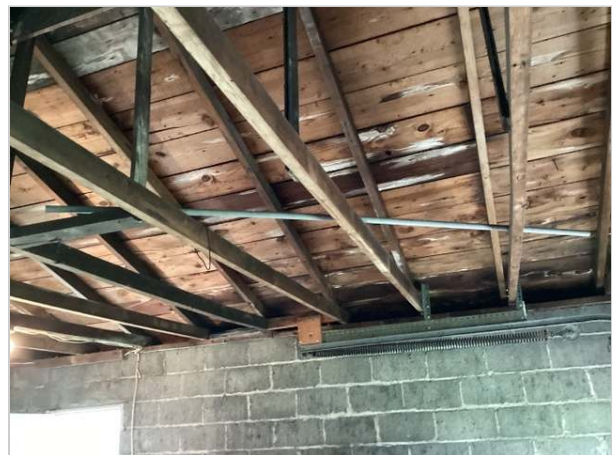
NOTE: ROOF DECK:

The roof deck as viewed from the garage is water marked. The cause of condition appears to be the result of active leaks. Repairs to the affected areas are required. Consult with a qualified contractor for repair.

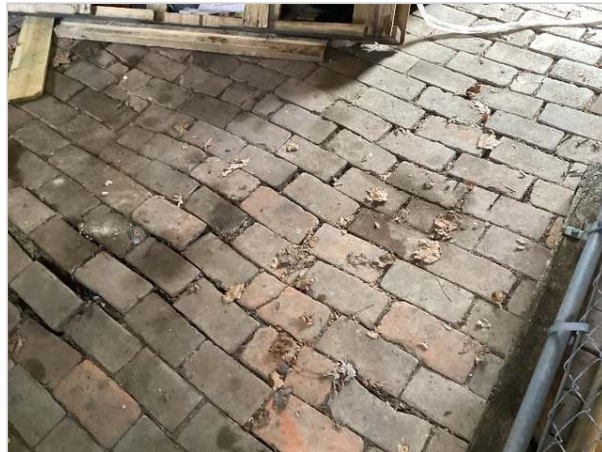
NOTE: GARAGE SLAB SETTLEMENT:

Settlement was noted on the garage floor slab. The settlement does not appear to be active. Settlement of concrete slabs is common and is usually not a problem, as there is no connection between the floor and structure of the home. It is not possible for us to positively determine if active settlement is occurring during a home inspection. The area should be monitored for evidence of new or continued settlement. Consult with a qualified contractor for further evaluation if required. Certain instances of settlement can damage floor or drain plumbing. Plumbing issues below floor level are not visible for inspection and therefore cannot be evaluated. Consult with a qualified plumber to have a sewer camera inspection performed if desired.

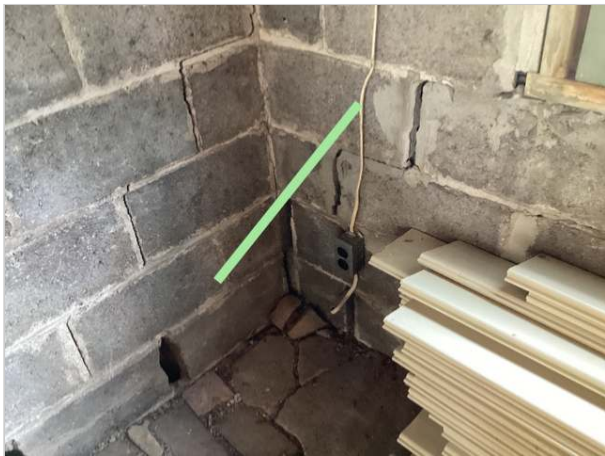
NOTE: FOUNDATION MOVEMENT:

There were significant horizontal and vertical earth-pressure type cracks observed on the garage foundation wall at the time of the inspection. There was also an inward bulge observed on the back foundation wall. The deflection on the wall was measured using a plumb line and found to be approximately 1 1/2-inches. The wall was considered stable at the time of the inspection. Consult with a company specializing in foundation repair for further evaluation and recommendations. This condition is most often associated with soil and / or water pressures. The displacement occurs incrementally as the wall yields to horizontal earth pressure. Surface grading around the foundation is questionable. Proper grading should be maintained to prevent foundation damage and water penetration.

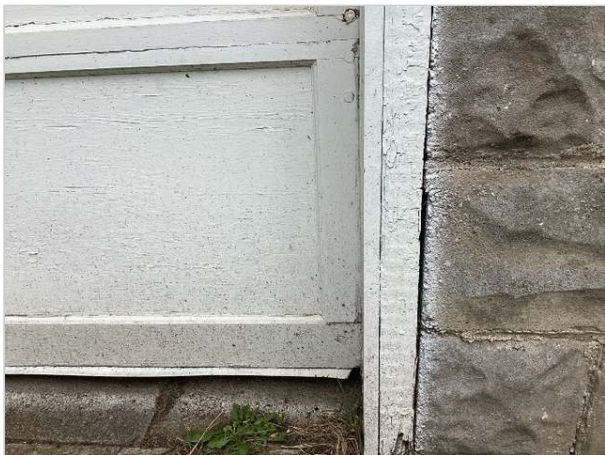
The exterior caulking around the doors is cracked or missing on the back of the garage. The caulking should be replaced to ensure the exterior of the home remains weather and water tight.

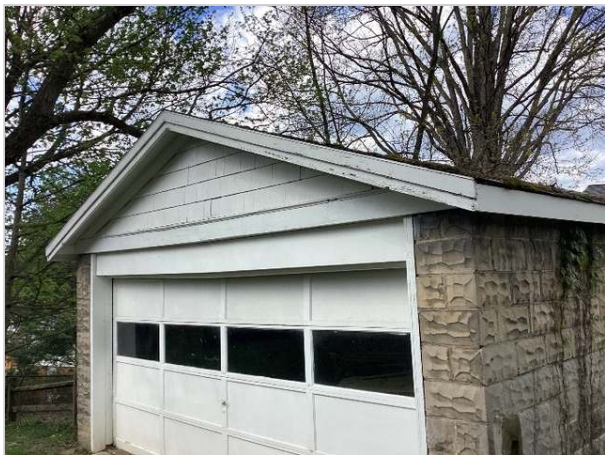
MAINTENANCE NOTE: PEELING PAINT:

Peeling paint was noted on the garage door and frame. In order to preserve the life of the exterior surfaces and materials, all areas should be scraped and painted.

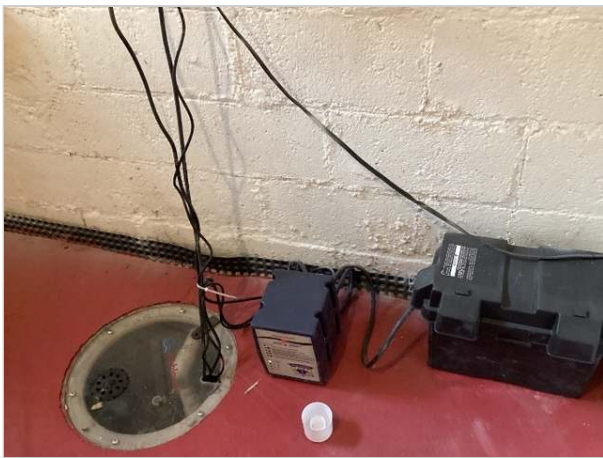
Front

There were signs of moisture on the front and rear. The area was not dry at the time of the inspection. Dampness on basement walls is not always a sign of water intrusion. The dampness can be the result of warm humid air making contact with cool walls. In many cases the humid air condenses on the wall and forms a layer of moisture. It is important to assess whether moisture on the basement walls is the result of water intrusion or condensation. The condition in this case appears to be a combination of moisture and water efflorescence. The exterior grading in the affected area is questionable. Many water intrusion problems can be controlled by improving the drainage on the exterior of the home. It is important that all roof drainage and surface water is directed away from the foundation. Any concern about this condition should be referred to a qualified contractor for evaluation and recommendations.

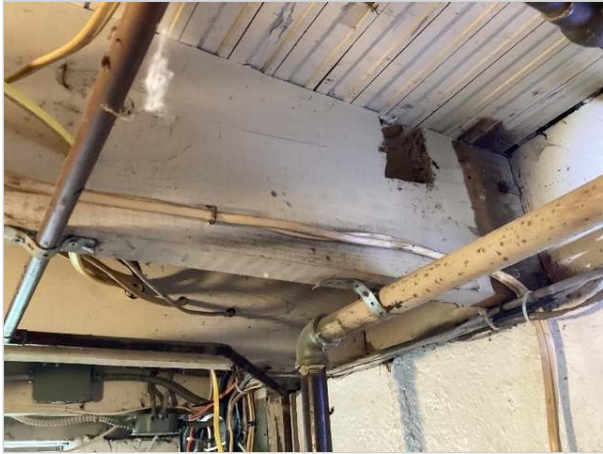
Front right

Several joists have been notched. This action has compromised the integrity of the joist. Consult with a qualified contractor for evaluation and recommendations.

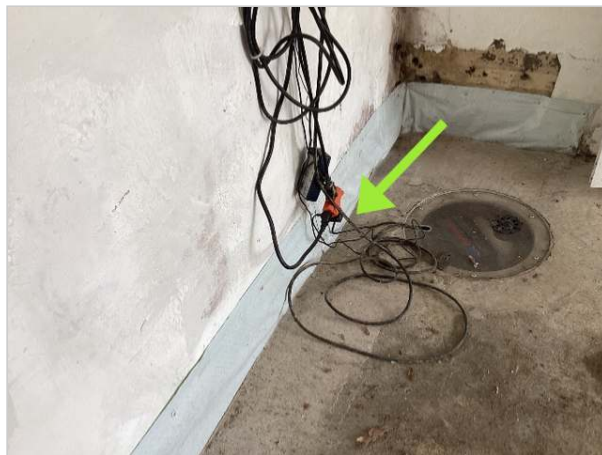
The sump pump is not properly wired. The pump should be connected to a permanently wired, grounded outlet that is located close to the sump. Consult with a qualified electrician for installation.

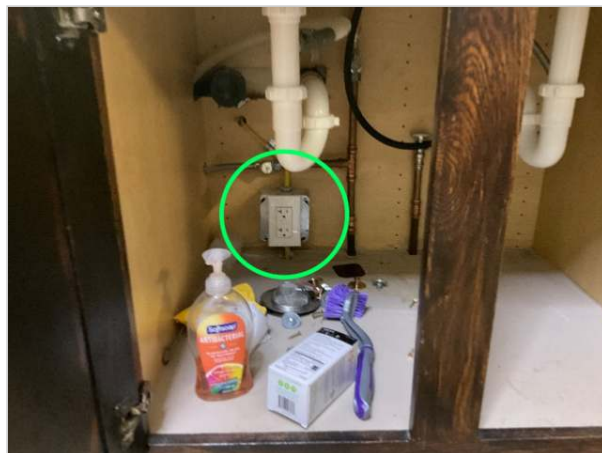
The GFCI outlet located in the kitchen is defective and should be replaced by a qualified electrician.
