Property Inspection Report

410 Pinkerton Road, Wexford, PA

INSPECTOR: Alexander T Laughlin

DATE OF INSPECTION: 1/12/2026

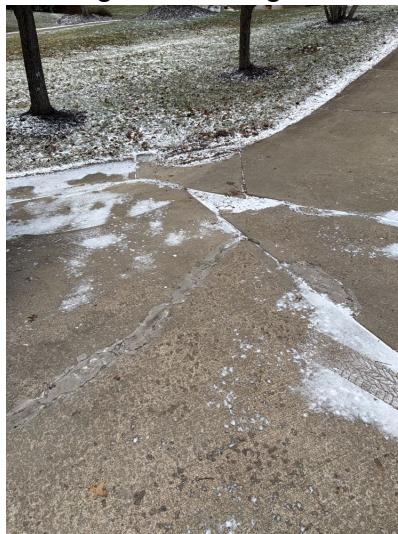
- The driveway is made of concrete.
- The driveway has areas of minor cracking and damage that is common for driveways as they age.

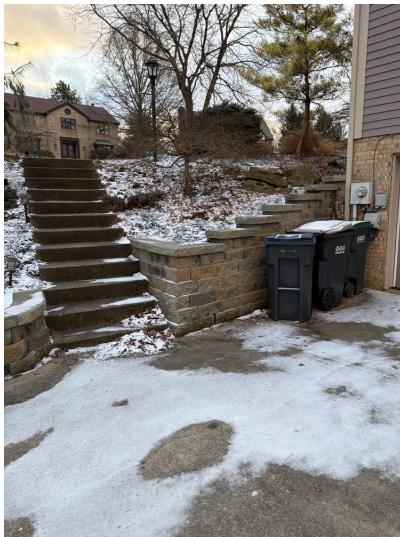
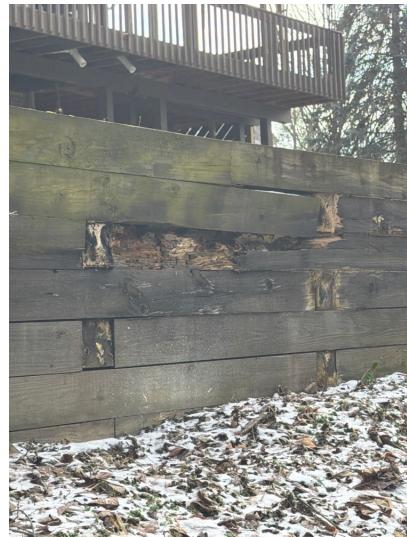
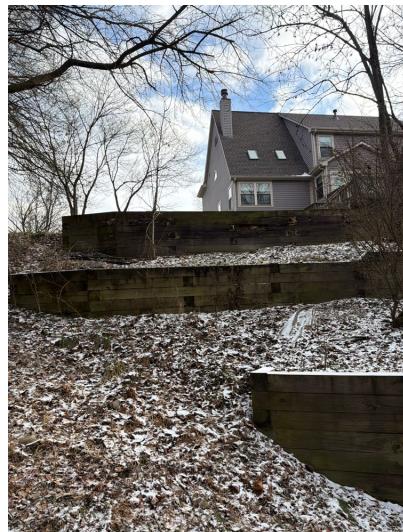
4. Yard Walls

- The yard walls have areas of movement and wood rot. They should be further evaluated and repaired or replaced by a contractor.

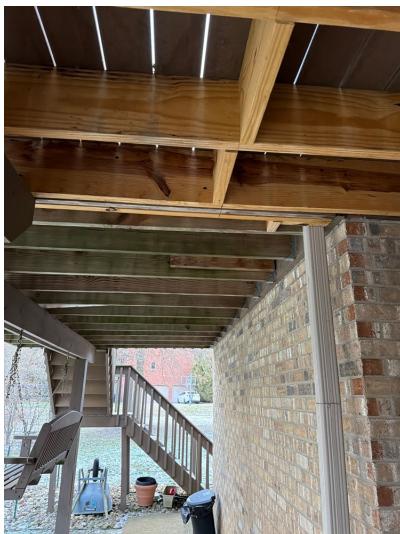
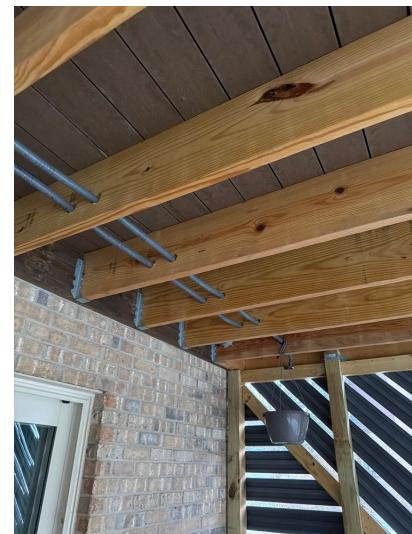
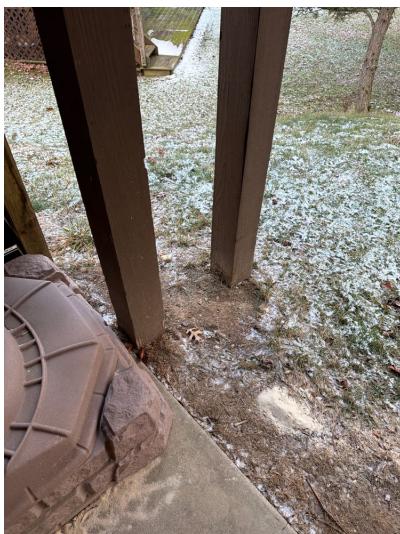
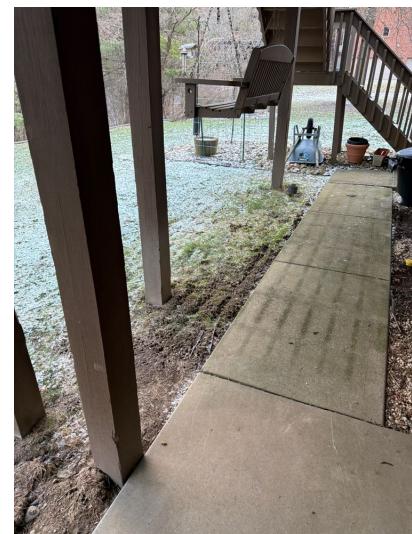
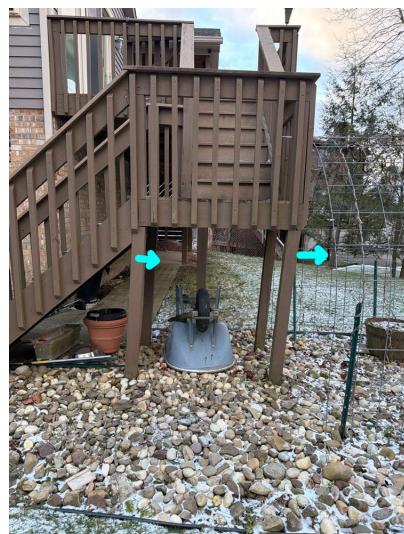
5. Decks

- Many decks in our area are not built properly or have permits that have been pulled to build the deck. You should ask the sellers if a permit was pulled for this deck.
- I was unable to determine if the deck columns were properly sitting on a footer. If the columns are not resting on a footer, they may be more prone to sagging or settling over the years.
- **The landing on the deck is leaning to one side. A contractor should evaluate and make all repairs as needed.**

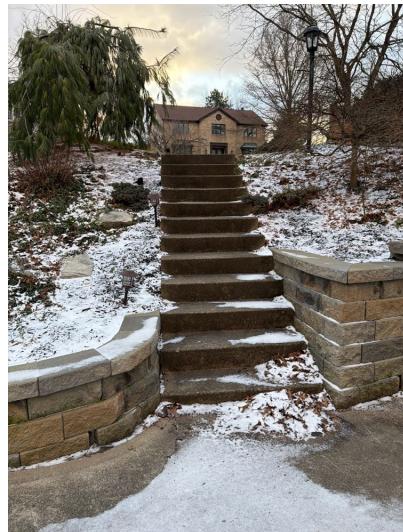
6. Steps and Hand Rails

- We recommend installing hand rails on any set of stairs that have three or more risers.

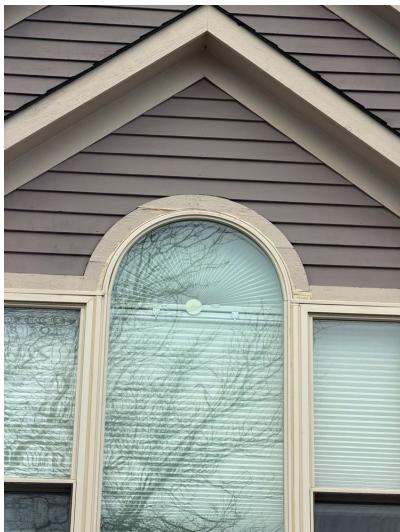
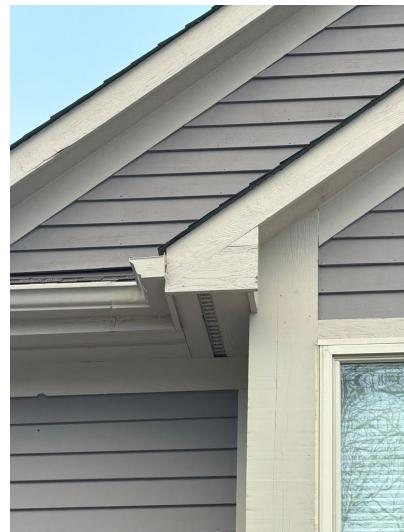
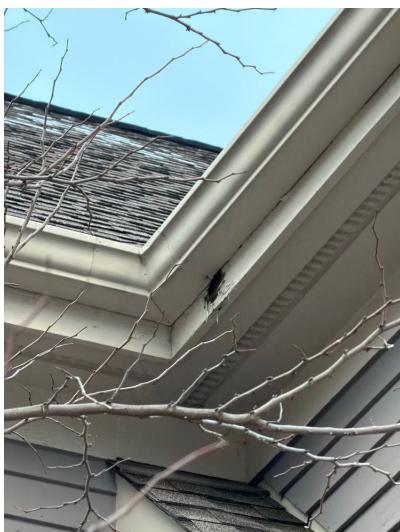
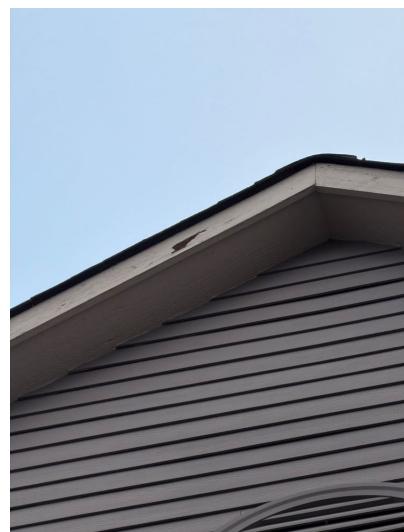
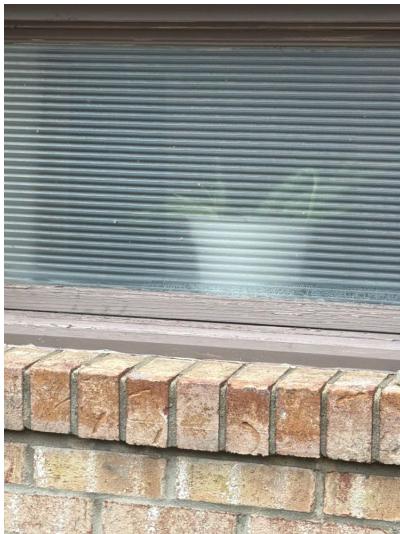
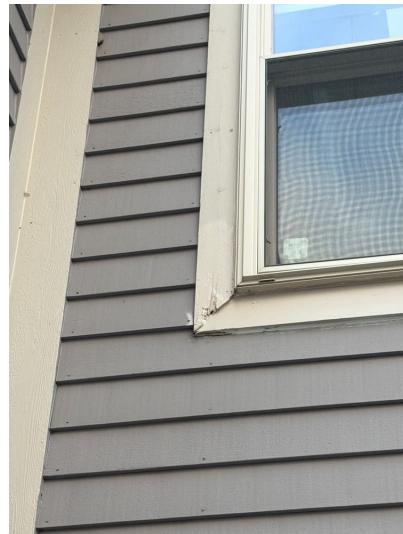
7. Exterior Trim

- There are areas of peeling paint and wood-rot visible on exterior of house. The peeling paint should be scraped and re-painted. Any areas of wood rot should be replaced.

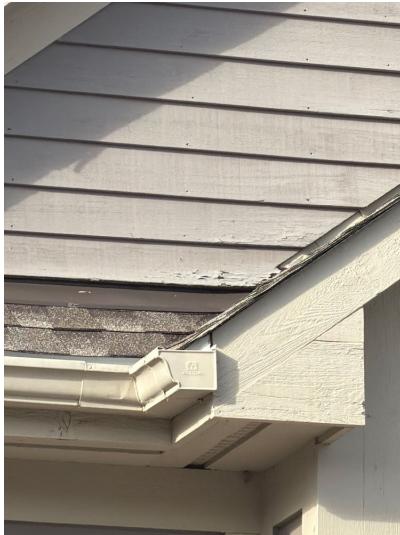
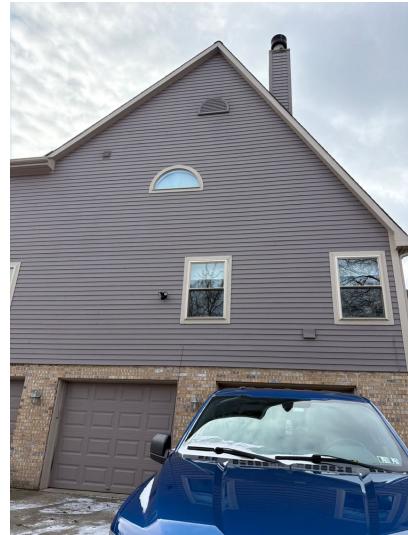
2. Wall Covering Condition

- There are areas of wood siding that has peeling paint and some moisture damage. It should be scraped and repainted, any damaged wood should be replaced. A contractor should evaluate and make repairs.

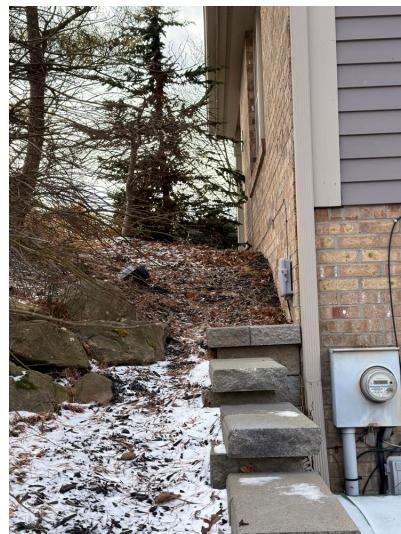
1. Grading Adjacent to House

- The exterior grading slopes towards the residence in areas and moisture intrusion is always a possibility given the location and terrain even when grading is properly done. The soil should slope away from the residence to a distance of around five feet, to keep moisture away from the foundation. Any areas of solid surfaces such as concrete, asphalt etc. should be caulked at the joint where it meets the structure. Proper grading of the exterior should be done now and maintained over the years of ownership.

The areas below grade such as basements and crawlspaces are most susceptible to moisture. Ensuring proper grading on the exterior of the house could have a significant reflection on the dampness of these underground areas. In my experience, proper exterior grading will help to slow down the moisture penetration into the areas of the structure that are underground, however other measures may need to be taken.

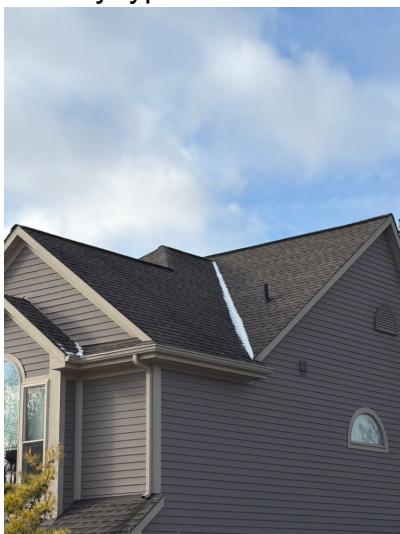
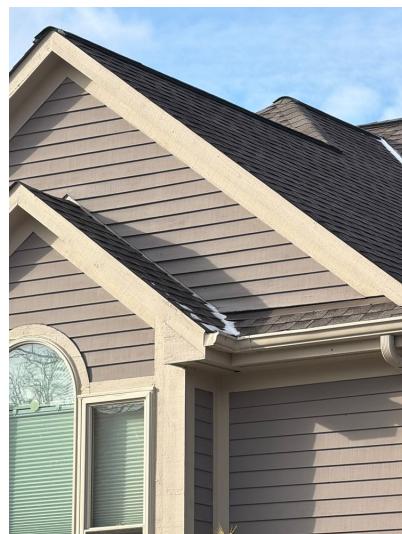
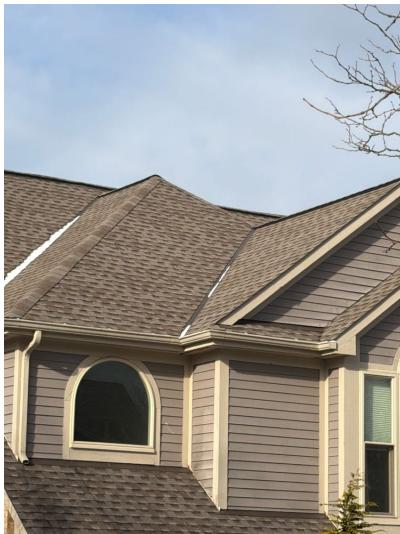
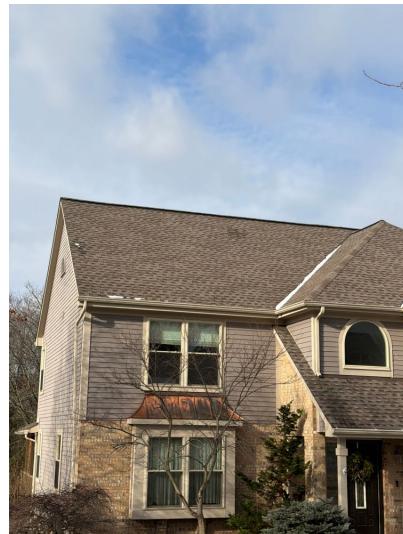
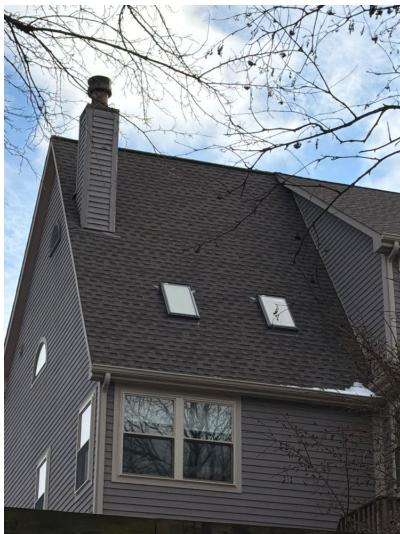
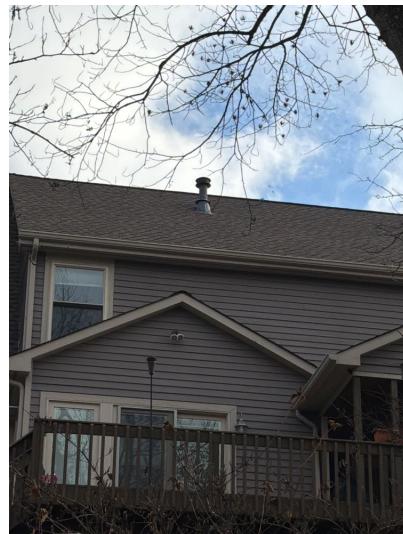
3. Age and General Evaluation

- The composition shingle roof appears to be around 5-8 years old. This is just an estimate and you should ask the sellers if they have an exact date of install. It is important to keep all receipts and documents for warranty and material maintenance requirements.
- The composition shingle roof is in acceptable condition. Our inspection does not include any guarantee for any type of roof leaks that may occur in the future.

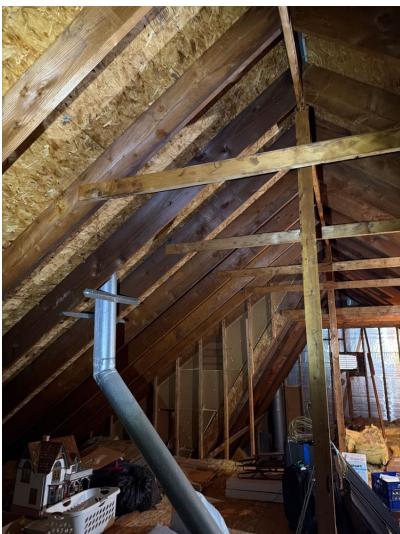
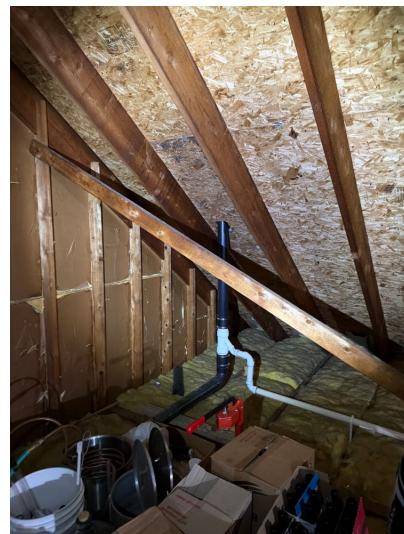
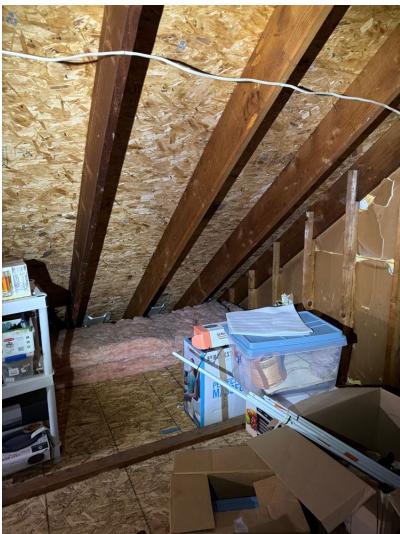
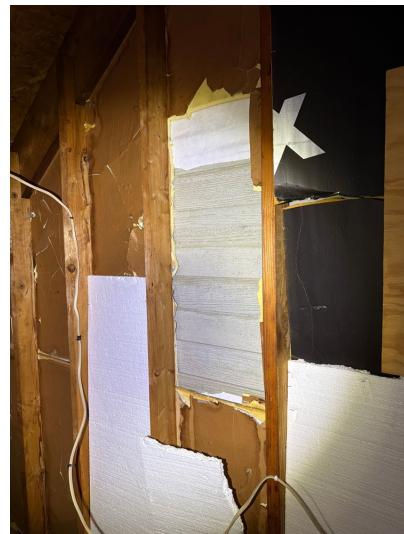
2. Framing

Attic		
Page 13 Item: 2	Framing	• The siding at the left side of the house is visible in the attic. You should consider properly sealing this section with house wrap and rigid foam insulation.

- The visible portions of the framing are in acceptable condition, and would conform to the standards of the year in which they were constructed.
- There are moisture stains or evidence of damage or past leakage to the roof sheathing. We did not feel that the stains were active at this time, although they should be monitored.
- **The siding at the left side of the house is visible in the attic. You should consider properly sealing this section with house wrap and rigid foam insulation.**

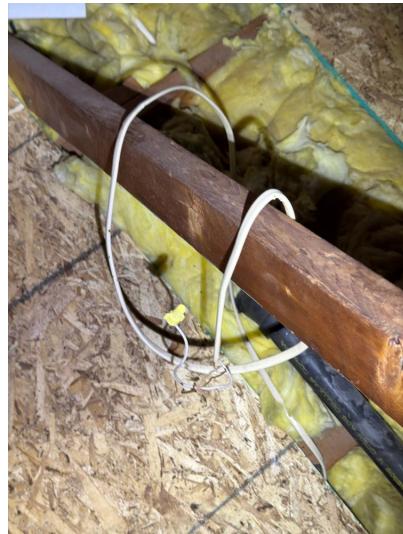
4. Electrical

- There is a loose wire in the attic that should be placed in a junction box.

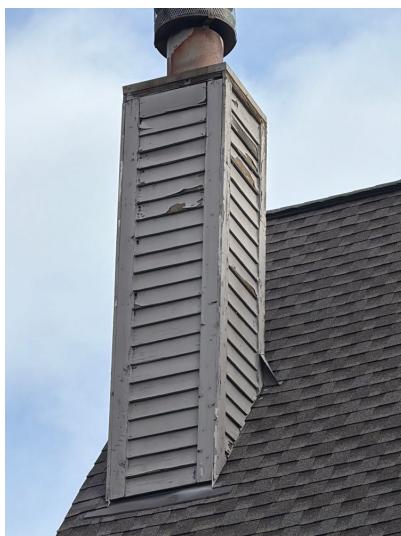
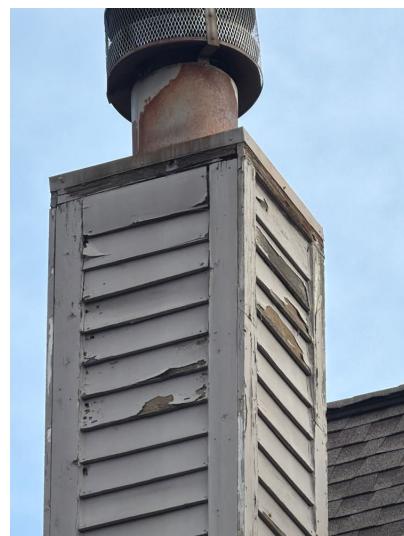
1. Chimney Walls

- The wood chimney walls are significantly rotted. Also the flue is rusted. Repairs should be made as needed by a certified contractor.

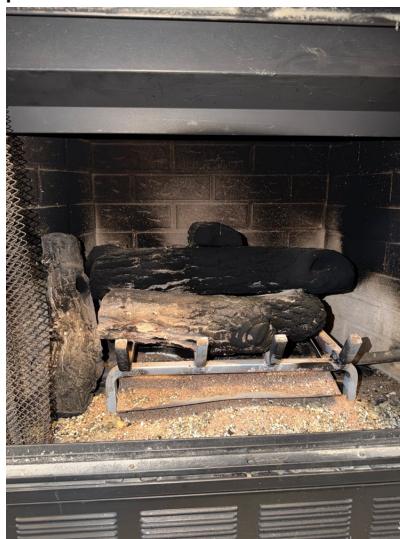
3. Fireplace

- The gas logs are a vented type and the damper must be open while they are in use. You may wish to add a damper-stop as a safety feature to ensure that they are not accidentally closed while in use. They appear to be in acceptable condition for their age.
- This fireplace is currently being used as a gas log fireplace and was inspected as such. If you ever wish to remove the gas logs and burn wood in this fireplace, it should be further evaluated by a chimney sweep, and determined if any repairs are needed first. We do not warrant or endorse this fireplace as a wood burning fireplace.

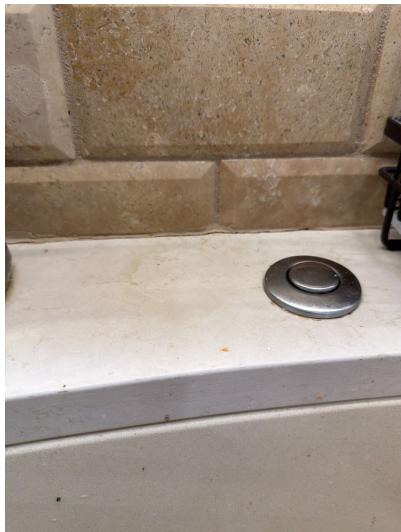
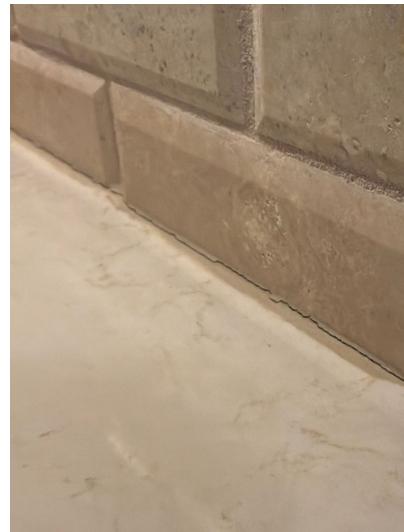
6. Counter Top

- A separation between the kitchen counter top and the wall should be grouted or caulked to help prevent moisture intrusion.

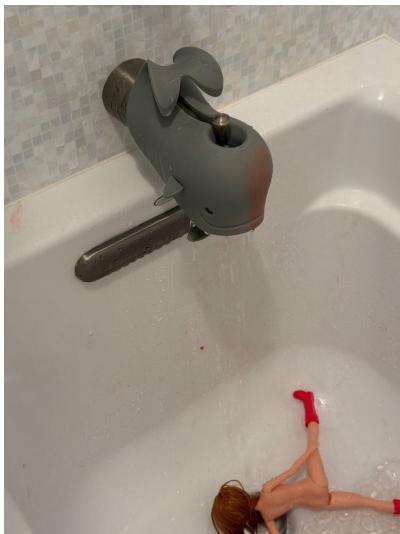
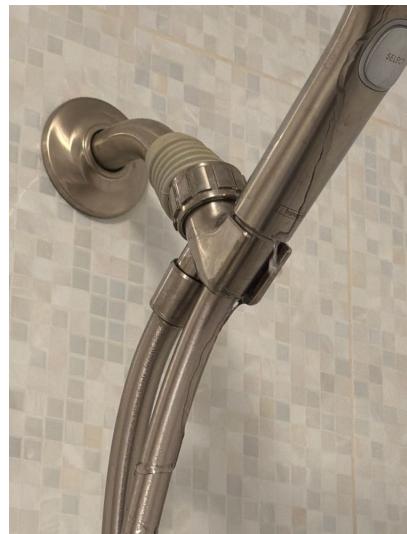
- The access area behind the tub was evaluated and there were no visible leakage at the time of the inspection.
- The shower diverter does not divert the water fully to the shower head while engaged. A plumber should further evaluate and make repairs as needed.
- The shower head leaks while the water is on and should be repaired by a plumber.

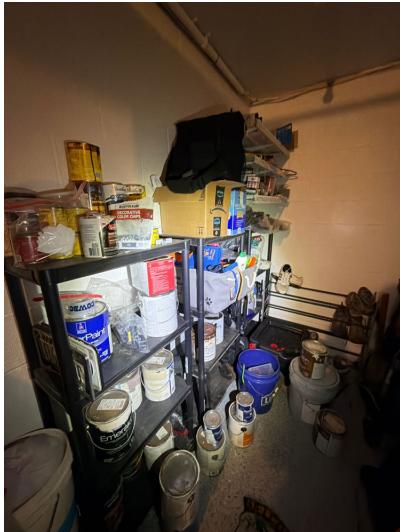
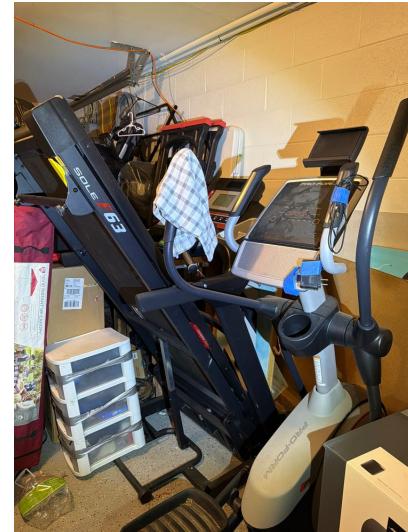
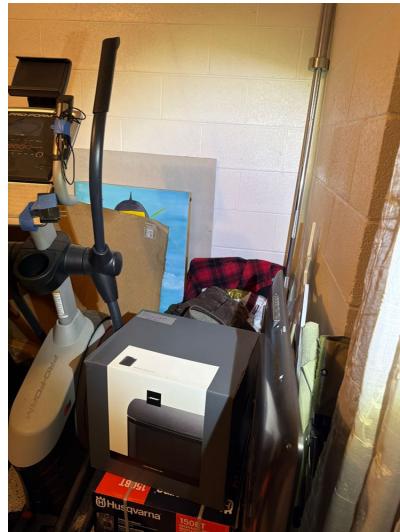
2. Moisture or Dampness

- There was no significant, visible moisture penetration in basement at time of inspection. There was storage in areas and some walls were covered with finish material. You should be aware that moisture in basements is common in our area, and this is not a guarantee against future moisture penetration.

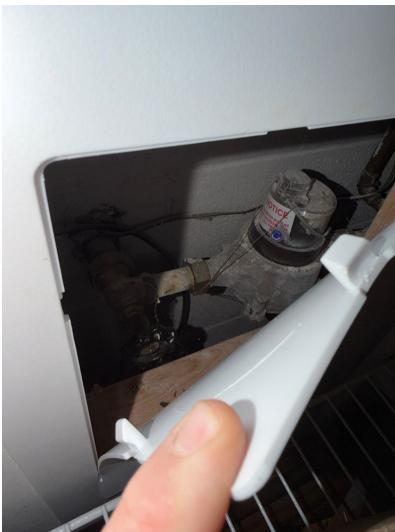
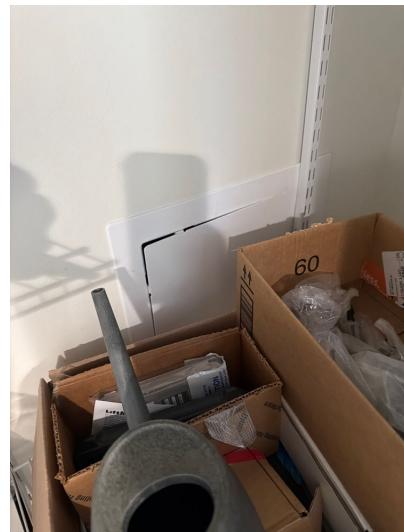
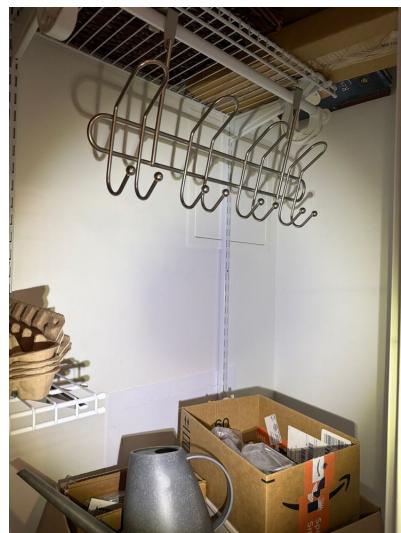
Water Supply		
Page 31 Item: 1	Main Water Shut Off Location	<ul style="list-style-type: none"> The main water shut off is located in the basement closet. A storage shelf was installed over both access panels to this water line. These panels should be made accessible in the case of an emergency shut off.
Plumbing/Waste Section		
Page 32 Item: 3	Drain Pipe Condition	<ul style="list-style-type: none"> We strongly recommend carrying underground pipe insurance on your home. This can help cover costly repairs to the home underground sewer lines and utilities. In most cases, you own all utilities from the house out to where it ties in at the main/street.
Water Heater		
Page 33 Item: 3	Combustion Chamber	<ul style="list-style-type: none"> The combustion chamber in the gas water heater is clean, and there is no evidence of leaks. However, it is beyond its design life and should be monitored for replacement.

- The main water shut-off valve is located in the basement.
- The main water shut off is located in the basement closet. A storage shelf was installed over both access panels to this water line. These panels should be made accessible in the case of an emergency shut off.

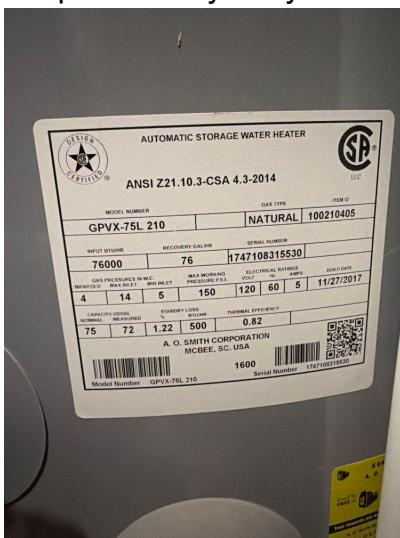
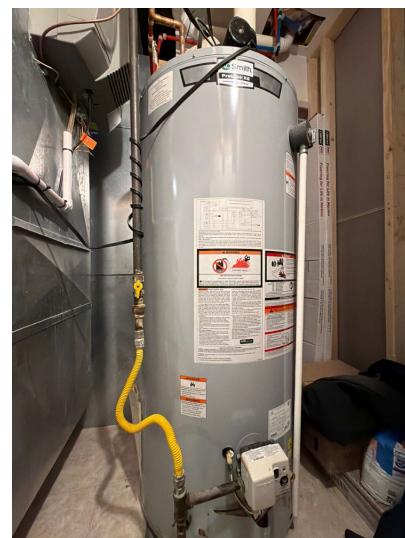
- Hot water is provided by a 9 year old, 75 gallon gas water heater that is located in the basement.

- The combustion chamber in the gas water heater is clean, and there is no evidence of leaks. However, it is beyond its design life and should be monitored for replacement.

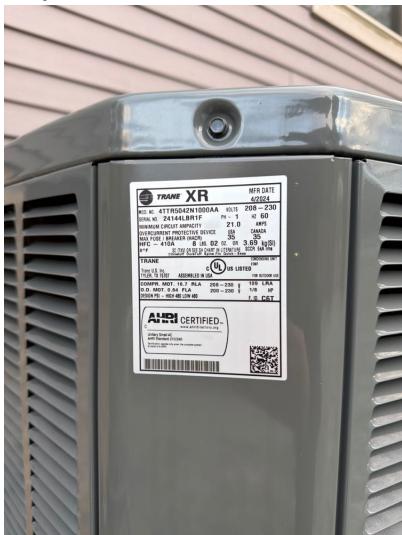
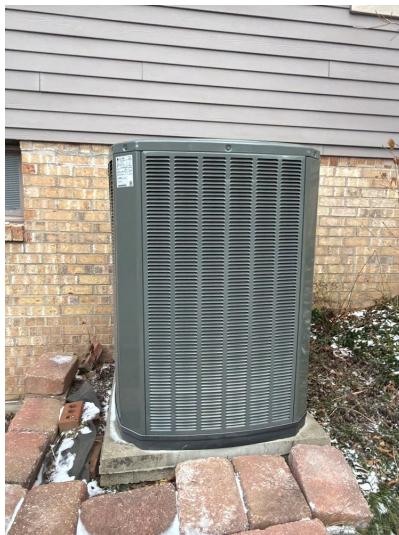
8. Condensing Coil

- The condensing coil should be covered when the season is over and not in use. Any vegetation should be kept clear and the unit should be maintained at level.
