HomeTeam® INSPECTION SERVICE

9 Banahasky Ln

Inspection #: 527-092024-5924

HOME INSPECTION REPORT

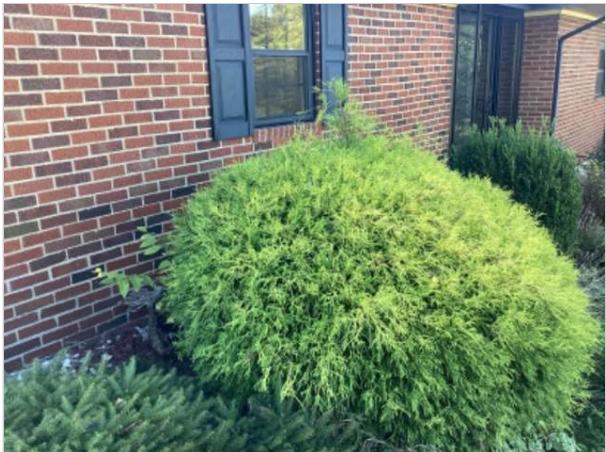
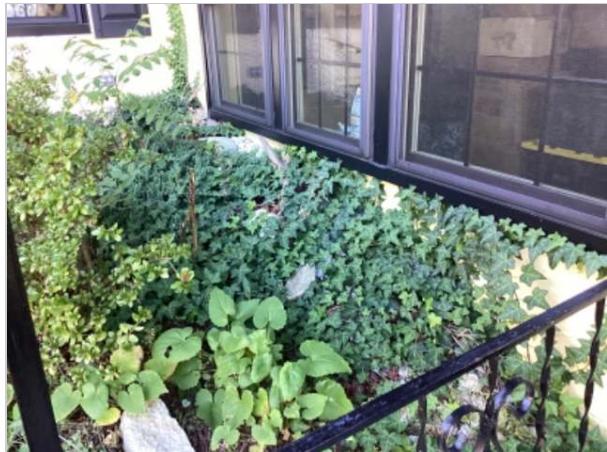
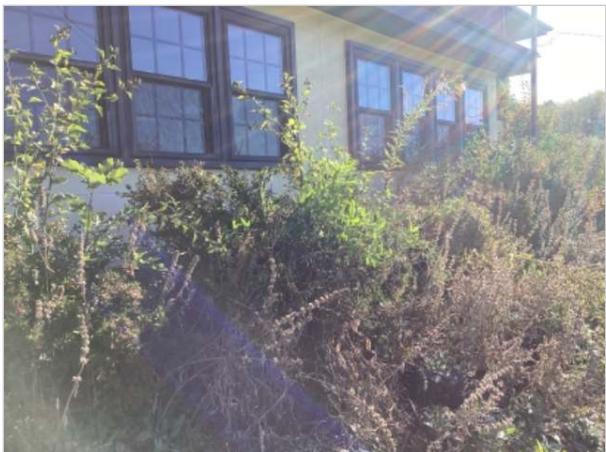
Extensive plant growth was observed against the home, in the all sides area of the house. Recommend removing this growth away from the siding to prevent possible damage including insect infestation.

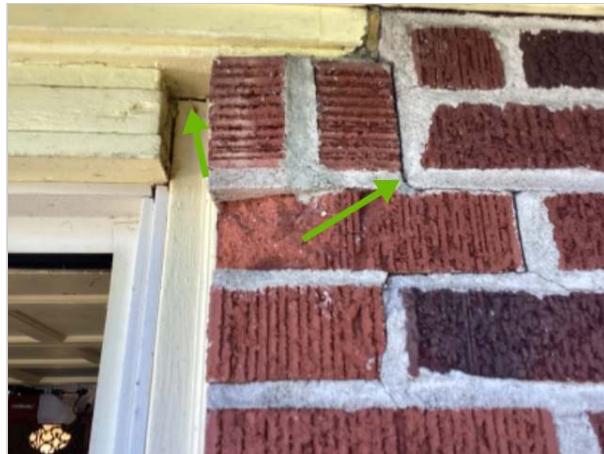
Right front

One or more cracks were noted on the brick veneer of the home. The cracks were located on the front. The cracks appear to have been caused by expansion and contraction, are common and do not usually have any structural significance. No structural concern on the brickwork was noted at the time of the inspection. All cracks should be monitored for significant changes in characteristics. Corrective action is not required. The cracks should be monitored for significant changes in characteristics. Consult with a qualified masonry contractor for evaluation if changes occur.

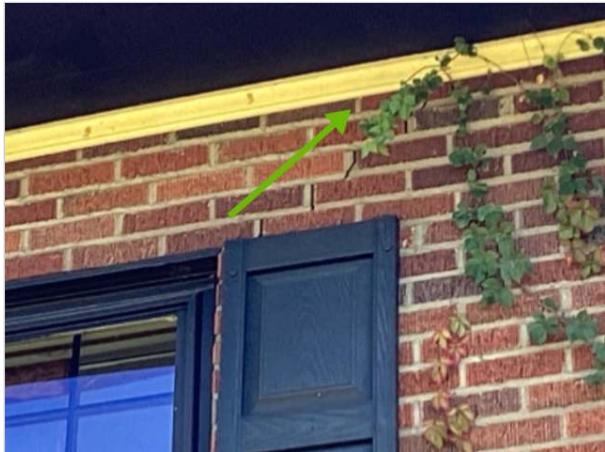
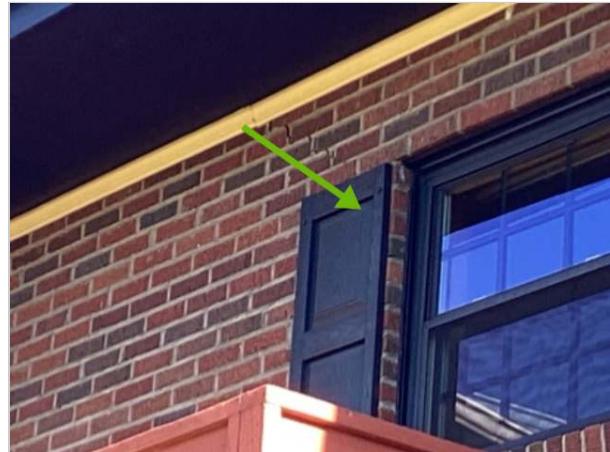
Rear

One or more of the steel lintels above the windows on the exterior of the home were noted to be rusting. Lintels support masonry materials above doors and windows. Keeping the lintels sealed and painted will prevent rusting and expansion. Expanded lintels can lead to cracks in the masonry on the exterior of the home.

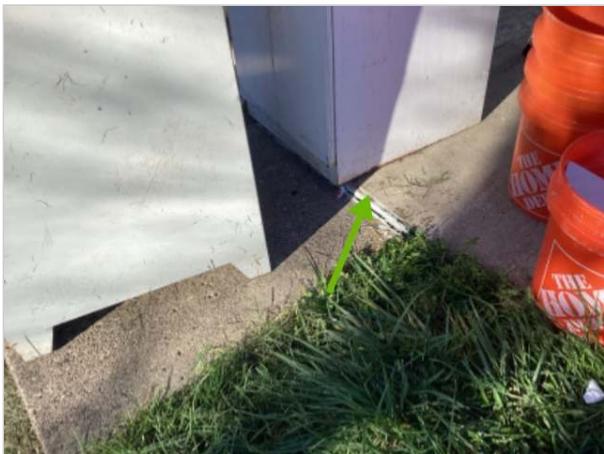
Front

There were several trip hazards found on the walkways around the house. The hazards can be repaired using a suitable or similar surfacing material to "feather" the out-of-level condition to make a smooth transition.

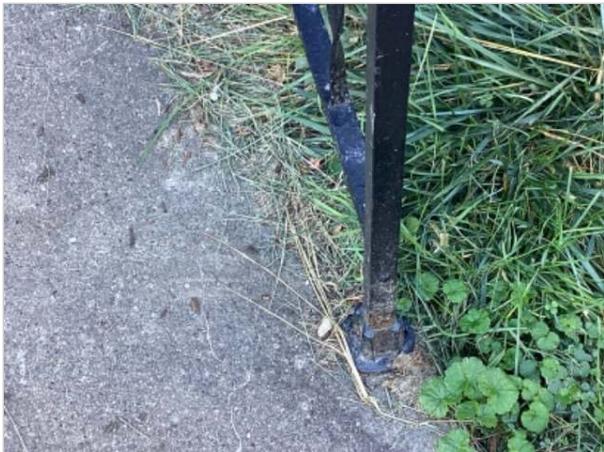
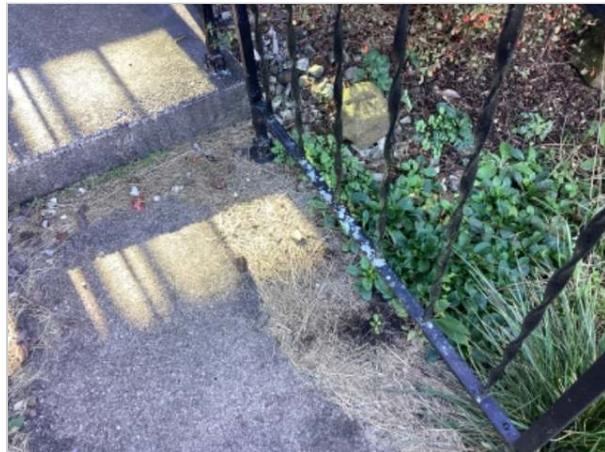
The front and side railings are severely rusted and may soon fail. The railings should be repaired, scraped and painted.

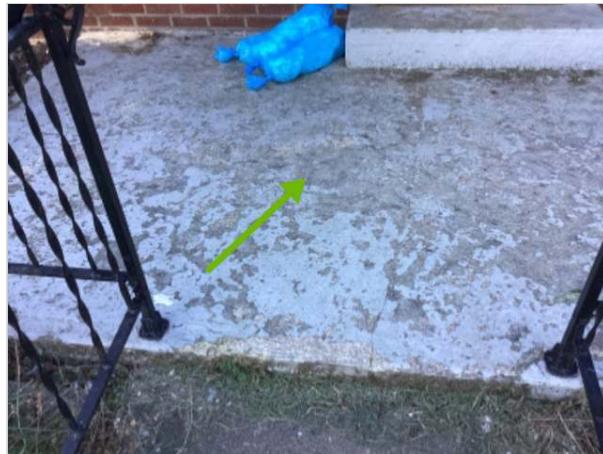
Peeling paint was noted on the porch. In order to preserve the life of the exterior surfaces and materials, all areas should be scraped and painted.

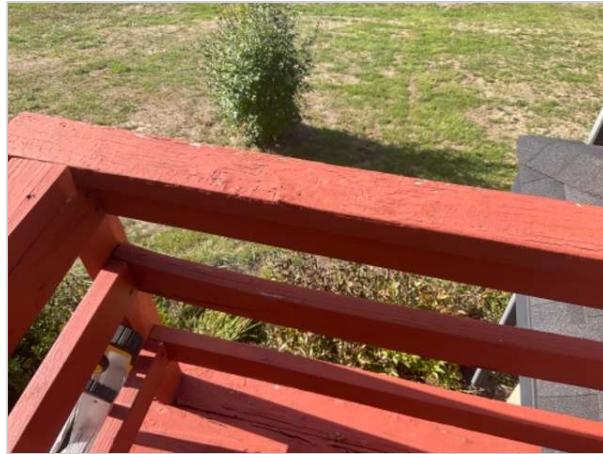
The balusters on the deck rail were installed horizontally rather than vertically and spaced greater than four inches apart. Generally accepted construction techniques provide for balusters to be installed vertically and spaced no greater than four inches apart. Larger baluster spacing can be a safety concern, and horizontally mounted balusters permit climbing. Local codes may require modification and / or installation of additional balusters. Consult with a general contractor for cost estimates for additional balusters.

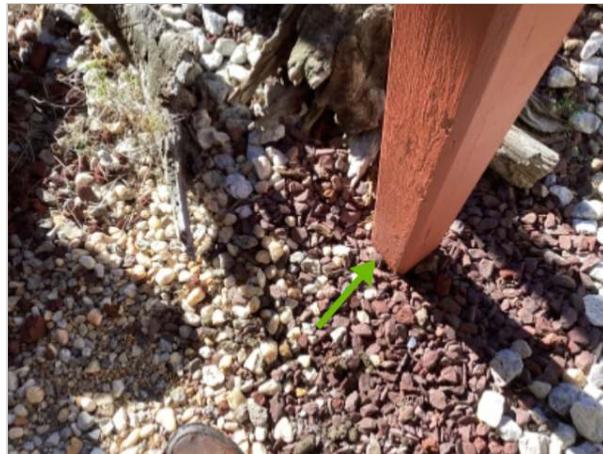
The *deck* support post(s) are making direct contact with the landscaping. Common practice is to mount support posts on concrete piers. The post is an important structural component and should be monitored for deterioration. A qualified contractor should be contacted for further evaluation and recommendations if desired.

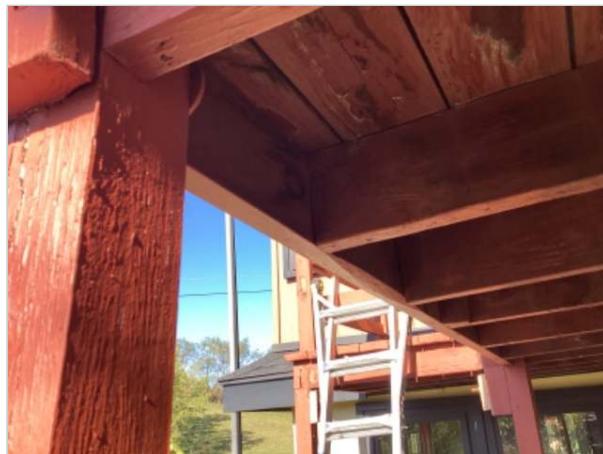
Missing joist hanger (s) were noted on one or more of the joists. The floor system was designed to have joist hangers installed in areas where perpendicular framing members are joined. Consult with a qualified contractor to install the missing joist hangers.

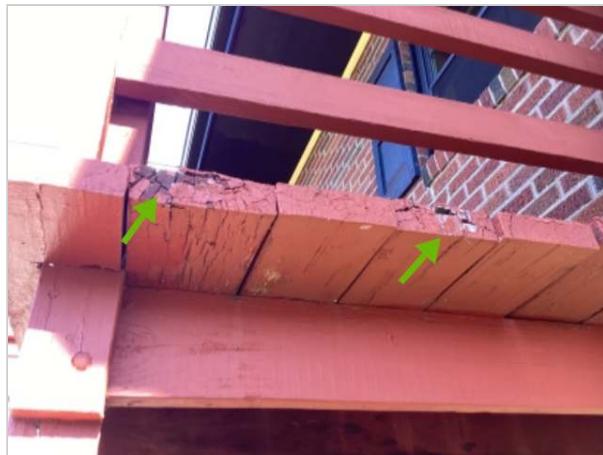
Several deck boards were deteriorated at the time of the inspection. Consult with a qualified contractor for replacement estimates.

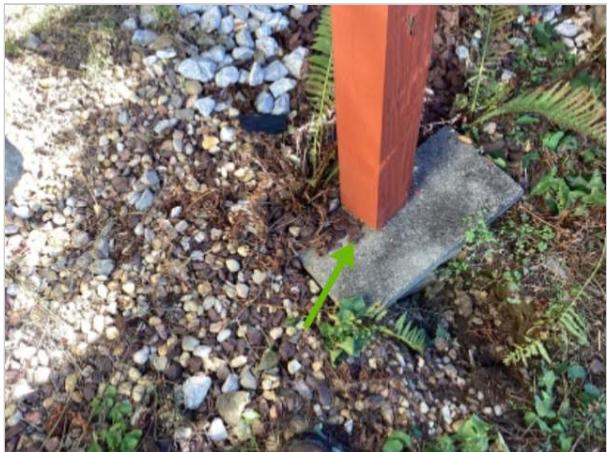
The deck vertical support posts on the are inadequate are deficient. The post is an important structural component and

should be repaired. Consult with a qualified contractor for recommendations.

Not secure

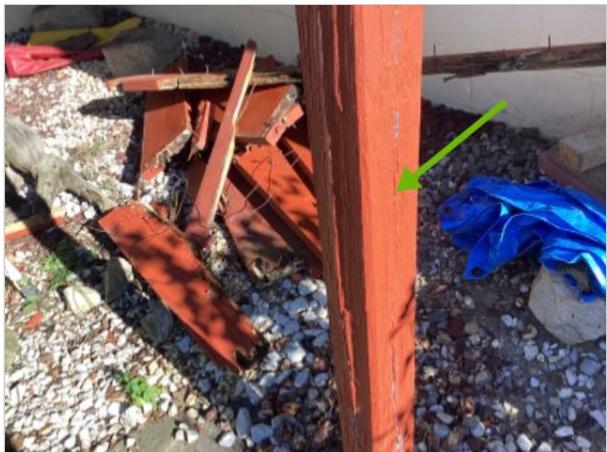
Showing deterioration

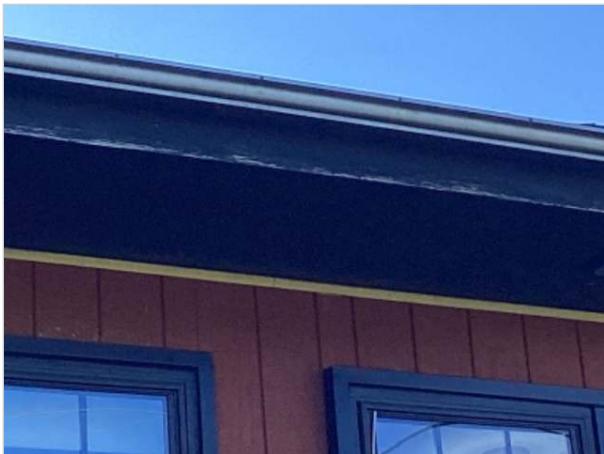
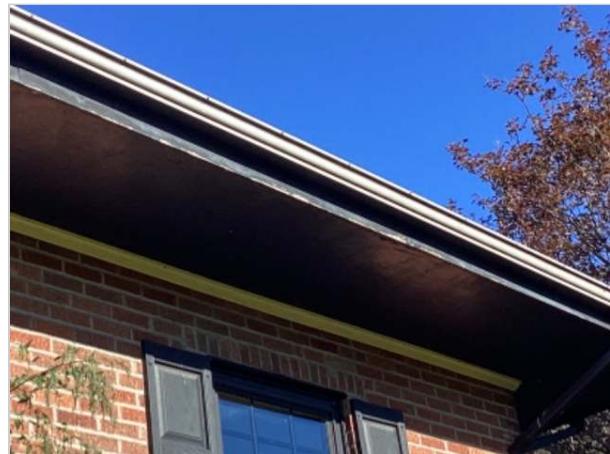
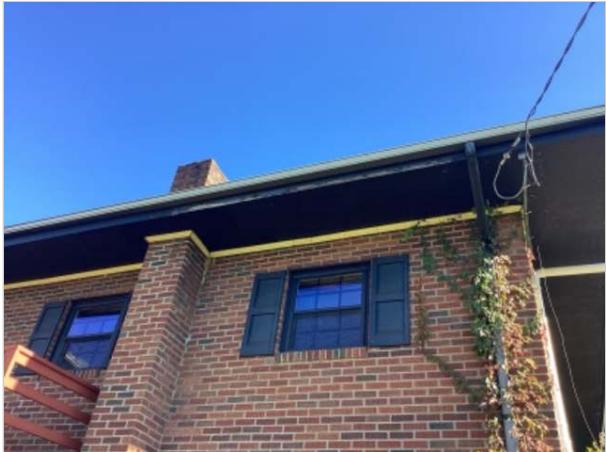
Peeling paint was noted on the wood soffit and fascia. In order to preserve the life of the exterior surfaces and materials, all areas should be scraped and painted.

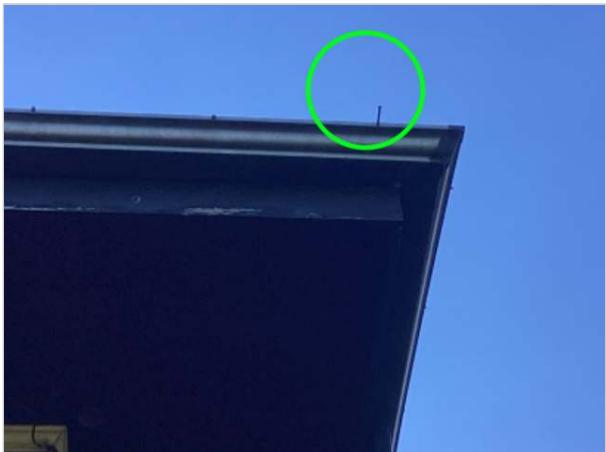
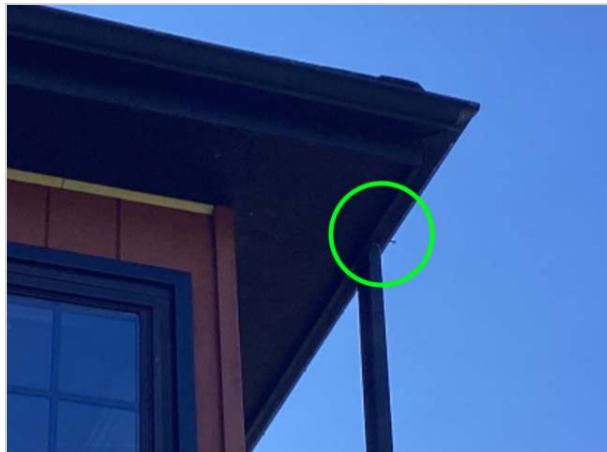
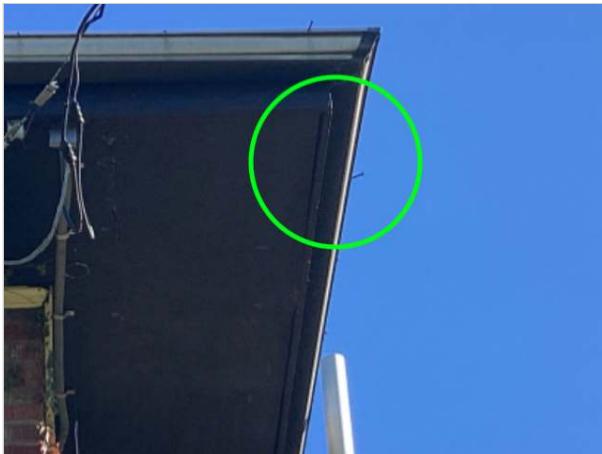
One or more of the gutter mounts was noted to be loose at the time of the inspection. This is a common condition and is caused by expansion and contraction, along with the freeze thaw cycles that we experience in this area. The mounts should be re-secured.

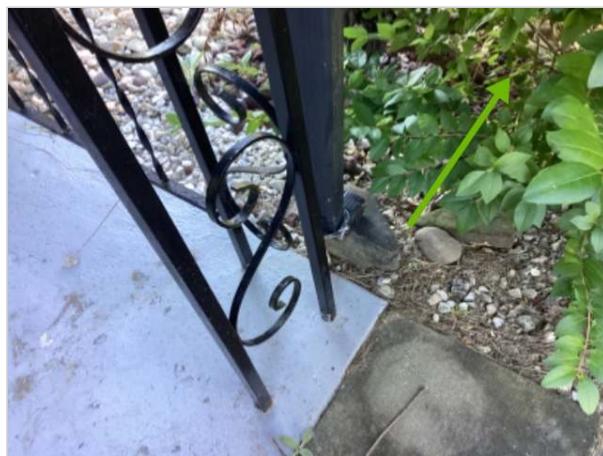
Rear right

The rear downspout was draining at or too close to the base of the foundation. All roof drainage should be directed at least six feet from the base of the foundation.

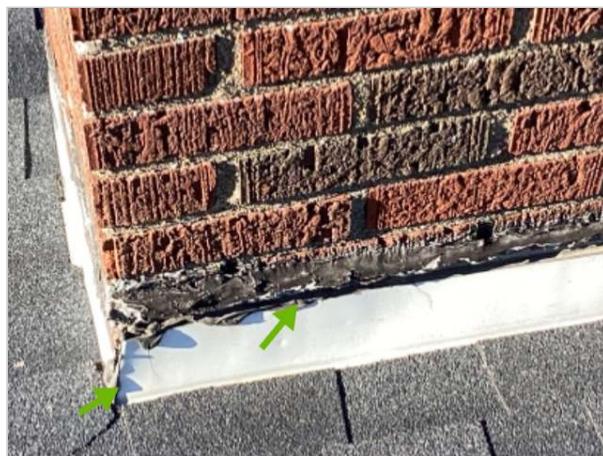
The flashing sealant on the back chimney is deteriorated. This is not necessarily the source of a leak. Evidence of any leak may be isolated to periods of heavy or extended rain. Consult with a qualified roofer for evaluation and repair as required.

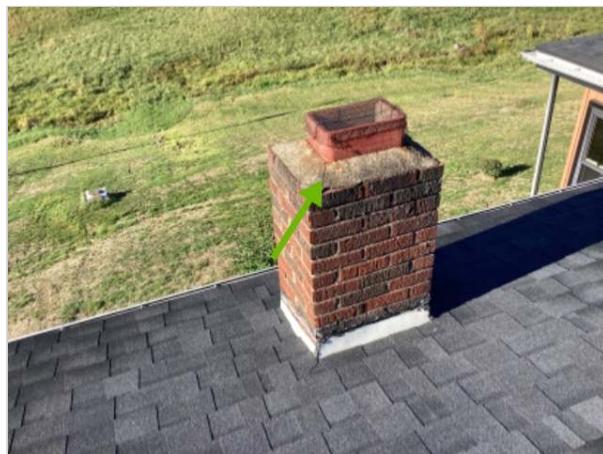
The rain hat on top of the chimney is missing. Repairs should be made by a qualified roofer.

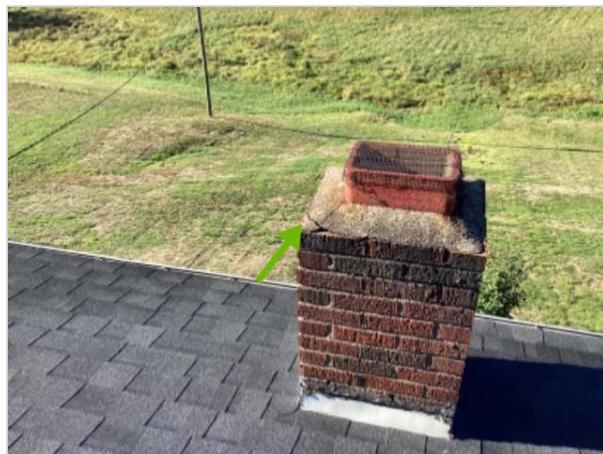
There were cracks on the top cap(s) of the chimney and repairs should be made to prevent further deterioration. Consult with a qualified masonry contractor for repair.

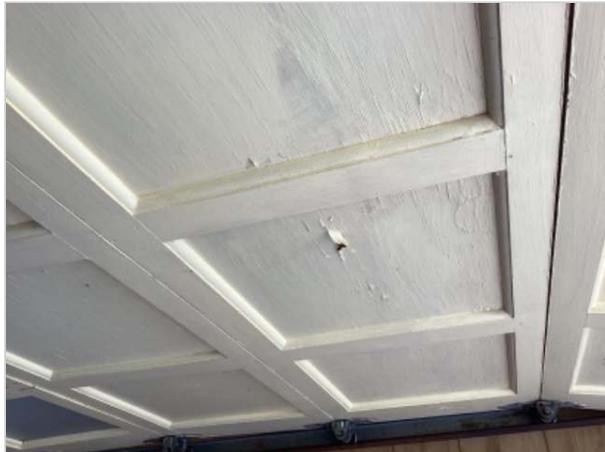
Peeling paint was noted on the garage door. In order to preserve the life of the exterior surfaces and materials, all areas should be scraped and painted.

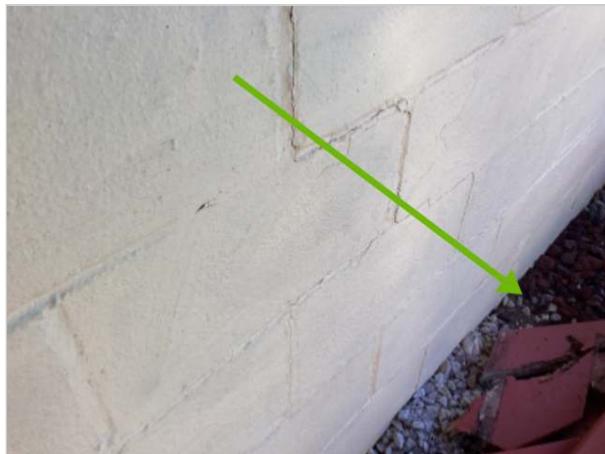
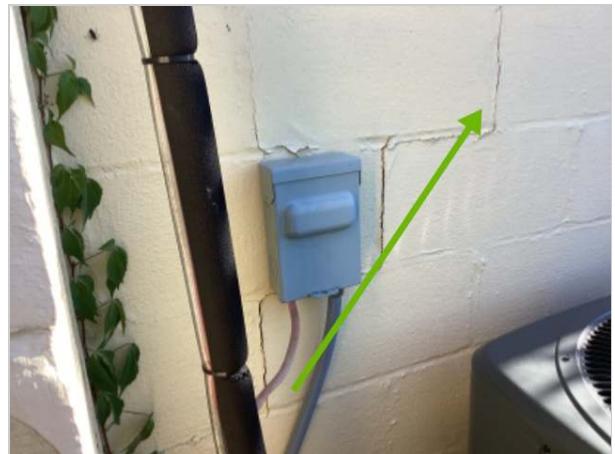
One or more cracks were noted on the exterior foundation walls. The cracks were located on the back. The cracks appear to have been caused by settlement. There was no evidence of active movement at the time of the inspection. Corrective action did not appear to be necessary. All cracks should be monitored for significant changes in characteristic. Consult with a contractor if the cracks change significantly or you desire another opinion on this condition.

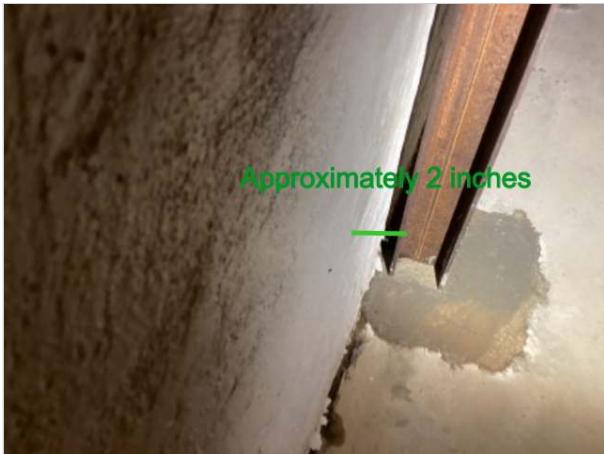
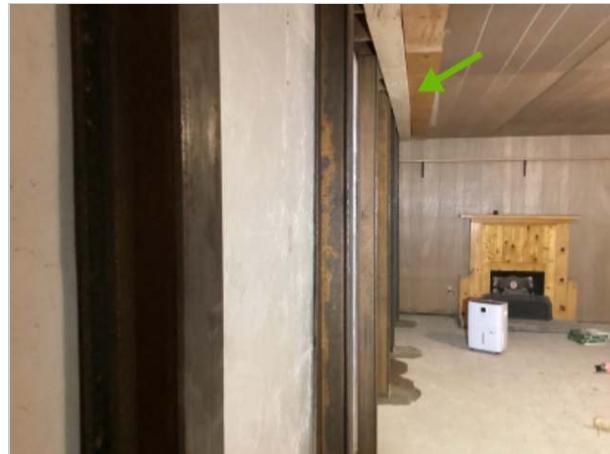
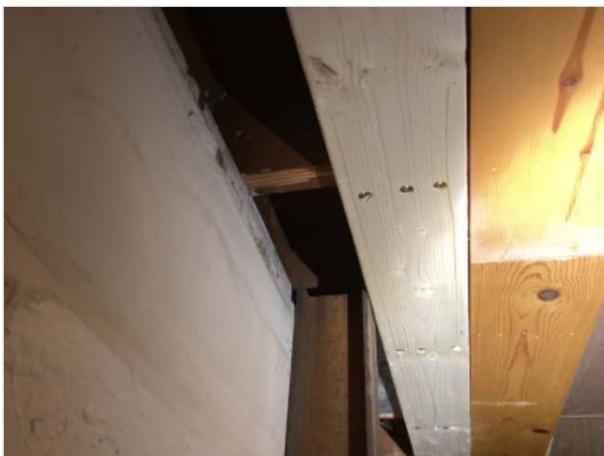
There was an inward bulge observed on the front foundation wall. The deflection on the wall was approximately 2-inches. Repairs have been made in the form of piers. The repairs usually include a transferrable warranty. The repairs are not of typical structural techniques. Recommend consultation with the current property owner for information on the warranty. Any significant change in the characteristic of the cracks or repairs should be referred to the company that made the repairs. This condition is most often associated with soil and / or water pressures. The displacement occurs incrementally as the wall yields to horizontal earth pressure. Surface grading around the foundation is questionable. Foundation repair companies usually require that the condition which caused the issue be corrected in order for the warranty to apply.

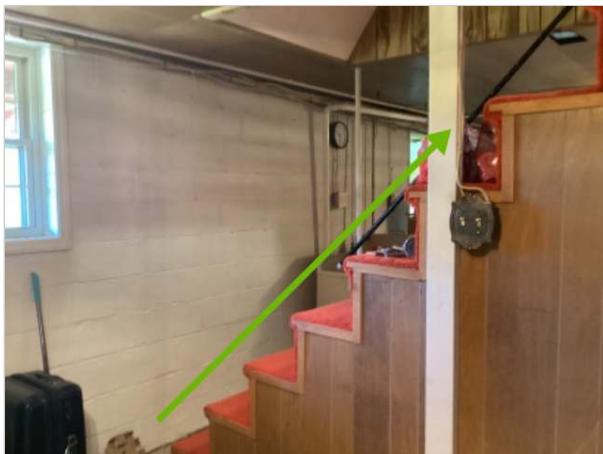
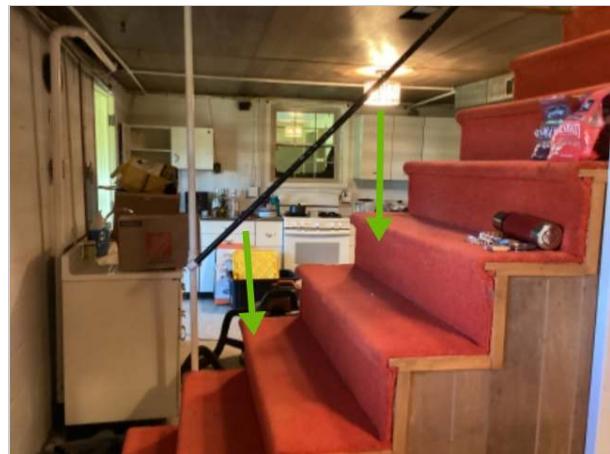
There was no handrail on the stairs leading to the basement. This can be a safety concern. Local building codes may also require the installation of a handrail.

Recommend vertical balusters

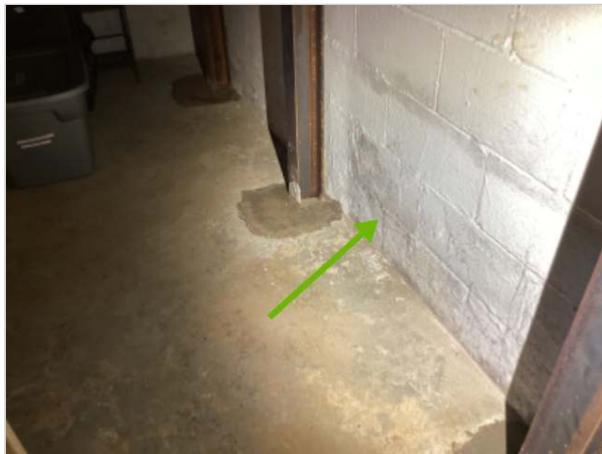
Right storage room

A substance with the characteristics of mold is visible in one or more areas of the basement. The EPA (<http://www.epa.gov/mold/moldresources.html>) advises consumers that areas less than ten square feet of coverage can usually be controlled using readily available household products. In the event the substance cannot be controlled, a certified mold testing and remediation firm should be contacted for a recommended course of action.

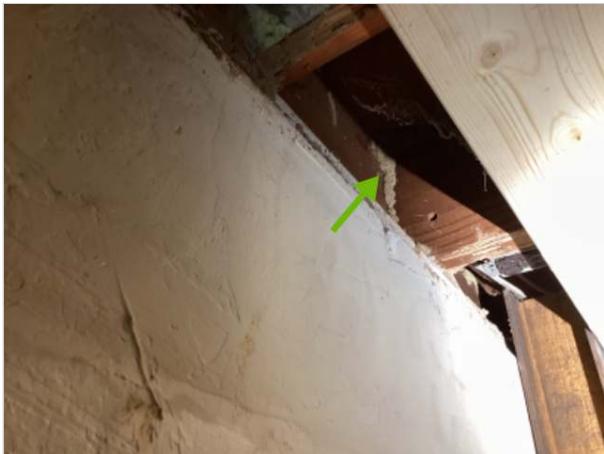
Evidence of termite activity was noted on the band joist and floor joists. The visible damage could not be thoroughly inspected due to the covered structure. Please note too that any assessment as to the extent of damage caused by termites is limited to the visible and readily accessible areas of the home. We are not able to determine the presence or extent of concealed damage.

Shelter tunnel

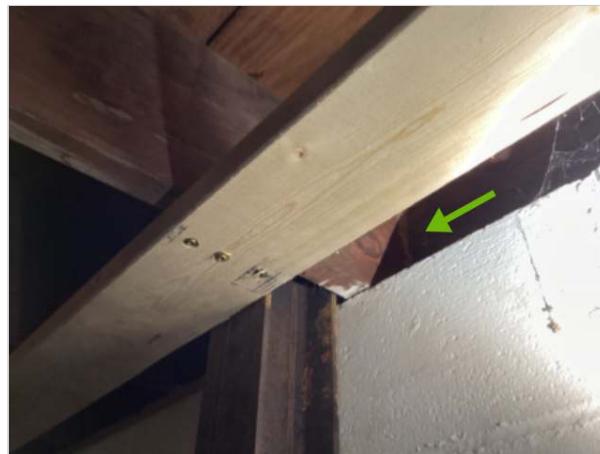
Evidence of termite activity was noted on the band joist and floor joists. The visible damage noted was insignificant and did not appear to have any structural significance. Repairs to the affected area (s) may be necessary. Consult with a qualified contractor for further evaluation. Please note too that any assessment as to the extent of damage caused by termites is limited to the visible and readily accessible areas of the home. We are not able to determine the presence or extent of concealed damage.

Shelter tunnel

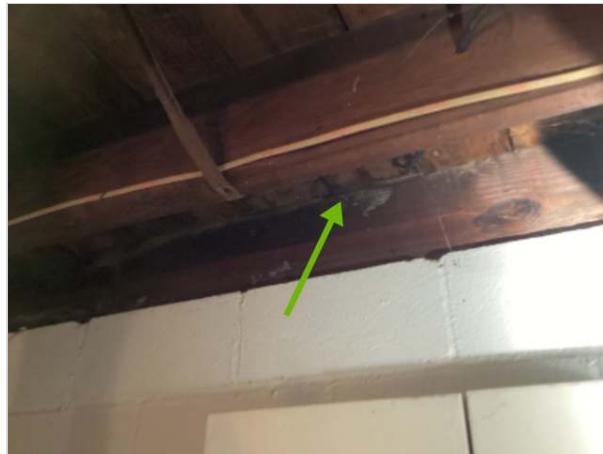
The floor joists and sub floor are water marked on the right rear basement floor structure. The area was dry at the time of the inspection. The wood on the affected area was not rotted. Repairs to the affected area may be necessary. Consult with a qualified contractor for repair recommendations.

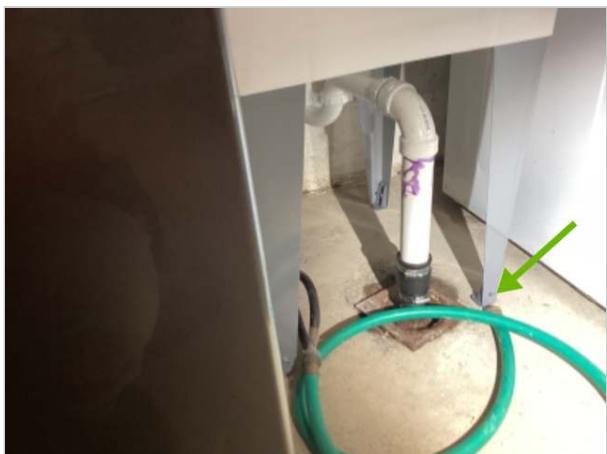
Tub not fastened

No faucet

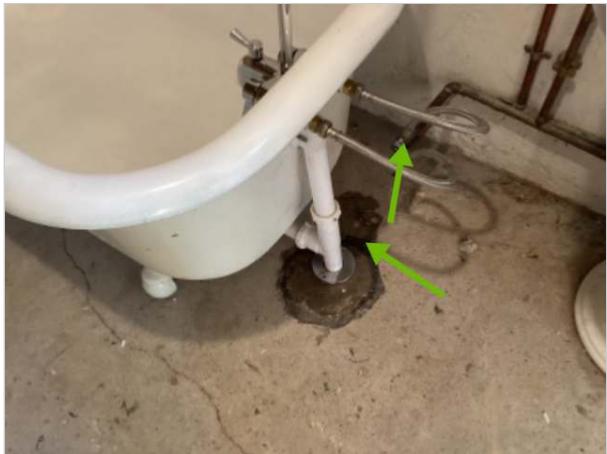
Valve leak

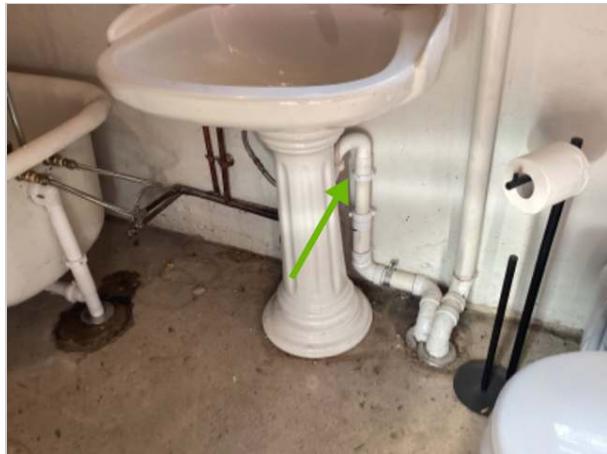
S trap

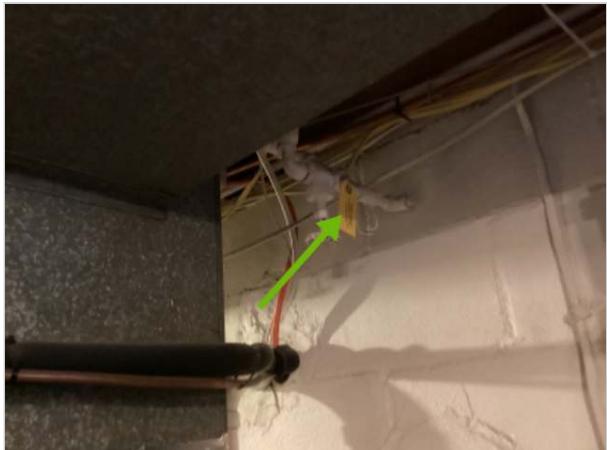
Over furnace

One or more gas leaks were detected during our testing in the main basement, basement kitchen and right storage room. Gas leaks represent a safety concern and should be promptly repaired by a qualified plumber.

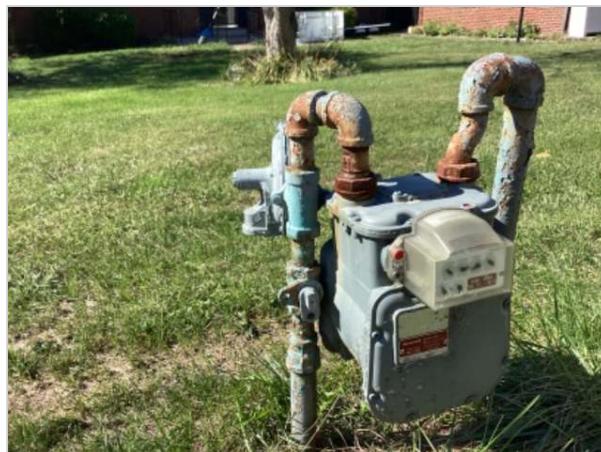
The exterior gas supply lines were *rusted*. *No leaks were found*. We recommend the gas supplier be contacted to inspect further.

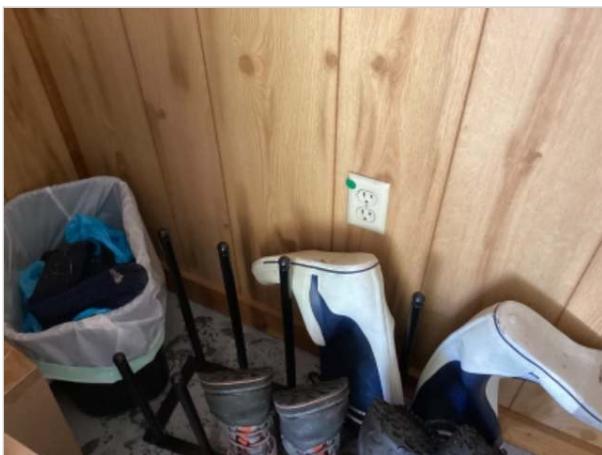
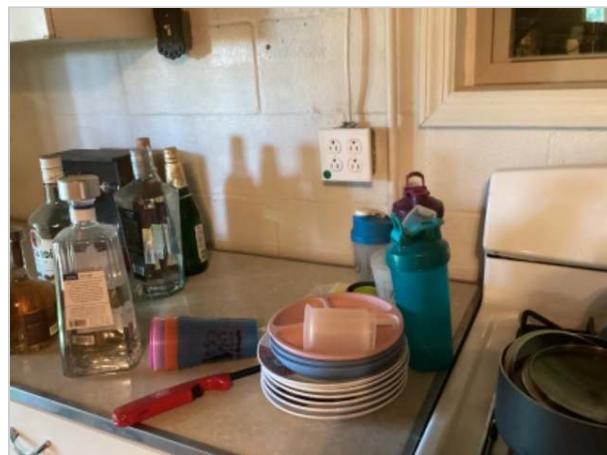
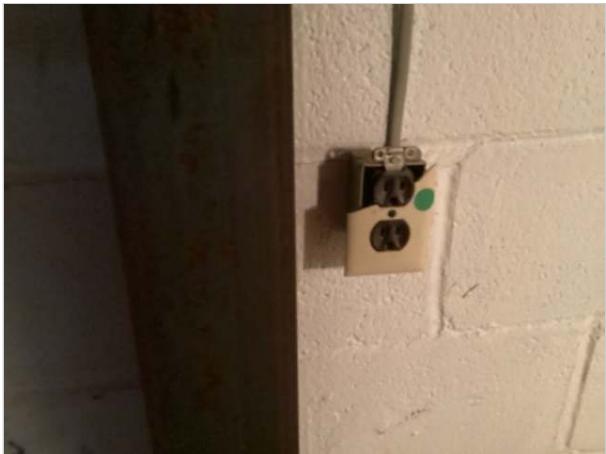
One or more three prong type outlets in the home tested as having an open ground. This means that the third prong, also known as the ground prong is not doing its job. This is usually caused by a missing ground connection at an electrical device in the circuit. This condition is usually easily correctable by an electrician. Open grounds in wet locations is considered a safety issue and should be corrected. The outlets that tested with this condition were marked with a "GREEN" dot for easy identification. The affected outlets were located in the basement. Please note that we only test outlets that are visible and readily accessible at the time of the inspection.

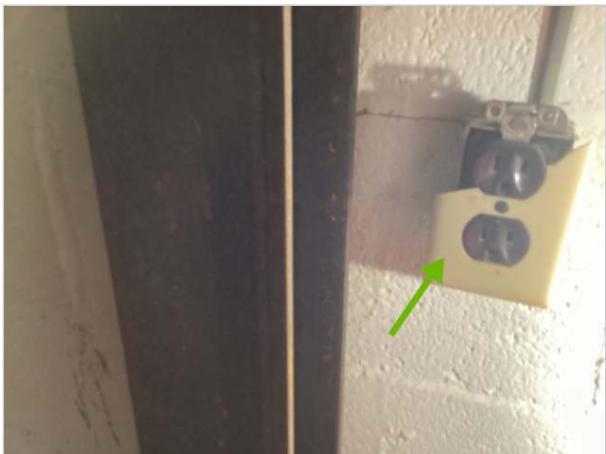
Right storage room

One or more missing switch or outlet covers were noted in the basement. All switch and outlet boxes should be properly covered to avoid a shock hazard. Electrical related repairs should be performed by a qualified electrician.

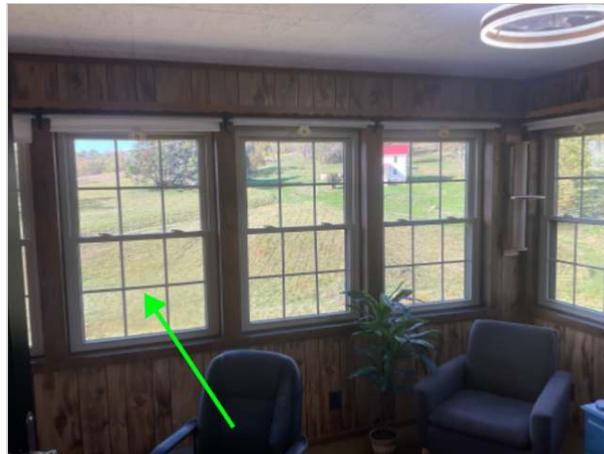
One or more of the insulated window panes throughout the home had a defective thermal seal. The window (s) were located in the sun room. A defective thermal seal can be identified when fogging is observed between the panes of glass. This statement should not be considered all inclusive. Our ability to identify defective thermal seals is affected by dirty glass, the angle by which we can view the windows, window coverings and the direction of the sun. It is not possible to identify mild cases of fogging between glass panes given the conditions that affect our view. Repair of the thermal seal can be accomplished by replacing the affected glass panel.

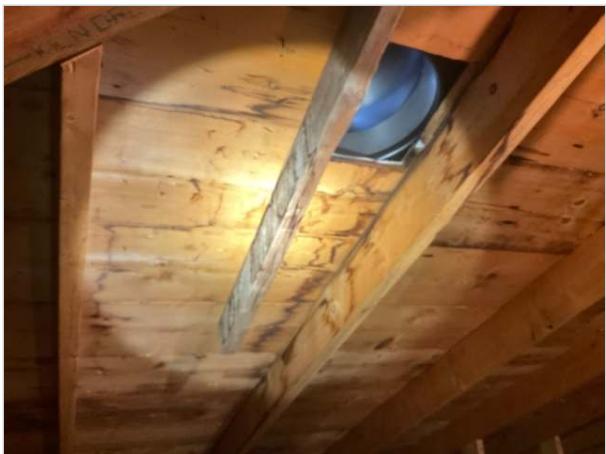
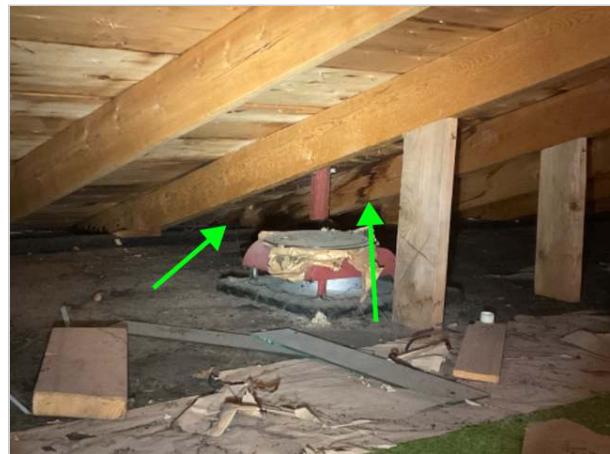
The roof deck as viewed from the attic is water marked. The cause of condition appears to be the result of previous leaks. Repairs to the affected areas No immediate action is required. The affected area (s) should be monitored for evidence of new leaks. Consult with a qualified contractor for repair if required.

examples of watermarked roof decking. All accessible watermarks were dry at the time of inspection

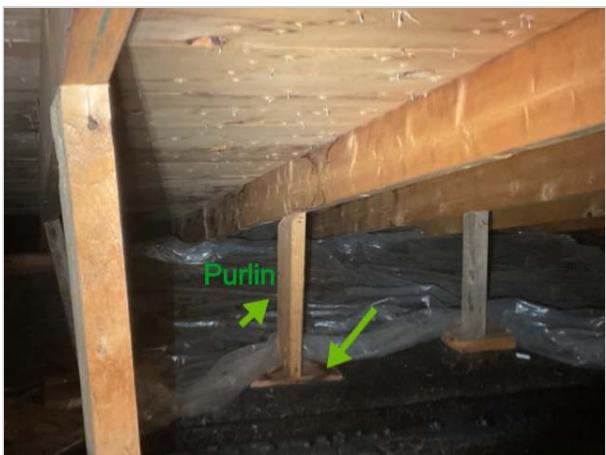
All of the vertical support purlins are based on the original roof.. The purlins are an important structural component and should be properly supported. It is our recommendation to consult with a qualified contractor to confirm the structure is adequate.

Purlin resting on roof

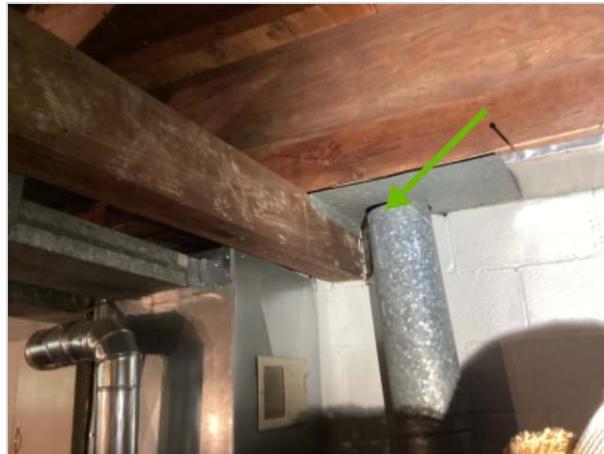
Right storage room

A section of ductwork is separated in the basement. The duct should be reconnected to ensure proper airflow. Consult with a qualified contractor for repair.
