INSPECTION SERVICE

571 Dewalt Dr

RE: Pittsburgh, PA 15234

Inspection #: 527-082025-6477

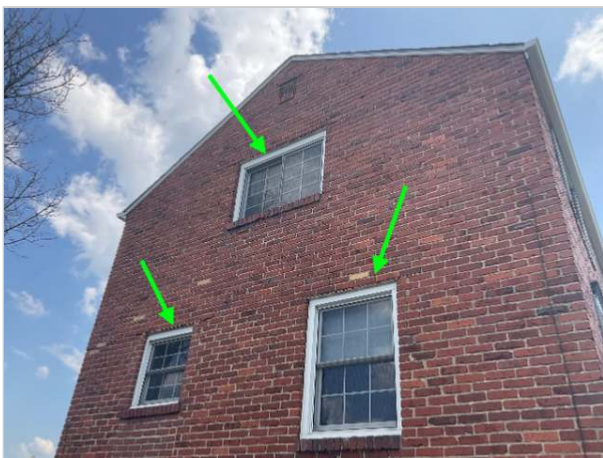
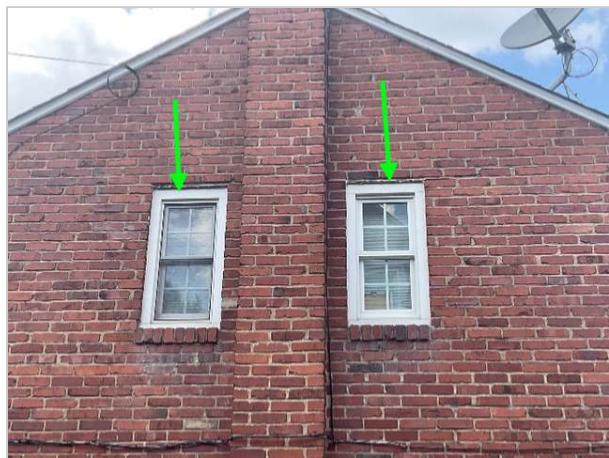
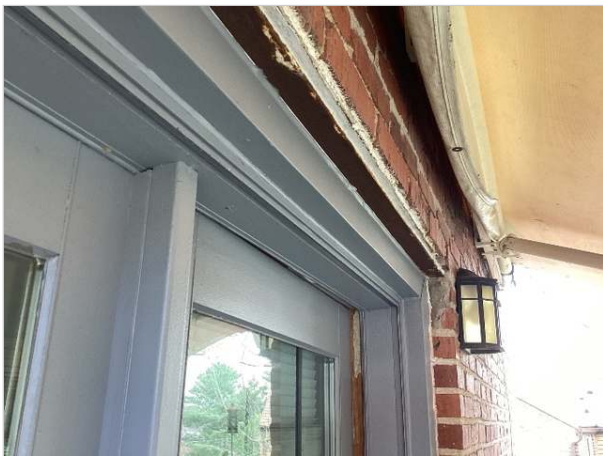
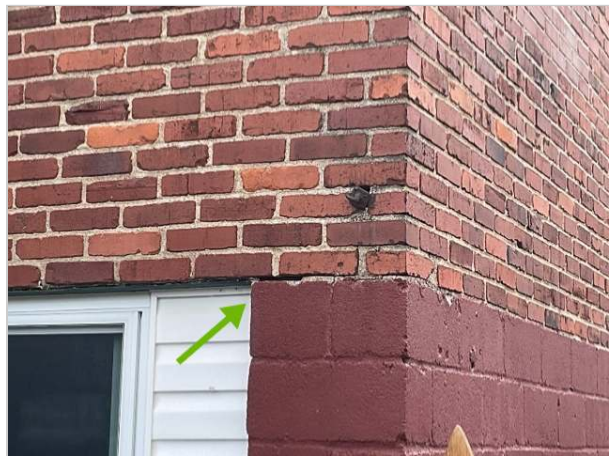
One or more of the steel lintels above the windows on the exterior of the home were noted to be rusting. Lintels support masonry materials above doors and windows. Keeping the lintels sealed and painted will prevent rusting and expansion. Expanded lintels can lead to cracks in the masonry on the exterior of the home.

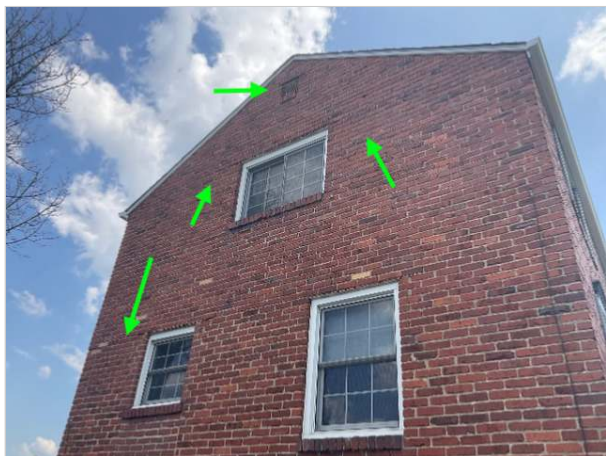
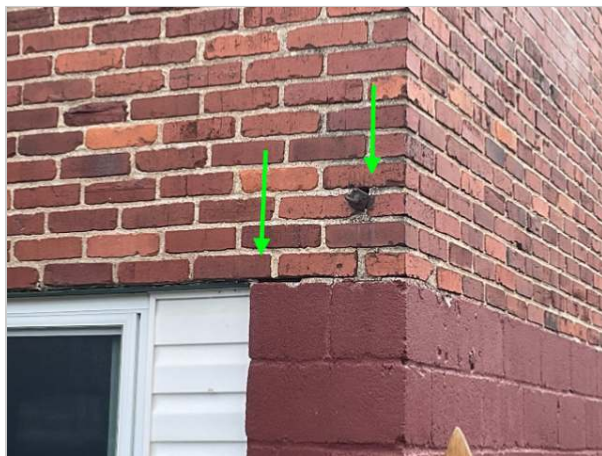
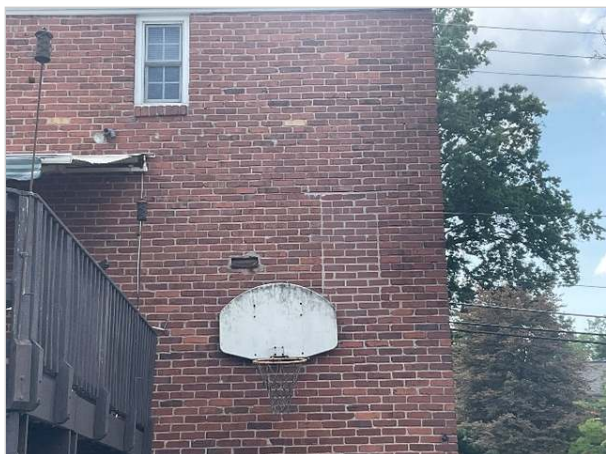
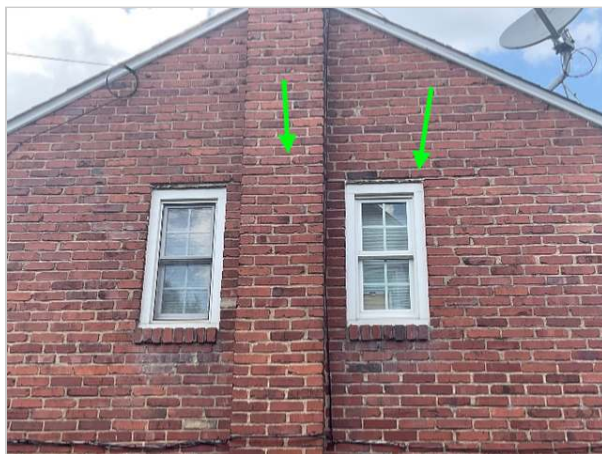
NOTE: MASONRY/MORTAR CRACKS:

One or more cracks were noted on the brick veneer of the home. The cracks were located on the all sides. The cracks appear to have been caused by expansion and contraction, are common and do not usually have any structural significance. No structural concern on the brickwork was noted at the time of the inspection. All cracks should be monitored for significant changes in characteristics. Corrective action is required. Consult with a qualified masonry contractor for repair estimates.

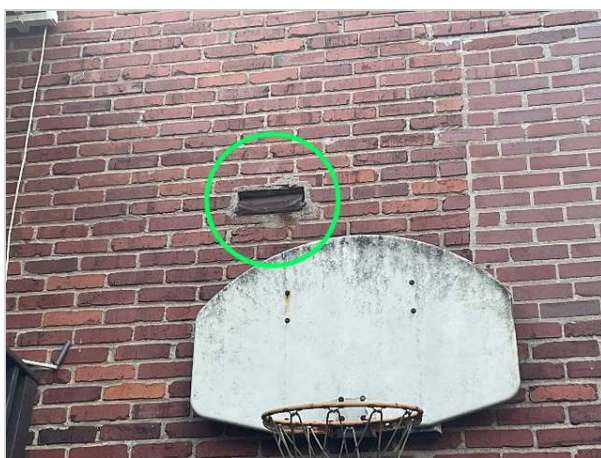
NOTE: SIDING:

A hole was noted in the siding on the back. This condition does not impact the structural integrity of the building, but can lead to water intrusion. Repairs should be made by a qualified contractor.

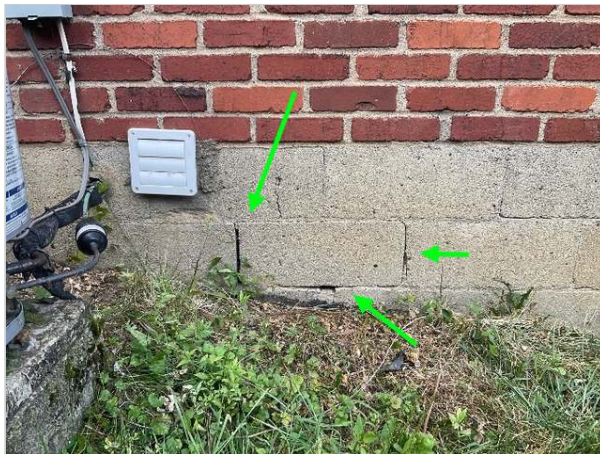
NOTE: MISSING FOUNDATION MORTAR:

Missing mortar was noted on the block on the right side of the home. There were no loose block noted. Small amounts of missing mortar are usually inconsequential. Extensive amounts of missing mortar can permit water intrusion. Consult with a qualified masonry contractor for repair estimates.

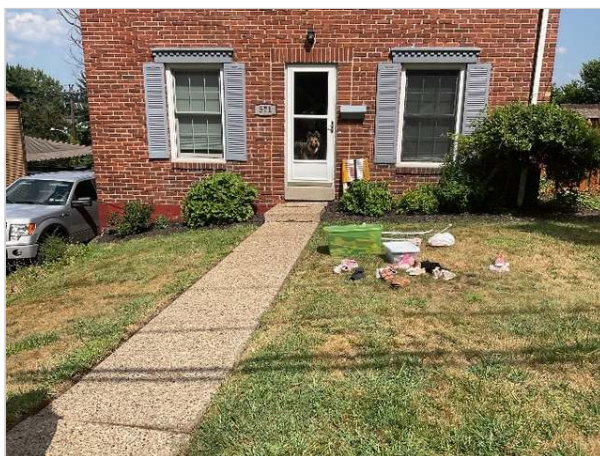
Settlement was noted on the front walkway slab. The settlement does not appear to be active. Settlement of concrete slabs is common and is usually not a problem. If the settlement causes the concrete slab to pitch toward the foundation of the home, it is possible that water will drain into the basement. In this case the slab was not pitched toward the foundation. It is not possible for us to positively determine if active settlement is occurring during a home inspection. The area should be monitored for evidence of new or continued settlement. Consult with a qualified contractor for further evaluation if required.

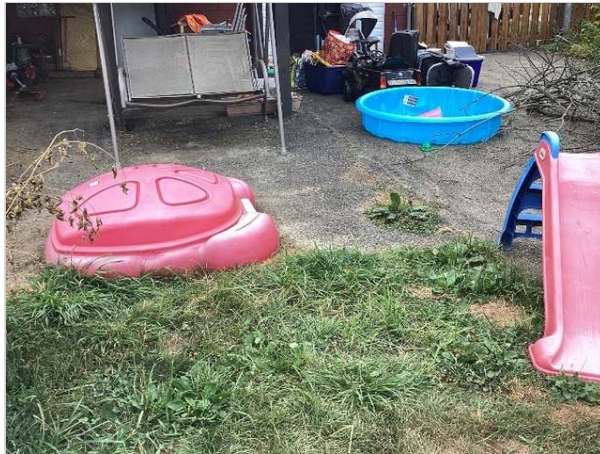
NOTE: SETTLEMENT:

Settlement was noted on the back patio slab. The settlement does not appear to be active. The patio appears to be the previous asphalt driveway. Consult with a qualified contractor for further evaluation if required.

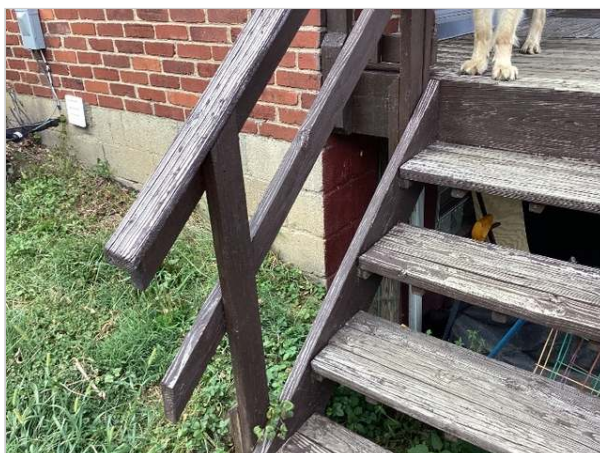
The balusters on the deck rail were installed horizontally rather than vertically and spaced greater than four inches apart. Generally accepted construction techniques provide for balusters to be installed vertically and spaced no greater than four inches apart. Larger baluster spacing can be a safety concern, and horizontally mounted balusters permit climbing. Local codes may require modification and / or installation of additional balusters. Consult with a general contractor for cost estimates for additional balusters.

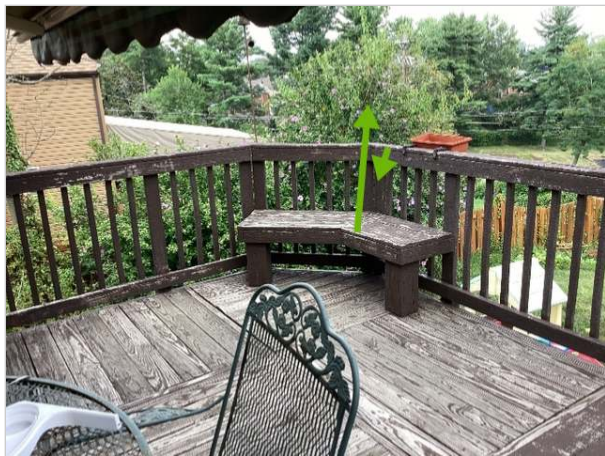
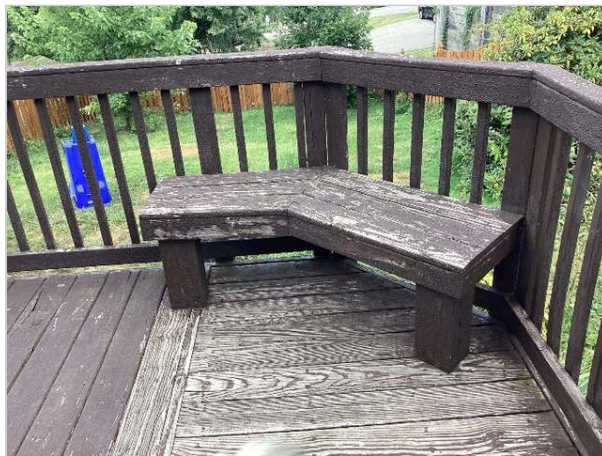
SAFETY NOTE: FALL HAZARD:

There is no barrier installed on the back porch. The absence of a proper rail or barrier constitutes a fall hazard and should be corrected. Consult with a qualified contractor for installation of a proper barrier.

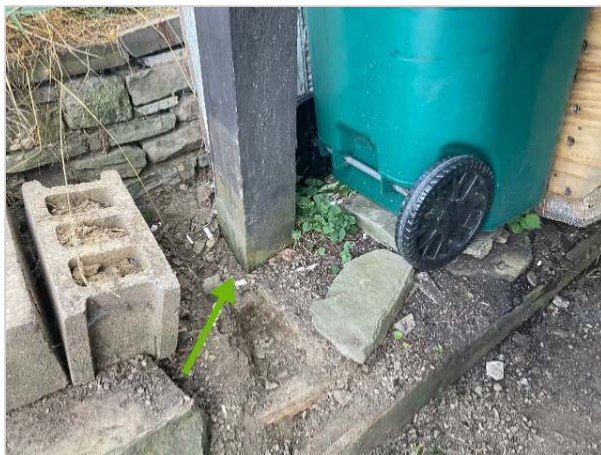
NOTE: DECK SUPPORT POST:

The *deck* support post(s) are making direct contact with the landscaping. Common practice is to mount support posts on concrete piers. The post is an important structural component and should be monitored for deterioration. A qualified contractor should be contacted for further evaluation and recommendations if desired.

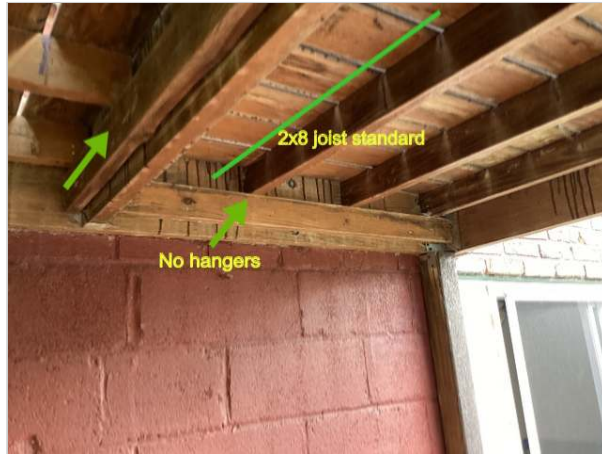
NOTE: SUB STRUCTURE :

The deck joists appear undersized. Improper fasteners were noted on the floor structure and missing joist hangers were noted. Separation was noted on several undersized joists. The substructure consists of 2x4 joists connected in an unconventional framing standard. The structure was secure at the time of inspection. Consult with a qualified contractor for recommendations if desired.

No joist hangers and 2 x4 joist

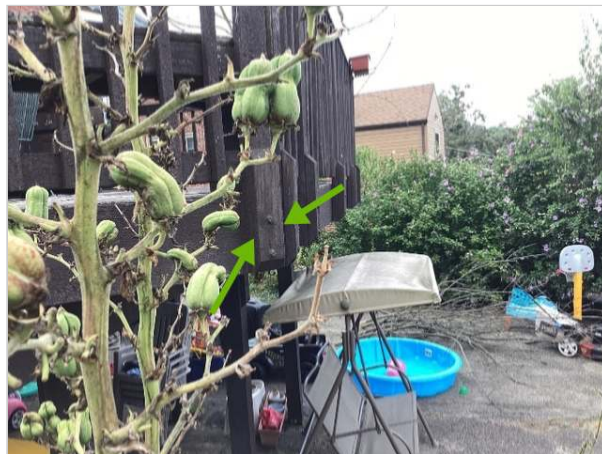
NOTE: EXTERIOR HANDRAIL:

The handrail on the back porch is fasten to the exterior band board. Standard practice is to install the post on the inside band joist with blocking and bolts. These connections should be monitored to ensure they remain secure. The handrails should be properly secured by a qualified contractor if desired.

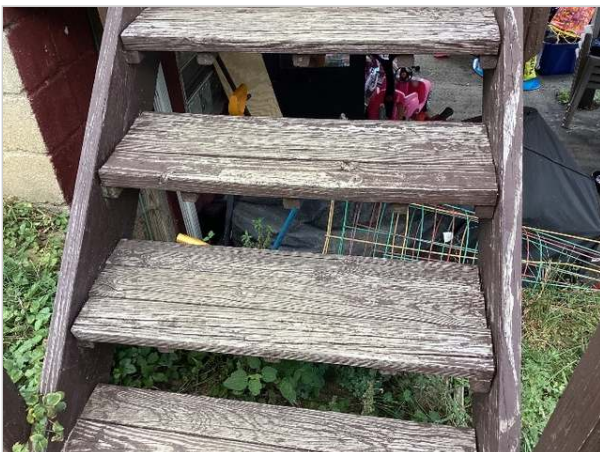
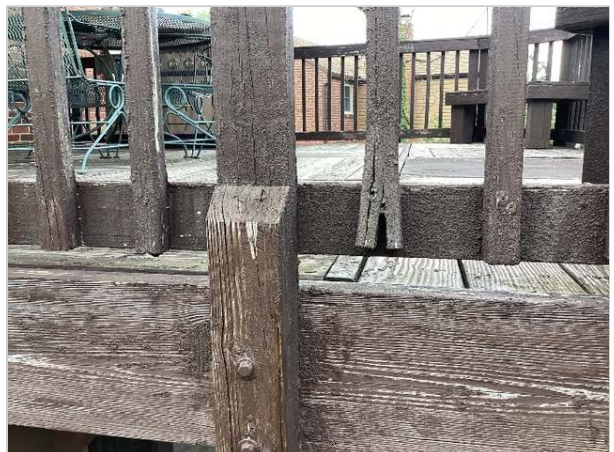
NOTE: DETERIORATED DECKING:

Many deck boards were deteriorated at the time of the inspection. Consult with a qualified contractor for replacement estimates.

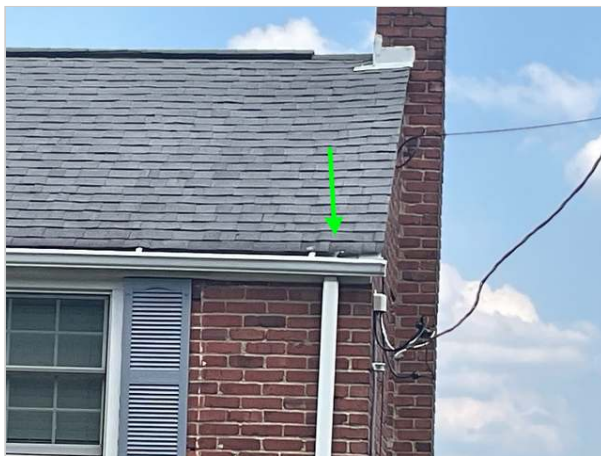
One shingles were damaged on the front of the roof at the time of the inspection. While this condition is not necessarily an indication of a leak, repairs should be made. Consult with a qualified roofer for repair.

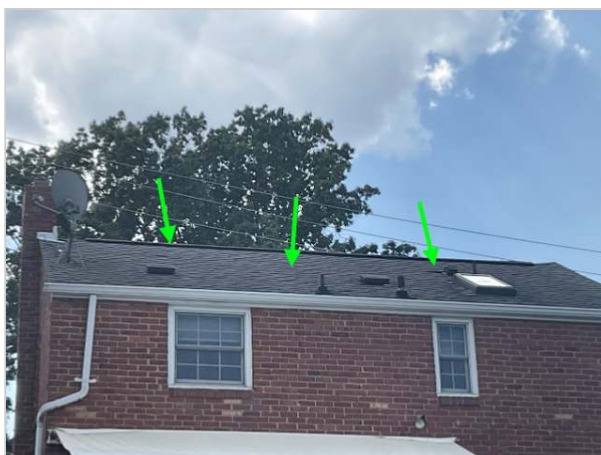
NOTE: POPPED NAILS ON ROOF:

One or more popped nails were noted on the roof at the time of the inspection. A popped nail can be identified by a lifted corner on a shingle. The heating and cooling of the roof will often cause roofing nails to lift under the shingles, causing the corner to lift. While it is not likely that the condition is causing a leak, the nails should be reset and sealed to prevent wind from getting under the shingle and possibly lifting the shingle off the roof. Consult with a qualified roofer for repair.

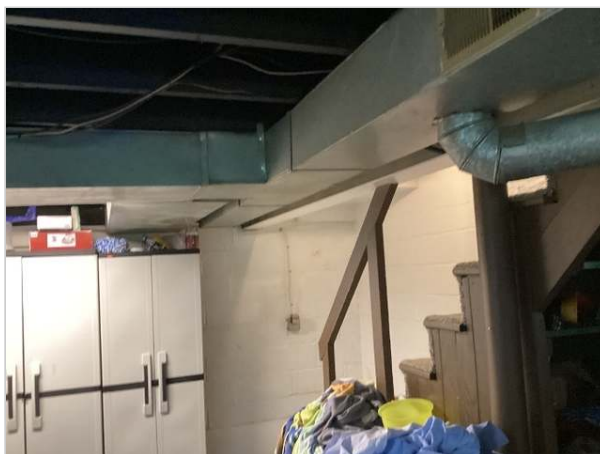
The balusters on the basement rail were installed horizontally rather than vertically and spaced greater than four inches apart. Generally accepted construction techniques provide for balusters to be installed vertically and spaced no greater than four inches apart. Larger baluster spacing can be a safety concern, and horizontally mounted balusters permit climbing. Local codes may require modification and / or installation of additional balusters. Consult with a general contractor for cost estimates for additional balusters.

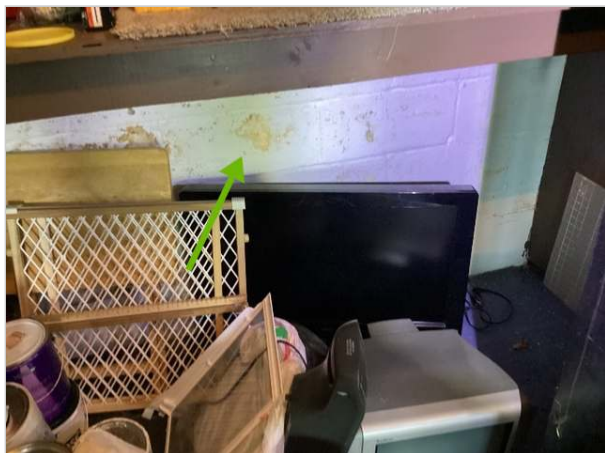
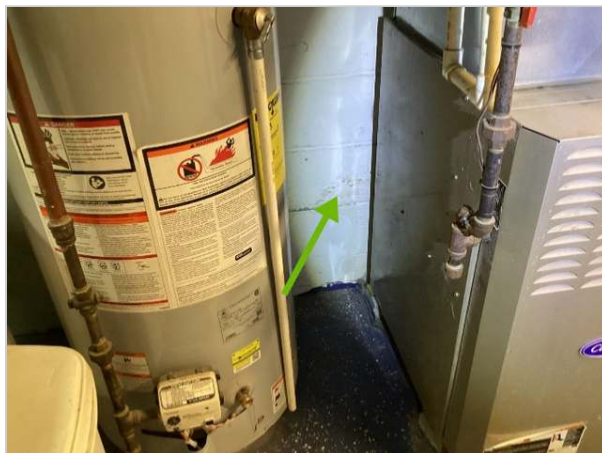
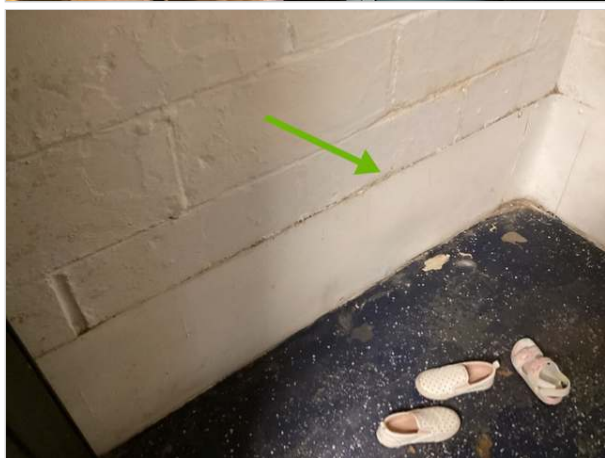
NOTE: BASEMENT MOISTURE EVIDENCE:

There were signs of moisture on the front and right basement walls. The area was dry at the time of the inspection. Dampness on basement walls is not always a sign of water intrusion. The dampness can be the result of warm humid air making contact with cool walls. In many cases the humid air condenses on the wall and forms a layer of moisture. It is important to assess whether moisture on the basement walls is the result of water intrusion or condensation. In this case, the efflorescence noted on the wall appears to be the result of moisture buildup on the exterior side of the foundation. The exterior grading in the affected area is questionable. Many water intrusion problems can be controlled by improving the drainage on the exterior of the home. It is important that all roof drainage and surface water is directed

away from the foundation. Any concern about this condition should be referred to a qualified contractor for evaluation and recommendations.

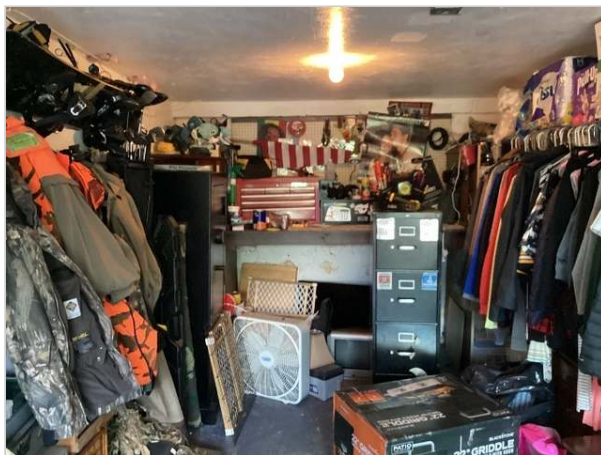
INFORMATIONAL NOTE: BASEMENT STORED ITEMS:

The basement was cluttered with many stored items and/or shelves at the time of inspection, therefore several areas were unable to be inspected.

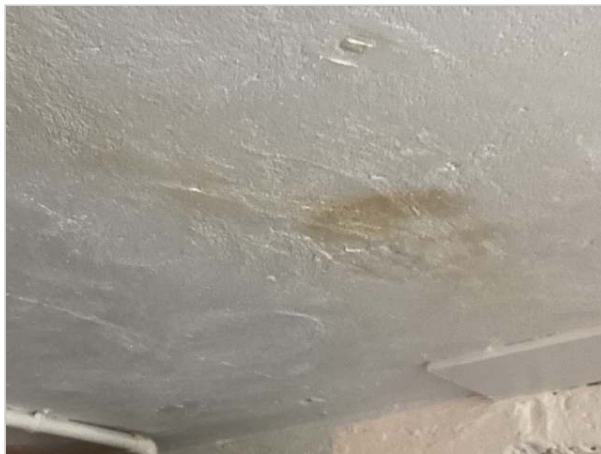
The basement ceiling is water marked below the kitchen from what appears to be a previous leak. The area was dry at the time of the inspection. No immediate action is required. The area should be monitored for evidence of new leaks. Consult with a qualified contractor for repair if required.

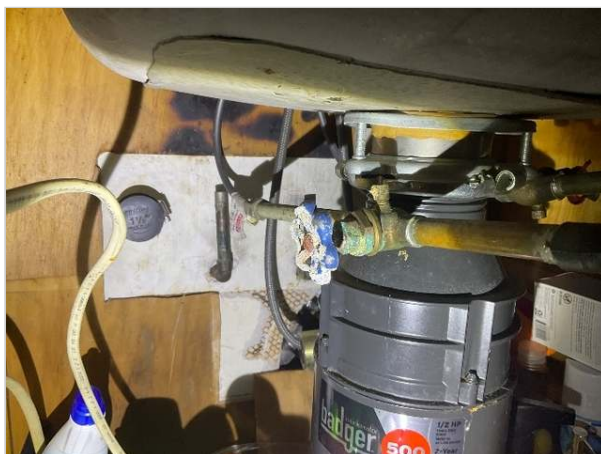
INFORMATIONAL NOTE: OLDER, CORRODED WATER SUPPLY VALVES:

Older and/or corroded water supply valves were noted in the home. Water supply valves are infrequently used and often corrode on the inside and outside of the valve. This condition is common and often renders the valve inoperable. We make no attempt to test any water valves in the home regardless of their condition, because doing so could result in a leak. If this is a concern, you should consult with a qualified plumber for further evaluation and testing.

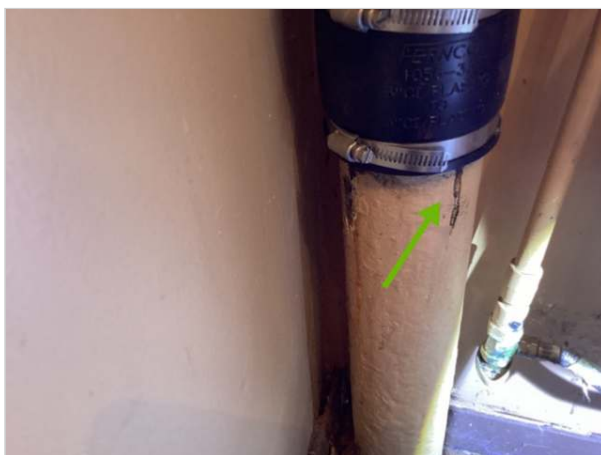
NOTE: DRAIN STACK:

A crack was noted on the drain stack at the rear of the basement. The drain was repaired and repairs appeared to be adequate. No leaks were detected at the drain stack at the time of the inspection. Consult with a qualified plumber for repair if desired.

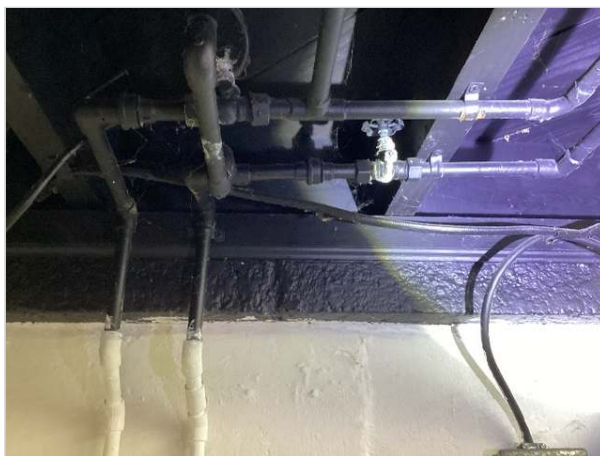
INFORMATIONAL NOTE: OLDER, CORRODED WATER SUPPLY VALVES:

Older and/or corroded water supply valves were noted in the home. Water supply valves are infrequently used and often corrode on the inside and outside of the valve. This condition is common and often renders the valve inoperable. We make no attempt to test any water valves in the home regardless of their condition, because doing so could result in a leak. If this is a concern, you should consult with a qualified plumber for further evaluation and testing.

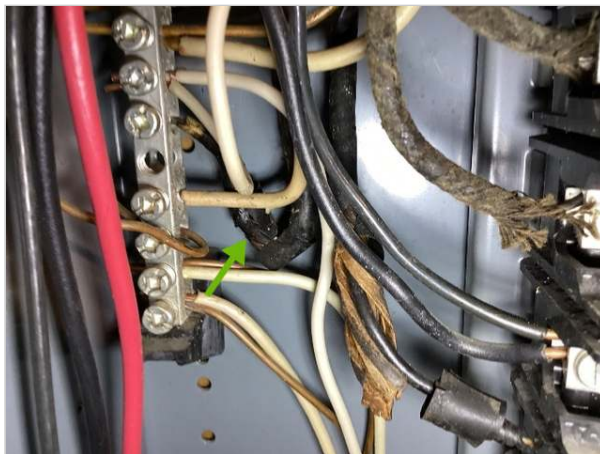
Exposed wires were noted in the panel. The wires should either be disconnected at the source or properly terminated/taped. Consult with a qualified electrician for repair.

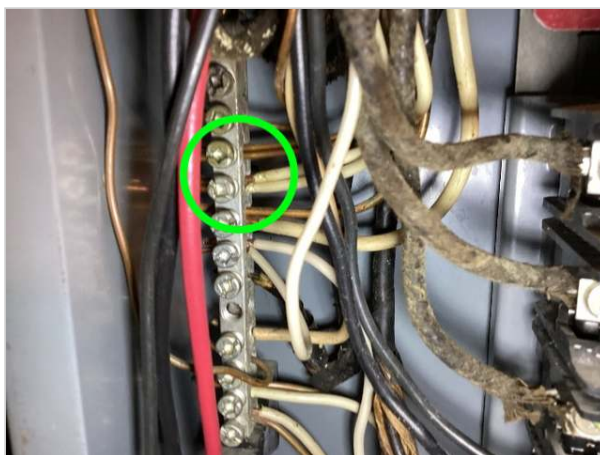
NOTE: DOUBLE LUGGED NEUTRAL WIRE:

One or more neutral wires were double lugged to the neutral bus bar. The screws that secure neutral wires to the bus bar are designed to secure one wire per screw. Double lugging can compromise the electrical connection and lead to overheating. Consult with a qualified electrician for evaluation and repair.

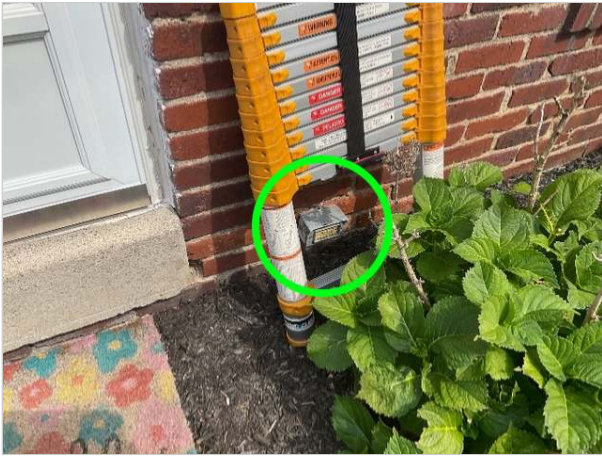
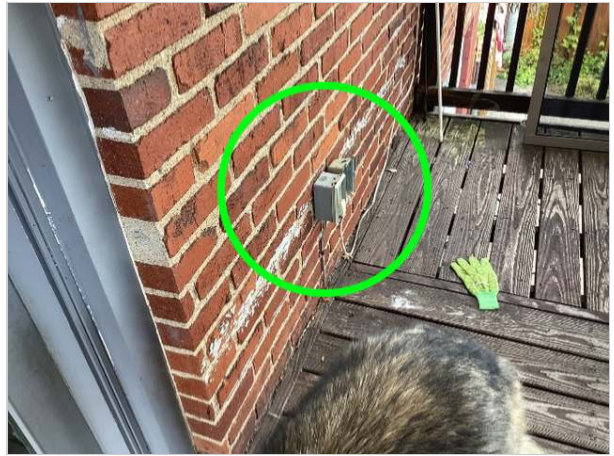
NOTE: MISSING EXTERIOR OUTLET COVER:

One or more exterior outlets were not properly covered. Outlet covers designed for use in wet locations should be installed on all exterior outlets.

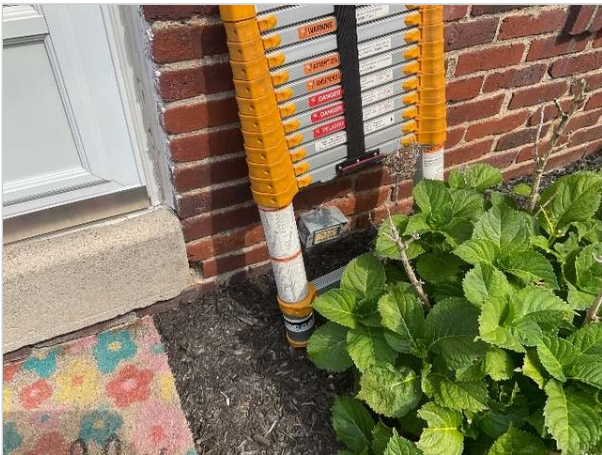
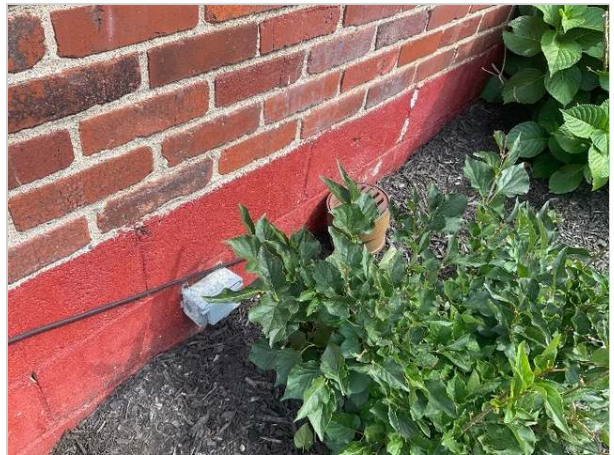
SAFETY NOTE: DEFECTIVE GFCI:

The GFCI outlet located at the exterior is defective and should be replaced by a qualified electrician.

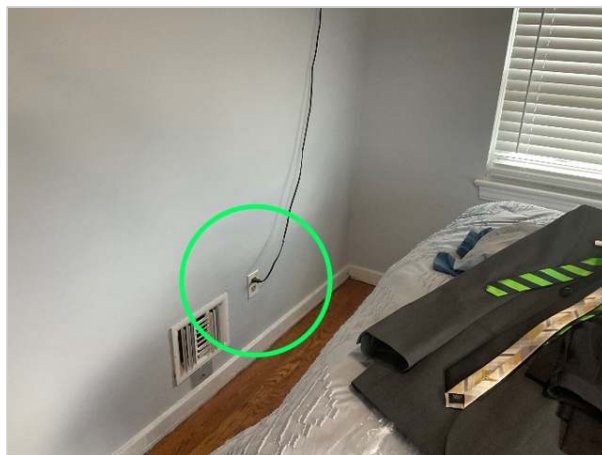
NOTE: HOT NEUTRAL REVERSE:

There were one or more receptacles in the home where the presence of hot and neutral wires were reversed. This is a safety concern and should be repaired by a licensed electrician. The outlets that tested with this condition were marked with a "YELLOW" dot for easy identification. The affected outlets were located in the bedroom to the left. Please note that we only test outlets that are visible and readily accessible at the time of the inspection.

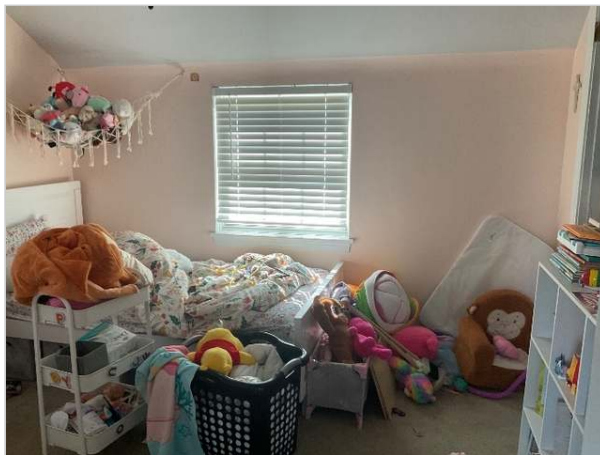
One or more of the windows would not stay in its placed position without support. This condition is usually caused by a defective balancer mechanism. Window balancers can be a rope and weight inside the window frame of older windows, or a combination of springs and ropes in newer windows. The window (s) were located in the bedroom. A defective balancer can be considered a safety issue if the sash falls rapidly. Repair or replacement of the balancer system may be required in order for the windows to stay in place without additional support.

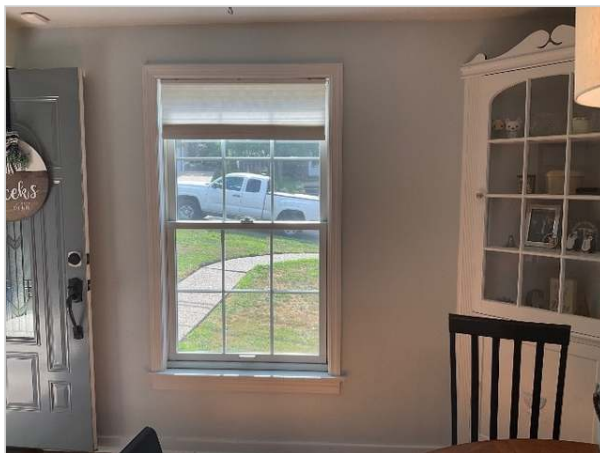
NOTE: WINDOWS WON'T OPEN:

located in the dining room. This condition could be caused by paint, obstructions or lack of use. Repairs or adjustments may be required. For safety reasons, it is important that at least one window opens in each room of the home.

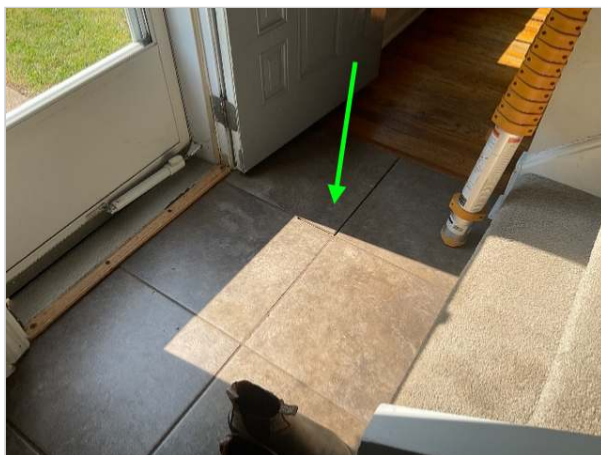
NOTE: SOFT FLOOR:

A section of the floor in the entry is soft. Consult with a qualified contractor for evaluation and repair as required.

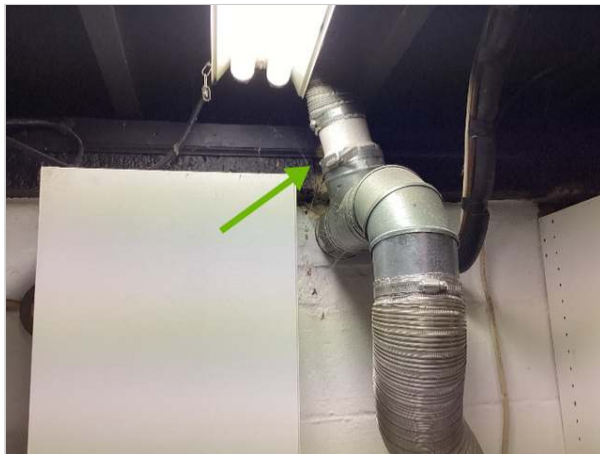
The dryer vent has a tee connection back to the basement. This will enable the backflow of dryer exhaust. We recommend removing the tee to enable direct access of ex exhaust to the exterior.

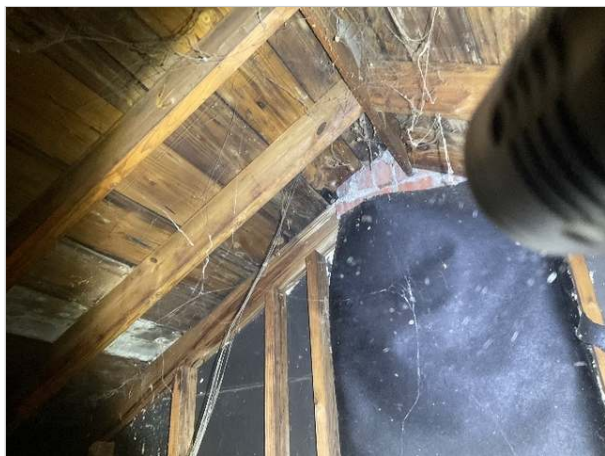
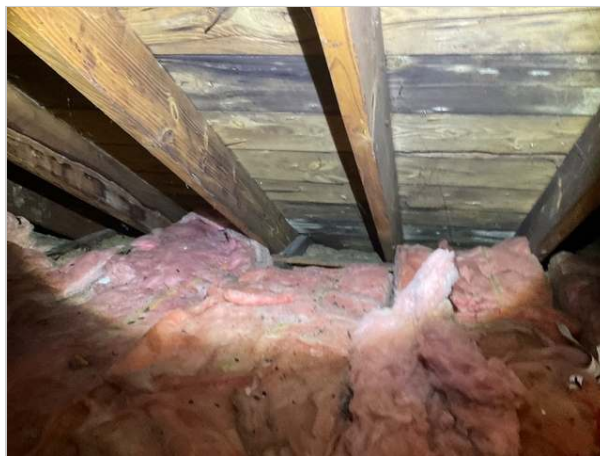
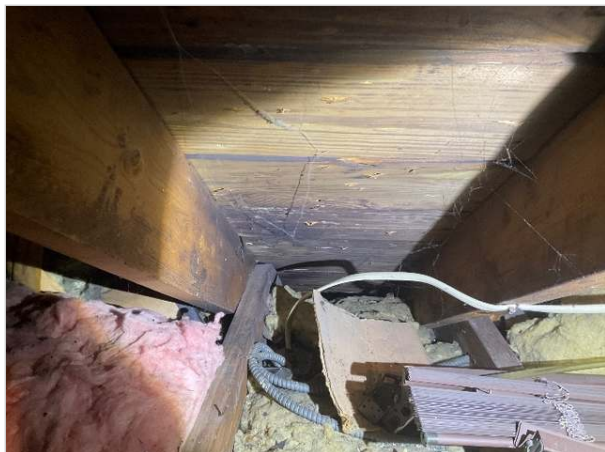
deteriorate the structure of the dwelling resulting in structural damage. Health effects include, but are not limited to: asthma, allergy symptoms, watery eyes, sneezing, wheezing, difficulty breathing, sinus congestion, blurry vision, sore throat, dry cough, aches and pains, skin irritation, bleeding of the lungs, headaches, memory loss and fever. As humans vary greatly in their chemical make-up, so does the individual's reaction to mold exposure. For some people, a small number of mold spores can cause ill effects. In others it may take many more. A substance with the characteristics of mold is visible in the attic. Since the attic is not a part of the living space, the condition may not have any affect on those that are sensitive to mold. The EPA (<http://www.epa.gov/mold/moldresources.html>) advises consumers that areas less than ten square feet of coverage can usually be controlled using readily available household products. In the event the substance cannot be controlled, a certified mold testing and remediation firm should be contacted for a recommended course of action.

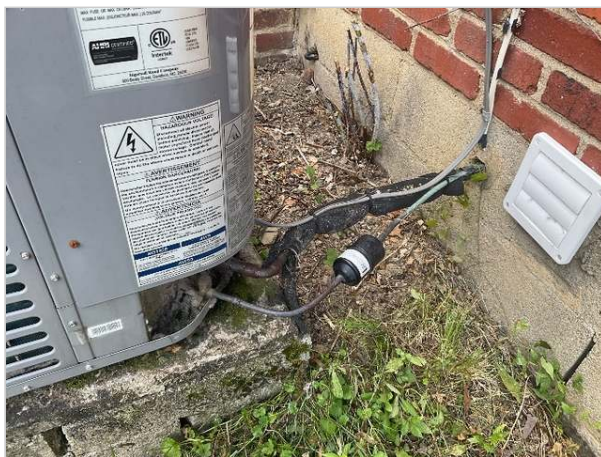
The insulation on the exterior air conditioning line set is damaged. This could affect the efficiency of the system and should be replaced.

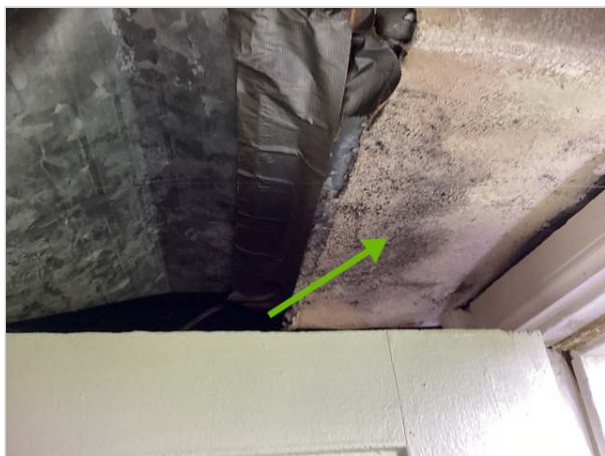
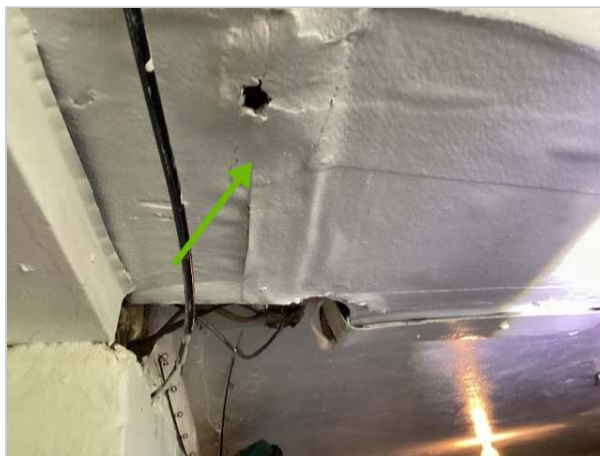
The air ducts in the basement were covered with a material that has the characteristics of asbestos. The material did not appear to be damaged or deteriorating at the time of the inspection. It is advisable to avoid disturbing the substance prior to any testing. The only way to confirm the contents of the material is to have a sample tested by a qualified laboratory. If the substance is of any concern, a qualified asbestos testing firm should be contacted.
