Inspection Report

590 Kenilworth Dr.
Pittsburgh Pa 15228

A Harmony Home Inspection, LLC

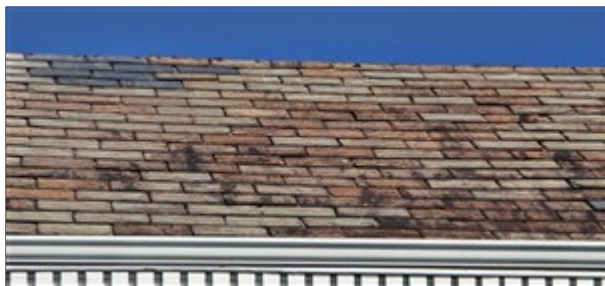
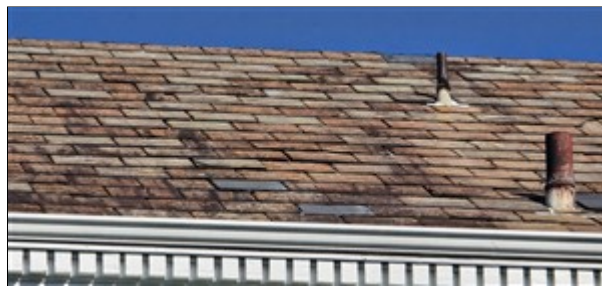
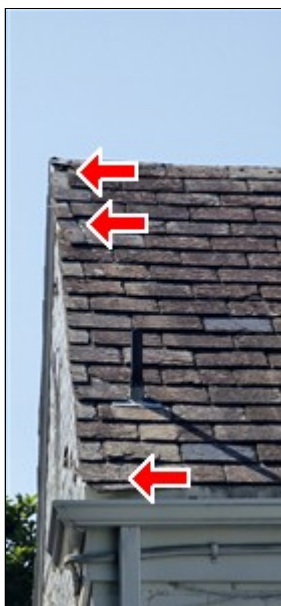
Areas of patches and repairs were observed at slate roof coverings.

Areas of worn, cracked, and broken slate were observed at the roof coverings.

Areas of shifted and fallen slate were observed at the right end of the roof. Some areas of exposed wood/holes in the roof coverings were observed at shifted slate.

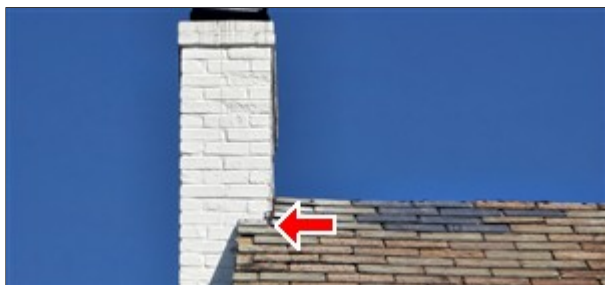
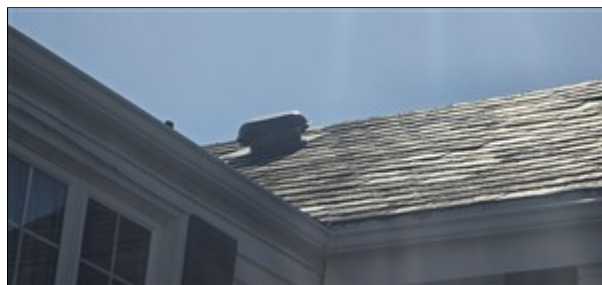
1.1 No visible flashing was observed at the front of the chimney.

Rusted flashing and cracked/worn sealant was observed at flashing at the side of the chimney.

Flashing was exposed and not properly covered with slate shingles at the rear of the roof.

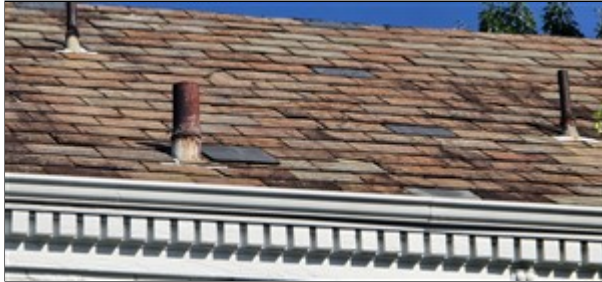
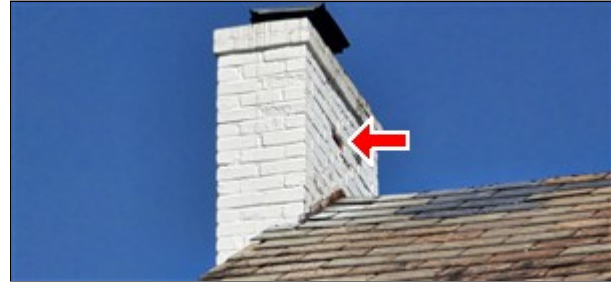
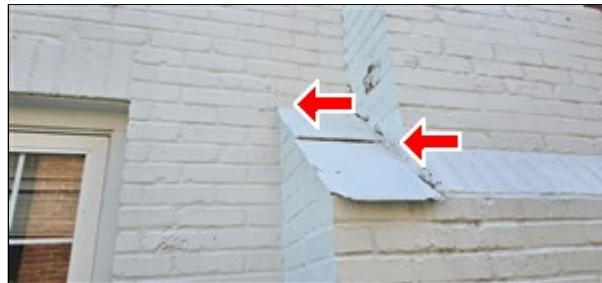
1.2 Rust was observed at plumbing vent pipes.

Worn sealant was observed at plumbing vent pipes.

Spalled bricks were observed at the side of the chimney at the rooftop.

Slate was not sealed at connections to the house brick siding and brick chimney at the chimney shoulders.

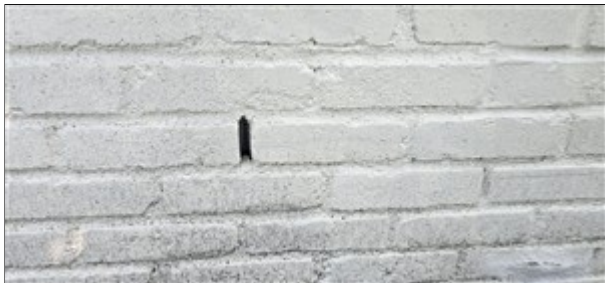
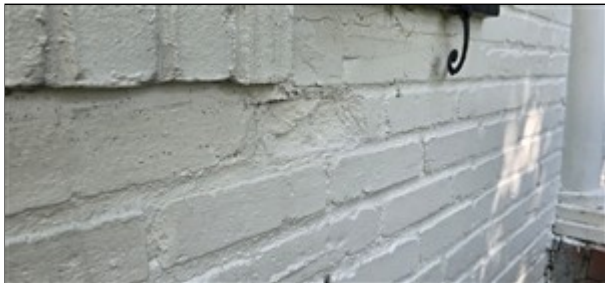
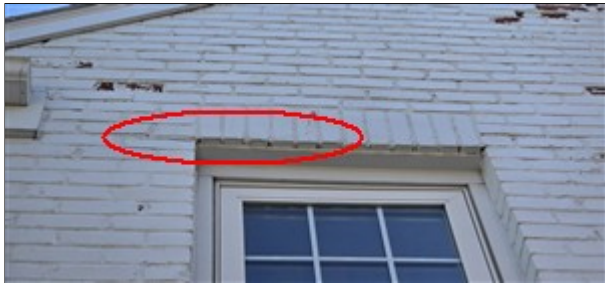
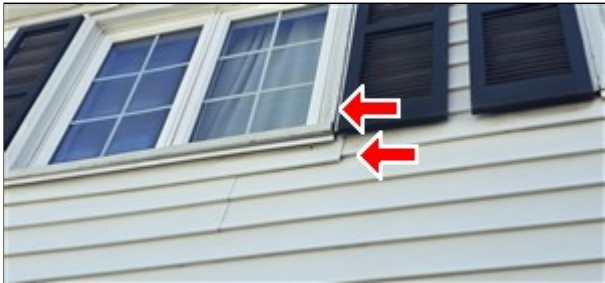
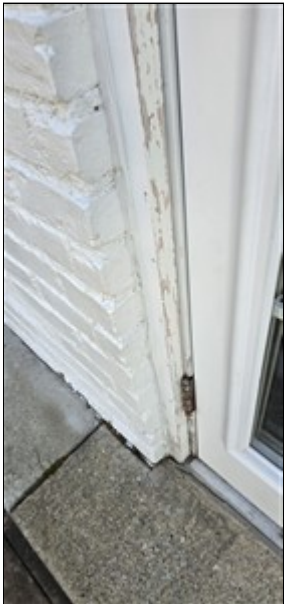
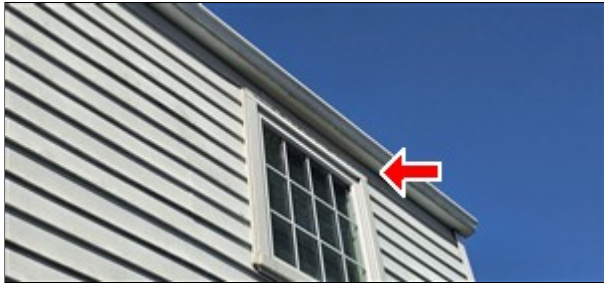
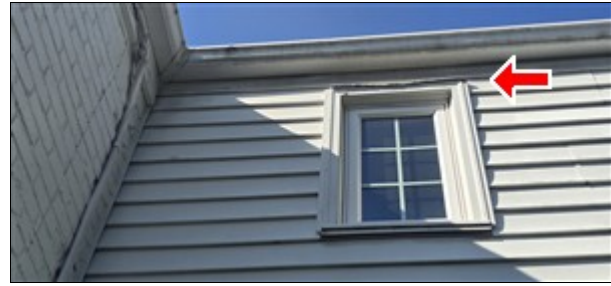
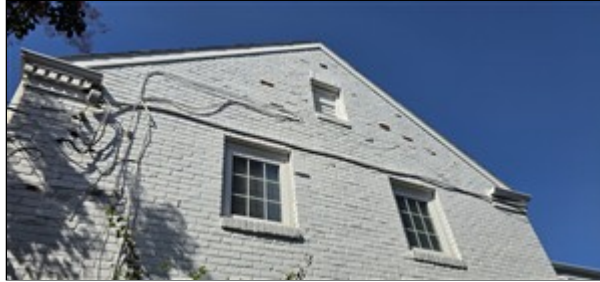
Cracks were observed at brick siding at the front family room window sill.

Spalled bricks were observed throughout the exterior at brick siding. The spalled bricks were painted over throughout the exterior.

Cracked mortar was observed at brick siding at the bottom corner of a left family room window sill.

Areas of missing paint were observed at brick siding at the left side of the house.

Eroded mortar and cracks in brick siding were observed at the top of a left bedroom window opening.

An opening for a window that was partially covered at one end was observed at brick siding at the rear addition.

Worn paint was observed at wood at the master bedroom windows. Wood was not sealed/painted at the ends/edges of the window frames.

Worn paint was observed at the patio door frame.

Wavy flashing was observed at the top of right master bedroom window openings.

Areas of spalled bricks were missing paint at the right side of the house.

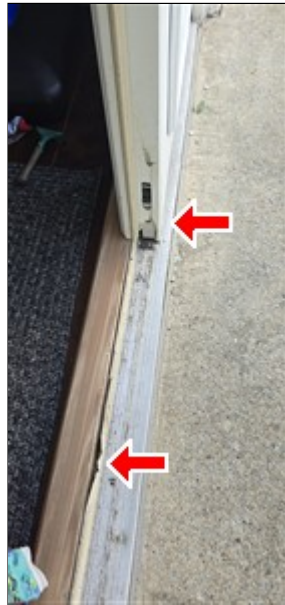
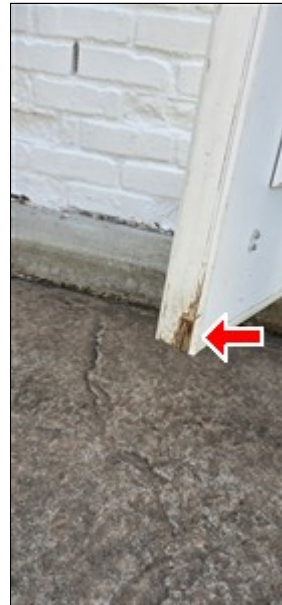
2.1 Torn weather seals were observed at the bottom of the patio door. Deteriorated wood was observed at the bottom corner of a french door. Cracked/broken plastic was observed at the bottom of the french door near the bottom locking pin.

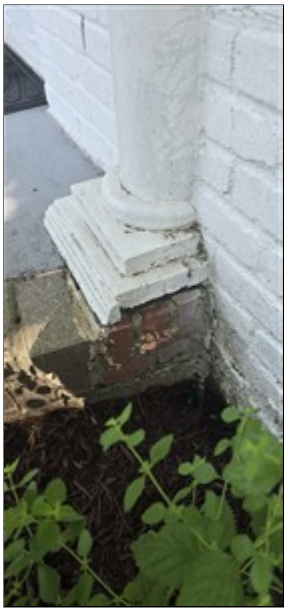
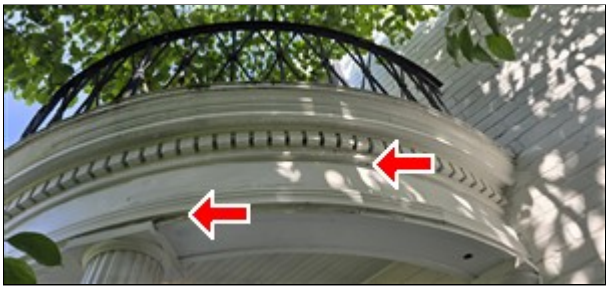
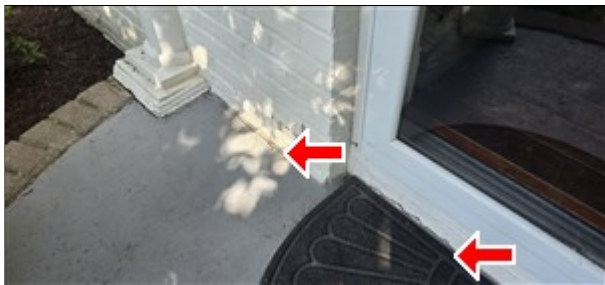
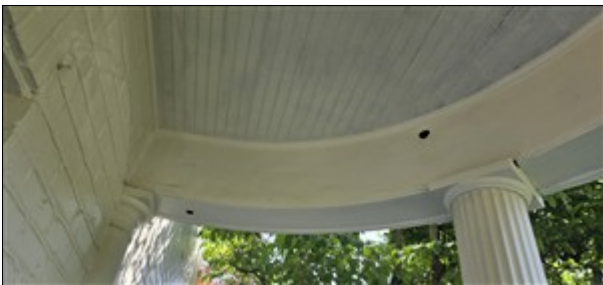
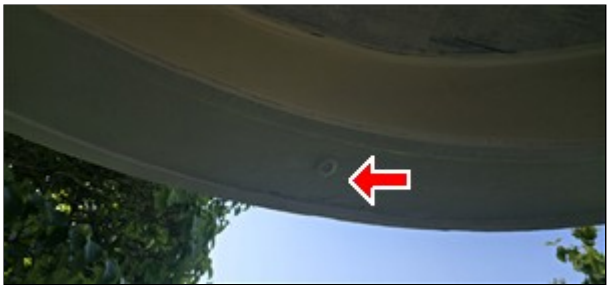
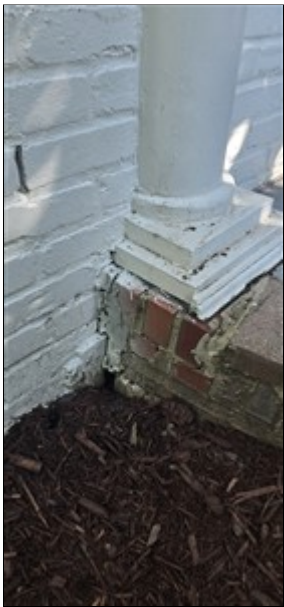
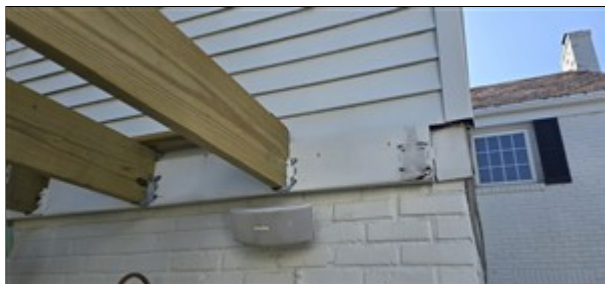
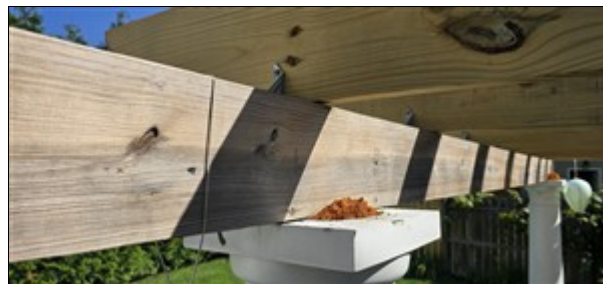
2.2 Cracked mortar was observed at brick below the front porch roof columns at the left and right sides of the porch.

Areas of peeling paint were observed at the front porch roof system.

Wood was deteriorated and not repaired at a removed/missing roof pergola joist from a previous roof.

Exposed spray foam was observed at the top of pergola roof columns. A hole was observed at the rear of one of these columns.

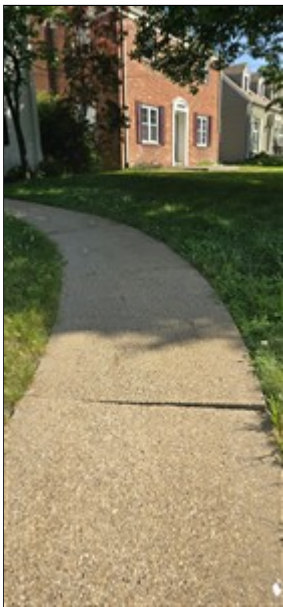
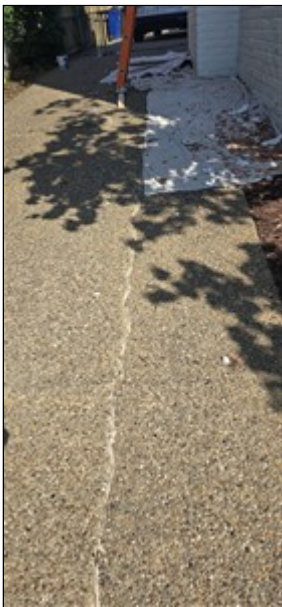
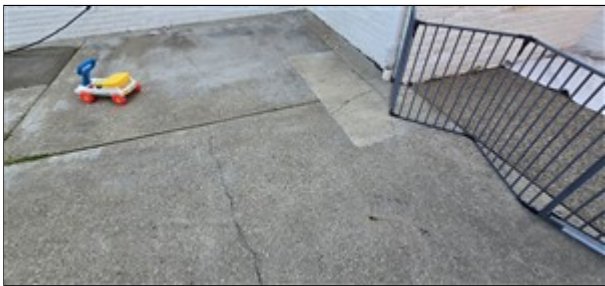
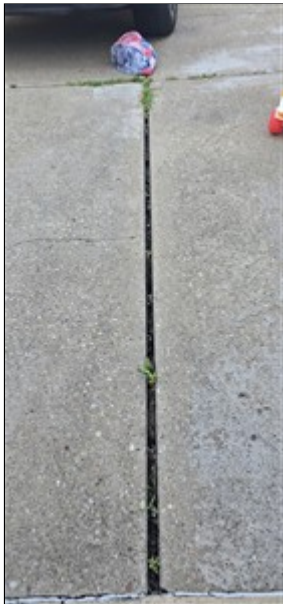
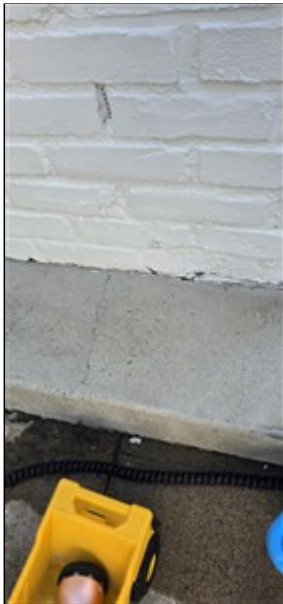
Settlement was observed at the front sidewalk.

Cracks were observed at the driveway and rear patio/areaways.

A missing expansion joint filler was observed between two pads at the concrete driveway at the rear of the family room.

Concrete was not sealed at connections to the house at the patio edge. Cracks were observed at areas of this raised edge.

Re-leveling was needed adjacent to the foundation wall where cement/soil sloped toward the house. If left unattended, this could lead to more basement moisture and dampness. Raising the level at the wall and maintaining a positive slope away can help divert run-off water away from the foundation.

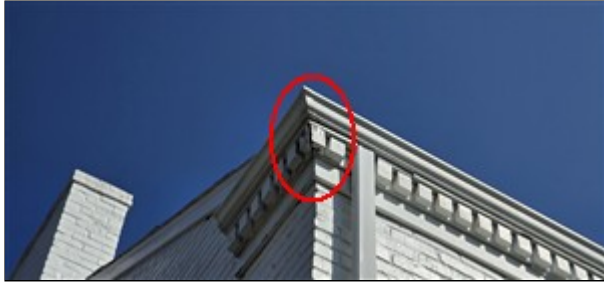
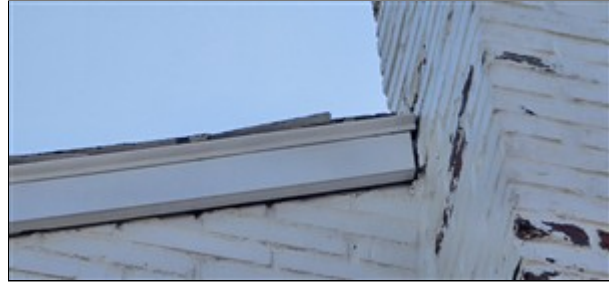
2.4 Peeling paint and a cracked/split wood piece was observed at fascia trim at the left front corner of the roof.

Fascia was not sealed at connections to brick chimney.

Rotted and missing wood was observed at fascia at the right front corner of the roof at the electric line connection to the house.

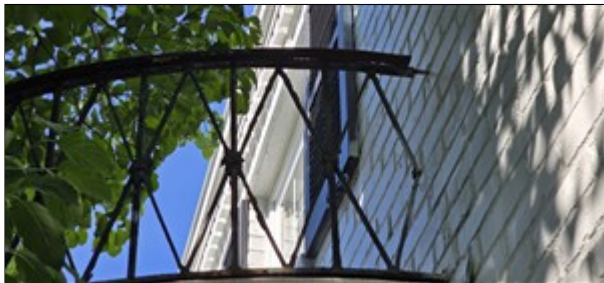
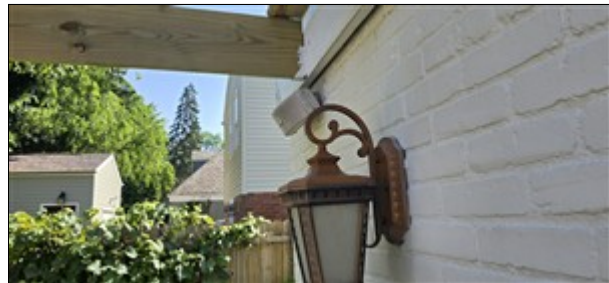
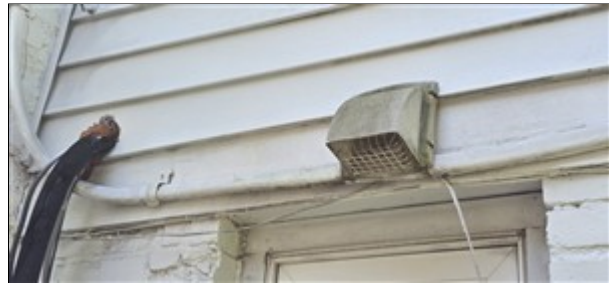
2.5 Rust was observed at the railing around the front porch roof. Metal was deteriorating at areas of this railing.

Missing caulking was observed at the rear patio wall light fixture.

Spray foam was observed instead of a proper weather seal where the A/C lineset entered siding.

An exhaust cover was not weather sealed to siding at the right side of the house.

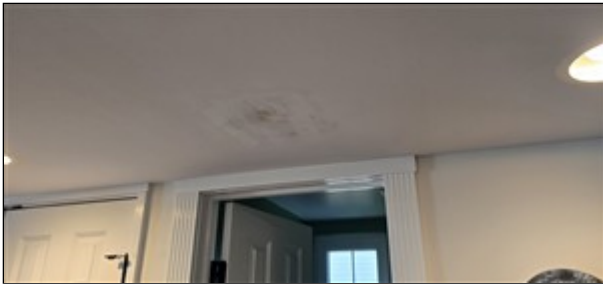
3.0 Picture 1

- 3.0 Limited visibility due to stored items.
- A patched repair was observed at the right side of the rear first floor room ceiling.

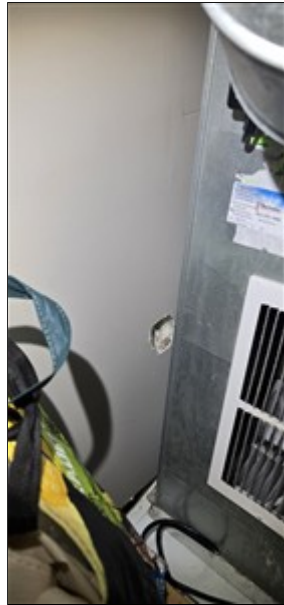
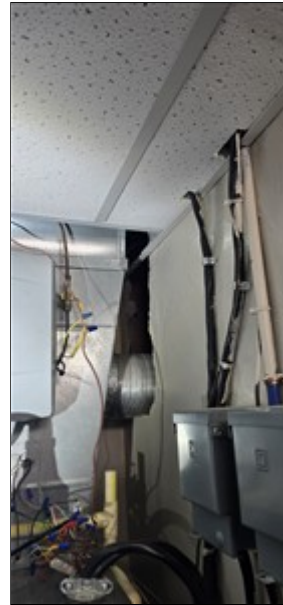
Holes and missing areas of wall coverings were observed at the furnace closet.

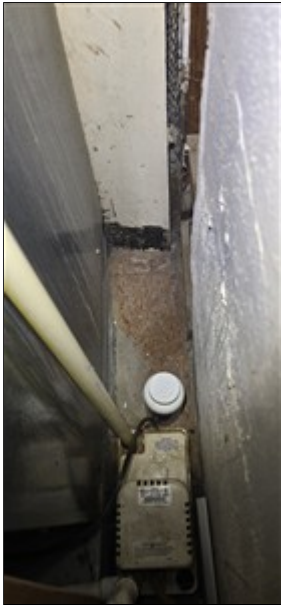
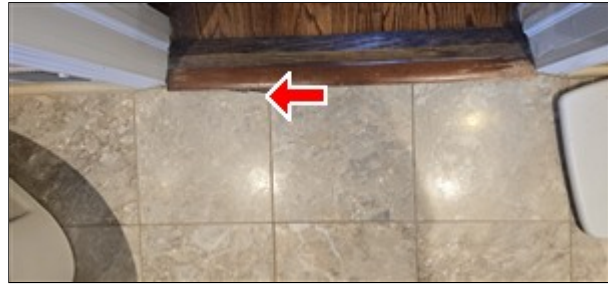
The floor next to the furnace was constructed with a material that has been known to contain asbestos. A laboratory test would be necessary to determine the composition. When material containing asbestos has been disturbed, it becomes friable (broken/airborne) and is considered unsafe. At the time of inspection, no visibly friable areas were observed; no samples were taken.

Cracked tiling was observed at the master bathroom floor.

A chipped tile edge was observed at the master bathroom floor at the doorway.

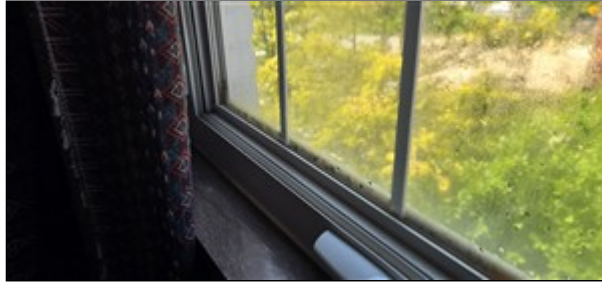
3.5 Picture 1

A gap was observed at weather seal at the window at the right side of the dining room when fully closed.

Casement crank style windows at the first floor bathroom, left side rear first floor room, right side of the kitchen, second floor hallway bathroom, front left of the left bedroom, and family room did not close when tested and had to be pulled shut.

Fogging was observed at the left front window at the left bedroom and windows at the rear right bedroom, master bedroom left side, and master bedroom closet.

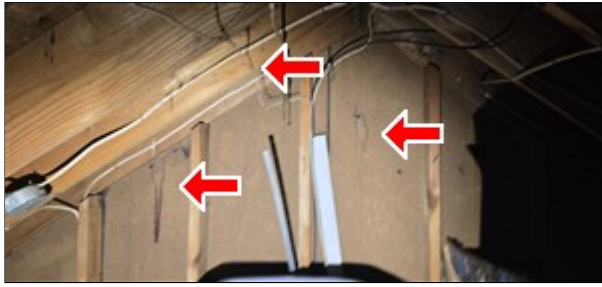
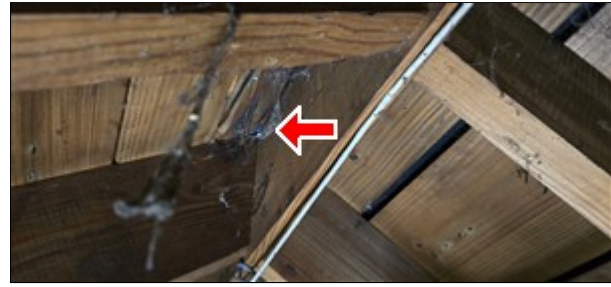
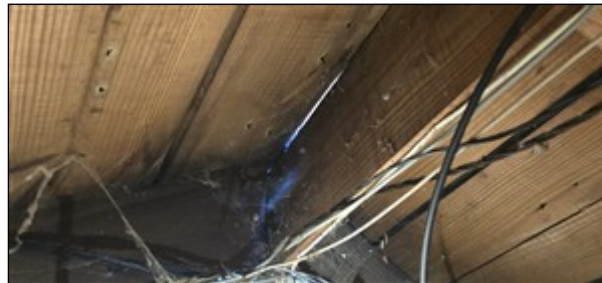
Moisture stains were observed at the left gable end wall and roof at the chimney area.

Daylight was observed at two areas at the ridge/peak of the roof at the left and right ends of the attic.

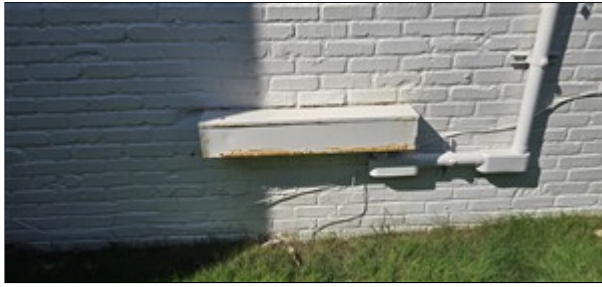
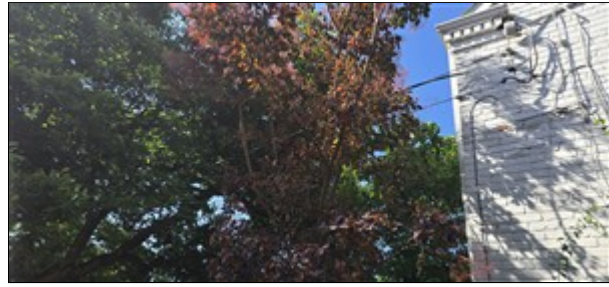
The weather head was not attached to the house at the front right corner of the exterior.

Rust was observed at the busway at the electric meter area.

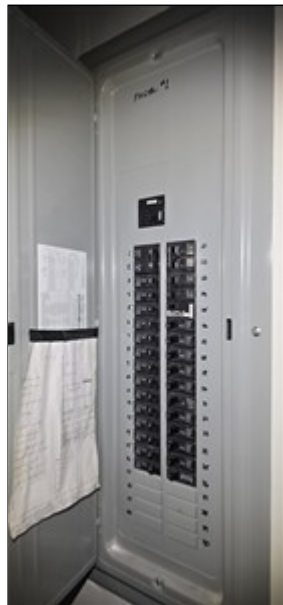
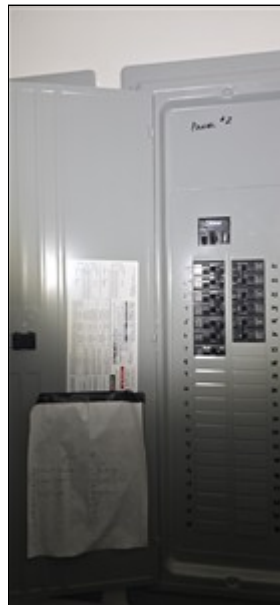
6.1 Two panel boxes were located at the utility closet at the rear living room.

Missing labels and no inspection stickers were observed at the panel boxes.

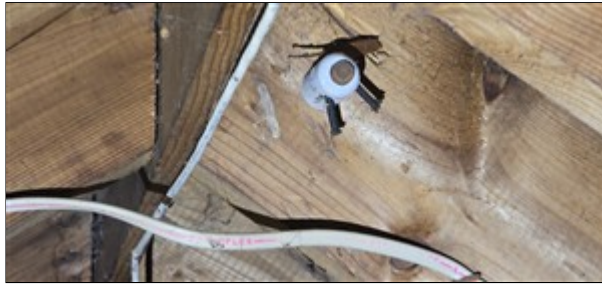
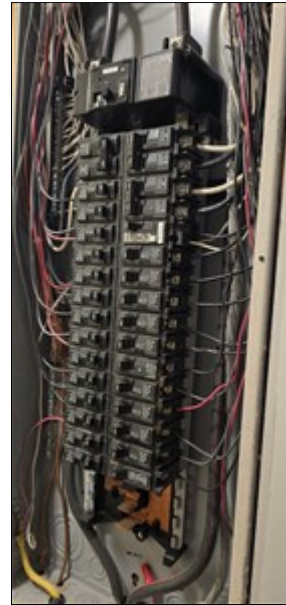
6.2 Disconnected knob and tube wiring was observed at the left end of the attic. Knob and tube wiring may exist at other areas of the house with limited or no access or visibility at the time of inspection.

Missing tie bars were observed at unpinned four wire circuits at the left panel box.

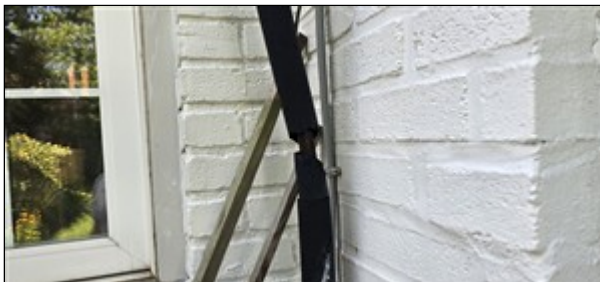
7.6 Picture 1

7.6 The foam sleeve on suction line was missing at some areas at the outside unit; this can cause energy loss and condensation.

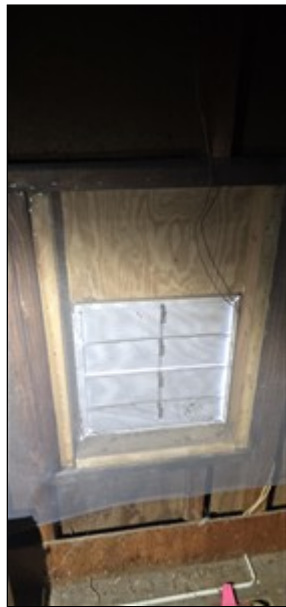
8.3 Picture 1

8.3 A single gable vent at the right side of the attic was the only air intake at the attic. Flaps were closed at this gable vent cover at the time of this inspection. Suggest adding/increasing ventilation.

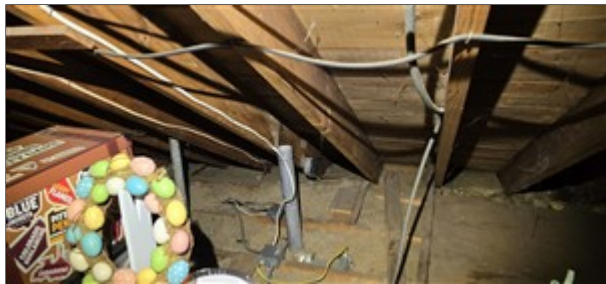
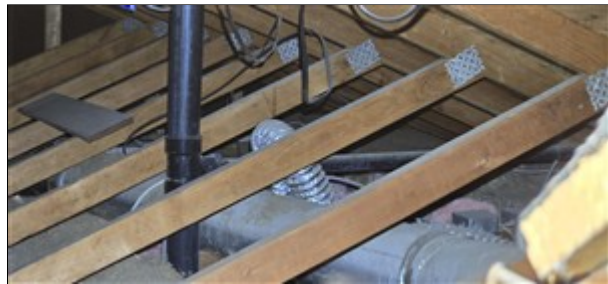
8.4 Bathroom fan(s) terminated in the attic; typically, fans terminate to the exterior.

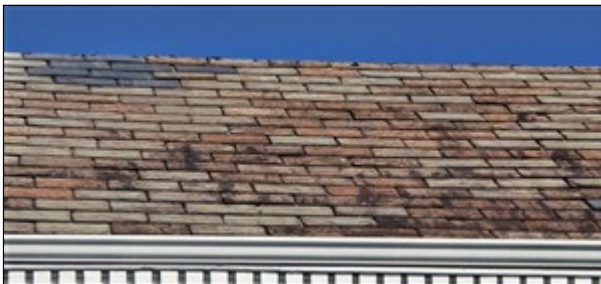
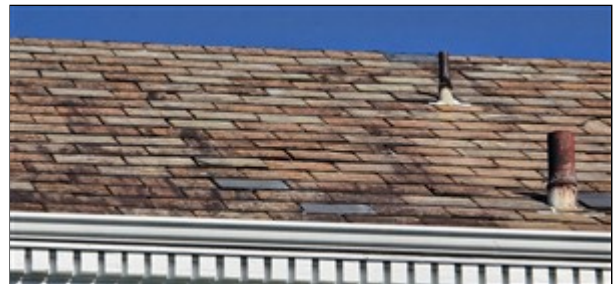
Areas of patches and repairs were observed at slate roof coverings.

Areas of worn, cracked, and broken slate were observed at the roof coverings.

Areas of shifted and fallen slate were observed at the right end of the roof. Some areas of exposed wood/holes in the roof coverings were observed at shifted slate.

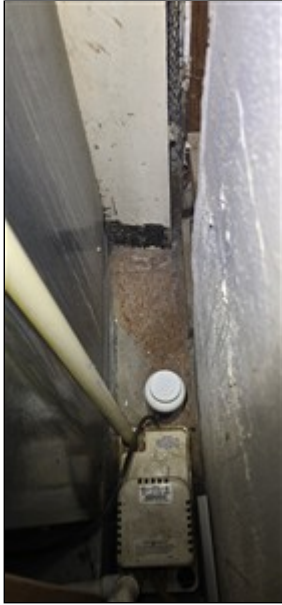
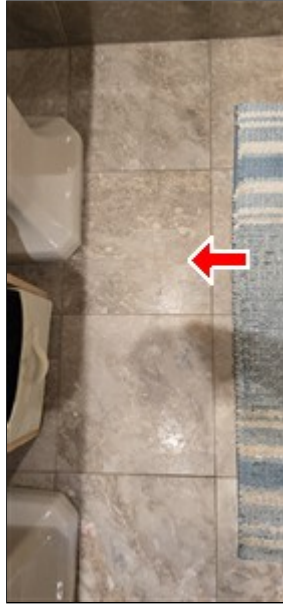
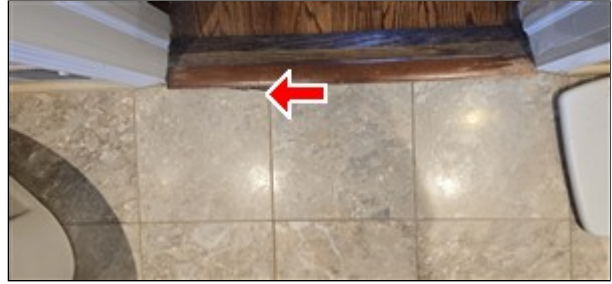
The floor next to the furnace was constructed with a material that has been known to contain asbestos. A laboratory test would be necessary to determine the composition. When material containing asbestos has been disturbed, it becomes friable (broken/airborne) and is considered unsafe. At the time of inspection, no visibly friable areas were observed; no samples were taken.

Cracked tiling was observed at the master bathroom floor.

A chipped tile edge was observed at the master bathroom floor at the doorway.

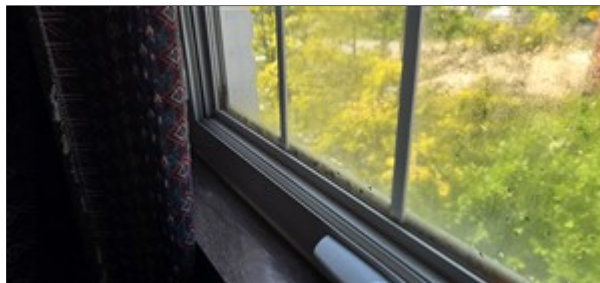
3.5 Picture 1

A gap was observed at weather seal at the window at the right side of the dining room when fully closed.

Casement crank style windows at the first floor bathroom, left side rear first floor room, right side of the kitchen, second floor hallway bathroom, front left of the left bedroom, and family room did not close when tested and had to be pulled shut.

Fogging was observed at the left front window at the left bedroom and windows at the rear right bedroom, master bedroom left side, and master bedroom closet.

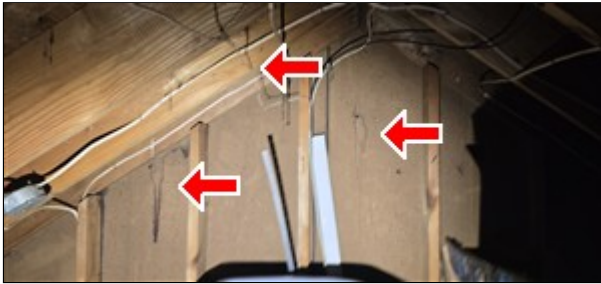
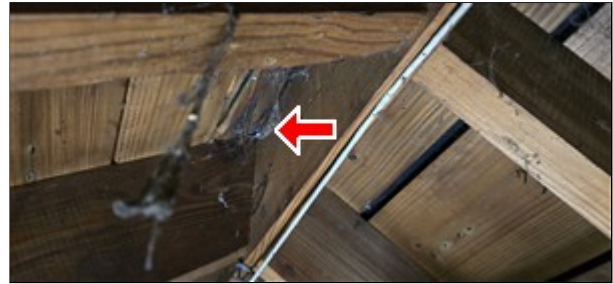
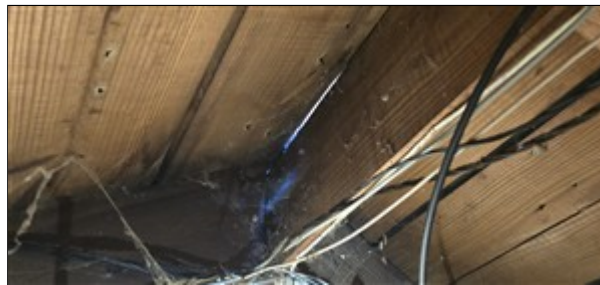
Moisture stains were observed at the left gable end wall and roof at the chimney area.

Daylight was observed at two areas at the ridge/peak of the roof at the left and right ends of the attic.

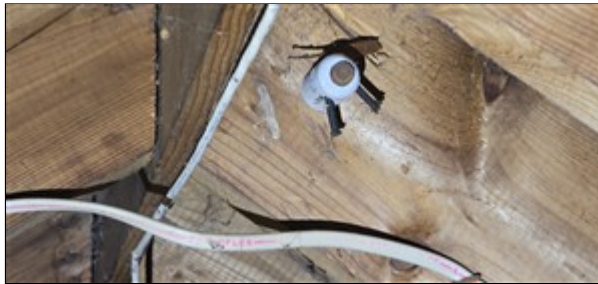
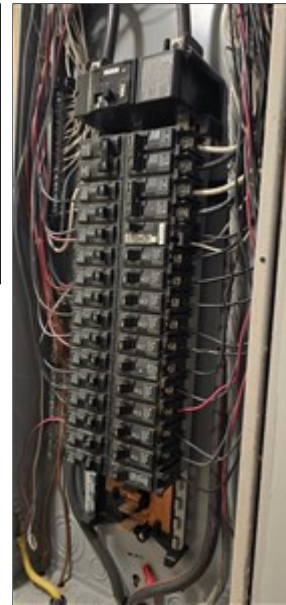
Disconnected knob and tube wiring was observed at the left end of the attic. Knob and tube wiring may exist at other areas of the house with limited or no access or visibility at the time of inspection.

Missing tie bars were observed at unpinned four wire circuits at the left panel box.
