**317 Old Farm Rd**

**RE: Pittsburgh, PA 15228**

**Inspection #: 527-112025-6616**

### *HOME INSPECTION REPORT*

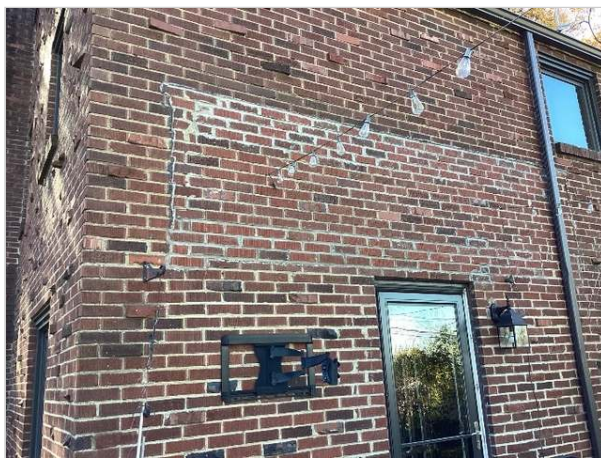
A repair was noted on the brickwork on the back of the home. There were no loose bricks noted.

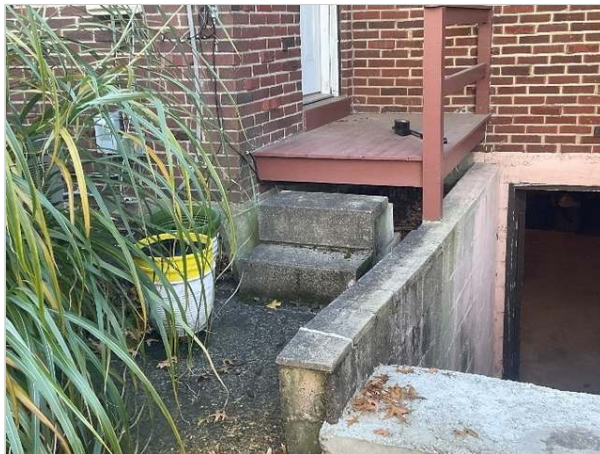
There were several trip hazards found on the walkways around the house. The hazards can be repaired using a suitable or similar surfacing material to "feather" the out-of-level condition to make a smooth transition.

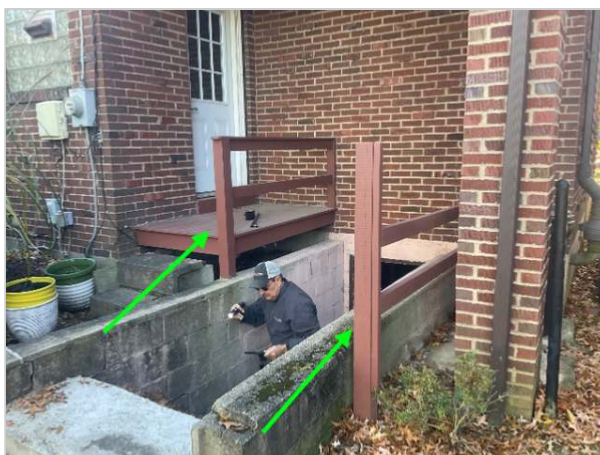
The balusters on the porch rail were were installed horizontally rather than vertically. Generally accepted construction techniques provide for balusters to be installed vertically and spaced no greater than four inches apart. Larger baluster spacing can be a safety concern, and horizontally mounted balusters permit climbing. Local codes may require modification and / or installation of additional balusters. Consult with a general contractor for cost estimates for additional balusters.

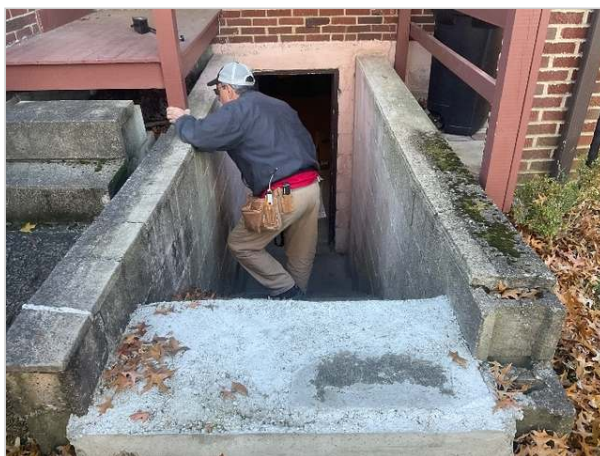
There were no handrails on the steps in the back. Local codes may require the installation of handrails in location where three or more steps are present.

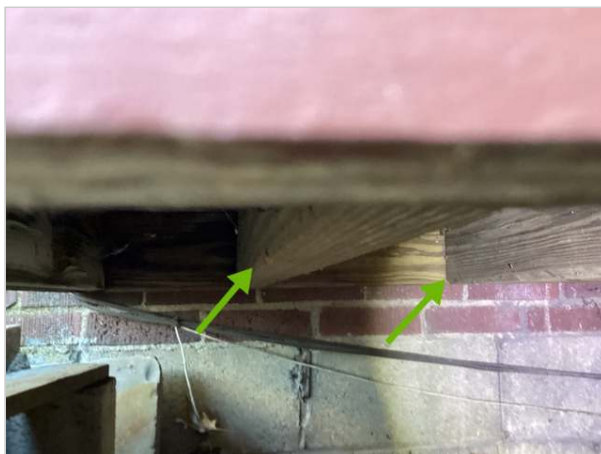
Missing joist hanger (s) were noted on one or more of the joists on the rear porch. The system was designed to have joist hangers installed in areas where perpendicular framing members are joined. Consult with a qualified contractor to install the missing joist hangers.

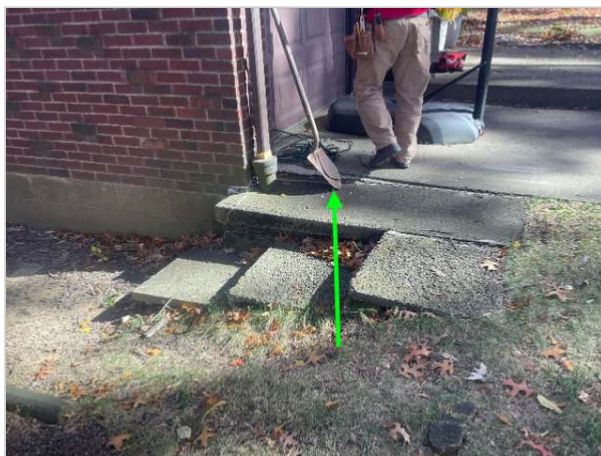
There were several trip hazards found on the driveway.. The hazards can be repaired using a suitable or similar surfacing material to "feather" the out-of-level condition to make a smooth transition.

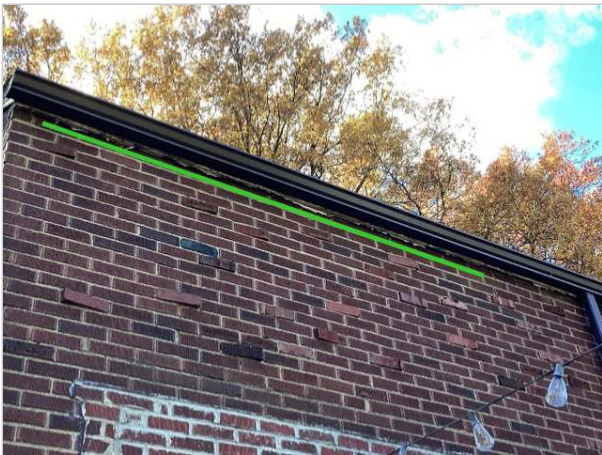
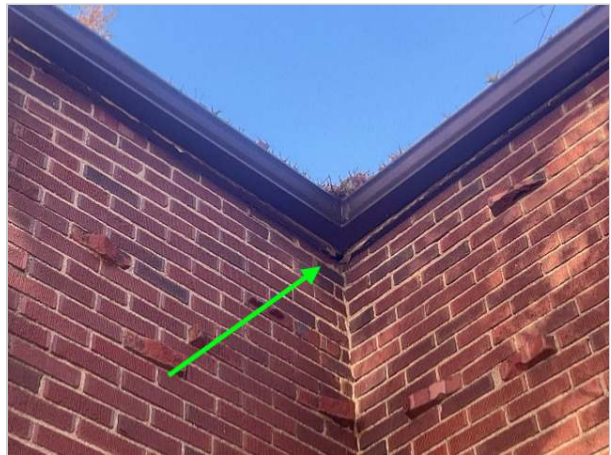
Front

Rotted wood was noted on the wood fascia . The areas should be repaired and sealed by a qualified contractor.

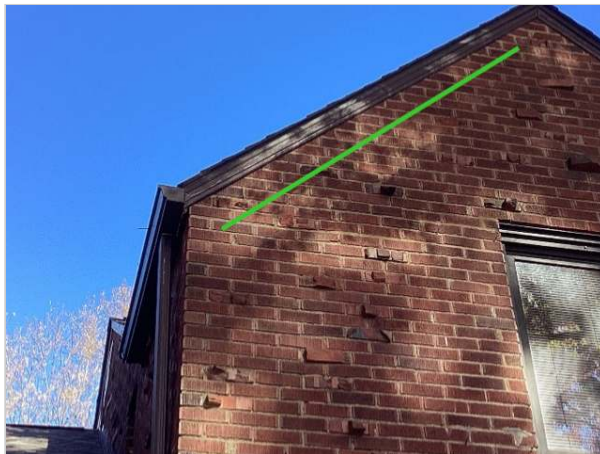
Peeling paint was noted on the wood fascia. In order to preserve the life of the exterior surfaces and materials, all areas should be scraped and painted.

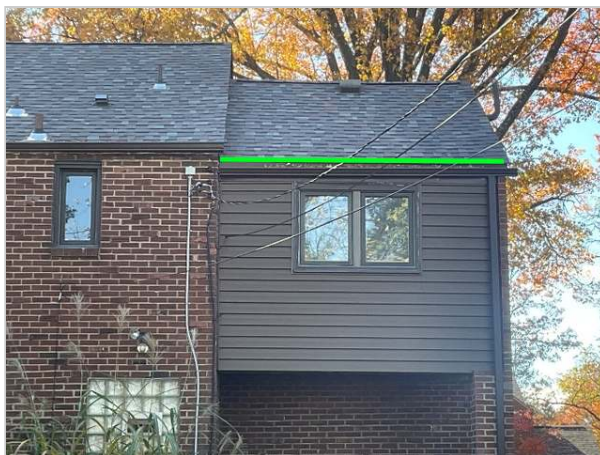
A low spot was noted in the rear gutter. This will affect proper drainage of roof water and could cause roof water to flow over the top of the gutter at the low spot. Consult with a qualified contractor for repair.

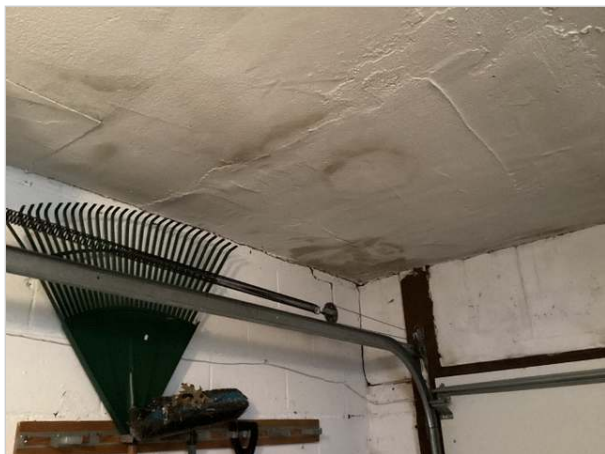
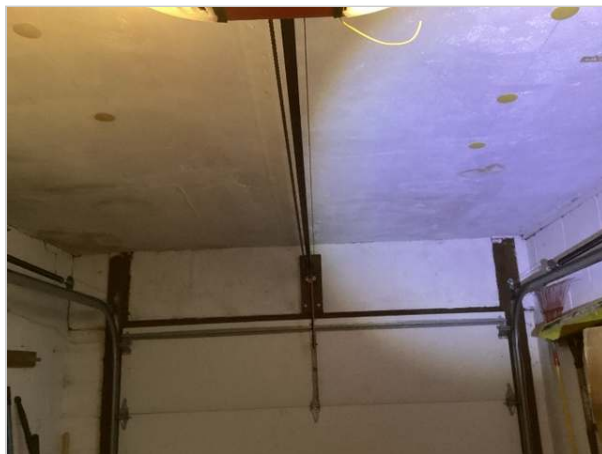
The garage ceiling is water marked from what appears to be a previous leak. The area was dry at the time of the inspection. No immediate action is required. The area should be monitored for evidence of new leaks. Consult with a qualified contractor for repair if required.

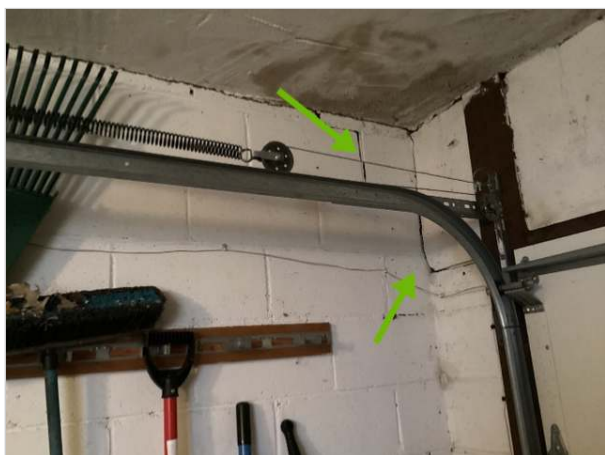
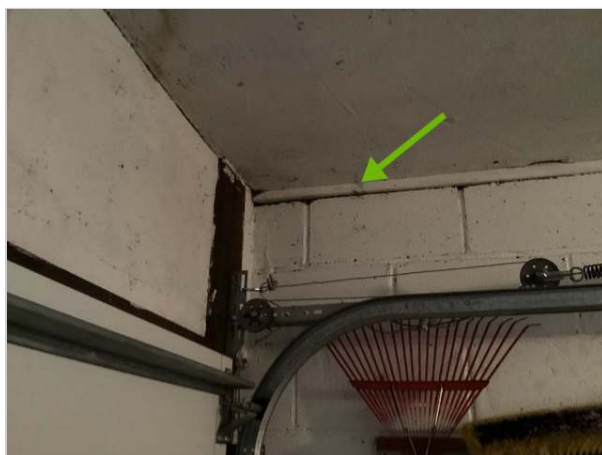
There were several minor, settlement cracks observed on the garage foundation. The cracks were 1/16-inch or less in width. These cracks are common and usually insignificant. All buildings experience some settlement. Settlement cracks most often occur within the first few years after construction as the soil under the structure accommodates itself to the load of the structure. However, the significance of cracks cannot always be judged by a single inspection. All cracks should be monitored for significant changes in characteristics. Consult with a company specializing in foundation repair if there is a marked change in the size or dimension of a crack.

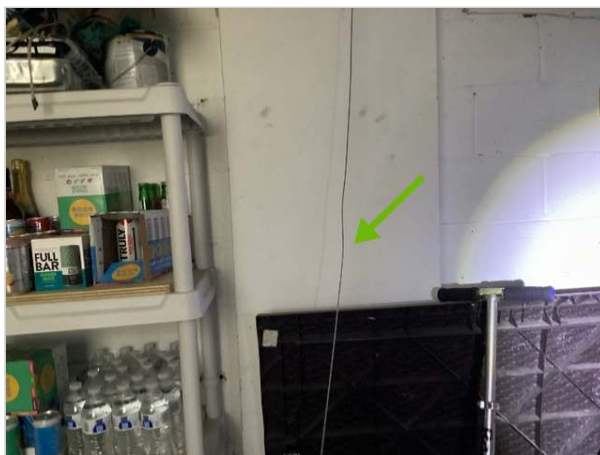
The installation of safety cables in the garage door springs will prevent a breaking spring from flying and possibly damaging objects in its path. The cables are inexpensive and easy to install and can be purchased at any home improvement store.

Right cable loose

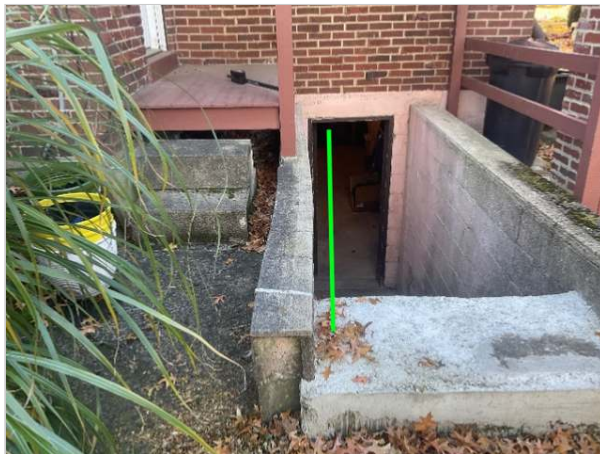
The area way retaining wall at the steps leading to the basement man door is pushed. There were significant vertical earth pressure type cracks observed in the wall. This condition is most often associated with soil and / or water pressure. The displacement occurs incrementally as the wall yields to horizontal earth pressure. The wall was stable at the time of the inspection. Repairs to the wall may be required. Consult with a qualified contractor for further evaluation and recommendations.

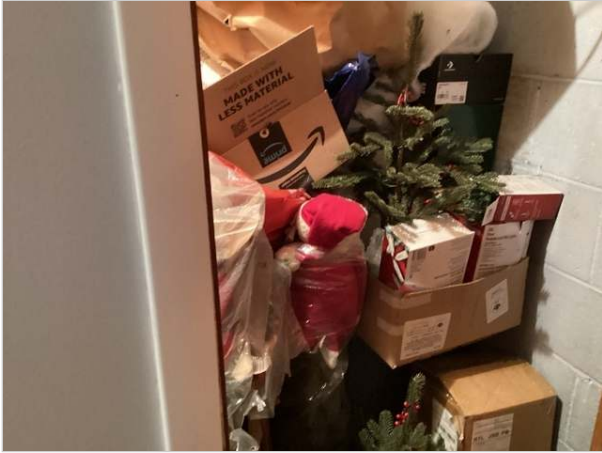
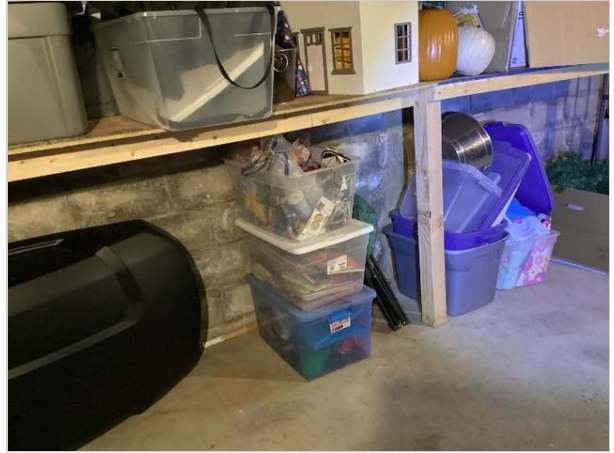
There were signs of moisture on the front and left basement walls. The area was dry at the time of the inspection. Dampness on basement walls is not always a sign of water intrusion. The dampness can be the result of warm humid air making contact with cool walls. In many cases the humid air condenses on the wall and forms a layer of moisture. It is important to assess whether moisture on the basement walls is the result of water intrusion or condensation. In this case, the efflorescence noted on the wall appears to be the result of moisture buildup on the exterior side of the foundation. The exterior grading in the affected area is questionable. Many water intrusion problems can be controlled by improving the drainage on the exterior of the home. It is important that all roof drainage and surface water is directed away from the foundation. Any concern about this condition should be referred to a qualified contractor for evaluation and recommendations.

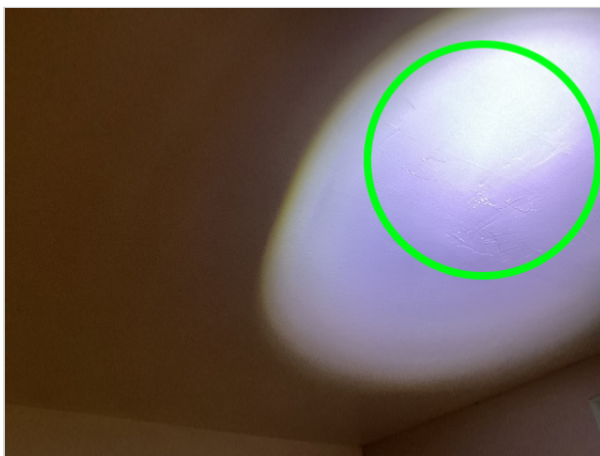
The basement ceiling is water marked below the kitchen from what appears to be a previous leak. The area was dry at the time of the inspection. No immediate action is required. The area should be monitored for evidence of new leaks. Consult with a qualified contractor for repair if required.

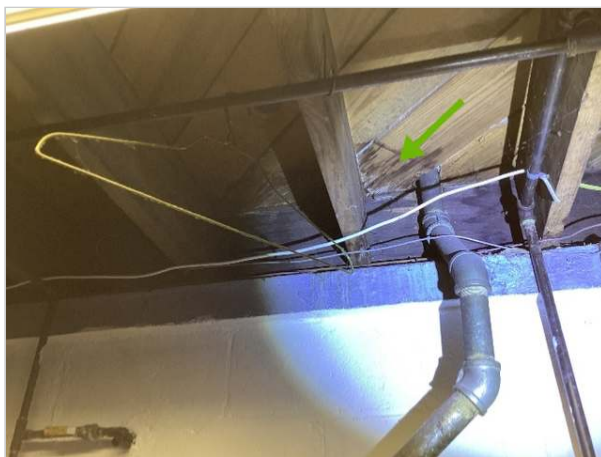
The floor joists and sub floor are water marked on the front basement floor structure. The area was dry at the time of the inspection. The wood on the affected area was not rotted. Repairs to the affected area does not appear to be necessary.No immediate action is required.

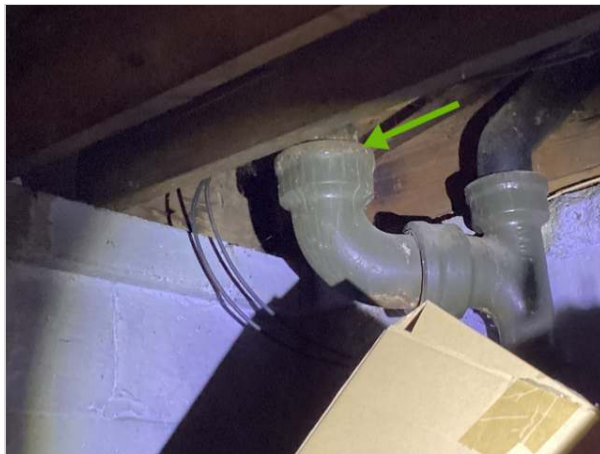
The drain stack near the front basement wall was rusted at the time of the inspection. Consult with a qualified plumber for repair.

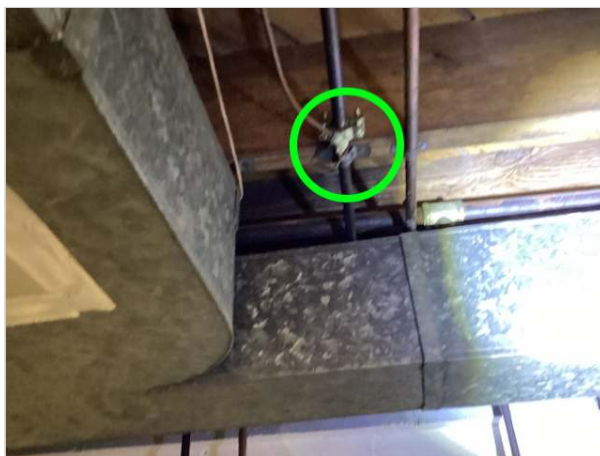
Humidifier valve

Older and/or corroded water supply valves were noted in the home. Water supply valves are infrequently used and often corrode on the inside and outside of the valve. This condition is common and often renders the valve inoperable. We make no attempt to test any water valves in the home regardless of their condition, because doing so could result in a leak. If this is a concern, you should consult with a qualified plumber for further evaluation and testing.

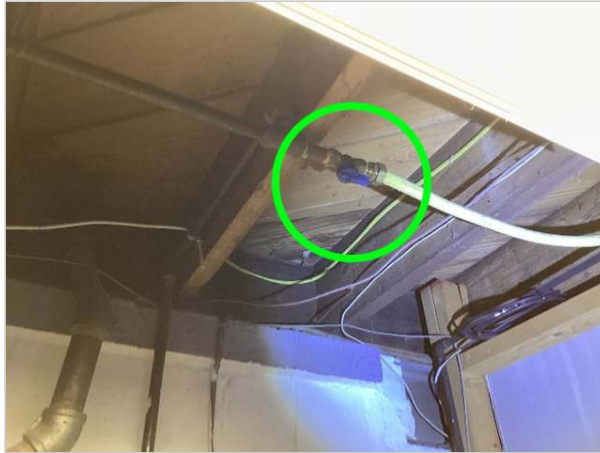
There was no apparent bonding on the interior gas line at the time of the inspection. Direct bonding is required for all yellow corrugated stainless steel gas-piping systems. More information is available at [www.csstsafety.com](http://www.csstsafety.com). Consult with a qualified electrician to ensure that the gas lines are appropriately bonded.

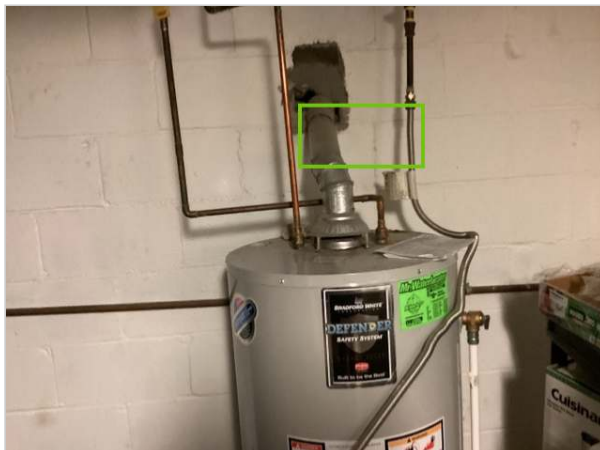
There is no expansion tank installed on the water heater. Expansion tanks relieve excessive pressure in the plumbing system and help lengthen the life of the water heater. These devices are installed on most newer water heaters. We recommend consulting with a qualified plumber for installation of an expansion tank. Depending on the terms, the lack of an expansion tank could affect any remaining manufacturer's warranty on the water heater.

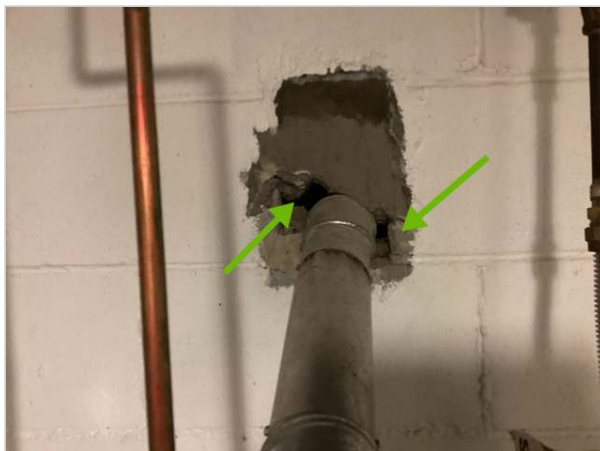
The water heater flue pipe is not sealed where it enters the chimney. In order to ensure proper venting of the flue gases that opening at the chimney should be properly sealed around the flue pipe. Consult with a qualified plumber for repair.

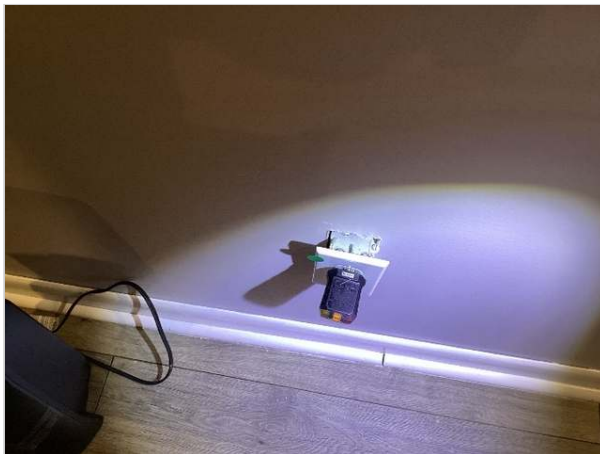
Basement

A loose outlet was noted in the basement. This could be a shock hazard due to exposed electrical contacts. The affected outlet(s) should be secured by a qualified contractor.

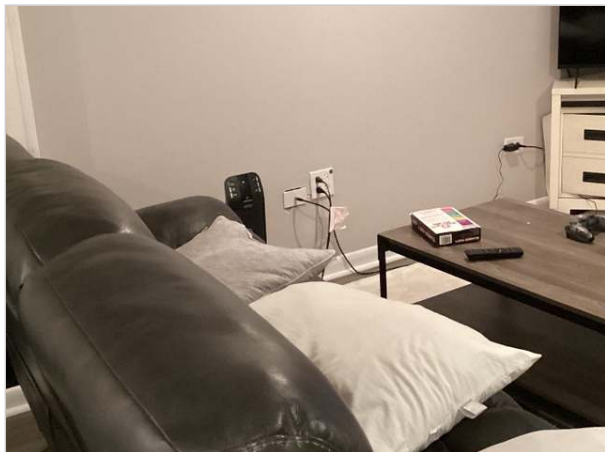
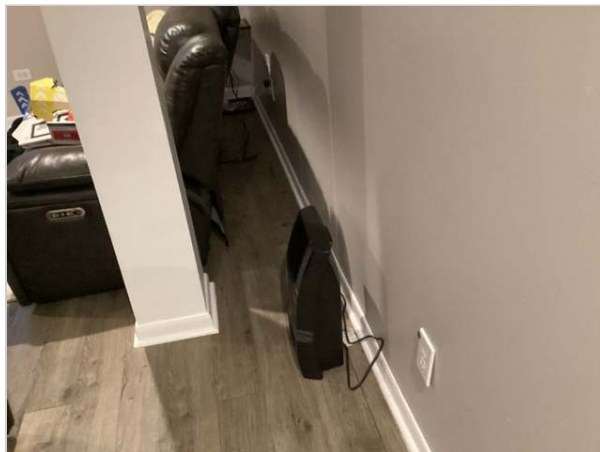
One or more three prong type outlets in the home tested as having an open ground. This means that the third prong, also known as the ground prong is not doing its job. This is usually caused by a missing ground connection at an electrical device in the circuit. This condition is usually easily correctable by an electrician. Open grounds in wet locations is considered a safety issue and should be corrected. The outlets that tested with this condition were marked with a "GREEN" dot for easy identification. The affected outlets were located in the basement. Please note that we only test outlets that are visible and readily accessible at the time of the inspection.

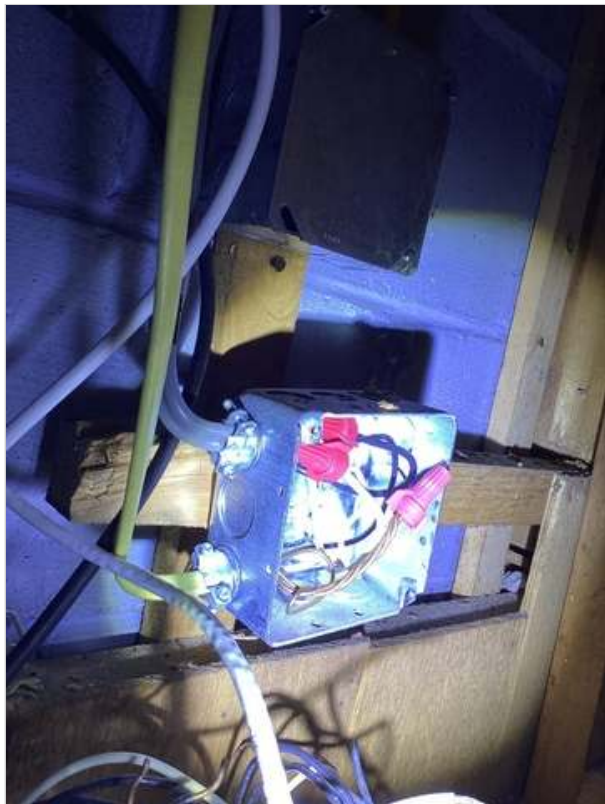
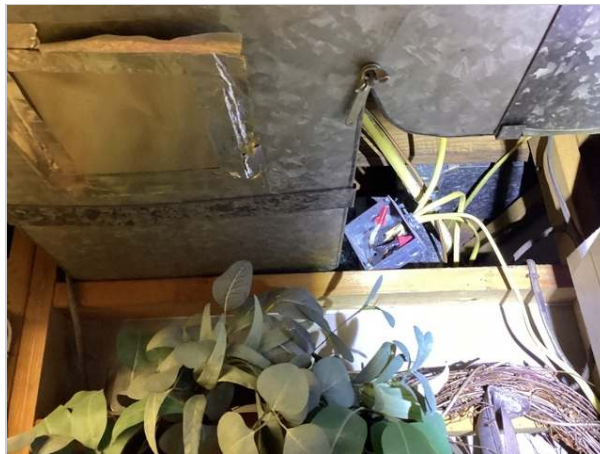
One or more uncovered junction boxes were noted in the basement. All electrical boxes should be covered to avoid a shock hazard. Electrical related repairs should be performed by a qualified electrician.

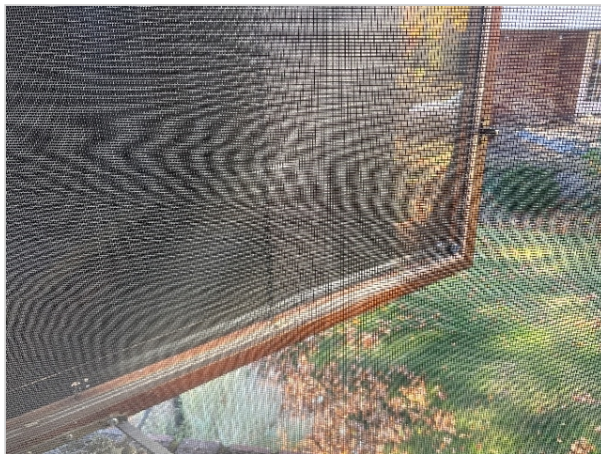
Rear bedroom

Cracked glass was noted on the bedroom window (s). For safety and security all cracked and broken glass should be replaced.

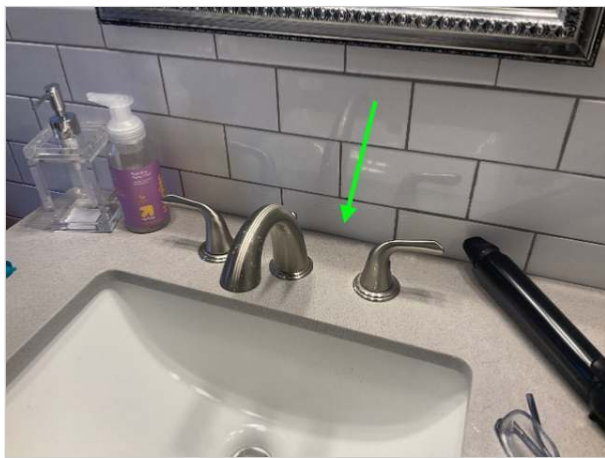
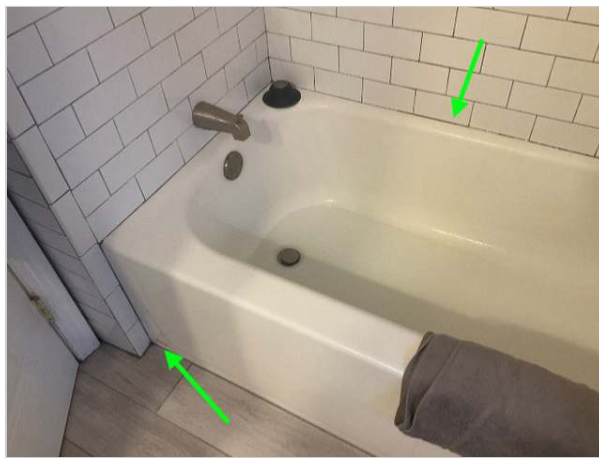
Failure to keep walls sealed can cause deterioration and extensive moisture damage including mold growth to the interior walls, which is not always visible at the time of the inspection. Some of the caulk was missing from around the sink and tub . These areas should be re-caulked to help prevent moisture penetration.

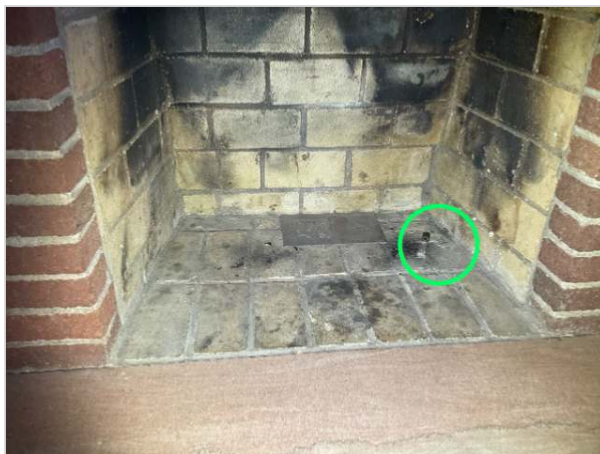
One or more unused gas lines were noted at the fireplace . The ends of the line (s) were open rather than capped. All unused gas lines should be capped so that gas will not leak into the home if a valve is mistakenly turned on.

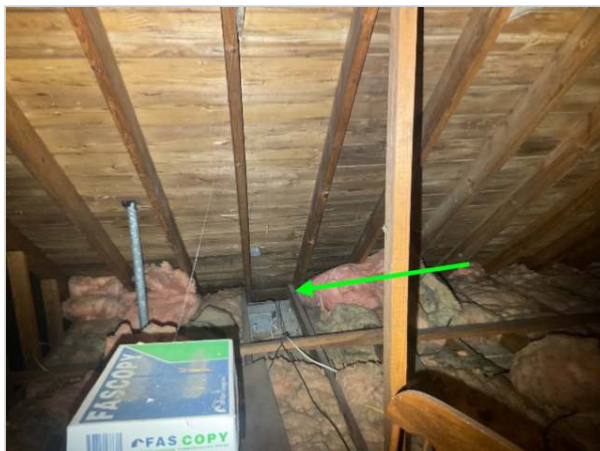
The full bath fan is discharging into the attic. Excessive moisture can build up in the insulation, creating a condition for mold growth. A duct should be installed from the fan exhaust to a roof vent.

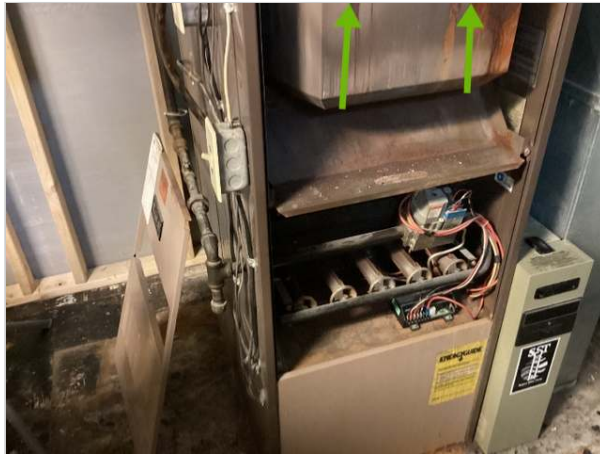
The furnace flue pipe is rusted through. This is a safety concern because flue gases containing carbon monoxide could enter the living area of the home. Consult with a qualified contractor for repair.

Rusted chamber with holes in flue

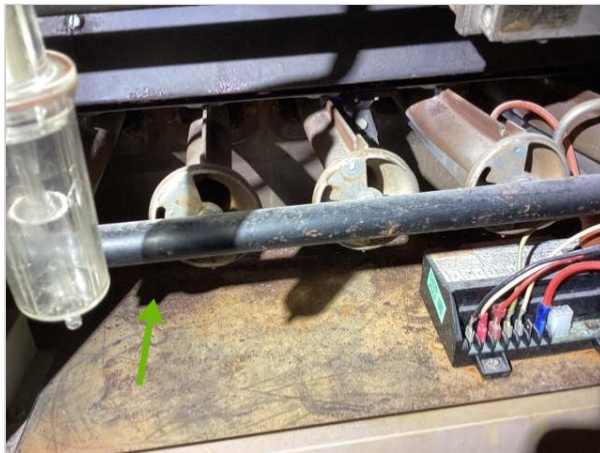
Evidence of water was noted inside the furnace compartment. The condition is most likely caused by a condensate leak in the furnace and/or air conditioning condensate drain lines. The water can also be caused by a leaking humidifier if one is installed. Water inside the furnace compartment can damage the furnace cabinet or other operational components and should be repaired. The furnace compartment was dry at the time of the inspection. Consult with a qualified heating contractor to determine the source of the water and correct the issue. Please also note that due to the seasonal use of heating and air conditioning systems, wet and dry conditions can change based on whether the inspection is performed during the heating or cooling season. The observation at the time of the inspection can be limited to seasonal conditions.

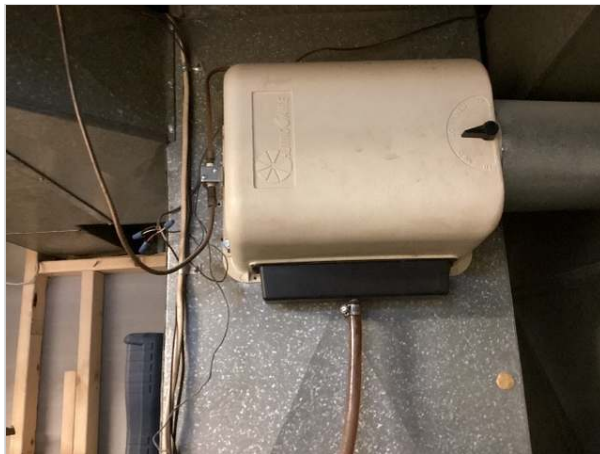
The humidifier did not appear to be functional at the time of the inspection. The humidistat was turned to maximum, but there was no indication that the unit turned on. Consult with a qualified contractor for evaluation and repair.

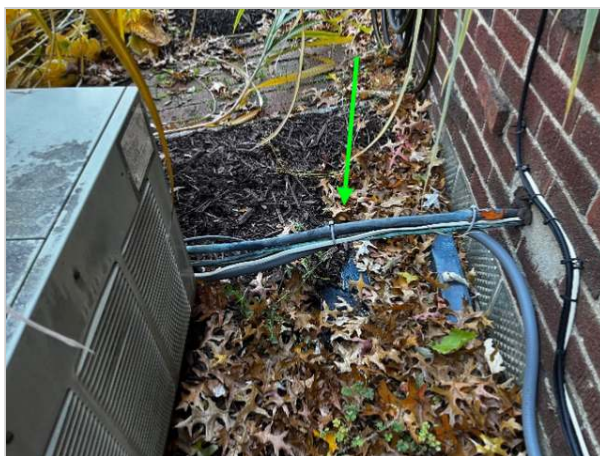
The insulation on the exterior air conditioning line set is missing. This could affect the efficiency of the system and should be replaced.
