**2360 W Gate Dr**

**RE: Pittsburgh, PA 15237**

**Inspection #: 527-062026-6913**

### HOME INSPECTION REPORT

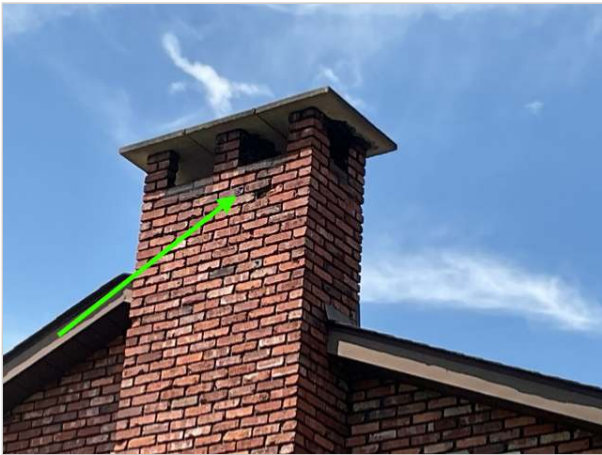
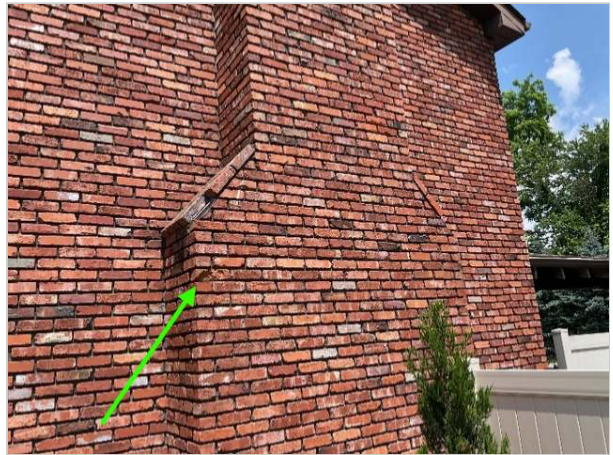
### *MAINTENANCE NOTE: SPALLING:*

Some spalling was noted on the brick of the home. Spalling is usually caused by moisture accumulation behind the surface. In cold weather, the moisture freezes and pushes the face off. In some cases the condition can be controlled by sealing the face with an appropriate masonry sealer. Consult with a qualified masonry contractor for recommendations.

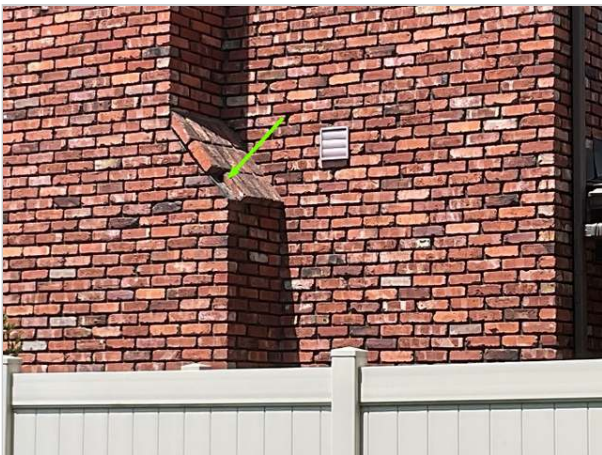
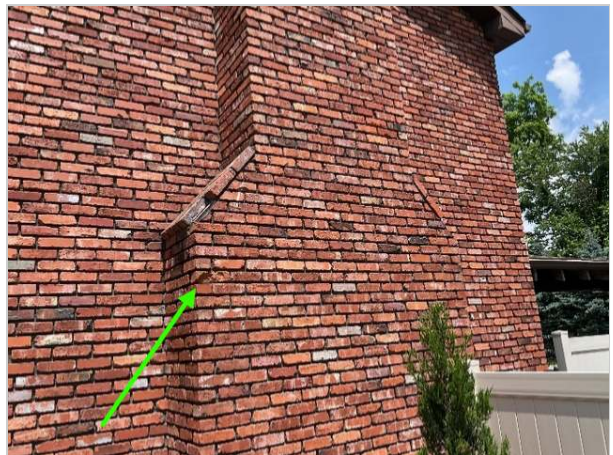
### *NOTE: MISSING MORTAR:*

Missing bricks was noted on the brickwork On the chimney of the home. There were missing bricks noted. Small amounts of missing mortar are usually inconsequential. Extensive amounts of missing mortar can permit water intrusion. Consult with a qualified masonry contractor for repair estimates.

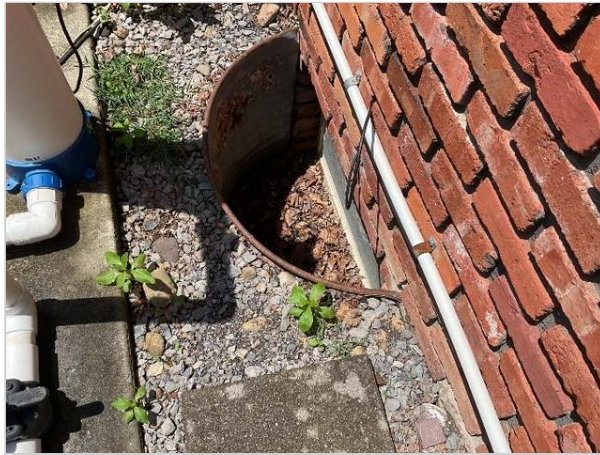
### ***SAFETY NOTE: FALL HAZARD:***

There is no barrier installed at the window wells. The absence of a proper rail or barrier constitutes a fall hazard and should be corrected. Consult with a qualified contractor for installation of a proper barrier.

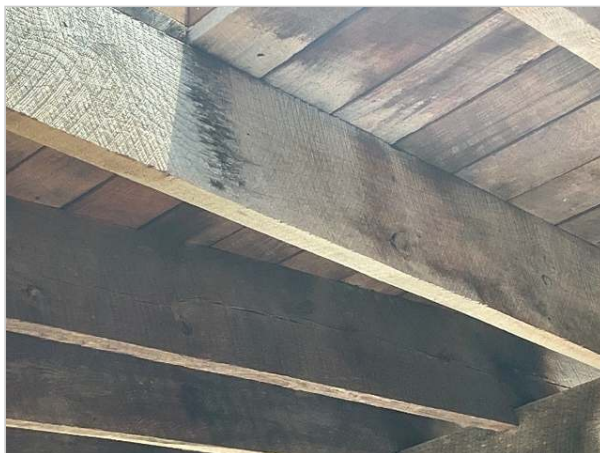
### ***NOTE: PATIO ROOF LEAK:***

Evidence of a roof leak was noted on the patio at the time of the inspection. The evidence is based on the water marks on the underside of the roof. Consult with a qualified contractor for evaluation and repair.

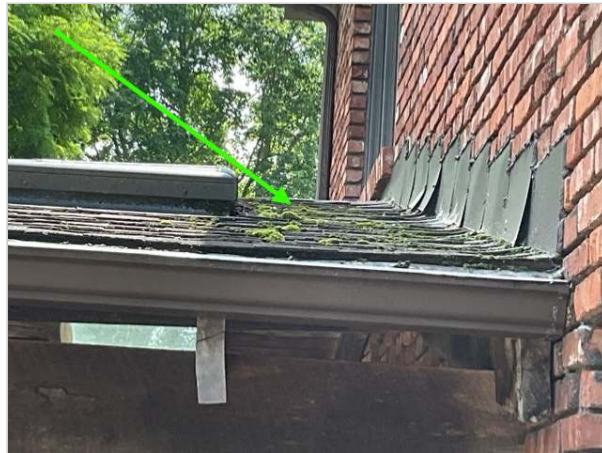
### NOTE: LOOSE FLASHING:

Loose flashing was noted on the back porch roof. Loose flashing could be a leak source. We cannot always determine if active leaks exist. Consult with a qualified roofer for further evaluation and repair.

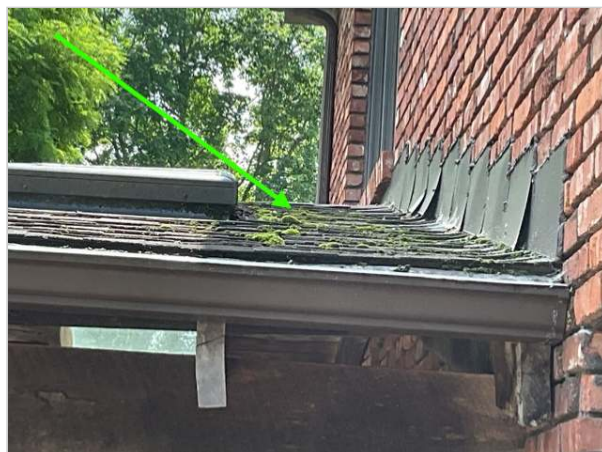
### NOTE: MOSS GROWTH ON ROOF:

Moss growth was noted on the porch roof. This condition is usually caused by a lack of sunlight on the roof due to trees or other cover. While the moss on the roof presents no hazard, advanced growth can cause the roof to hold moisture and debris. The consequences of moss growth on roofs is widely debated. While cleaning products are available for moss removal, simply cutting back trees can remove the conditions that cause moss growth. Consult with a qualified contractor for further evaluation if desired.

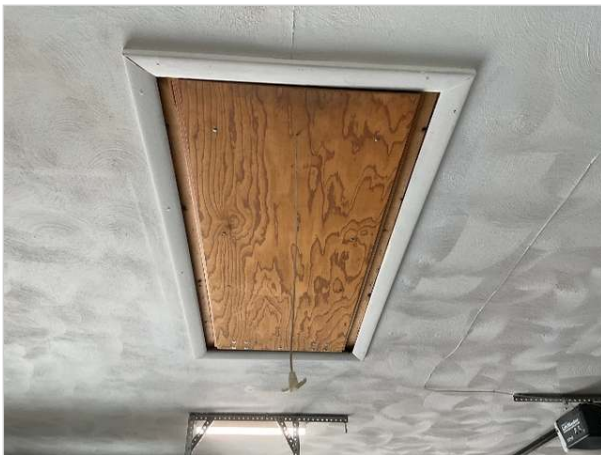
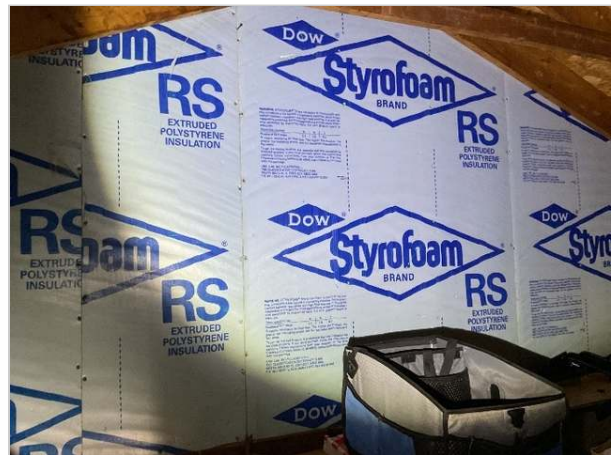
### ***SAFETY NOTE: GARAGE WALL / CEILING:***

The finish on the garage ceiling and any partition walls between the garage and basement or living space is designed to provide a barrier between the garage and living space in the event of a fire. One or more openings were noted in the garage ceiling. Repairs should be made to the ceiling to maintain the integrity of this important safety feature.

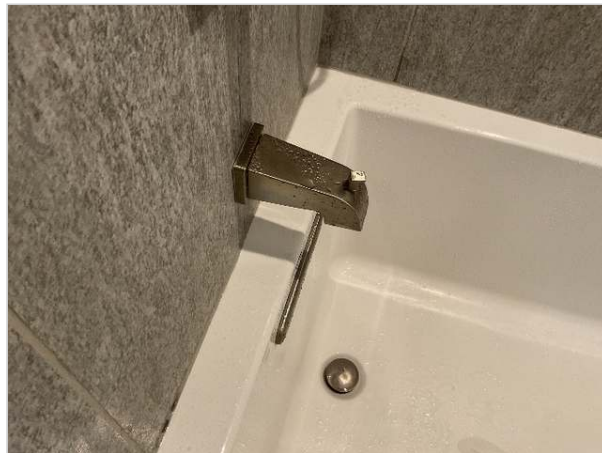
Minor plumbing issues were noted during the inspection. This is not intended to be an all inclusive list. Concealed, latent or intermittent plumbing issues may not be apparent during the testing period. Consult with a qualified plumber for further evaluation and repairs as required.

- 1/2 bath sink stop and waste valve is inoperable.
- Laundry tub is not secured to the floor. The tub should be secured to the floor to prevent movement of the drain and water lines and possible leaks.
- Full bath shower diverter leaks through at the spigot.
- Full bath tub plumbing (spout) is loose in the wall.
- 
-

loose tub spout

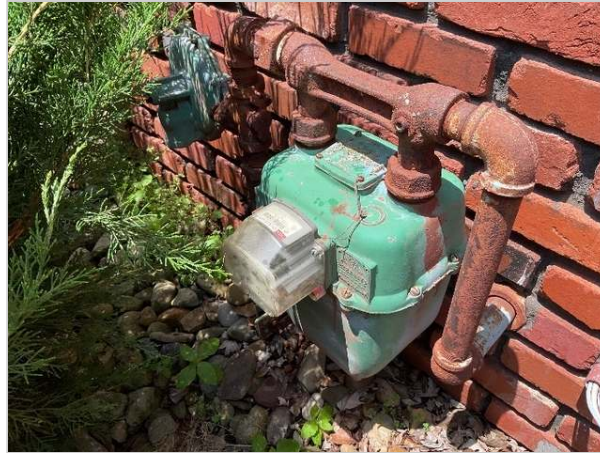
**NOTE: EXTERIOR GAS SUPPLY LINE:**

The exterior gas supply lines were *rusted*. *No leaks were found*. We recommend the gas supplier be contacted to inspect further.

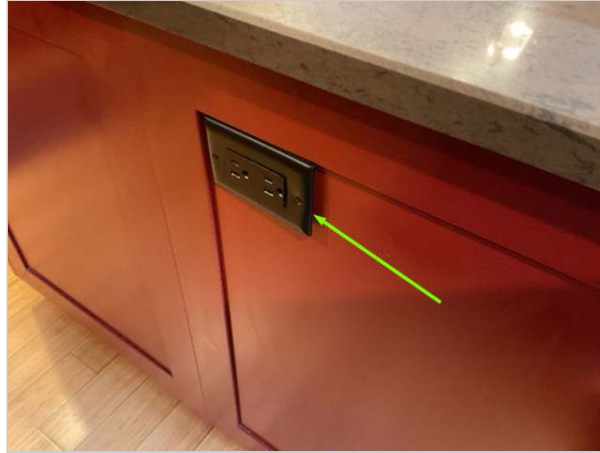
kitchen

***SAFETY NOTE: LOOSE OUTLET:***

A loose outlet was noted in the kitchen. This could be a shock hazard due to exposed electrical contacts. The affected outlet(s) should be secured by a qualified contractor.

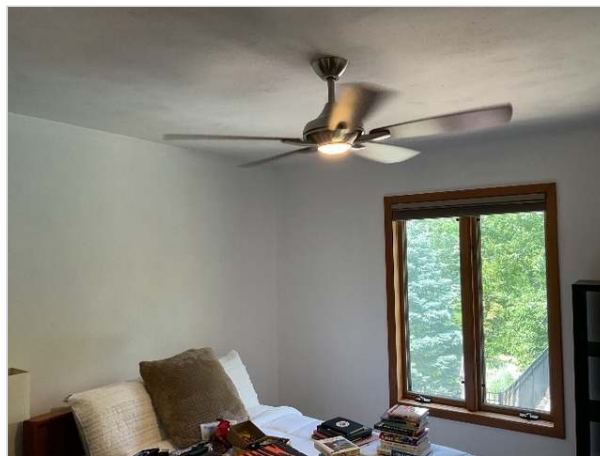
left rear bedroom

***NOTE: PADDLE FAN OUT OF BALANCE:***

The paddle fan in the rear bedroom appears to be out of balance because it is loose in the ceiling box. The fan wobbles when turning. The fan could be improperly installed or the mounting screws are loose. Consult with a qualified contractor for evaluation and repair.

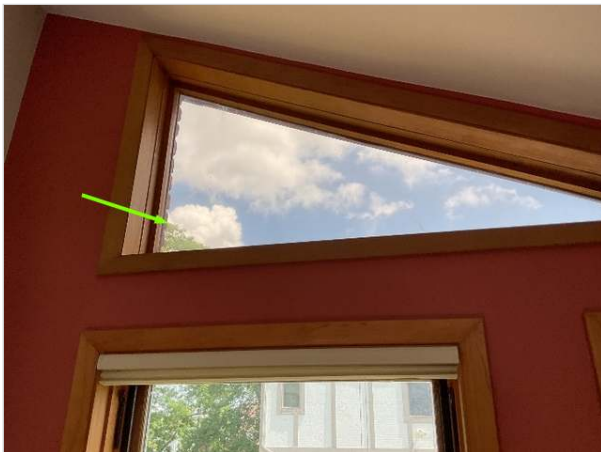
loft

### NOTE: THERMAL SEALS:

Multiple insulated window panes throughout the home had a defective thermal seal. The windows were located on the second floor. A defective thermal seal can be identified when fogging is observed between the panes of glass. This statement should not be considered all inclusive. Our ability to identify defective thermal seals is affected by dirty glass, the angle by which we can view the windows, window coverings and the direction of the sun. It is not possible to identify mild cases of fogging between glass panes given the conditions that affect our view. Repair of the thermal seal can be accomplished by replacing the affected glass panel.

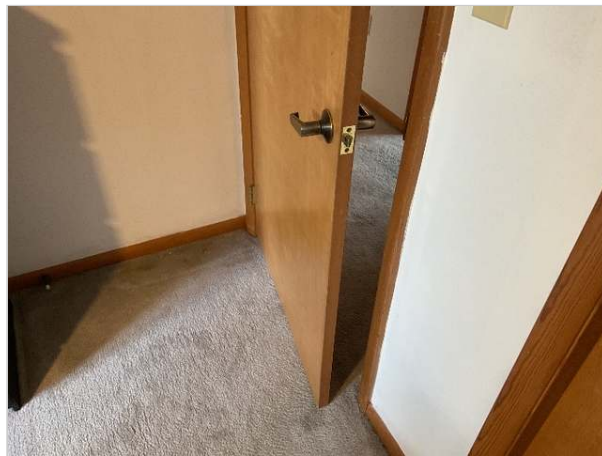
left rear bedroom

**INFORMATIONAL NOTE: INTERIOR DOORS:**

One or more of the interior doors sticks or is otherwise in need of adjustment. The door was noted in the bedroom. While we noted that this condition exists during the inspection, it does not constitute a safety concern or a material defect. Additionally, the relative humidity can affect sticky doors, so a door that sticks on a humid day may not stick on a dryer day. Repairs to interior doors is usually minor in cost and can be easily corrected by any handyman.

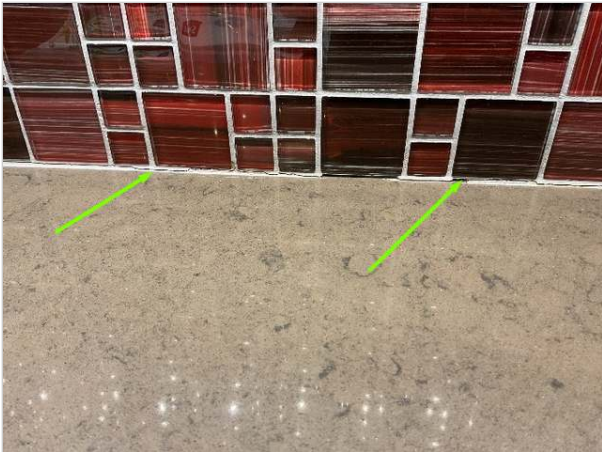
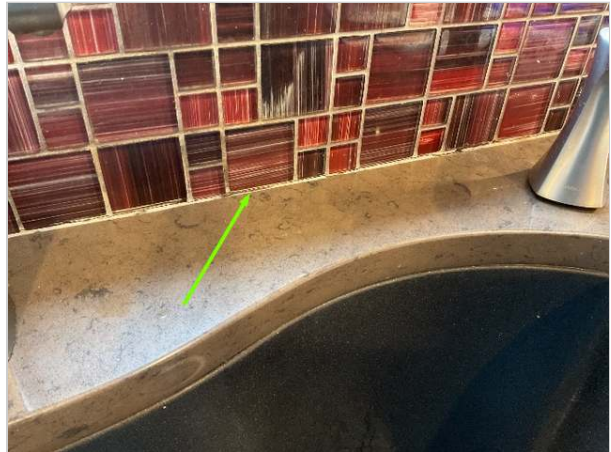
### *MAINTENANCE NOTE: KITCHEN CAULK:*

Failure to keep walls sealed can cause deterioration or moisture damage including mold growth to the interior walls, which is not always visible at the time of the inspection. The kitchen counter countertop should be caulked to ensure that water remains on the counter and sink surfaces.

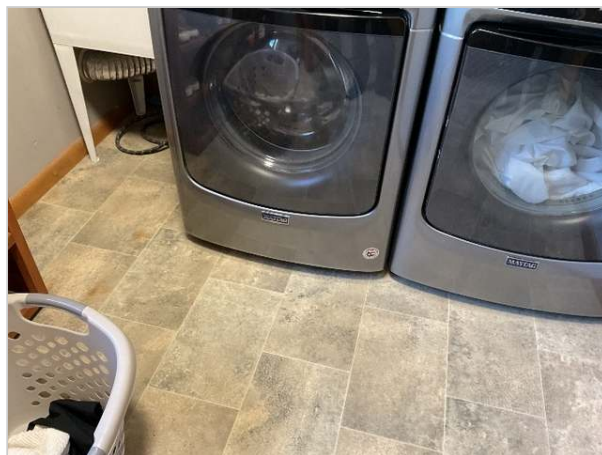
### *NOTE: WASHER PAN:*

There is no water collection pan installed under the washer in the laundry. The collection pan will capture water from the washer in the event of a leak. A collection pan should be installed by a qualified contractor.

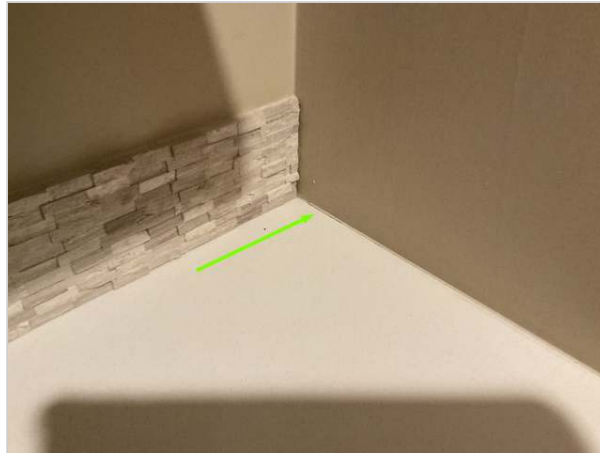
### *MAINTENANCE NOTE: BATHROOM CAULKING:*

Failure to keep walls sealed can cause deterioration and extensive moisture damage including mold growth to the interior walls, which is not always visible at the time of the inspection. Some of the caulk was missing from around the

sink top . These areas should be re-caulked to help prevent moisture penetration.

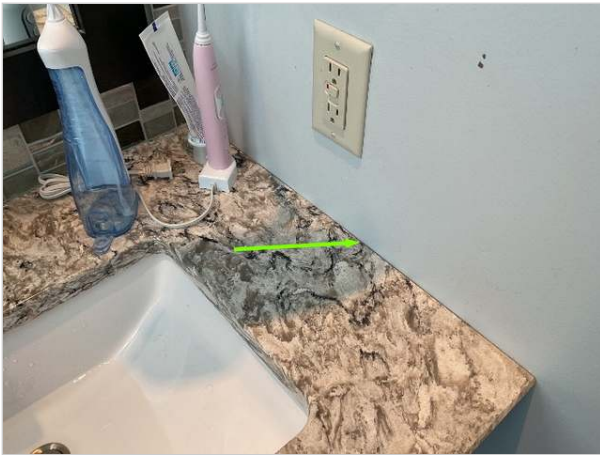
master sinktop

### **MAINTENANCE NOTE: BATHROOM CAULKING:**

Failure to keep walls sealed can cause deterioration and extensive moisture damage including mold growth to the interior walls, which is not always visible at the time of the inspection. Some of the caulk and grout was missing from around the sink top and shower enclosure. These areas should be re-caulked and re-grouted to help prevent moisture penetration.

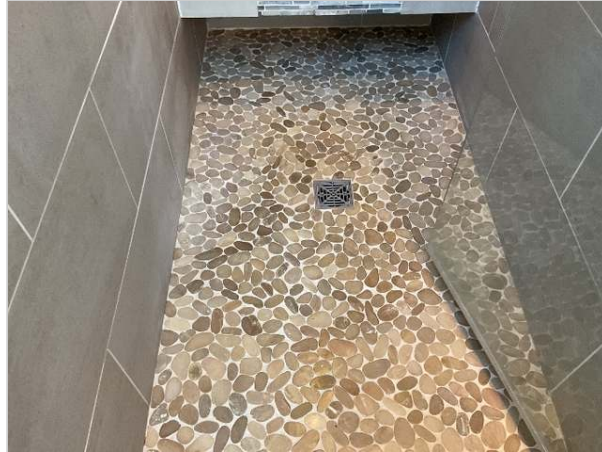
### **INFORMATIONAL NOTE: WALK-IN SHOWER:**

A walk-in shower was located in the master bath. The base of the shower was constructed of ceramic tile. While no leaks were noted at the time of the inspection, this type of shower is more prone to leaks than a standard tub or precast shower base. The waterproof membrane or shower pan, which is the primary water proofing material is installed beneath the finished floor and is not visible from the interior of the shower or the subfloor below. We cannot verify the integrity of the shower pan or concealed portions of the drain. Additionally, our test of the unit cannot simulate an actual shower and therefore is not a guarantee that the unit is free of leaks. The cosmetic condition of the tile or grout is not considered during the inspection. The absence or presence of cracks in the tile or joints is not an indication of a leak free unit.

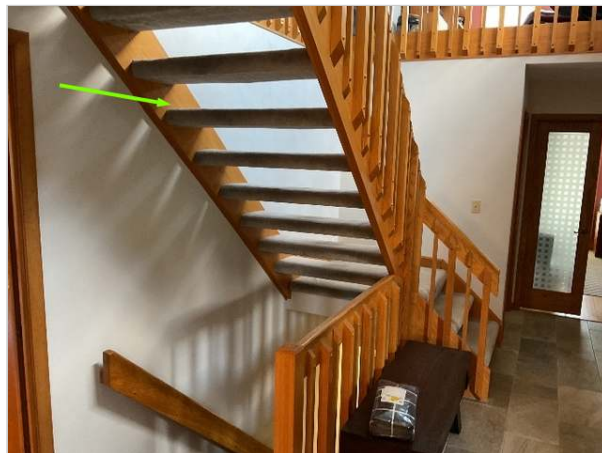
**SAFETY NOTE: OPEN BACK STAIR RISERS:**

The risers or backs of the second floor stairs are open. This could be a fall hazard for small children. Consult with a qualified contractor for evaluation and recommendations.

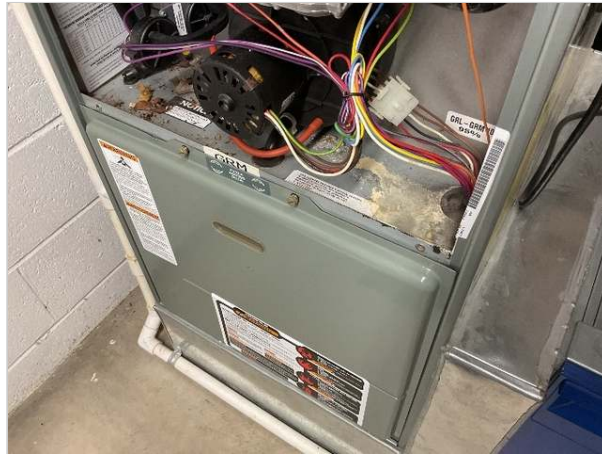
*NOTE: WATER INSIDE FURNACE COMPARTMENT:*

Evidence of water was noted inside the furnace compartment. The condition is most likely caused by a condensate leak in the furnace and/or air conditioning condensate drain lines. The water can also be caused by a leaking humidifier if one is installed. Water inside the furnace compartment can damage the furnace cabinet or other operational components and should be repaired. The furnace compartment was dry at the time of the inspection. Consult with a qualified heating contractor to determine the source of the water and correct the issue. Please also note that due to the seasonal use of heating and air conditioning systems, wet and dry conditions can change based on whether the inspection is performed during the heating or cooling season. The observation at the time of the inspection can be limited to seasonal conditions.
