**727 Newport Dr**  
**RE: Pittsburgh, PA 15234**  
**Inspection #: 527-052025-6270**

### HOME INSPECTION REPORT

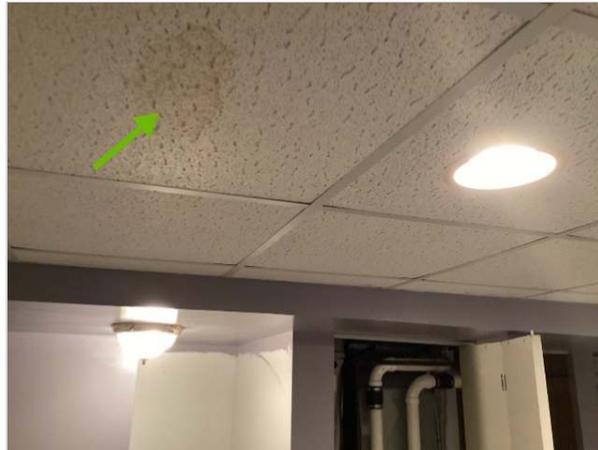
The basement ceiling is water marked below the living area from what appears to be a previous leak. The area was dry at the time of the inspection. No immediate action is required. The area should be monitored for evidence of new leaks. Consult with a qualified contractor for repair if required.

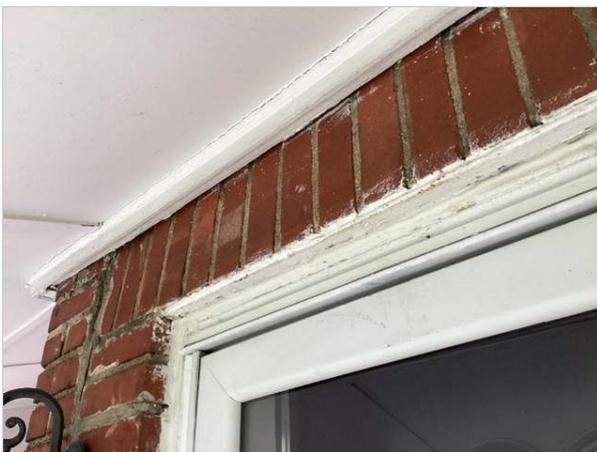
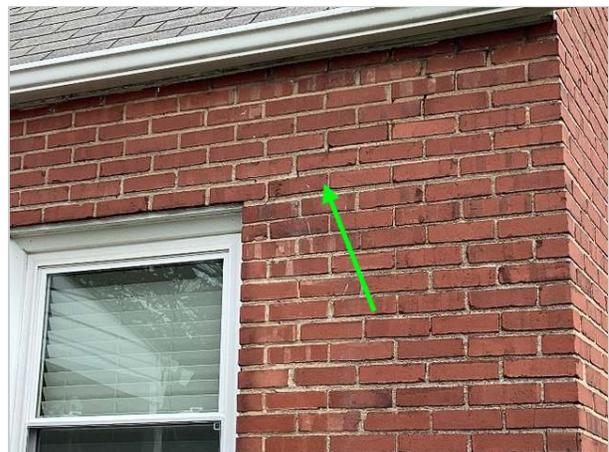
One or more of the steel lintels above the windows on the exterior of the home were noted to be rusting. Lintels support masonry materials above doors and windows. Keeping the lintels sealed and painted will prevent rusting and expansion. Expanded lintels can lead to cracks in the masonry on the exterior of the home.

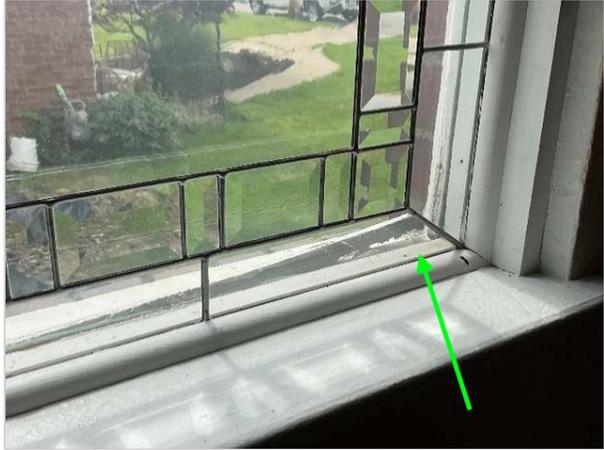
Dining room

Rotted wood was noted around the windows. The areas should be repaired and sealed by a qualified contractor.

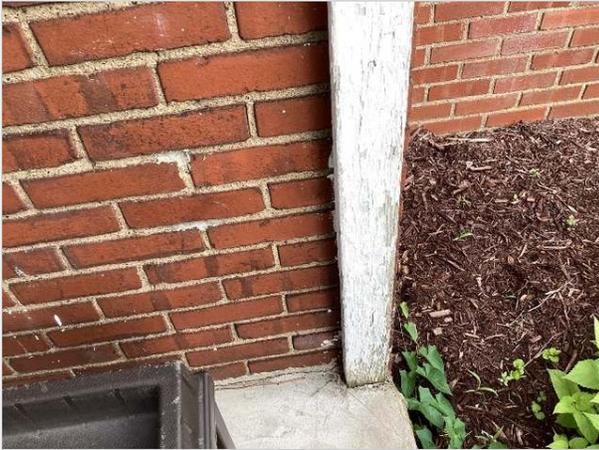
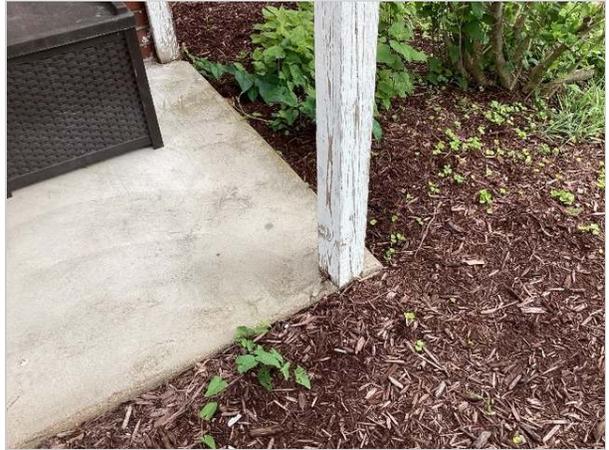
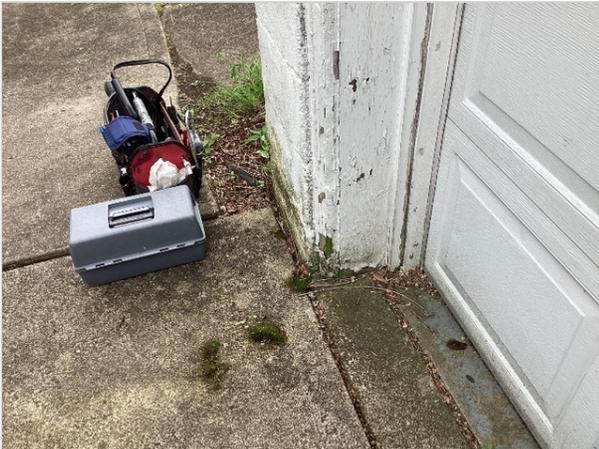
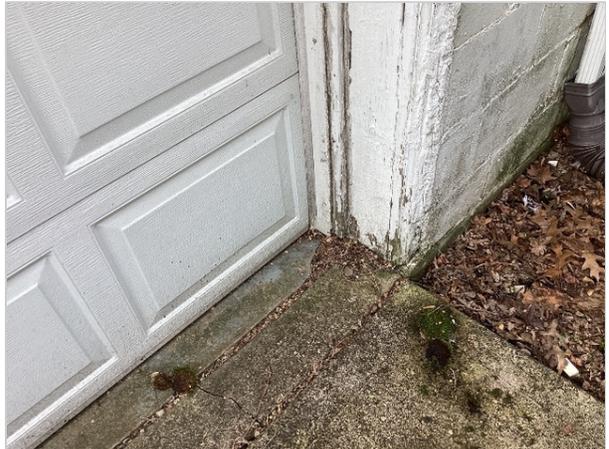
Peeling paint was noted on many areas of the exterior. In order to preserve the life of the exterior surfaces and materials, all areas should be scraped and painted.

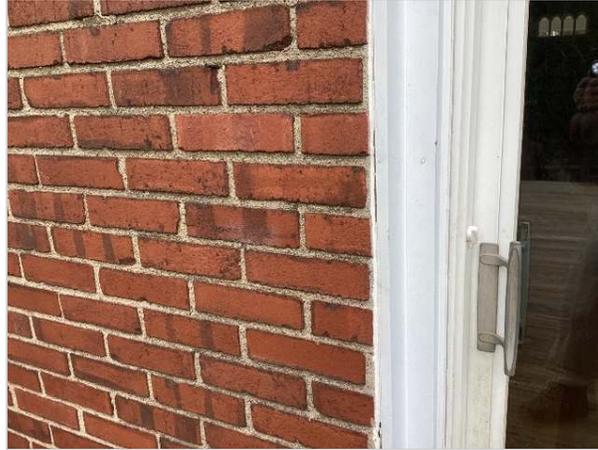
The exterior caulking around the doors is cracked or missing on the back of the home. The caulking should be replaced to ensure the exterior of the home remains weather and water tight.

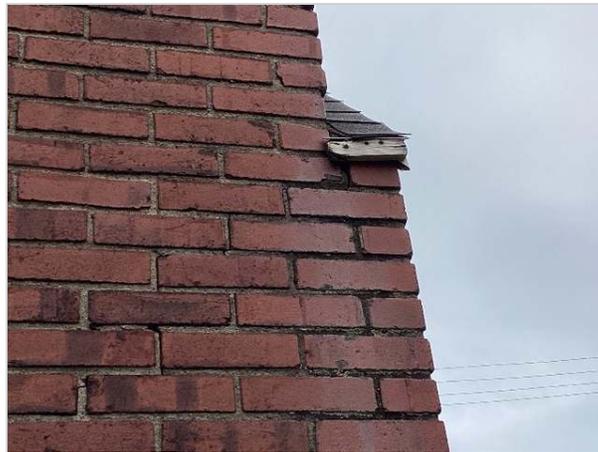
Rotted wood was noted on the wood soffit . The areas should be repaired and sealed by a qualified contractor.

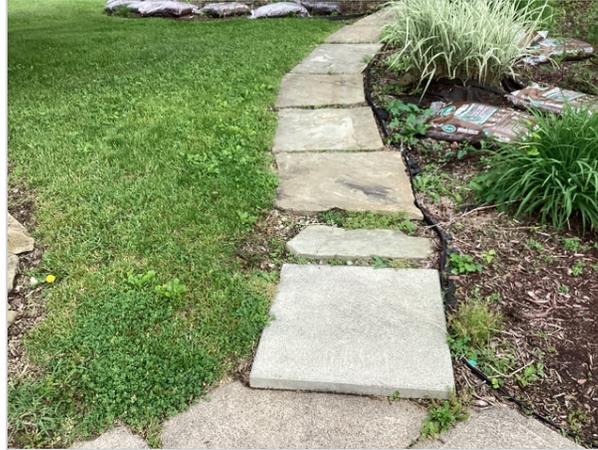
There were several trip hazards found on the walkways around the house. The hazards can be repaired using a suitable or similar surfacing material to "feather" the out-of-level condition to make a smooth transition.

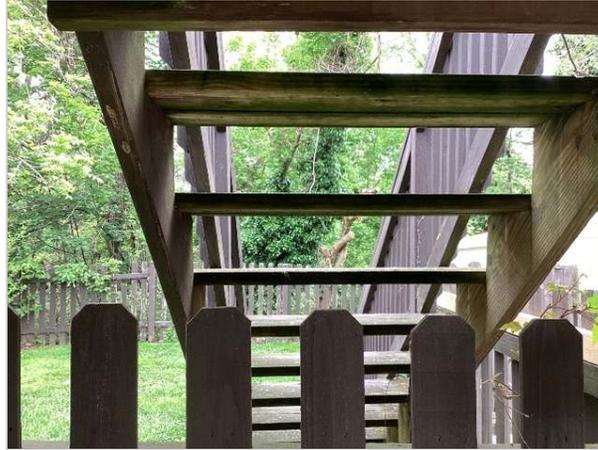
The risers or backs of the deck stairs are open. This could be a fall hazard for small children. Consult with a qualified contractor for evaluation and recommendations.

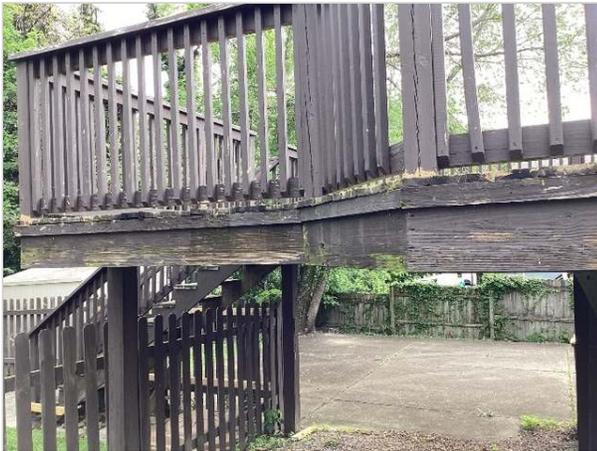
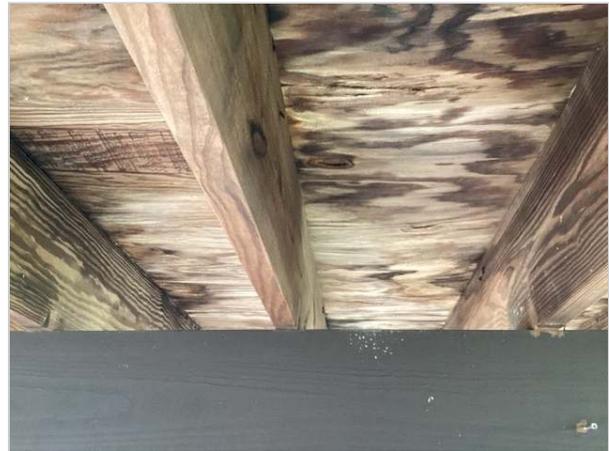
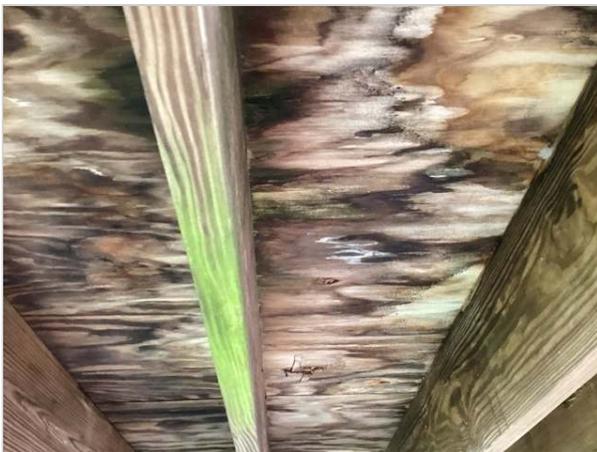
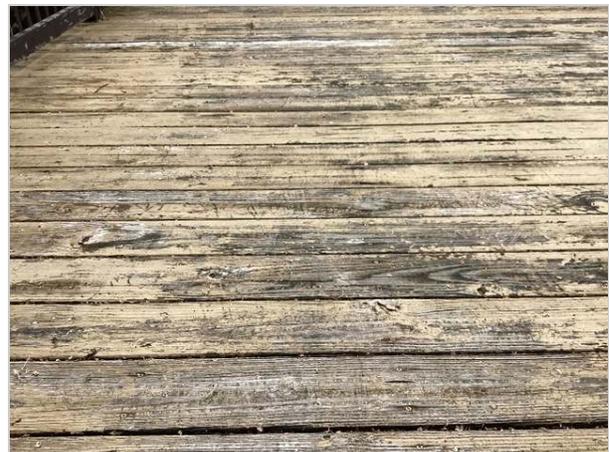
Many deck boards were deteriorated at the time of the inspection. Consult with a qualified contractor for replacement estimates.

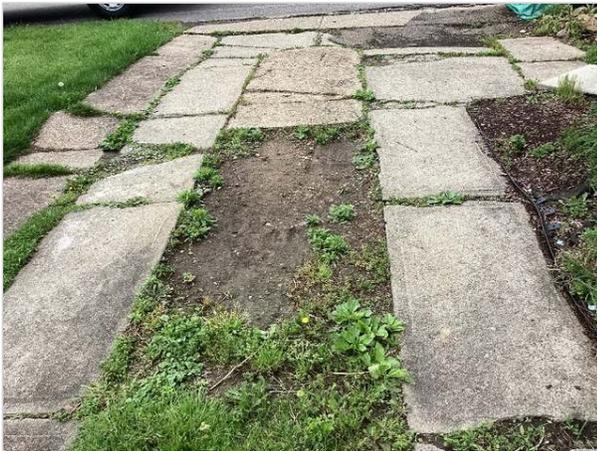
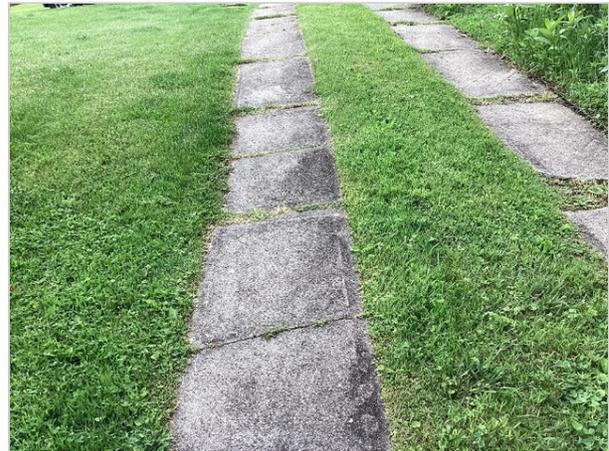
There were several trip hazards found on the driveway. The hazards can be repaired using a suitable or similar surfacing material to "feather" the out-of-level condition to make a smooth transition.

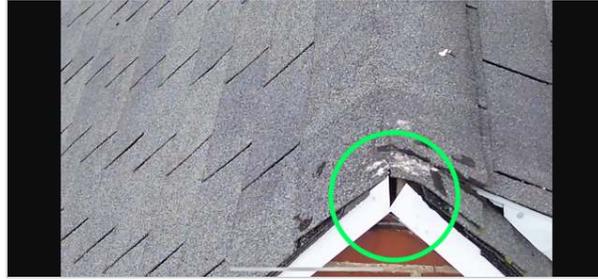
Loose fascia was noted on the right side. Consult with a qualified contractor for repair.

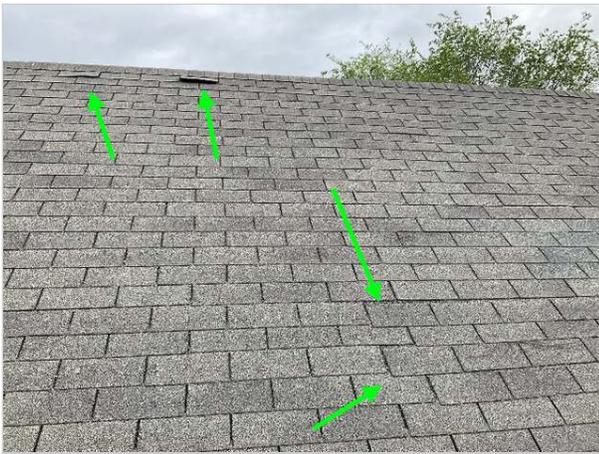
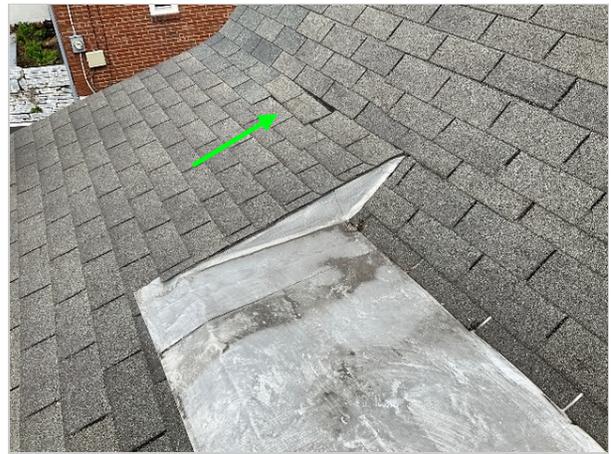
Several shingles were out of position on the front of the roof at the time of the inspection. While this condition is not necessarily an indication of a leak, repairs should be made. Consult with a qualified roofer for repair.

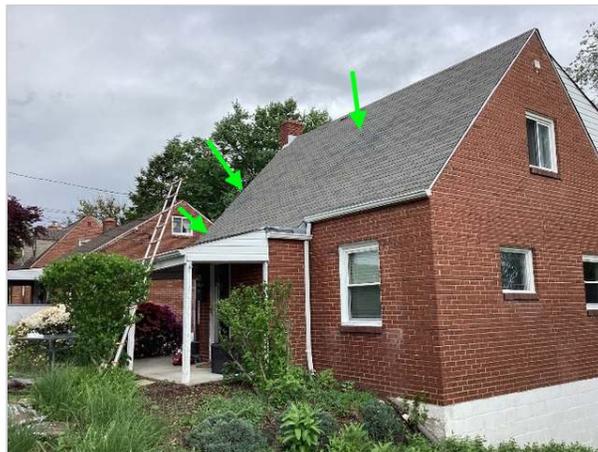
An adequate roof repair was noted on the front. The repair appeared to be made correctly. There was no evidence of an active roof leak noted at the time of inspection. It is recommended that a qualified roofing contractor be consulted for further evaluation and recommendations.

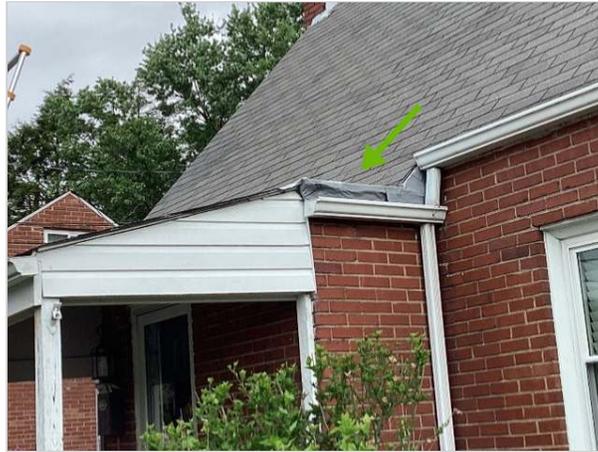
Loose flashing was noted on the front porch roof. Loose flashing could be a leak source. We cannot always determine if active leaks exist. Consult with a qualified roofer for further evaluation and repair.

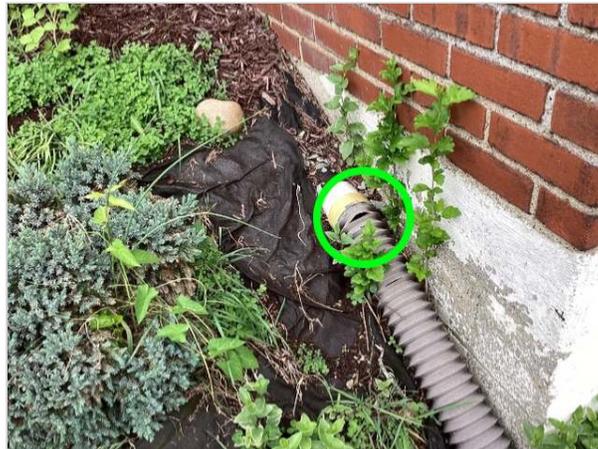
Damaged downspout extension were noted on the right front. Gutters and downspouts help facilitate proper drainage of roof water away from the foundation of the home. Consult with a qualified, reputable contractor to install proper roof drainage.

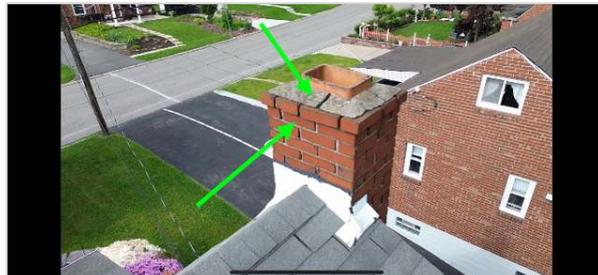
There were cracks on the top cap(s)of the chimney and repairs should be made to prevent further deterioration. Consult with a qualified masonry contractor for repair.

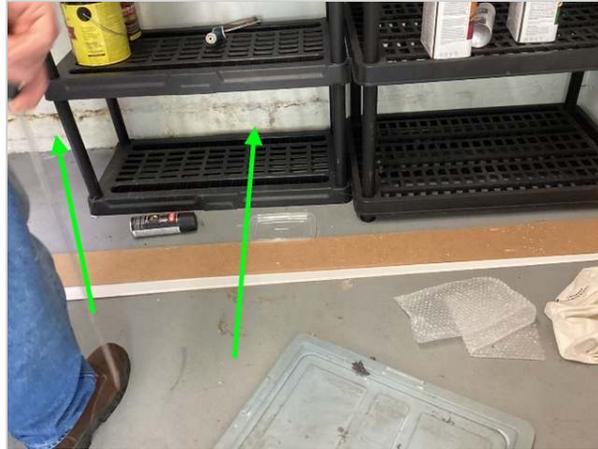
There were signs of moisture on the rear garage wall. The area was dry at the time of the inspection. Dampness on garage walls is not always a sign of water intrusion. The dampness can be the result of warm humid air making contact with cool walls. In many cases the humid air condenses on the wall and forms a layer of moisture. It is important to assess whether moisture on the walls is the result of water intrusion or condensation. In this case the condition appears to be the result of water intrusion. The exterior grading in the affected area is questionable. Many water intrusion problems can be controlled by improving the drainage on the exterior of the home. It is important that all roof drainage

and surface water is directed away from the foundation. Any concern about this condition should be referred to a qualified contractor for evaluation and recommendations.

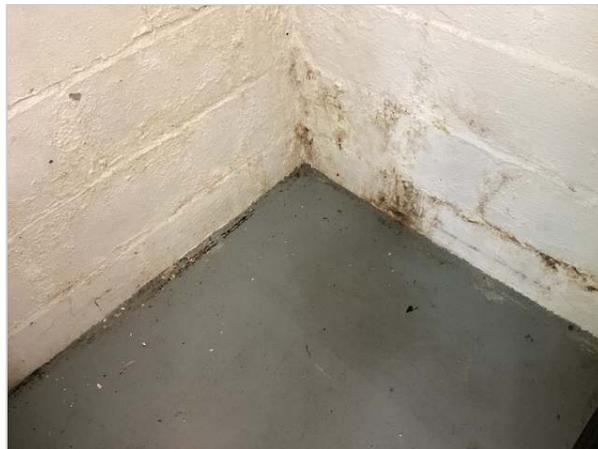
A substance with the characteristics of mold is visible in one or more areas of the garage. The EPA (<http://www.epa.gov/mold/moldresources.html>) advises consumers that areas less than ten square feet of coverage can usually be controlled using readily available household products. In the event the substance cannot be controlled, a certified mold testing and remediation firm should be contacted for a recommended course of action.

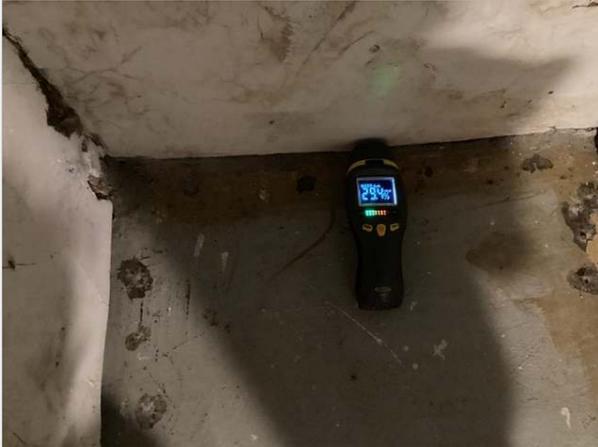
Front left

There were signs of moisture on the front and left basement walls. The area was dry at the time of the inspection. Dampness on basement walls is not always a sign of water intrusion. The dampness can be the result of warm humid air making contact with cool walls. In many cases the humid air condenses on the wall and forms a layer of moisture. It

is important to assess whether moisture on the basement walls is the result of water intrusion or condensation. In this case the condition appears to be the result of water intrusion. The exterior grading in the affected area is questionable. Many water intrusion problems can be controlled by improving the drainage on the exterior of the home. It is important that all roof drainage and surface water is directed away from the foundation. Any concern about this condition should be referred to a qualified contractor for evaluation and recommendations.

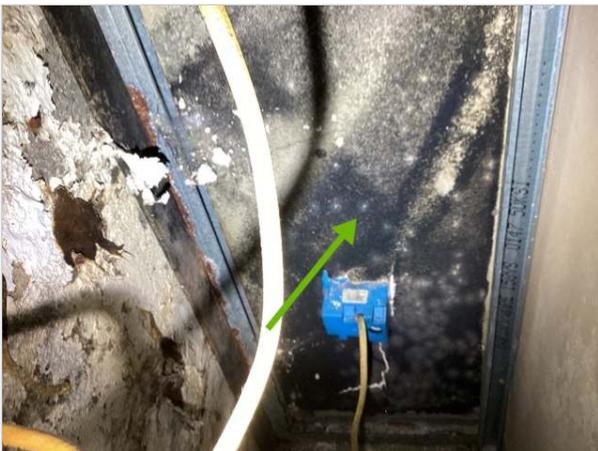
Behind drywall in electric panel area

A substance with the characteristics of mold is visible in one or more areas of the basement, note that when possible mold like substance was found behind the drywall. . The EPA (<http://www.epa.gov/mold/moldresources.html>) advises consumers that areas less than ten square feet of coverage can usually be controlled using readily available household products. In the event the substance cannot be controlled, a certified mold testing and remediation firm should be contacted for a recommended course of action.

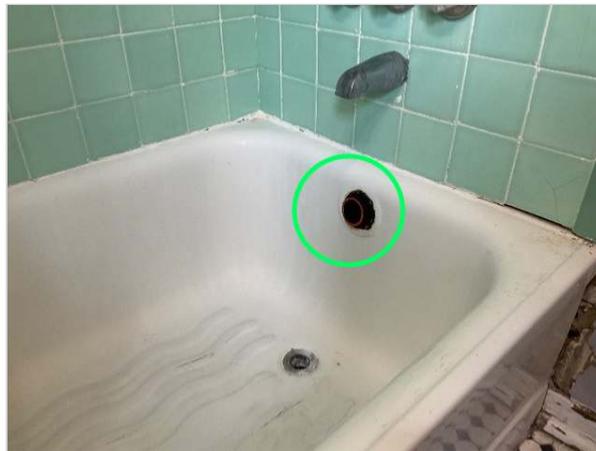
An open plumbing vent pipe was noted in the bathroom. The area should be properly covered to prevent debris falling into the plumbing. Consult with a qualified plumber for repair.

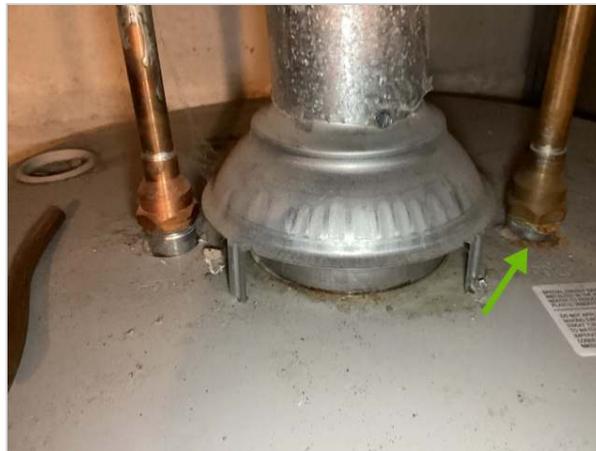
A leaky plumbing fitting was noted on a cold water supply line above the water heater. Consult with a qualified plumber for repair.

Evidence of seeping leak

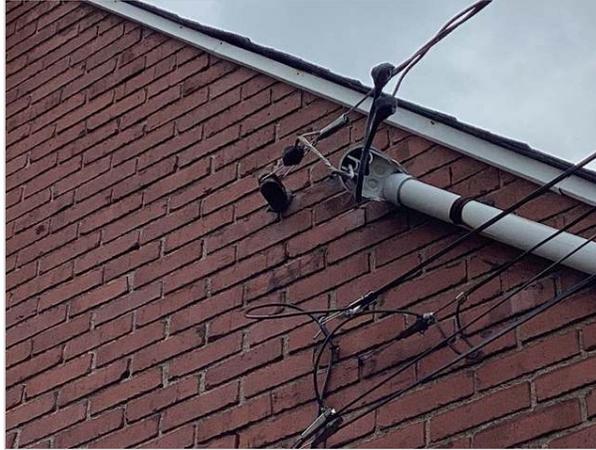
The weatherhead at the top of the electric service entrance cable is not attached. Consult with a qualified electrician for repair.

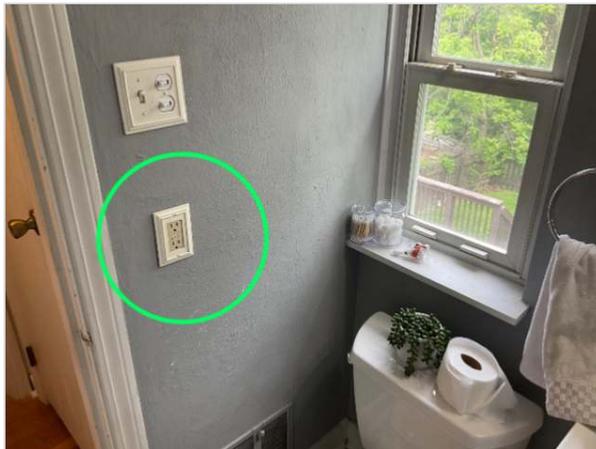
A loose outlet was noted in the in the bathroom. This could be a shock hazard due to exposed electrical contacts. The affected outlet(s) should be secured by a qualified contractor.

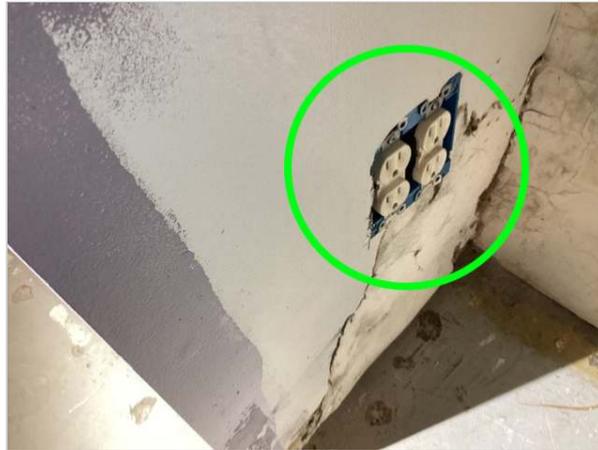
One or more missing switch or outlet covers were noted in the basement. All switch and outlet boxes should be properly covered to avoid a shock hazard. Electrical related repairs should be performed by a qualified electrician.

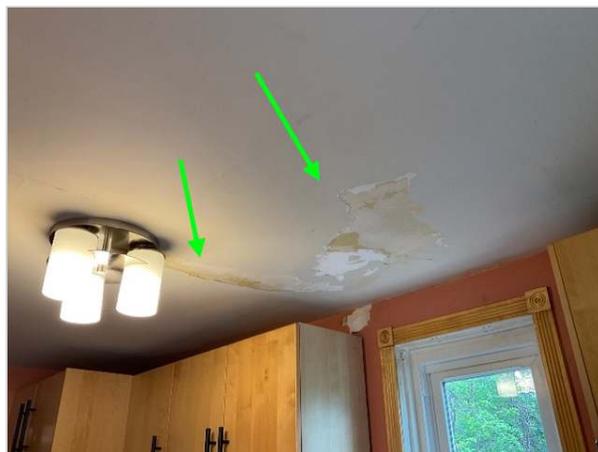
Cracked or bubbling paint was noted on the ceiling in the kitchen. This condition appeared to be caused by water. There was evidence of water damage at the shower walls directly above the area at the time of the inspection. Any damaged areas should be scraped, repaired, leveled and primed prior to applying a finish coat of paint.

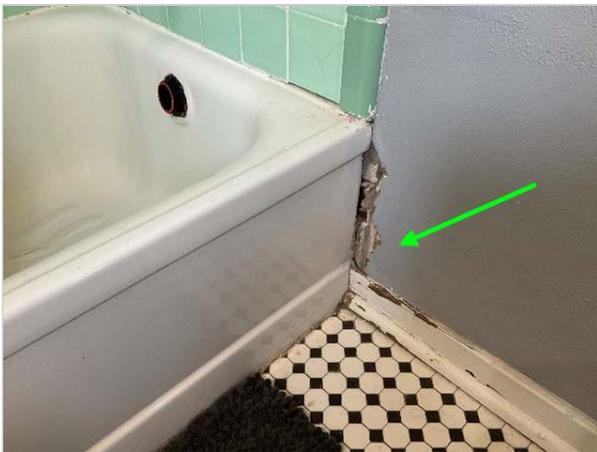
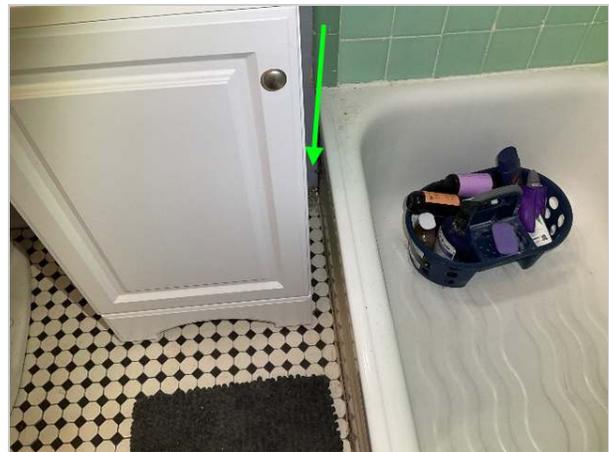
The walls in the tub / shower area show evidence of water damage. Concealed water damage may exist behind the finished surface. Determining the existence of concealed damage or defects is beyond the scope of this visual inspection. Consult with a qualified contractor to further evaluate the area and recommend repair methods and provide estimates if applicable.

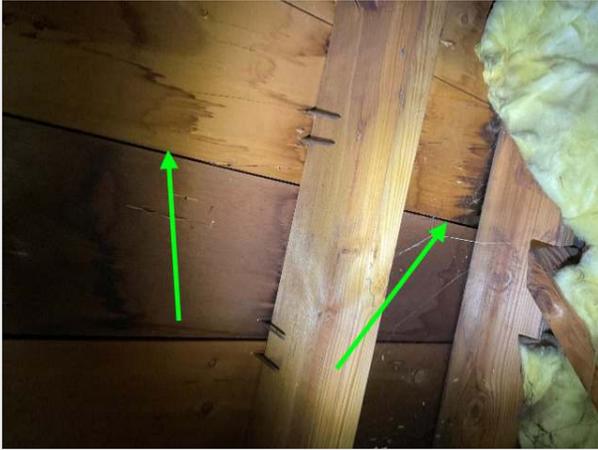
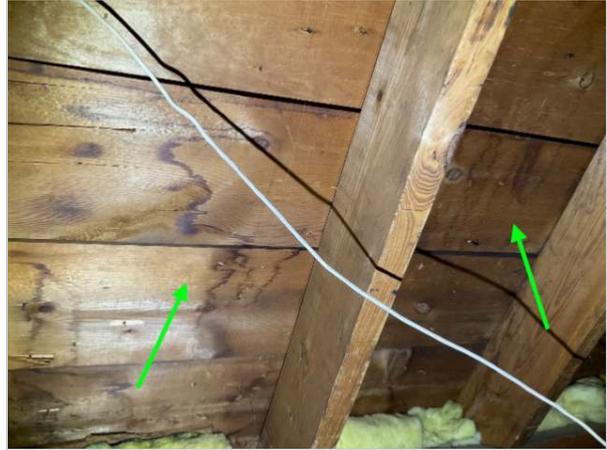
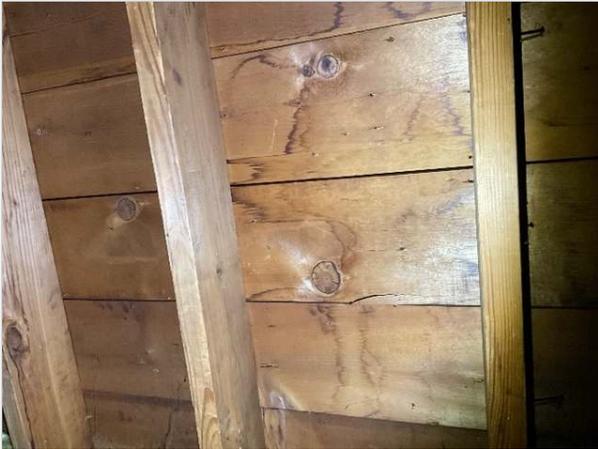
The roof deck as viewed from the attic is water marked. The cause of condition appears to be the result of previous leaks. Repairs to the affected areas are not required. Areas should be monitored during times of heavy rains for any changes or new watermarks.
