Your Inspection Report

579 Kelso Rd
Pittsburgh, PA 15243

INSPECTION DATE:
Wednesday, March 4, 2026

RE: Report No. 2570
579 Kelso Rd
Pittsburgh, PA
15243

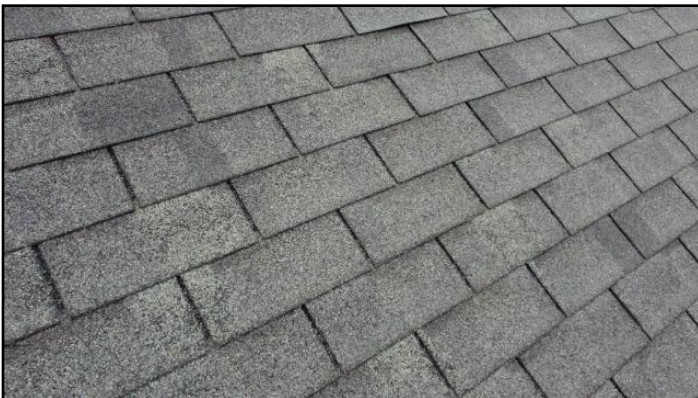
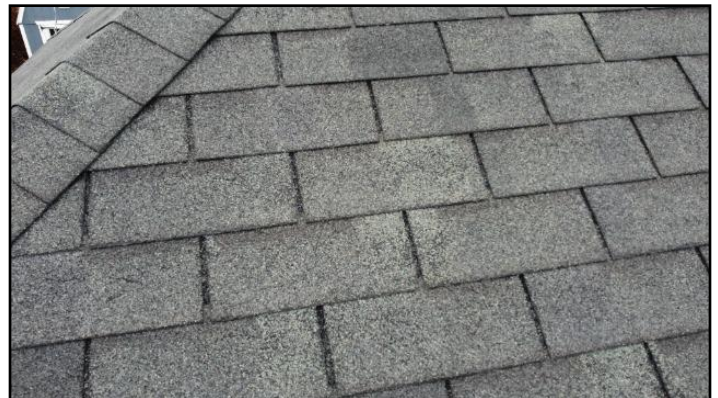
1. Condition: • Aging

Location: Throughout Exterior Roof

2. Aging

3. Aging

Task: Replace

Time: 5-10 years

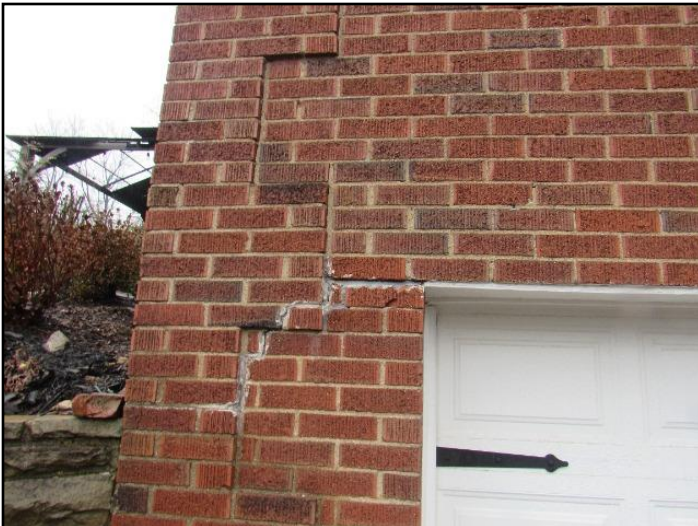
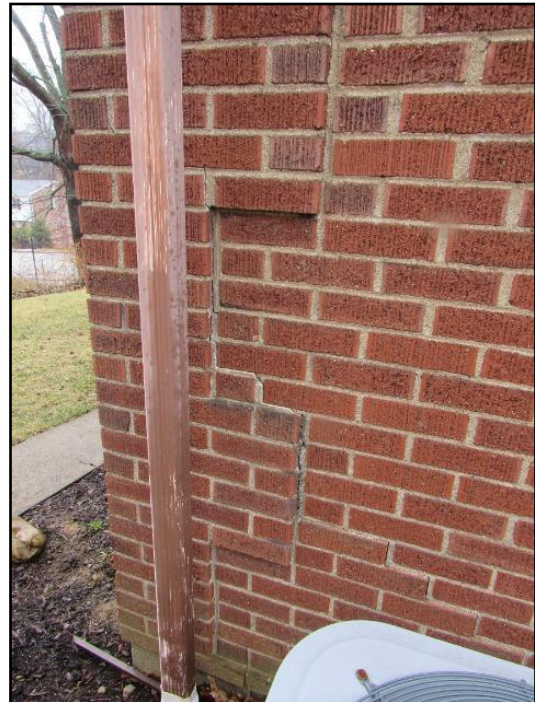
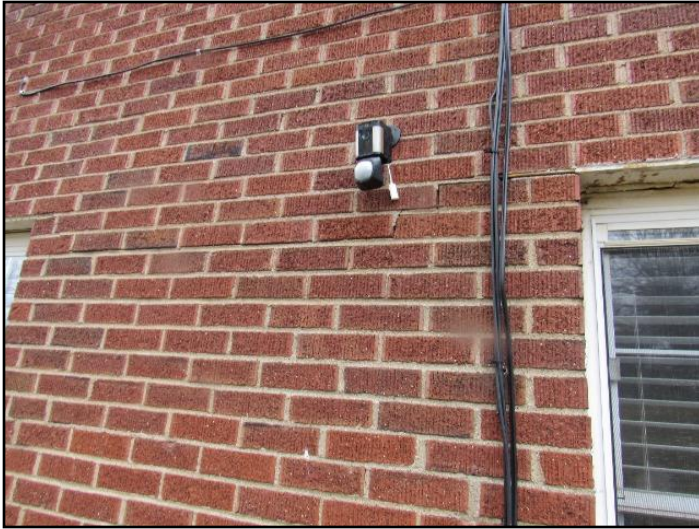
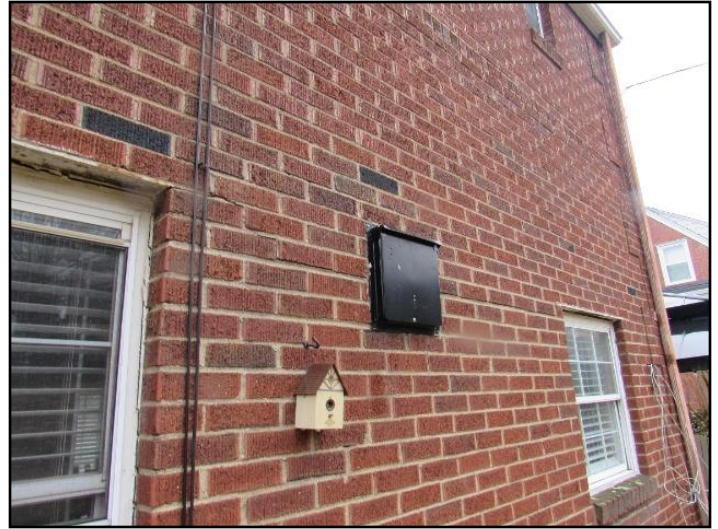
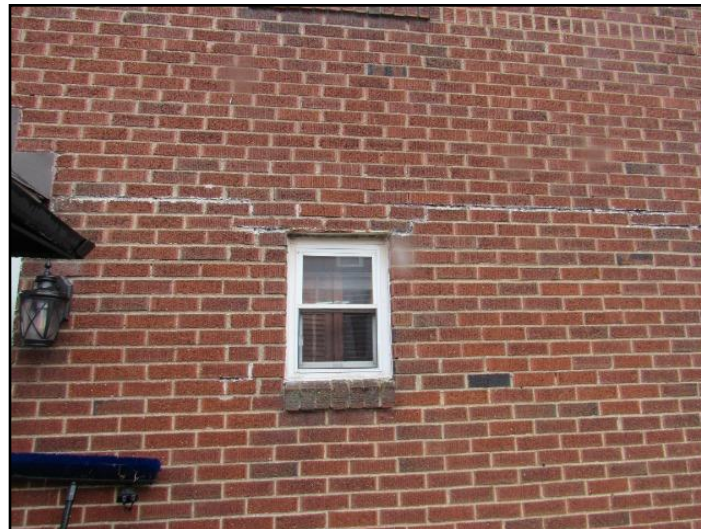
2. Condition: • [Cracked](#)

Implication(s): Chance of water entering building | Weakened structure | Chance of movement

Location: Various Exterior

4. Cracked

5. Cracked

6. Cracked

7. Cracked

8. Cracked

Task: Monitor

Time: Ongoing

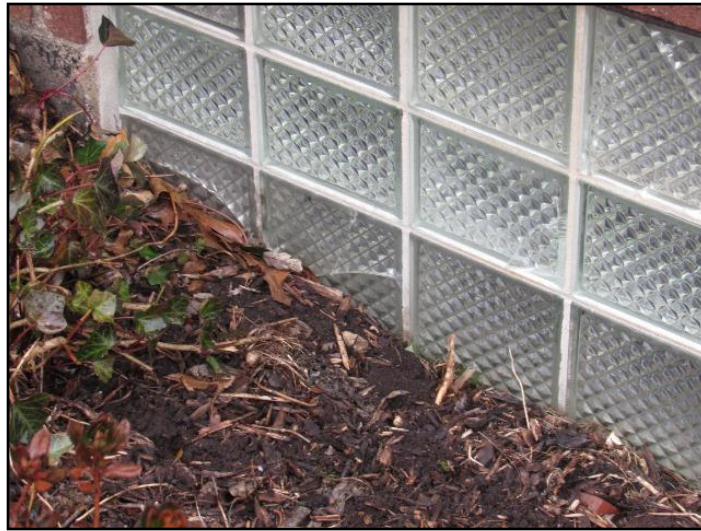
3. Condition: • [Cracked](#)

Location: Left Exterior

9. Cracked

Task: Replace

Time: When practical

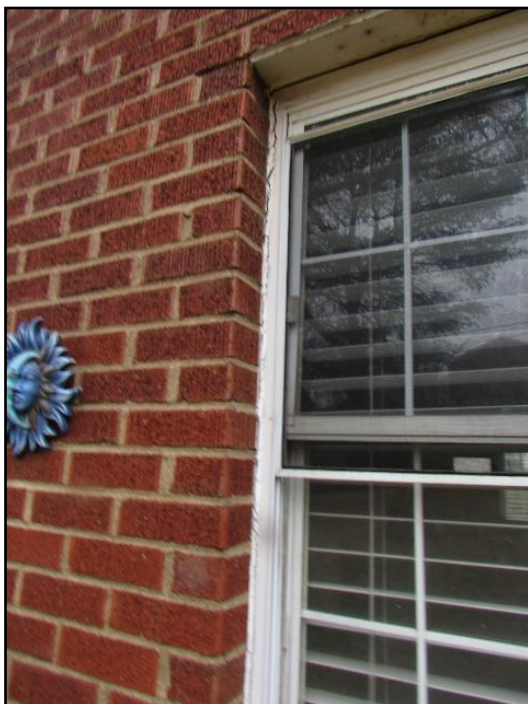
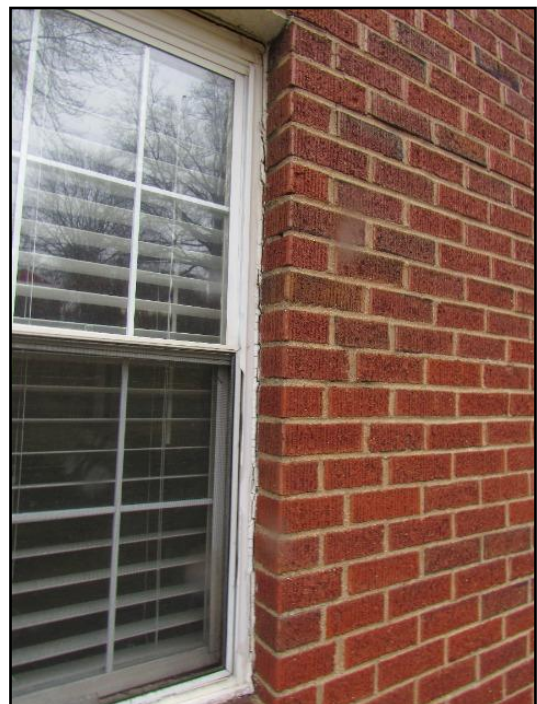
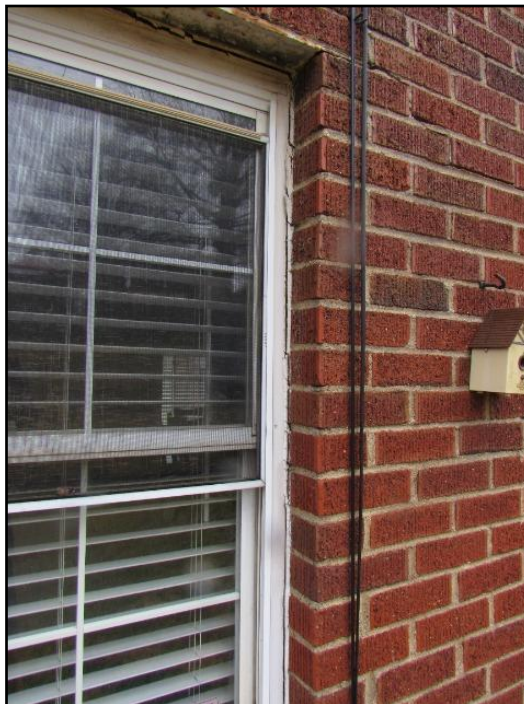
4. Condition: • [Caulking loose, missing or deteriorated](#)

Implication(s): Chance of water damage to structure, finishes and contents | Increased heating and cooling costs

Location: Various Exterior

10. Caulking loose, missing or deteriorated

11. Caulking loose, missing or deteriorated

12. Caulking loose, missing or deteriorated

Task: Repair Improve Correct

Time: Regular maintenance When practical

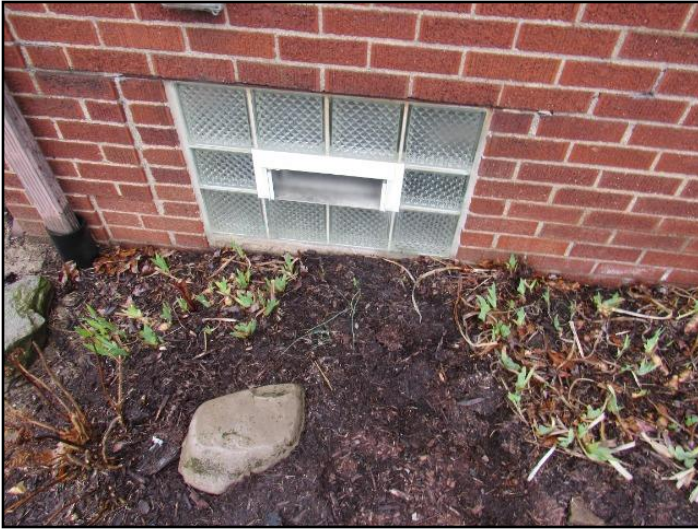
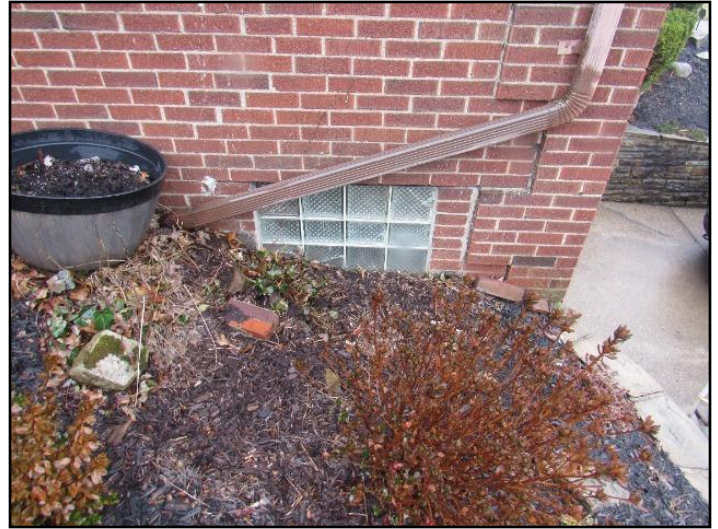
5. Condition: • [Missing](#)

Implication(s): Chance of water damage to structure, finishes and contents | Material deterioration

Location: Various Exterior

13. Missing

14. Missing

Task: Improve Correct

Time: When practical

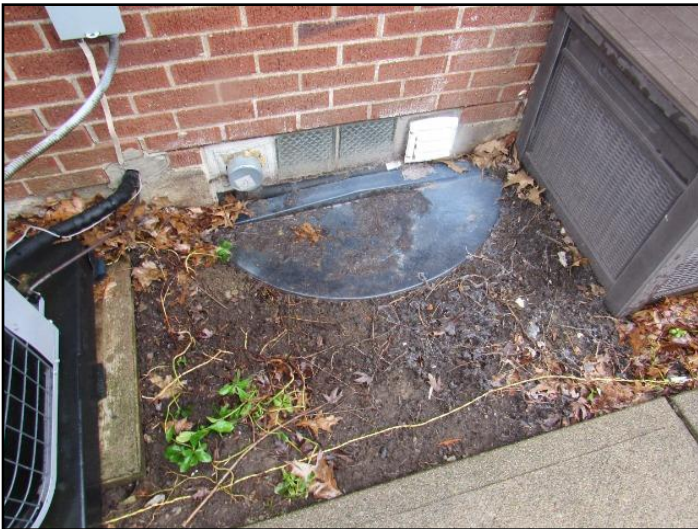
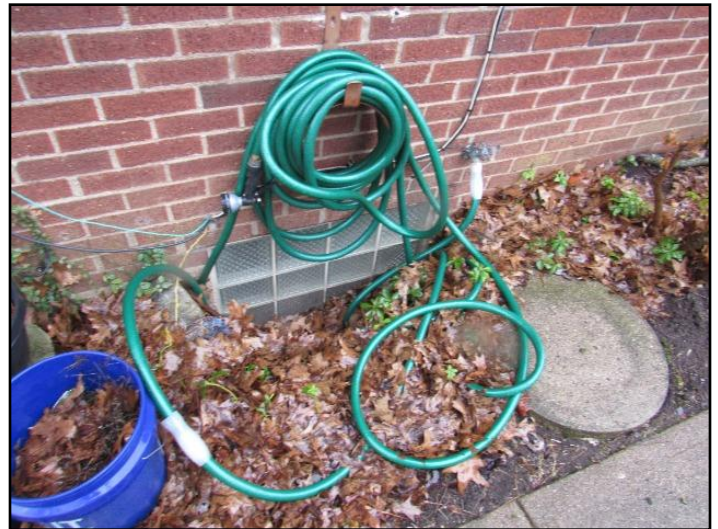
6. Condition: • Top of window well not above grade

Implication(s): Water damage to finishes

Location: Rear Exterior

Task: Improve Correct

Time: When practical

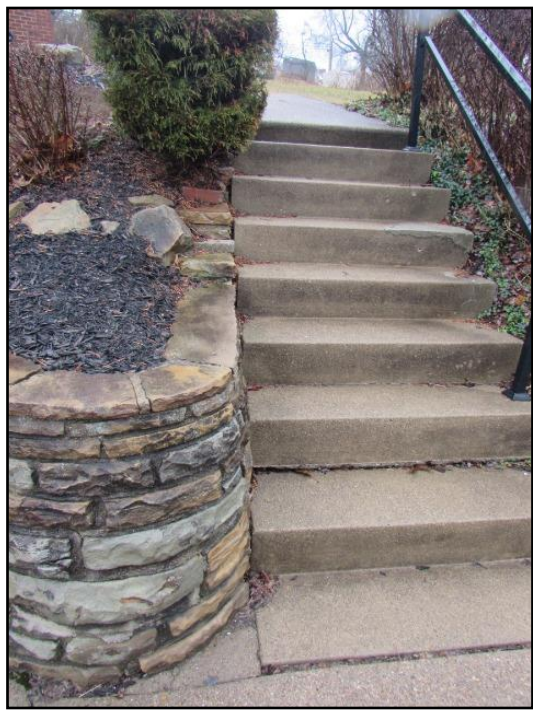
7. Condition: • [Steps or landings settling or heaving](#)

Implication(s): Weakened structure | Trip or fall hazard

Location: Front Walkway

17. Steps or landings settling or heaving

Task: Monitor

Time: Ongoing

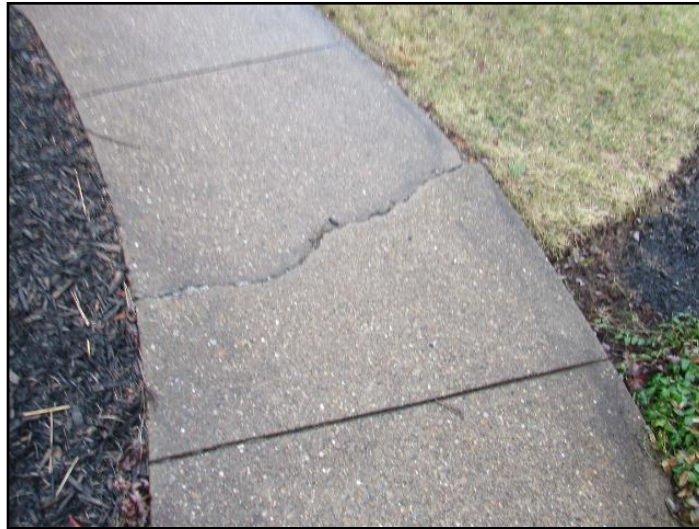
8. Condition: • [Cracked or damaged surfaces](#)

Implication(s): Trip or fall hazard

Location: Front Walkway

18. Cracked or damaged surfaces

Task: Repair or replace

Time: Discretionary

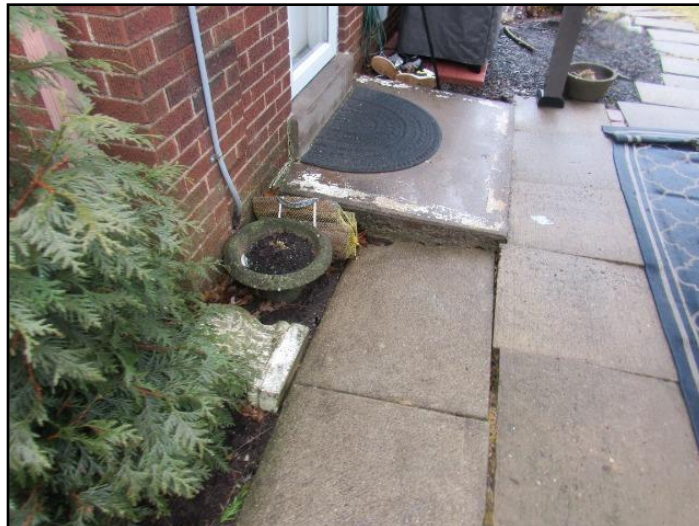
9. Condition: • Settlement

Location: Left Exterior

19. Settlement

Task: Improve Correct

Time: When practical

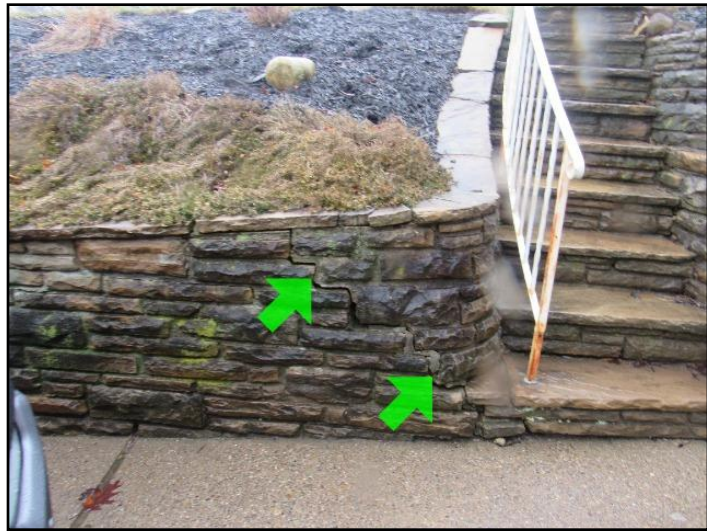
10. Condition: • [Cracked](#)

Implication(s): Weakened structure | Chance of movement

Location: Left Driveway

20. Cracked

Task: Monitor

Time: Ongoing

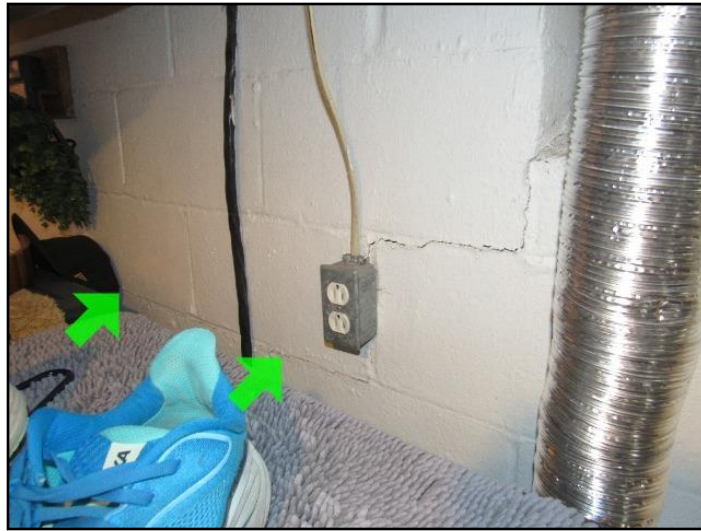
11. Condition: • [Cracked horizontally](#)

Implication(s): Chance of structural movement

Location: Rear Basement Utility Room

21. Cracked horizontally

Task: Monitor

Time: Ongoing

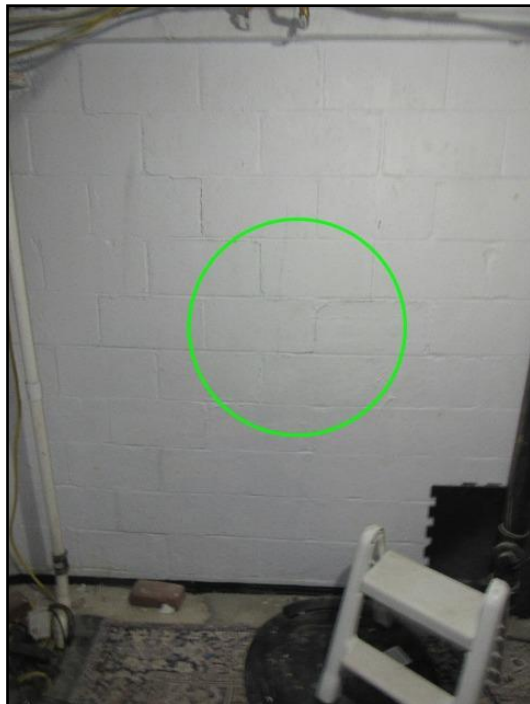
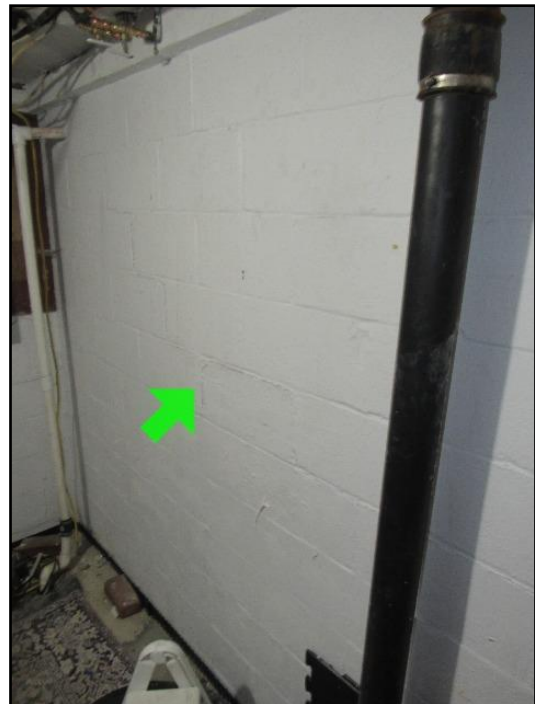
12. Condition: • [Bowed, bulging or leaning](#)

Implication(s): Weakened structure | Chance of structural movement

Location: Rear Left Garage

22. Bowed, bulging or leaning

23. Bowed, bulging or leaning

Task: Further evaluation by Structural Engineer

Time: As soon as possible

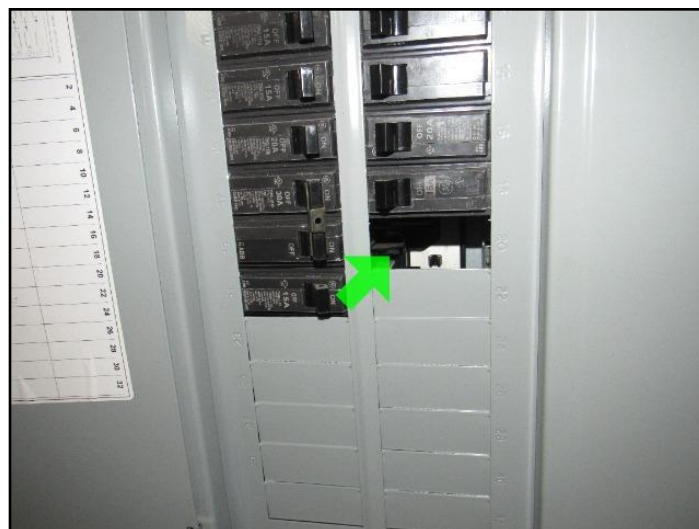
13. Condition: • [Openings in panel](#)

Implication(s): Electric shock | Fire hazard

Location: Garage

25. Openings in panel

Task: Improve Correct

Time: As soon as possible

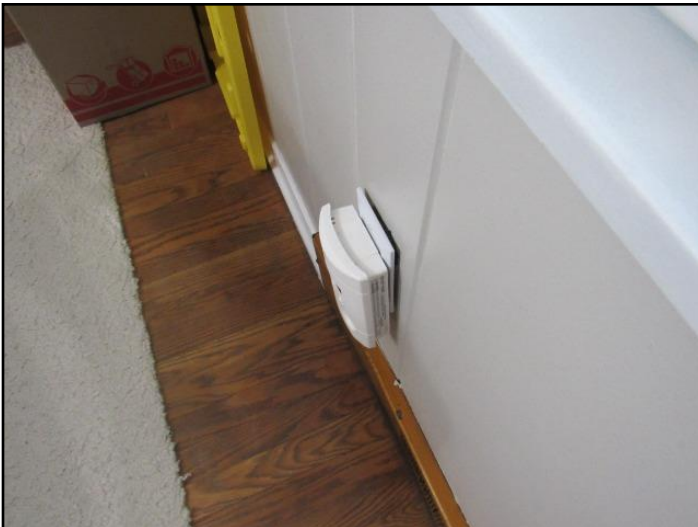
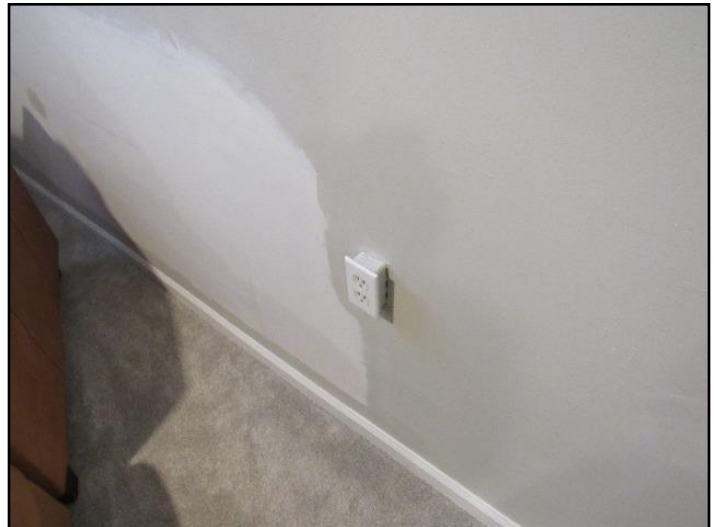
14. Condition: • [Loose](#)

Implication(s): Electric shock | Fire hazard

Location: Various Basement First Floor Dining Room

26. Loose

27. Loose

Task: Repair Improve Correct

Time: When practical

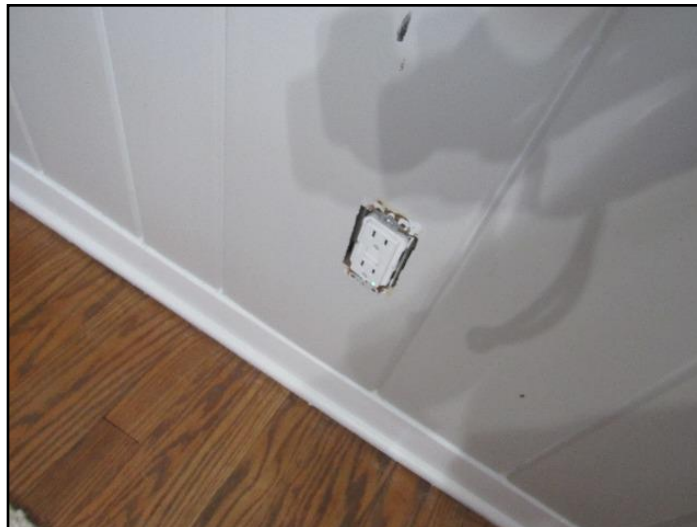
15. Condition: • [Missing](#)

Implication(s): Electric shock

Location: First Floor Dining Room

28. Missing

Task: Improve Correct

Time: As soon as possible

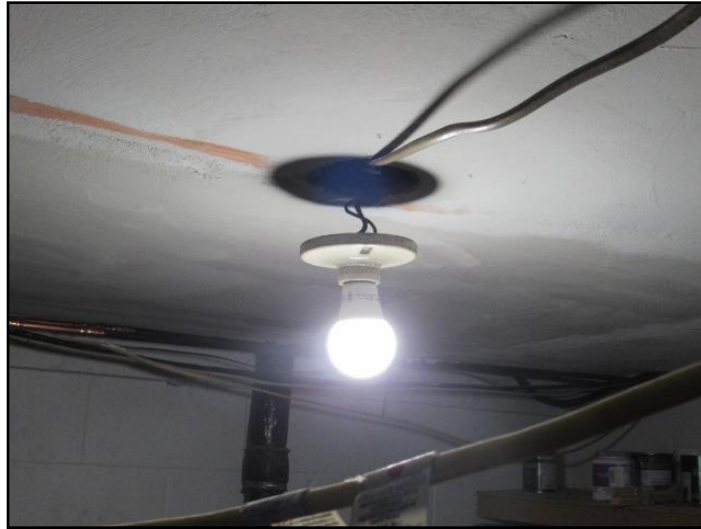
16. Condition: • [Loose](#)

Implication(s): Electric shock | Fire hazard

Location: Garage

29. Loose

Task: Repair Improve Correct

Time: As soon as possible

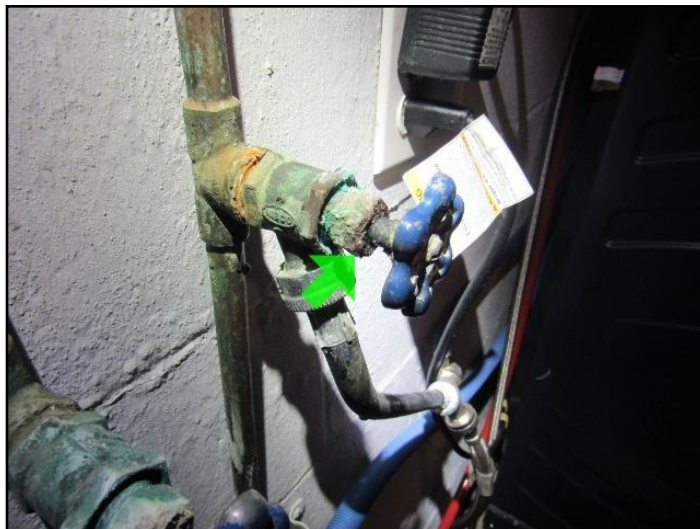
20. Condition: • [Leak](#)

Implication(s): Chance of water damage to structure, finishes and contents | System inoperative

Location: Basement Utility Room

36. Leak

Task: Repair or replace

Time: As soon as possible

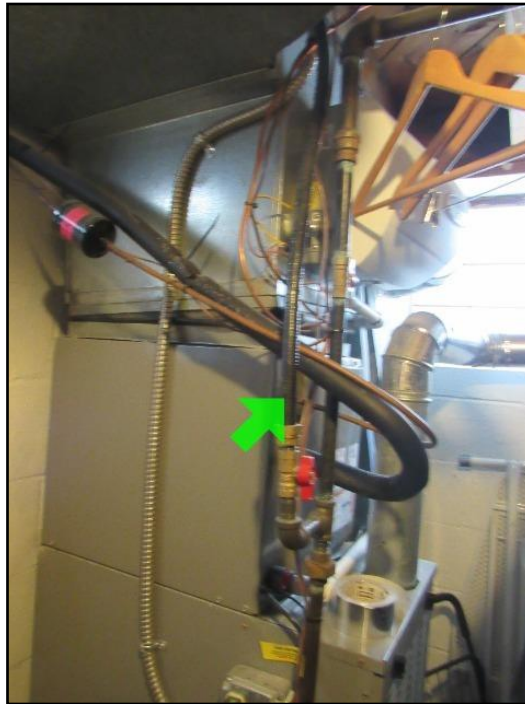
21. Condition: • Piping not properly bonded

CSST flexible gas line requires bonding.

Implication(s): Fire or explosion

Location: Basement

37. Piping not properly bonded

Task: Improve Correct

Time: As soon as possible

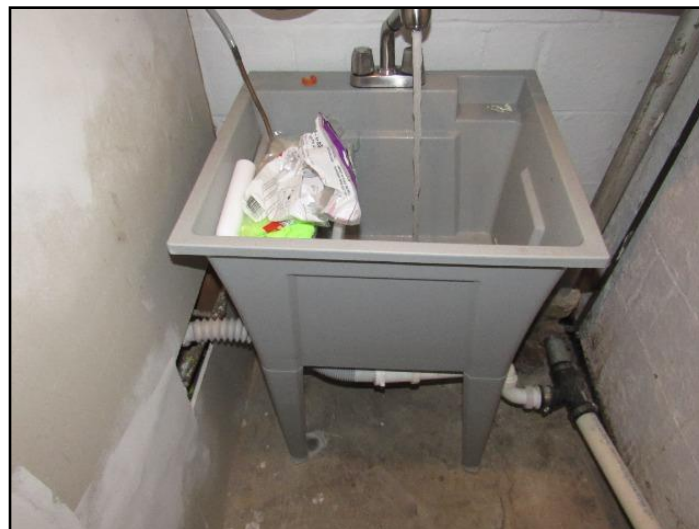
22. Condition: • [Loose](#)

Stationary sink not secured to floor or wall

Implication(s): Chance of water damage to structure, finishes and contents | Damage or physical injury due to falling materials | Sewage entering the building

Location: Basement Utility Room

38. Loose

Task: Improve Correct

Time: When practical

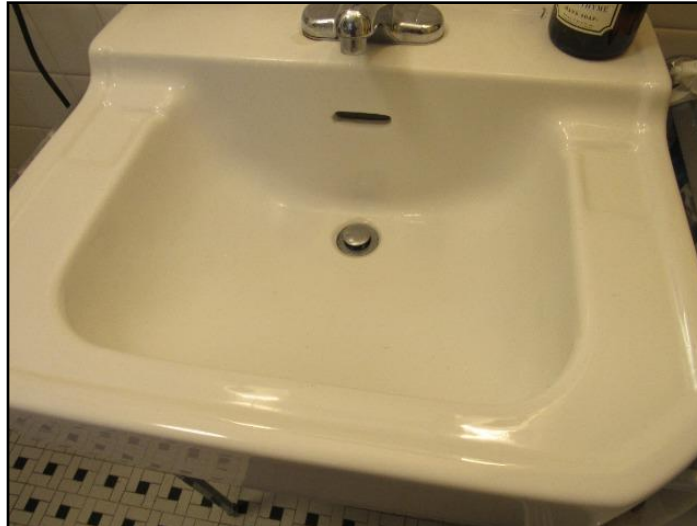
23. Condition: • Drain stop ineffective
Implication(s): Nuisance | Reduced operability
Location: Second Floor Bathroom
Task: Repair Improve Correct
Time: Discretionary

39. Drain stop ineffective

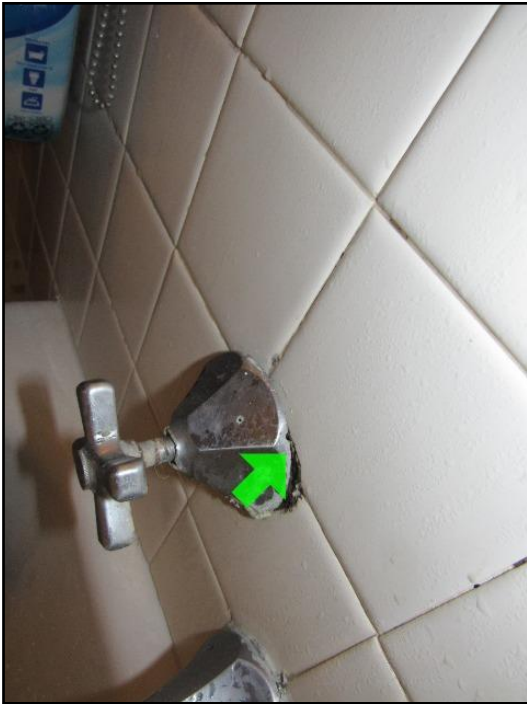
24. Condition: • [Caulking loose, missing or deteriorated](#)
Implication(s): Chance of water damage to structure, finishes and contents
Location: Second Floor Bathroom
Task: Improve Correct
Time: When practical

40. Caulking loose, missing or deteriorated

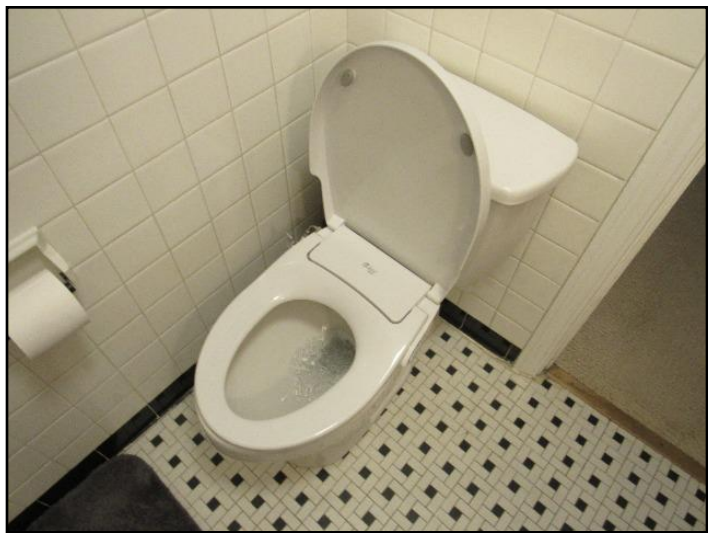
25. Condition: • [Loose](#)

Implication(s): Chance of water damage to structure, finishes and contents | Sewage entering the building | Possible hidden damage

Location: Second Floor Bathroom

41. Loose

Task: Repair Improve Correct

Time: As soon as possible

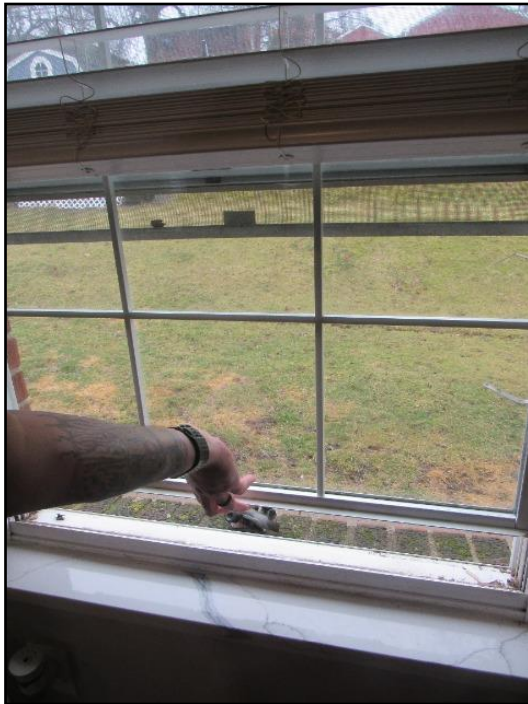
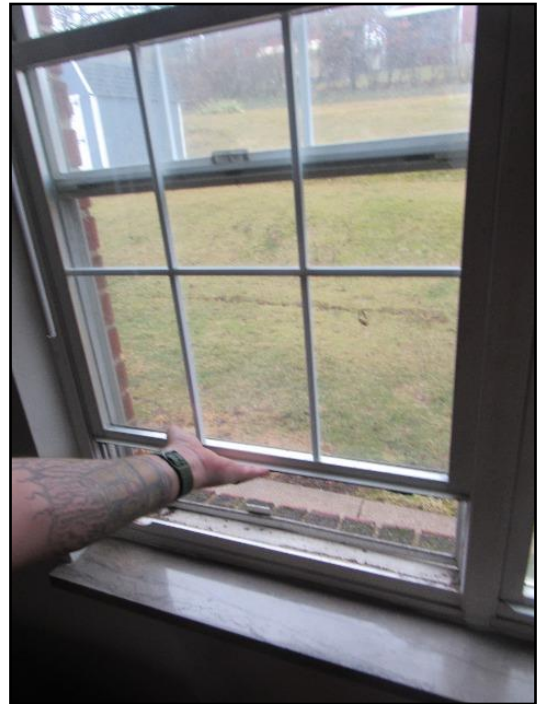
26. Condition: • [Won't stay open](#)

Location: Various First Floor Living Room Kitchen

42. Won't stay open

43. Won't stay open

Task: Repair Improve Correct

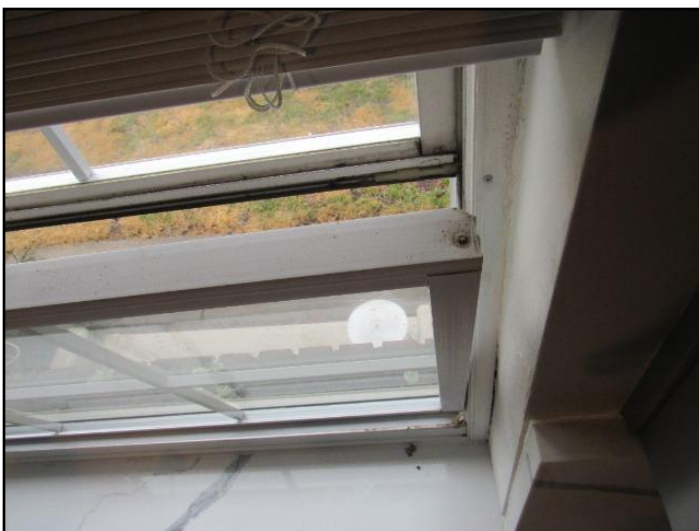
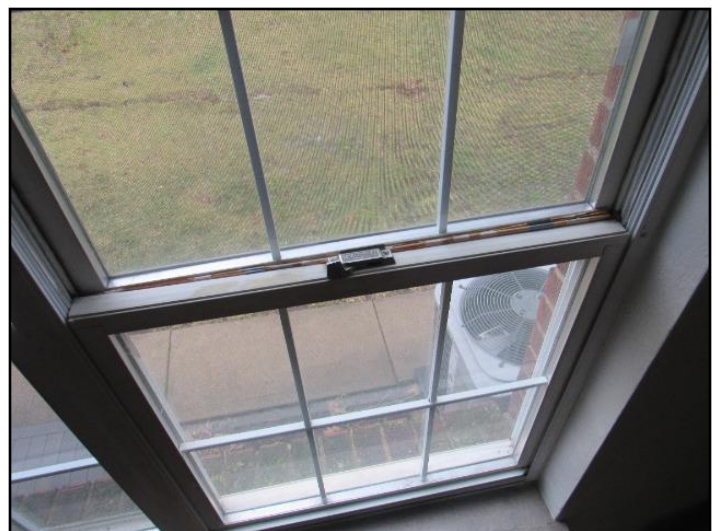
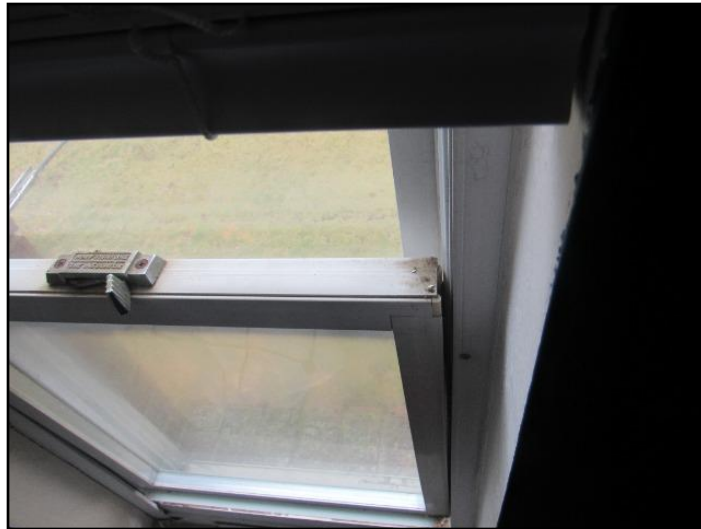
27. Condition: • [Loose fit](#)

Implication(s): Chance of damage to finishes and structure

44. Loose fit

45. Loose fit

46. Loose fit

Task: Repair or replace

Time: As soon as possible

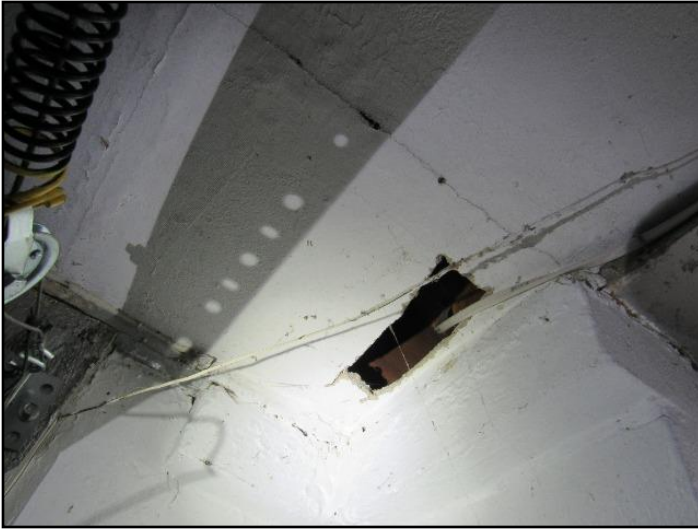
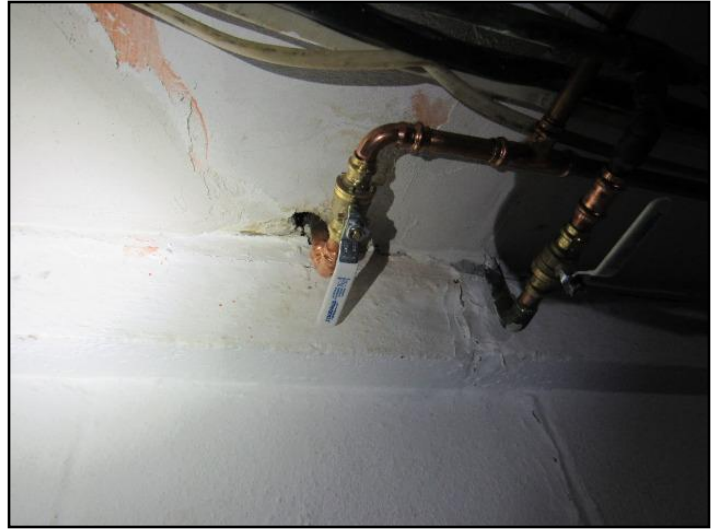
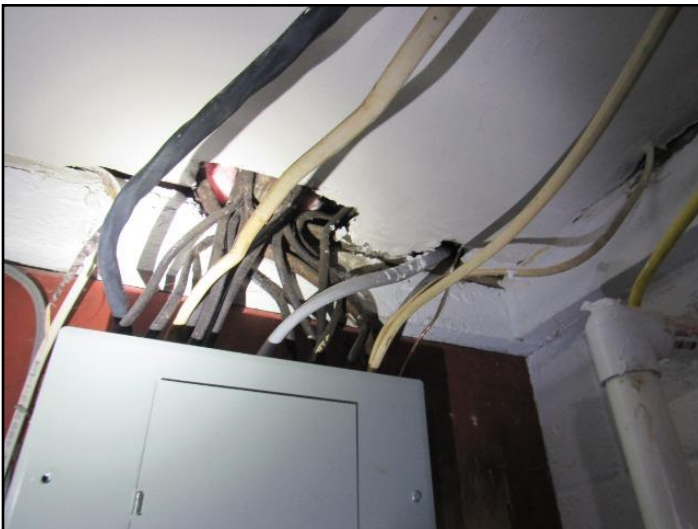
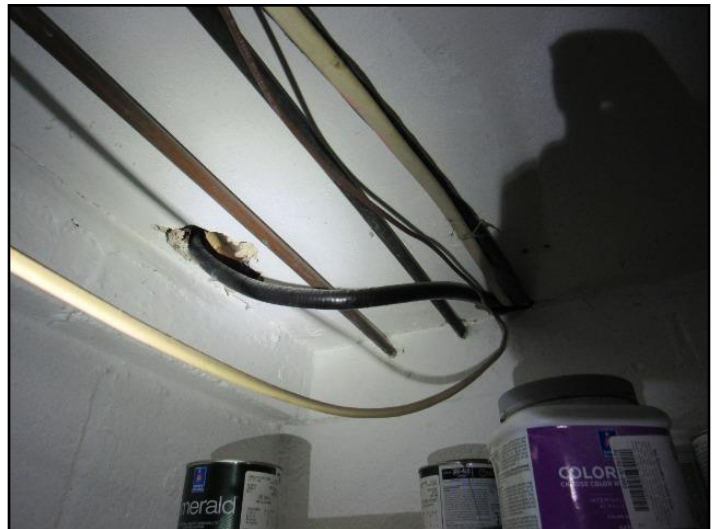
28. Condition: • [Not fireproof](#)

Implication(s): Fire hazard

47. Not fireproof

48. Not fireproof

49. Not fireproof

50. Not fireproof

Task: Improve Correct

Time: As soon as possible
