Property Inspection Report

HIGH TOUCH

1652 Norsen Drive, Pittsburgh, PA

DATE OF INSPECTION: 4/13/2026

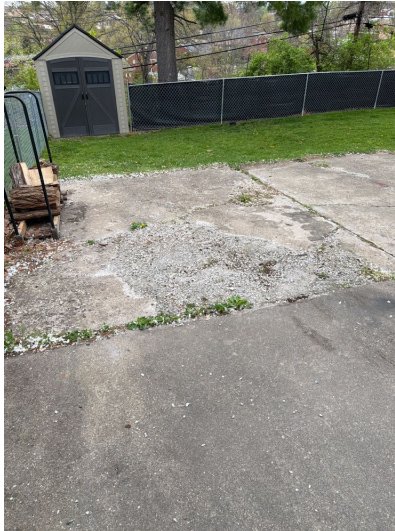
2. Driveway

- The driveway is made of concrete.
- [The driveway has areas of cracking and damage that is common for driveways as they age.](#)

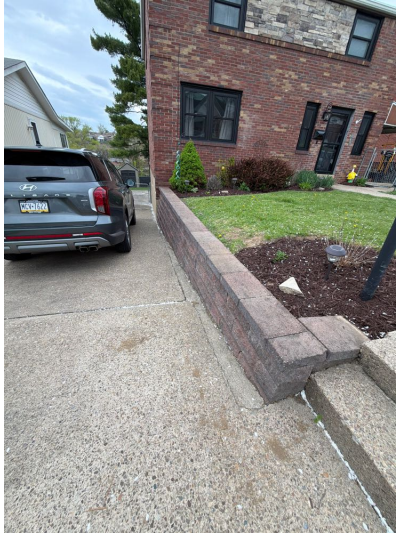
3. Yard Walls

- The yard walls are functional. As with any exterior wall, they should be monitored and future repairs should be expected.

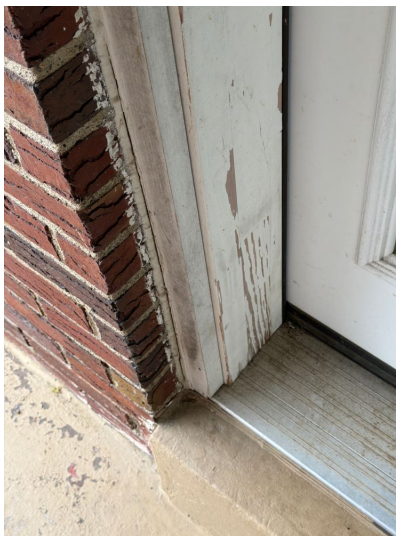
4. Exterior Trim

- There are some areas of peeling paint on exterior of house. Peeling paint should be scraped and repainted.

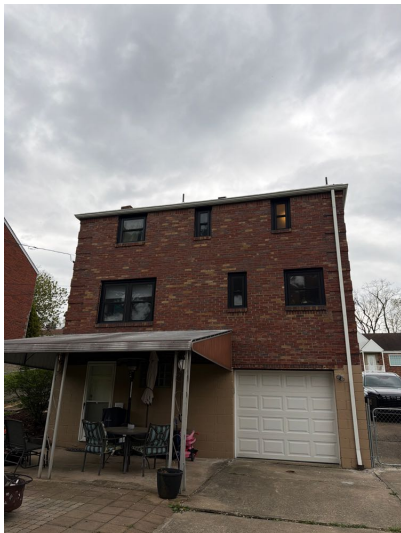
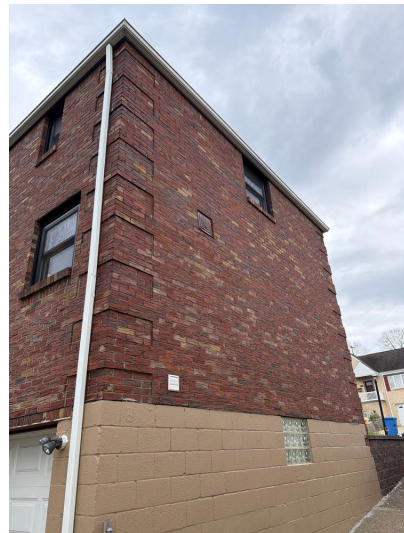
2. Wall Covering Condition

- There are areas of mortar that need monitored and future repairs will be needed.

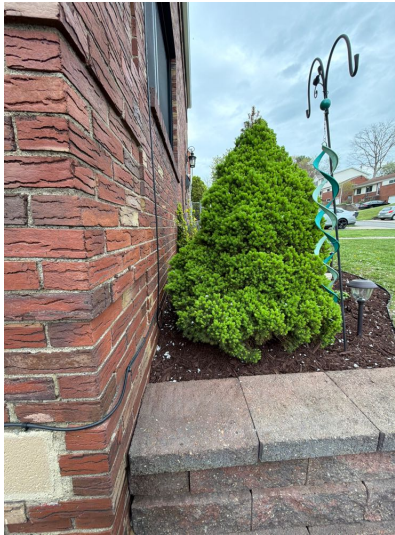
1. Grading Adjacent to House

- The exterior grading slopes towards the residence in areas and moisture intrusion is always a possibility given the location and terrain even when grading is properly done. The soil should slope away from the residence to a distance of around five feet, to keep moisture away from the foundation. Any areas of solid surfaces such as concrete, asphalt etc. should be caulked at the joint where it meets the structure. Proper grading of the exterior should be done now and maintained over the years of ownership.

The areas below grade such as basements and crawlspaces are most susceptible to moisture. Ensuring proper grading on the exterior of the house could have a significant reflection on the dampness of these underground areas. In my experience, proper exterior grading will help to slow down the moisture penetration into the areas of the structure that are underground, however other measures may need to be taken.

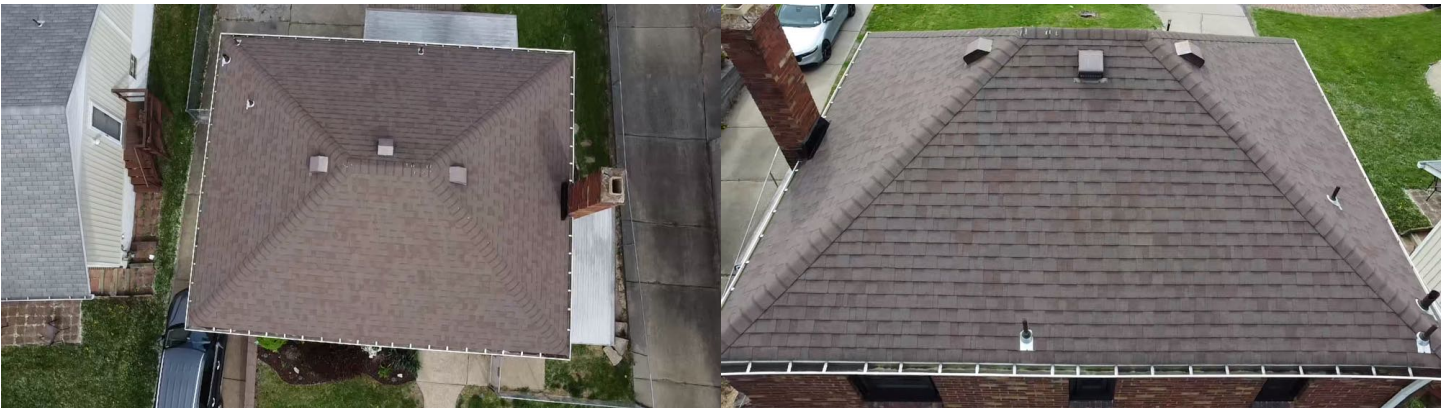
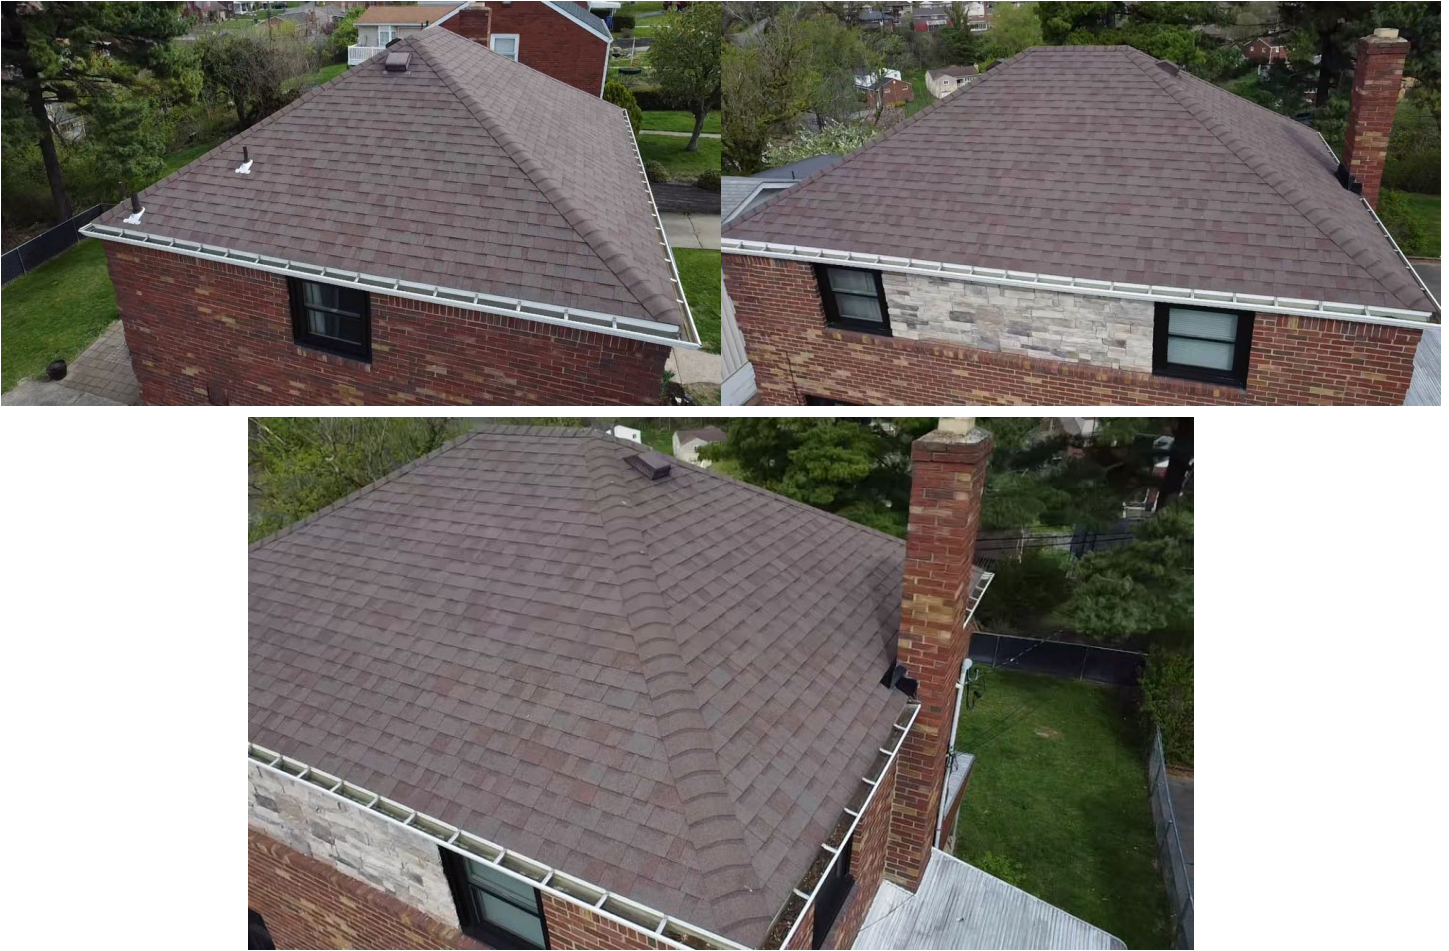
3. Age and General Evaluation

- The composition shingle roof appears to be around 5 years old. This is just an estimate and you should ask the sellers if they have an exact date of install. It is important to keep all receipts and documents for warranty and material maintenance requirements.
- The composition shingle roof is in acceptable condition. Our inspection does not include any guarantee for any type of roof leaks that may occur in the future.

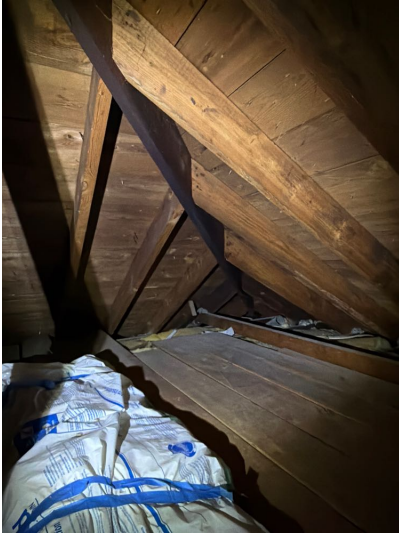
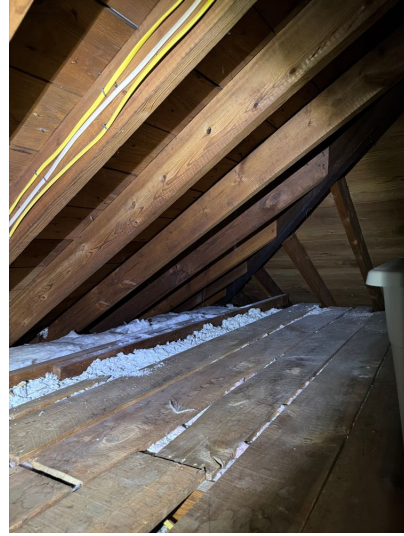
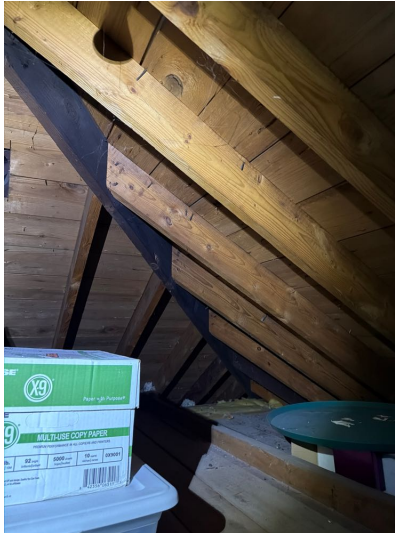
2. Framing

- The visible portions of the framing are in acceptable condition, and would conform to the standards of the year in which they were constructed.

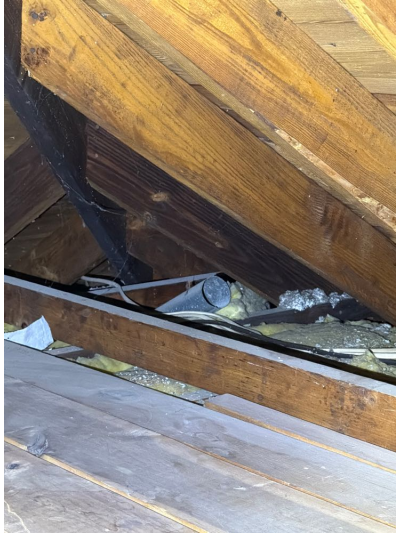
4. Exhaust Vents

- A bathroom exhaust duct vents within the attic, and should be extended to an exterior port. A qualified contractor should further evaluate and make repairs as needed.

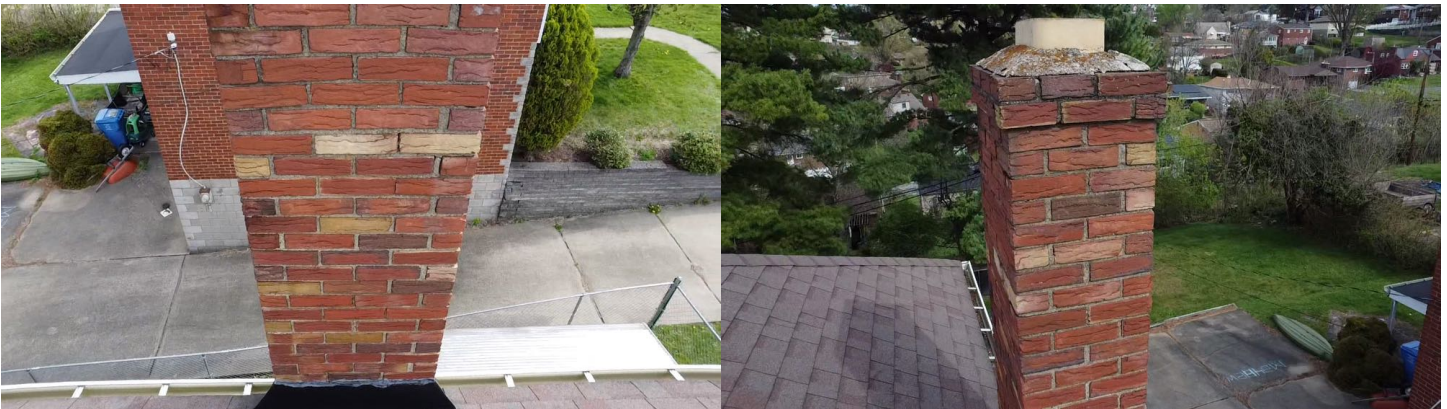
1. Chimney Walls

- The chimney has areas of missing mortar that should be repointed. A chimney sweep or qualified contractor should further evaluate each chimney and make repairs as needed.

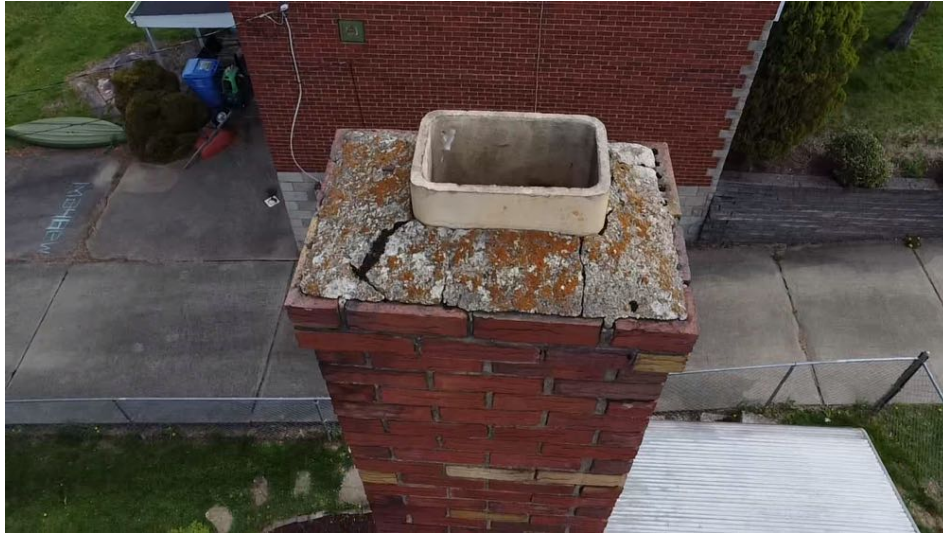
3. Chimney Crown

- The chimney crown, which is designed to seal the chimney wall and divert rainwater, is cracked and should be repaired to help prevent moisture penetration. A qualified contractor or chimney sweep should further evaluate and make repairs as needed.

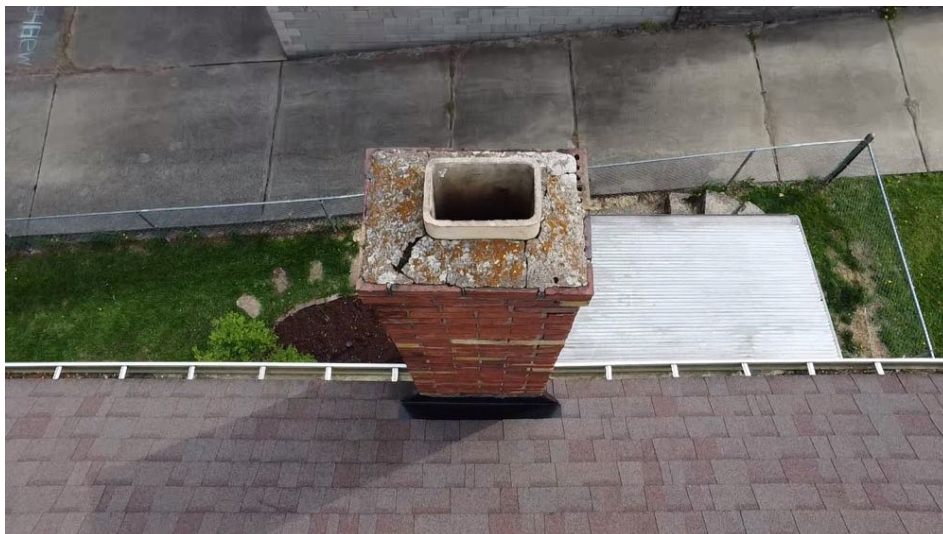
5. Weather Cap

- There is no weather cap on the chimney. A weather cap with a screen should be installed to help keep out moisture, rodents and birds.

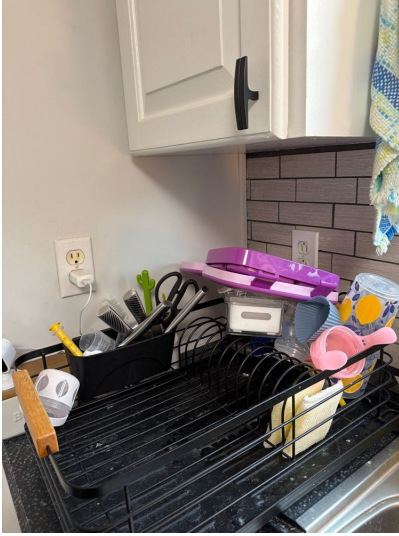
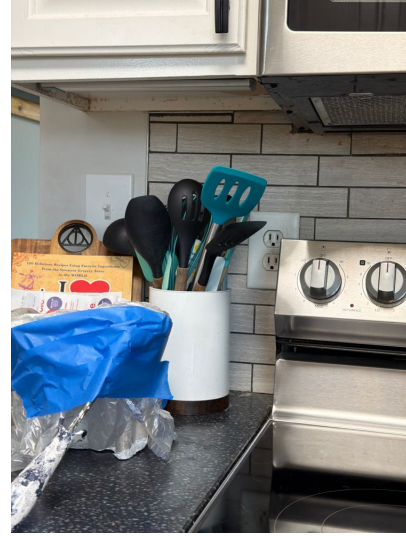
13. Outlets

- Several counter top outlets should be upgraded to have ground fault protection.

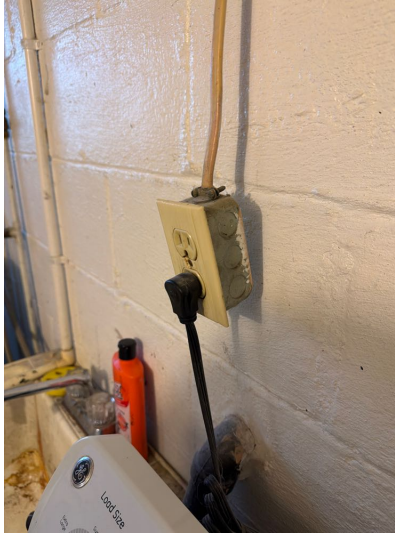
5. Outlets

- The outlets in the laundry room should be updated to have ground fault protection. Also, the junction box, on the right side, should be secured to the wall. An electrician should make repairs.

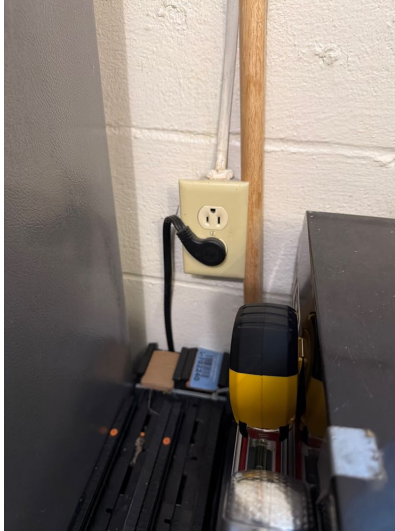
9. Outlets

- One of the outlets in the garage should be upgraded to have ground fault protection. The outlet that controls the automatic opener should not be ground fault protected. An electrician should make repairs.

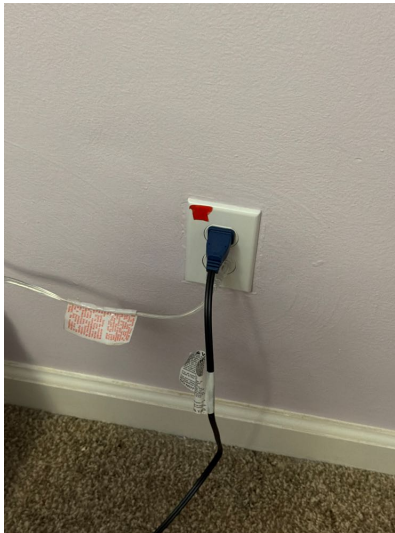
- Several of the outlets are obstructed by furniture and were not tested.
- One of the outlets is wired with reversed polarity and should be repaired by an electrician.

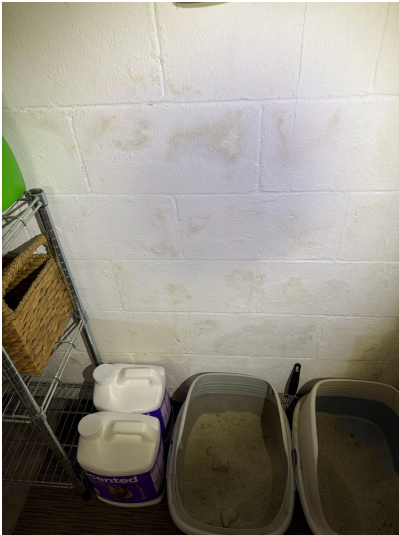
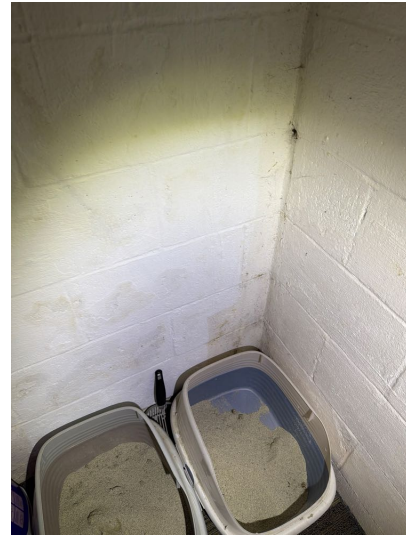
2. Moisture or Dampness

- There is efflorescence or staining on the basement or lower level walls, which is caused by moisture intrusion. This in our area is not uncommon, however, it should be controlled. The exterior grading around the house should be built up to slope away from the house at a drop of 5 inches over 5 feet. As with most basements, you should know that future moisture penetration is possible.

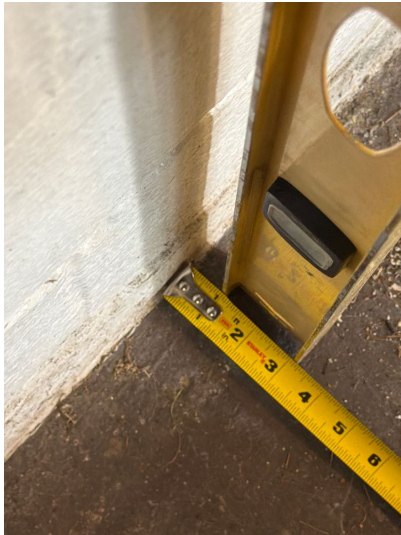
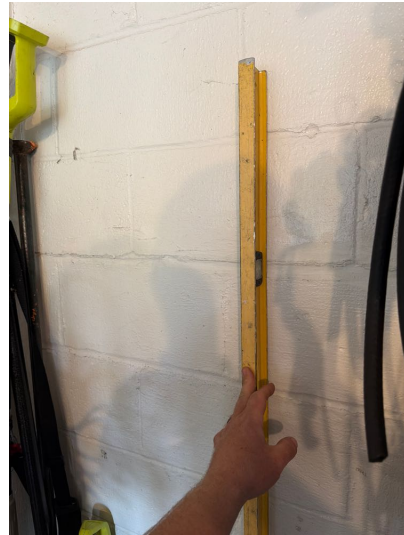
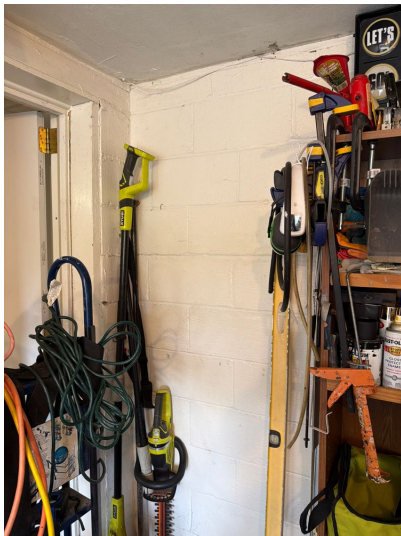
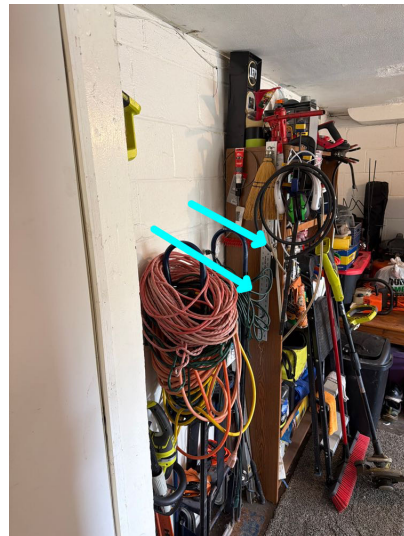
5. Foundation

Page 26 Item: 5	Foundation	<ul style="list-style-type: none"> • There are areas of cracking or movement in the foundation walls. In most cases this is from moisture freezing against the wall, expanding, which is causing a shift at the wall. This is also called hydrostatic pressure. There are areas of movement at some walls at this property that have shifted the wall more than an inch. A certified contractor should further evaluate. Repairs should be made as needed. The exterior grading should be sloped away from the house at these areas as well.
Plumbing/Waste Section		
Page 30 Item: 3	Drain Pipe Condition	<ul style="list-style-type: none"> • We strongly recommend carrying underground pipe insurance on your home. This can help cover costly repairs to the home underground sewer lines and utilities. In most cases, you own all utilities from the house out to where it ties in at the main/street.

- The foundation is made of block.
- Areas of the foundation are covered with drywall or other finish material, which limited my ability to inspect for moisture or structural movement.
- There are areas of cracking or movement in the foundation walls. In most cases this is from moisture freezing against the wall, expanding, which is causing a shift at the wall. This is also called hydrostatic pressure. There are areas of movement at some walls at this property that have shifted the wall more than an inch. A certified contractor should further evaluate. Repairs should be made as needed. The exterior grading should be sloped away from the house at these areas as well.

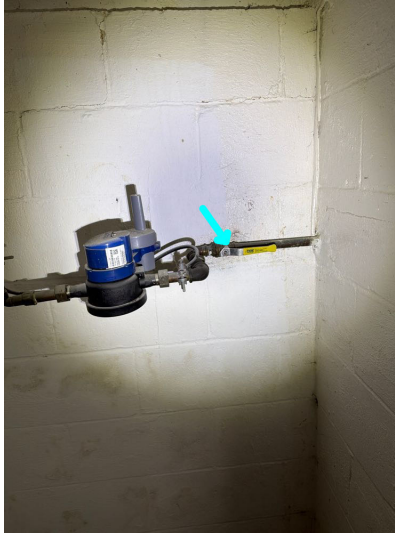
- The main water shut-off valve is located in the basement.

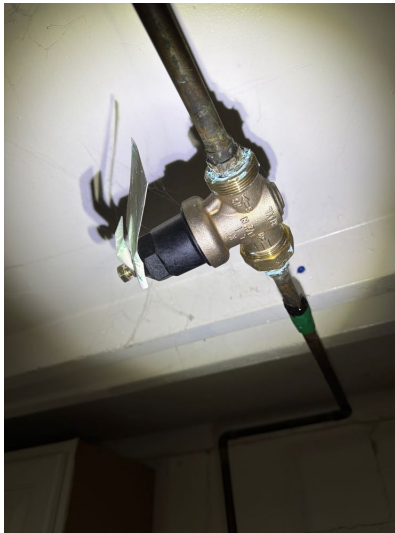
- A water pressure regulator is in place on the plumbing system.

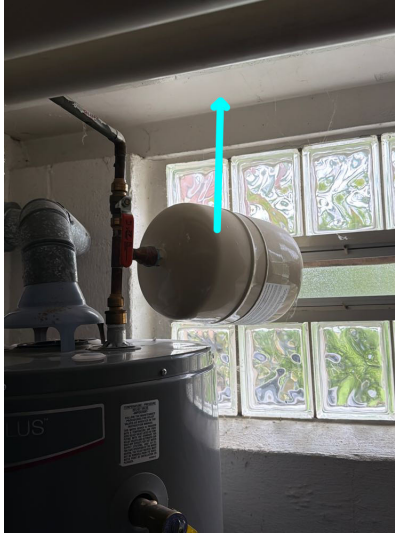
5. Check Valve And Expansion Tank

- There is an **expansion tank** on this water system. I recommend securing this tank with a strap, to the ceiling. This helps hold the weight of the tank.

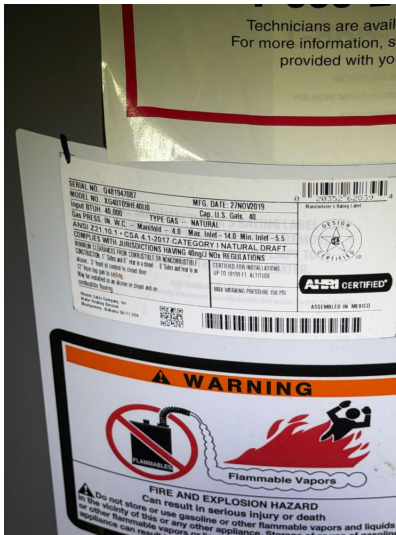
- Hot water is provided by a 7 year old, 40 gallon gas water heater that is located in the basement.

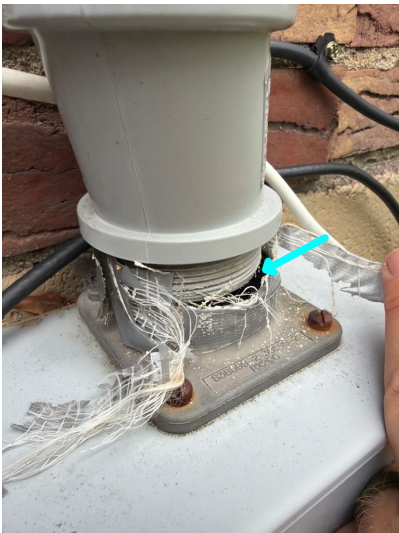
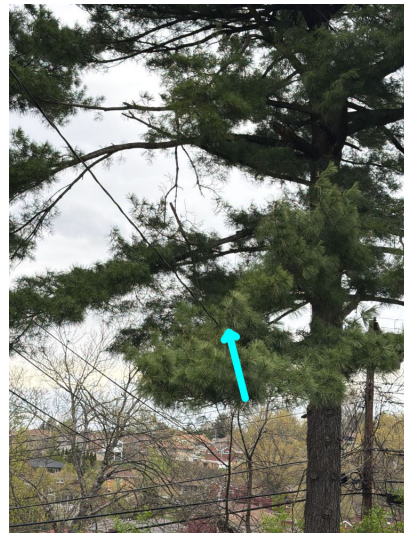
- The overhead conductor lines are in contact with tree limbs that should be trimmed away.
- The conduit on the service entrance has pulled away from the meter box. This should be sealed to help prevent moisture penetration into the meter and then into the main panel. A certified electrician should evaluate and make all repairs as needed.

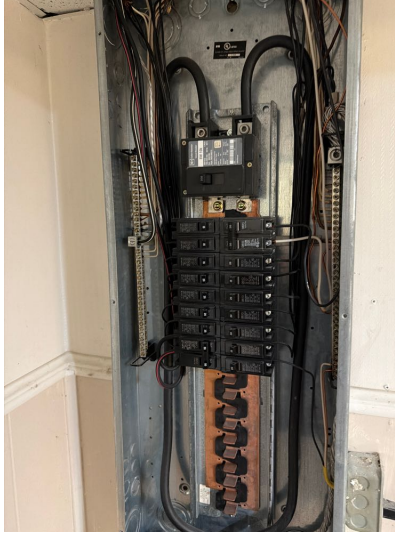
4. Main Panel

- The main panel and its components have no visible deficiencies.

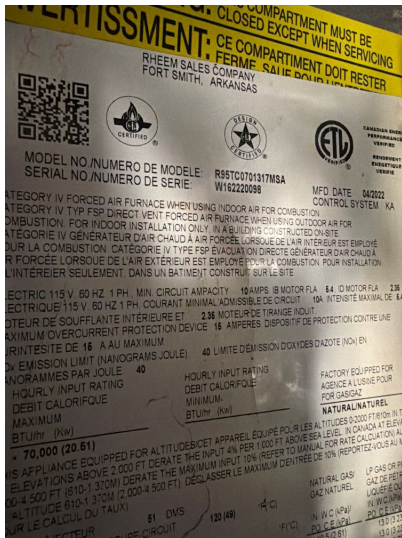
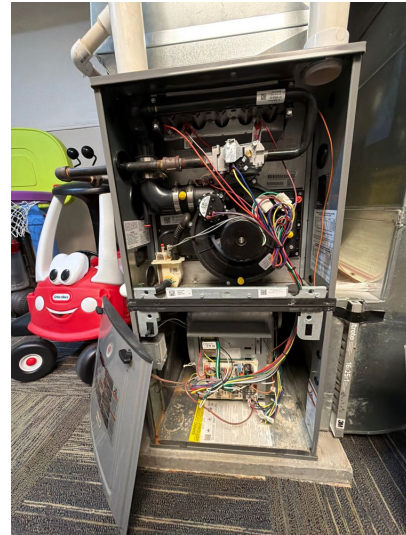
- The furnace is functional. It should be cleaned and serviced annually and the air filter changed or cleaned monthly.

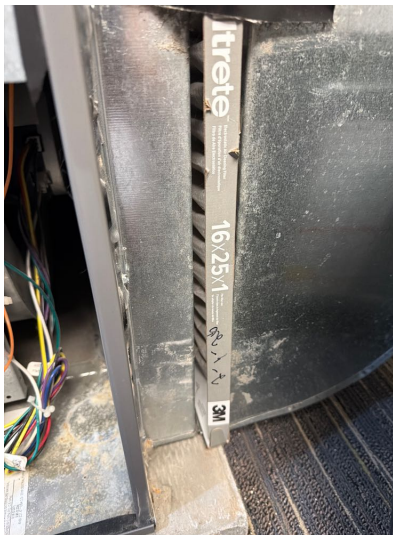
- The return-air compartment is in acceptable condition. The filter should be changed every 3 months.

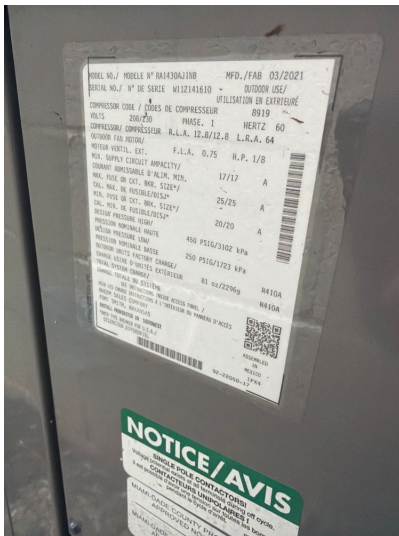
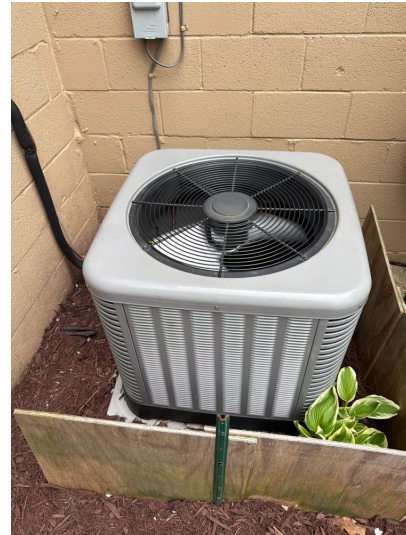
8. Condensing Coil

- The condensing coil responded to the thermostat and is functional.
