**5947 Wallace Ave**

**RE: Bethel Park, PA 15102**

**Inspection #: 527-102025-6589**

### *HOME INSPECTION REPORT*

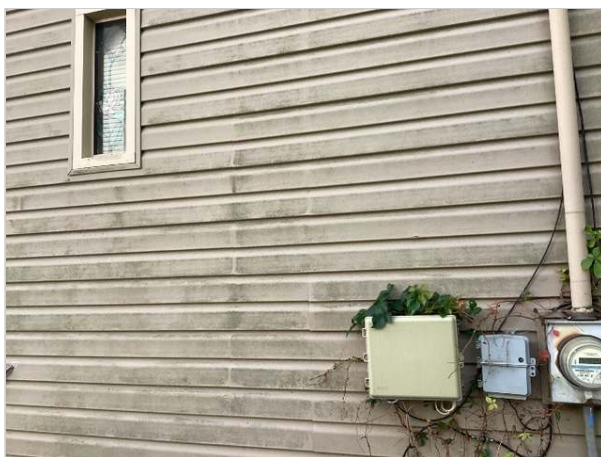
Moss growth was noted on the right . While cleaning products are available for moss removal, simply cutting back trees can remove the conditions that cause moss growth. Consult with a qualified contractor for further evaluation if desired.

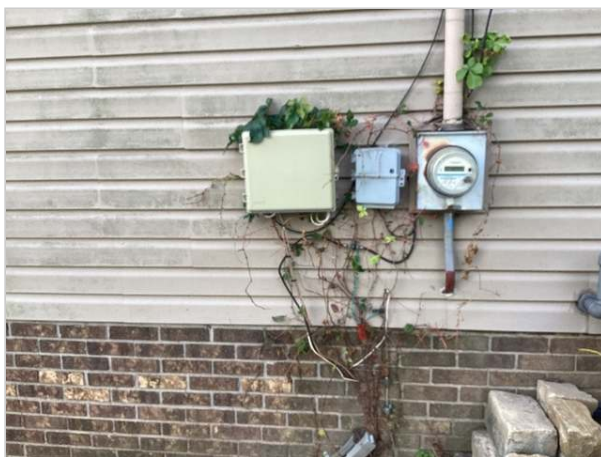
### *NOTE: OVER GROWTH:*

Extensive plant growth was observed against the home, in the left side area of the house. Recommend removing this growth away from the siding to prevent possible damage including insect infestation.

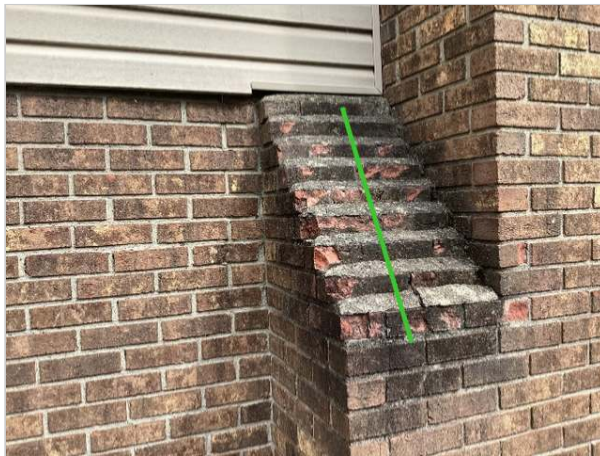
### *MAINTENANCE NOTE: SPALLING:*

Some spalling was noted on the brick of the home. Spalling is usually caused by moisture accumulation behind the surface. In cold weather, the moisture freezes and pushes the face off. In some cases the condition can be controlled by sealing the face with an appropriate masonry sealer. Consult with a qualified masonry contractor for recommendations.

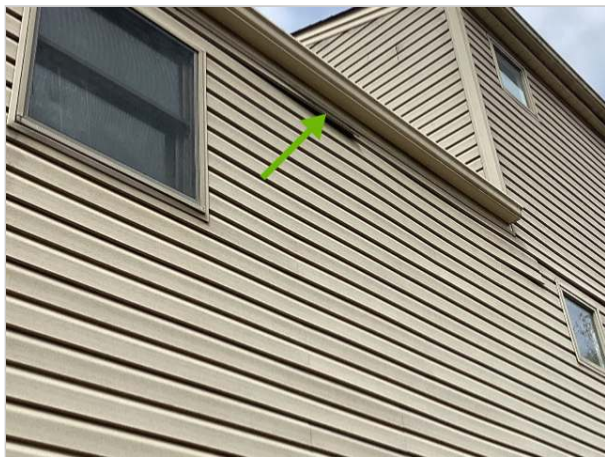
**NOTE: LOOSE SIDING:**

Loose siding was noted on the back of the home. The siding should be reattached.

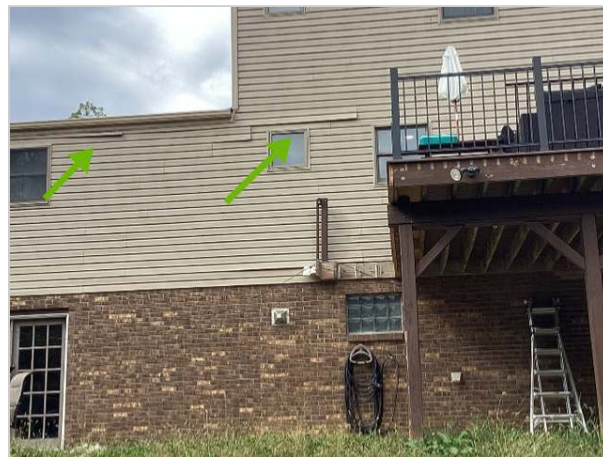
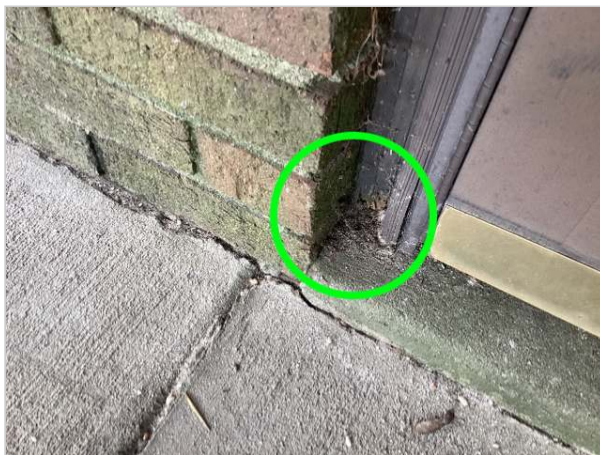
**NOTE: EXTERIOR WOOD ROT:**

Rotted wood was noted on the wood trim . The areas should be repaired and sealed by a qualified contractor.

Rear door frame

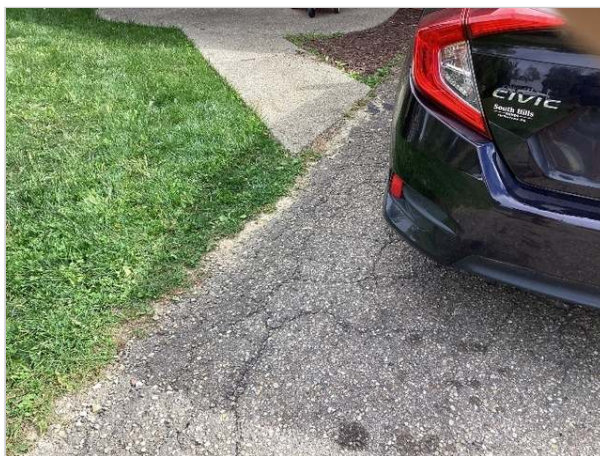
### *SAFETY NOTE: TRIP HAZARDS:*

There were several trip hazards found on the walkways around the house. The hazards can be repaired using a suitable or similar surfacing material to "feather" the out-of-level condition to make a smooth transition.

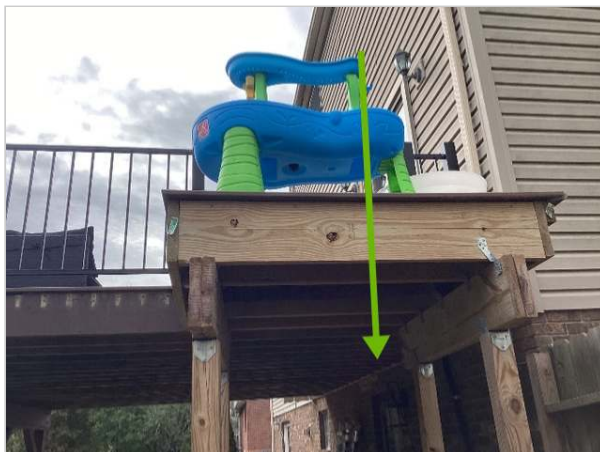
***SAFETY NOTE: FALL HAZARD:***

There is no barrier installed on the back porch. The absence of a proper rail or barrier constitutes a fall hazard and should be corrected. Consult with a qualified contractor for installation of a proper barrier.

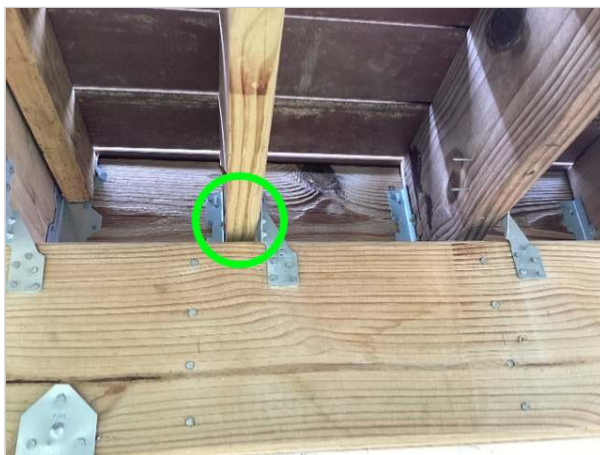
***SAFETY NOTE: DECK ANCHORING:***

The ledger board for the deck is bolted to the main structure of the home with carriage bolts. Carriage bolts are not recommended for a ledger board. Carriage bolts are not as strong as hex bolts and their smaller head surface can damage the ledger. Generally accepted deck construction techniques require the deck to be bolted to the main structure of the home at regular intervals. We recommend the bolts also include a washer to add support. Consult with a qualified contractor to anchor the deck to the home with bolts.

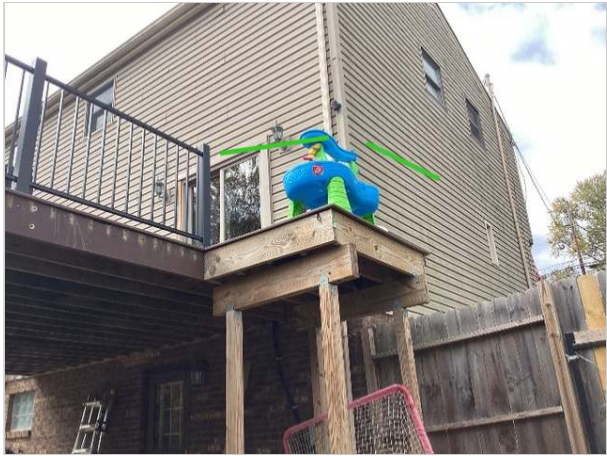
***NOTE: EXTERIOR HANDRAILS:***

There were no handrails on the steps on the deck. Local codes may require the installation of handrails in location where three or more steps are present.

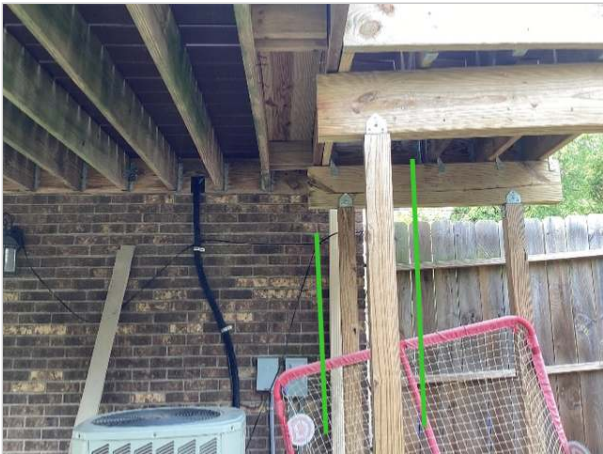
**NOTE: DECK SUPPORT POST:**

The rear vertical support post on the deck are not plumb. The post is an important structural component and should be repaired. Consult with a qualified contractor for recommendations.

Vertical post do not appear plumb

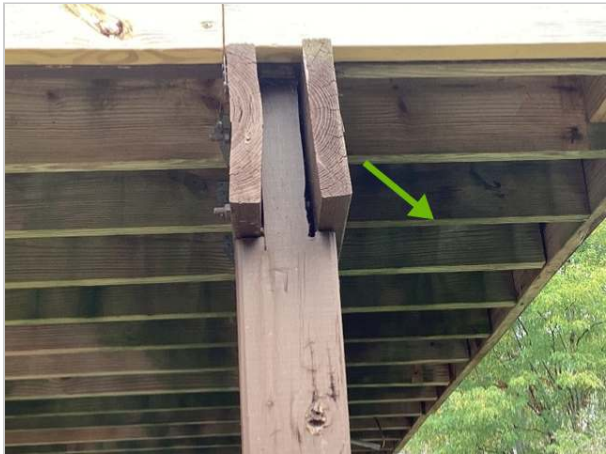
Outside beam separation

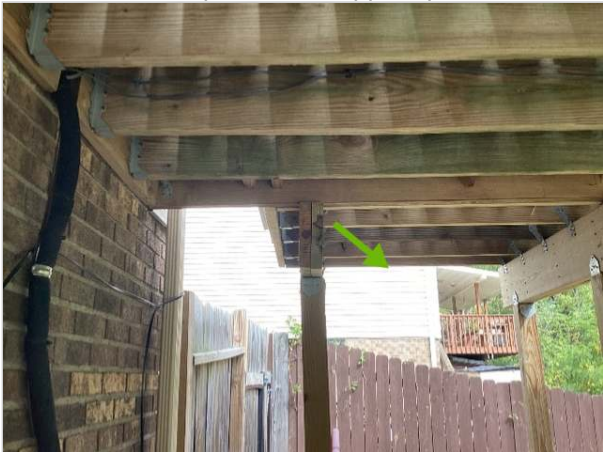
Header not plumb

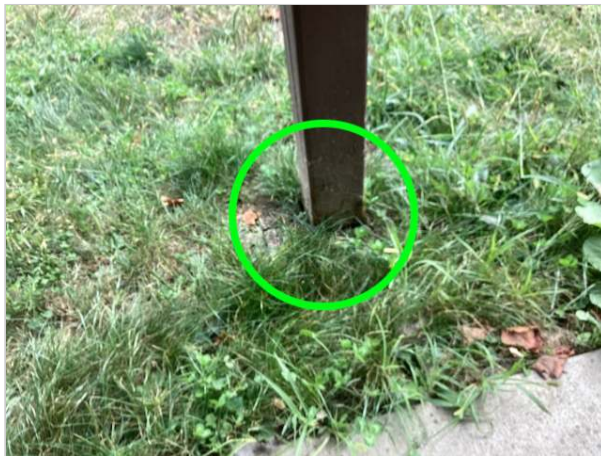
The deck support post(s) are making direct contact with the landscaping. Common practice is to mount support posts on concrete piers. The post is an important structural component and should be monitored for deterioration. A qualified contractor should be contacted for further evaluation and recommendations if desired.

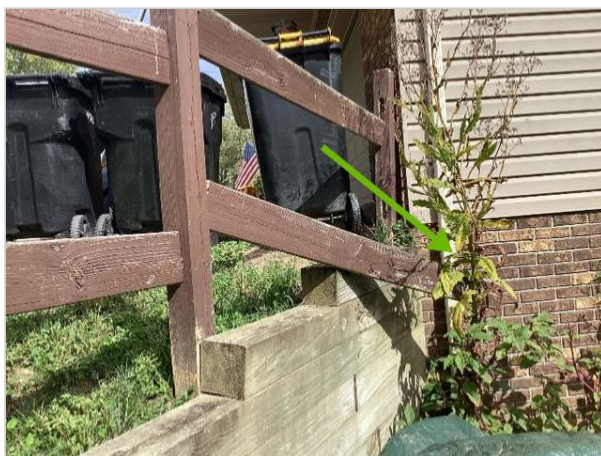
### *SAFETY NOTE: FALL HAZARD:*

There is no barrier installed on the right retaining wall. The absence of a proper rail or barrier constitutes a fall hazard and should be corrected. Consult with a qualified contractor for installation of a proper barrier.

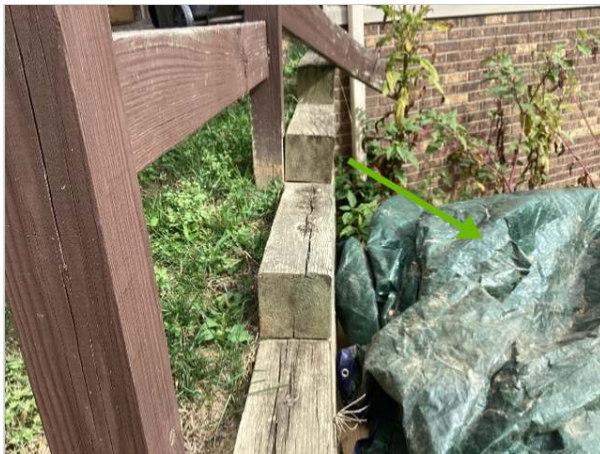
### *NOTE: RETAINING WALL:*

The right retaining wall is leaning inward. There were significant vertical earth pressure type cracks observed in the wall. This condition is most often associated with soil and /or water pressure. The displacement occurs incrementally as the wall yields to horizontal earth pressure. The wall was stable at the time of the inspection. Repairs to the wall may be required. Consult with a qualified contractor for repair estimates

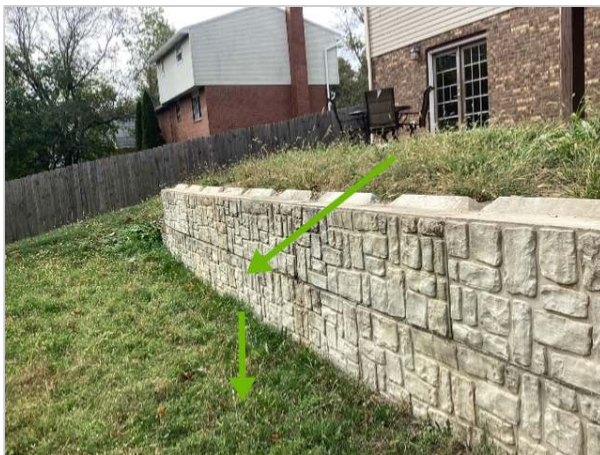
### *SAFETY NOTE: FALL HAZARD:*

There is no barrier installed on the rear retaining wall. The absence of a proper rail or barrier constitutes a fall hazard and should be corrected. Consult with a qualified contractor for installation of a proper barrier.

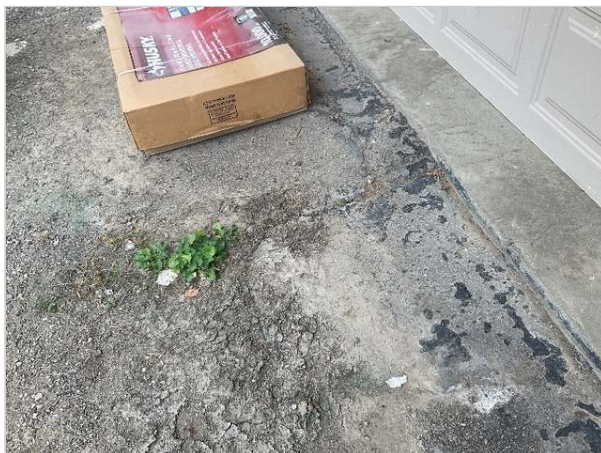
Settlement was noted on the front driveway . The settlement does not appear to be active. Settlement of is common and is usually not a problem. If the settlement causes the slab to pitch toward the foundation of the home, it is possible that water will drain into the basement. In this case the slab was not pitched toward the foundation. It is not possible for us to positively determine if active settlement is occurring during a home inspection. The area should be monitored for evidence of new or continued settlement. Consult with a qualified contractor for further evaluation if required.

Depression in driveway

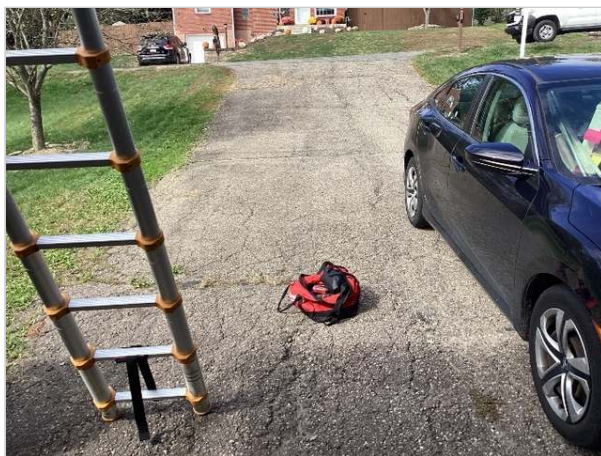
**MAINTENANCE NOTE: SPALLING:**

Some spalling was noted on the driveway of the home. Spalling is usually caused by moisture accumulation behind the surface. In cold weather, the moisture freezes and pushes the face off. In some cases the condition can be controlled by sealing the face with an appropriate sealer. Consult with a qualified masonry contractor for recommendations.

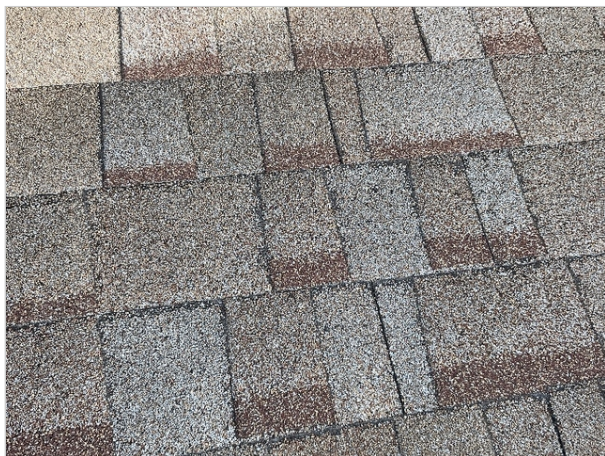
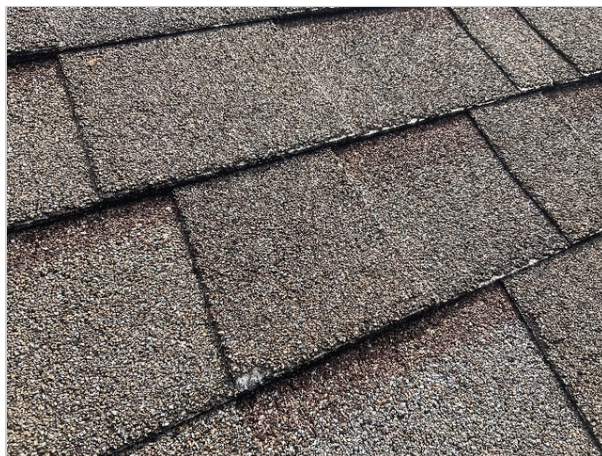
Signs of wear and age

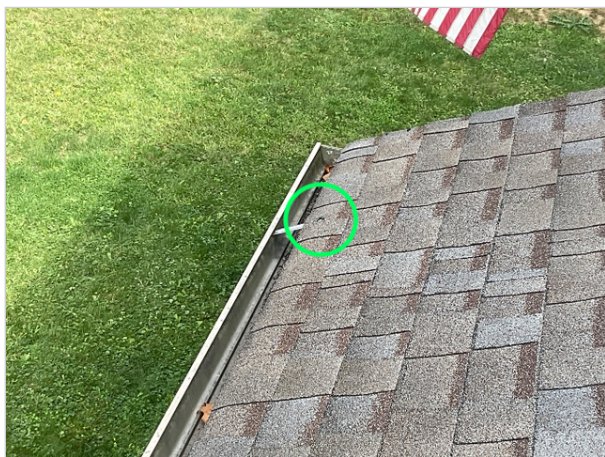
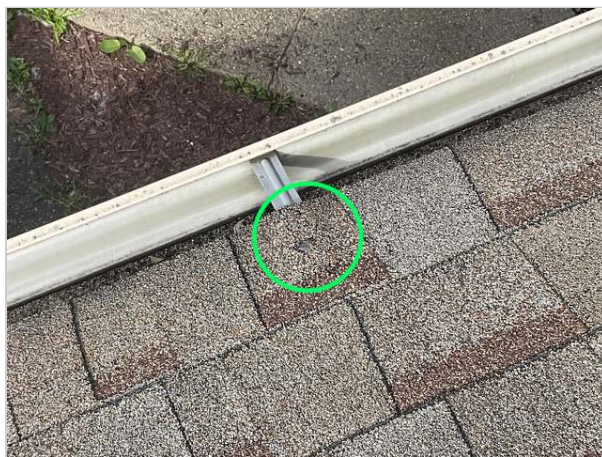
**NOTE: ROOF SHINGLES:**

Several shingles were damaged above the gutter mounts of the roof at the time of the inspection. While this condition is not necessarily an indication of a leak, repairs should be made. Consult with a qualified roofer for repair.

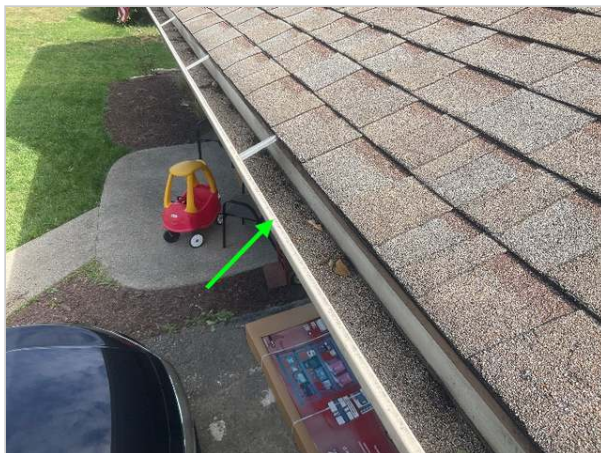
All of the gutters were in need of cleaning at the time of the inspection. Clogged gutters can cause roof drainage water to drain at the base of the foundation, causing basement water problems. The gutters should be cleaned.

shingle aggregate debris noted in gutters

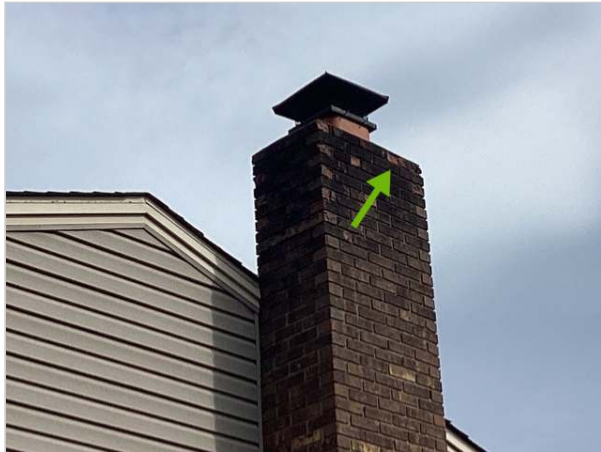
Some spalling of the brick was noted on the chimney. Spalling of the brick is usually caused by moisture accumulation behind the brick. In cold weather, the moisture freezes and pushes the face off the brick. Additional spalling can be controlled by ensuring that the mortar cap around the top of the chimney is intact and sealed.

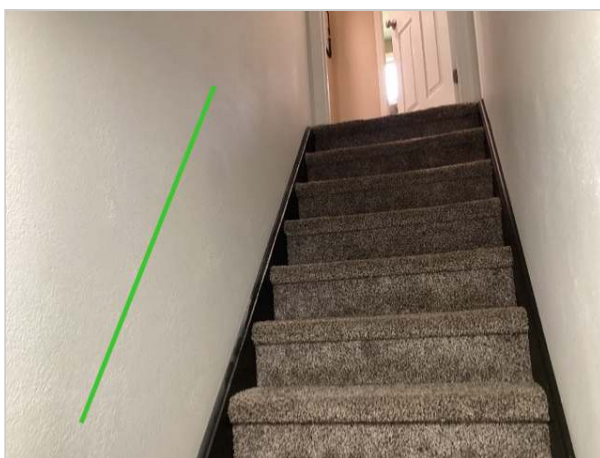
***SAFETY NOTE: MISSING HANDRAIL:***

There was no handrail on the stairs leading to the basement. This can be a safety concern. Local building codes may also require the installation of a handrail.

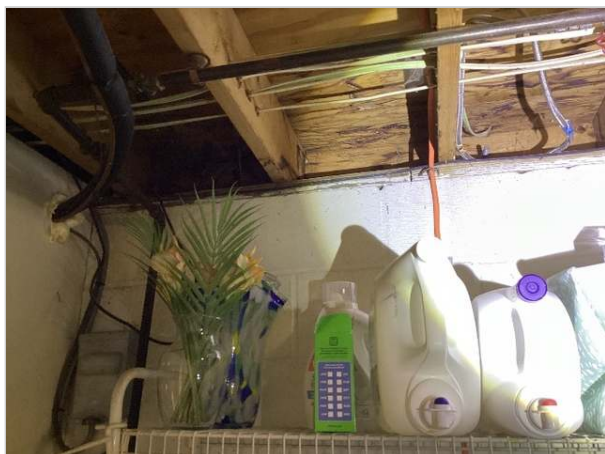
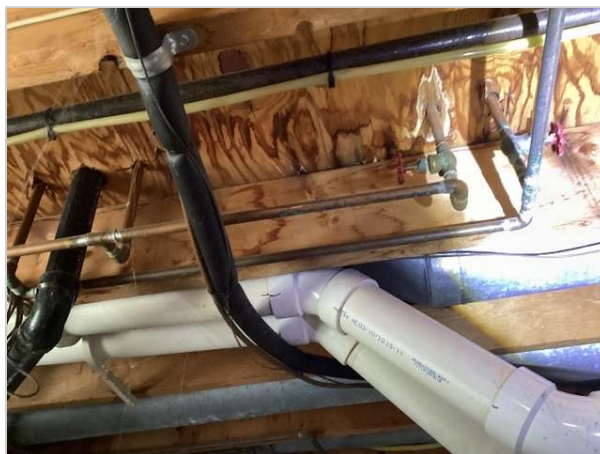
The floor joists and sub floor are water marked below the kitchen basement floor structure. The area was dry at the time of the inspection. The wood on the affected area was not rotted. Repairs to the affected area does not appear to be necessary.No immediate action is required.

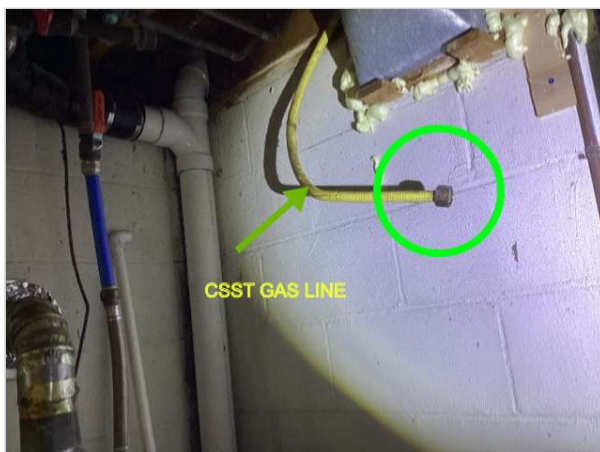
One or more unused gas lines were noted in the basement . The ends of the line (s) were open rather than capped. All unused gas lines should be capped so that gas will not leak into the home if a valve is mistakenly turned on.

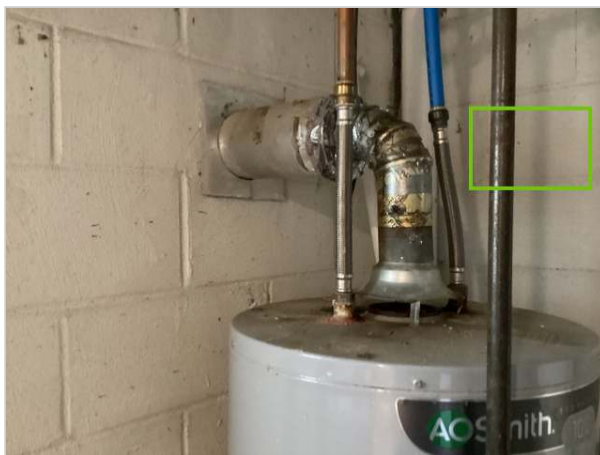
There is no expansion tank installed on the water heater. Expansion tanks relieve excessive pressure in the plumbing system and help lengthen the life of the water heater. These devices are installed on most newer water heaters. We recommend consulting with a qualified plumber for installation of an expansion tank. Depending on the terms, the lack of an expansion tank could affect any remaining manufacturer's warranty on the water heater.

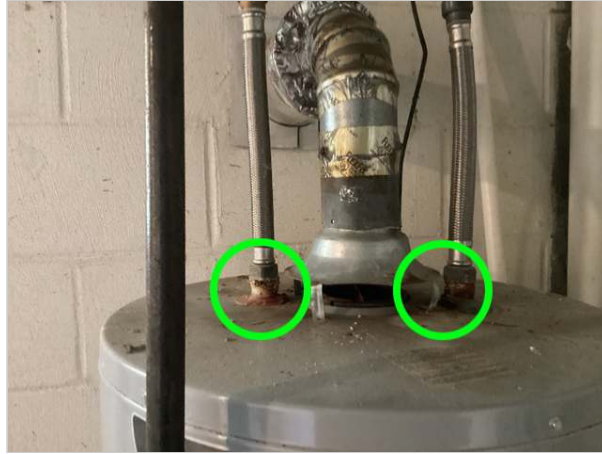
### *INFORMATIONAL NOTE: OLDER, CORRODED WATER SUPPLY VALVES:*

Older and/or corroded water supply valves were noted in the home. Water supply valves are infrequently used and often corrode on the inside and outside of the valve. This condition is common and often renders the valve inoperable. We make no attempt to test any water valves in the home regardless of their condition, because doing so could result in a leak. If this is a concern, you should consult with a qualified plumber for further evaluation and testing.

Evidence of corrosion

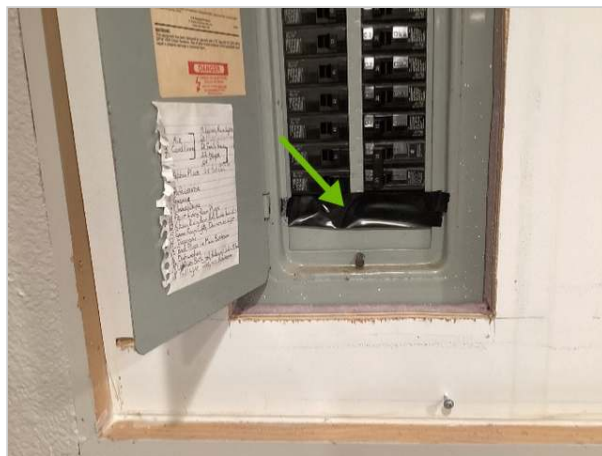
One or more electrical fixture knockout(s) was noted in the electric service panel. All service panel openings should be covered to prevent access to high voltage and risk of electrical shock. Electrical related repairs should be performed by a qualified electrician.

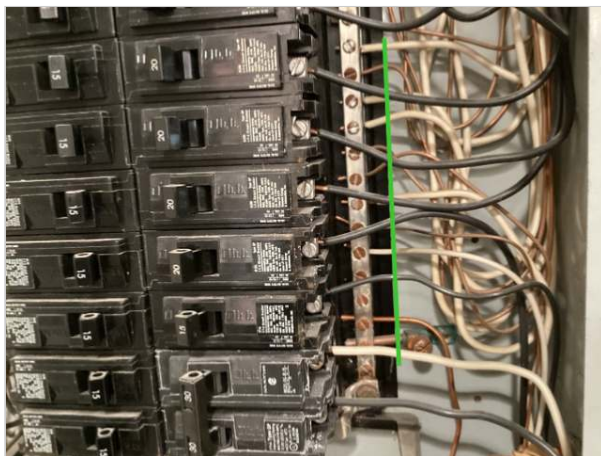
### *SAFETY NOTE: CORROSION IN THE MAIN SERVICE PANEL:*

Corrosion was observed in the main electric panel. Corrosion on terminal screws can result in overheating of terminals and possible arcing problems in the panel. It is recommended that a licensed electrician evaluate the condition of the service panel.

Rusted lugs

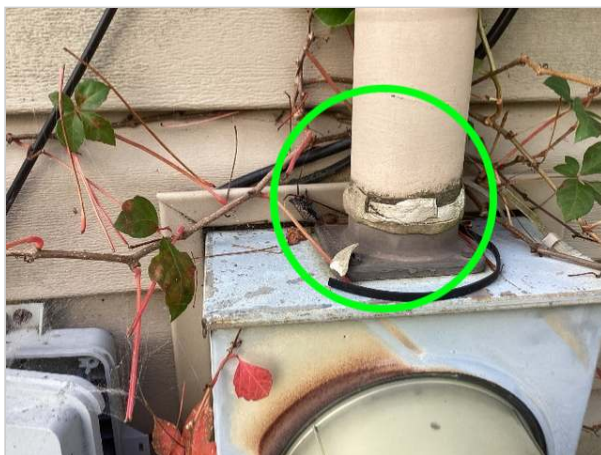
The sealant at the top of the electric meter box is cracked and decayed. The sealant should be replaced to ensure that water does not enter the electric service panel.

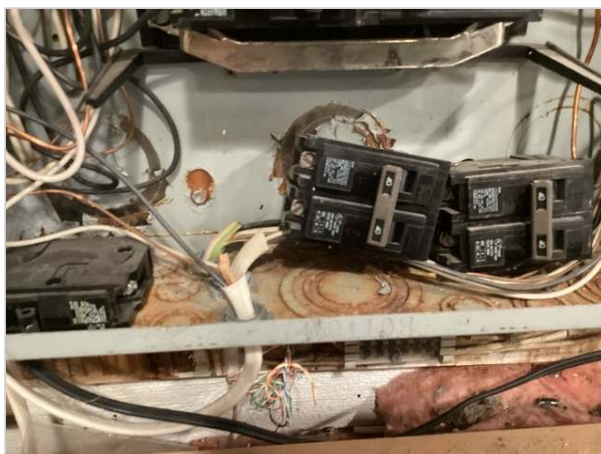
**NOTE: WATER EVIDENCE IN PANEL:**

There was evidence of water intrusion in the main service panel. The interior of the panel was dry at the time of the inspection. Moisture in the service panel can lead to corrosion of the electrical connections, a safety concern. Consult with a qualified electrician to evaluate the exterior seals on the electrical service and repair as required.

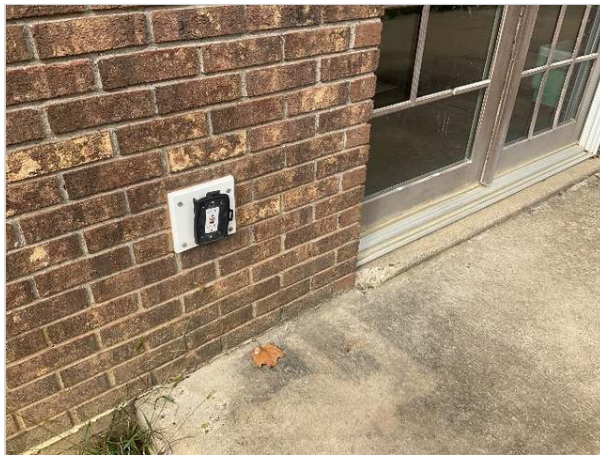
A loose outlet was noted in the exterior. This could be a shock hazard due to exposed electrical contacts. The affected outlet(s) should be secured by a qualified contractor.

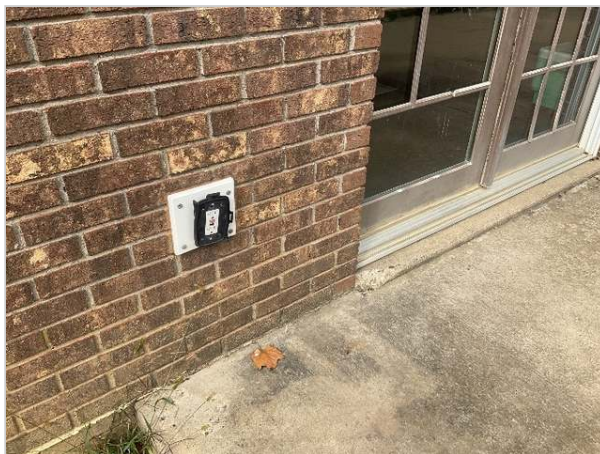
***SAFETY NOTE: DEFECTIVE GFCI:***

The GFCI outlet located on the exterior is defective and should be replaced by a qualified electrician.

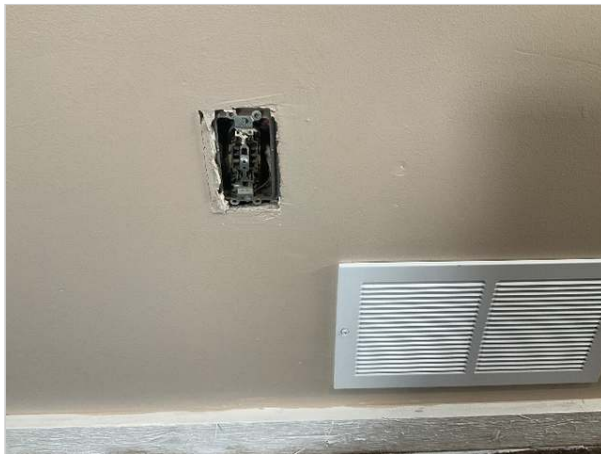
***SAFETY NOTE: BROKEN OUTLET:***

A broken outlet was noted in the bedroom. This could be a shock hazard due to exposed electrical contacts. The affected outlet(s) should be replaced by a qualified contractor.

Live outlet noted in master bedroom

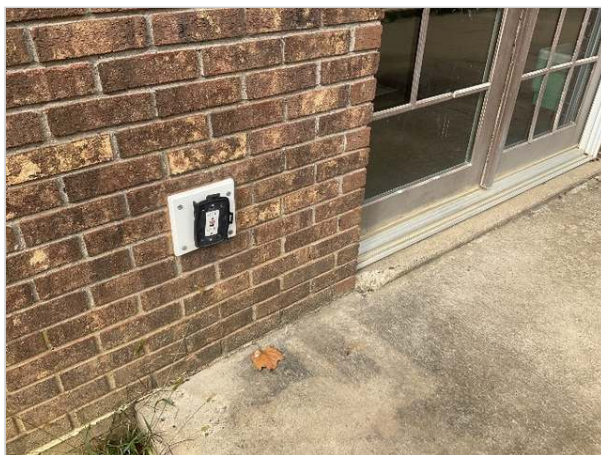
One or more exterior outlets were not properly covered. Outlet covers designed for use in wet locations should be installed on all exterior outlets.

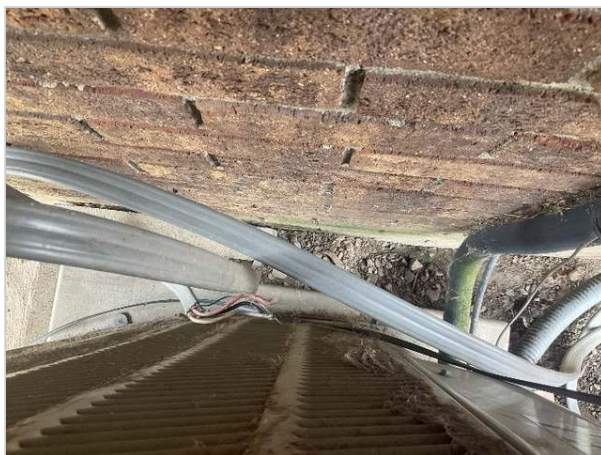
**NOTE: OPEN ELECTRICAL SPLICES:**

Open electrical splices were noted behind the ac unit. All electrical splices should be enclosed in an approved and covered electrical box. Electrical related repairs should be performed by a qualified electrician.

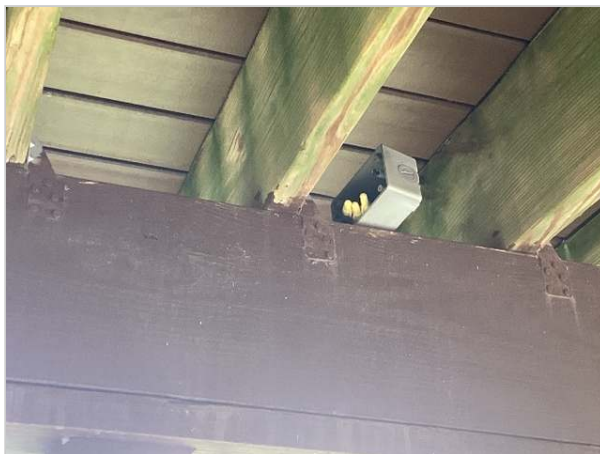
**NOTE: UNCOVERED ELECTRICAL JUNCTION BOX:**

shock hazard. Electrical related repairs should be performed by a qualified electrician.

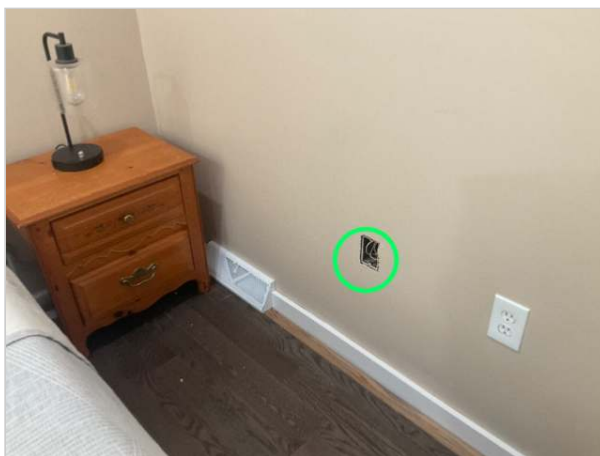
**SAFETY NOTE: MISSING SWITCH OR OUTLET COVERS:**

One or more missing switch or outlet covers were noted in the master bedroom. All switch and outlet boxes should be properly covered to avoid a shock hazard. Electrical related repairs should be performed by a qualified electrician.

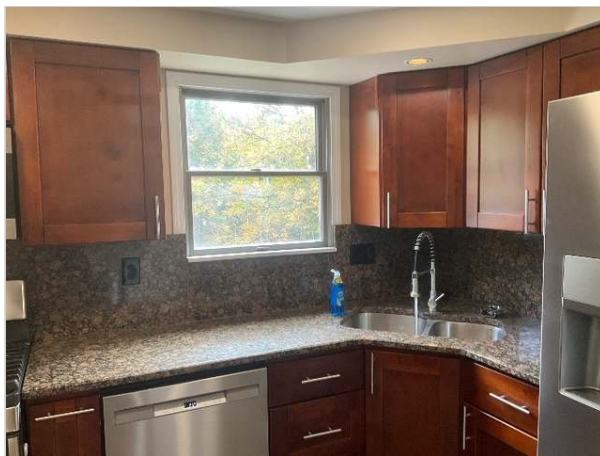
One or more of the insulated window panes throughout the home had a defective thermal seal. The window (s) were located in the kitchen. A defective thermal seal can be identified when fogging is observed between the panes of glass. This statement should not be considered all inclusive. Our ability to identify defective thermal seals is affected by dirty glass, the angle by which we can view the windows, window coverings and the direction of the sun. It is not possible to identify mild cases of fogging between glass panes given the conditions that affect our view. Repair of the thermal seal can be accomplished by replacing the affected glass panel.

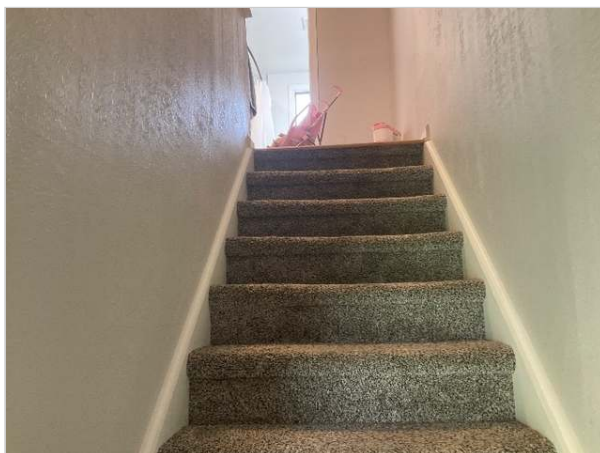
There was no handrail on the stairs leading to the second floor. This can be a safety concern. Local building codes may also require the installation of a handrail.
