2740 Shelly St

RE: Pittsburgh, PA 15203

Inspection #: 527-062025-6372

HOME INSPECTION REPORT

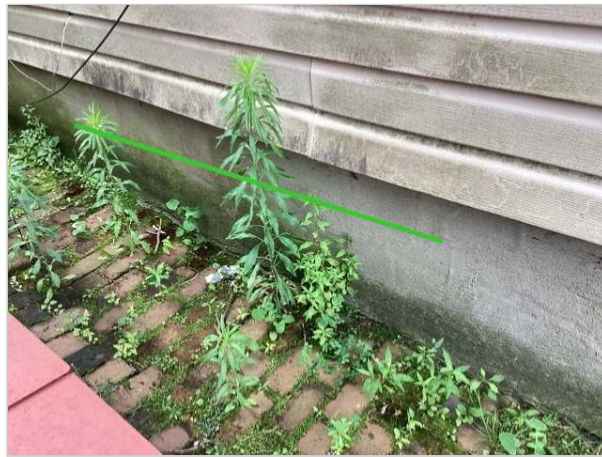
Left bottom

NOTE: LOOSE SIDING:

Loose siding was noted on the left side of the home. The siding should be reattached.

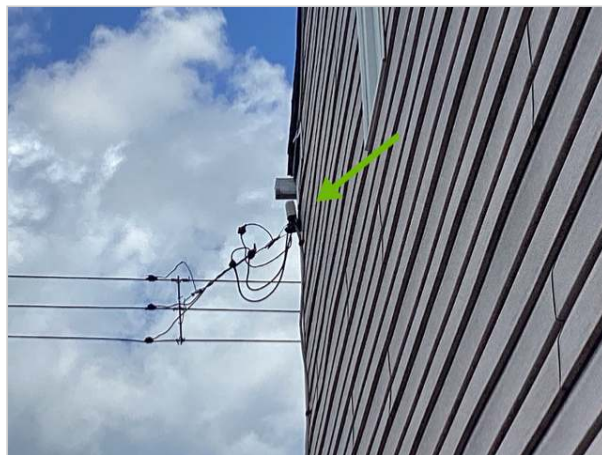
NOTE: LOOSE WEATHER HEAD:

The weatherhead at the top of the electric service entrance cable is not attached. Consult with a qualified electrician for repair.

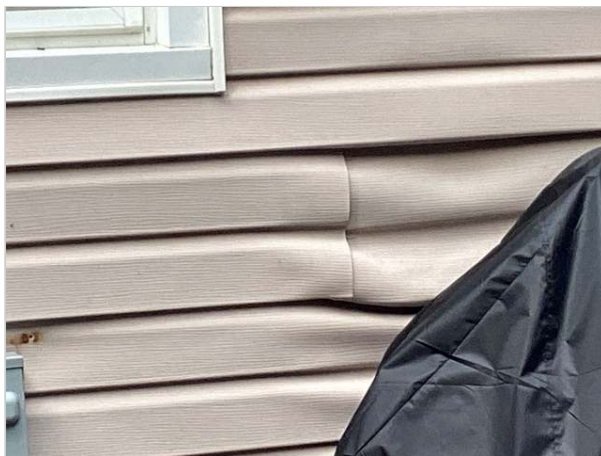
NOTE: SIDING:

Melted siding was noted in the siding on the back. This condition does not impact the structural integrity of the building, but can lead to water intrusion. Repairs should be made by a qualified contractor.

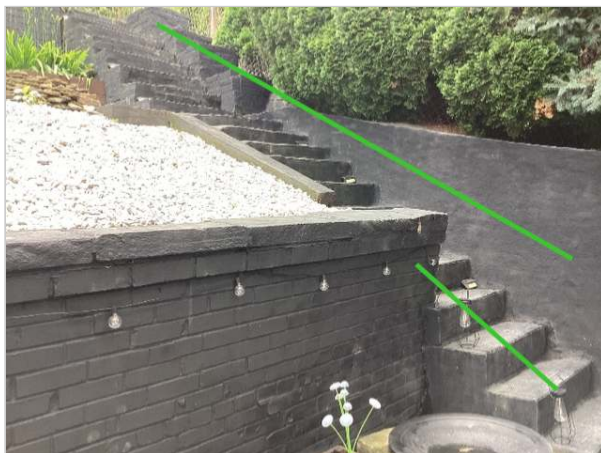
NOTE: EXTERIOR HANDRAILS:

There were no handrails on the steps in the back. Local codes may require the installation of handrails in location where three or more steps are present.

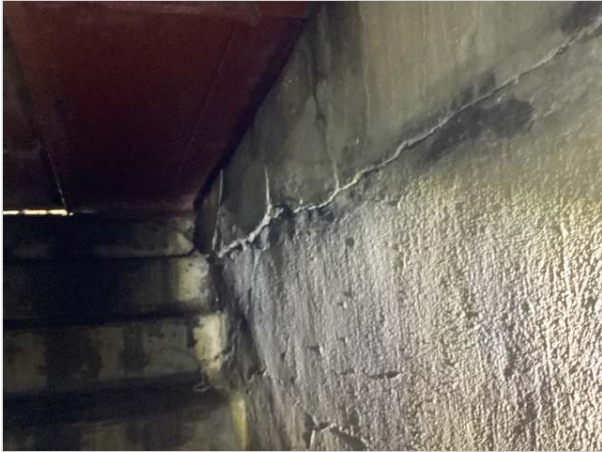
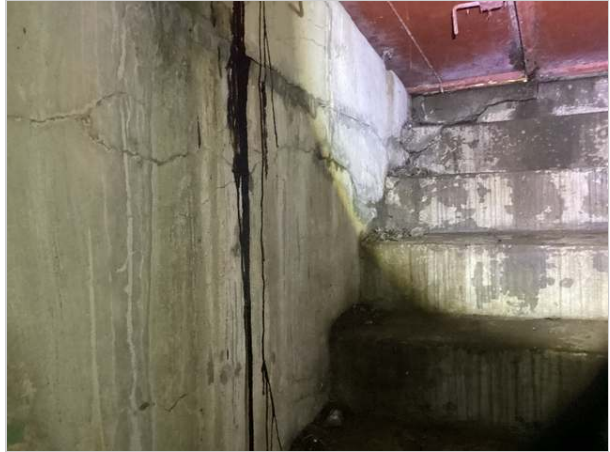
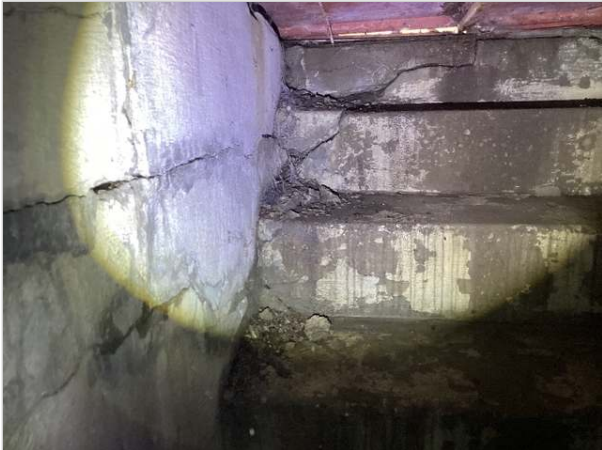
NOTE: AREA WAY RETAINING WALL:

The area way retaining wall at the steps leading to the basement access through the Bilco-type door is leaning inward. There were significant vertical earth pressure type cracks observed in the wall. This condition is most often associated with soil and / or water pressure. The displacement occurs incrementally as the wall yields to horizontal earth pressure. The wall was stable at the time of the inspection. Repairs to the wall may be required. Consult with a qualified contractor for further evaluation and recommendations.

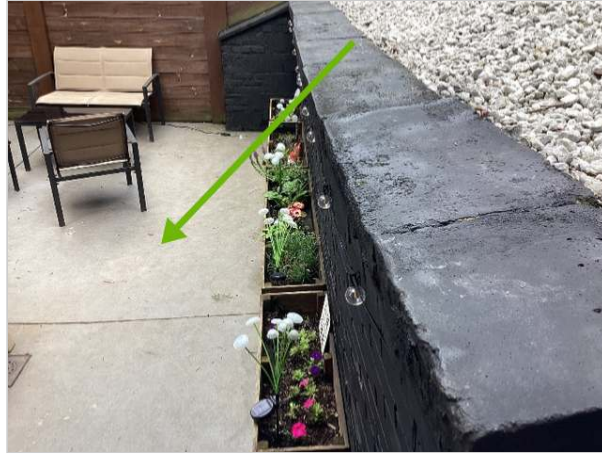
SAFETY NOTE: FALL HAZARD:

There is no barrier installed on the rear retaining wall. The absence of a proper rail or barrier constitutes a fall hazard and should be corrected. Consult with a qualified contractor for installation of a proper barrier.

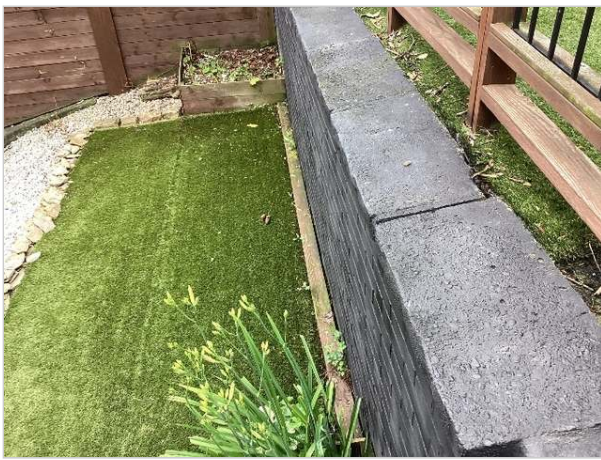
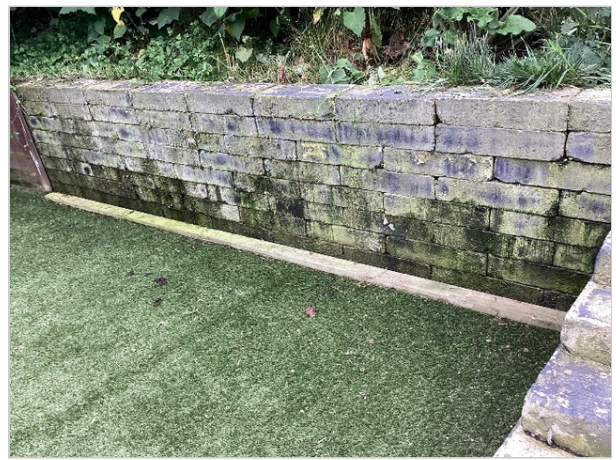
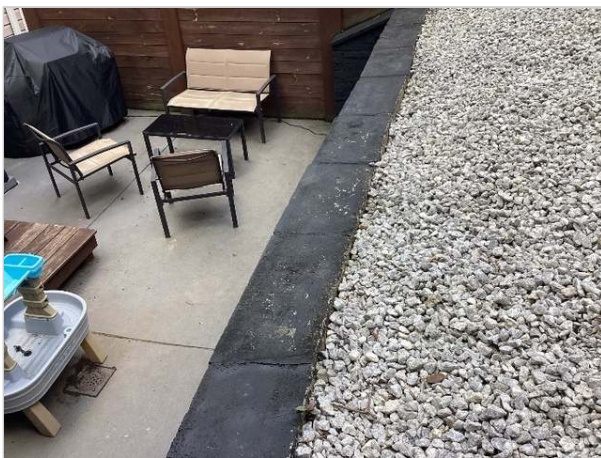
NOTE: RETAINING WALL:

The rear retaining walls are leaning inward. The displacement occurs incrementally as the wall yields to horizontal earth pressure. The walls were stable at the time of the inspection. Repairs to the wall may be required. Consult with a qualified contractor for repair estimates

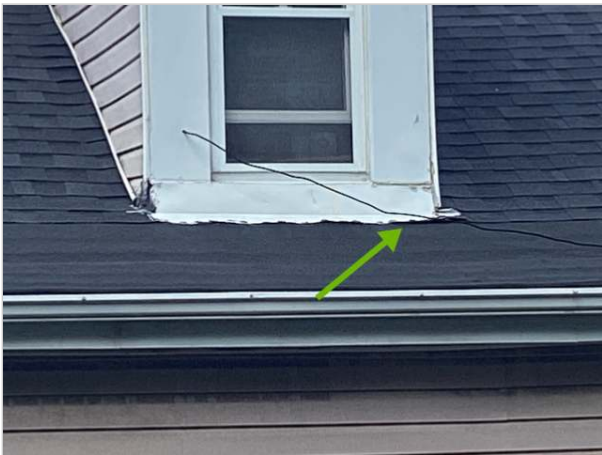
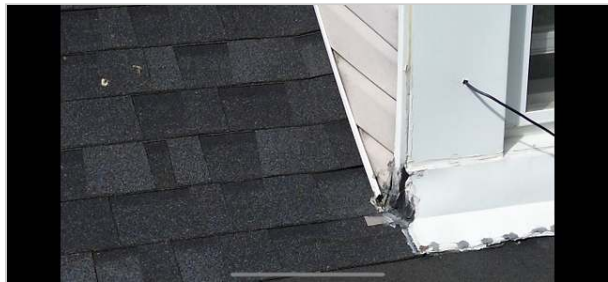
NOTE: LOOSE FLASHING:

Loose and damaged flashing was noted on the back dormer. Loose flashing could be a leak source. We cannot always determine if active leaks exist. Consult with a qualified roofer for further evaluation and repair.

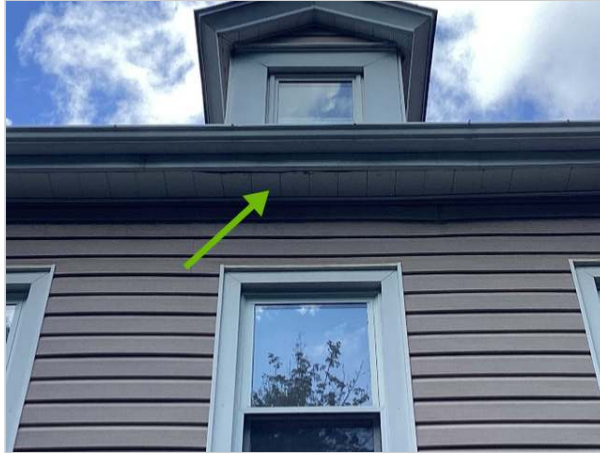
NOTE: SOFFIT & FASCIA:

Loose soffit was noted on the back. Consult with a qualified contractor for repair.

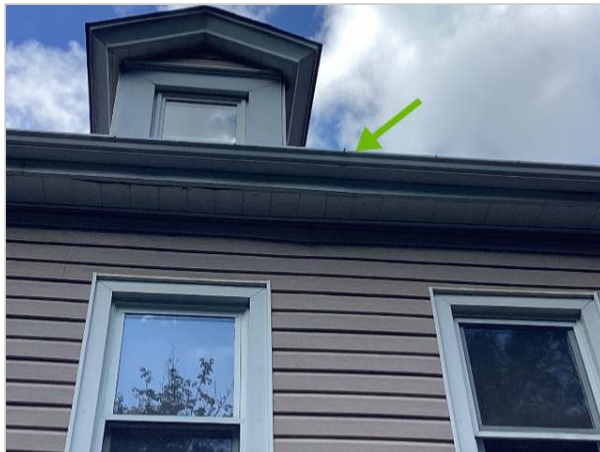
NOTE: LOOSE GUTTER MOUNTS:

One or more of the gutter mounts was noted to be loose at the time of the inspection. This is a common condition and is caused by expansion and contraction, along with the freeze thaw cycles that we experience in this area. The mounts should be re-secured.

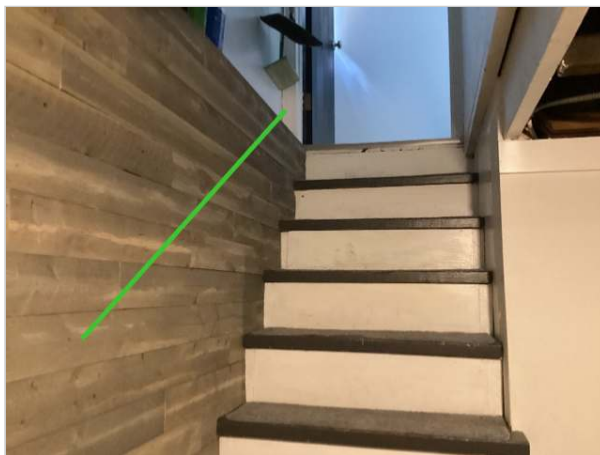
SAFETY NOTE: MISSING HANDRAIL:

There was no handrail on the stairs leading to the basement. This can be a safety concern. Local building codes may also require the installation of a handrail.

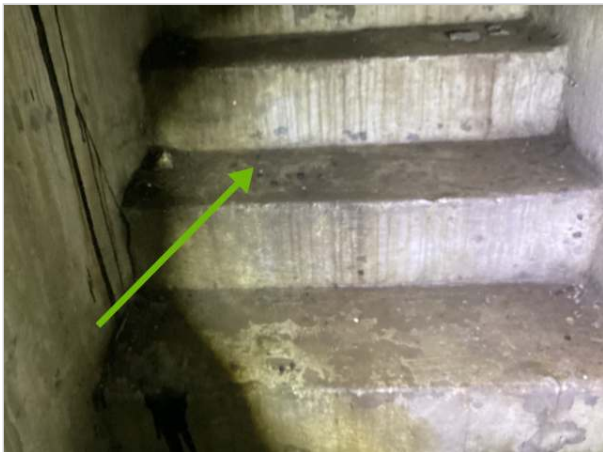
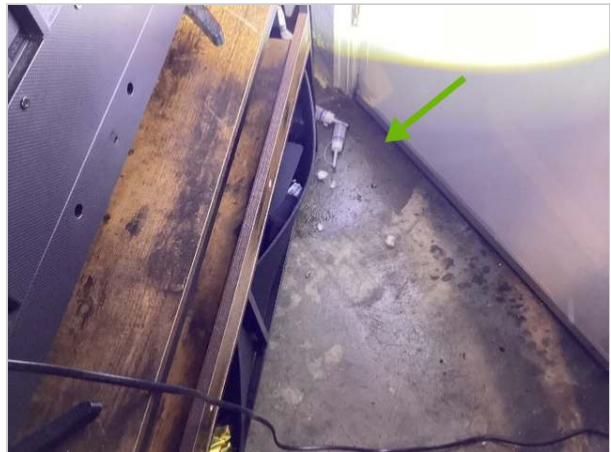
Water

NOTE: BASEMENT MOISTURE EVIDENCE:

There were signs of moisture on rear area way. The area was not dry at the time of the inspection. Dampness on basement walls is not always a sign of water intrusion. The dampness can be the result of warm humid air making contact with cool walls. In many cases the humid air condenses on the wall and forms a layer of moisture. It is important to assess whether moisture on the basement walls is the result of water intrusion or condensation. In this case the condition appears to be the result of water intrusion. The exterior grading in the affected area is questionable. Many water intrusion problems can be controlled by improving the drainage on the exterior of the home. It is important that all roof drainage and surface water is directed away from the foundation. Any concern about this condition should be referred to a qualified contractor for evaluation and recommendations.

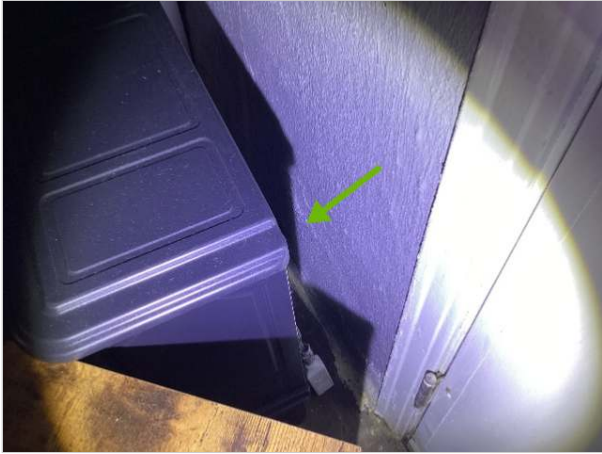
Rear wall efflorescence

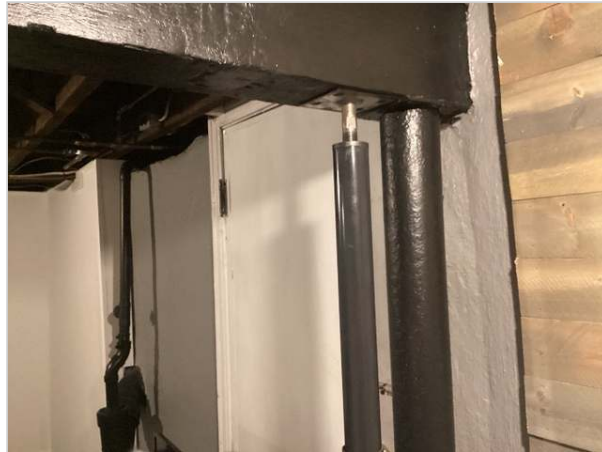
NOTE: BASEMENT SUPPORT POST:

The adjustable support post installed to provide vertical support to the main beam is not designed for permanent installation. These posts are designed to provide temporary support during repair and are not meant to support the weight of the structure on a long term basis. Additionally, a proper vertical support post should be installed on a concrete footing, usually located below the floor. Consult with a qualified contractor or structural engineer for evaluation and recommendations.

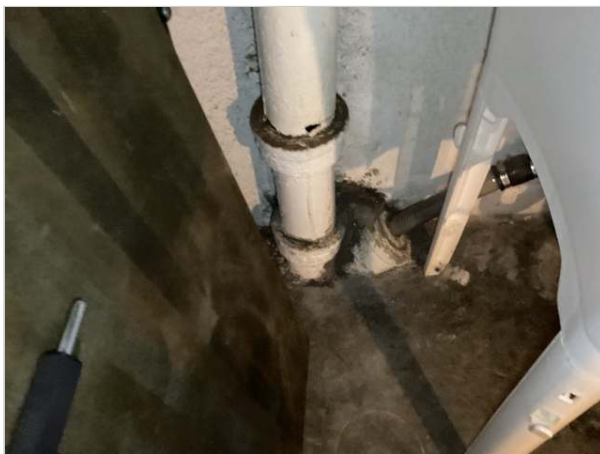
NOTE: DRAIN STACK:

The drain stack near the front basement wall was rusted at the time of the inspection. Consult with a qualified plumber for repair.

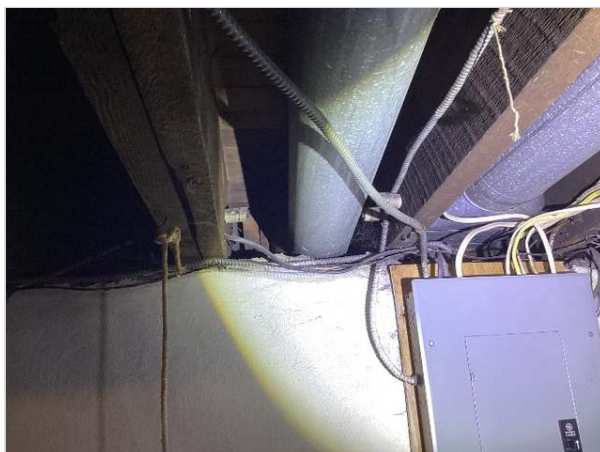
NOTE: INACTIVE KNOB & TUBE WIRING:

Inactive knob and tube wiring was observed in the home. All visible sections of the knob and tube wiring were tested and found to be inactive. Most of this wiring is concealed in walls, ceilings and insulation where its condition cannot be completely evaluated.

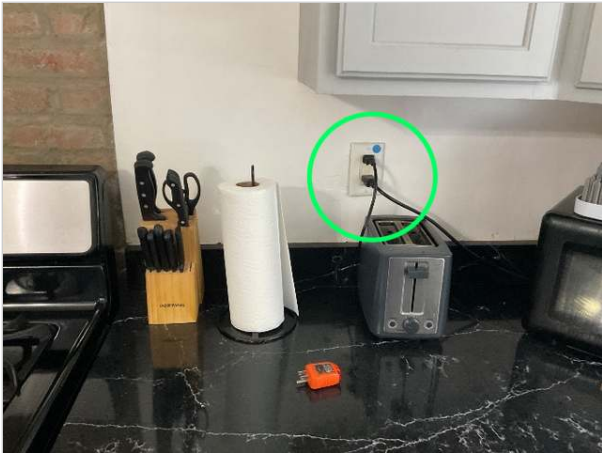
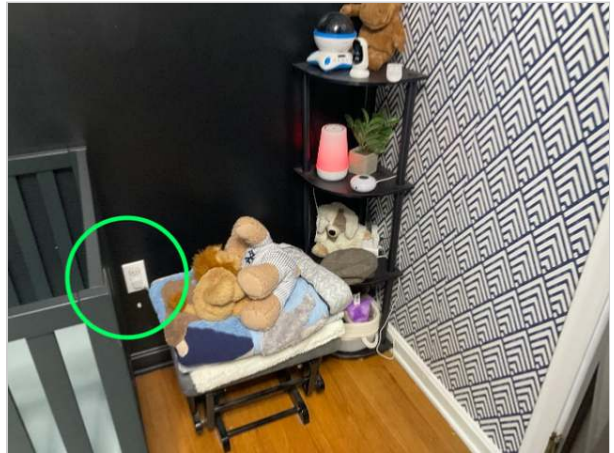
SAFETY NOTE: DEFECTIVE GFCI:

The GFCI outlet located the kitchen and bedroom is defective and should be replaced by a qualified electrician.

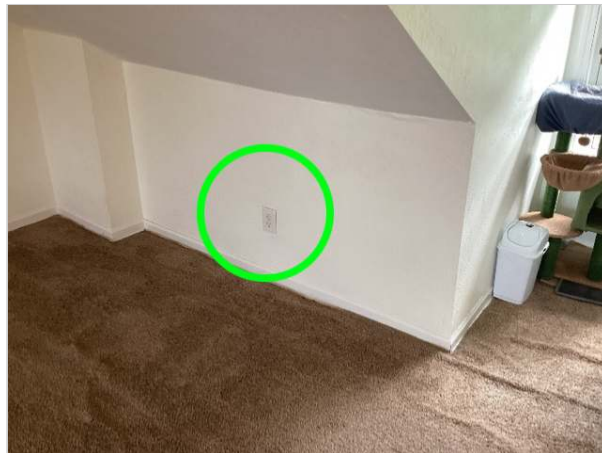
SAFETY NOTE: LOOSE OUTLET:

A loose outlet was noted in the 3rd floor. This could be a shock hazard due to exposed electrical contacts. The affected outlet(s) should be secured by a qualified contractor.

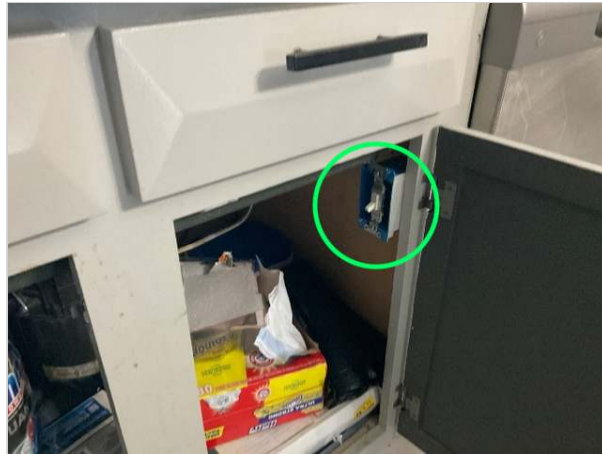
SAFETY NOTE: MISSING SWITCH OR OUTLET COVERS:

One or more missing switch or outlet covers were noted under the kitchen sink. All switch and outlet boxes should be properly covered to avoid a shock hazard. Electrical related repairs should be performed by a qualified electrician.

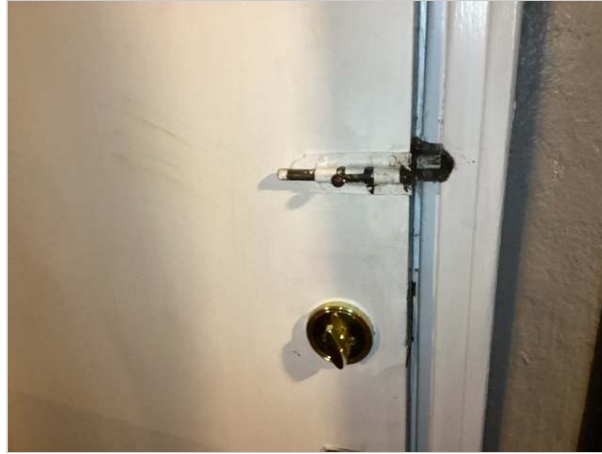
SAFETY NOTE: INOPERABLE LOCK:

The garage man-door lock is inoperable or otherwise in need of repair. For personal security consult with a qualified locksmith for repair.

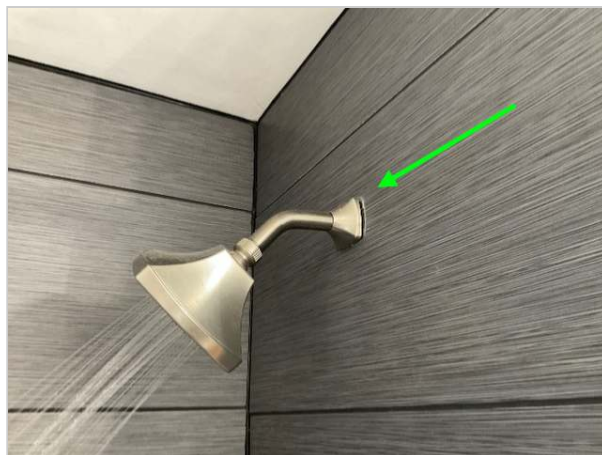
MAINTENANCE NOTE: BATHROOM CAULKING:

Failure to keep walls sealed can cause deterioration and extensive moisture damage including mold growth to the interior walls, which is not always visible at the time of the inspection. Some of the caulk was missing from around the shower and tub . These areas should be re-caulked to help prevent moisture penetration.

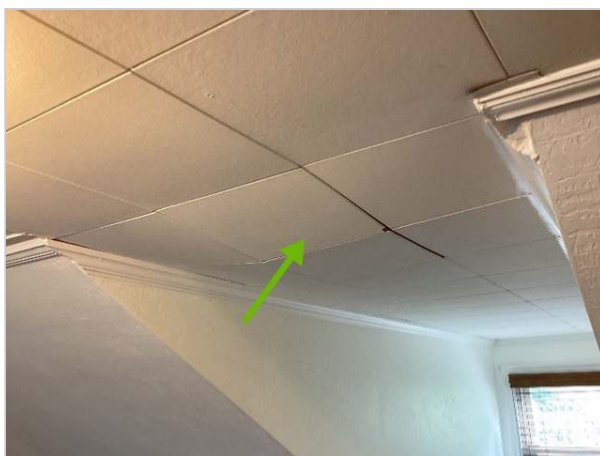
NOTE: WATER MARKS THIRD LEVEL:

Water marks with minor surface damage was noted on the ceiling in the third floor bedroom. No immediate action is required. The affected area (s) should be monitored for evidence of new leaks. Consult with a qualified contractor for repair if required.

Sagging tiles
