# Property Inspection Report

**30 Colecrest Street, Carnegie, PA**

DATE OF INSPECTION: 7/17/2025

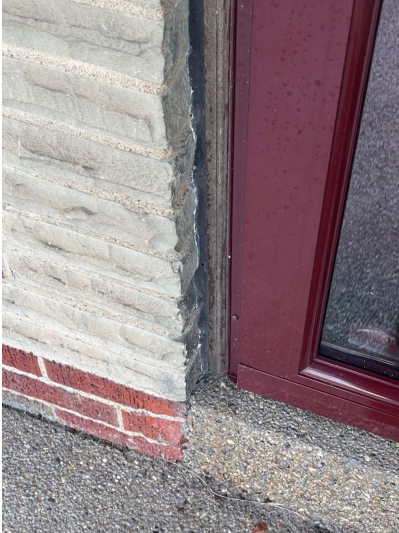
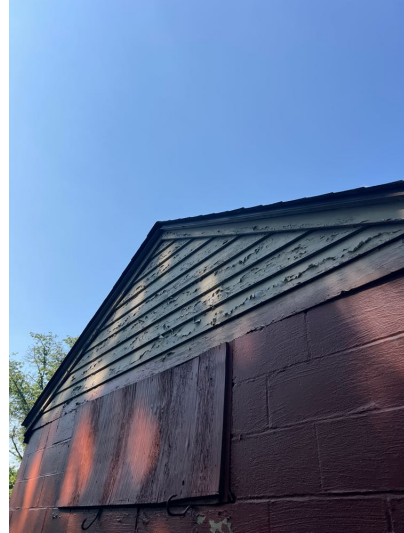
## 5. Exterior Trim

- There are areas of peeling paint and wood-rot visible on exterior of house and garage. The peeling paint should be scraped and re-painted. Any areas of wood rot should be replaced.

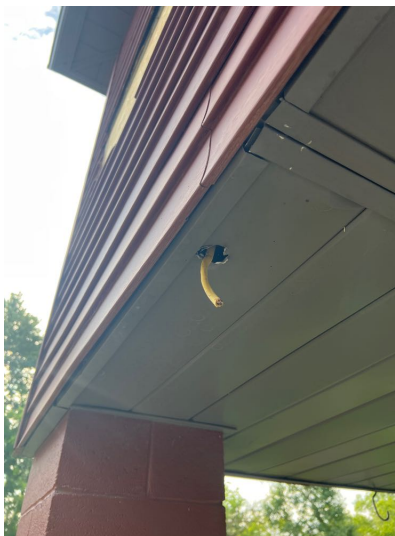
## 8. Lights

- The exterior lights of the residence are functional. However, we do not inspect or evaluate decorative or gas lights.
- There is a loose wire on exterior of house which should be removed by an electrician or properly installed in to a junction box.

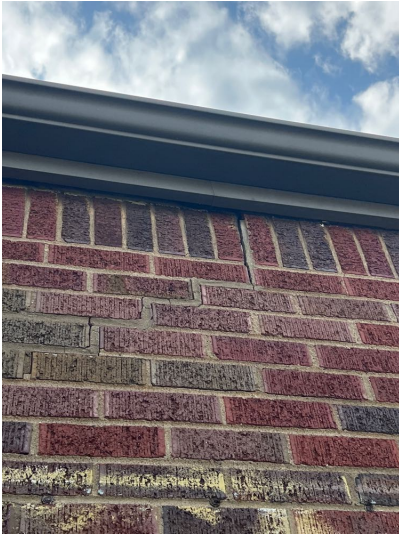
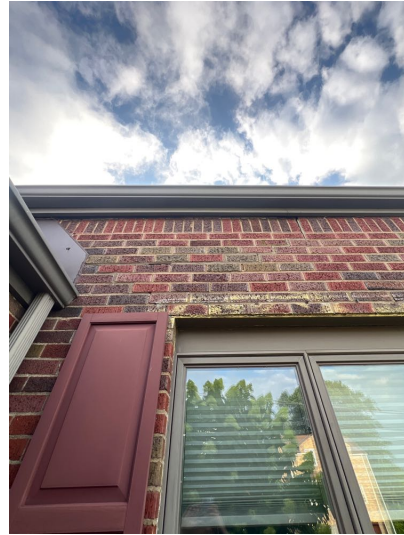
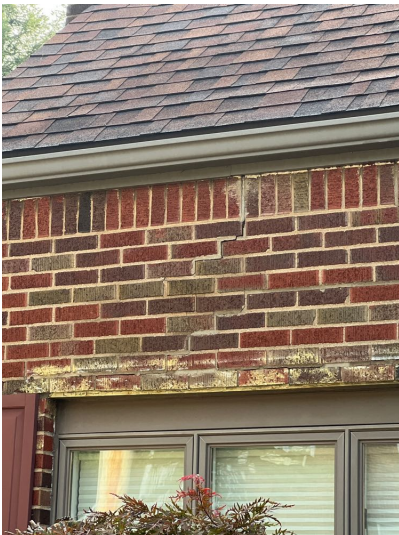
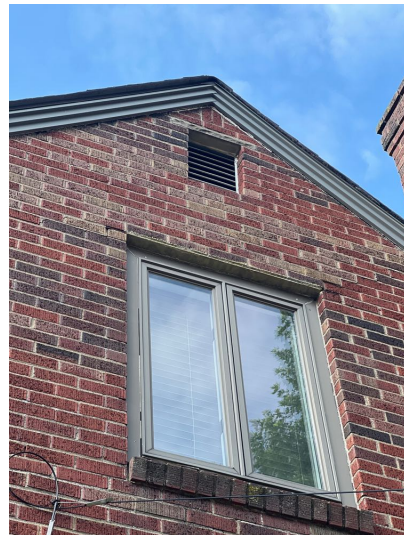
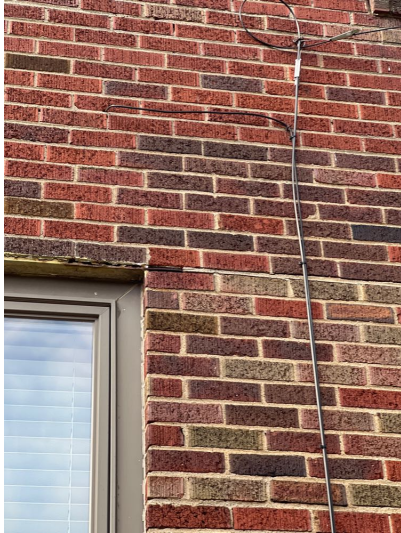
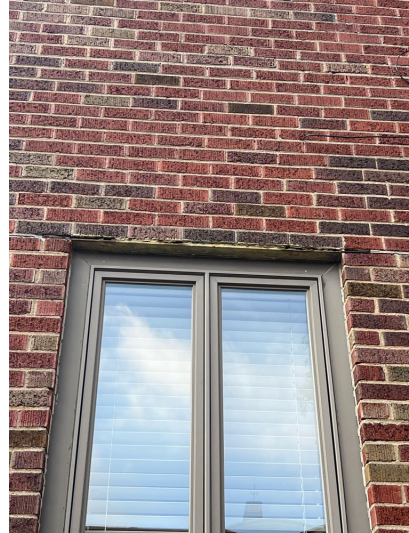
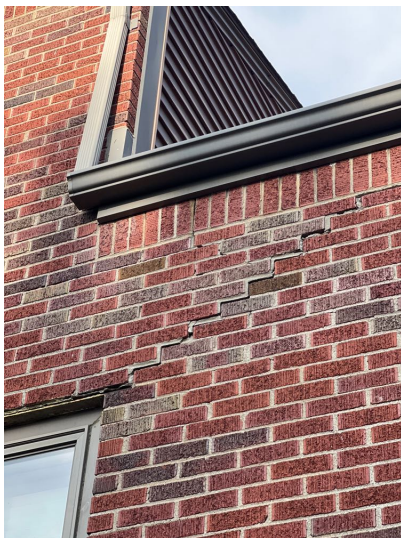
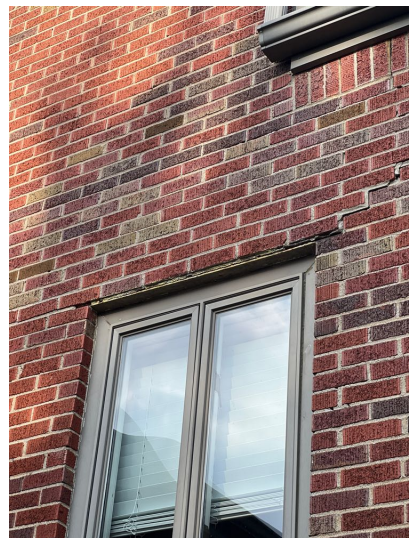
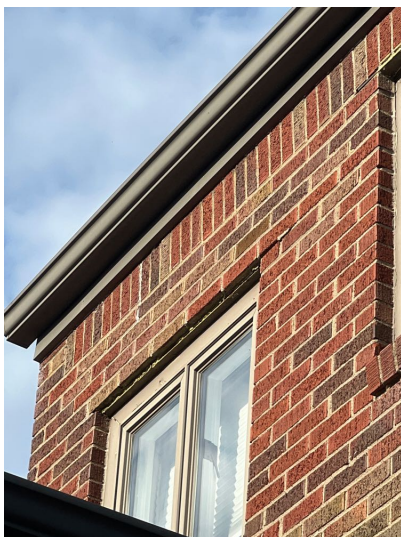
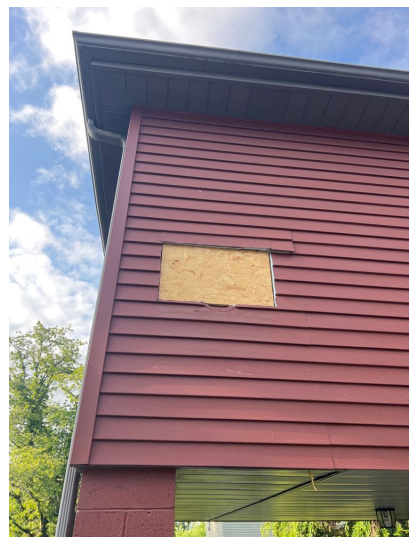
## 2. Wall Covering Condition

- Areas of missing mortar need repaired to help prevent further damage. A mason should evaluate the entire house and make all repairs needed.
- Some areas of siding are loose and missing. A Contractor should further evaluate and make repairs as needed.
- The window lintels are rusted and have visible deflection, which has resulted in brick movement and missing mortar. A contractor should further evaluate and make repairs as needed.

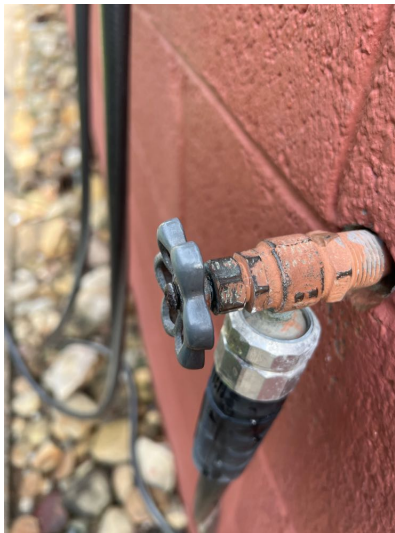
## 1. Garden Hose Bibs

- A hose bib on the exterior leaks while in use and should be repaired or replaced by a plumber.

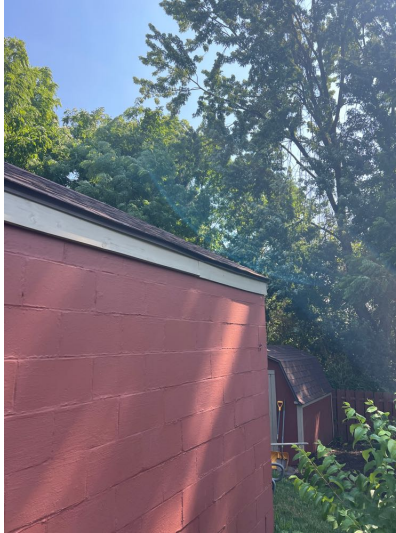
## 4. Gutters

- There are no gutters on the garage roof, which are recommended for the maintenance of the foundation. I recommend that a contractor install a complete gutter system in this area.

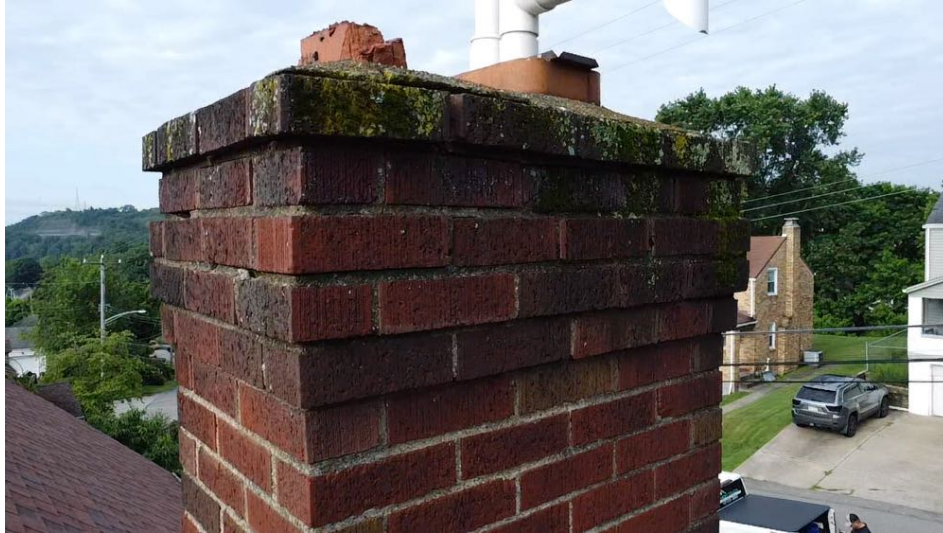
- The chimney has areas of missing mortar that should be repointed. A chimney sweep or qualified contractor should further evaluate each chimney and make repairs as needed.

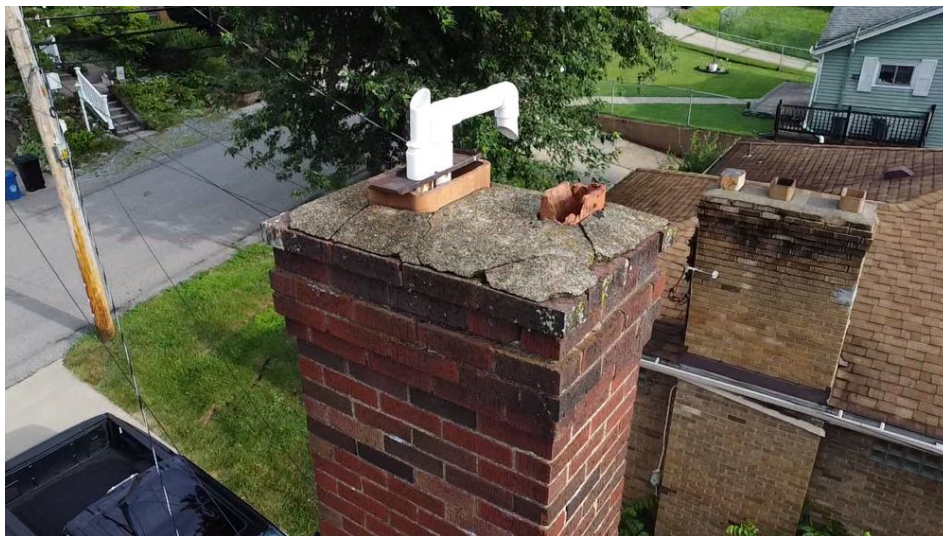
- The chimney crown, which is designed to seal the chimney wall and divert rainwater, is cracked and should be repaired to help prevent moisture penetration. A qualified contractor or chimney sweep should further evaluate and make repairs as needed.

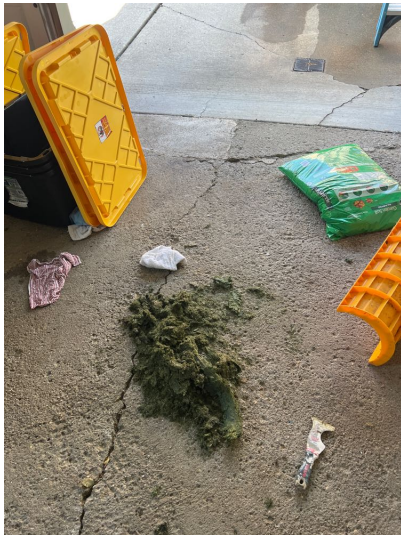
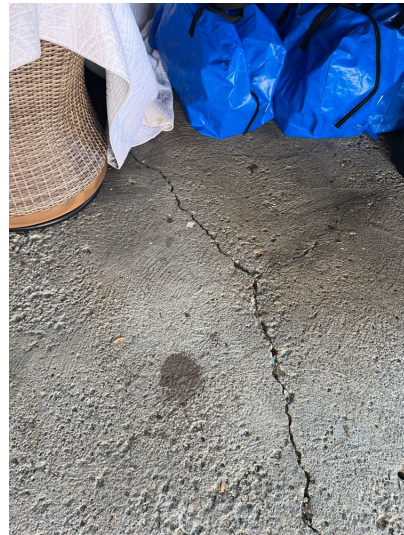
- The garage slab is cracked, but not load-bearing. We do not feel that repairs are needed, however if you wish, a contractor could evaluate.

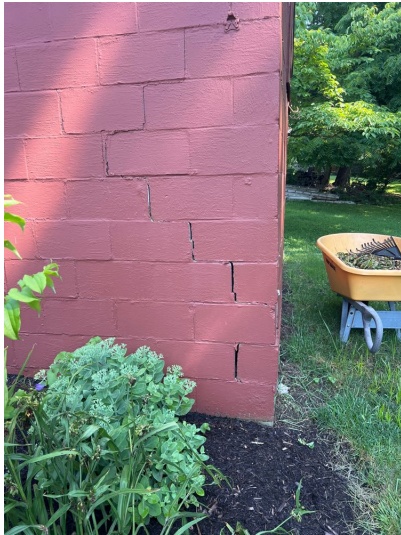
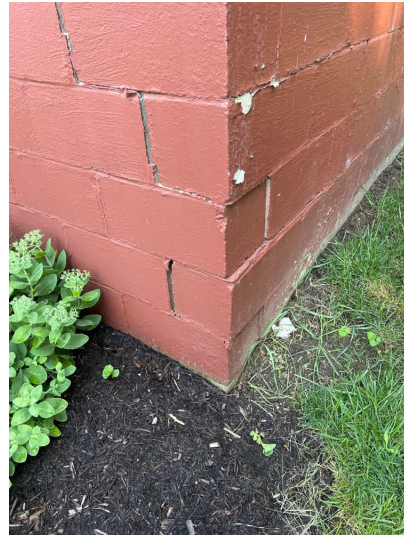
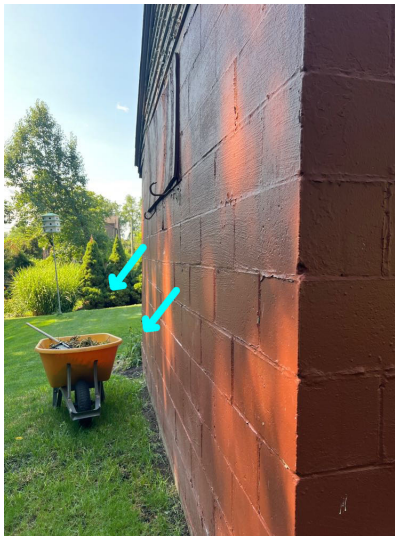
## 3. Walls And Ceiling

- The rear foundation wall of the garage has a significant amount of movement and damage. Repairs should be made by a certified contractor as needed.

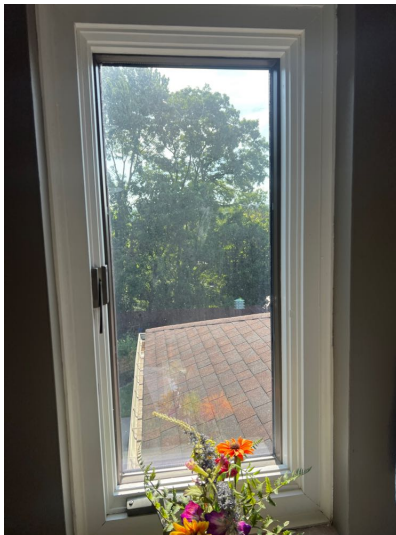
- The windows in this room are dual glazed.
- A dual-glazed window has a broken hermetic seal that has fogged the glass.

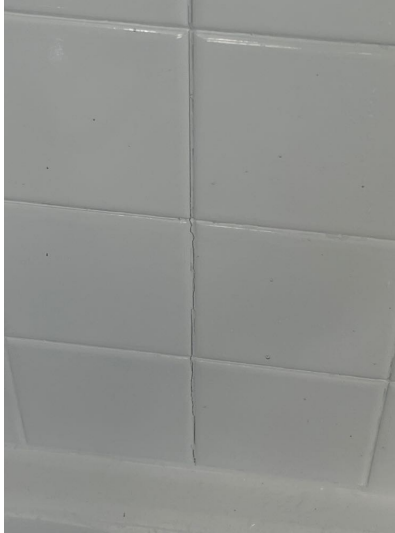
- The access area behind the tub was evaluated and there were no visible leakage at the time of the inspection.
- There are open grout-joints in the tiles around the tub area of the bathroom that should be sealed to prevent moisture damage. A contractor should further evaluate and make repairs as needed.

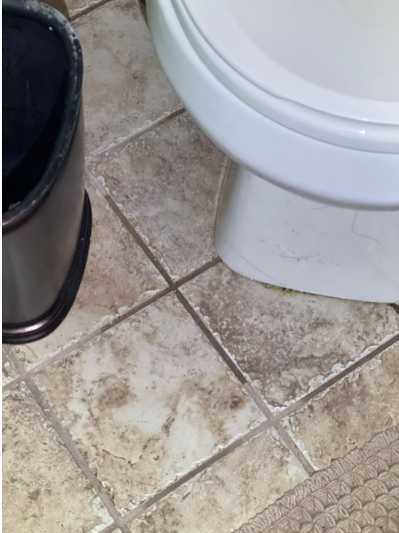
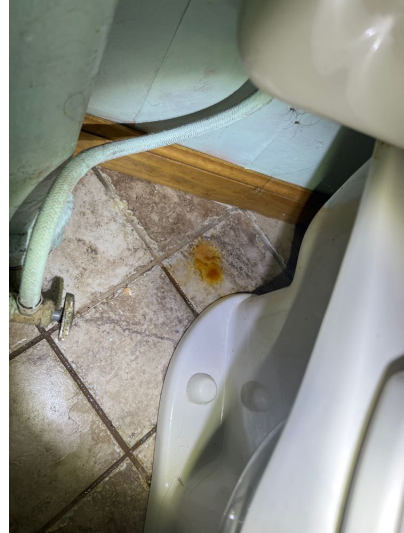
- The toilet was leaking on the floor and should be further evaluated by a plumber and repaired as needed.

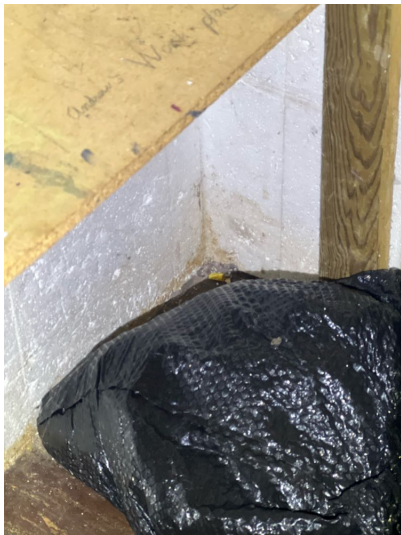
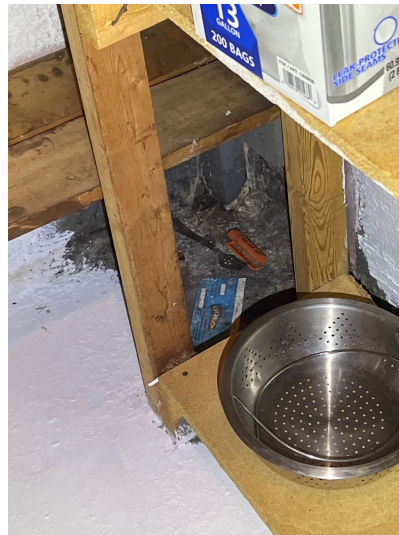
## 2. Moisture or Dampness

- There is efflorescence or staining on the basement or lower level walls, which is caused by moisture intrusion. This in our area is not uncommon, however, it should be controlled. The exterior grading around the house should be built up to slope away from the house at a drop of 5 inches over 5 feet. As with most basements, you should know that future moisture penetration is possible.

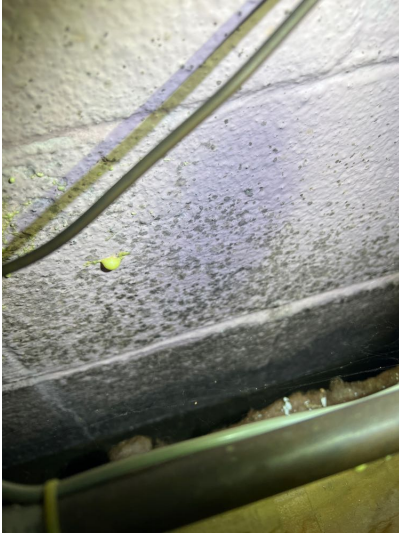
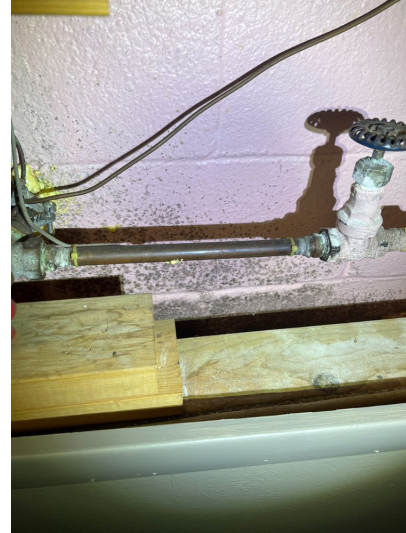
## 4. Foundation

- There are areas of cracking or movement in the foundation walls. In most cases this is from moisture freezing against the wall, expanding, which is causing a shift at the wall. This is also called hydrostatic pressure. There are areas of movement at some walls at this property however, I do not feel that they are necessarily an issue that need repaired or evaluated by a certified contractor at this time. However, you may wish to have a specialist evaluate. If the moisture is not controlled, as noted in the grading section of the report, then future repairs should be expected in these areas of the basement.

- There is an unidentified moldlike substance in the basement, which should be further evaluated by a specialist.

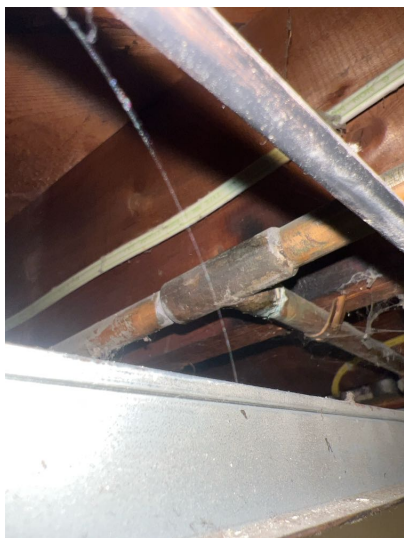
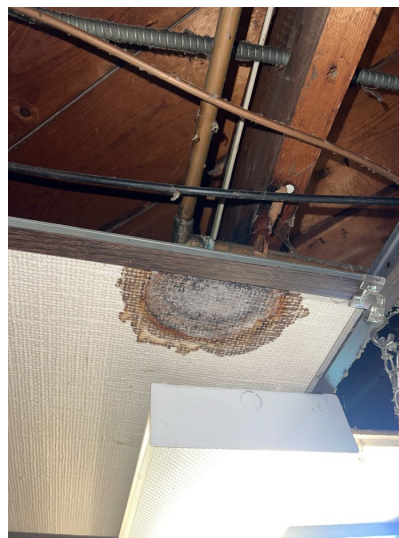
## 3. Water Pipe Condition

- The plumbing components are older and there are signs of aging and corrosion. Repairs should be expected in the future.
- There is a leak at a fitting in basement, above the washer, which should be repaired by a plumber.

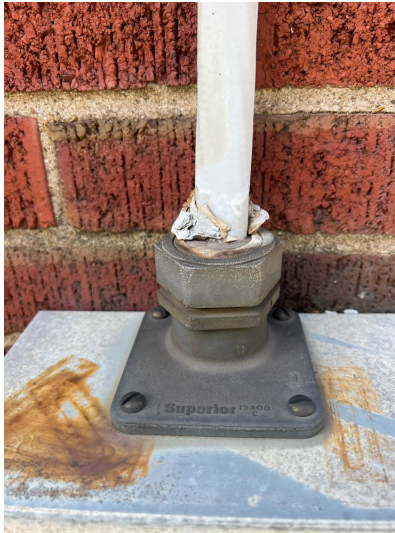
- Putty at service entrance to meter is drying out and opened. It should be resealed to help prevent water entry.

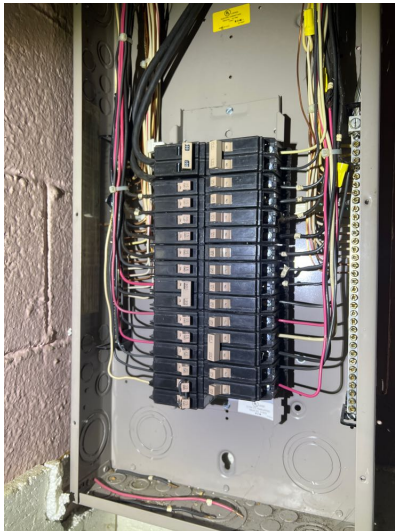
## 4. Main Panel

- The main electrical panel is not an original installation and has no inspection sticker on it. This panel should be inspected by an electrical inspector.
