# Property Inspection Report

**3074 Piney Bluff Drive, , PA**

DATE OF INSPECTION: 7/21/2026

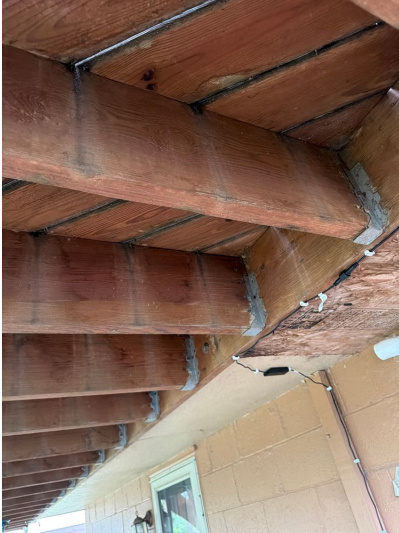
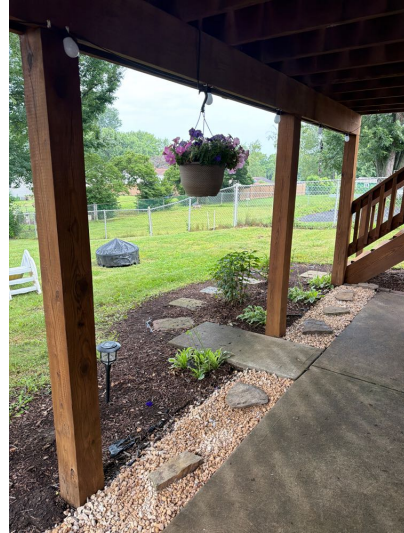
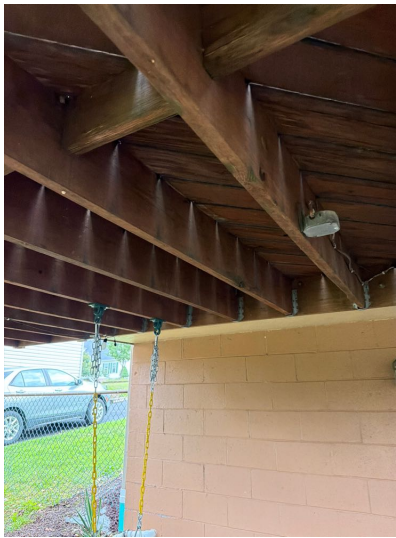
- The wood decks are in acceptable condition, and should be maintained and periodically sealed.
- Many decks in our area are not built properly or have permits that have been pulled to build the deck. You should ask the sellers if a permit was pulled for this deck.
- I was unable to determine if the deck columns were properly sitting on a footer. If the columns are not resting on a footer, they may be more prone to sagging or settling over the years.

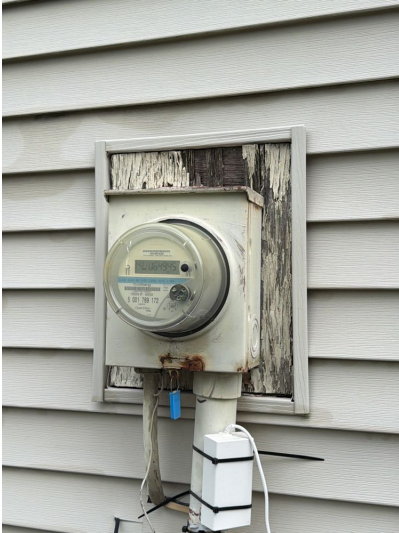
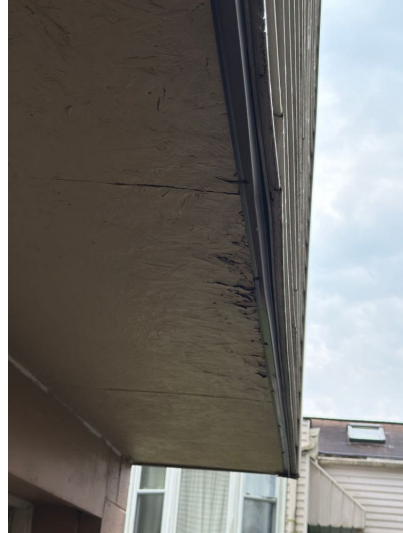
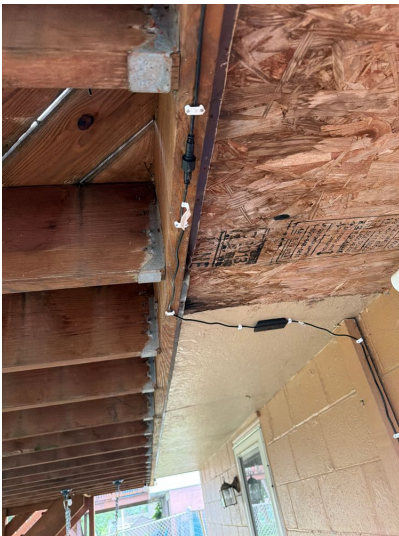
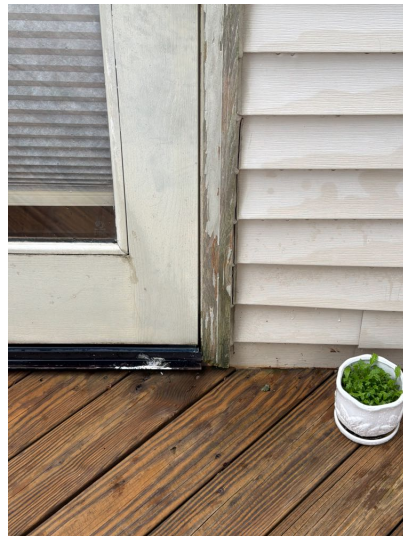
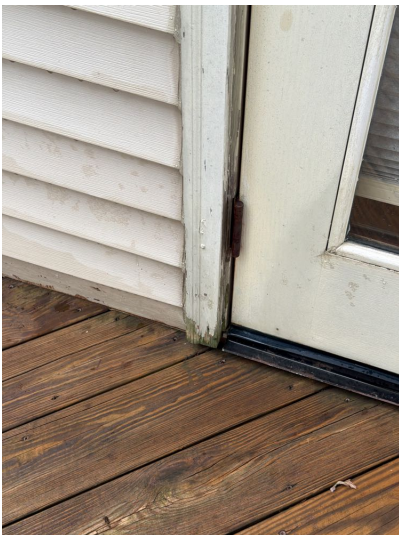
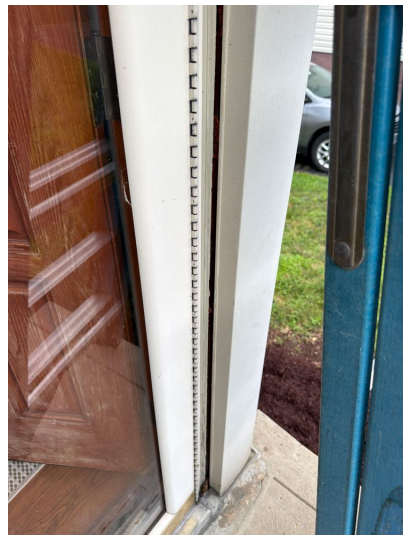
## 5. Exterior Trim

| Exterior Components | | |
|---|---|---|
| Page 6 Item: 5 | Exterior Trim | <ul style="list-style-type: none"> <li>• There are areas of peeling paint and wood-rot visible on exterior of house. The peeling paint should be scraped and re-painted. Any areas of wood rot should be replaced.</li> <li>• The wood behind the service meter is significantly rotted. This could potentially allow moisture behind the meter and behind the siding. Repairs should be made as needed.</li> <li>• The trim piece at the front right side is loose and needs sealed around the door frame. Repairs should be made as needed to help prevent moisture intrusion.</li> </ul> |

- There are areas of peeling paint and wood-rot visible on exterior of house. The peeling paint should be scraped and re-painted. Any areas of wood rot should be replaced.
- The wood behind the service meter is significantly rotted. This could potentially allow moisture behind the meter and behind the siding. Repairs should be made as needed.
- The trim piece at the front right side is loose and needs sealed around the door frame. Repairs should be made as needed to help prevent moisture intrusion.

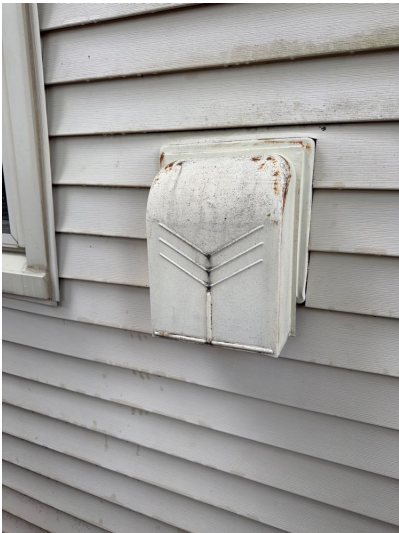
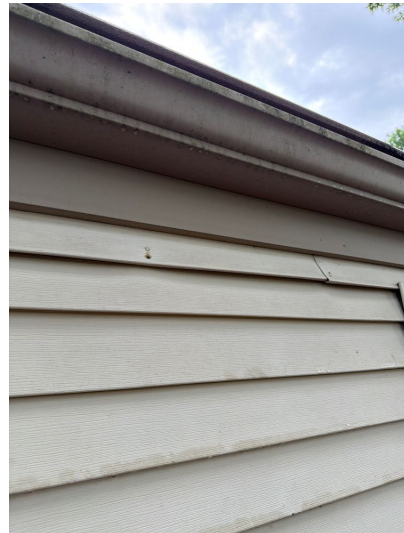
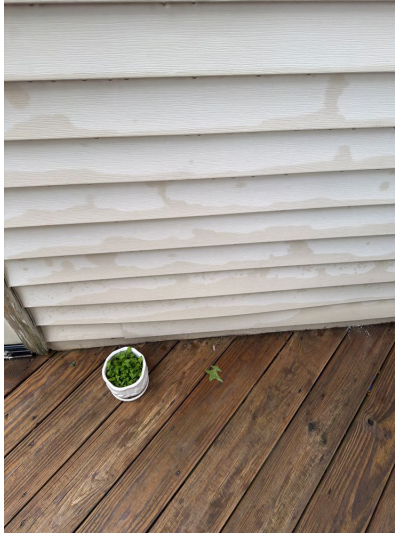
- The exterior house walls are clad with a combination of stone and vinyl siding.

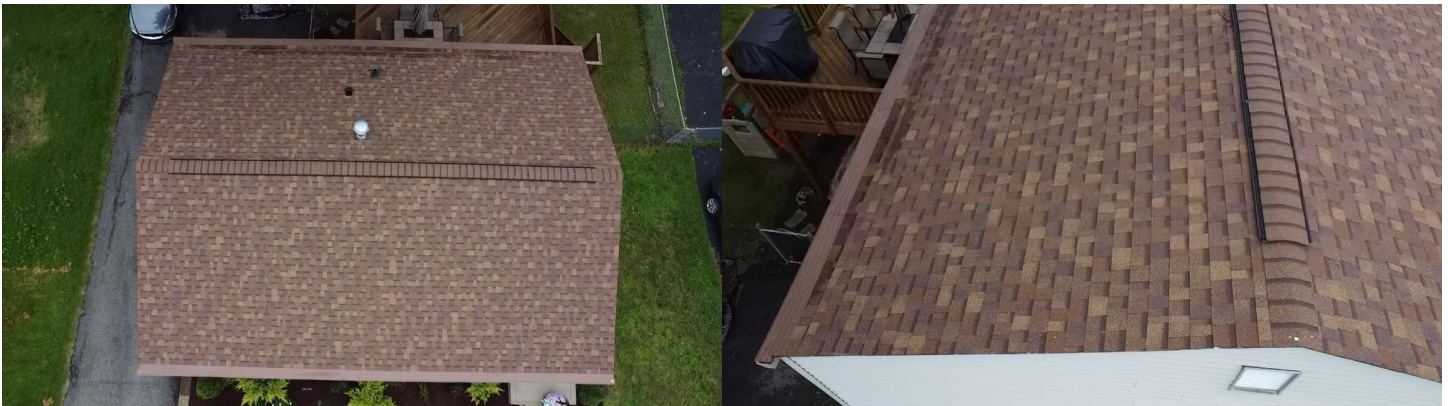
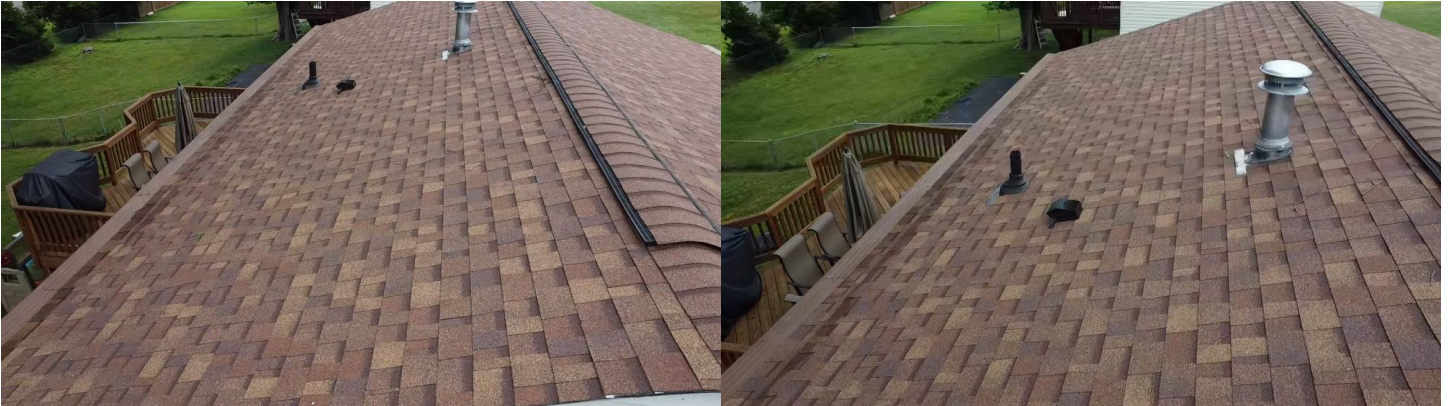
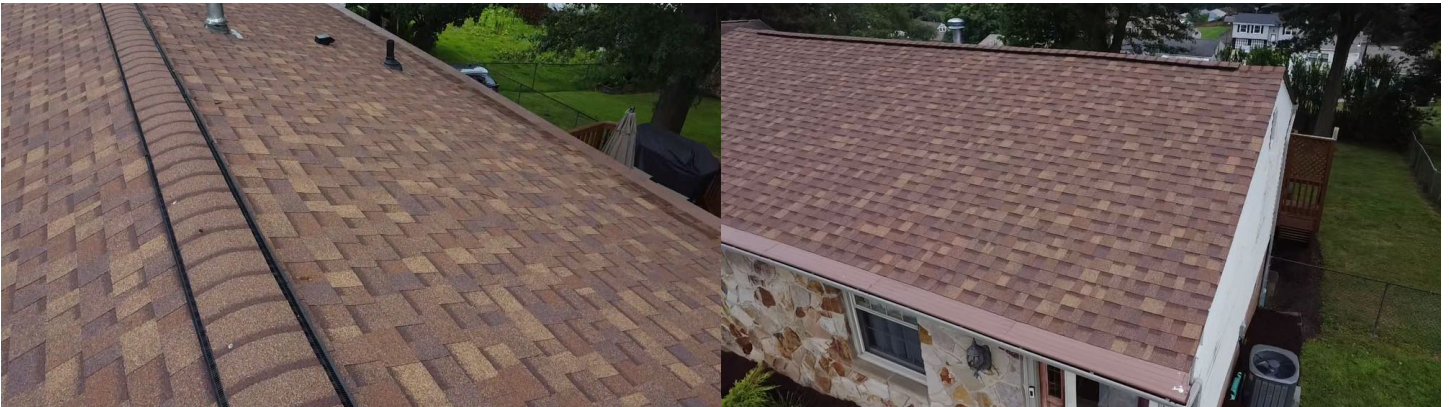
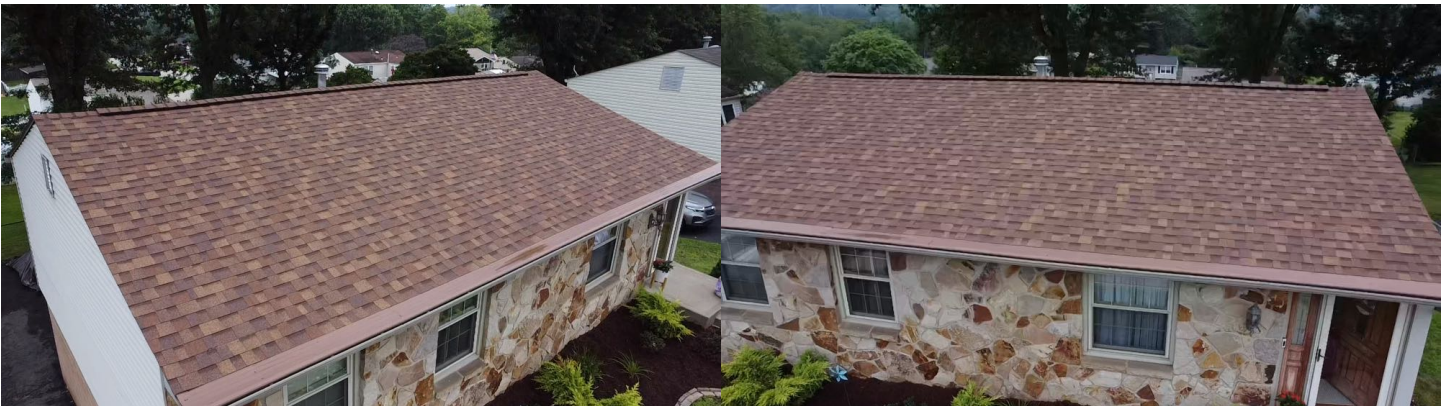
- The composition shingle roof appears to be 3 years old. This is just an estimate and you should ask the sellers if they have an exact date of install. It is important to keep all receipts and documents for warranty and material maintenance requirements.
- The composition shingle roof is in acceptable condition. Our inspection does not include any guarantee for any type of roof leaks that may occur in the future.

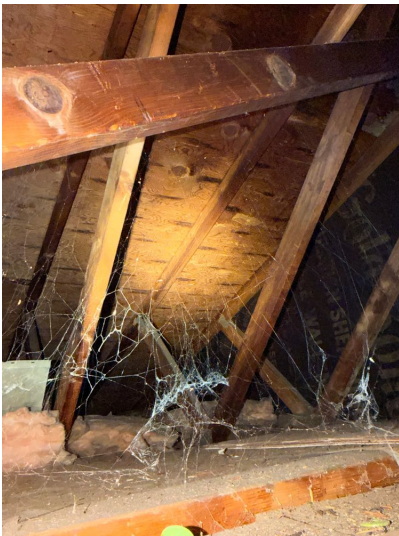
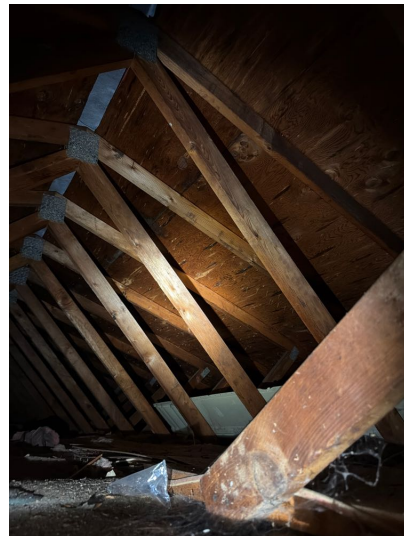
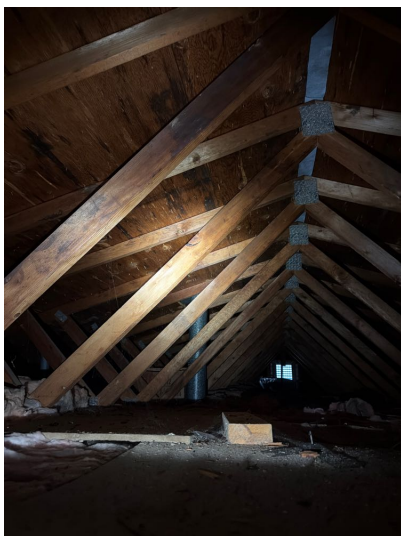
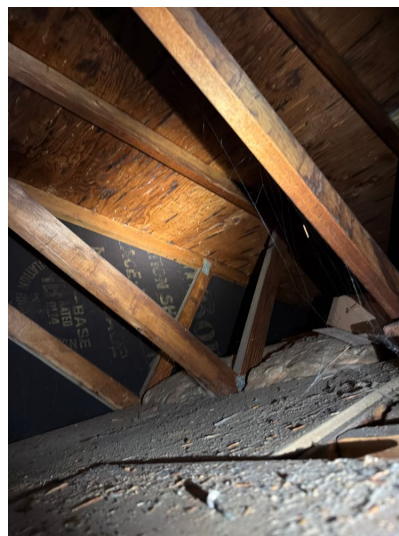
- The visible portions of the framing are in acceptable condition, and would conform to the standards of the year in which they were constructed.
- The roof framing is made of a factory-built truss system.
- There are moisture stains or evidence of damage or past leakage to the roof sheathing. We did not feel that the stains were active at this time, although they should be monitored.

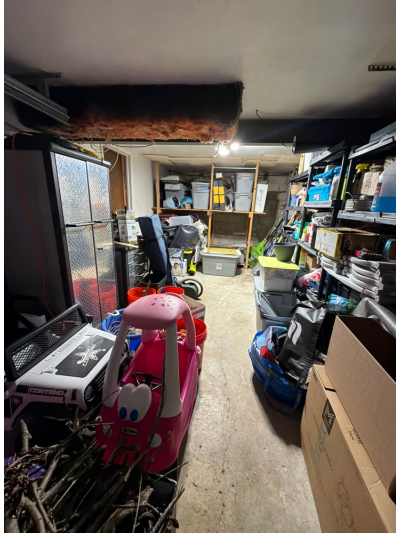
- The garage slab was covered and obstructed at the time of the inspection. I was unable to view the entire slab and evaluate.

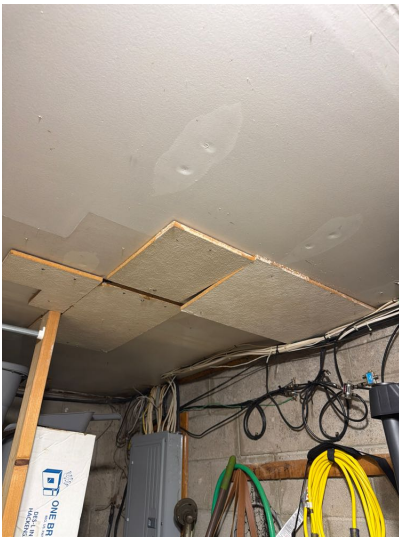
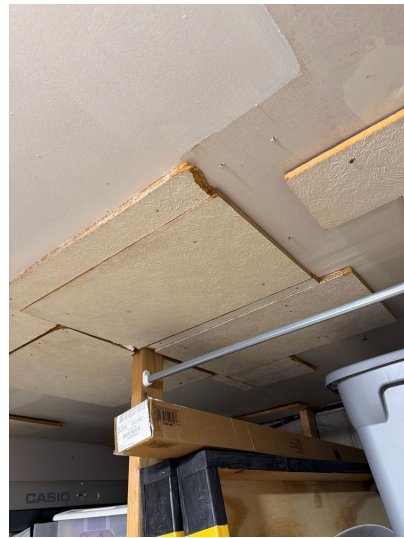
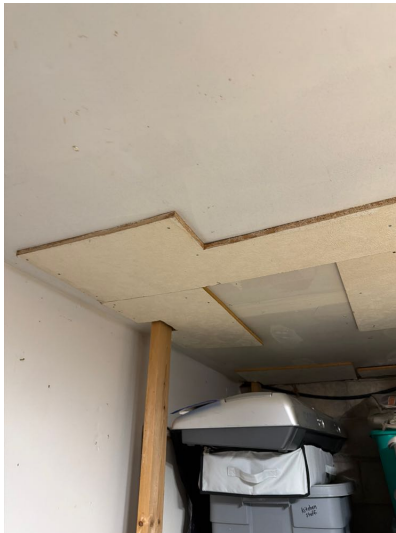
### 3. Firewall

| Garage | | |
|---|---|---|
| Page 16 Item: 3 | Firewall | <ul style="list-style-type: none"> <li>There are voids, and holes in the drywall that were covered with a material that are not fire rated, in the garage ceiling. These voids should be filled in or covered over with a fire-rated material to help maintain the necessary firewall separation between this garage and the living quarters. A contractor should make repairs.</li> </ul> |

- There are voids, and holes in the drywall that were covered with a material that are not fire rated, in the garage ceiling. These voids should be filled in or covered over with a fire-rated material to help maintain the necessary firewall separation between this garage and the living quarters. A contractor should make repairs.

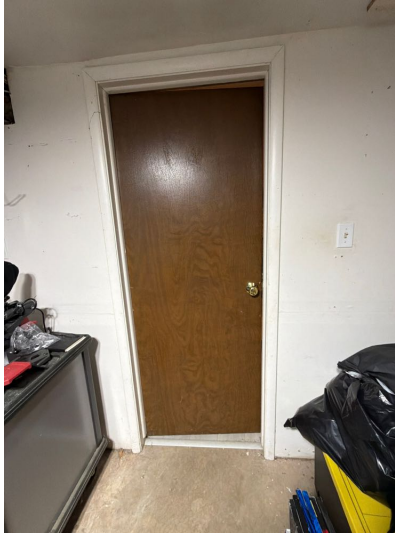
#### 4. Entry Door To House

| Garage | | |
|---|---|---|
| Page 17 Item: 4 | Entry Door To House | <ul style="list-style-type: none"> <li>The entry door from the garage, into the house does not appear to be fire-rated. A fire-rated door should be installed to help prevent the spread of a fire into the living space.</li> </ul> |

- The entry door from the garage, into the house does not appear to be fire-rated. A fire-rated door should be installed to help prevent the spread of a fire into the living space.

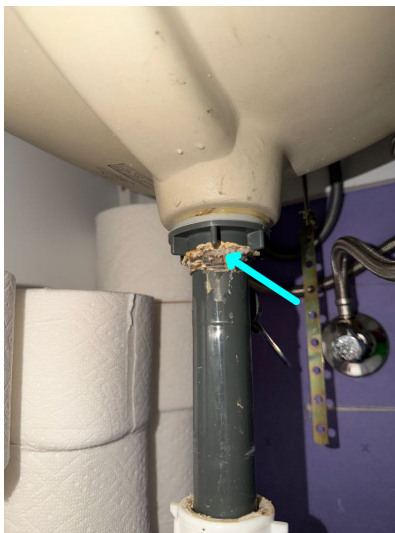
| Garage | | |
|---|---|---|
| Page 21 Item: 5 | Sink | <ul style="list-style-type: none"> <li>There is a leak at the drain below the bathroom sink, which should be repaired by a plumber.</li> </ul> |

- There is a leak at the drain below the bathroom sink, which should be repaired by a plumber.

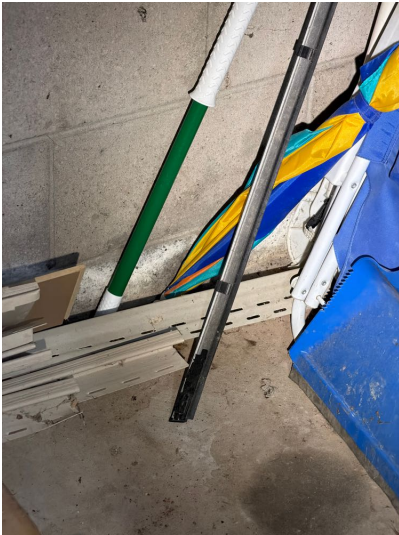
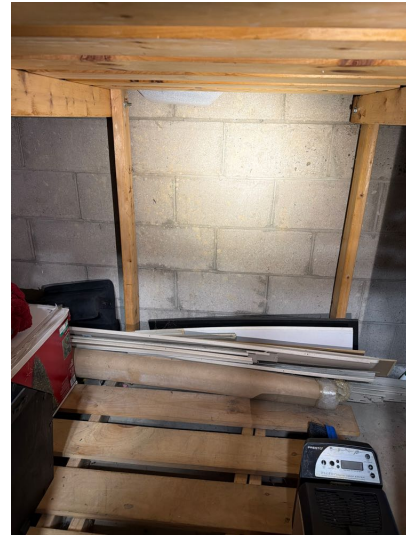
#### 2. Moisture or Dampness

| Garage | | |
|---|---|---|
| Page 22 Item: 2 | Moisture or Dampness | <ul style="list-style-type: none"> <li>There is efflorescence or staining on the basement or lower level walls, which is caused by moisture intrusion. This in our area is not uncommon, however, it should be controlled. The exterior grading around the house should be built up to slope away from the house at a drop of 5 inches over 5 feet. As with most basements, you should know that future moisture penetration is possible.</li> </ul> |

- In this basement, there is a float-activated sump pump. It was tested and found to be functional. I recommend asking the current homeowner for more information on this system such as date of install, location and distance covered by a french-drain or system serving the sump pit, and also if there is a current warranty.
- There is efflorescence or staining on the basement or lower level walls, which is caused by moisture intrusion. This in our area is not uncommon, however, it should be controlled. The exterior grading around the house should be built up to slope away from the house at a drop of 5 inches over 5 feet. As with most basements, you should know that future moisture penetration is possible.

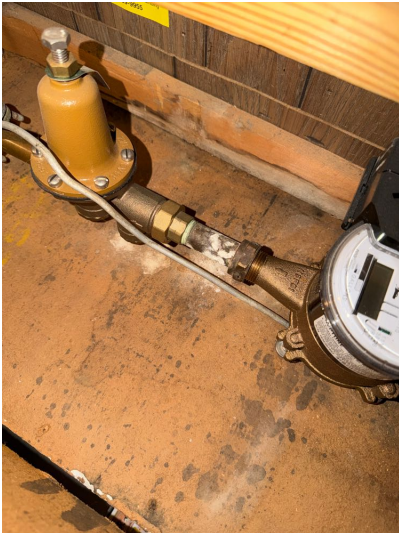
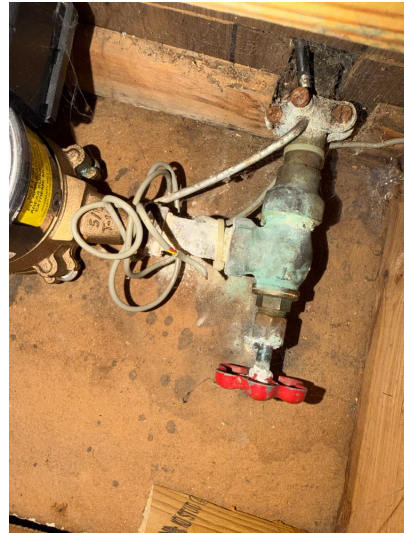
## 3. Water Pipe Condition

- The plumbing components are older and there are signs of aging and corrosion. Repairs should be expected in the future.

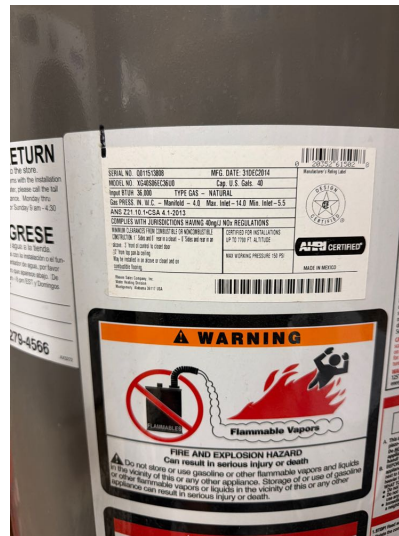
- Hot water is provided by a 12 year old, 40 gallon gas water heater that is located in the basement.

- The combustion chamber in the gas water heater is clean, and there is no evidence of leaks. However, it is beyond its design life and should be monitored for replacement.

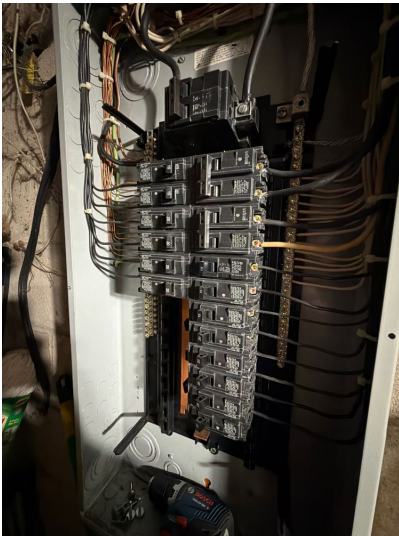
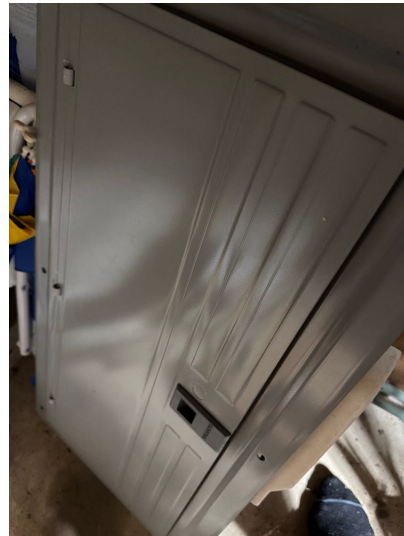
| Garage | | |
|---|---|---|
| Page 29 Item: 4 | Main Panel | <ul style="list-style-type: none"> <li>The main electrical panel is not an original installation and has no inspection sticker on it. This panel should be inspected by an electrical inspector.</li> </ul> |

- The main electrical panel is not an original installation and has no inspection sticker on it. This panel should be inspected by an electrical inspector.
