**181 Macek Dr**  
**RE: Pittsburgh, PA 15227**  
**Inspection #: 527-102025-6578**

### HOME INSPECTION REPORT

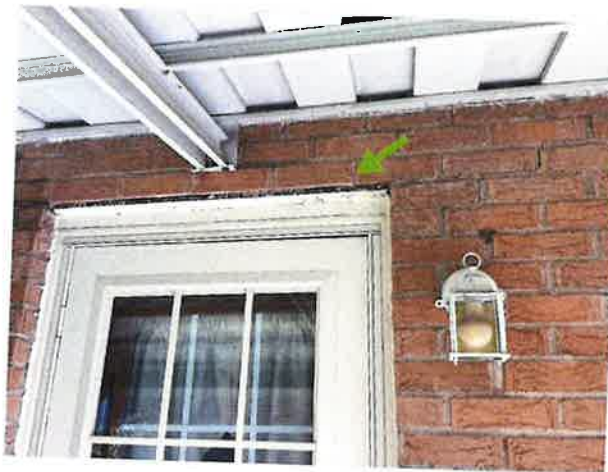
One or more of the steel lintels above the windows on the exterior of the home were noted to be rusting. Lintels support masonry materials above doors and windows. Keeping the lintels sealed and painted will prevent rusting and expansion. Expanded lintels can lead to cracks in the masonry on the exterior of the home.

Recommend sealing

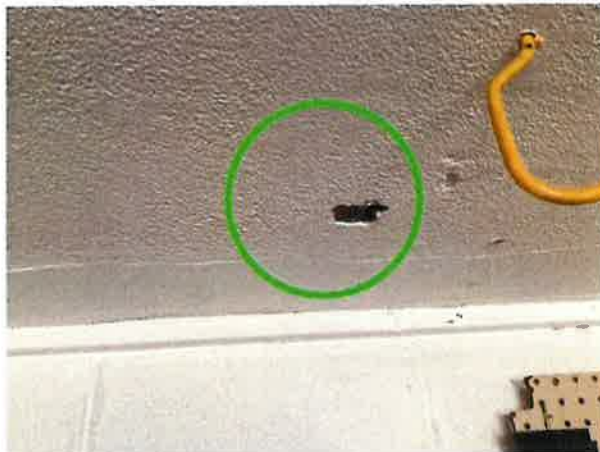
provide a barrier between the garage and living space in the event of a fire. One or more openings were noted in the garage ceiling. Repairs should be made to the ceiling to maintain the integrity of this important safety feature.

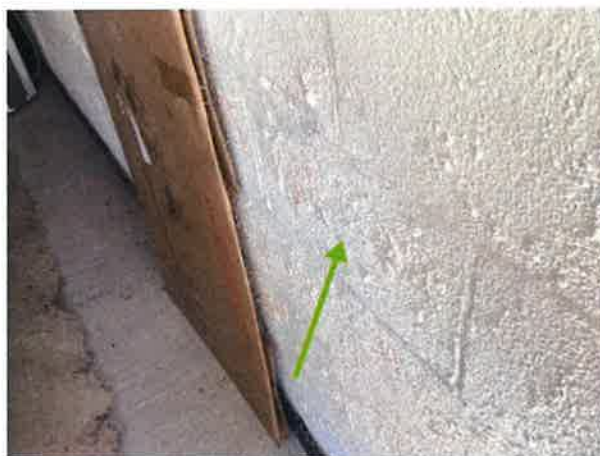
There were signs of moisture on the right garage wall. The area was dry at the time of the inspection. Dampness on garage walls is not always a sign of water intrusion. The dampness can be the result of warm humid air making contact with cool walls. In many cases the humid air condenses on the wall and forms a layer of moisture. It is important to assess whether moisture on the walls is the result of water intrusion or condensation. In this case, the efflorescence noted on the wall appears to be the result of moisture buildup on the exterior side of the foundation. The exterior grading in the affected area is questionable. Many water intrusion problems can be controlled by improving the drainage on the exterior of the home. It is important that all roof drainage and surface water is directed away from the foundation. Any concern about this condition should be referred to a qualified contractor for evaluation and recommendations.

Efflorescence

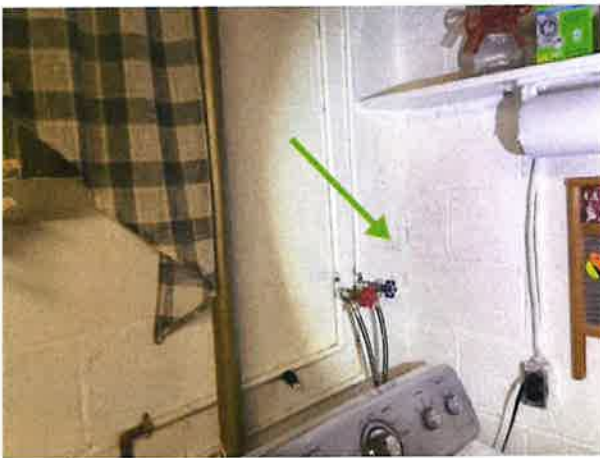
Laundry room left rear

There were signs of moisture on the front and left basement walls. The area was dry at the time of the inspection. Dampness on basement walls is not always a sign of water intrusion. The dampness can be the result of warm humid air making contact with cool walls. In many cases the humid air condenses on the wall and forms a layer of moisture. It is important to assess whether moisture on the basement walls is the result of water intrusion or condensation. In this case, the efflorescence noted on the wall appears to be the result of moisture buildup on the exterior side of the foundation. The exterior grading in the affected area is adequate. Many water intrusion problems can be controlled by improving the drainage on the exterior of the home. It is important that all roof drainage and surface water is directed away from the foundation. Any concern about this condition should be referred to a qualified contractor for evaluation and recommendations.

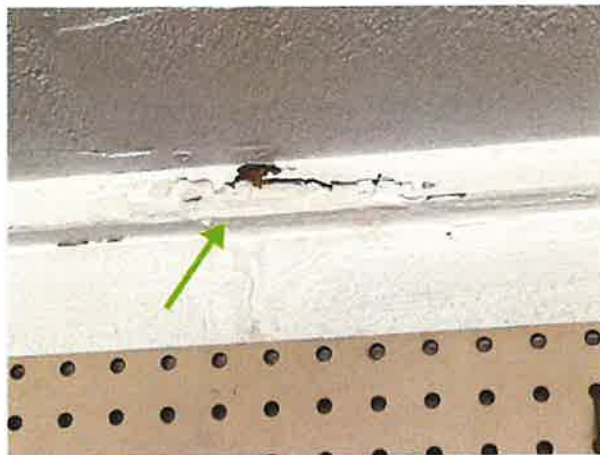
Garage back wall

Evidence of termite activity was noted on the sill plate. The visible damage noted was insignificant and did not appear to have any structural significance. Repairs to the affected area (s) did not appear to be necessary. Please note too that any assessment as to the extent of damage caused by termites is limited to the visible and readily accessible areas of the home. We are not able to determine the presence or extent of concealed damage.

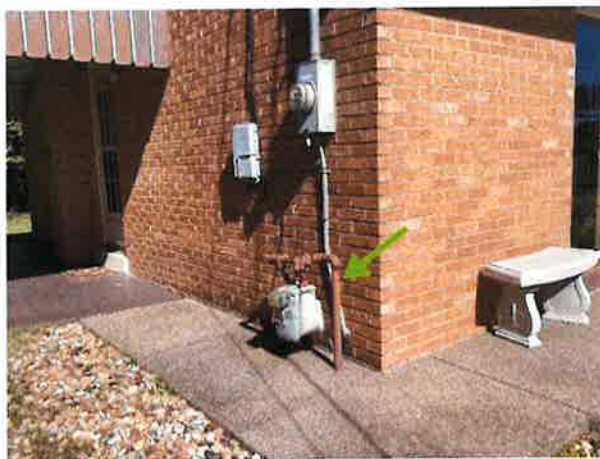
The exterior gas supply lines were *rusted*. *No leaks were found*. We recommend the gas supplier be contacted to inspect further.

Rust

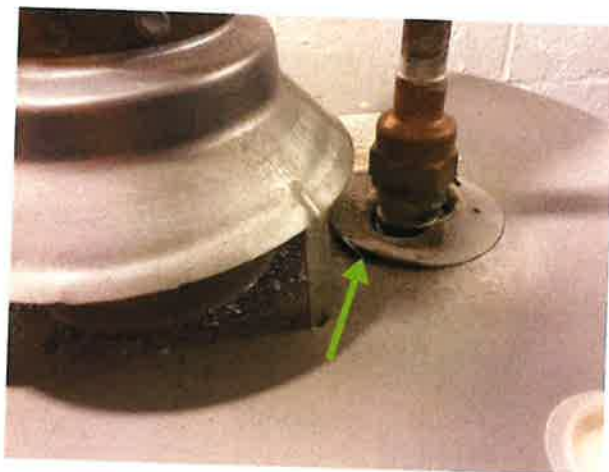
Evidence of backdrafting was noted on the water heater. The visible evidence consisted of melted plastic at the inlet and outlet tubes. The water heater did have an adequate draft at the time of the inspection. Environmental conditions can affect the proper draft of the heater, causing differing symptoms. Consult with a qualified plumber for further evaluation.

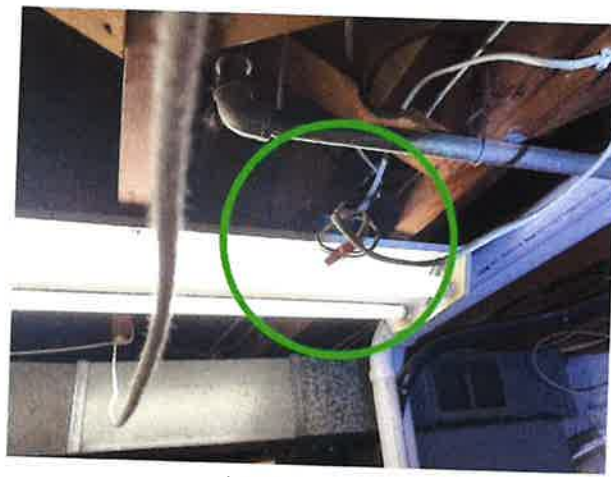
Laundry room

Open electrical splices were noted in the basement. All electrical splices should be enclosed in an approved and covered electrical box. Electrical related repairs should be performed by a qualified electrician.

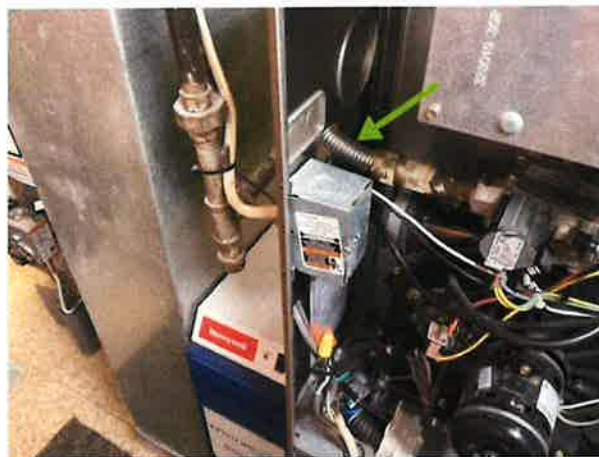
The gas line leading to the furnace consists of flexible pipe passing through the metal furnace cabinet. The gas piping that passes through the cabinet wall should consist of hard pipe. Consult with a qualified plumber for repair.

Should be solid pipe
