**762 Lebanon Ave**  
**RE: Pittsburgh, PA 15228**  
**Inspection #: 527-072026-6971**

### *HOME INSPECTION REPORT*

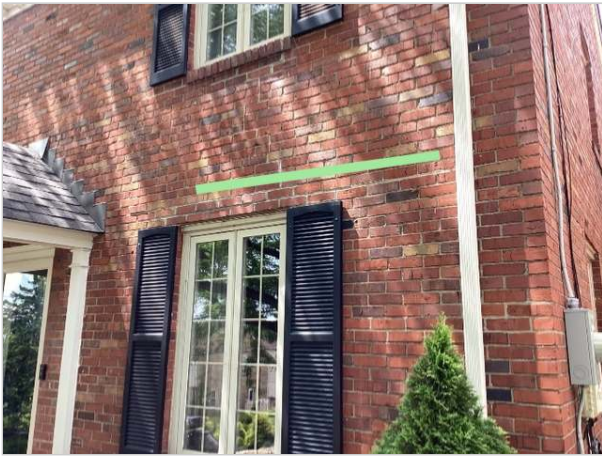
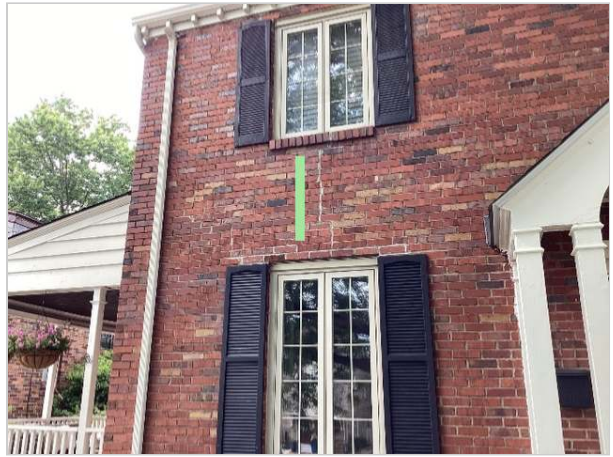
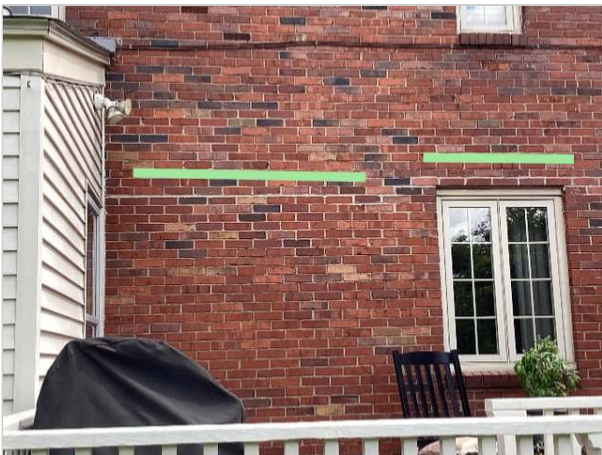
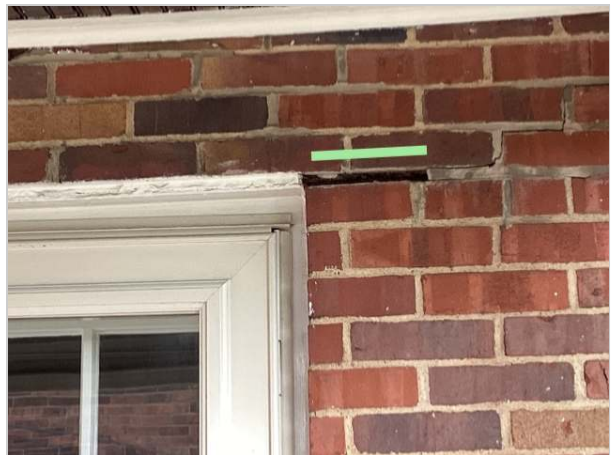
One or more of the steel lintels above the windows on the exterior of the home were noted to be rusting. Lintels support masonry materials above doors and windows. Keeping the lintels sealed and painted will prevent rusting and expansion. Evidence of adequate repairs were noted in most areas. Expanded lintels can lead to cracks in the masonry on the exterior of the home.

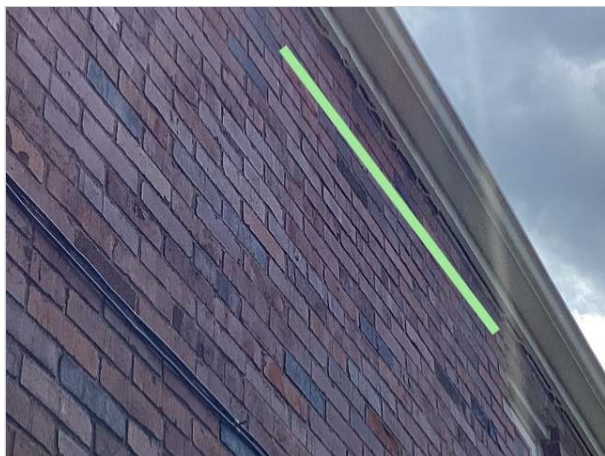
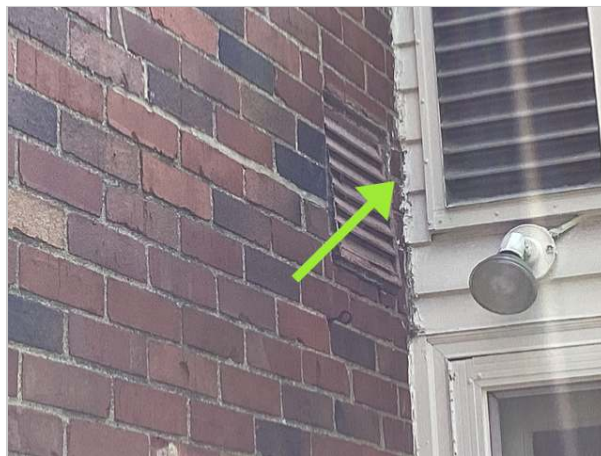
The exterior caulking around the several areas is cracked or missing on the back of the home. The caulking should be replaced to ensure the exterior of the home remains weather and water tight.

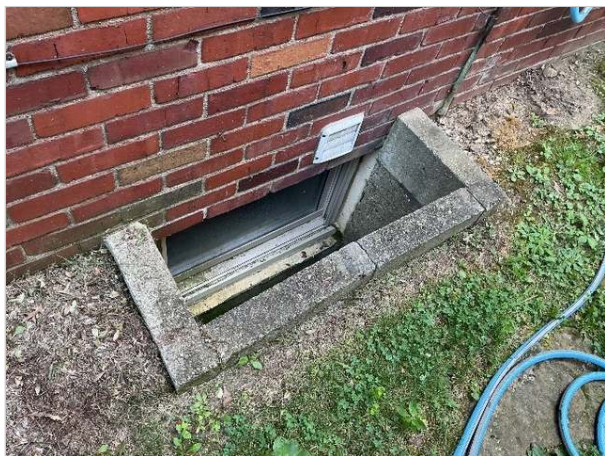
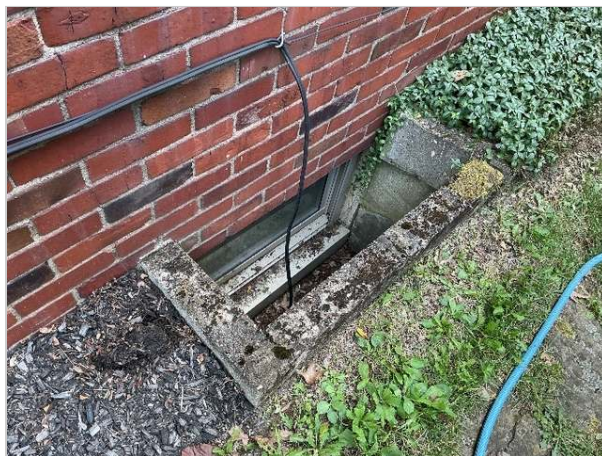
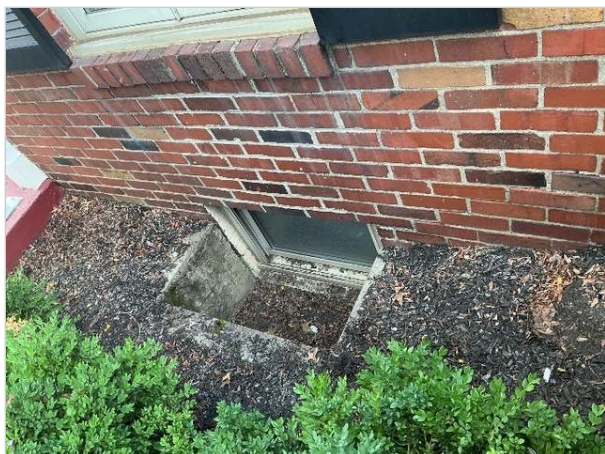
There is no barrier installed at the window wells. The absence of a proper rail or barrier constitutes a fall hazard and should be corrected. Consult with a qualified contractor for installation of a proper barrier.

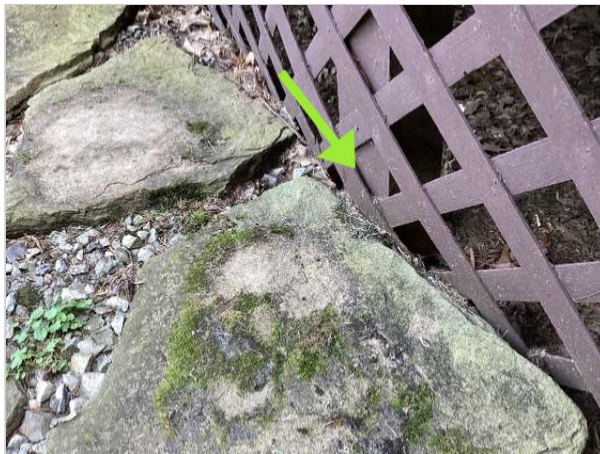
The *deck* support post(s) are making direct contact with the landscaping. Common practice is to mount support posts on concrete piers. The post is an important structural component and should be monitored for deterioration. A qualified contractor should be contacted for further evaluation and recommendations if desired.

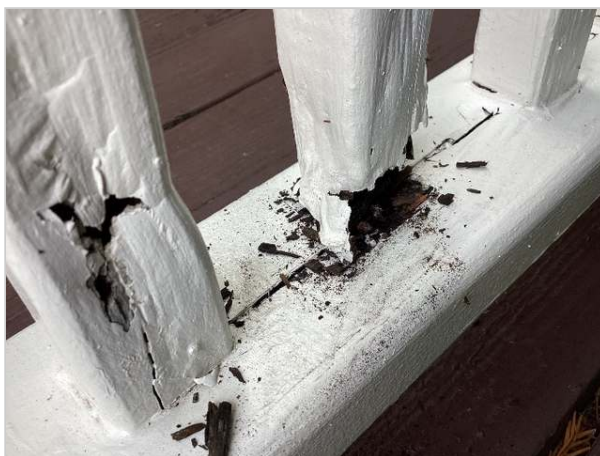
Rotted wood was noted on the deck rail . The areas should be repaired and sealed by a qualified contractor.

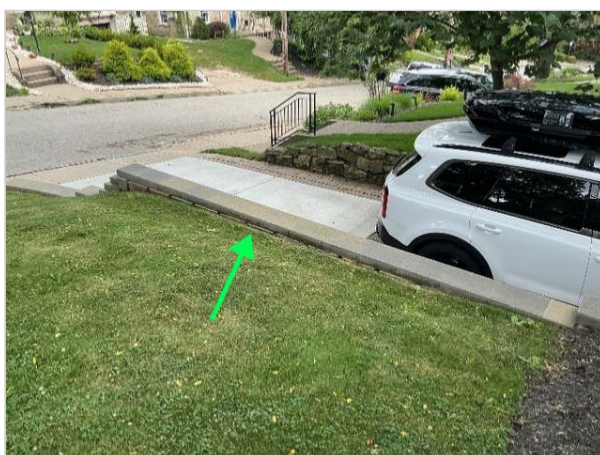
There is no barrier installed on the left retaining wall. The absence of a proper rail or barrier constitutes a fall hazard and should be corrected. Consult with a qualified contractor for installation of a proper barrier.

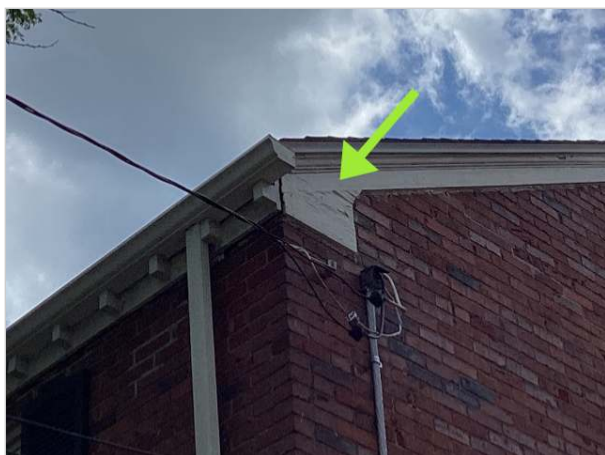
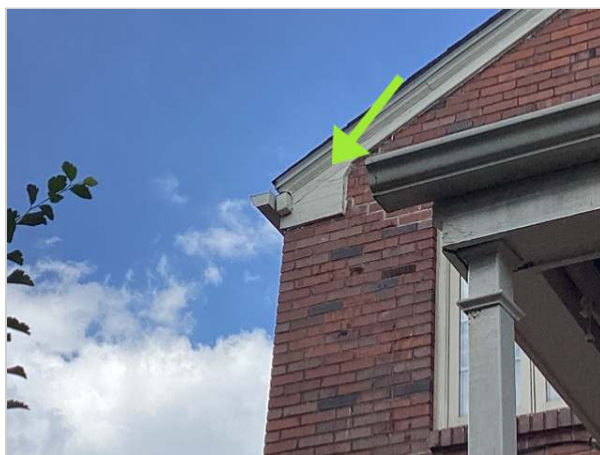
Peeling paint was noted on one or more areas of the exterior. In order to preserve the life of the exterior surfaces and materials, all areas should be scraped and painted.

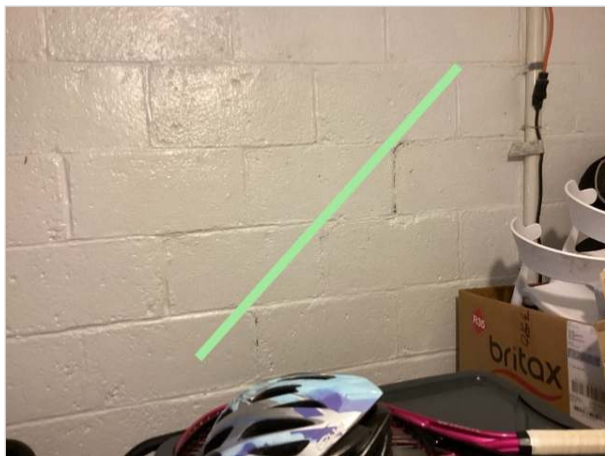
Garage

One or more cracks were noted on the foundation walls. The cracks were located on the left side. The cracks appear to have been caused by settlement. There was no evidence of active movement at the time of the inspection. Corrective action did not appear to be necessary. All cracks should be monitored for significant changes in characteristic. Consult with a contractor if the cracks change significantly or you desire another opinion on this condition.

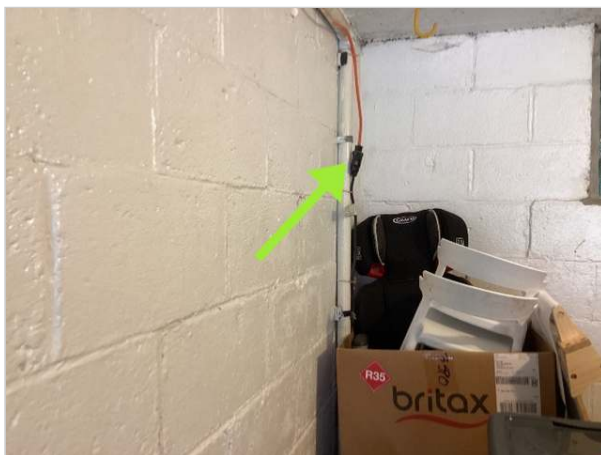
The sump pump is not properly wired. The pump should be connected to a permanently wired, grounded outlet that is located close to the sump. Consult with a qualified electrician for installation.

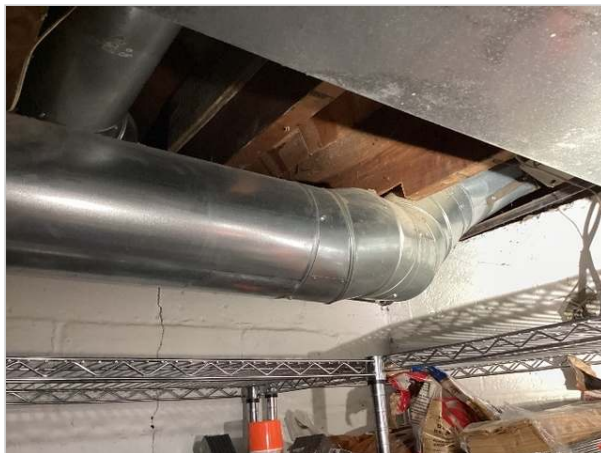
Joist number 2 as counted from the rear has been notched. This action has compromised the integrity of the joist. Consult with a qualified contractor for evaluation and recommendations.

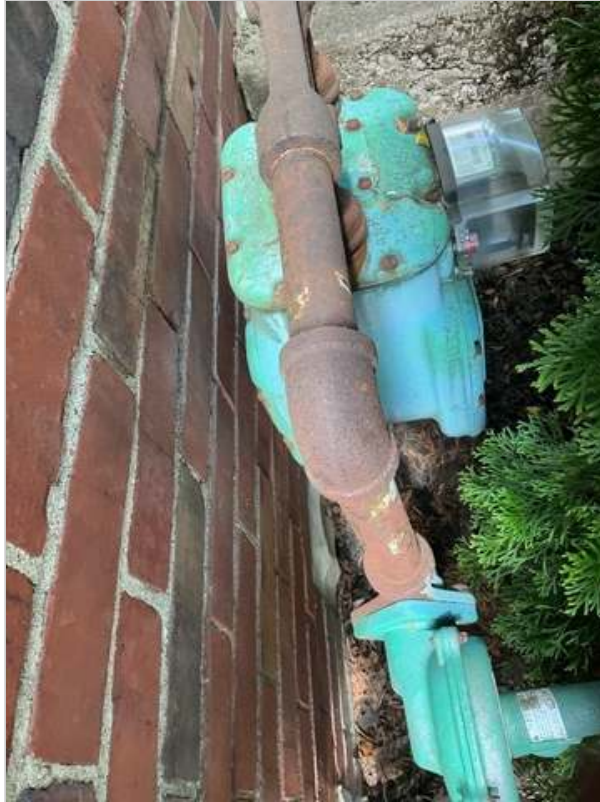
The exterior gas supply lines were *rusted*. *No leaks were found*. We recommend the gas supplier be contacted to inspect further.

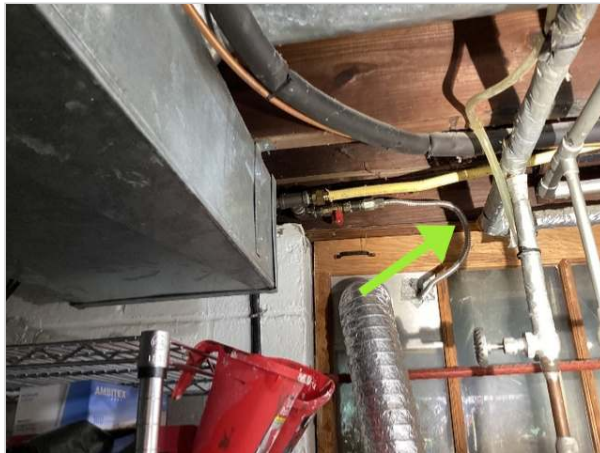
Some of the gas appliances in the home are plumbed with soft copper tubing. The tubing was observed on the gas line (s) feeding the fireplace. This may or may not be an issue based on the local jurisdiction. Some areas permit the use of soft copper tubing while others do not. Consult with a qualified plumber for further evaluation and recommendations.

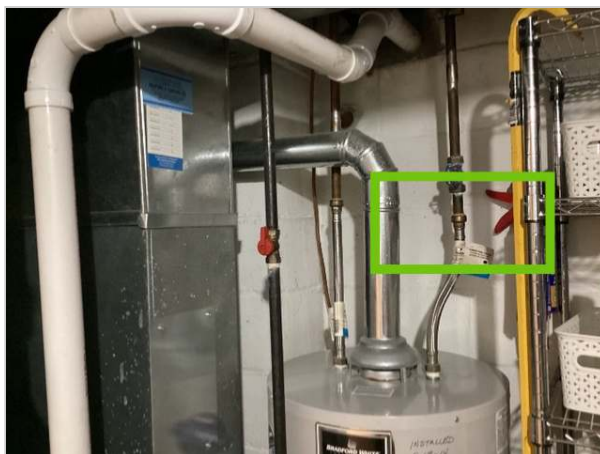
There is no expansion tank installed on the water heater. Expansion tanks relieve excessive pressure in the plumbing system and help lengthen the life of the water heater. These devices are installed on most newer water heaters. We recommend consulting with a qualified plumber for installation of an expansion tank. Depending on the terms, the lack of an expansion tank could affect any remaining manufacturer's warranty on the water heater.

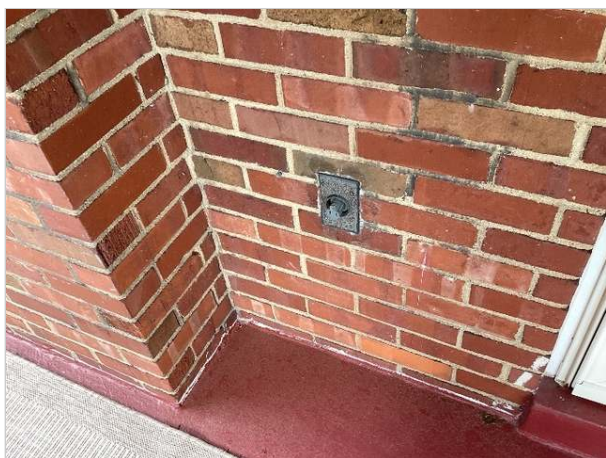
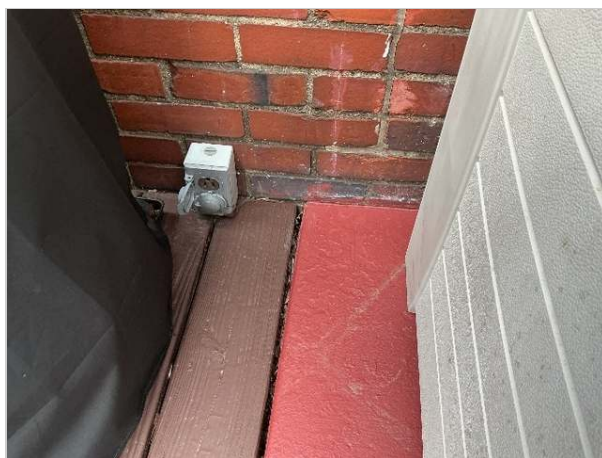
Two prong outlets were found in one or more locations in the home. At the time this home was constructed, two-prong outlets were the standard construction. Two-pronged outlets were not grounded (open-ground), and are considered to be outdated by today's standards. In many cases, the outlets can be easily upgraded to three-prong type. In cases where the outlets cannot be easily upgraded, the installation of GFCI's in kitchens, baths, garages, basements, outdoor receptacles, and any other high-risk areas, will increase the overall safety of the electrical system. A qualified electrician should be consulted when working on or updating the electrical system in your home.

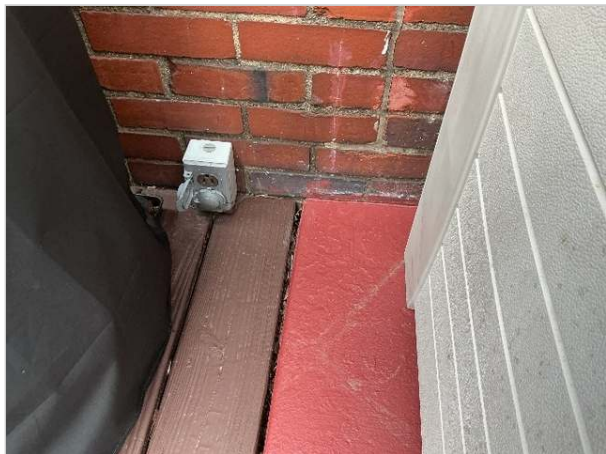
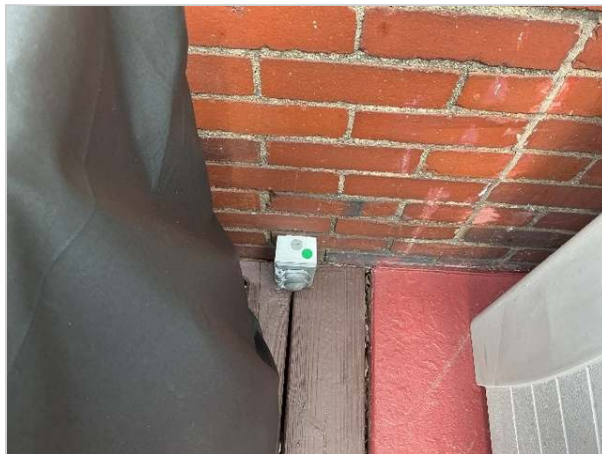
One or more three prong type outlets in the home tested as having an open ground. This means that the third prong, also known as the ground prong is not doing its job. This is usually caused by a missing ground connection at an electrical device in the circuit. This condition is usually easily correctable by an electrician. Open grounds in wet locations is considered a safety issue and should be corrected. The outlets that tested with this condition were marked with a "GREEN" dot for easy identification. The affected outlets were located in the deck left side. Please note that we only test outlets that are visible and readily accessible at the time of the inspection.

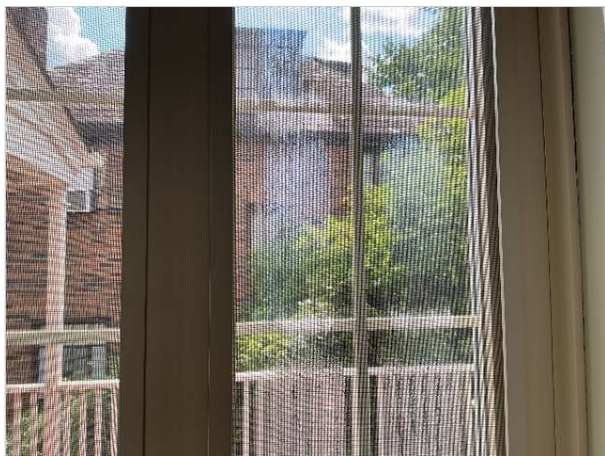
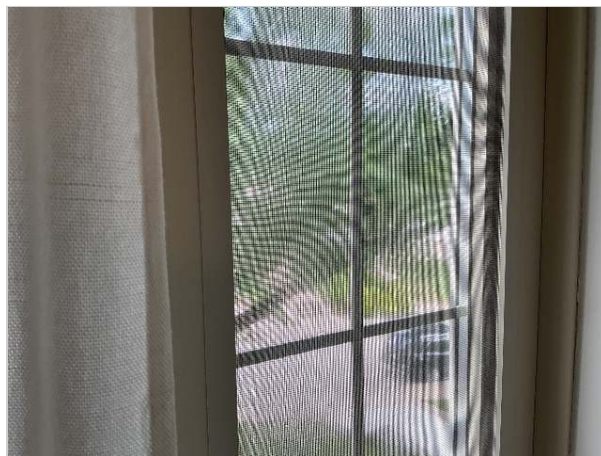
One or more of the insulated window panes throughout the home had a defective thermal seal. The window (s) were located in the living room. A defective thermal seal can be identified when fogging is observed between the panes of glass. This statement should not be considered all inclusive. Our ability to identify defective thermal seals is affected by dirty glass, the angle by which we can view the windows, window coverings and the direction of the sun. It is not possible to identify mild cases of fogging between glass panes given the conditions that affect our view. Repair of the thermal seal can be accomplished by replacing the affected glass panel.

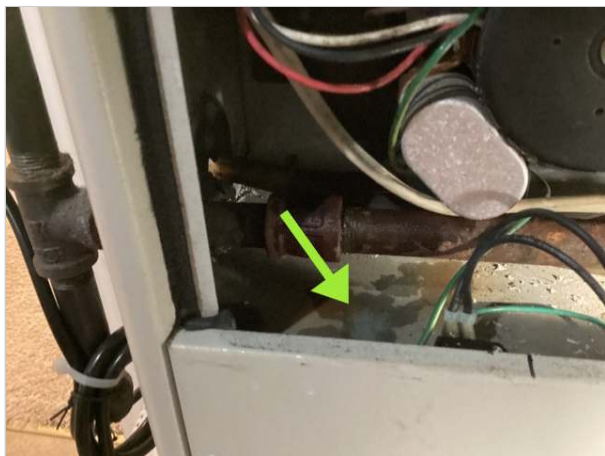
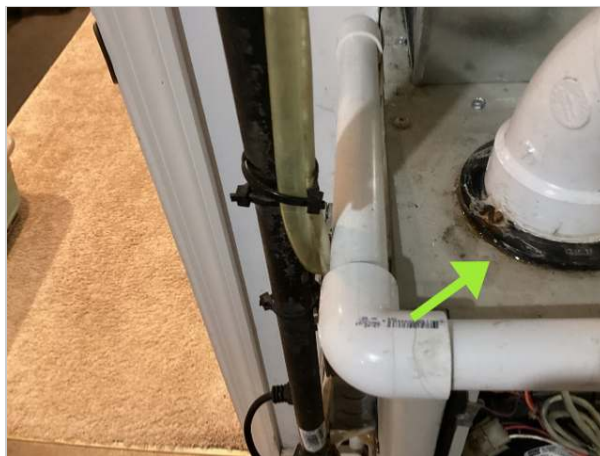
Water was noted inside the furnace compartment. The condition is most likely caused by a condensate leak in the furnace and/or air conditioning condensate drain lines. The water can also be caused by a leaking humidifier if one is installed. Water inside the furnace compartment can damage the furnace cabinet or other operational components and should be repaired. The furnace compartment was wet at the time of the inspection. Consult with a qualified heating contractor to determine the source of the water and correct the issue. Please also note that due to the seasonal use of heating and air conditioning systems, wet and dry conditions can change based on whether the inspection is performed during the heating or cooling season. The observation at the time of the inspection can be limited to seasonal conditions.
