306 Fourth Ave
RE: Pittsburgh, PA 15222
Inspection #: 527-092024-5903

HOME INSPECTION REPORT

The following notable items were observed during the inspection performed at 306 Fourth Ave Apt 501, Pittsburgh, PA 15222:

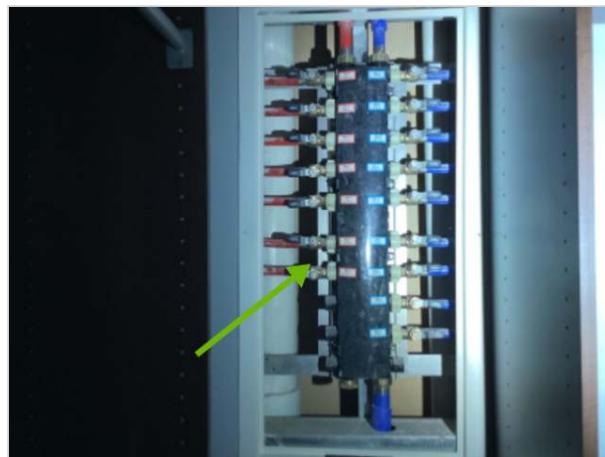
Shutoff manifold

The water service is provided by the building supply. The shut offs are in the main bedroom closet. Since it is the buyers right to have all utilities operable for the home inspection, we will attempt to turn the main water valve on for the inspection. The HomeTeam is not responsible for leaks caused by operating the valve.

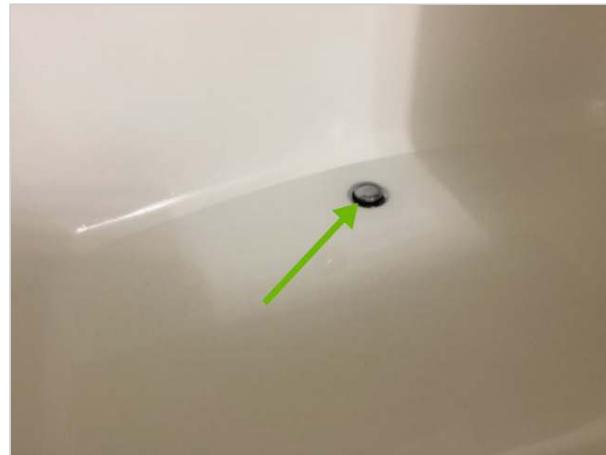
- Full bath tub stop and waste valve is inoperable.

Minor plumbing issues were noted during the inspection. This is not intended to be an all inclusive list. Concealed, latent or intermittent plumbing issues may not be apparent during the testing period. Consult with a qualified plumber for further evaluation and repairs as required.

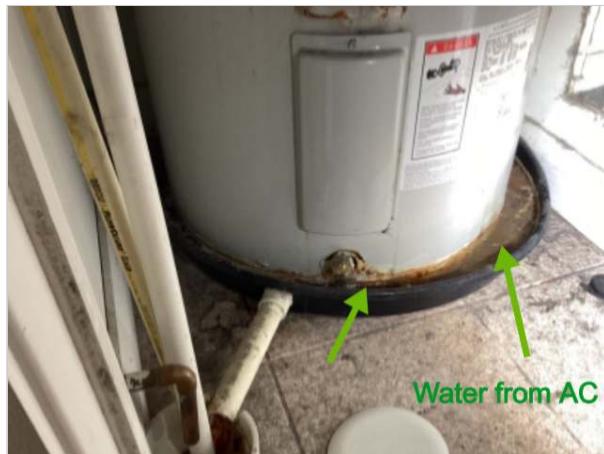
Rust

The water heater base is rusted. This could lead to failure. Consult with a qualified contractor for repair.

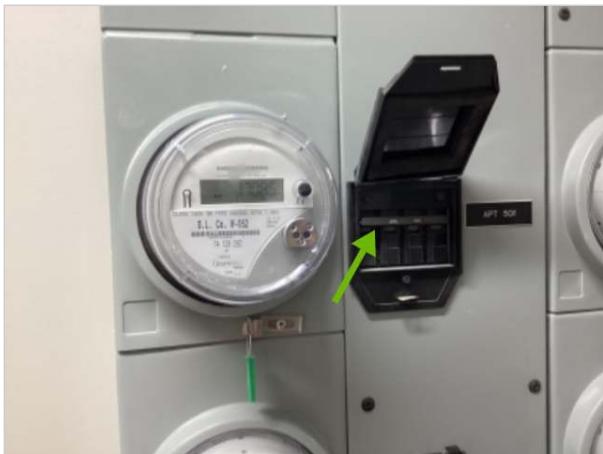
Disconnect

An electric service sub-panel was located on the bedroom wall, and was manufactured by General Electric. The service disconnect switch for this panel was located at the meter stack, and was rated at 200 amps. The branch circuits within the panel were copper. These branch circuits and the circuit breaker to which they were attached appeared to be appropriately matched. The visible wiring consisted primarily of the Romex type and appeared to be in good condition.

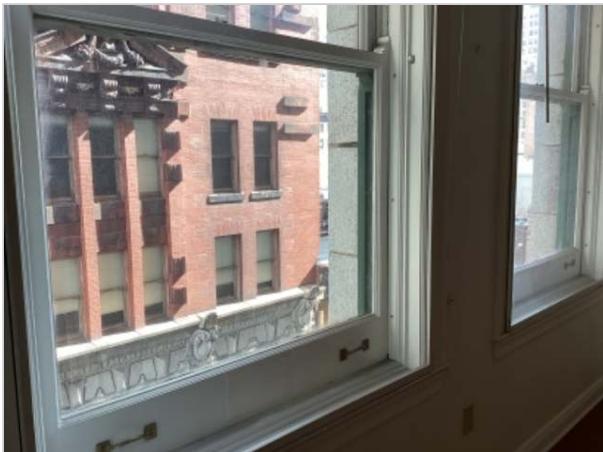
One or more of the windows were covered with plastic. This is generally done to prevent wind and draft intrusion. The plastic prevents opening of the windows. Consequently, we could not test any plastic covered windows for proper operation. Consult with the current property owner for information on the condition and operation of the windows.

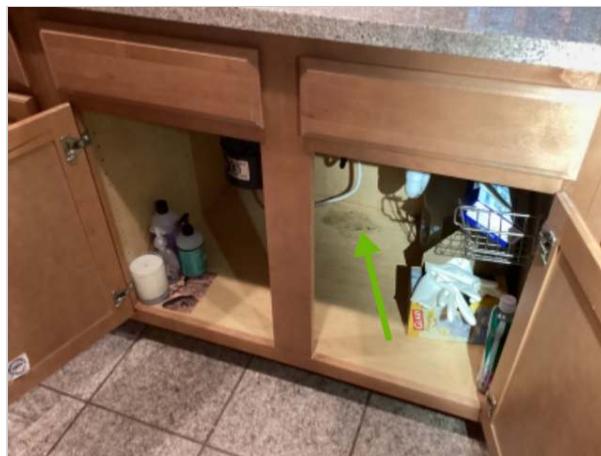
The kitchen sink base cabinet is water damaged from leaks. Repairs should be made to the cabinet.

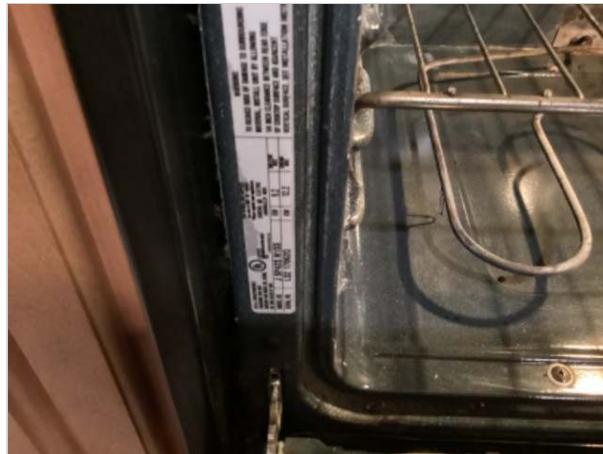
Newer ranges include an anti-tip bracket designed to provide protection when excess force or weight is applied to an open oven door. The bracket is not visible or readily accessible since it is usually installed beneath a rear foot. Applying excessive force on the oven door can damage the hinge or spring so, we do not confirm the presence of a bracket. HomeTeam recommends that anti-tip brackets be installed on all free-standing ranges.

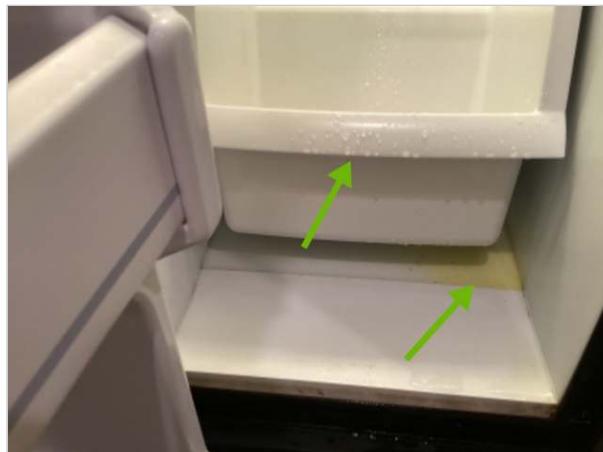
A leaky ice maker fitting was noted on the refrigerator in the kitchen. Consult with a qualified plumber for repair.

Water dripping

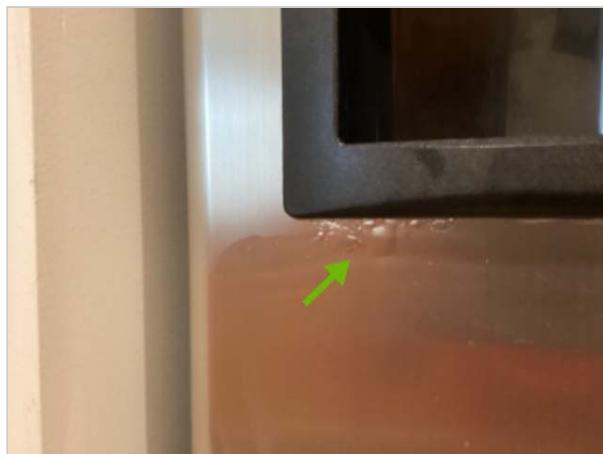
The cladding on the refrigerator was damaged. Evaluation and repair should be made by a qualified contractor.

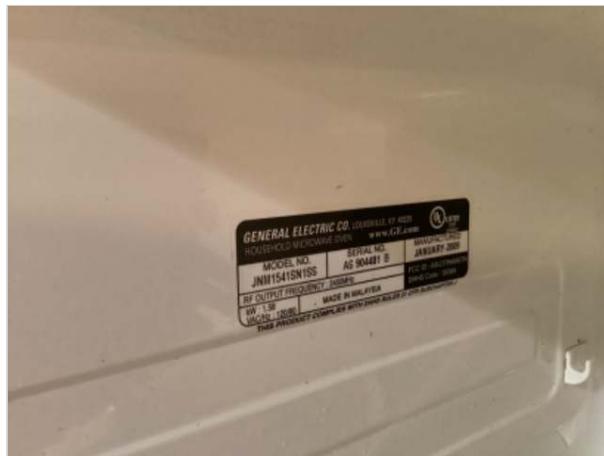
The surface light would not light. Consult with an appliance repair service.

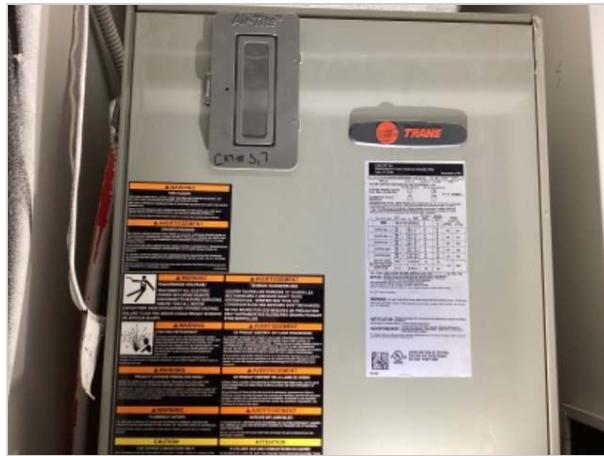
Termination of HVAC condensate lines was raised above the floor drain or drain inlet. The condensate lines were not trapped. HVAC condensate lines must be trapped and not in contact with wet drain inlets to prevent the possible migration of bacteria and mold into the air-handling system. The system was not tested due to ice buildup. The unit does not appear to have been recently serviced. It is recommended that the furnace be cleaned and serviced by a qualified contractor upon taking ownership of the property. The furnace should be serviced annually to maintain safe and efficient operation.

The furnace was not tested due to concerns of water damage from ice build up on coil. Consult with a qualified heating contractor for evaluation and repair.

We recommend a pan and secondary condensate drain be installed under the heating unit. Efforts should be made to ensure the condensation is directed into a proper drain.

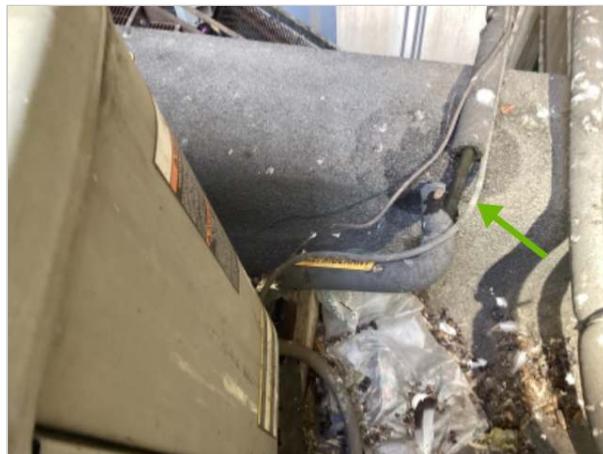
The insulation on the exterior air conditioning line set is damaged. This could affect the efficiency of the system and should be replaced.

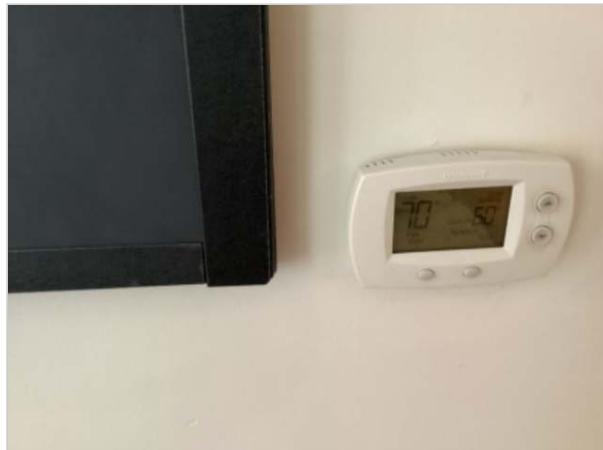
The control for the heating and air conditioning system was a 24 volt thermostat located on the living room wall of the home. The thermostat was manufactured by Honeywell and was found to be in working order.
